**Legislative Council Panel on Home Affairs
Subcommittee on Heritage Conservation**

Preservation of King Yin Lei at 45 Stubbs Road, Hong Kong

**Summary of the Report on Site Investigation and Restoration Options
King Yin Lei at 45 Stubbs Road, Hong Kong**

Layout plans and relevant photos of the site to be granted to the owner of King Yin Lei for land exchange

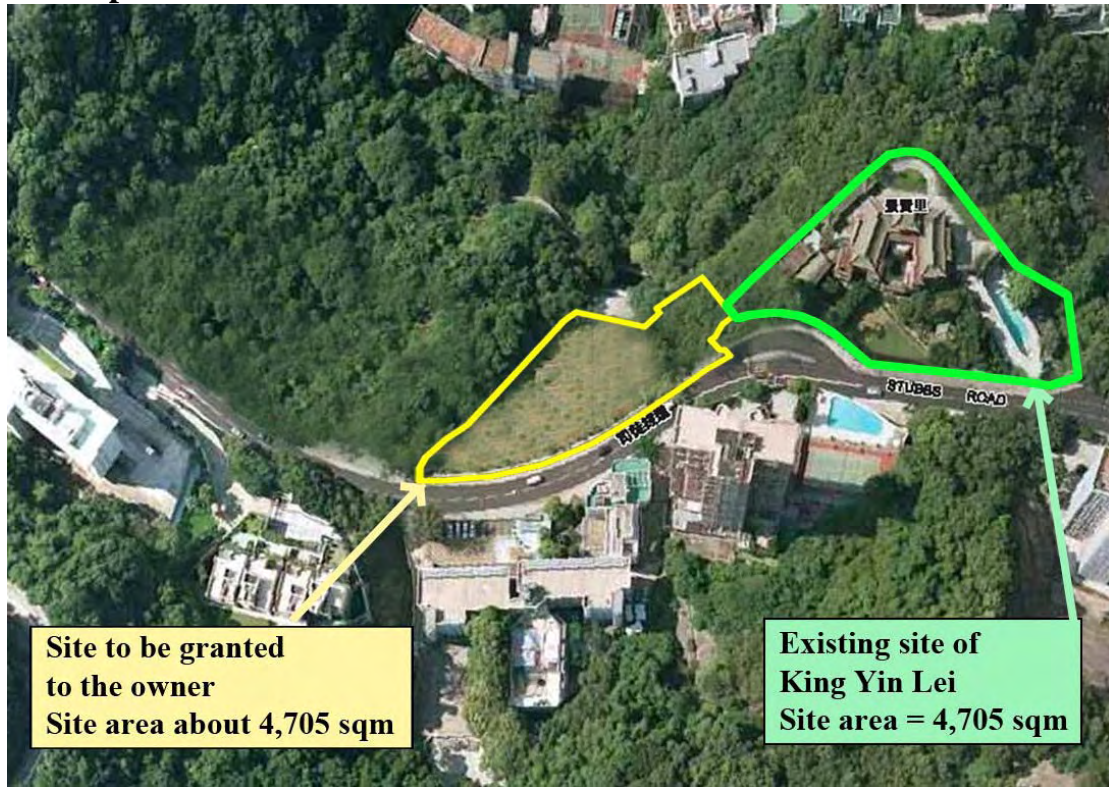
Aerial photo of the sites

7. The site we are considering granting is a man-made slope with slope stabilisation works undertaken in 2002 to the west of King Yin Lei. Although it is currently zoned as “Green Belt” under the Peak Area Outline Zoning Plan, it is a man-made slope with little vegetation. For details, please see the layout plan and relevant photos at **Annex C**.

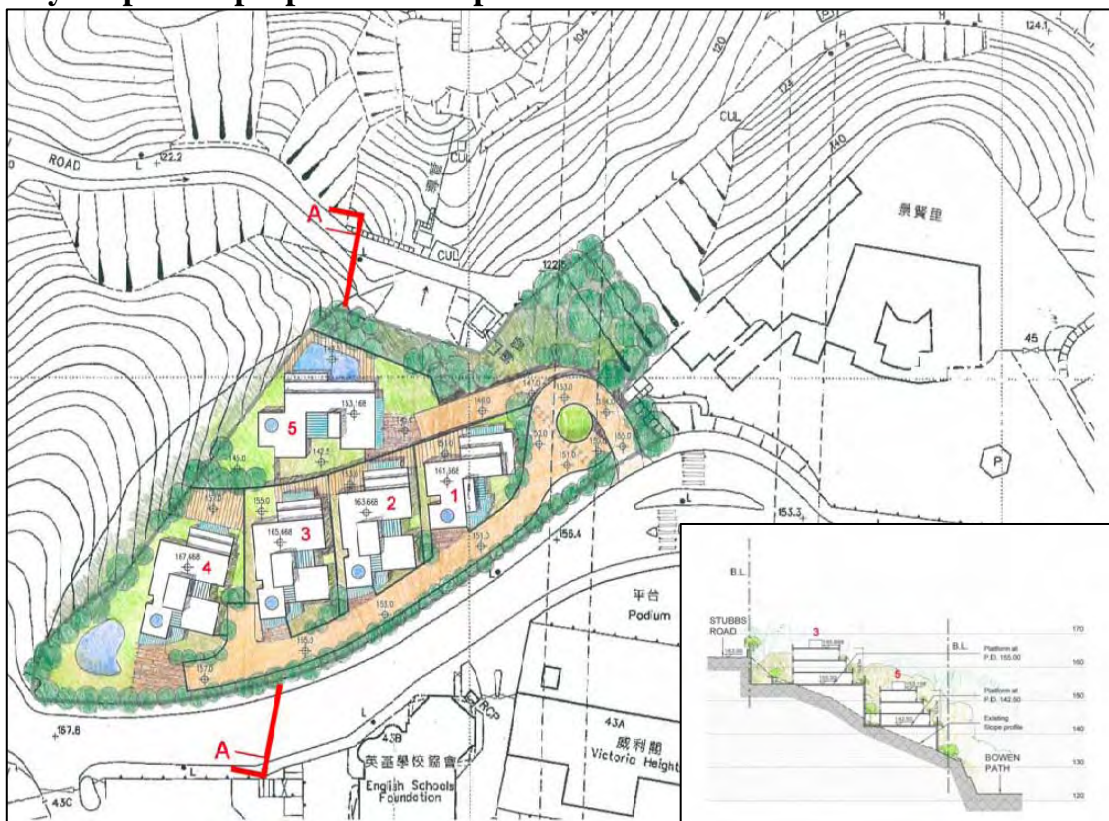
Layout plan of proposed development

8. The owner plans to construct five residential houses on the new site within the permissible plot ratio. The proposed development will not adversely affect the density, traffic load, landscape and greenery of the area or the vista of the neighbourhood. As the proposed development involves rezoning the new site from “Green Belt” to “Residential (Group C) 1”, approval from the Town Planning Board will be required. It is also subject to agreement by the concerned departments in accordance with the established procedures. We will seek approval of the Chief Executive in Council for the proposed non-in-situ land exchange in due course.

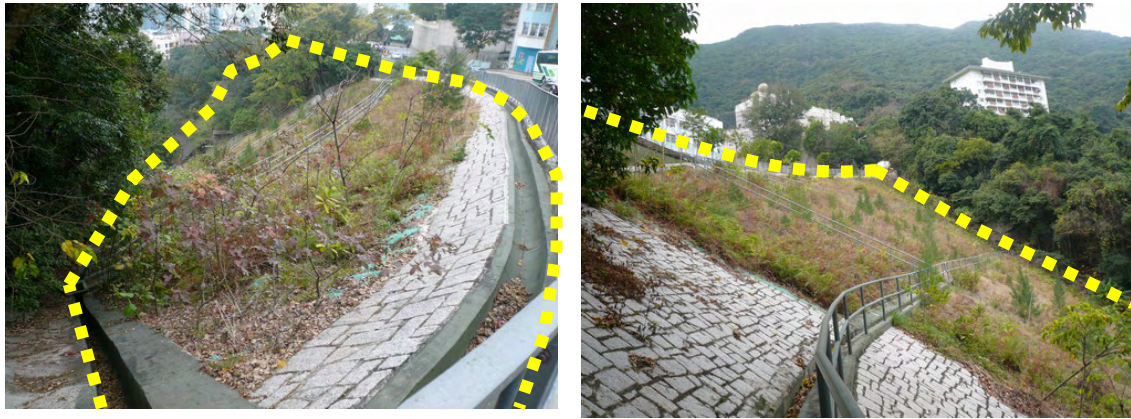
View on the man-made slope as at January 2008

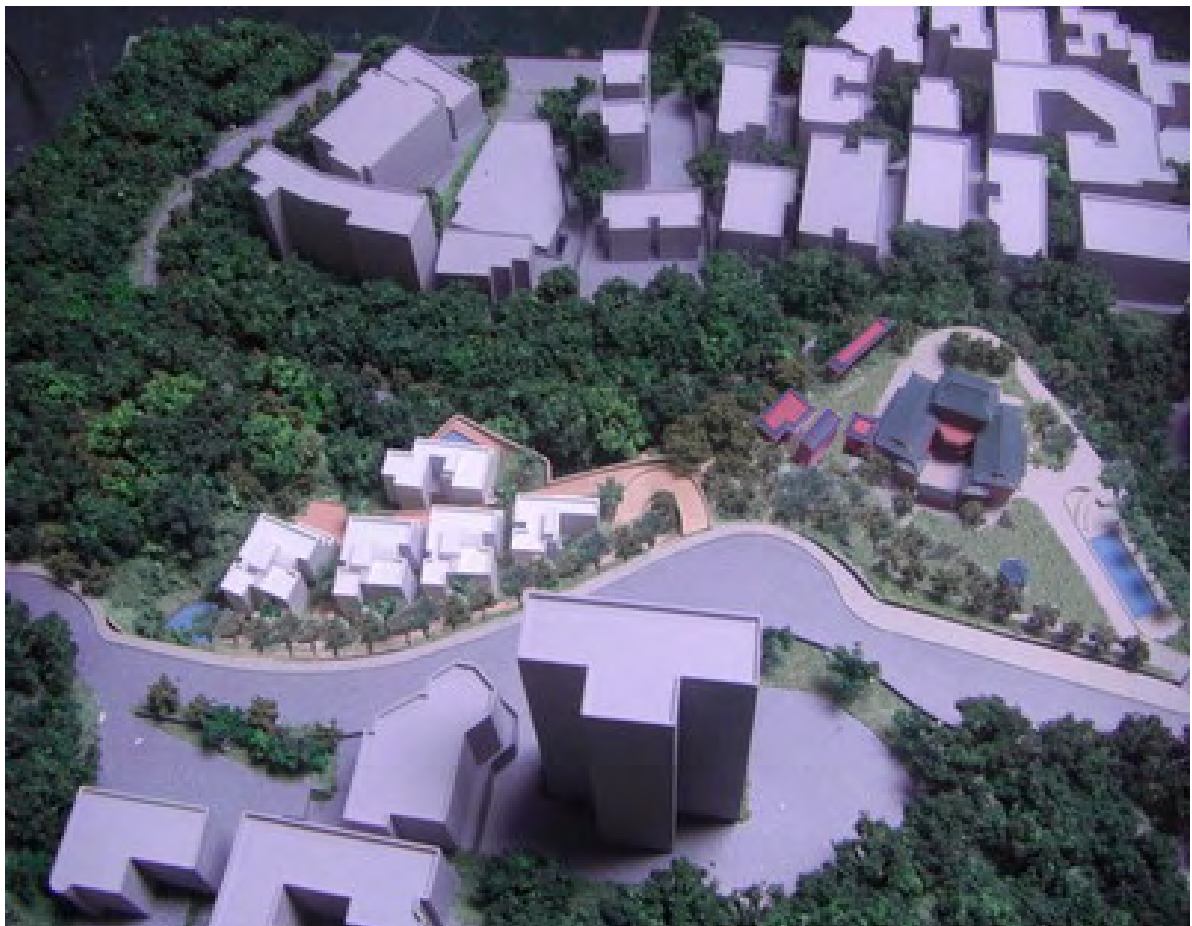
Layout of proposed development

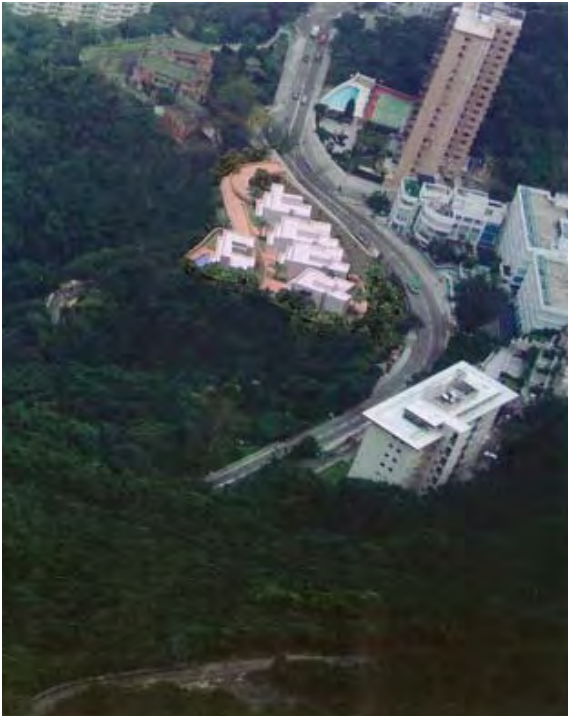
Aerial view showing new houses covering up the man-made slope without affecting view of residential and institutional buildings

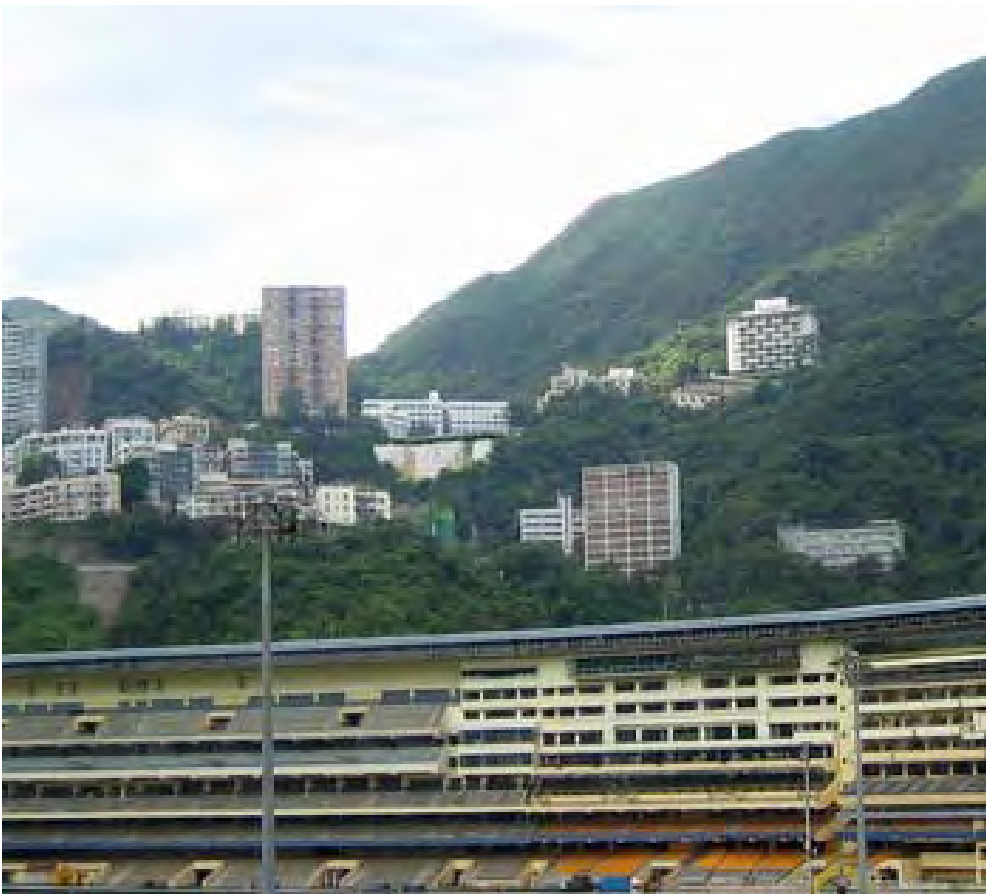
New houses helping to cover up man-made slope and enhance cityscape
