## **Legislative Council Panel on Development**

### **Policy and Matters Relating to Preservation of Historical Remains Discovered at Works Sites**

**Development Bureau  
November 2012**

# 11. Cultural Heritage Impact

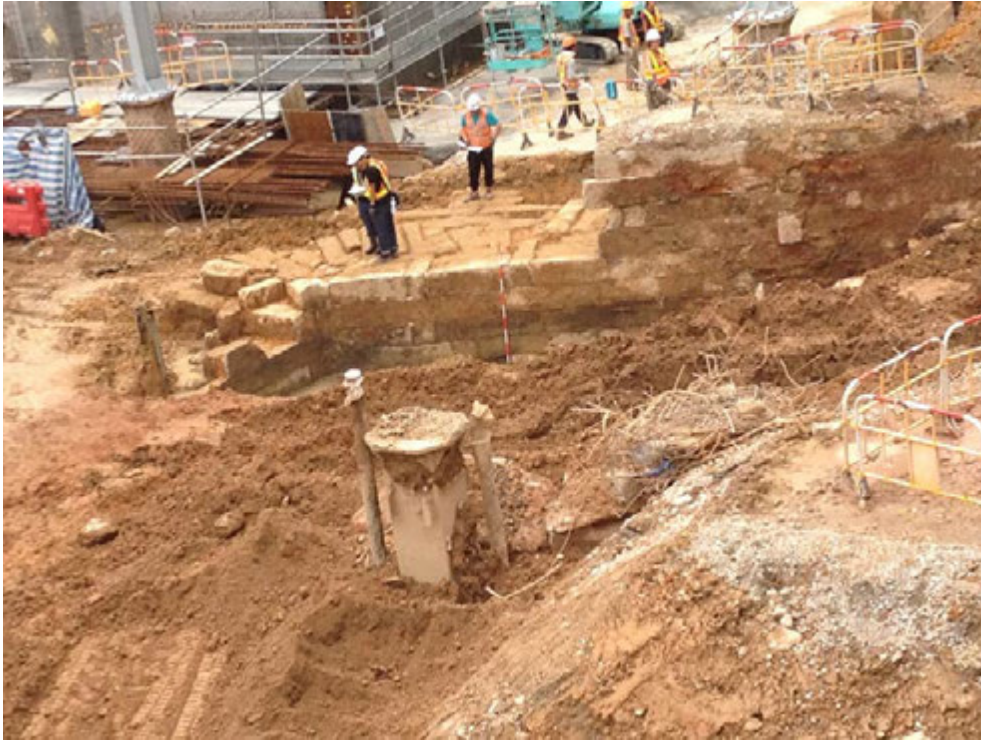
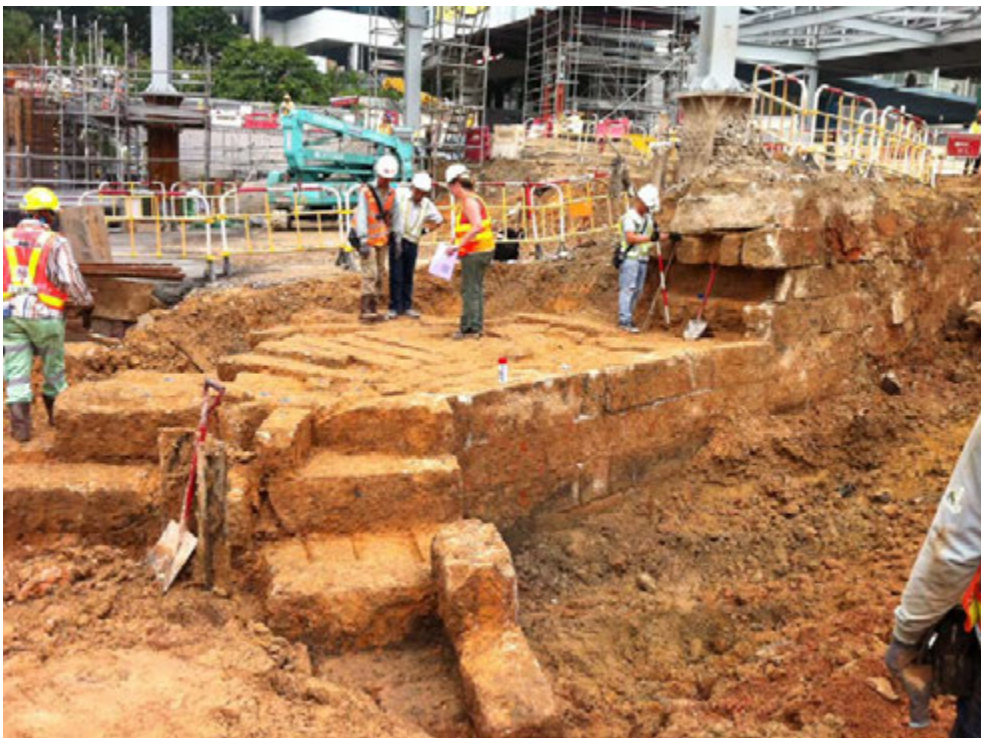
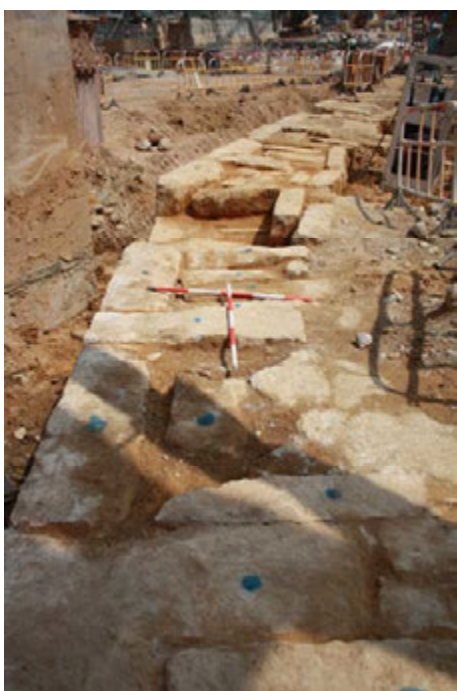
**Photos of the Remains Discovered at the Works Site  
at Harcourt Garden in Admiralty by the MTRCL**

26 September 2012	AMO's staff of the curator grade who have received professional archaeological training ("professionals of the AMO") conducted a site visit and discussed with the archaeologist commissioned by the MTRCL. Both sides agreed that the structural remains were not part of the Wellington Battery, but a fragment of the seawall of the mid-19th century, which has been damaged by various works in the early years.

<b>Time</b>	<b>Events</b>
First Half of October 2012	The archaeologist commissioned by the MTRCL considered that since the remains discovered were remains of a seawall which have been damaged by various projects in the early years, the heritage value of the remains discovered is relatively low, and since the location of the remains discovered is critical for the extension of Admiralty Station, it is not appropriate to preserve the remains discovered in-situ. The archaeologist recommended that a detailed recording such as by photography, drawing and written description be conducted. This suggestion was made in accordance with the relevant condition in the licence for the archaeological works (i.e. the archaeological watching brief should be conducted in accordance with the information submitted by the applicant when applying for the licence; and the information concerned stipulated that the applicant should consult and obtain the agreement with the AMO on the follow-up works for the materials discovered). After consideration, the AMO agreed with the above-mentioned arrangement, and suggested that some of the blocks of the seawall be salvaged for reuse and appropriate interpretation in the future. The MTRCL accepted the suggestion of the AMO, and has stored those blocks in good condition properly.

research team, as well as Dr. Kwong Chi-man, who is the Research Assistant Professor of the History Department of the Hong Kong Baptist University and has been studying military history, to the works site, and the remains were further confirmed as remains of a damaged seawall but not those of a battery.
