2012年11月27日會議  
討論文件

立法會發展事務委員會  
有關保存在地盤發現的歷史遺跡的政策和事宜

## 港鐵在金鐘夏慤花園工程地盤發現歷史遺蹟

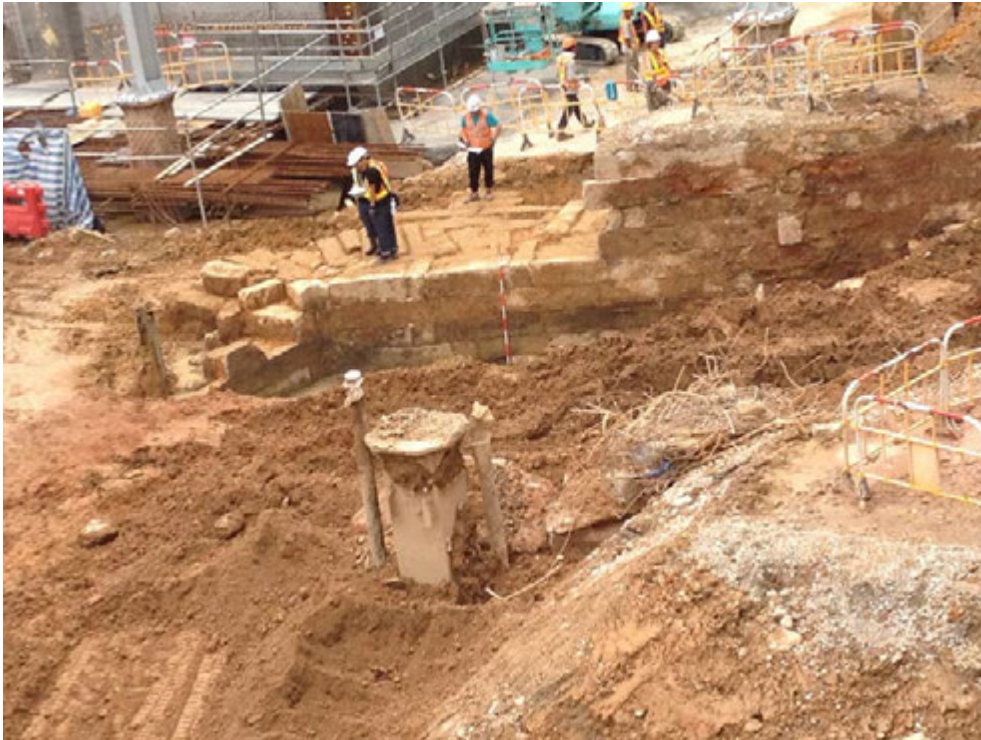
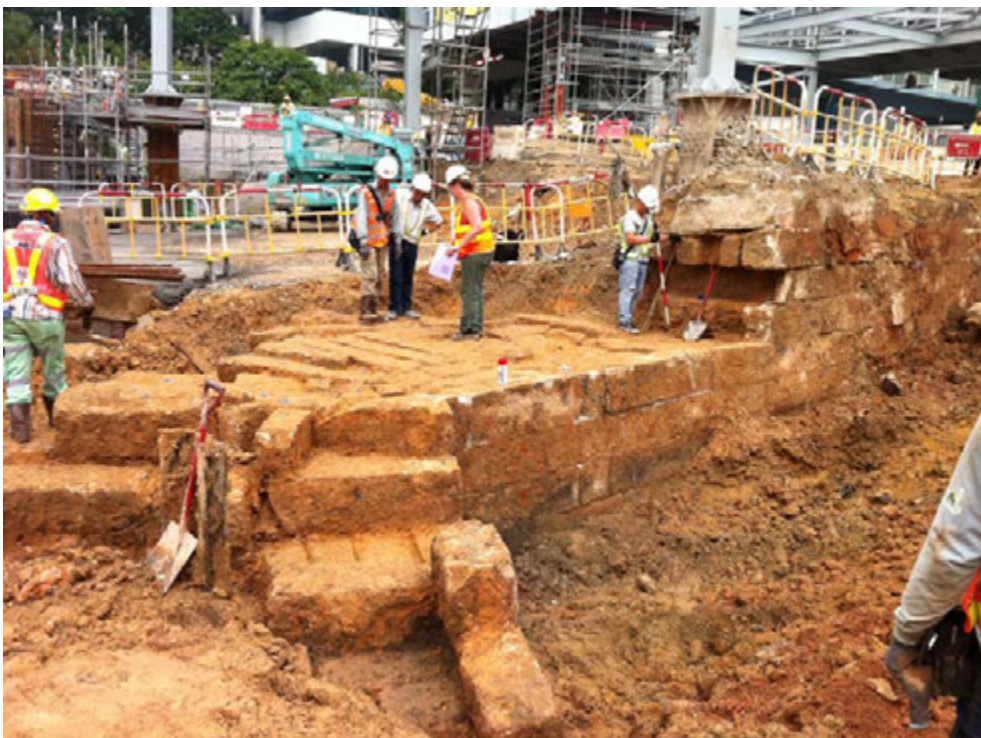
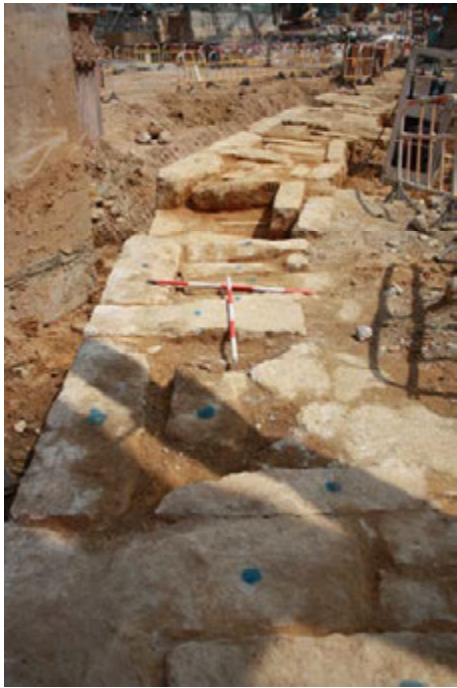
港鐵在金鐘夏慤花園工程地盤所發現的遺蹟的相片

時間	有關事項
2010年10月	根據獲批准的南港島線(東段)工程環評報告建議，港鐵須在夏慤花園工地施工期間，委聘考古學家進行考古觀察。
2011年5月	根據《古蹟條例》，港鐵委聘的考古學家（該考古學家曾多次參與香港的考古發掘）就有關考古工作向古物事務監督轄下的古蹟辦遞交牌照申請，列出考古觀察的操作安排(包括進行考古挖掘的範圍和方法，以及如有發現，會通知古蹟辦)。經古蹟辦審核，並獲得古諮會的支持下，古物事務監督向申請人發出牌照。
2011年6月	港鐵委聘的考古學家通知古蹟辦在夏慤花園工地開始進行考古觀察。期間，古蹟辦與港鐵委聘的考古學家保持溝通以了解最新情況。
2012年9月25日	古蹟辦接獲港鐵委聘的考古學家通報發現遺跡（相片見 <u>附件B</u> ）。此通報是根據考古工作牌照的有關條款發出(即規定考古觀察須按牌照申請人在申請牌照時所提交的資料進行；而有關申請資料述明申請人如發現構築物遺跡須通知古蹟辦)。
2012年9月26日	古蹟辦派內部具專業考古學訓練的博物館館長職系人員（“古蹟辦專業人員”）實地視察及與港鐵委聘的考古學家討論，雙方均認為被發現的建築構件並不是威靈頓炮台的一部分，而是十九世紀中期的海堤的一小部分，並且海堤已受到早年多次工程所破壞。
2012年10月上旬	港鐵委聘的考古學家指出由於所發現的遺跡是殘存海堤，海堤亦已受到早年多次工程所破壞，遺跡文物價值相對不高，且位於金鐘站擴建工程施工的主要位置，不宜原址保存，並建議以詳細紀錄的方法，包括利用照片、繪圖及

時間	有關事項
	文字方式紀錄。此建議是根據考古工作牌照的有關條款提出(即規定考古觀察須按牌照申請人在申請牌照時所提交的資料進行;而有關申請資料述明申請人須就發現的物品的跟進工作徵詢古蹟辦及取得其同意)。古蹟辦經研究後,同意上述處理方法,並建議將部分海堤的石塊保存下來,日後再利用及作適當詮釋。港鐵接納古蹟辦的建議,並已將狀況良好的石塊妥為存放。
2012年10月18日	古蹟辦專業人員再次實地視察,確定未有更多遺跡發現。

9. 目前,有關考古觀察的工作仍在進行。港鐵委聘的考古學家會於**2013**年中南港島線(東段)考古工作完成後,把詳細報告提交古蹟辦。一如其他考古發現的安排,古蹟辦會向古諮會匯報相關發現。雖然,於金鐘夏慤花園發現的遺跡只為殘存海堤,文物價值相對不高,但鑑於公眾對是次發現的關注,古蹟辦於**2012**年**11**月**1**日已安排古諮會成員到港鐵工地現場視察。此外,古蹟辦亦安排了香港大學房地產及建設系專門研究香港採石業歷史的潘新華教授和其研究團隊的馬冠堯工程師,以及香港浸會大學歷史系研究軍事歷史的研究助理教授鄭智文博士到工地視察,進一步認定遺跡為殘存海堤,而不是炮台遺跡。
