Revitalising Historic Buildings Through Partnership Scheme

The Blue House Cluster

Resource Kit

(Second Edition updated on 30 Sep 2009)

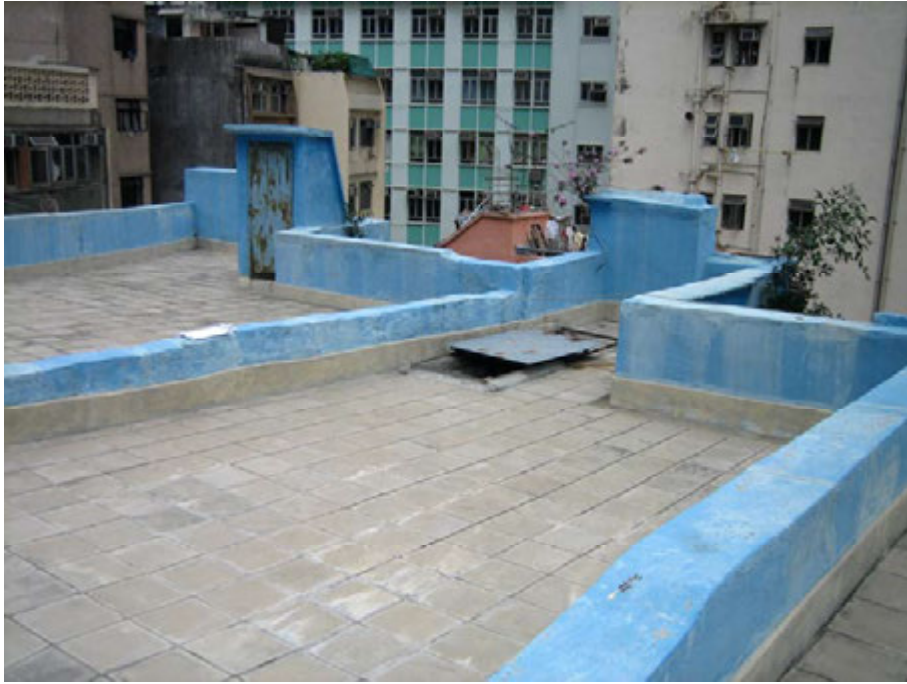
Roofs of 72 and 72A Stone Nullah Lane

The roof is constructed of a reinforced concrete slab and beam system, supported by brick walls. Roof of 72, 72A and 74 Stone Nullah Lane were recently refinished and properly maintained. Roof of 74A Stone Nullah Lane was not satisfactorily maintained. Visible spalling finishes was found on brick parapet wall. Part of the roof was accumulated with debris. Access to the roof is provided by individual steel ladder at the kitchen of each of the flats on 3/F.

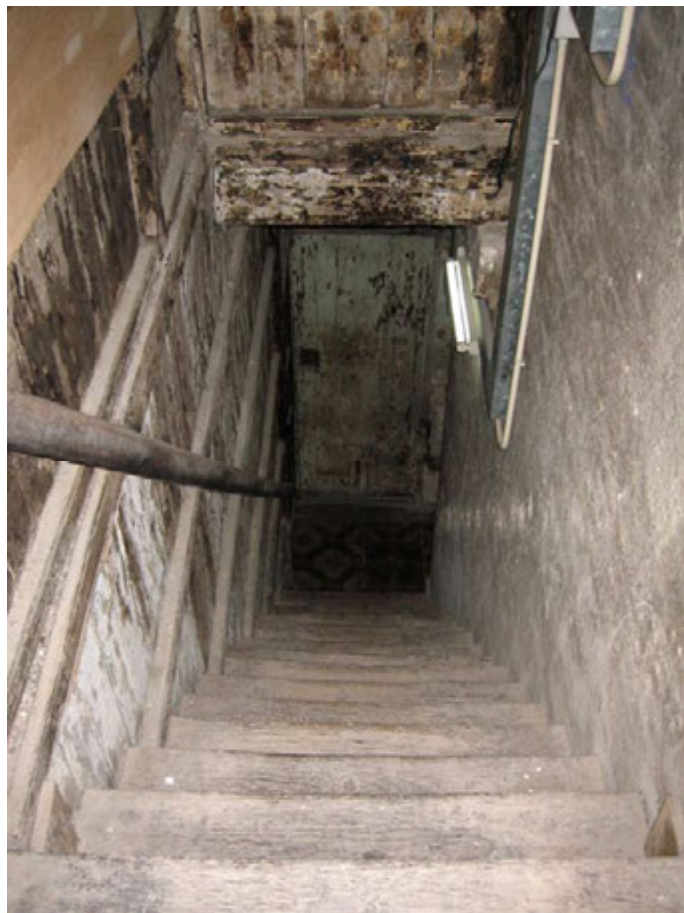
View of one internal timber stair

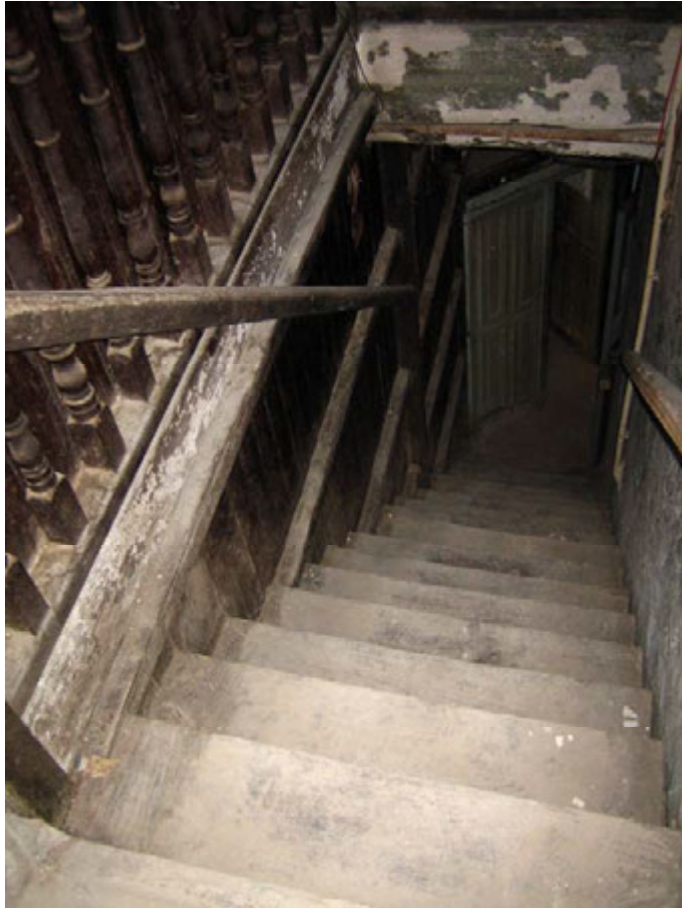
View of one internal timber stair

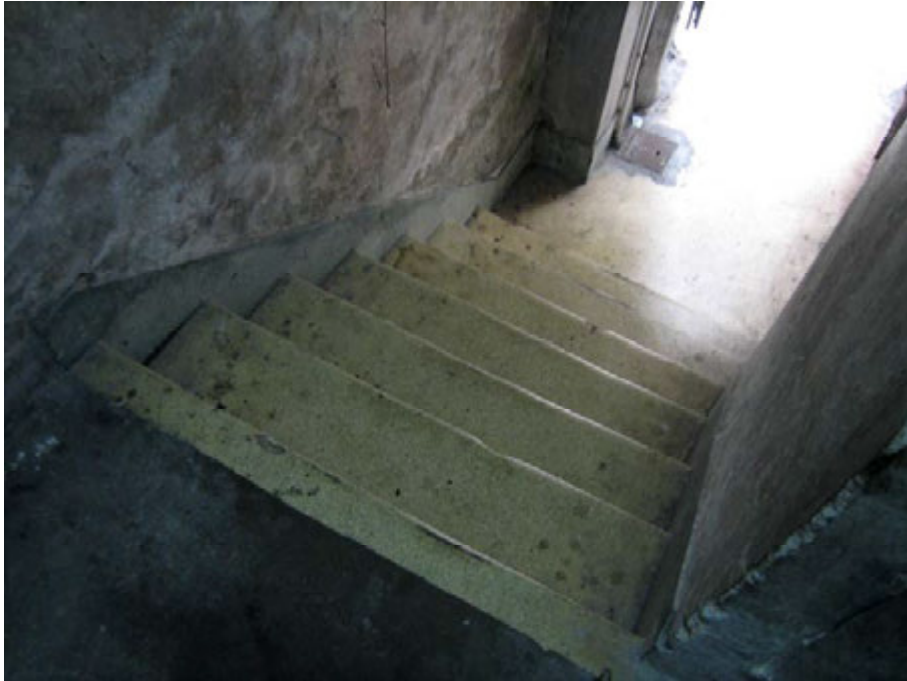
View of one internal reinforced concrete staircase

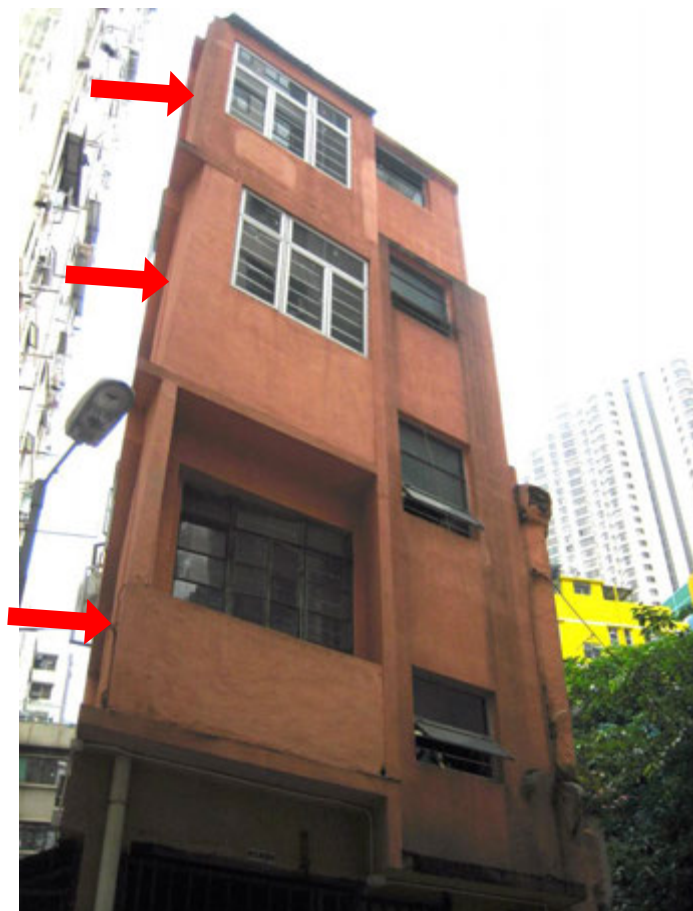
Unauthorized balconies and projecting structures on the first, second and third floor
(indicated by red arrows)

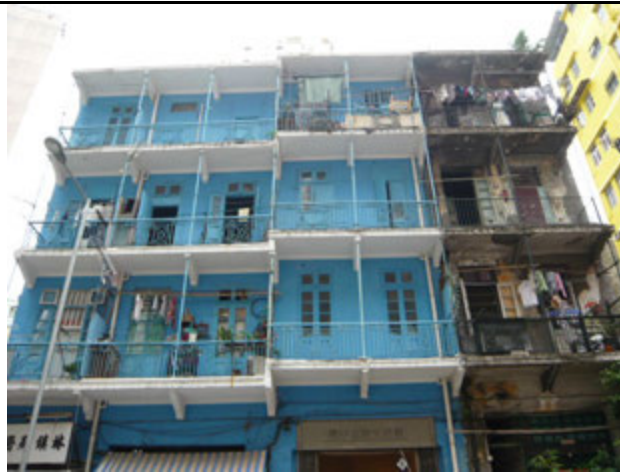
1.1) **Stone Nullah Lane façade**, including the cantilevered concrete verandahs with the wrought-iron balustrades with geometrical patterns and concrete brackets supporting the verandahs

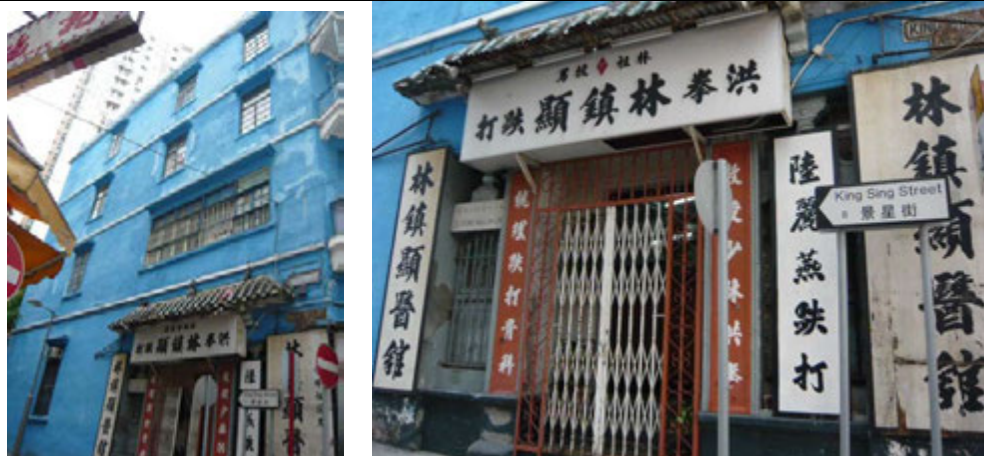
1.2) **King Sing Street façade**, including four horizontal plaster bands with mouldings, aligned with concrete floor slabs, all rectangular window openings (but most of the actual windows are not original and need not be retained); concrete window cills and heads, and canopies supported by moulded concrete brackets. The recessed entrance of the “Bone-setter” shop at G/F, including granite steps, glazed ceramic dragon-carp/ pearl decorations above the door and metal grilles

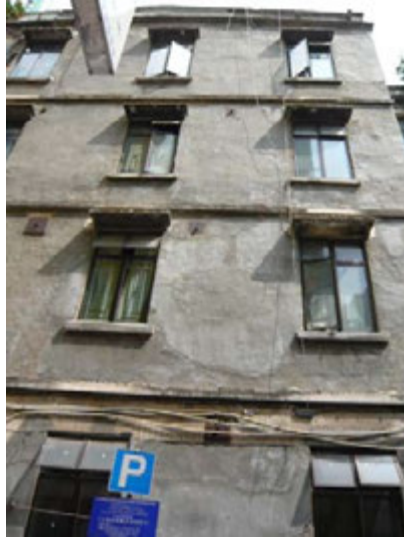
1.3) **Hing Wan Street façade**, including all rectangular window openings (but most windows are not original and need not be retained), with concrete hoods and window cills; four horizontal brick/plaster bands aligned with floor slabs

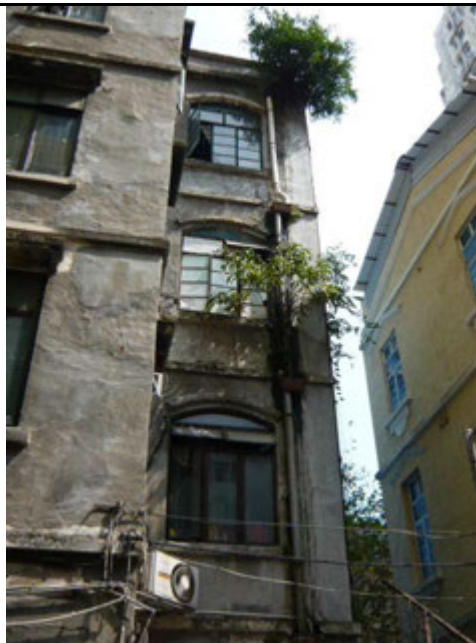
1.4) **Hing Wan Street elevation (set back)**, including the original segmental window openings (but not the modern metal windows), window cills and heads, and four horizontal bands on wall

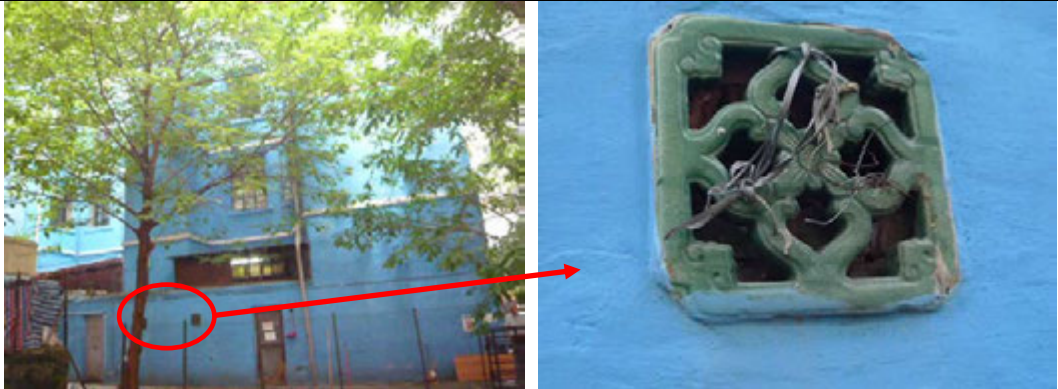
1.5) **Rear façade**, including all horizontal plaster bands, window openings (but not modern metal windows), window cills and heads, brick boundary wall with ceramic grille-tiles and backyard, together with the back scavenging lane

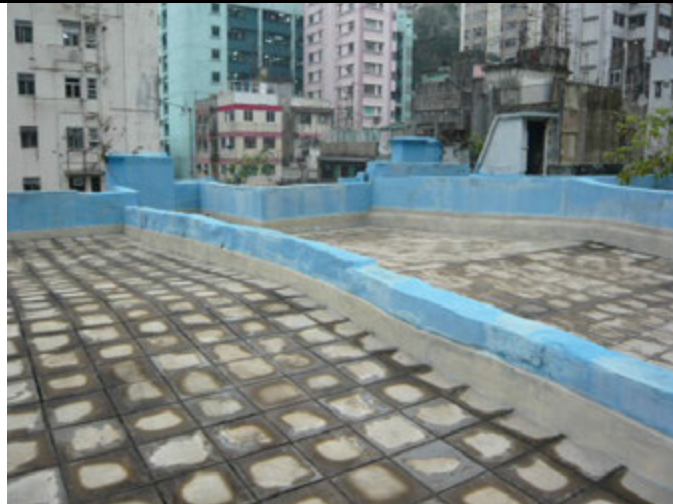
1.6) **Roof**, including parapet walls, Canton tiled covering, staircase hoods and brick chimney

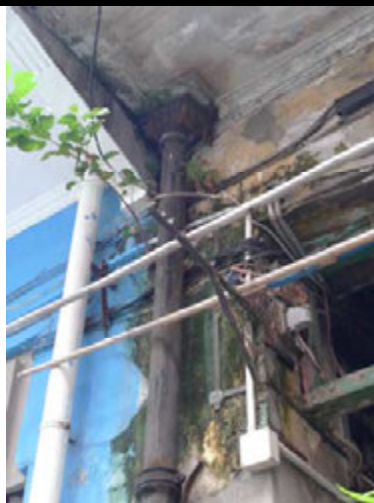
1.7) Rainwater drainage system with cast iron hopper and pipes

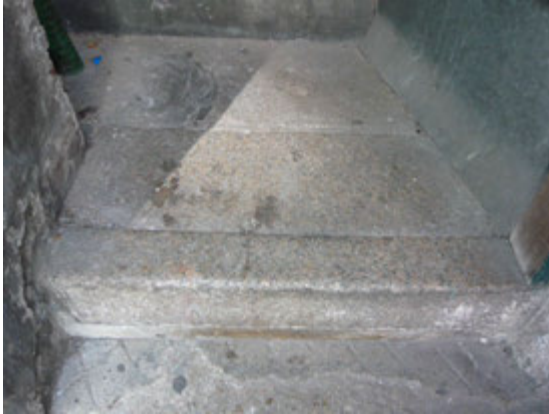
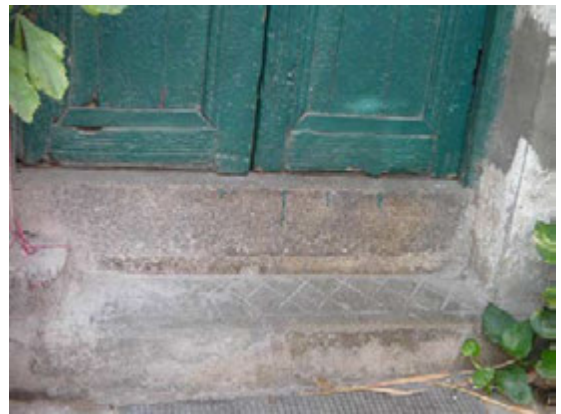
1.8) All granite steps at the entrances to the common stairs of the tenements between 72 & 72A and 74 & 74A Stone Nullah Lane (concrete steps need not be retained)

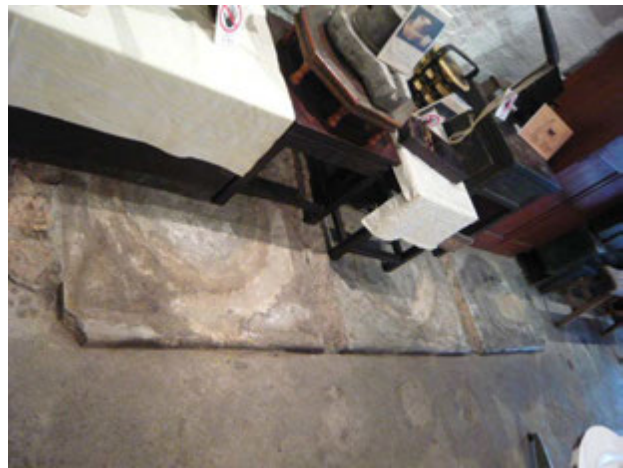
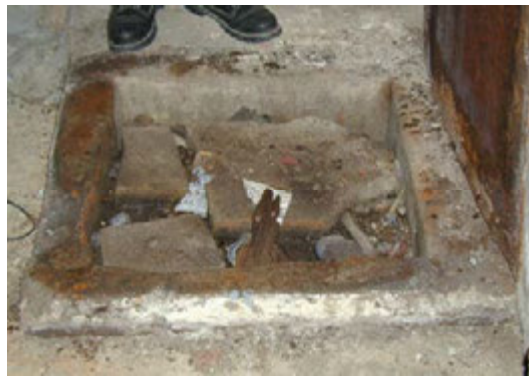
1.9) Remains of the Old Wine Shop at G/F of 74 Stone Nullah Lane, including brick/cement bases for wine jars, glazed fan light above entrance and underground pit for wine storage in Rear Yard

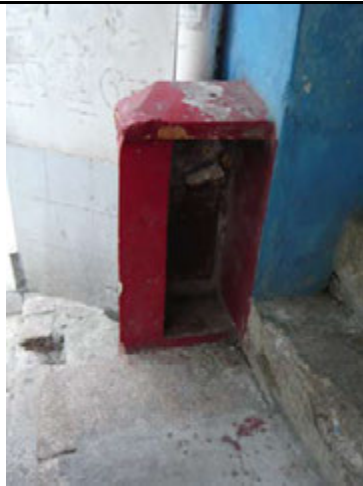
1.10) Earth God Shrine at the entrance of 72A Stone Nullah Lane

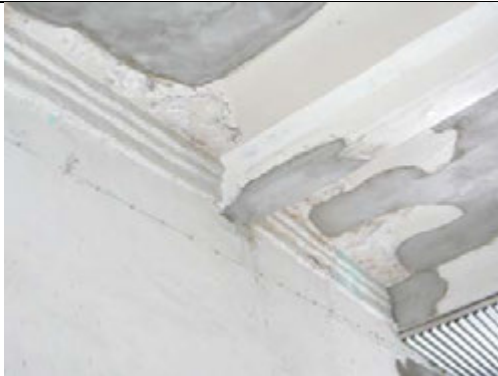
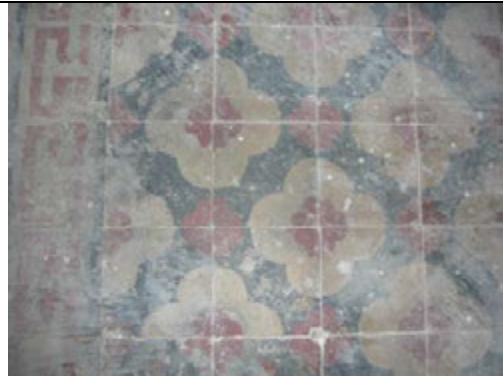
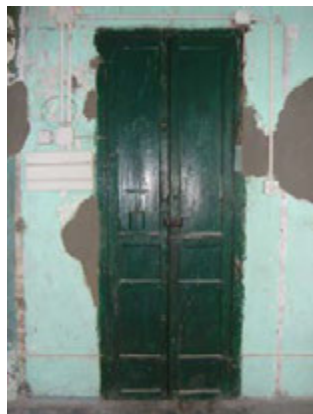
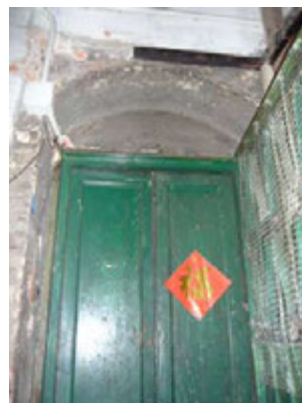
1.11) **Living Rooms** - The brick/plaster corbelled moulding to the ceiling, structural beams, patterned floor tiling, the French door openings to the balconies (but some doors are new replacements which are not required to be preserved), original timber entrance door with “spy hole” and the arched recess to the entrance doorways (but not all living units have arched recess to the entrance doorway)

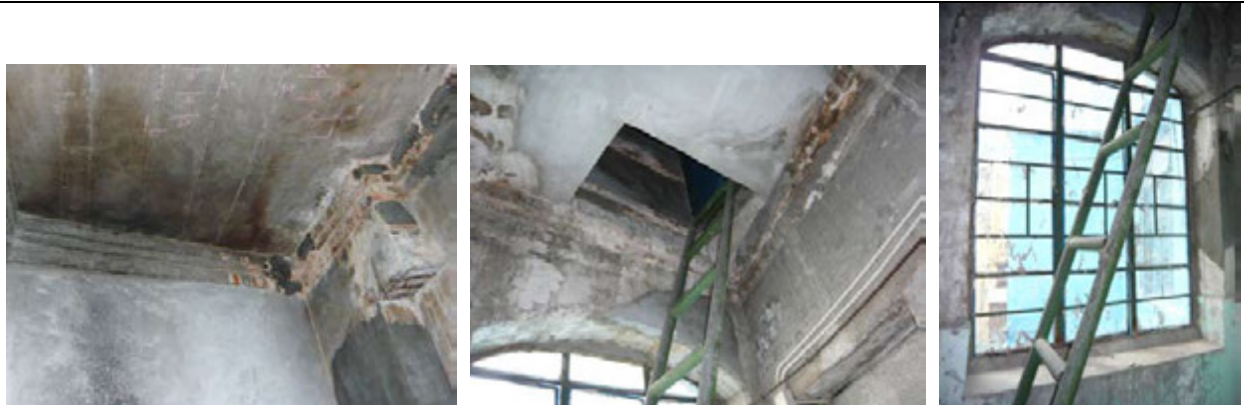
1.12) **Kitchens** - Brick corbelling along the edge of the ceiling and the arched segmental windows. Trap door to roof at the top floor of 72 & 72A Stone Nullah Lane

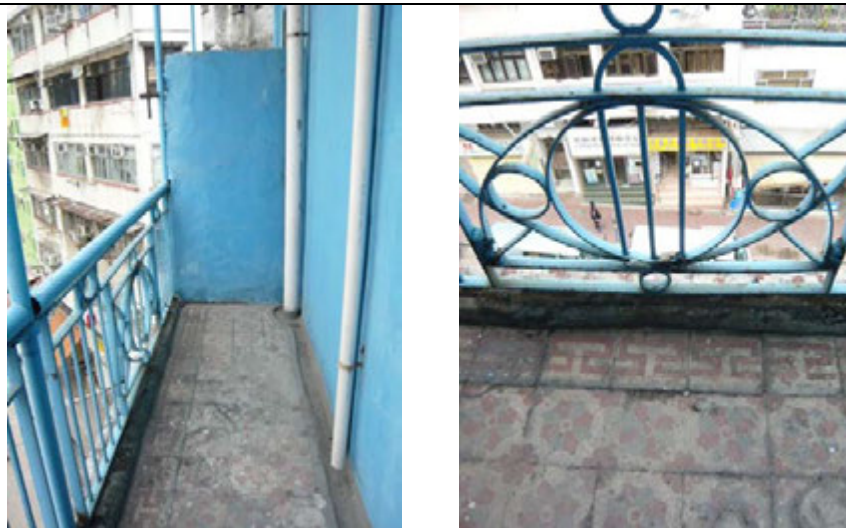
1.13) **Balconies facing Stone Nullah Lane** - Original tiled floor in floral patterns

Architectural Feature	Required Treatment
1.6) Balconies facing Stone Nullah Lane	Balconies must not be enclosed by glazing or other materials, and should remain open as at present. Damaged metal balustrades should be repaired or replaced to tie in with the design of adjacent balustrades. If upgrading works are required to the balustrades to meet the current requirements of Buildings Ordinance, the works should be carried out to cause minimum visual and structural disturbance to the original feature, and the design of which should be subject to AMO's approval. No objection to removal of the later brick partitions between balconies.

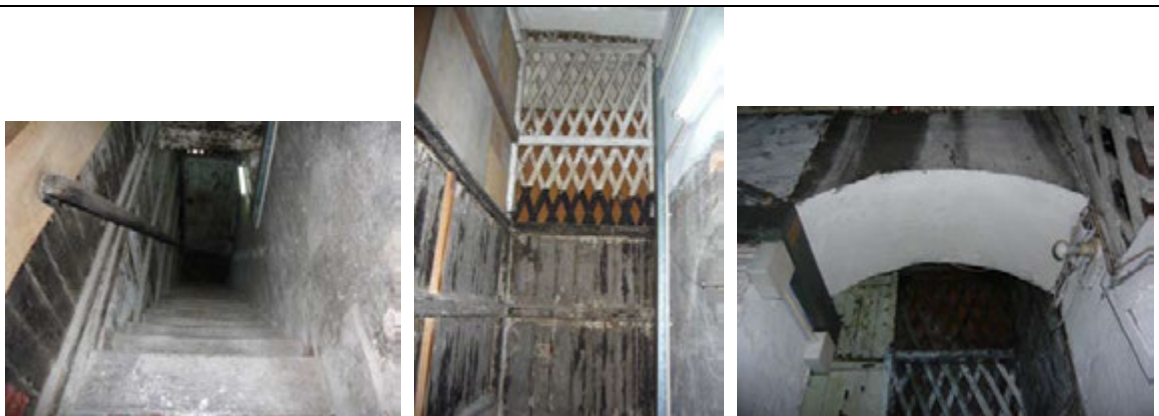
1.14) **Common stairs** - Common stair serving 72 & 72A Stone Nullah Lane and the stair serving 74 & 74A Stone Nullah Lane, including all archways at the landing, timber panels with wooden lattices and remains of ceramic tiling

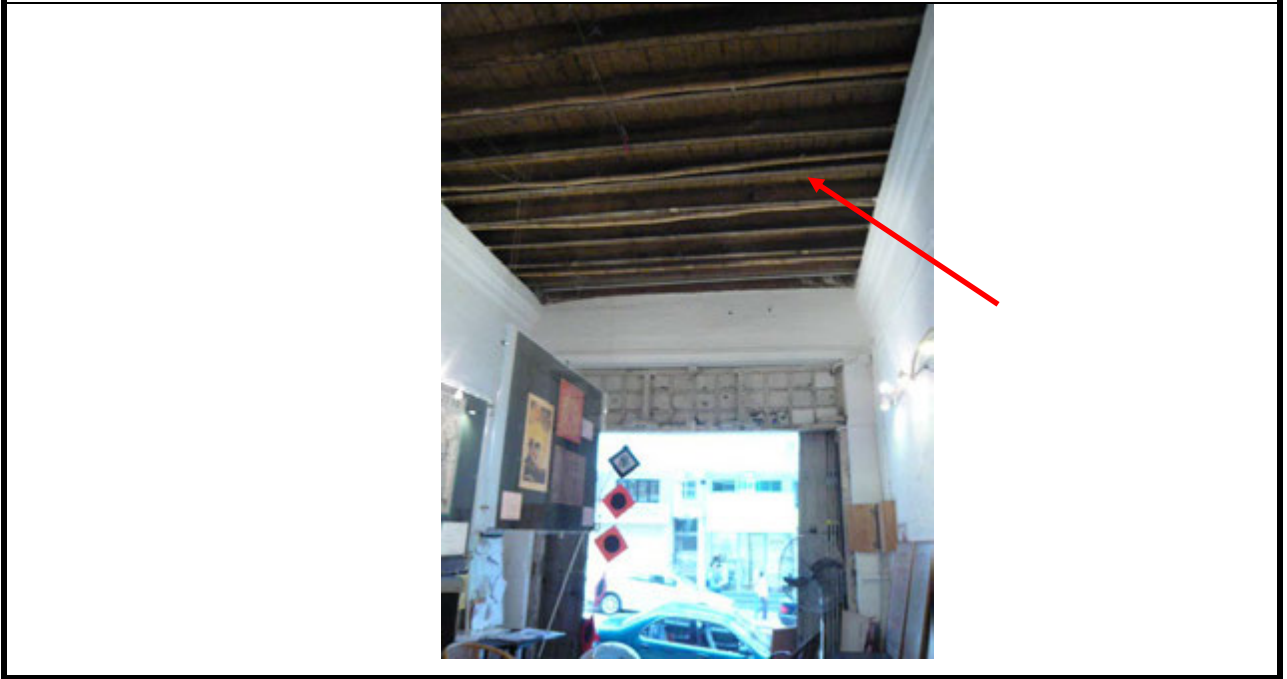
1.15) Timber Floors – Timber elements including timber joists and battens of the floors

Architectural Feature	Required Treatment
1.13) Timber Floors	All timber elements including timber joists and battens of the timber floors should be preserved in-situ. Where improvement works to the timber floors to fulfill the requirements of the Buildings Ordinance in structural and fire safety aspects are required due to change-in-use of the building, such works and their corresponding disturbance to the timber floors should be submitted to AMO for approval from conservation point of view.

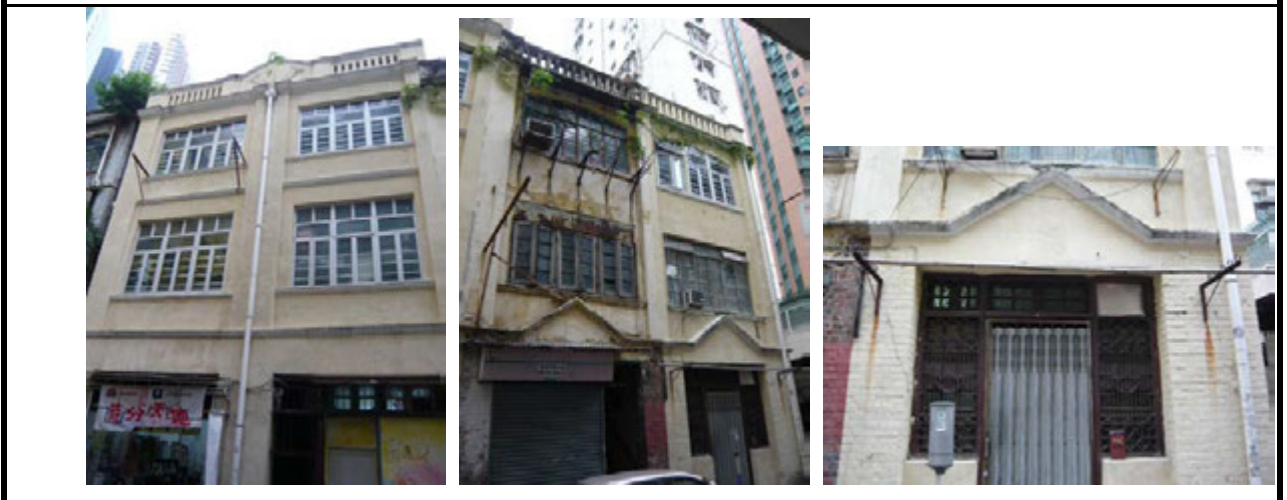
2.1) Front Elevation facing Hing Wan Street - Ornamental parapets to all four houses; horizontal decorative mouldings along parapets; decorative plaster geometric features; decorative pediments between G/F and 1/F at 2 & 4 Hing Wan Street; all window openings of the four houses, including segmental windows at 2/F of 2 & 4 Hing Wan Street; glazed timber doors at 2 Hing Wan Street; wrought-iron grilles to G/F and 1/F of 2 and 4 Hing Wan Street

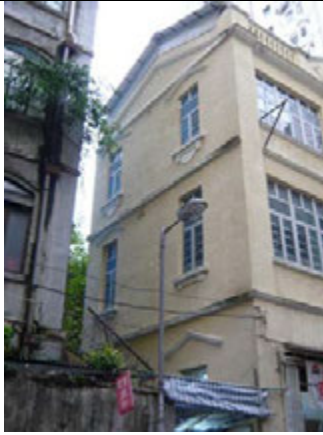
2.2) **Side Elevation to Stone Nullah Lane** - Three horizontal bands with mouldings, all window openings including concrete window cills (but actual windows are not original and need not be retained), triangular-shaped mouldings at high level and over the windows

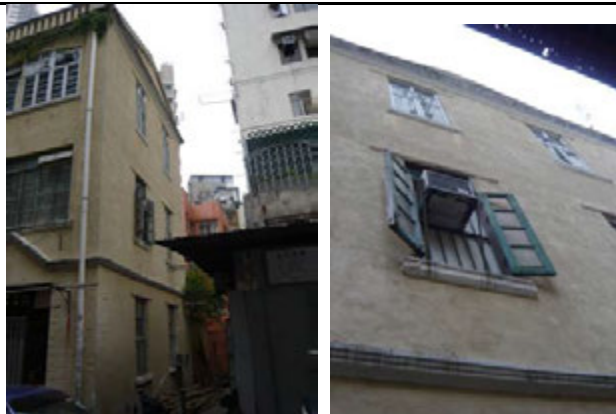
2.3) **Side Elevation to King Sing House** – All window openings (All aluminium windows are not required to be preserved except one original wooden window at 1/F which should be preserved); window cills and heads, line of moulding between the G/F and 1/F; triangular-shaped mouldings at high level

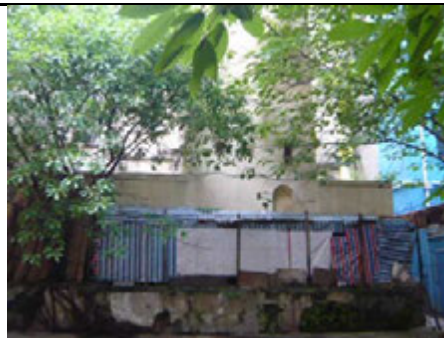
2.4) **Rear Elevation** – All window openings (but not modern metal windows) with window cills and heads; plastered brick façade; brick boundary wall and the backyard

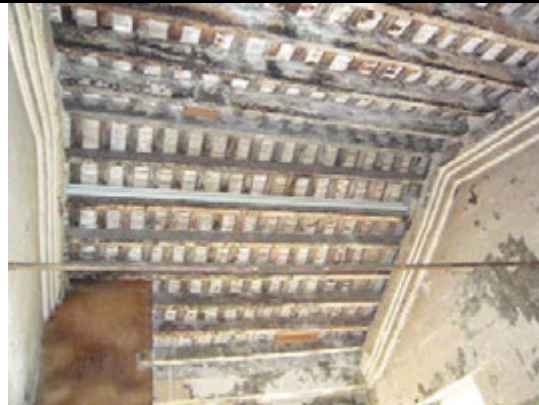
2.5) **Roof** - Chinese tiled pitched roofs, including original China-fir timber purlins; brick chimney stacks and staircase hoods

Architectural Feature	Required Treatment
2.4) Roof	<p>The majority of the round purlins have some termite damage, but the hardwood purlins seem to be in good condition. A termite system should be put in place to safeguard the timber members of the roof. The underside of the roof shows signs of rainwater leakage, and all broken and displaced tiles should be made good and roof should be maintained in a waterproof condition. The architectural features of the roof must be preserved, namely, chimneys, roof tiles, timber purlins, staircase hoods and parapet walls. All unauthorised structures and coverings to the roofs of the four houses should be removed in order to reveal the original pitched roof form.</p>

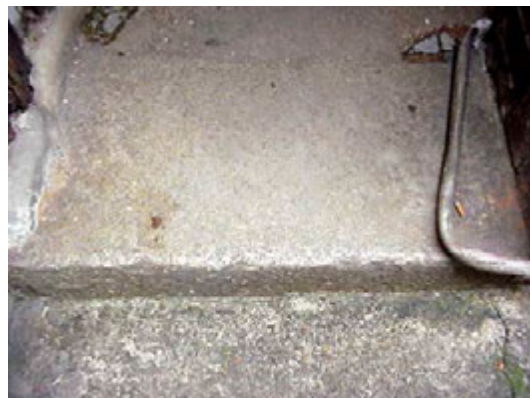
2.6) All granite thresholds to the G/F front entrances of all units

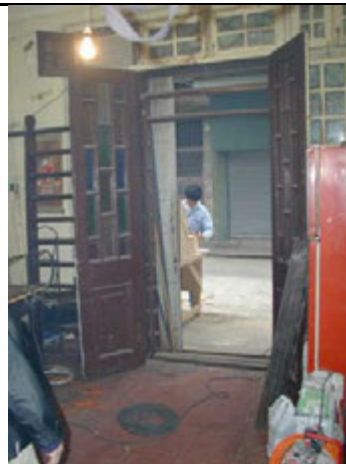
2.7) **2 Hing Wan Street** - Timber security bars and Main Entrance door

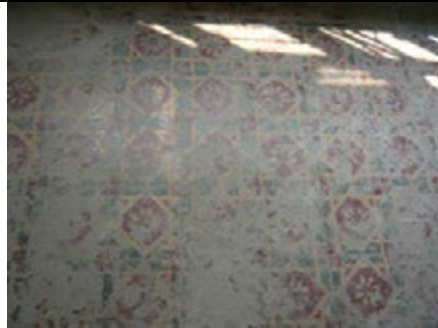
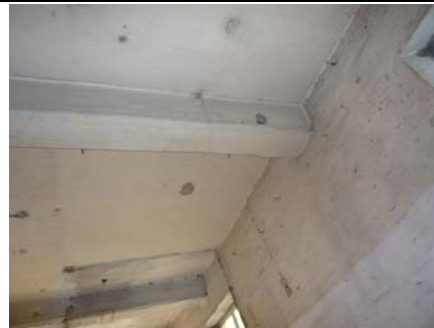
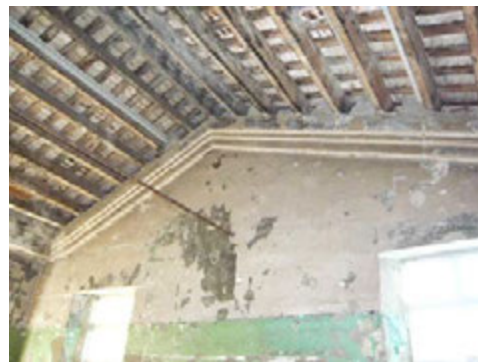
2.8) **Living Rooms** - All structural beams, ceramic patterned floor tiling; window openings (but most actual windows are not original and may be replaced); brick/plaster corbelling to underside of roof; original panelled timber doors (but not the new replacement doors)

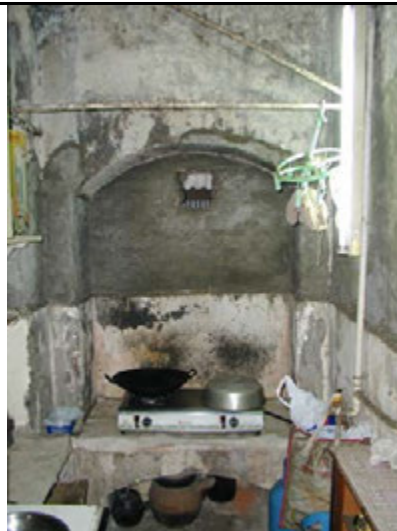
2.9) **Kitchens and Utility Areas** - At least one example of an existing brickwork cooking stove, together with its chimney flue should be preserved in-situ

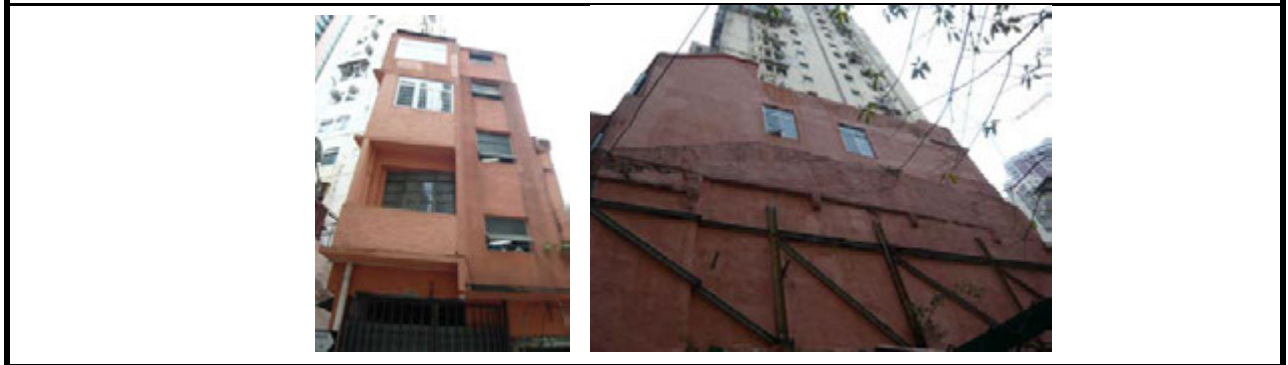
3.1) **External Walls**- One side elevation still has the evidence of an older shop house structure remaining attached to the brick wall which should be kept. All existing window openings to the building should be preserved except those related to the unauthorised building works (but the actual modern metal windows are not original and need not be retained)

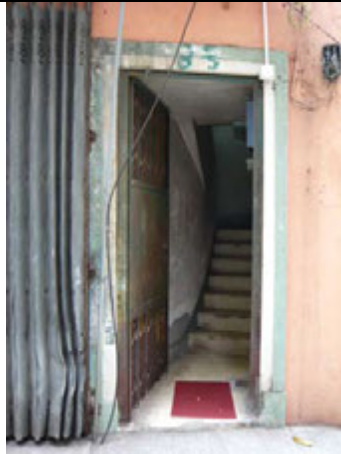
3.2) Main Entrance - Terrazzo 'two-tone' treatment around the frame of the entrance door

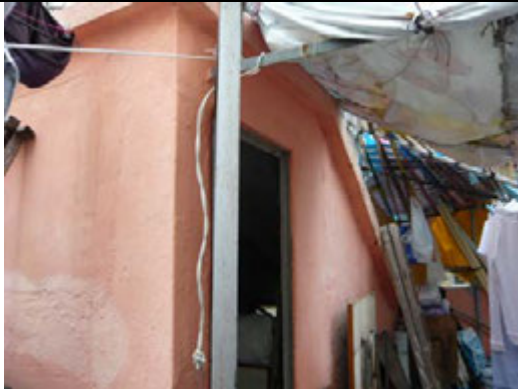
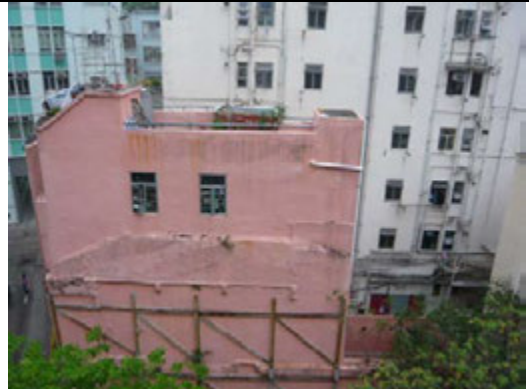
3.3) Roof - The parapet walls and the staircase hood

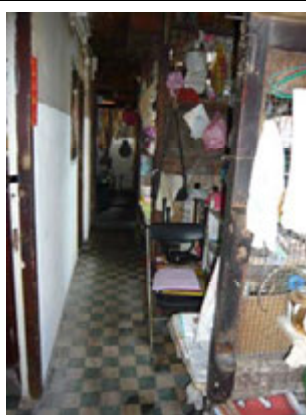
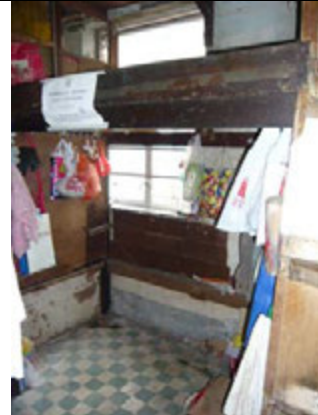
3.4) Flooring - Green and white ceramic tiling in the common areas

Architectural Feature	Required Treatment
3.5) Original ceramic floor tiles	All original floor tiles (in green and white) at the common areas of the building should be cleaned (using bristle or nylon brushes and clean water (corrosive cleaning chemicals must not be used). Modification works to the floor slabs to make them structurally capable for adaptive re-use may be permitted, provided the floor tiles are retained in-situ and prior approval from AMO is given to the scale and location of the proposed modification works.

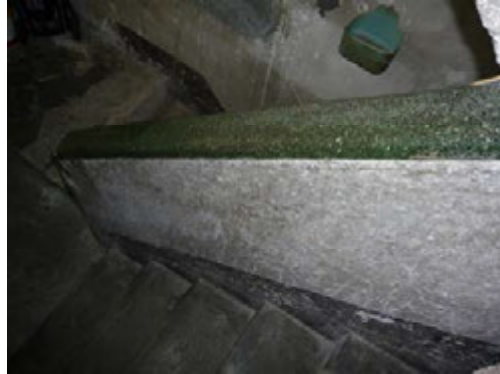
3.5) **Staircase** - Terrazzo 'two-tone' treatment to the staircase steps, skirting and balustrade, which echoes the style of the main entrance, should be preserved

Architectural Feature	Required Treatment
3.6) Staircase	Terrazzo finishes of the staircase should be preserved, cleaned and repaired where necessary (non-corrosive cleaning chemicals must not be used). Upgrading works to the staircase may be permitted, provided prior approval from AMO is obtained on the scale of the works.

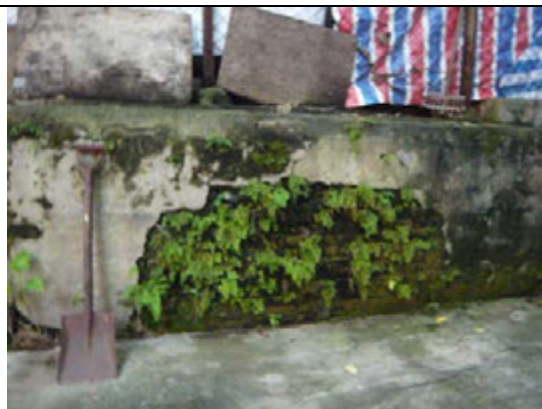
4.1) Grey brick retaining wall supporting the rear scavenging lane serving Hing Wan Street

Architectural Feature	Required Treatment
4.2) Brick retaining wall	There is a historic grey brick retaining wall supporting the rear scavenging lane serving Hing Wan Street. The damaged parts of the wall should be repaired. The black stains should be cleaned off and vegetation should be removed. Alterations to suit modern days' requirements may be permitted subject to AMO's approval. In any case, access to back door of Yellow House should be maintained.

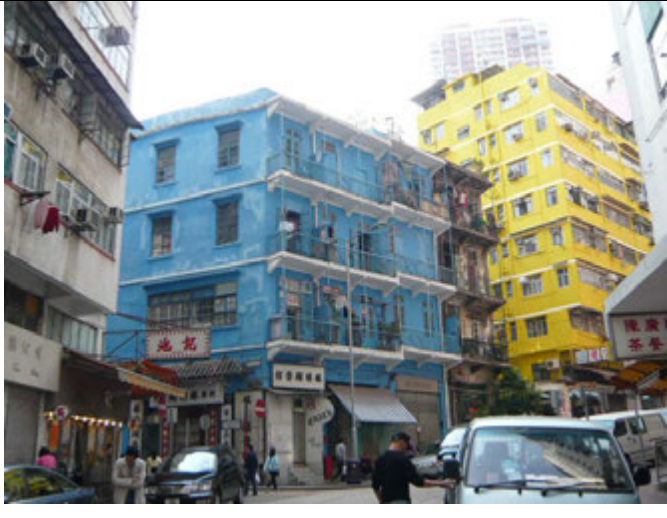
Architectural Feature	Required Treatment
1.1) Building structure	All structural elements should be inspected, repaired and protected. If new structural support is essential, it should be designed to be as unobtrusive as possible, in order to preserve the historic fabric of the buildings. No objection to replacement of damaged brickwork and timber members if they are beyond repair, provided all replacement items match the original material and design. Proposals for any replacement items should be submitted to AMO for comment. A termite monitoring system to protect timber structures should be installed where appropriate.

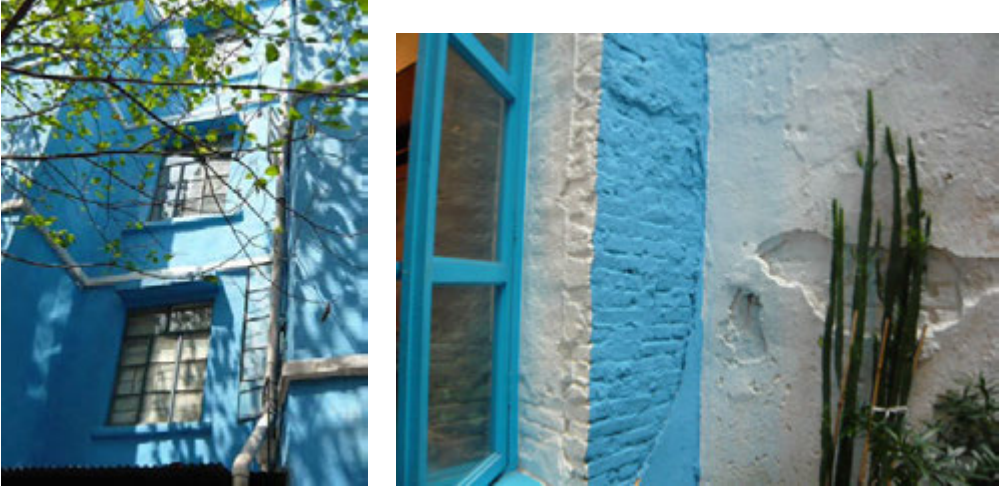
Architectural Feature	Required Treatment
1.2) External walls	Repair any damaged sections of brickwork and rendering using similar materials. No restriction on the proposed colour scheme, provided the paint system is reversible (i.e. permanent coating systems are not allowed).

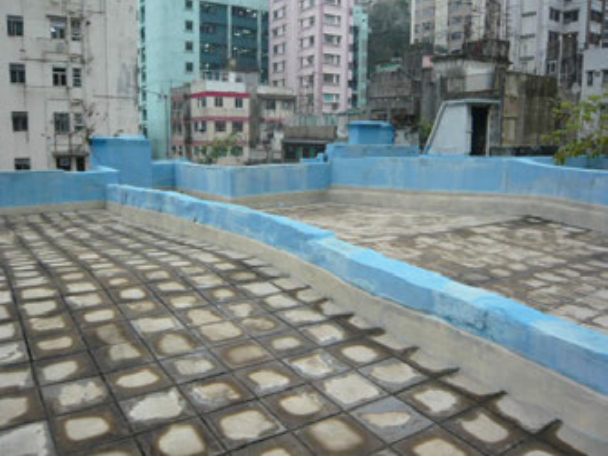
Architectural Feature	Required Treatment
1.3) Roof	Roof should be maintained in a waterproofed condition, while preserving the architectural features, namely brick chimney, Canton tiles, staircase hood and parapet walls. The roof may be turned into a usable space (subject to Buildings Ordinance requirements), provided no permanent structures are built on the roof.

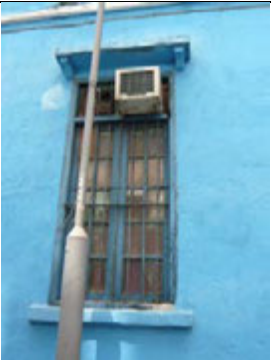
Architectural Feature	Required Treatment
1.4) Windows	No window opening is to be enlarged or modified in any way. But, most of the actual windows are recent replacements in aluminium or steel and they should be replaced by timber-framed windows in traditional style. Details of examples of original timber windows are available from AMO. Where new air-conditioning units are required, they should be provided in less obvious locations or by discrete split-unit type.

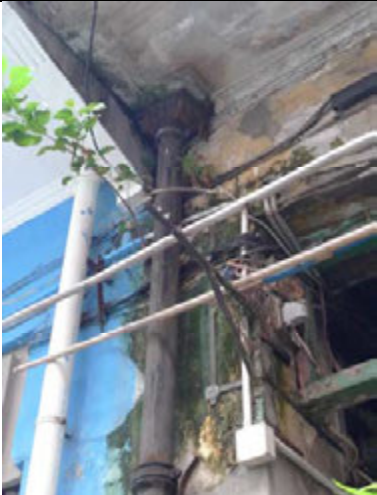
Architectural Feature	Required Treatment
1.5) Rainwater drainage system with cast iron hopper and pipes	Check condition of the existing rainwater drainage system. Preserve in-situ and repair as necessary the historic cast-iron hoppers and pipes. Some rainwater pipes has been replaced with new uPVC pipes or/ and connected to later-added sewage pipes. They should be restored with cast-iron replicas and disconnected from the sewage system. Remove any inappropriate later-added rainwater pipes (or air conditioning condensation pipes).

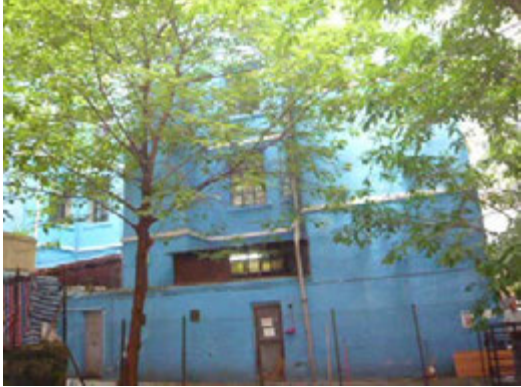
Architectural Feature	Required Treatment
1.7) Rear yard	Any proposal for new built over the rear yard should be submitted to AMO for approval. They should be supplemented with sound justification to demonstrate their necessity.

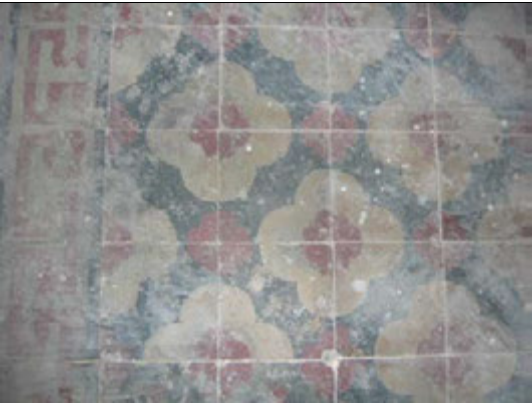
Architectural Feature	Required Treatment
1.8 Original patterned floor tiles	All original decorative ceramic floor tiles (including simple floral pattern, geometric pattern, etc) at interiors of the building should all be retained in-situ and cleaned (using bristle or nylon brushes and clean water - corrosive cleaning chemicals must not be used). Modification works to the floor slabs in order to make them structurally capable for adaptive re-use may be permitted. But, the tiles must be retained in-situ and the proposed scale and location of the works requires the approval of AMO.

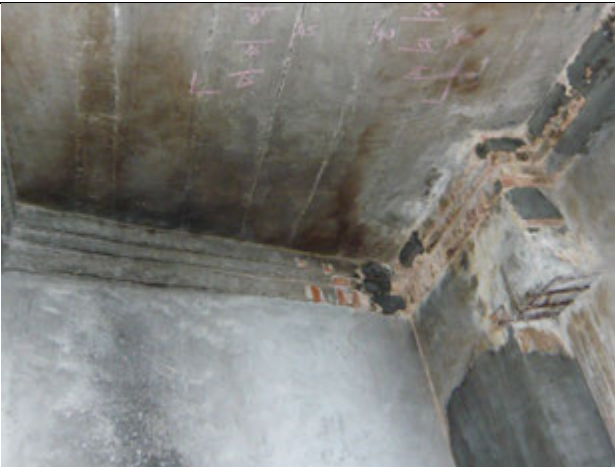
Architectural Feature	Required Treatment
1.9) Corbelled brick/plaster moulding to the ceilings	Some corbelled brick/plaster moulding to ceiling of the living rooms and kitchens have been damaged. They should be repaired and reinstated using the existing design and materials.

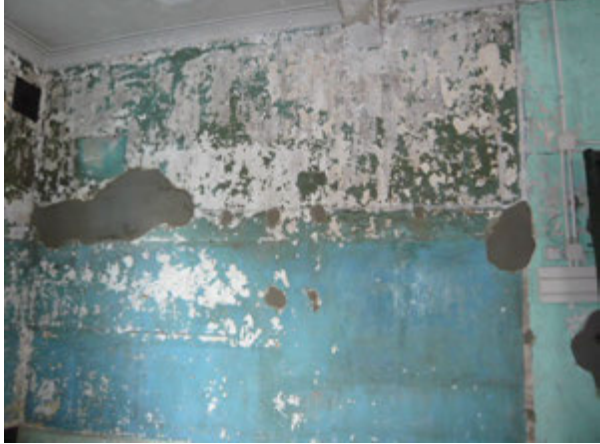
Architectural Feature	Required Treatment
1.10) Interior walls	Defective areas of interior plastered walls should be repaired by “patch repair” as required, using similar material. There is no restriction to proposed painting treatment, provided a reversible paint system is used. Demolition/ openings made to the non-loading bearing internal walls and floor slabs may be allowed subject to the advice of a Registered Structural Engineer.

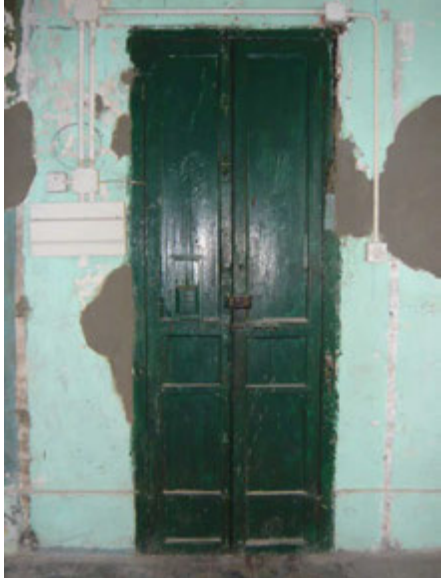
Architectural Feature	Required Treatment
1.11) Entrance doors to tenements	There is no objection to replacing recent non-historic doors with doors of traditional style and materials. However, all existing original timber doors (complete with door fittings and observation openings) should be retained, repaired and repainted.

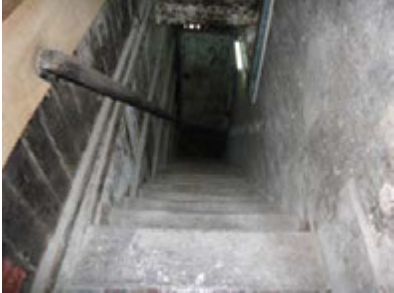
Architectural Feature	Required Treatment
1.12) Internal staircases	Upgrading work to the staircase to meet with the current building control standards may be permitted, provided that the proposed design and materials are approved by AMO.

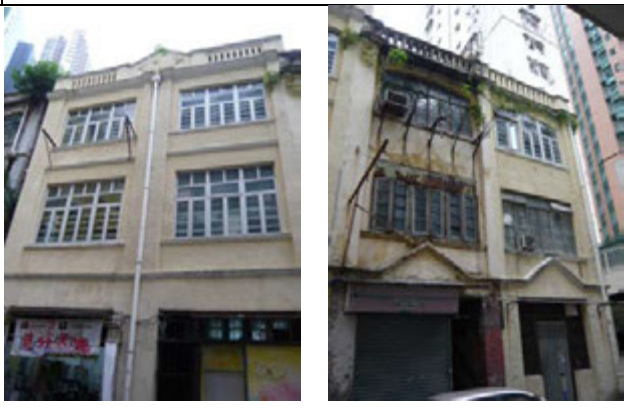
Architectural Feature	Required Treatment
2.1) Building structure	<p>All structural elements must be inspected, repaired and protected. If any structural strengthening is considered necessary under the current building control requirements (for example, for an adaptive reuse which demands a higher loading capacity), it should be designed as unobtrusive as possible, in order to preserve the historic fabric of the buildings. Damaged brickwork and structural timber members may be replaced with similar materials if beyond repair. Generally, all replacement items should match the original material and design. Proposals for any replacement items should be submitted to AMO for comment. A termite monitoring system to protect timber structures should be installed in appropriate locations.</p>

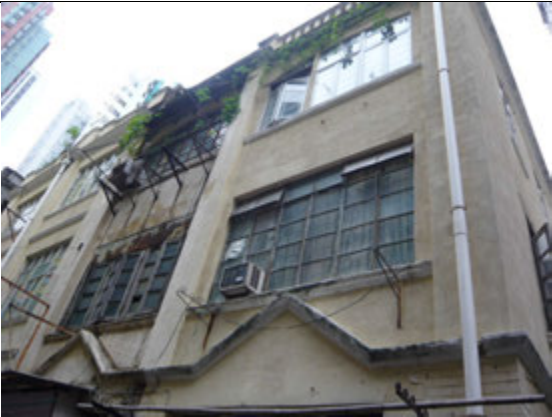
Architectural Feature	Required Treatment
2.2) External walls	Repair any damaged sections of brickwork using similar bricks, mortar and rendering. No restriction on proposed colour scheme (the existing recent yellow colour need not be retained), but the paint system must be reversible (i.e. permanent coating systems not allowed). The old metal hanging brackets, dilapidated canopies and window-type air-conditioning units must be cleared away.

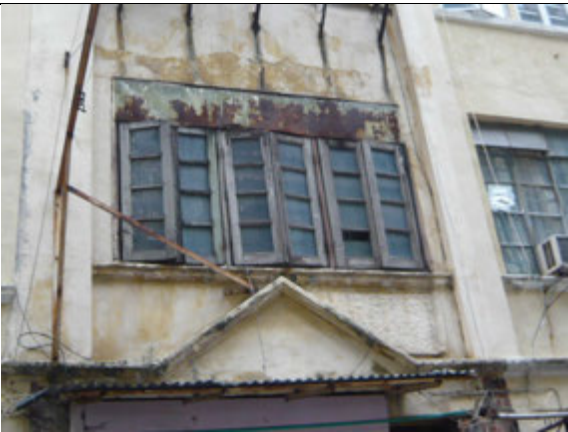
Architectural Feature	Required Treatment
2.3) Windows	No window openings are to be enlarged or modified in any way. But, most of the windows and their frames are recent replacements in metal and they should be replaced by timber-framed windows in traditional style. Details of examples of original timber windows are available from AMO. Where new air-conditioning units are required they should be provided in less obvious locations or by discrete split-unit type.

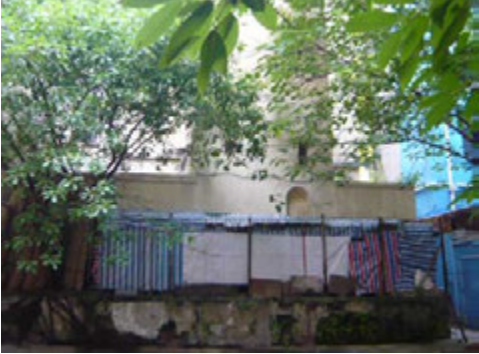
Architectural Feature	Required Treatment
2.5) Rear yard	<p>Any proposal for new built over the rear yard should be submitted to AMO for approval. They should be supplemented with sound justification to demonstrate their necessity.</p>

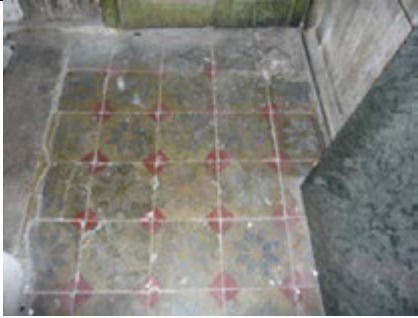
Architectural Feature	Required Treatment
2.6) Original patterned ceramic floor tiles	All original decorative ceramic floor tiles at interiors of the building should be retained in-situ, cleaned with bristle or nylon brushes and clean water (corrosive cleaning chemicals must not be used). New replacement tiles are acceptable if the damaged tiles are beyond repair and the replacements are of similar style and pattern. Strengthening of the floor slabs to make them structurally capable for new adaptive re-use may be permitted, provided the original floor tiles are retained in-situ and the proposed scale and location of the works are approved by AMO.

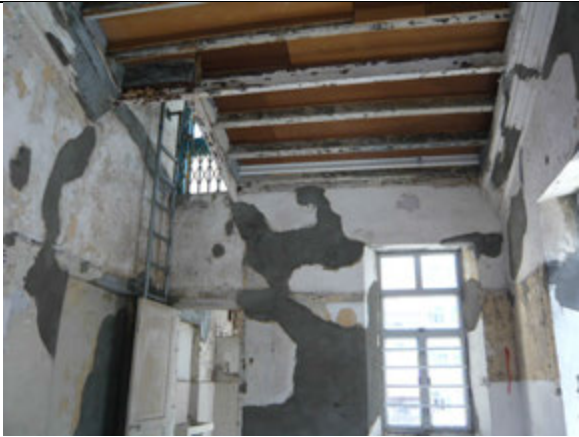
Architectural Feature	Required Treatment
2.7) Interior walls	Defective areas of plastered walls should be “patch repaired” using similar material. There is no restriction to proposed painting treatment, provided a reversible paint system is used. Demolition/openings made to the non-loading bearing internal walls and floor slabs may be allowed subject to the advice of a Registered Structural Engineer

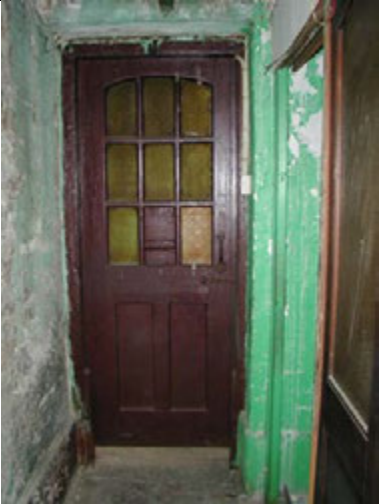
Architectural Feature	Required Treatment
2.8) Entrance doors to tenements	All existing original timber doors (complete with door fittings and observation openings) should be retained, repaired and repainted. However, there is no objection to replacing the modern doors by new doors in traditional style and materials.

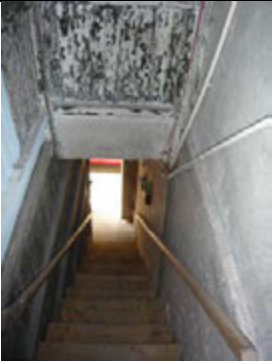
Architectural Feature	Required Treatment
2.9) Common stairs	The interiors require a thorough redecoration. Method statements of any upgrading work to the stairs to comply with the current building control requirements should be submitted to AMO for approval.
