Revitalising Historic Buildings Through Partnership Scheme

The Blue House Cluster

Resource Kit

(Second Edition updated on 30 Sep 2009)

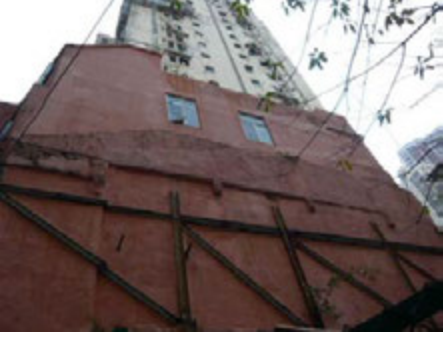
Architectural Feature	Required Treatment
3.1) Building structure	All structural elements must be inspected, repaired and protected, except the unauthorised building works. If any structural strengthening is considered essential under the current building control requirements (for example, for an adaptive reuse which demands a higher loading capacity), it should be designed as unobtrusive as possible, in order to preserve the historic fabric of the buildings. Damaged brickwork and structural timber members may be replaced with similar materials if beyond repair. Generally, all replacement items should match the original material and design. Proposals for any replacement items should be submitted to AMO for comment.

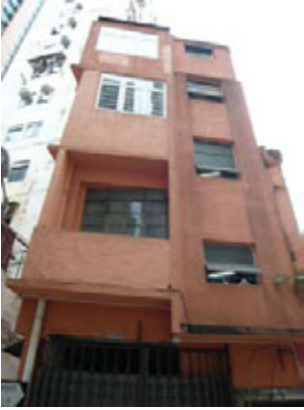
Architectural Feature	Required Treatment
3.3) Main entrance	Thoroughly clean the coloured terrazzo rendering at the Front Entrance, in order to make an attractive contrast with the grey Shanghai plaster on the remainder of the walls at the front elevation.

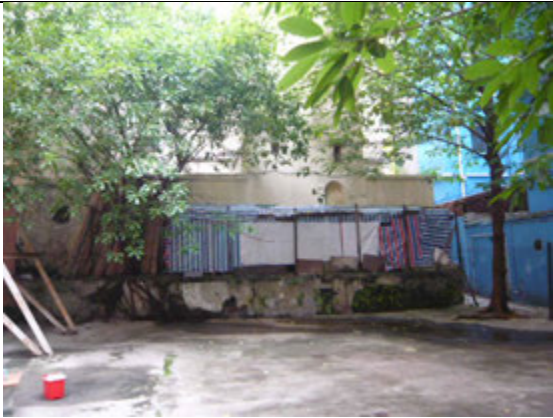
Architectural Feature	Required Treatment
4.2) Brick retaining wall	There is a historic grey brick retaining wall supporting the rear scavenging lane serving Hing Wan Street. The damaged parts of the wall should be repaired. The black stains should be cleaned off and vegetation should be removed. Alterations to suit modern days' requirements may be permitted subject to AMO's approval. In any case, access to back door of Yellow House should be maintained.

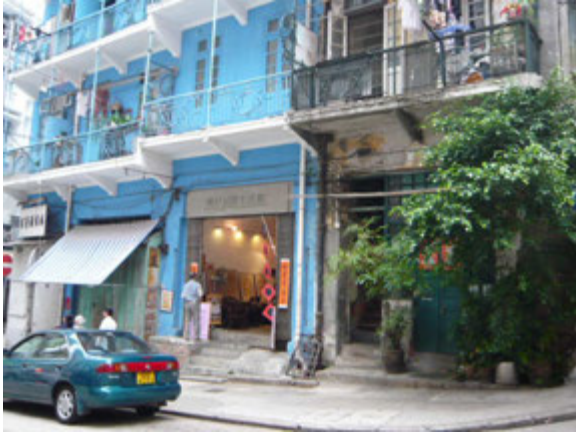
Architectural Feature	Recommended Treatment
1.2) Shop front at King Sing Street Elevation	Recommended to take down all the recent plastic signs of the “Bone-setter” shop in order to reveal the older sign for “Wah To Hospital” behind. Make good all disturbed wall surfaces using materials matching with the existing walls.

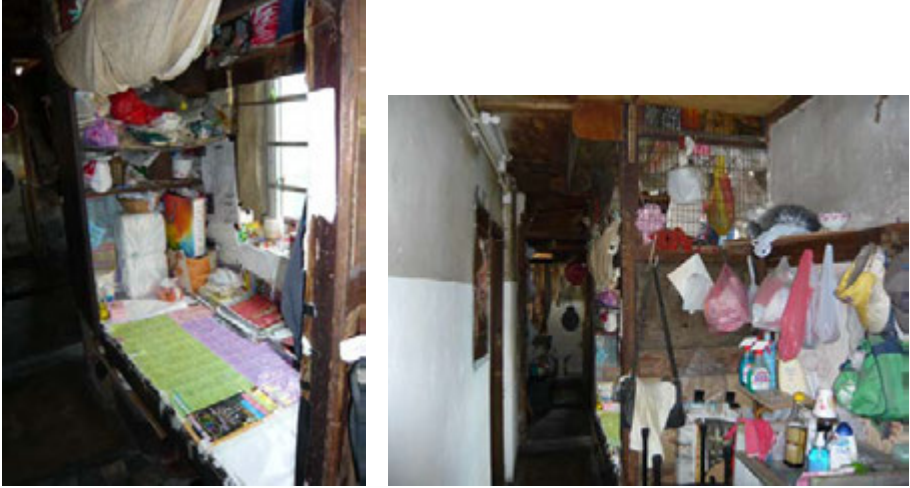
Architectural Feature	Recommended Treatment
3.1) Internal setting	An example of the existing setting of the shared dwelling units (including double-rack beddings) may be retained for heritage interest purposes as far as possible, as there are very few remaining examples of such a typical tenement living environment in Hong Kong.

The table's bottom section contains two photographs. The left photograph shows a narrow room with a double-rack bed structure. The bed has a green and purple patterned coverlet. The room is cluttered with various items, including bags and containers, hanging from the ceiling and on shelves. The right photograph shows a similar narrow room, viewed from a different angle, highlighting the double-rack bed structure and the dense arrangement of items, including plastic bags and bottles, illustrating the typical tenement living environment.
