**Revitalising Historic Buildings
Through Partnership Scheme**

Fong Yuen Study Hall

Resource Kit

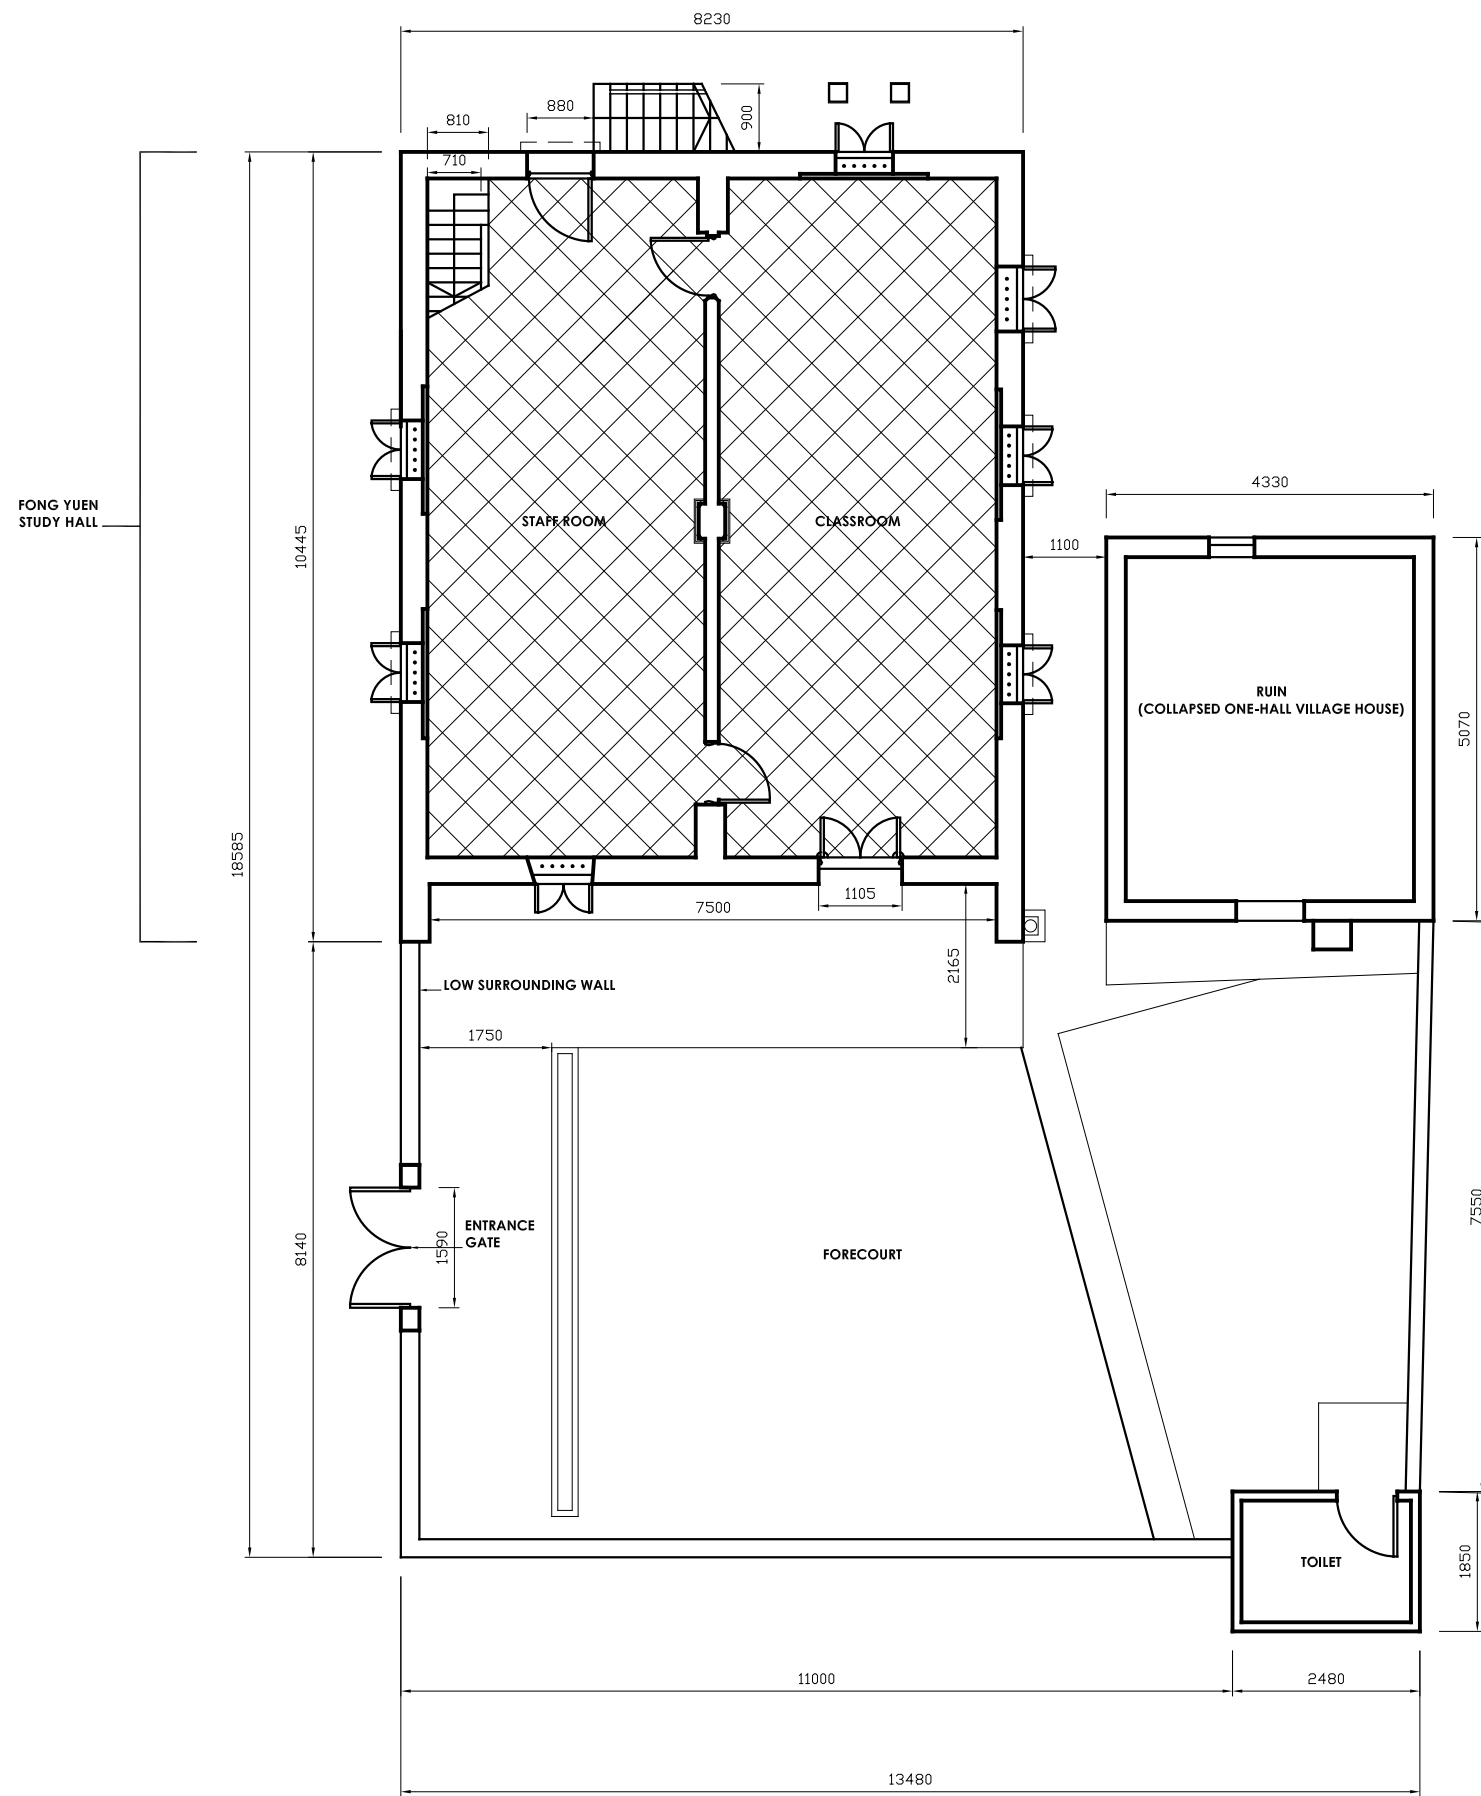
ARCHITECTURAL SERVICES DEPARTMENT
project	CARTOGRAPHIC SURVEY OF FONG YUEN STUDY HALL MA WAN
drawing title	GROUND FLOOR PLAN WITH FORECOURT
scale	1 : 100 (A3)
drawing no	FYS-P-01
date	28 JAN 2008
submitted by

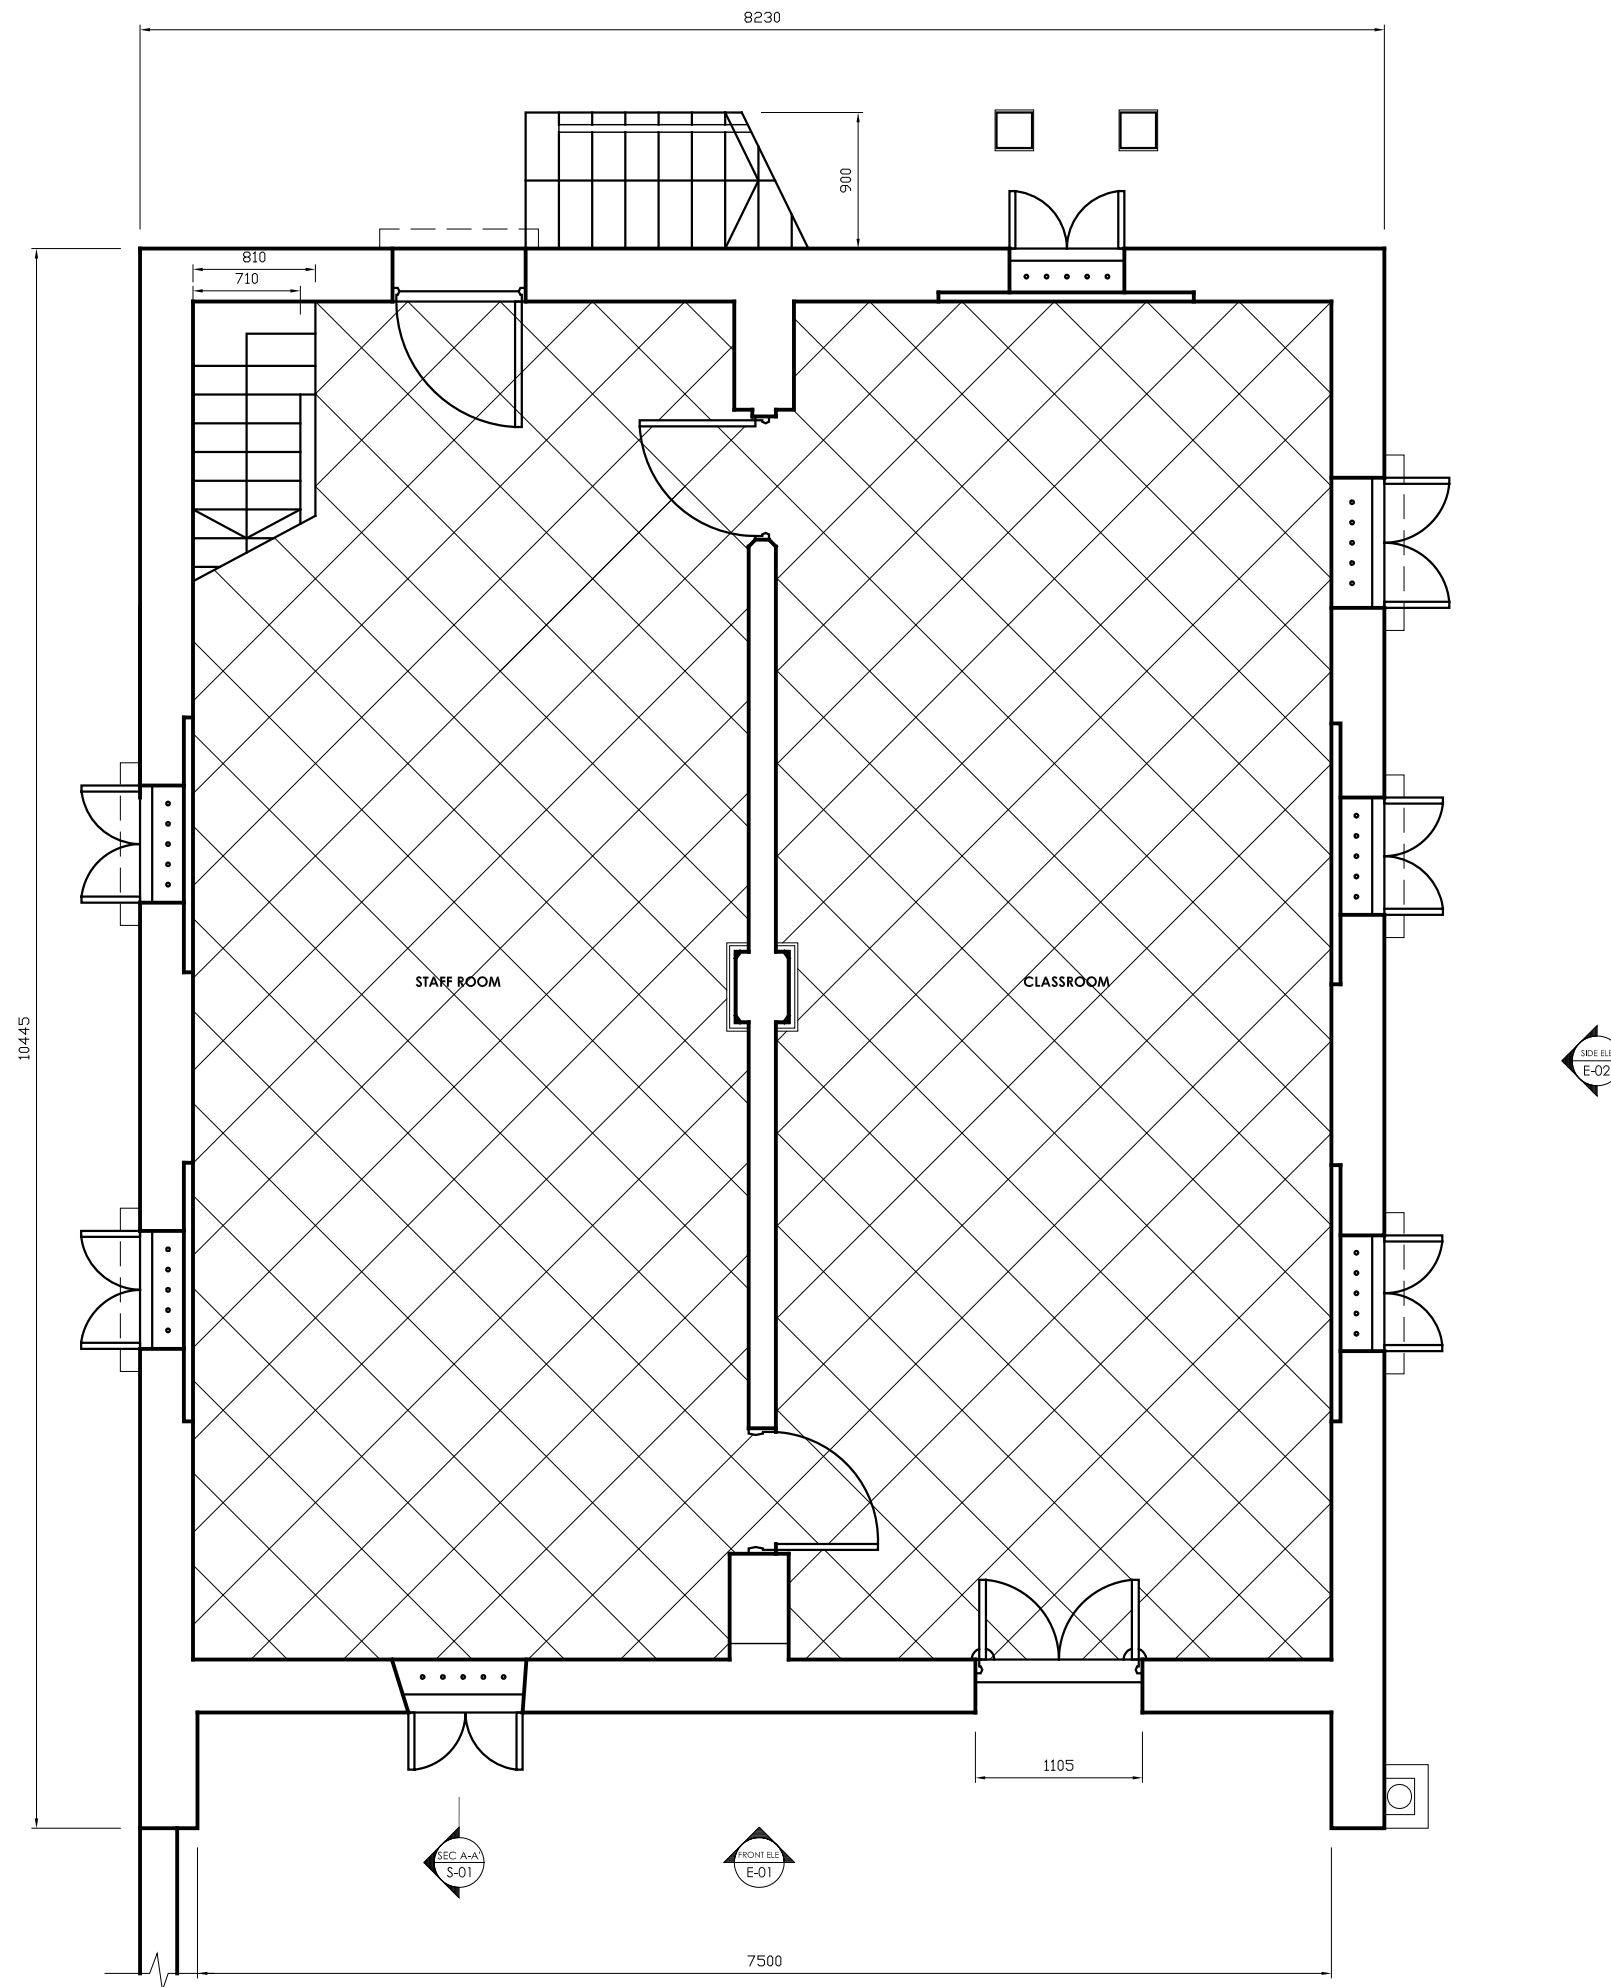
ARCHITECTURAL SERVICES DEPARTMENT
project	CARTOGRAPHIC SURVEY OF FONG YUEN STUDY HALL MA WAN
drawing title	GROUND FLOOR PLAN WITHOUT FORECOURT
scale	1 : 50 (A3)
drawing no	FYS-P-02
date	28 JAN 2008
submitted by

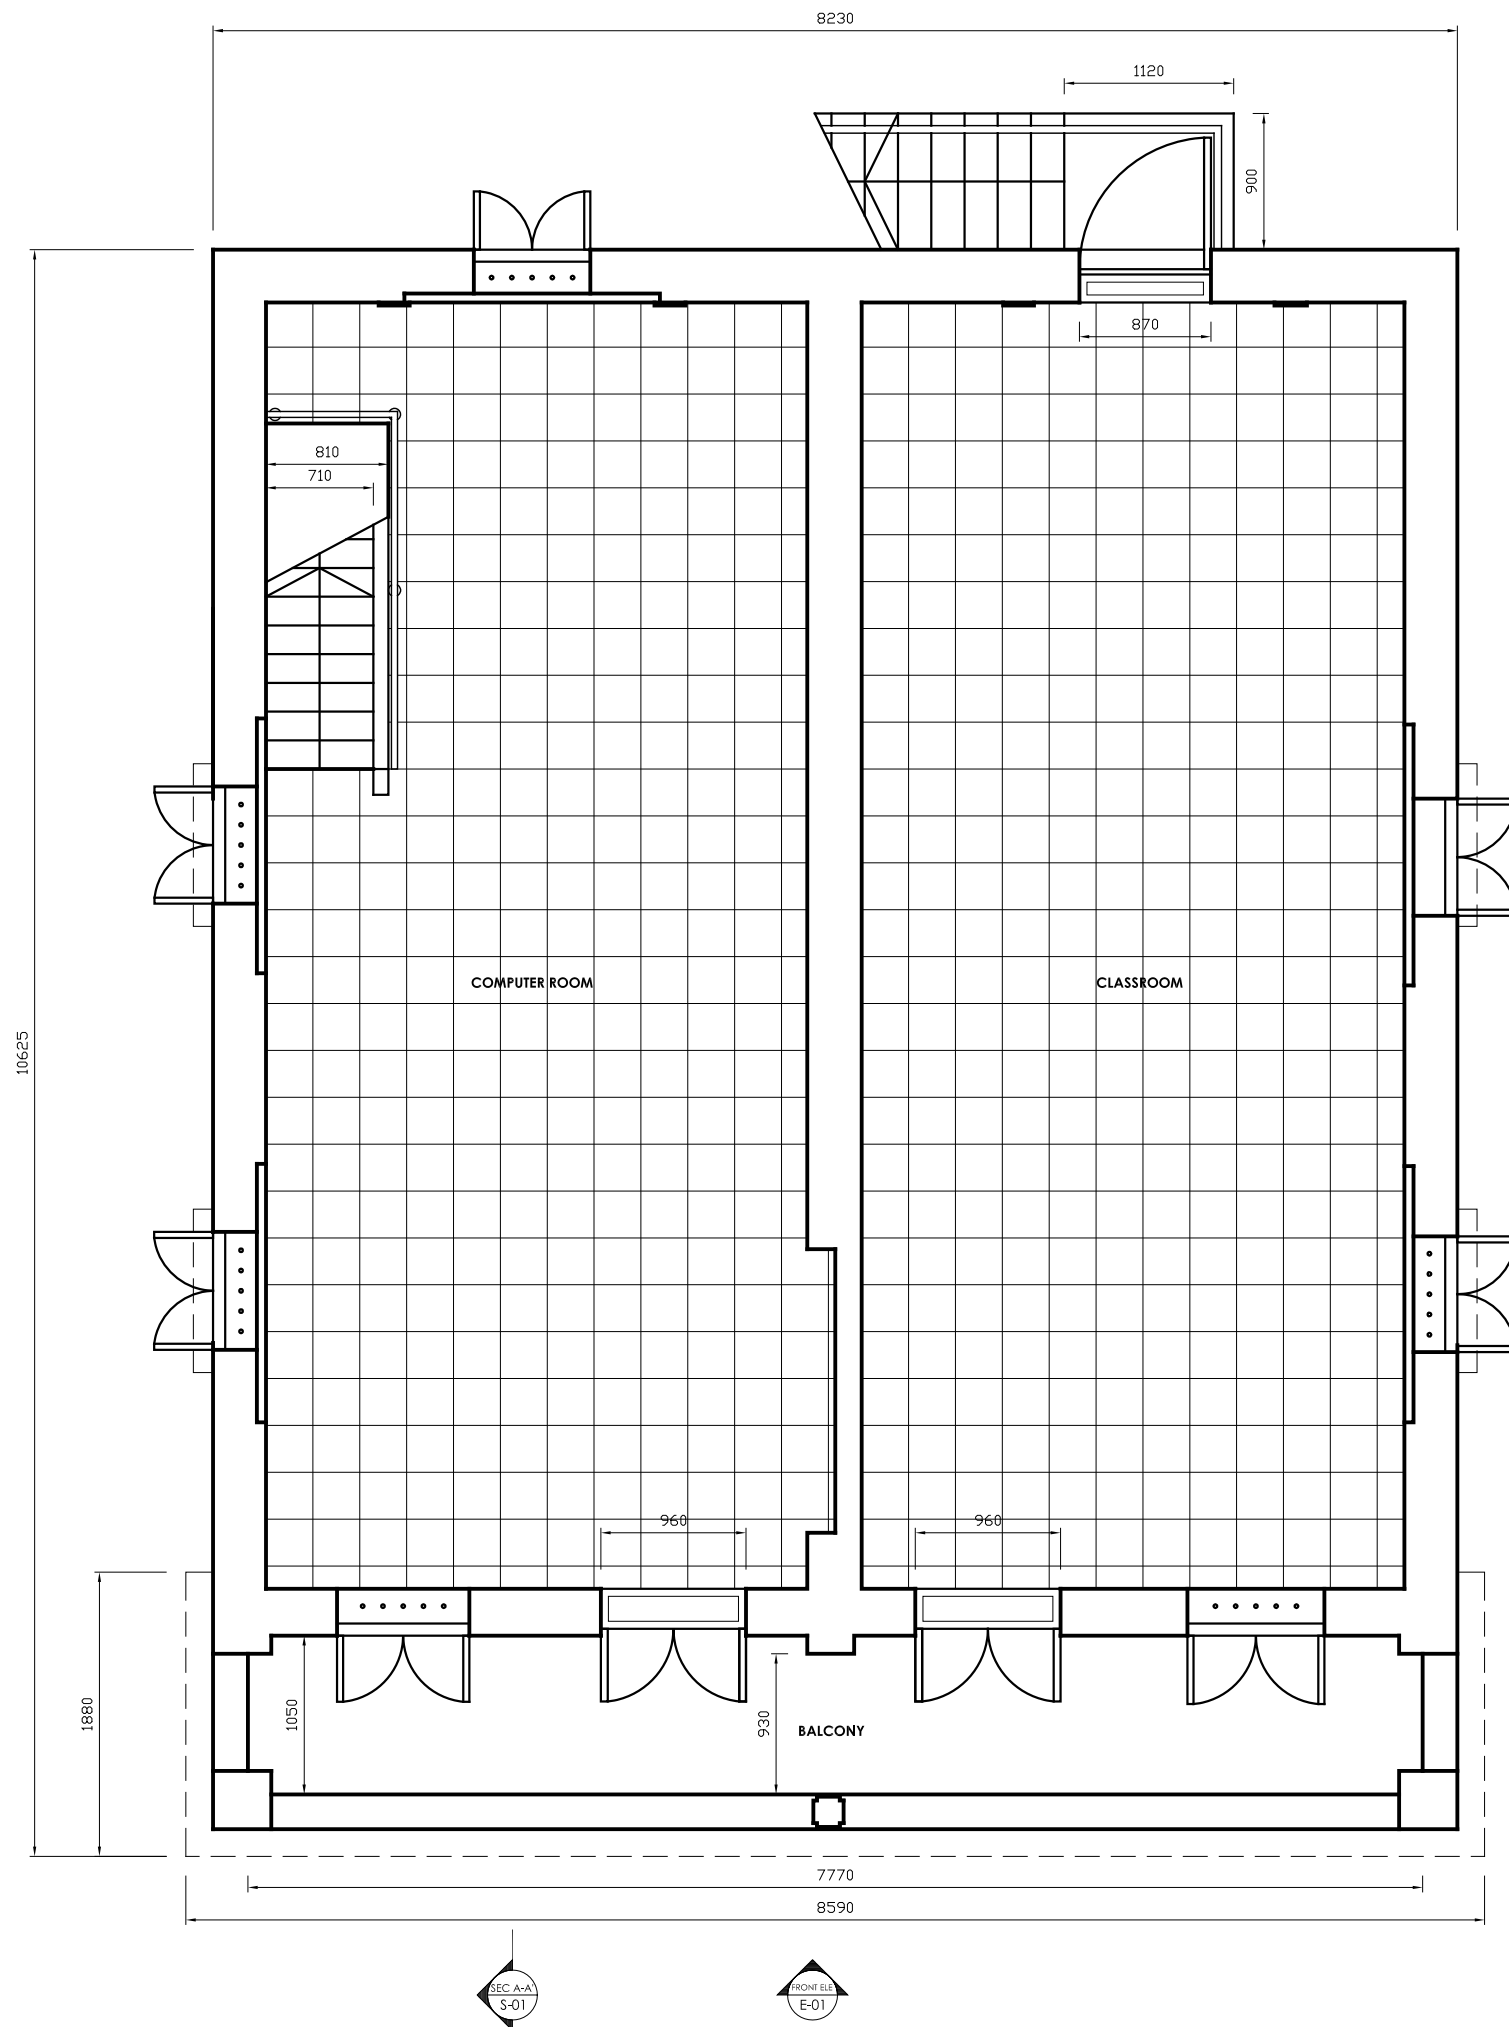
ARCHITECTURAL SERVICES DEPARTMENT
project	CARTOGRAPHIC SURVEY OF FONG YUEN STUDY HALL MA WAN
drawing title	FIRST FLOOR PLAN
scale	1 : 50 (A3)
drawing no	FYS-P-03
date	28 JAN 2008
submitted by

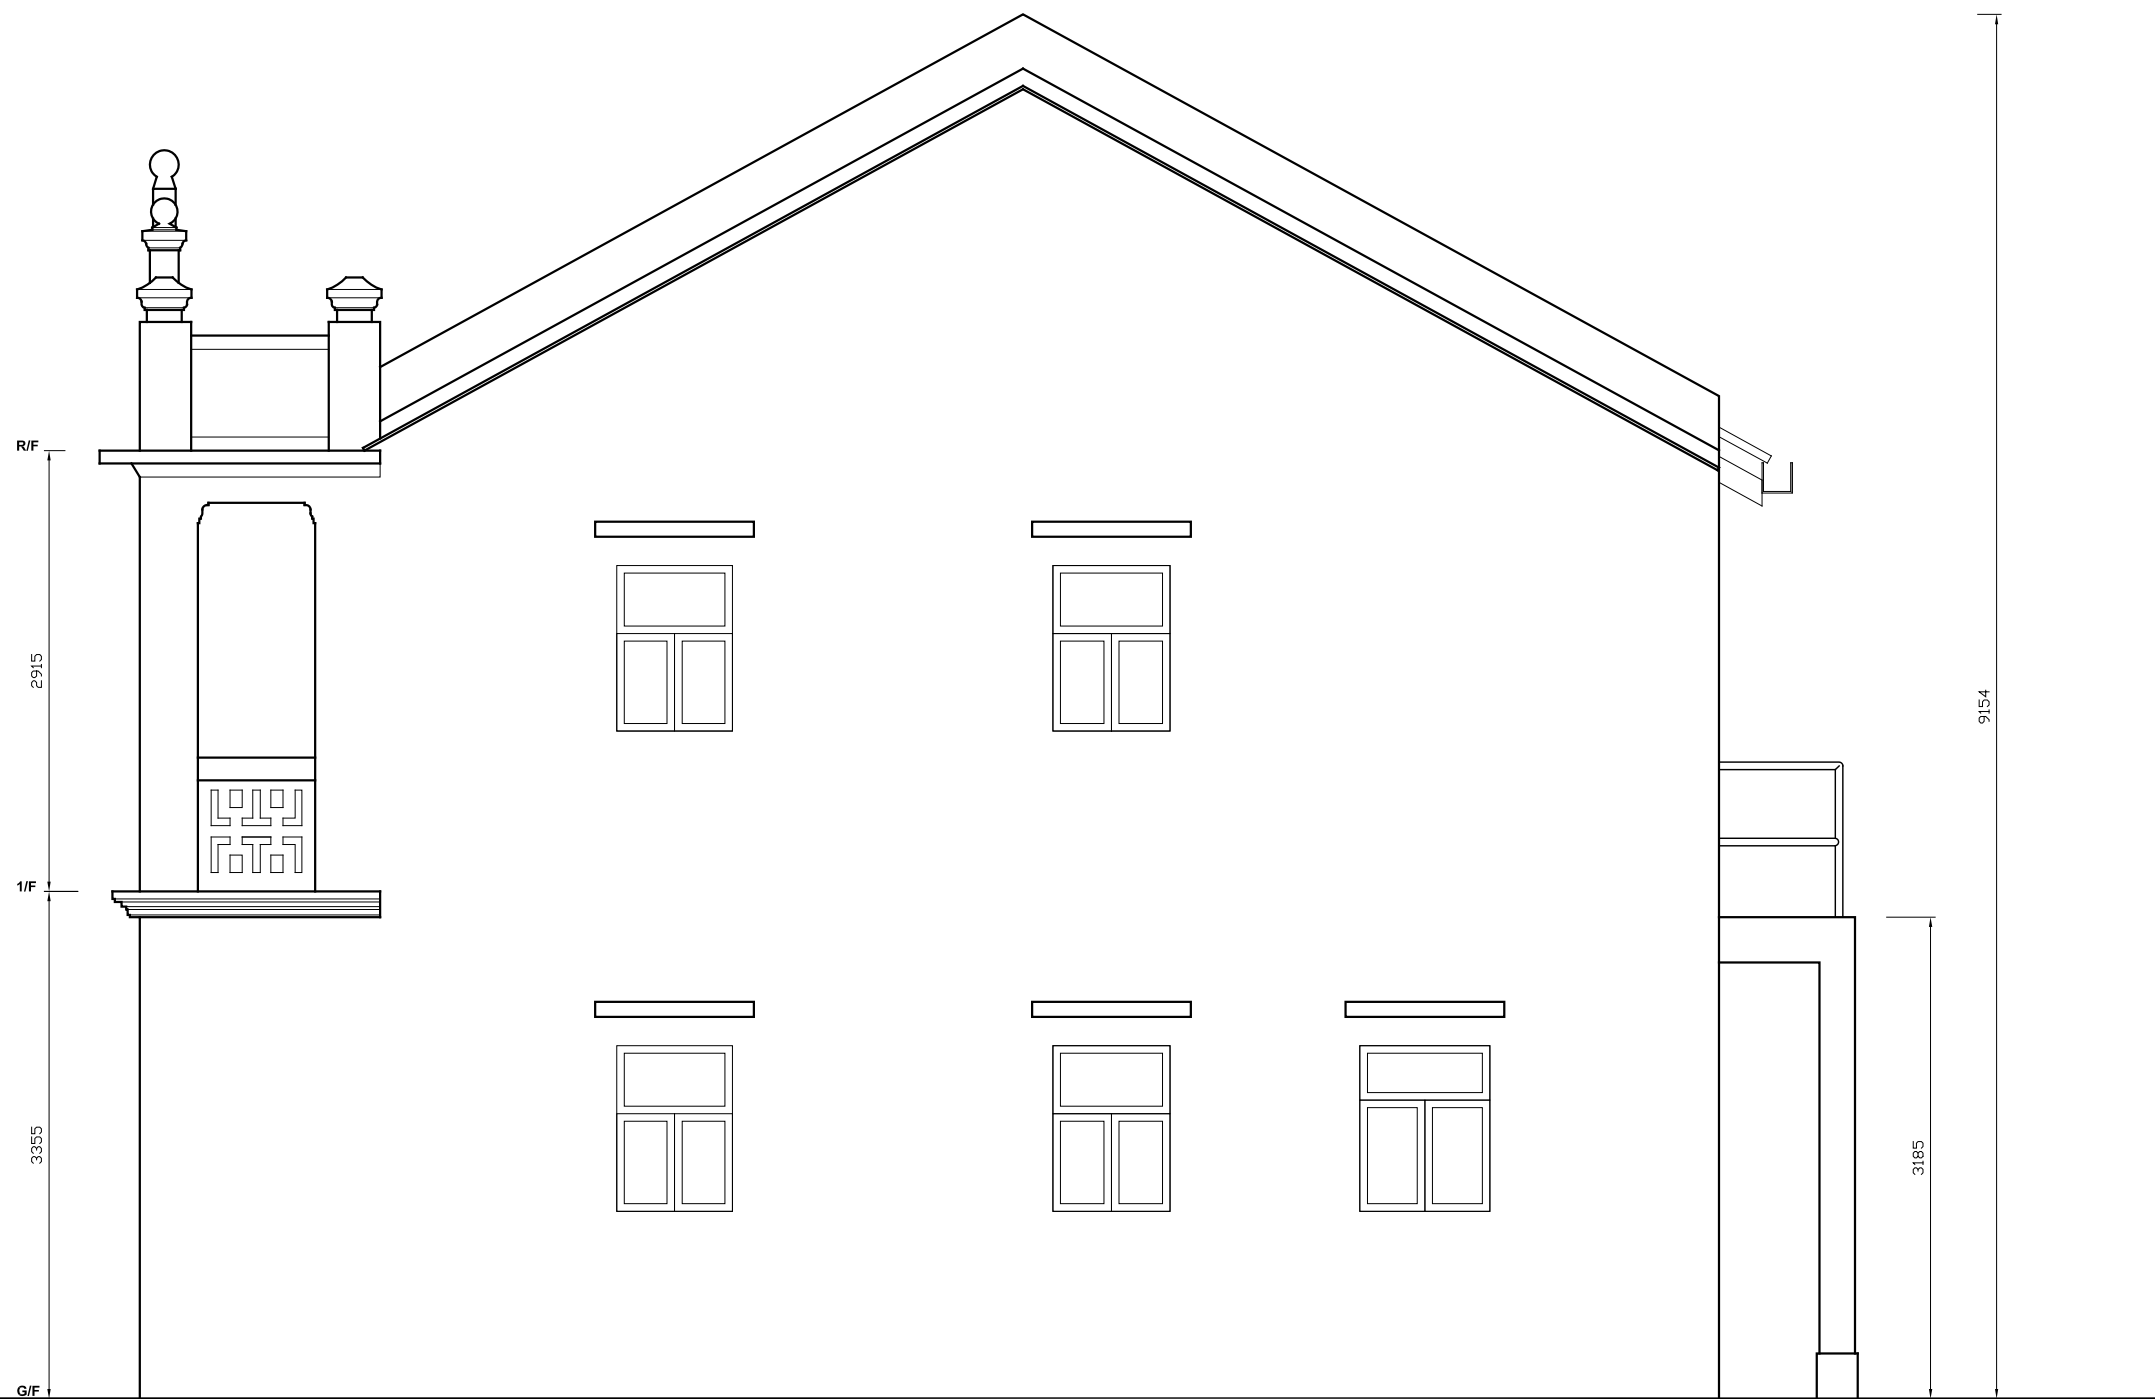
ARCHITECTURAL SERVICES DEPARTMENT
project	CARTOGRAPHIC SURVEY OF FONG YUEN STUDY HALL MA WAN
drawing title	SIDE ELEVATION
scale	1 : 50 (A3)
drawing no	FYS-E-02
date	28 JAN 2008
submitted by

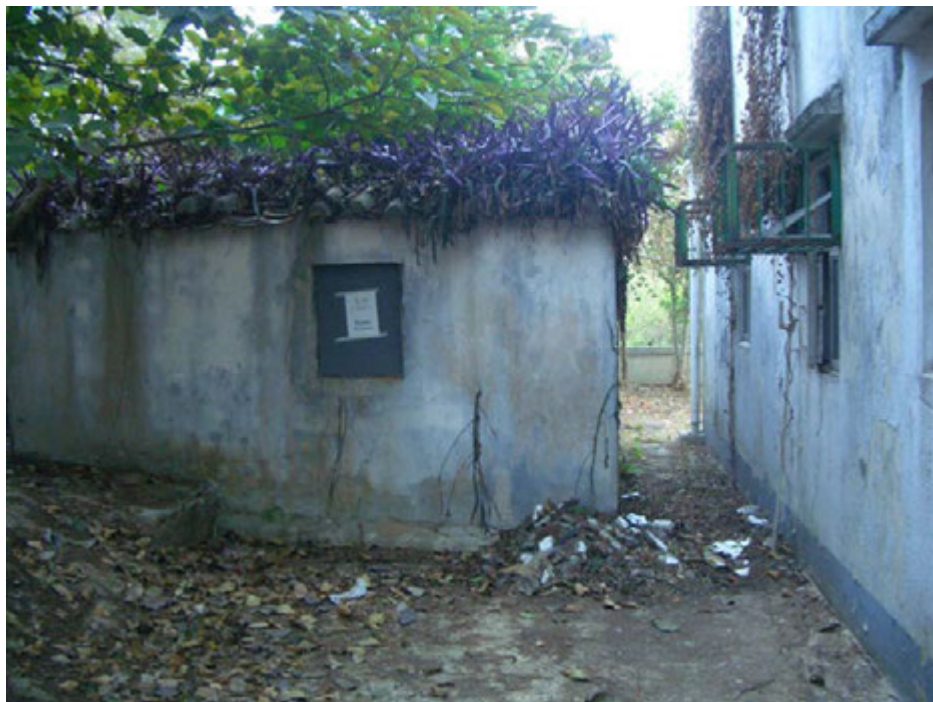
View of one-hall village house

It is said that the one-hall Chinese-styled village house used to be a kitchen annexed to the Study Hall. It is now in ruinous conditions. Its roof is almost totally collapsed while the interior is in a chaotic situation with wild vegetation and broken pieces of the roof structure.

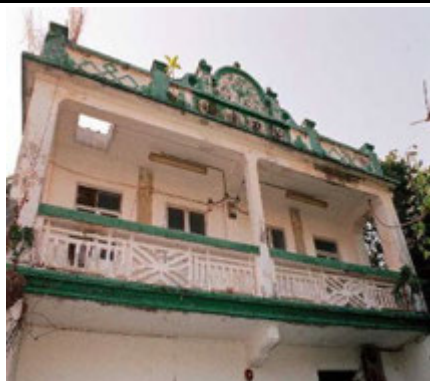
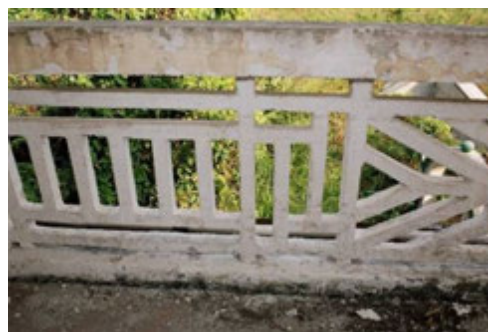
2.6) Open balcony at first floor level on front façade including columns, geometric pattern balustrading and shaped bracket under floor slab

Architectural Feature	Required Treatment
b) Front balcony	Repair cracked and spalling concrete to front balcony balustrading, beams and columns and soffit of floor slab; prepare and paint to match existing. Do not enclose the cantilever balcony.

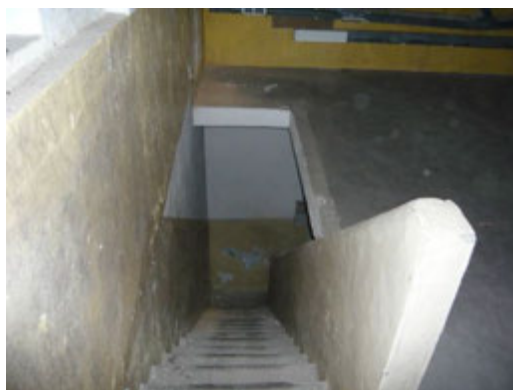
3.3) Straight flight reinforced concrete staircase from ground floor to first floor (Upgrading works to comply with current standards may be permitted)

Architectural Feature	Required Treatment
c) Staircase	May need upgrading in order to comply with fire safety standards and proposals should be submitted to AMO for approval. Alternatively the staircase can be partitioned off and not used.

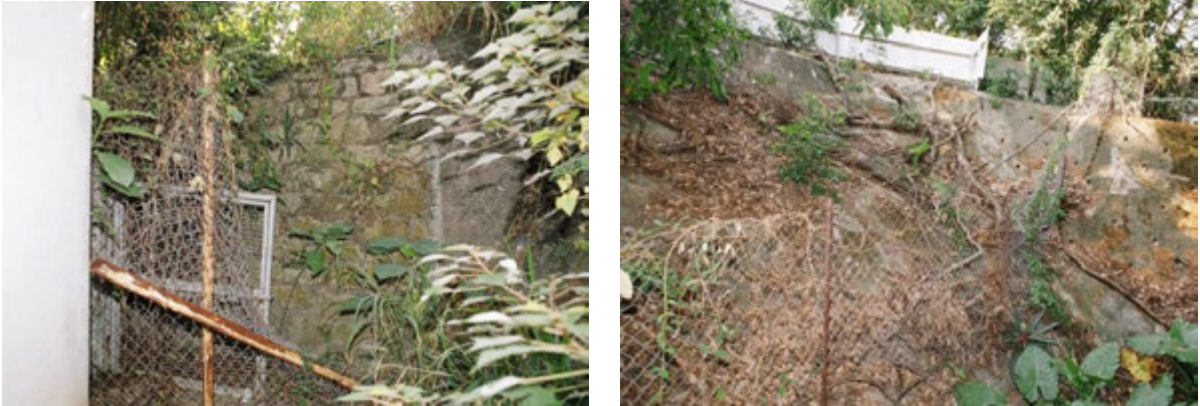
Architectural Feature	Required Treatment
a) Boundary fence	The unsightly chain link fence around the site should be replaced with a new security fence of suitable design.

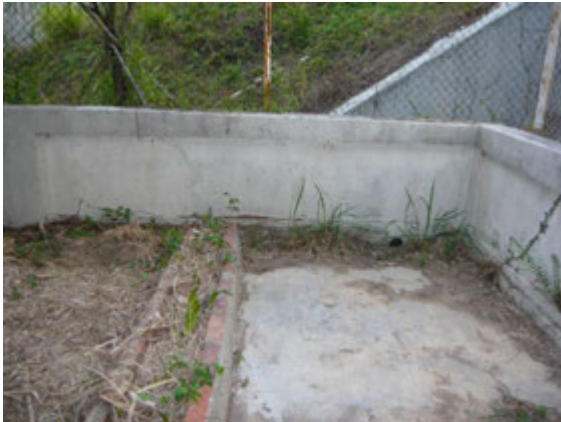
Architectural Feature	Required Treatment
b) Boundary wall	The low boundary wall around the garden shall be repaired and repainted to match existing.

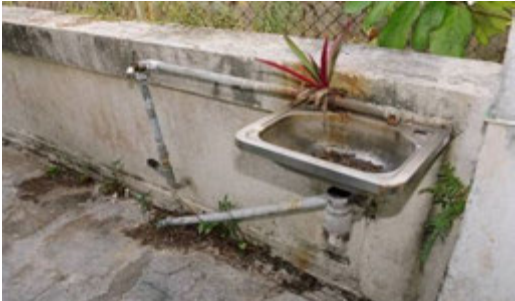
Architectural Feature	Required Treatment
d) Sink	Demolish and clear away old sink and plumbing attached to boundary wall.

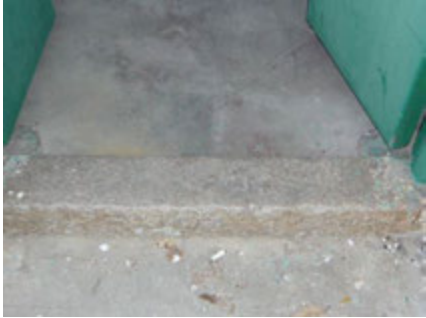
Architectural Feature	Required Treatment
d) Doors	Doors are not original and can be replaced. But the granite threshold to door should be preserved and remain unpainted.

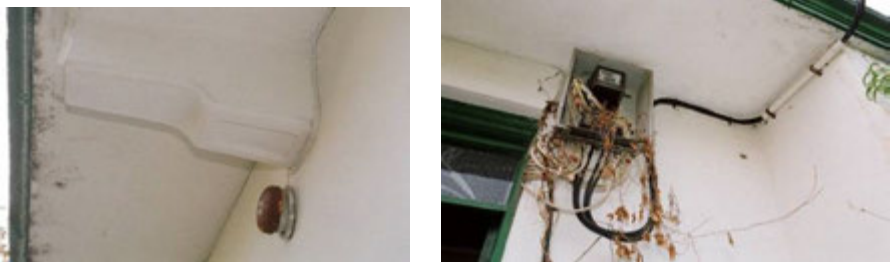
Architectural Feature	Required Treatment
f) Redundant cables	Disconnect and remove redundant cables and make good wall surfaces. Relocate the CLP electricity meter on ground floor.

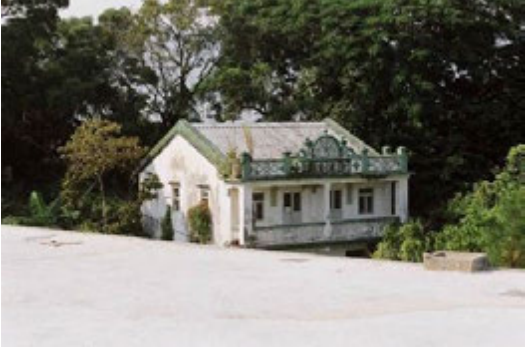
Architectural Feature	Required Treatment
g) Pitched roof	The pitched roof is not original but do not alter the pitch form of the roof.

The roof, that was originally built with ceramic pan tiles supported by timber rafters and purlins, was replaced by metal roofing supported by metal truss in 1998.

There are some steel trusses with steel purlins erected for supporting the roof. It is estimated that the original roof had been replaced and some strengthening works carried out at an intermediate date in its history.

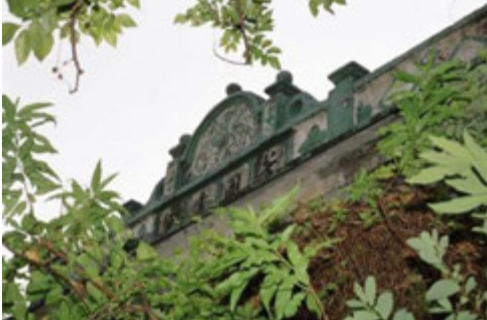
Architectural Feature	Required Treatment
i) Ornamental parapet wall to flat roof	Repair any spalling plaster; restore and repaint mouldings and features.

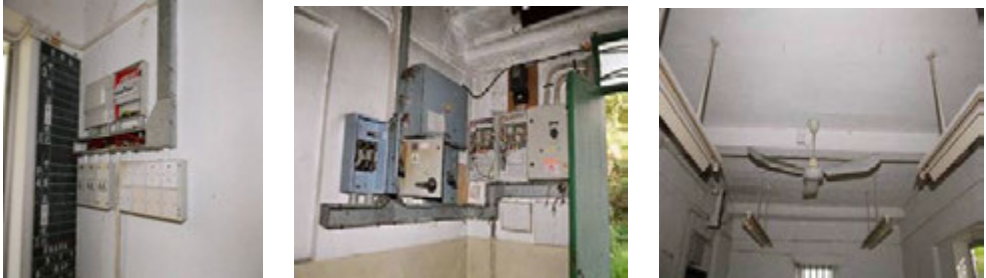
Architectural Feature	Required Treatment
a) Redundant cables and conduit, ducting, switch boxes, distribution boards, light fittings, ceiling fans etc.	Disconnect and remove redundant building services installations, rewire as necessary and make good wall surfaces.

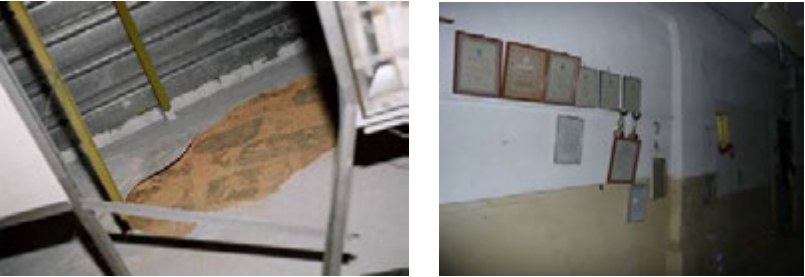
Architectural Feature	Required Treatment
b) Walls	Repair spalling plaster, holes and cracks and repaint surfaces. The front part of the middle partition wall on the upper floor may be latter addition and can be demolished, subject to the advice of a Registered Structural Engineer.

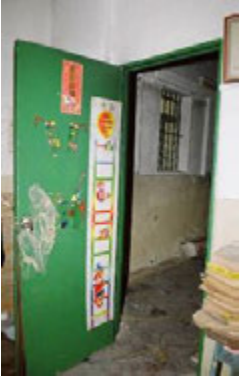
Architectural Feature	Required Treatment
d) Flush doors	Internal flush doors should be repaired/replaced and painted to match existing.

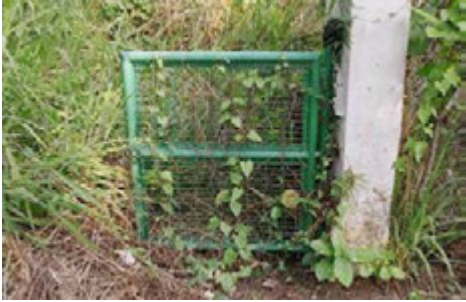
Architectural Feature	Recommended Treatment
a) Entrance gates	The entrance gates are not original and recommended to be replaced with new gates of suitable design.

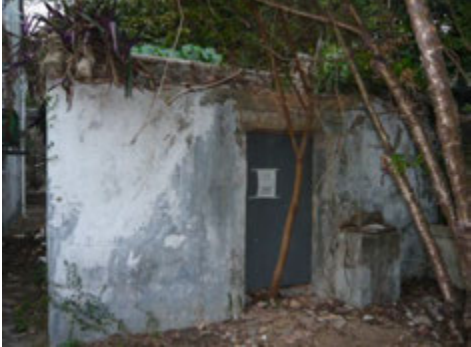
Architectural Feature	Recommended Treatment
b) Kitchen Annex	Recommended to be demolished for safety reasons and the resulting debris cleared away, or restored if required.

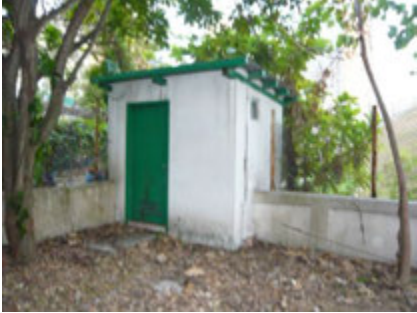
Architectural Feature	Recommended Treatment
c) Toilet Annex	The Toilet Annex does not appear to be a historic building. But in view its good conditions, it is recommended to keep and re-use the building for e.g. plant room or alike. Do not cause any disturbance to the large tree beside the toilet in the forecourt.

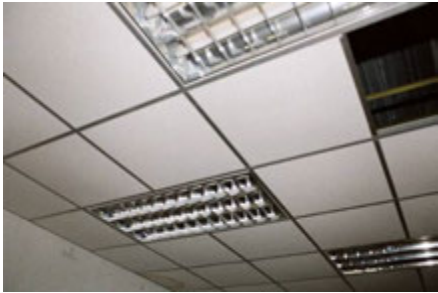
Architectural Feature	Recommended Treatment
a) First floor suspended ceiling and light fittings	Recommended to be removed to expose the pitched form of the roof, if functionally not required.

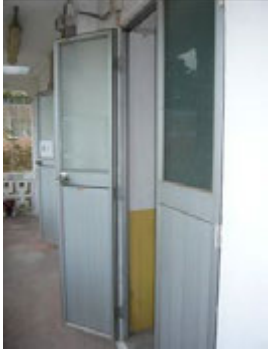
Architectural Feature	Recommended Treatment
c) Doors (including balcony doors)	Aluminum doors are not original and recommended to be replaced by timber doors of traditional style of the period.
