**Revitalising Historic Buildings
Through Partnership Scheme**

Old Tai Po Police Station

Resource Kit

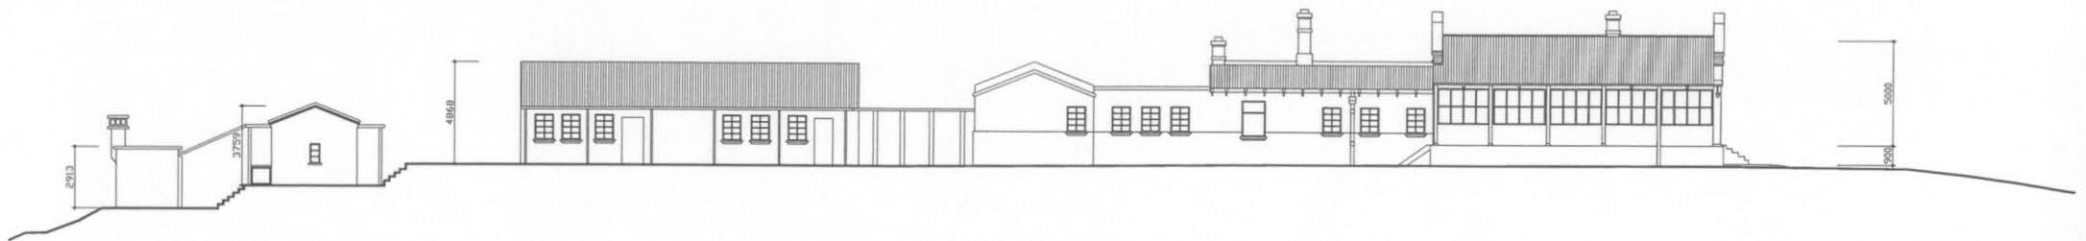
SOUTH ELEVATION

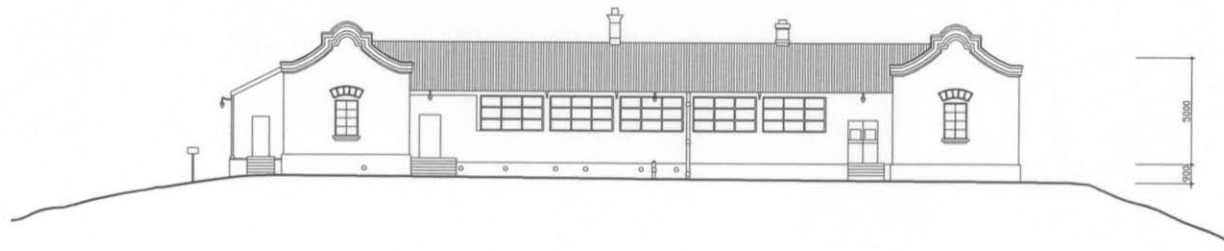
EAST ELEVATION

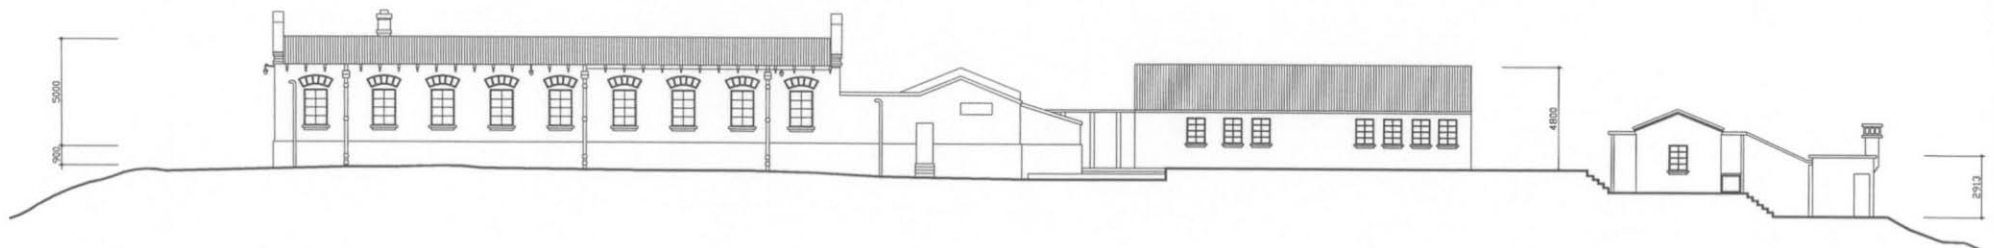
NORTH ELEVATION

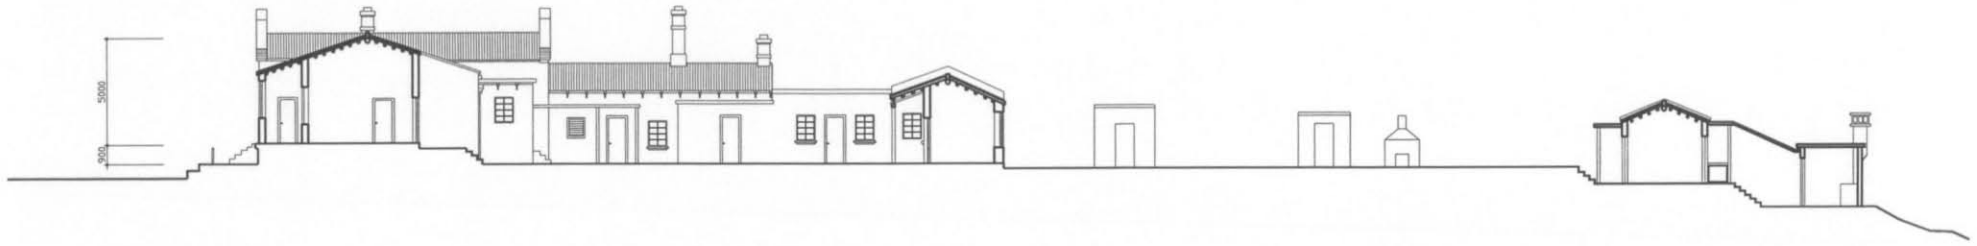
SECTION A

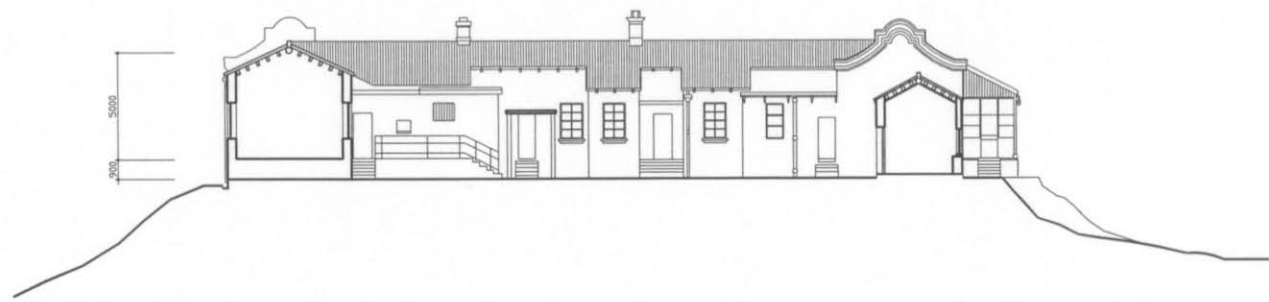
SECTION B

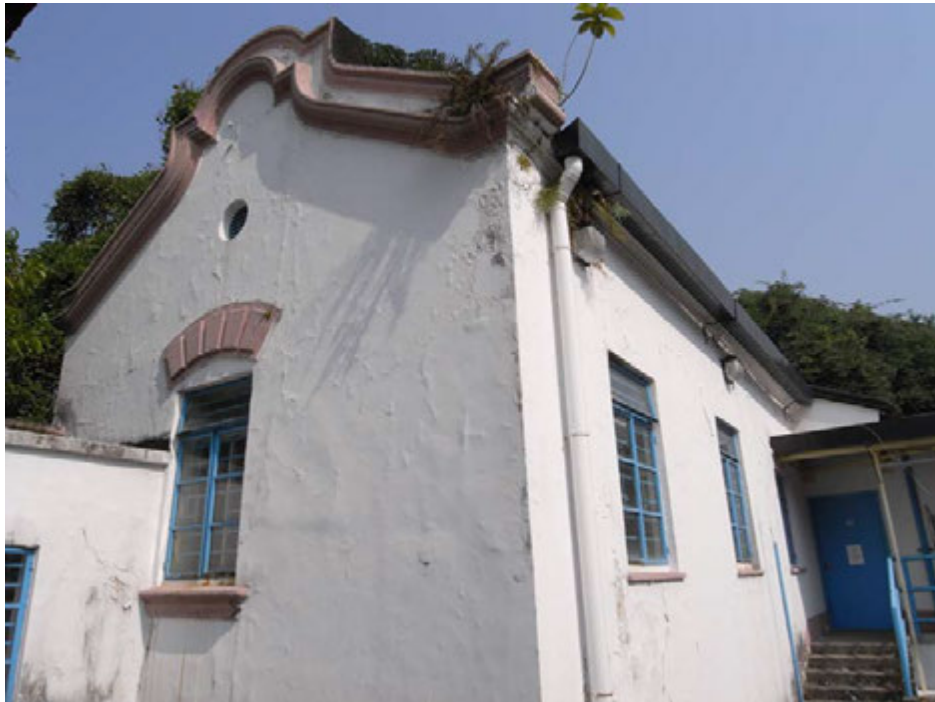
View of cat-arched gable wall at internal courtyard of Main Building

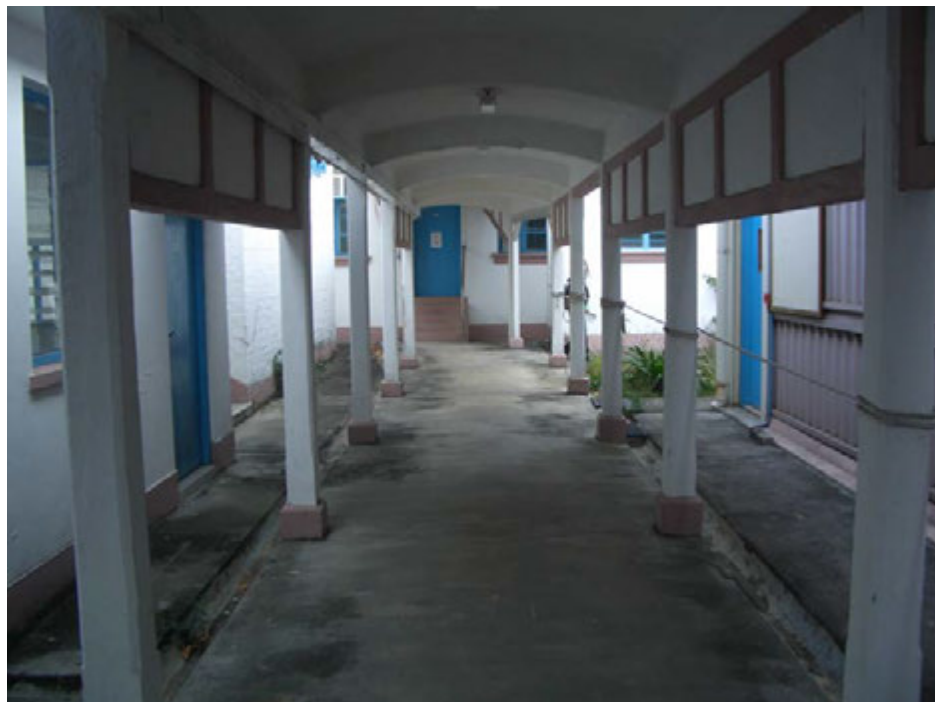
View of corridor at internal courtyard of Main Building

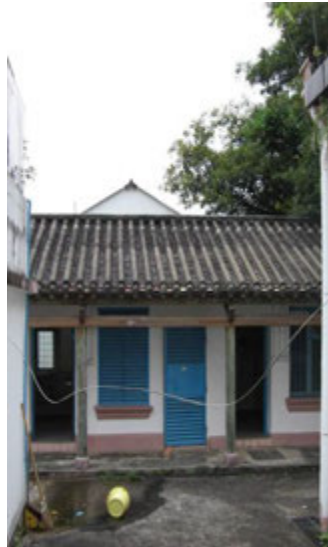
1.8) Plaster mouldings to gable wall of the roof of the North Wing

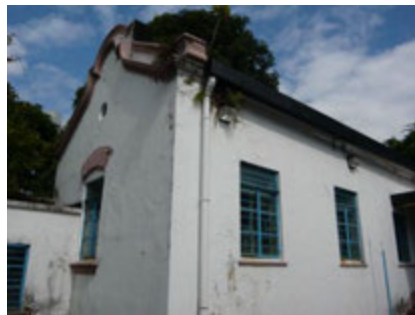
1.10) Cast iron drain pipe and hopper head, located outside the Cell Unit at Rear Wing

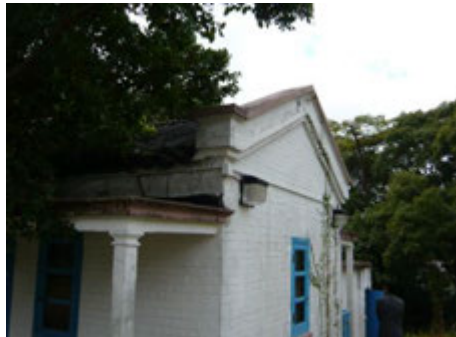
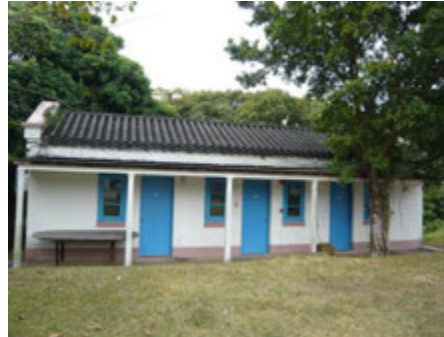
2.1) Chinese pitched roof, timber truss details and tile works

Structurally, the roofs of the Main Building are in good conditions. However, if the steel roofs need to be replaced in future, it is recommended that timber construction, based on the roof of the Staff Quarters Block, be used as a reference. If replacement of the roof is carried out, further structural investigation should be carried out for such works.

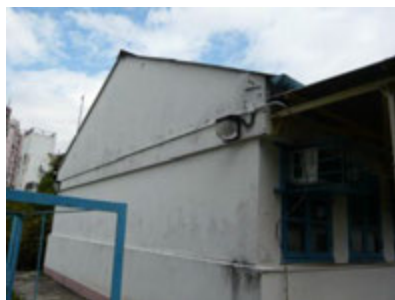
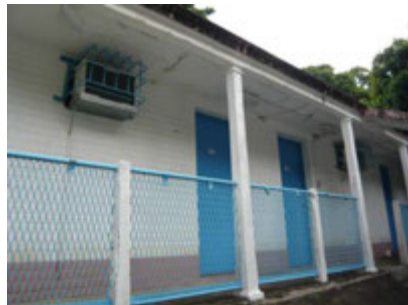
2.2) Painted external walls with brickwork texture

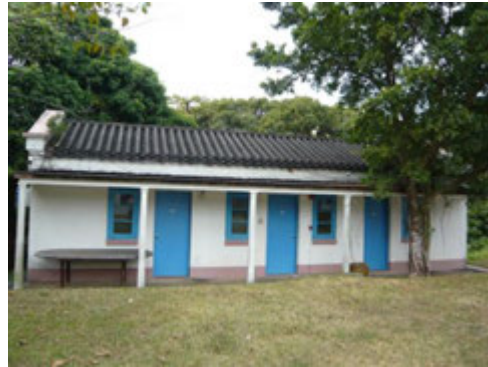
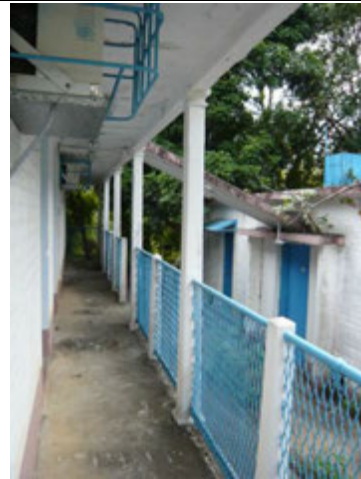
2.3) Open verandahs along front and rear elevations and the tapered columns

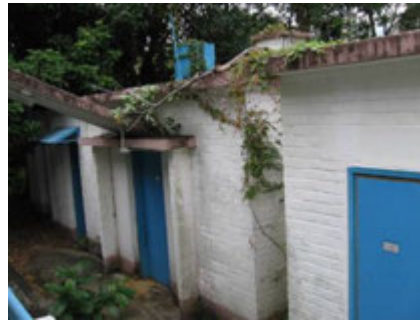
2.4) Toilet/ Kitchen Annex attached to the rear of the building

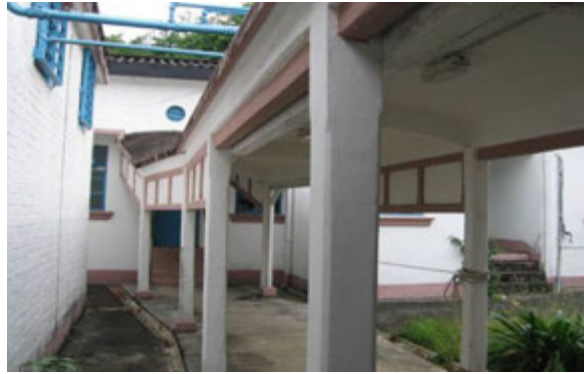
3.1) Covered walkway attached to the Main Building

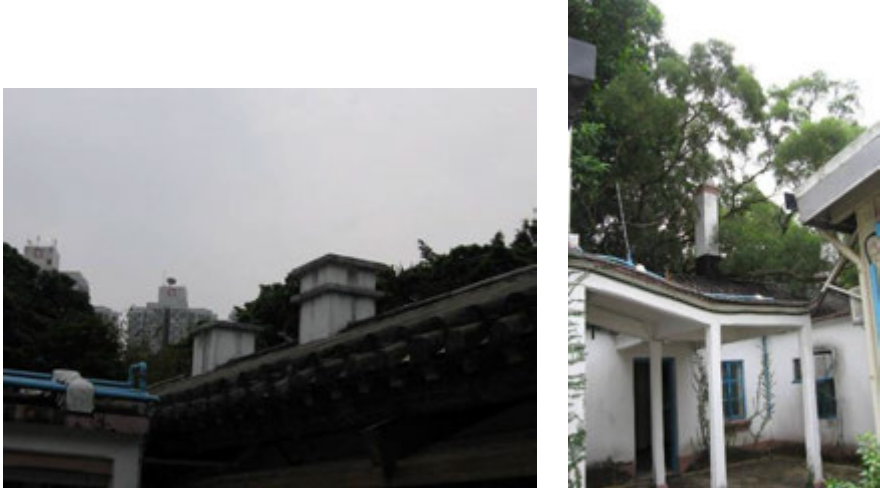
Architectural Feature	Required Treatment
b) Rendered brick chimney stacks (4 nos)	Clean down and repaint to match existing; permanent coating systems are not permitted.

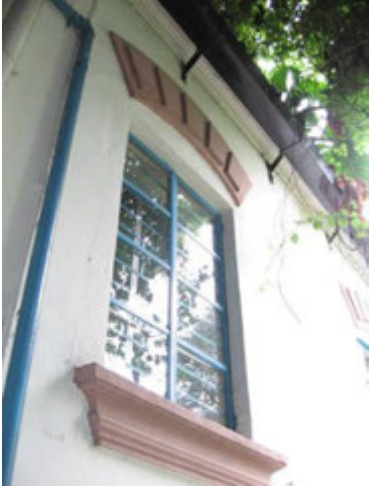
Architectural Feature	Required Treatment
c) Ornamental window arches and window cills (presently painted red colour)	Carefully remove the red paint, in order to expose the original brick surfaces of the arches and cills. Window openings should not be enlarged.

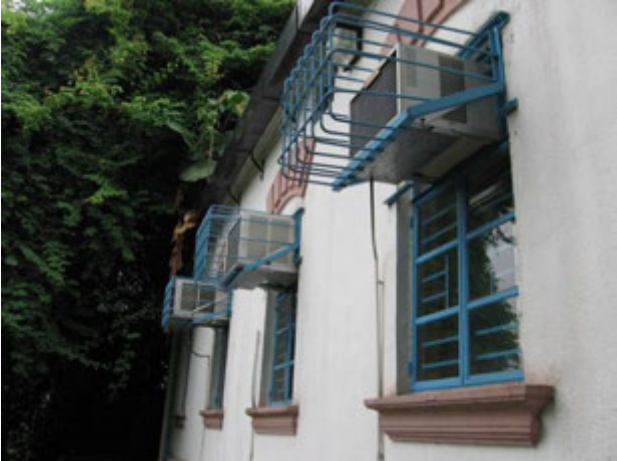
Architectural Feature	Required Treatment
d) Window mounted air conditioning units	Remove air conditioners and make-good window frames where disturbed. Where new air-conditioning units are required they should be provided in less obvious locations or by discrete split-unit type.

Building Services	Existing Provisions
MVAC Installation	■ Window type room coolers are installed. According to the Conservation Guidelines, they must be removed. New split-type air conditioning to be installed at less obvious locations.

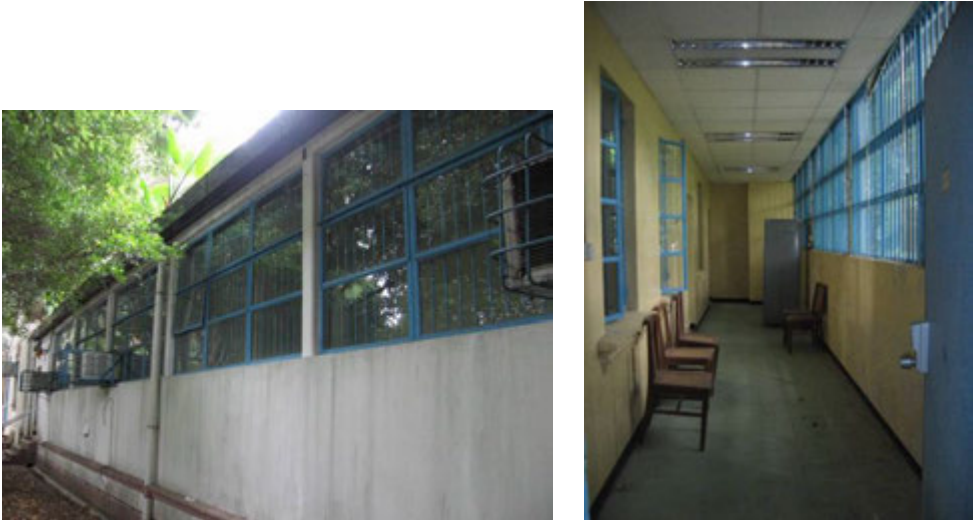
Architectural Feature	Required Treatment
<p>e) Original open verandah at front elevations (East)</p>	<p>The old verandah has been modernized by addition of modern metal windows and brick enclosures, so there is no objection to the removal of the windows or to re-instating the original open-air nature of the verandahs. If re-instate, the balustrade should be reconstructed and original windows along verandah should be reconstructed with reference to the Staff Quarters.</p>

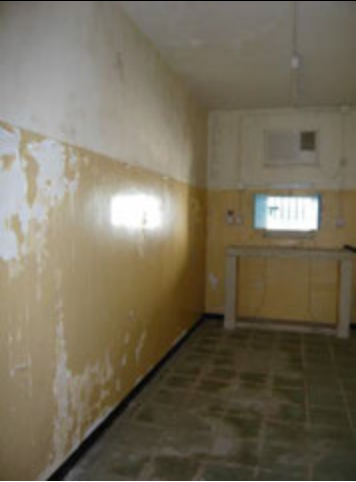
Architectural Feature	Required Treatment
g) Armoury	To be re-used, cleaned and maintained. The metal door and the opening for gun loading should retain unaltered.

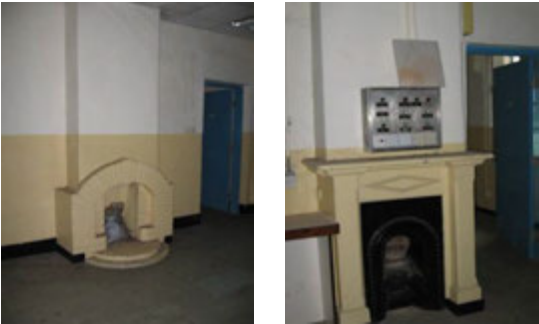
Architectural Feature	Required Treatment
h) Fireplaces inside the building	All fireplaces to be retained in-situ. They should be opened up if blocked and restored with same materials.

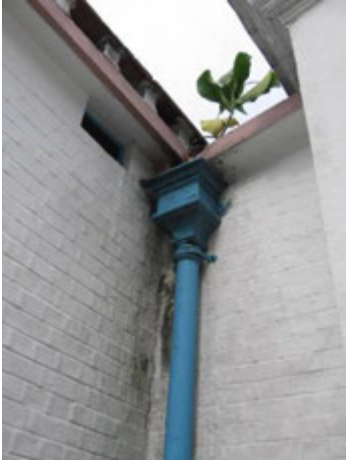
Architectural Feature	Required Treatment
i) Cast iron drain pipe and hopper head, located outside the Cell Unit at Rear Wing.	To remove vegetation in the pipes to prevent blockage of drains that may cause water entering into the walls

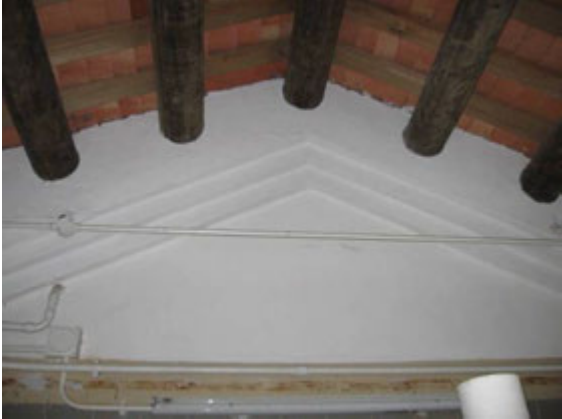
Architectural Feature	Required Treatment
j) Beams, truss system and roof	To install termite monitoring system to all timber areas. The roof structure using steel truss and purlins should be removed and replaced by timber roof system. Reference should be made to the roof construction at the Staff Quarters.

Owing to damage to the original roof of the Main Building, all the timber pitched roofs of its front and rear portions were replaced with steel truss and purlins, laid with roof tiles to match the original profile. However, no proper cartographic record of the original timber roof truss was carried out before its demolition.

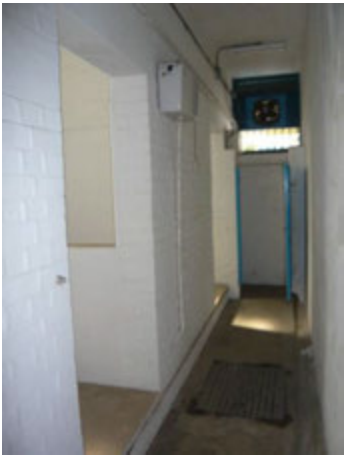
Architectural Feature	Required Treatment
k) Internal walls	No or minimum openings to load-bearing walls should be carried out unless with approval from AMO.

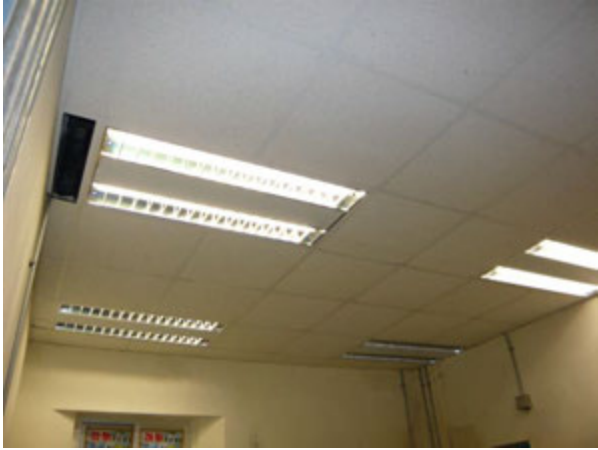
Architectural Feature	Required Treatment
m) Ceilings	Remove suspended ceiling to check roof leakage. No objection to reinstating them if necessary.

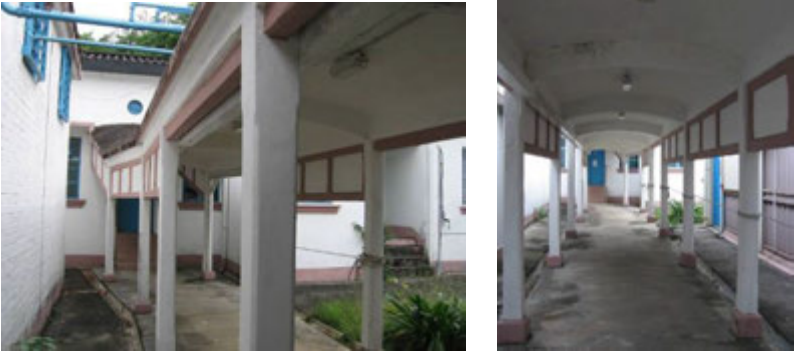
Architectural Feature	Required Treatment
n) Covered walkway attached to the Main Building	This appears to be an original structure that should be retained in-situ, repaired and repainted as necessary. However, modern additions should be removed.

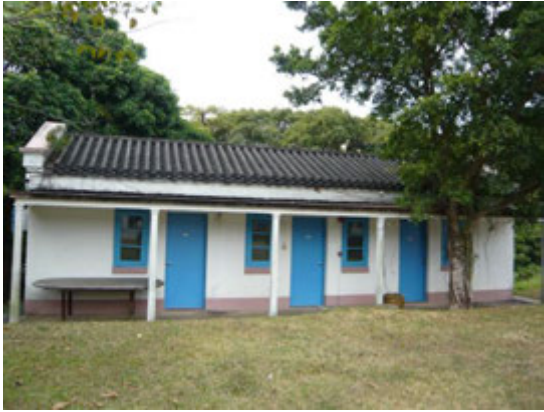
Architectural Feature	Required Treatment
a) Chinese pitched roof	The pitched roof style and form should be retained. Remove vegetation and check for any loose roof tiles and replace as necessary.

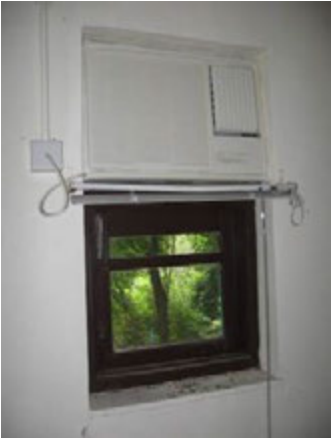
Architectural Feature	Required Treatment
c) Windows	Remove existing wall mounted air conditioning units and make-good to brickwork. Any replacement air-conditioning units required should be provided in less obvious locations (e.g. at rear of building)

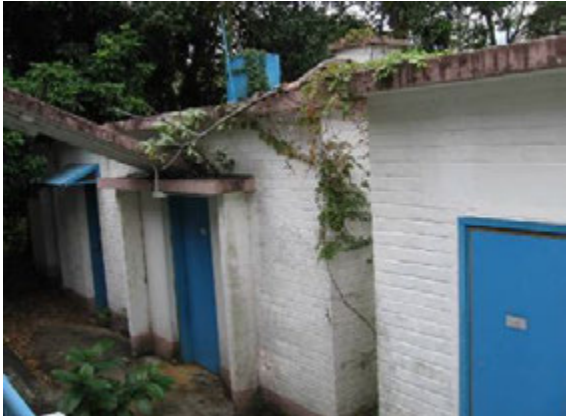
Architectural Feature	Required Treatment
d) Toilet/ Kitchen Annex attached to the rear of the building	Repair these small buildings, which are part of the original complex. Clean down and repaint by reversible paints.

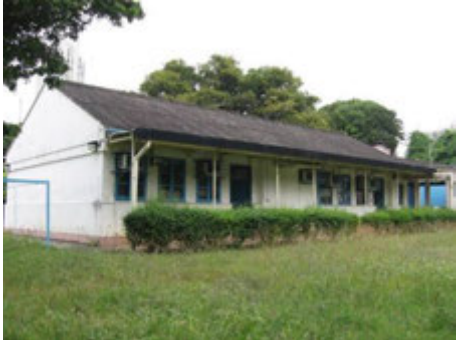
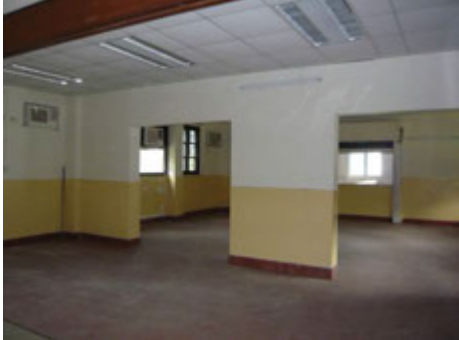
Architectural Feature	Required Treatment
<p>a) This single storey block is considered less historic, however the open verandah must be retained in order to harmonize with the overall style of the remainder of buildings on-site.</p>	<p>There is no objection, on heritage grounds to major internal changes, providing the structural stability of the building is not affected. The modern corrugated roof may be replaced if necessary by a more compatible roof covering. The proposed external redecoration should also be in keeping with the historic appearance of the site. Kitchen facilities may be stripped out if not required; walls and floor surface should be made good.</p>

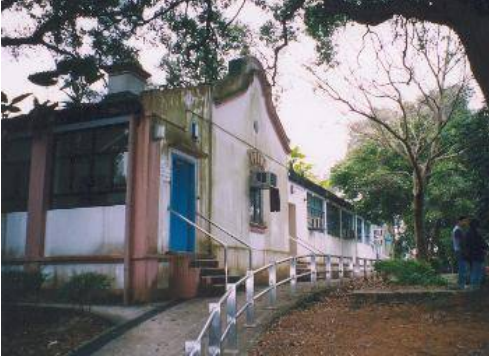
Architectural Feature	Required Treatment
b) Post fencing along the footpath leading to the site	Repair and replace defective bars and posts where necessary. However, no objection to replacing by new fence if necessary.

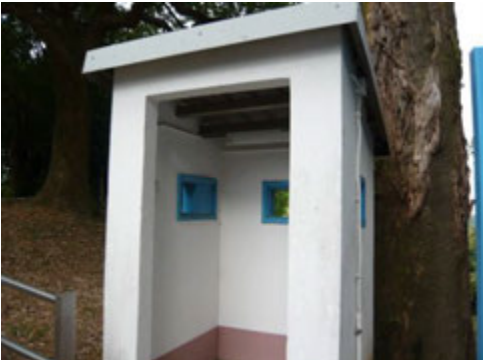
Architectural Feature	Required Treatment
d) Entrance guard post	Repaint and maintain

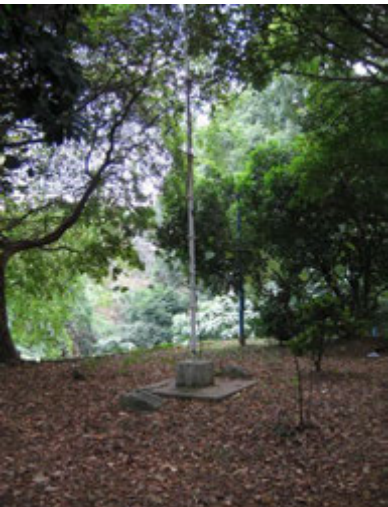
Architectural Feature	Required Treatment
e) Flagpole and Cannon rests	The flagpole at frontyard should be retained and maintained. The two rests for original cannons should be retained.

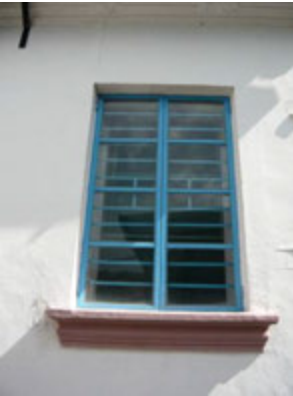
Architectural Feature	Required Treatment
a) Window frames	It is recommended that all external windows be reconstructed with timber frames in order to reveal the historic outlook of the building. Design can be referred to design of the same period. Good reference can be made to the Staff Quarters.

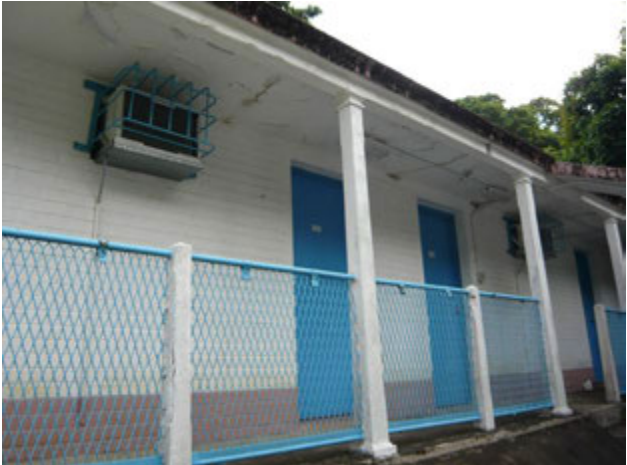
Architectural Feature	Required Treatment
a) External painted brick wall	Recommended to remove white paint from face of brickwork to expose original face of red bricks.

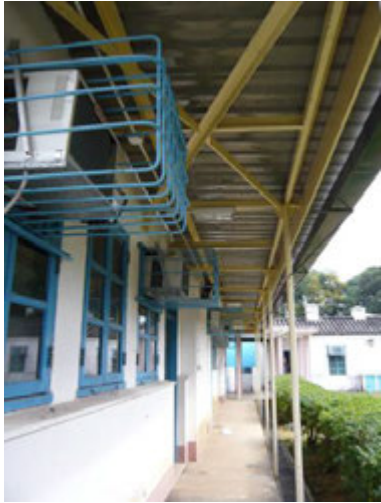
Architectural Feature	Required Treatment
a) Steel canopy structure	Recommended to reconstruct by timber structure similar to that of the Staff Quarters in order to harmonize with the overall style of the remainder of buildings on-site.

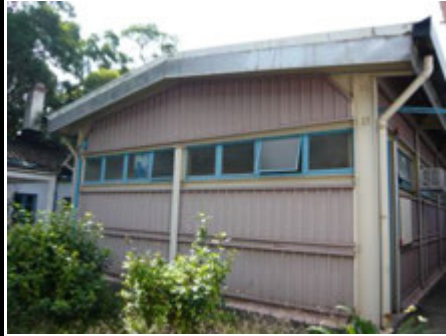
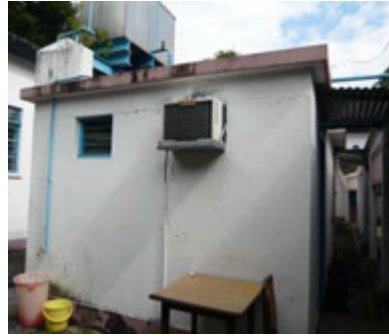
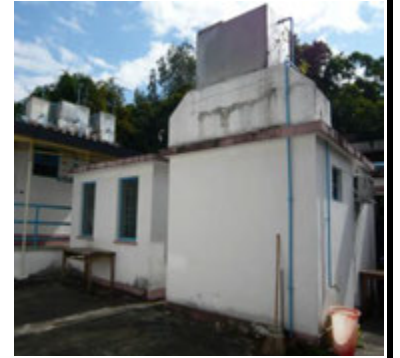
Architectural Feature	Required Treatment
b) Four outbuildings at main building openyard	They have no historic interest and recommended to be demolished in order to improve passage circulation and overall historic appearance of the site
