**Revitalising Historic Buildings**

**Lady Ho Tung Welfare Centre**

**Resource Kit**

Date: 16 December 2013

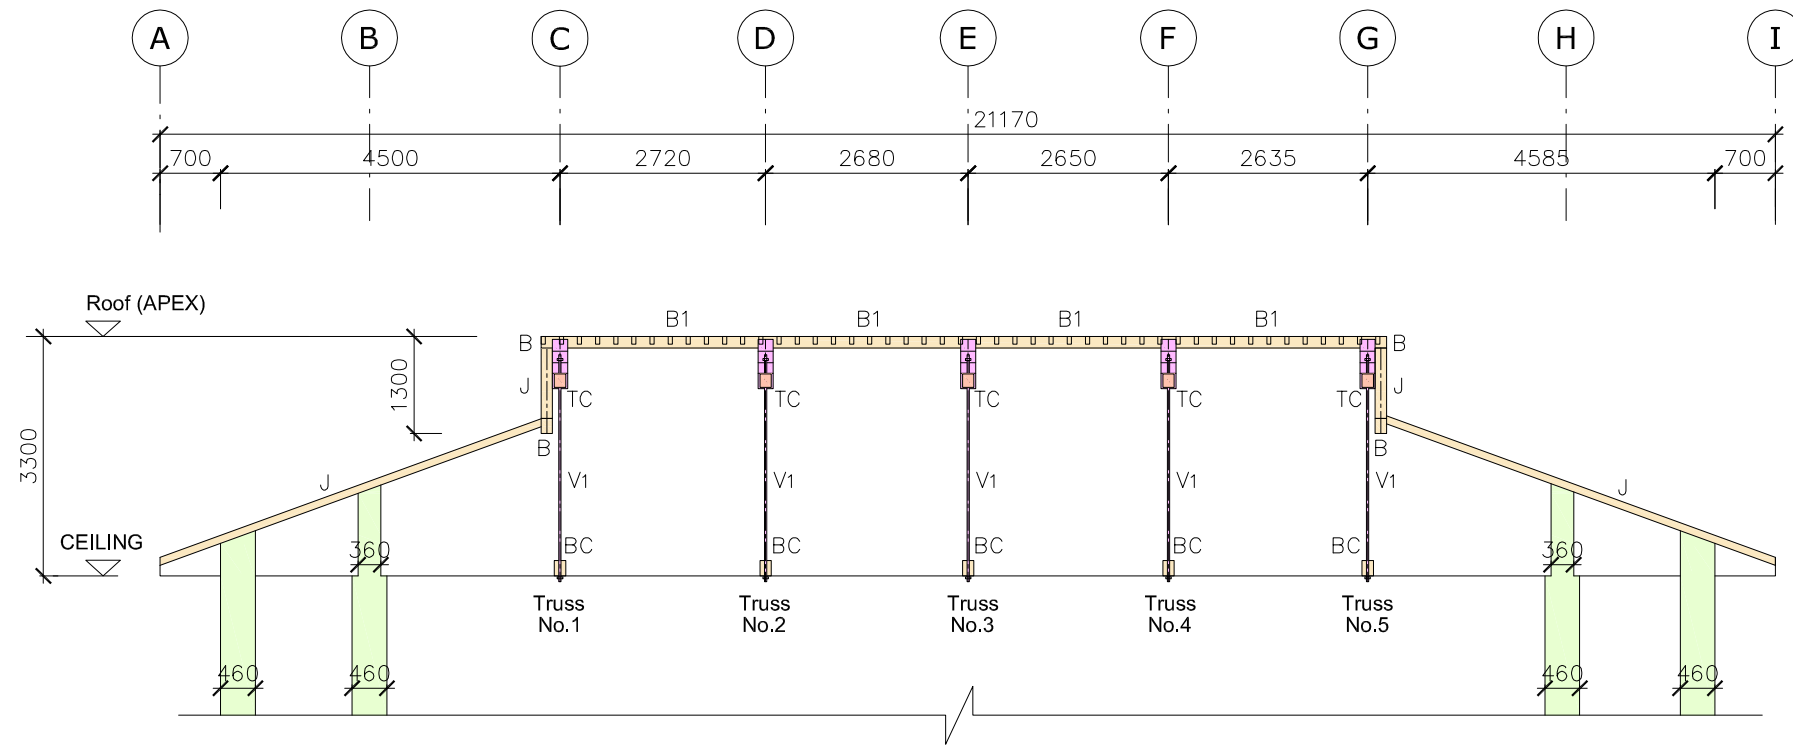
**SECTION X1-X1(MAIN BLOCK)**  
SCALE 1 : 100

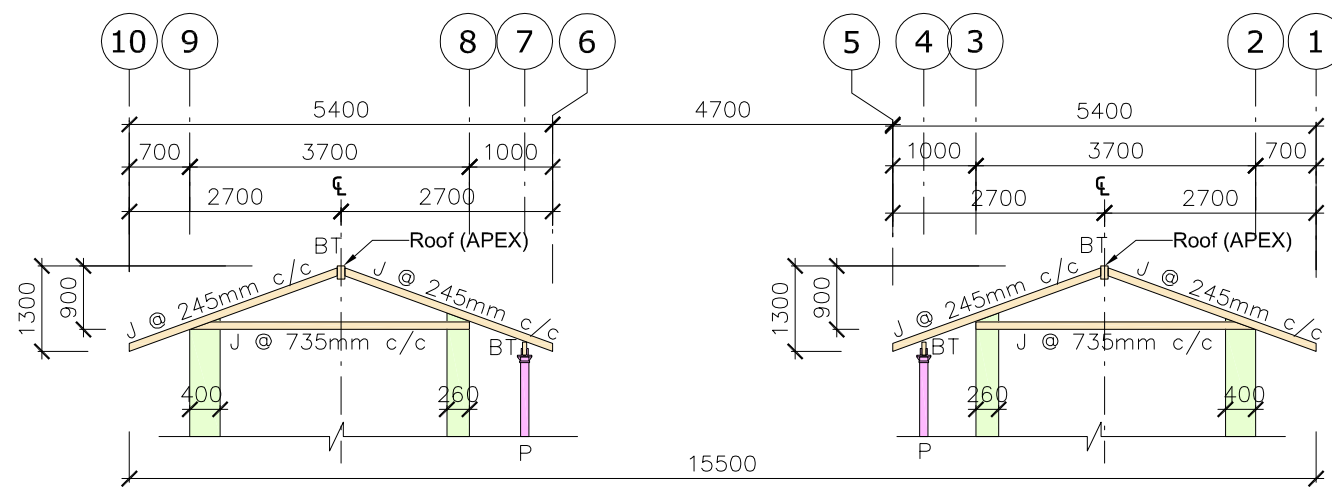
**SECTION Y2-Y2 (BUNGALOW BLOCK)**

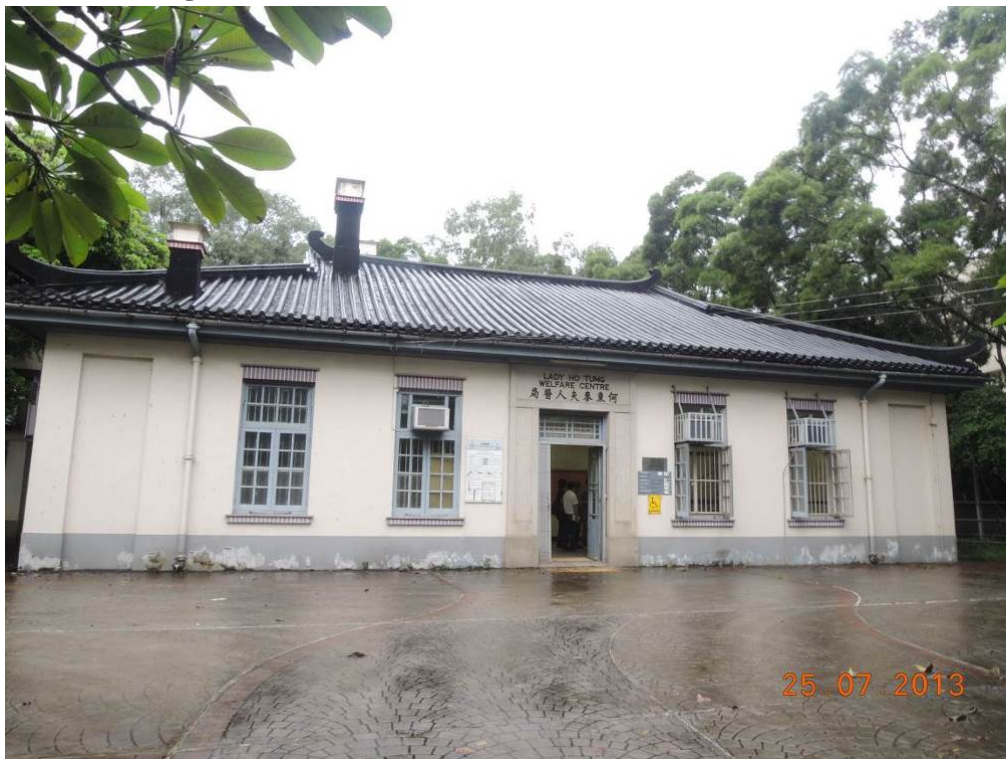
2.1 Front elevation of the Main Block facing main entrance

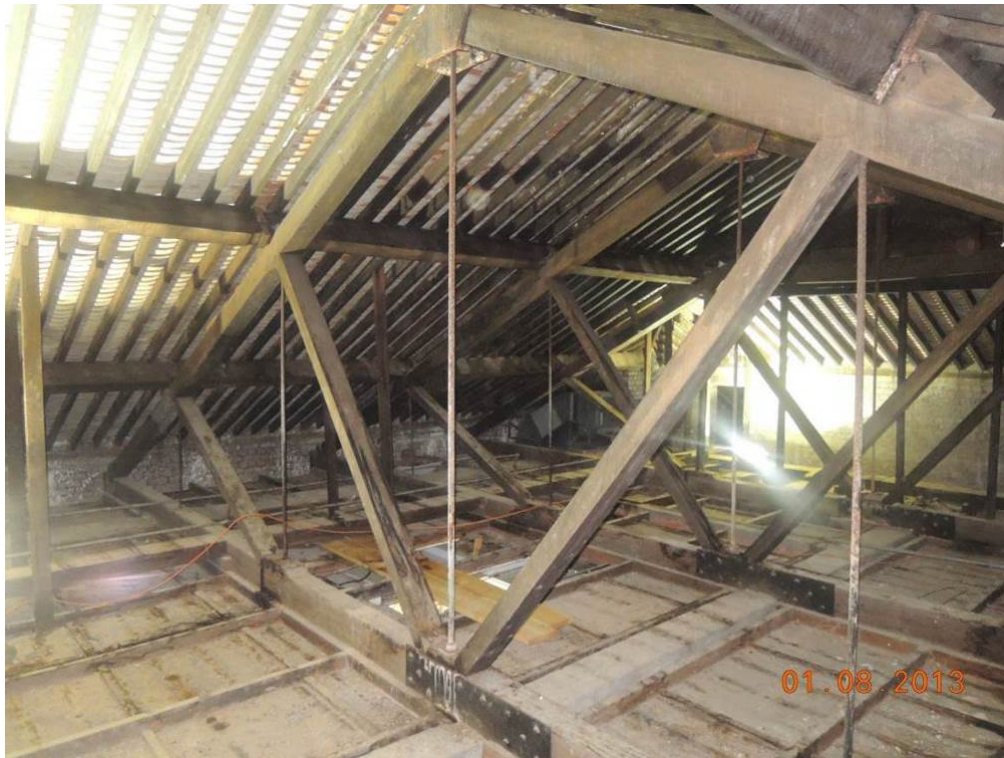
2.6 Roof truss structure at Main Block

Visual inspection at the ceiling void indicated that repair works had been carried out in a few areas to provide additional vertical timber supports for defective timber roof rafters at the east and west side of the timber roof structure.

(i) Some localised leakages were found underneath the tile-timber pitched roof which would have ill effect to the timber truss members. The leakage area was in the centre portion of the apex of the all timber trusses. The wet and dry condition will cause the deterioration of structural timbers. The deterioration of timber would impair the structural integrity of trusses and reduce the structural capacity to support the intended roof dead and imposed load. It was not certain at the time of inspection whether damages had been done to the observed defective timber rafters. Further investigation on this aspect is needed

(ii) Some localised timber rafter deterioration found and repair works had been carried out with improper details. It appeared that these repair works were intended to provide vertical timber post support for those defective roof timber rafters along top of trusses no 1 and 5. However these timber posts were sitting on the bottom chord of trusses at inclined angles. This vertical offset alignment would cause eccentric twisting effect to the bottom chord of the timber trusses which had not been designed for. Rectification works including the removal of these improper repair works should be carried out as soon as practically possible.

(iii) Mild corrosion (estimation of corrosion was in the order of section reduction in 10% to 20% ranges) had been found in all steel tension members and steel connection joint between timber members (top chord, bottom chord and diagonal strut) and steel member (tension rods between top and bottom timber chords). Reduction in steel section would reduce the structural capacity of the steel section in the original design for supporting the intended dead & imposed loads.

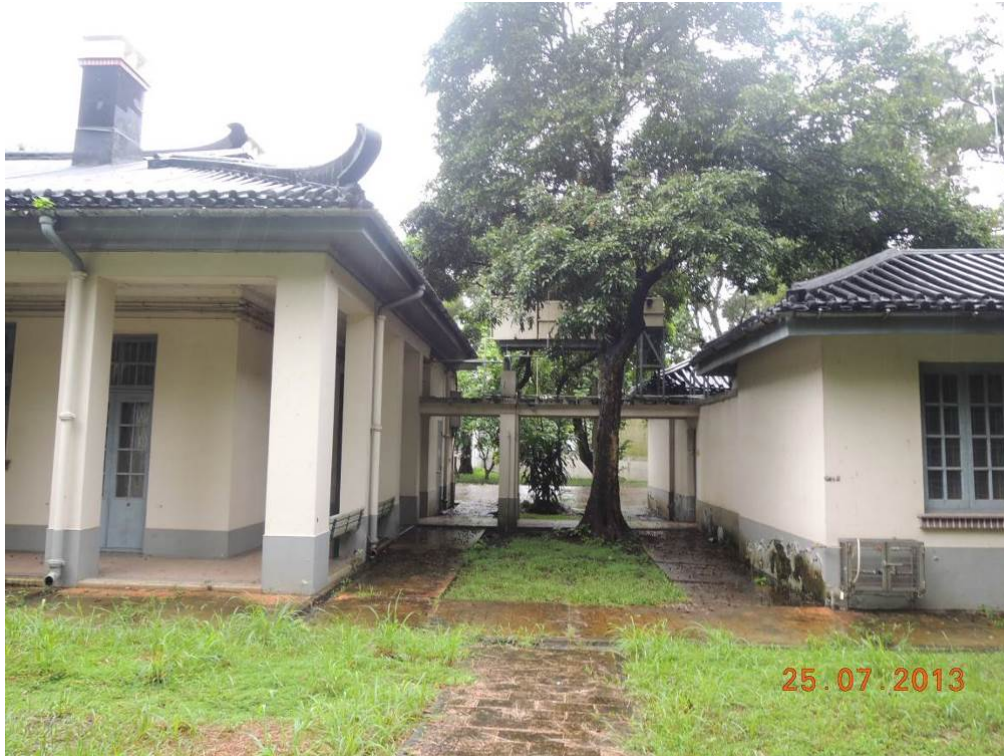
4.1 Covered walkway connecting the Main Block and the Bungalow

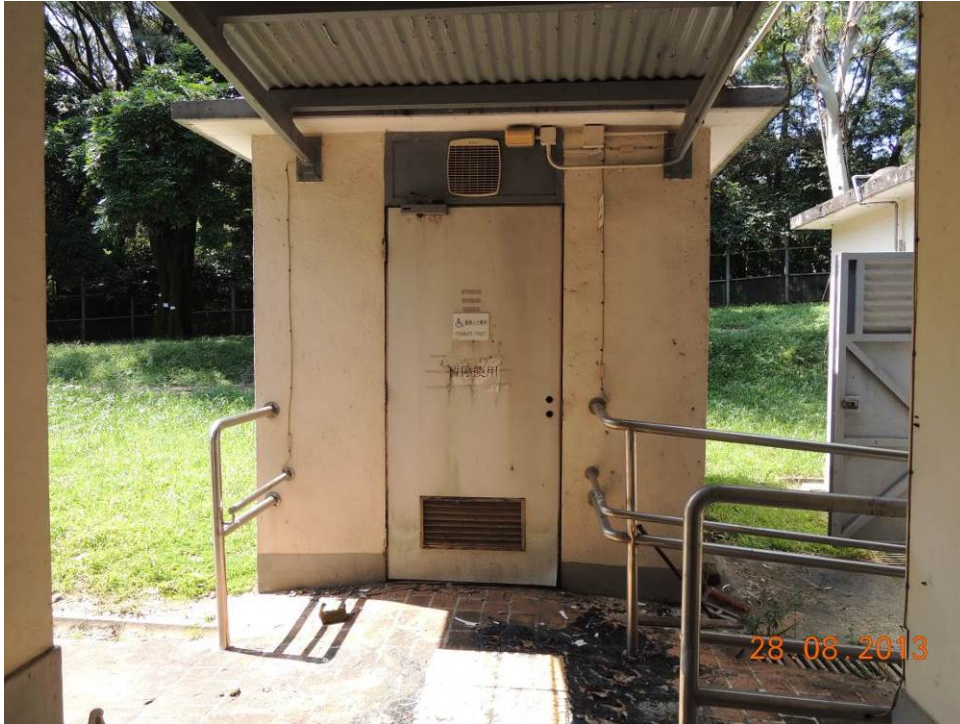
5.2 Disabled toilet facing the Main Block

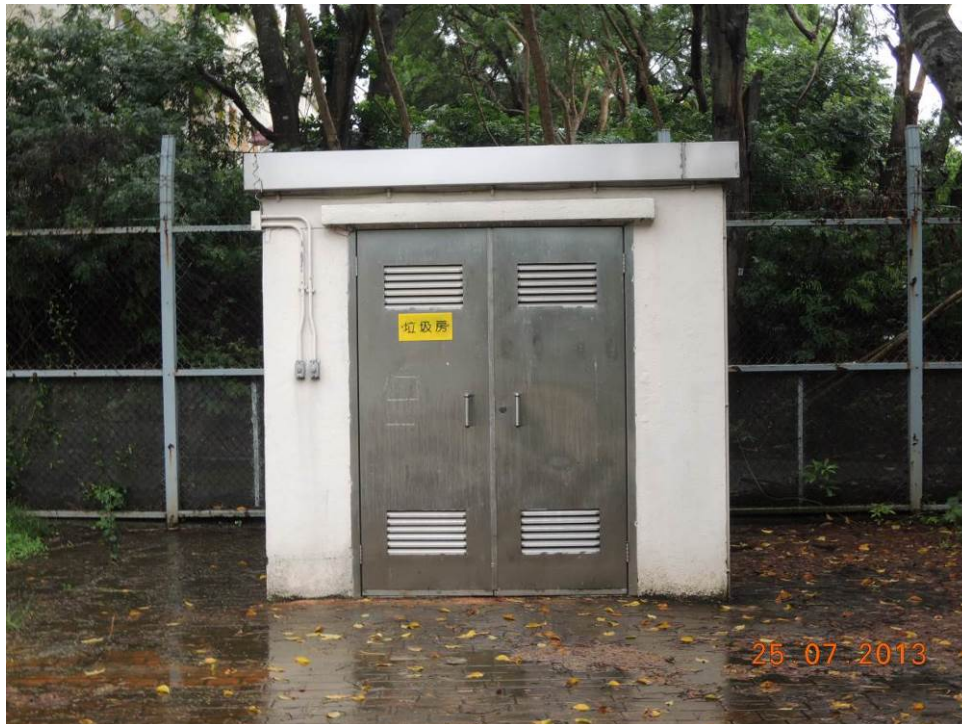
6.1 Refuse collection chamber

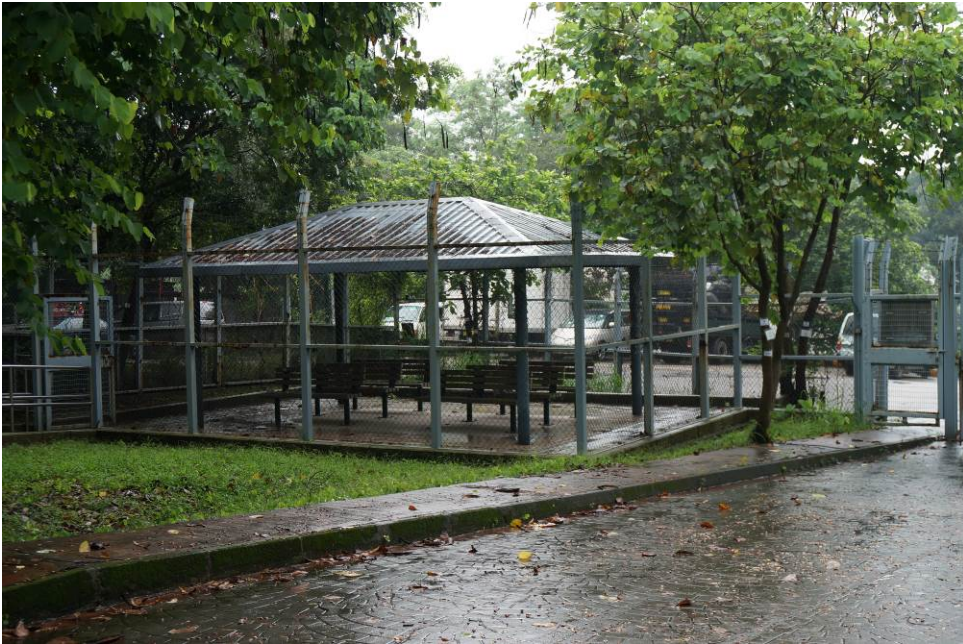
7.1 Pavilion near site entrance

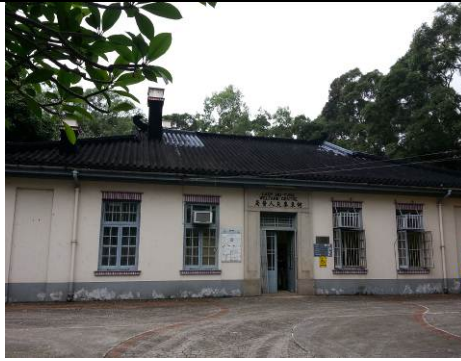
1.2) Stone doorcase and threshold of the main entrance, including the inscriptions “LADY HO TUNG WELFARE CENTRE” and 「何東麥夫人醫局」 on the lintel.

<b>Architectural Feature</b>	<b>Required Treatment</b>
1.2) Stone doorcase and threshold of the main entrance, including the inscriptions on the lintel	The stone doorcase and threshold of the main entrance, including the inscriptions on the lintel should be preserved in-situ and should be fully protected during the course of any works. Granite surfaces should not be painted or treated with permanent coating system. They should be cleaned with bristle or nylon brushes and clean water. No corrosive cleaning chemical is allowed. If new sign is to be put over the inscriptions on the lintel, the works should be carried out in a reversible manner without causing damage to the stonework and inscriptions.

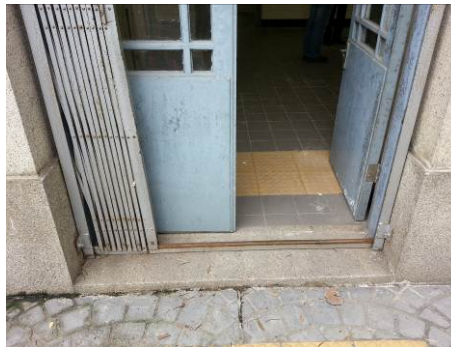
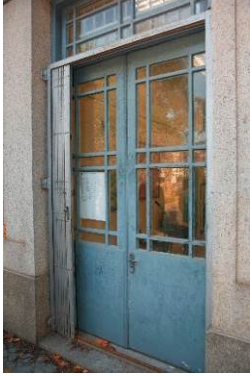
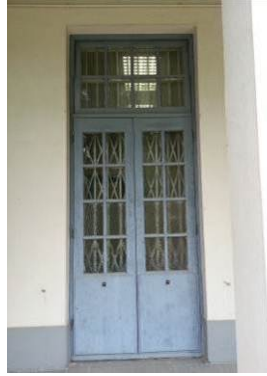
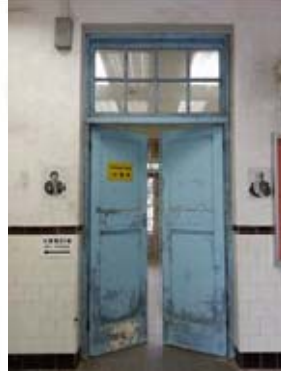
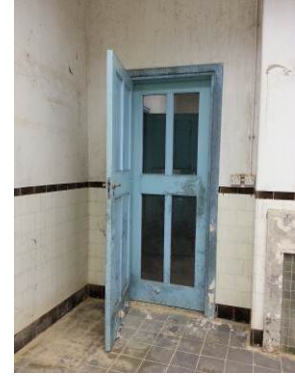
1.3) Main entrance door, external doors to the verandah, internal timber doors to the Treatment Room and Interview Room, including door panels with grid pattern, door frames, fanlight, horizontal pivoted windows, insects screens, original glazing scheme of obscure and clear glass, and original ironmongeries.

Main entrance door

External door to verandah with horizontal pivoted windows

Internal door to Treatment Room

Internal door to Interview Room with insects screen

Architectural Feature	Required Treatment
<p>1.3) Main entrance door, external doors to the verandah, internal timber doors to the Treatment Room and the Interview Room</p>	<p>Ease, adjust and overhaul all doors, insects screens, horizontal pivoted windows above and fanlight, repair and repaint as necessary. No alteration to the internal door opening of the Treatment Room where located at the axis of the Building is allowed. Original glazing scheme of obscure and clear glass should be retained. The later-added window-type air-conditioning units with supports and burglar bars should be removed and the window openings above the doors should be restored to horizontal pivoted windows of design which follows those original pivoted windows that have been retained on the elevations. Remove the Bostwick gates as they hinder public appreciation to the original timber doors. Original door ironmongeries should be overhauled and repaired. New ironmongery installations may be permitted for security reason subject to AMO's approval.</p>

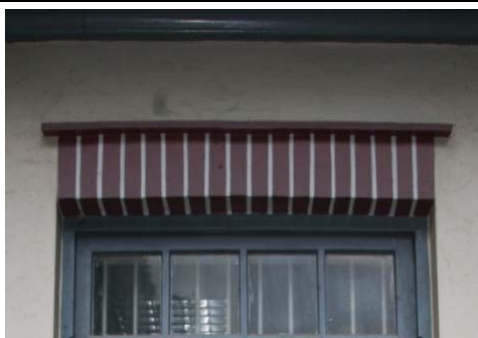
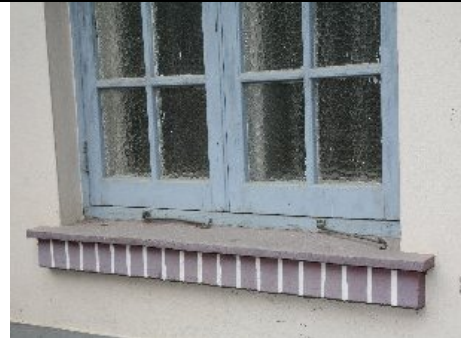
1.4) Window heads and quarry-tiled window sills painted in red with white brick lines.

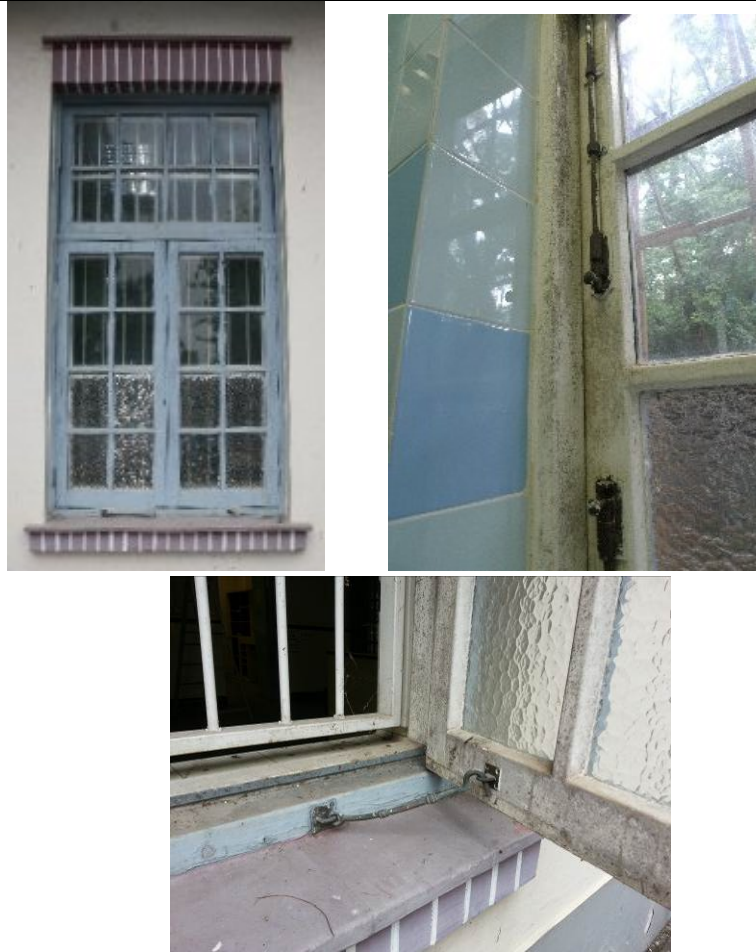
1.5) Timber casement windows and horizontal pivoted windows on top, including original glazing scheme of obscure and clear glass, original ironmongeries and window frames.

Architectural Feature	Required Treatment
1.5) Timber casement windows and horizontal pivoted windows on top	Ease, adjust and overhaul all windows, repair and repaint as necessary. Remove all the later-added window type air-conditioning units with supports and restore to horizontal pivoted windows of design which follows those original pivoted windows that have been retained on the facades. Original ironmongeries should be overhauled and repaired. Original glazing scheme of obscure and clear glass should be retained. Remove the burglar bars behind the top windows so that the original or restored horizontal pivoted windows can be opened fully. No objection to remove the burglar bars installed behind the casement windows

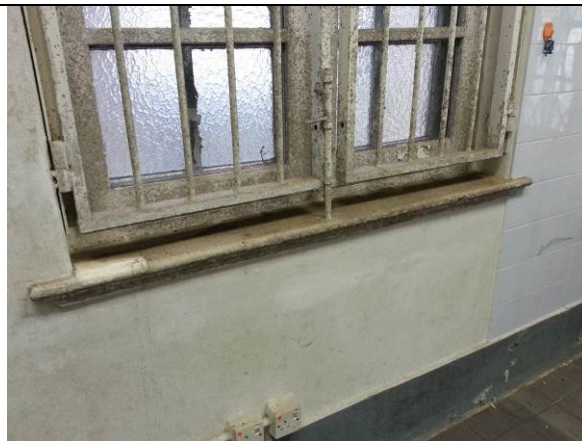
1.6) Original internal wooden window sills with mouldings.

Architectural Feature	Required Treatment
1.6) Original internal wooden window sills with mouldings	Original wooden window sills should be retained. Repair and repaint as necessary.

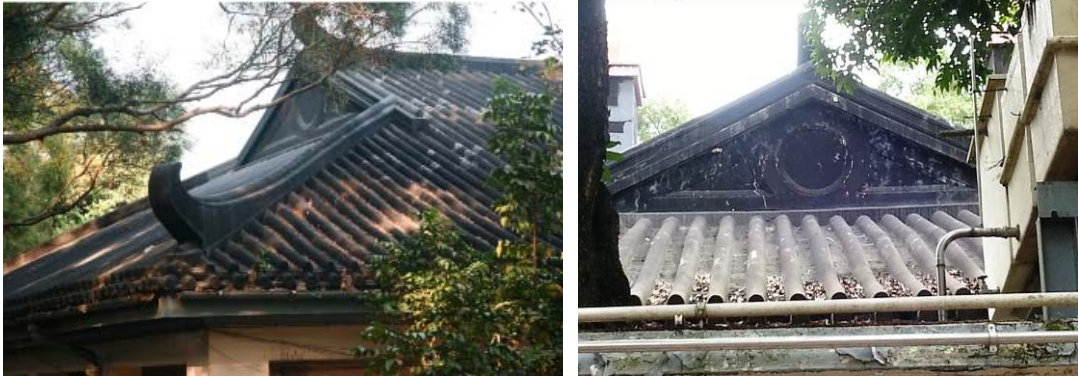
1.7) Chinese style roof with hip and gable roof structure, including curled-up ends of roof ridges and circular decorative moulding on pediment.

Architectural Feature	Required Treatment
1.7) Chinese style roof with hip and gable roof structure, including curled-up ends of roof ridges and circular decorative moulding on pediment	Check waterproofing condition. If leaking problem is observed, the roof should be carefully repaired with Chinese pan-and-roll tiles to match existing. Remove any vegetation, leaves, twigs and debris.

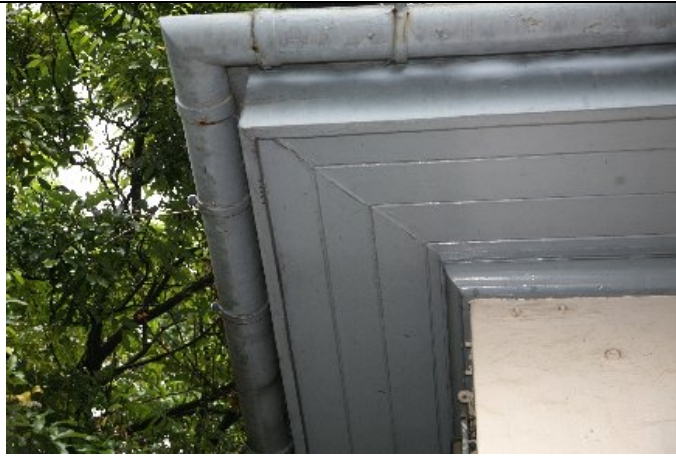
1.8) Over-hanging roof eaves with suspended timber battened ceiling

Architectural Feature	Required Treatment
1.8) Over-hanging roof eaves with suspended timber battened ceiling	Check the over-hanging eaves and suspended ceiling for rot and replace any damaged timber as necessary. Remove any vegetation, leaves, twigs and debris. Repaint as necessary.

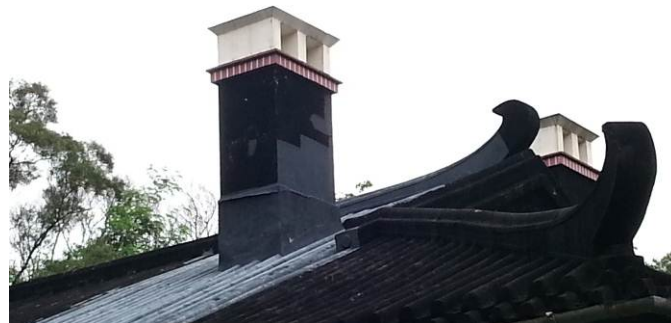
1.9) Chimney stacks with ornamental band painted in red and white brick lines.

Architectural Feature	Required Treatment
1.9) Chimney stacks with ornamental band painted in red and white brick lines.	Retain the ornamental chimney stacks in the original condition which should not be altered in any way. Repair and repaint in the same colour scheme as necessary.

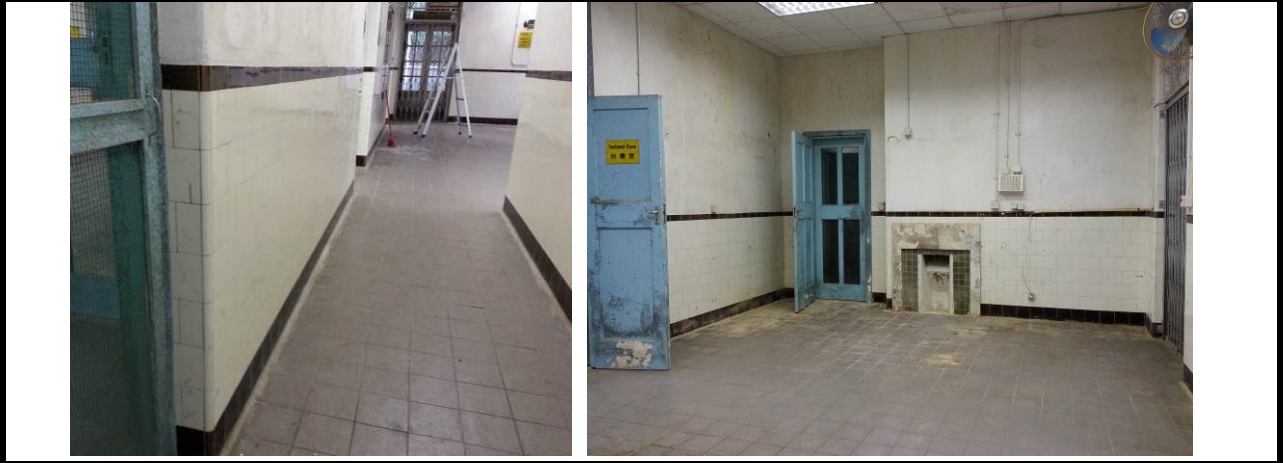
1.11) Original glazed wall tiles in the Waiting Hall and Treatment Room.

Architectural Feature	Required Treatment
1.11) Original glazed wall tiles in the Waiting Hall and Treatment Room	Protect old wall tiles during the course of works. Clean them to remove dirt and stains. Original tiles should not be removed, but it is permitted to cover them with drywall furring as long as the installation work is reversible and no anchors or fixings are made to the tiling itself.

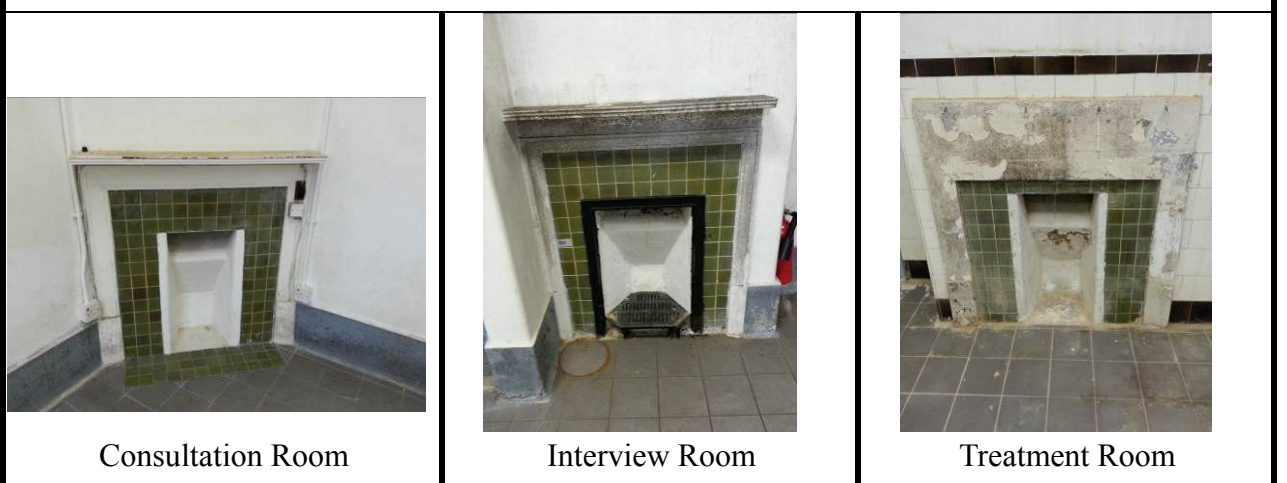
1.12) Fireplaces (3 Nos.) in the Consultation Room, Treatment Room and Interview Room, including tiling, surrounds, grates, hearths and mantel shelf.

Consultation Room

Interview Room

Treatment Room

Architectural Feature	Required Treatment
1.12) Fireplaces (3 Nos.) in the Consultation Room, Treatment Room and Interview Room, including tiling, surrounds, grates, hearths, and mantel shelf	The fireplaces should be protected during the course of work and be restored as appropriate. Hooks attached to the mantelpiece of the Treatment Room fireplace should be removed and the surround be repaired to match existing. The fireplaces should not be covered and should be exposed for public appreciation.

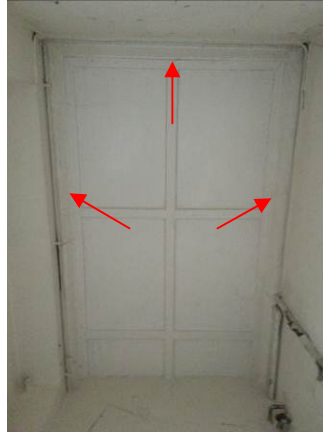
1.13) Moulded cornices at ceilings.

View to ceiling

Architectural Feature	Required Treatment
1.13) Moulded cornices at and ceilings	The moulded cornices should not be disturbed. Repair and repaint as necessary.

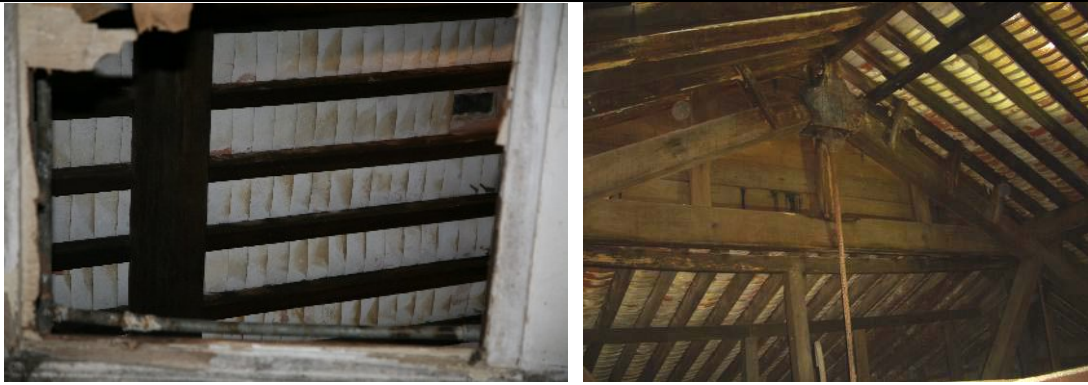
1.14) Timber roof structure.

Architectural Feature	Required Treatment
1.14) Timber roof structure	Check and repair the defective timber rafters, timber purlins and timber trusses as necessary. At least part of the timber roof structure should be exposed for appreciation.

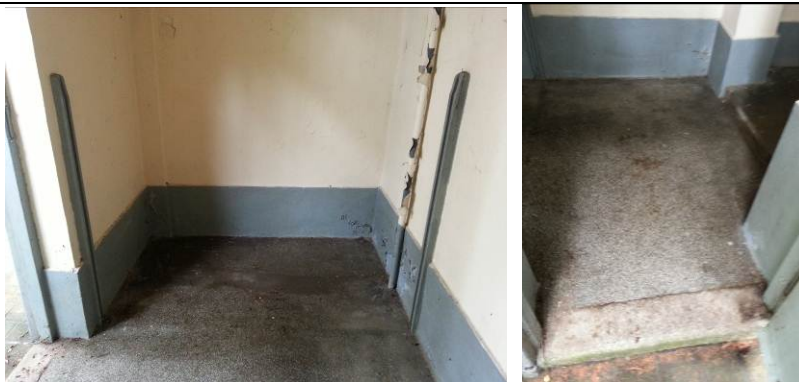
1.15) Timber fence holder, terrazzo floor finishes and the granite threshold in the Watchman Room.

Architectural Feature	Required Treatment
1.15) Timber fence holder, terrazzo floor finishes and the granite threshold in the Watchman Room	The timber fence holder and terrazzo floor finishes should be preserved in-situ. Repair and repaint the fence holder and clean the terrazzo floor finishes and granite threshold by non-corrosive detergent as necessary. No objection to covering the terrazzo floor finishes but should be in a reversible manner.

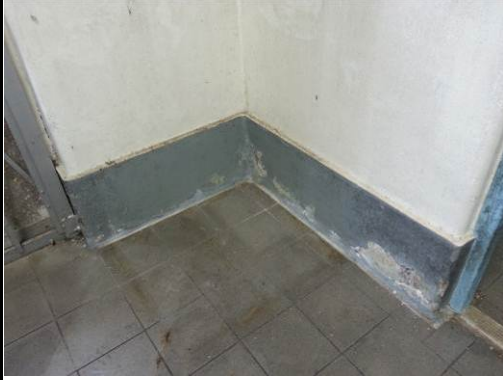
1.16) Original cement skirting.

Architectural Feature	Required Treatment
1.16) Original cement skirting	Original cement skirting should be retained. Repair and repaint as necessary. No objection to covering the skirting but should be in a reversible manner.

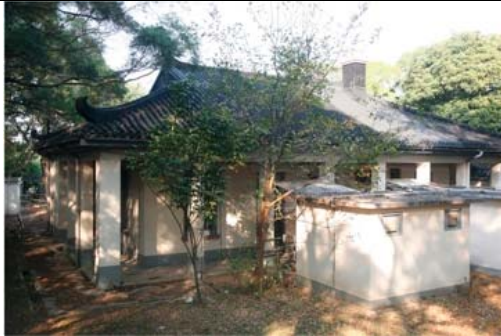
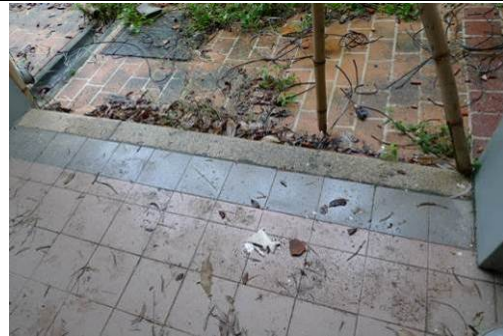
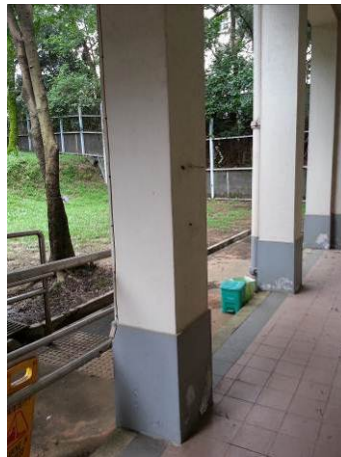
1.17) Colonnaded verandah, including concrete square columns and granite edge stones to paving.

Architectural Feature	Required Treatment
1.17) Colonnaded verandah, including the square concrete column and granite edge stones to paving	The verandah should not be enclosed in any way. Repair and repaint as necessary. The type of paint should match existing and be approved by AMO as appropriate. The granite edge stones should be preserved in-situ and cleaned. If the paving of verandah is to be repaved, the design and materials of the new paving should be submitted to AMO for approval.

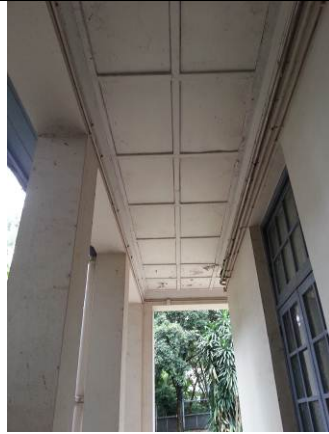
1.18) Timber suspended ceiling along the colonnaded verandah.

Architectural Feature	Required Treatment
1.18) Timber suspended ceiling along the open colonnaded verandah	The suspended ceiling should be retained in timber materials. Replacing the timber suspended ceiling with new grid system and new timber panels is allowed in condition that the materials should be approved by AMO, and the existing grid pattern and moulded cornices should be kept.

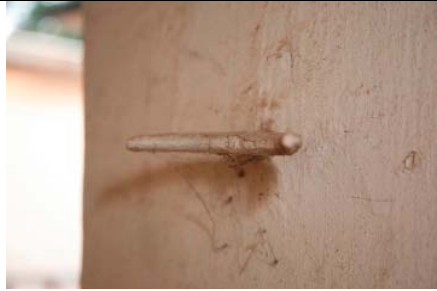
1.19) Cow's horn cleats mounted on the verandah columns.

Architectural Feature	Required Treatment
1.19) Cow's horn cleats mounted on the verandah columns	The cow's horn cleats should be retained. Repair and repaint as necessary.

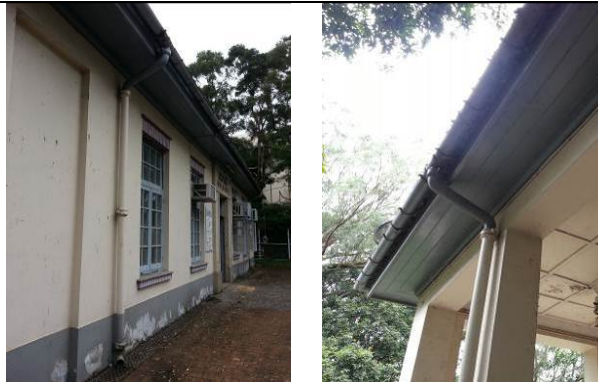
1.20) Cast iron rainwater pipes and eave gutters at the elevations.

Architectural Feature	Required Treatment
1.20) Cast iron rainwater pipes and eave gutters at the elevations	The cast iron rainwater pipes with swan's neck bends and the eave gutters should be preserved in-situ. Repair and restore their functions and repaint the eave gutters and rainwater pipes as necessary.

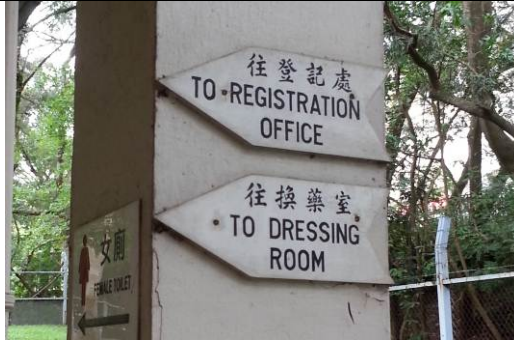
1.21) Original wooden directional signs in arrow shape including the inscriptions 「往登記處」  
“TO REGISTRATION OFFICE” and 「往換藥室」 “TO DRESSING ROOM”.

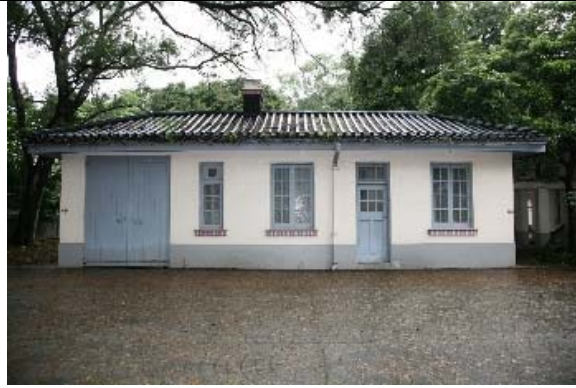
2.1) All elevations with rendered and painted external walls.

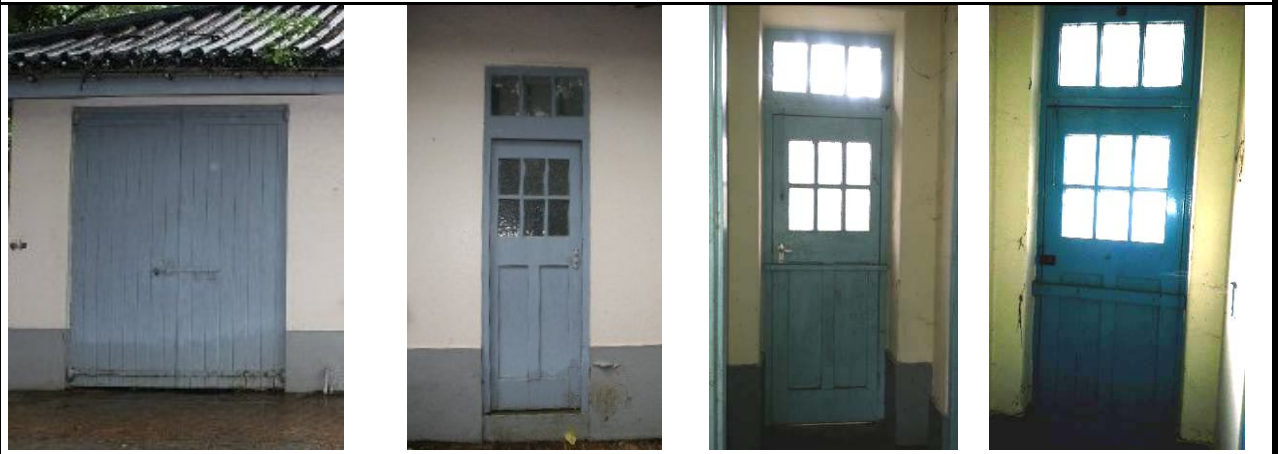
2.2) Timber battened doors to the Garage and all original external timber doors, including door panels with grid pattern, door frames, fanlights, original glazing scheme of obscure and clear glass, granite thresholds and original ironmongeries and timber door bars.

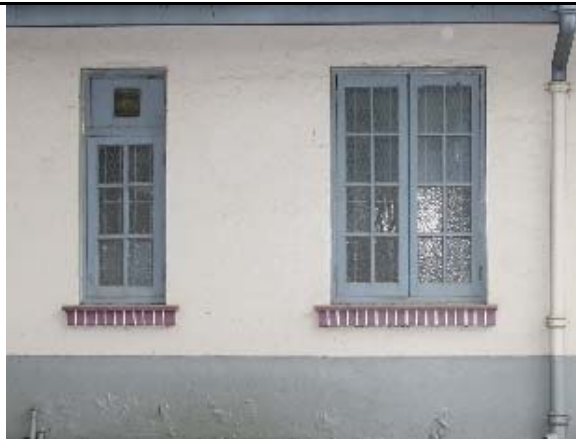
2.3) Quarry-tiled window sills painted in red with white brick lines.

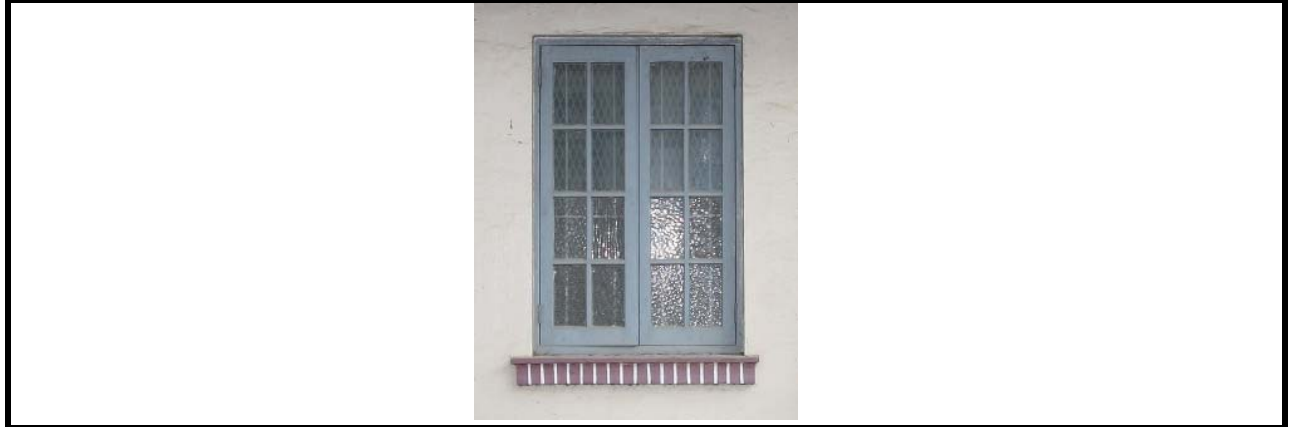
2.4) Timber casement windows including original glazing scheme of obscure and clear glass, ironmongeries and window frames.

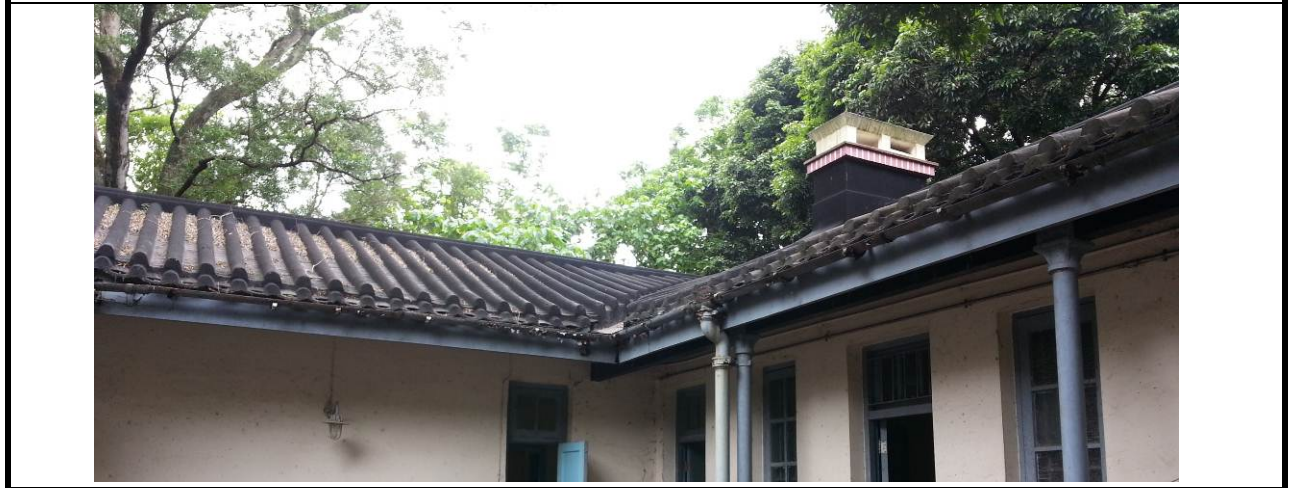
2.5) Chinese pitched roof.

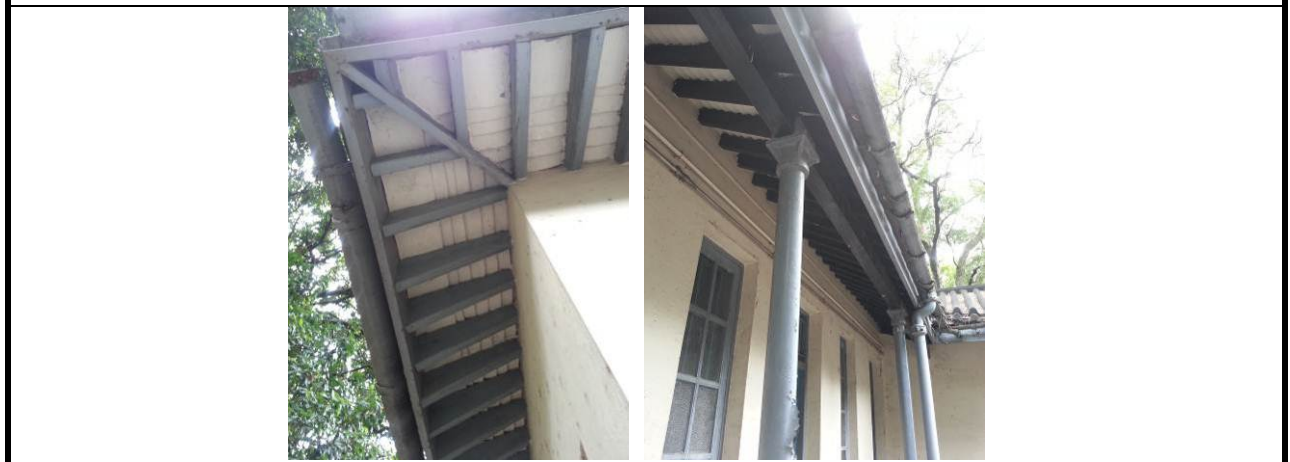
2.6) Over-hanging roof eaves.

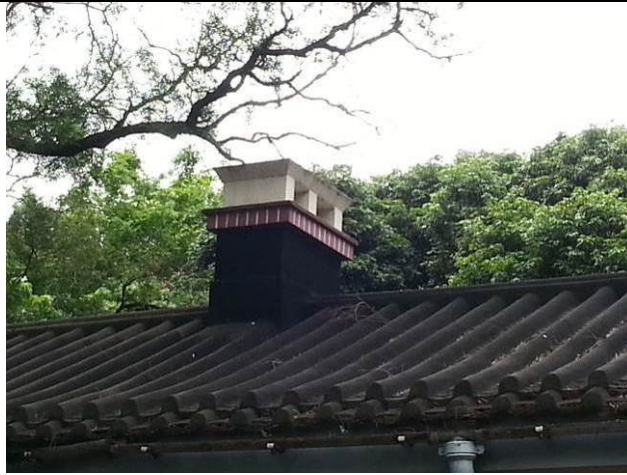
2.7) Chimney stacks with ornamental band painted in red and white brick lines.

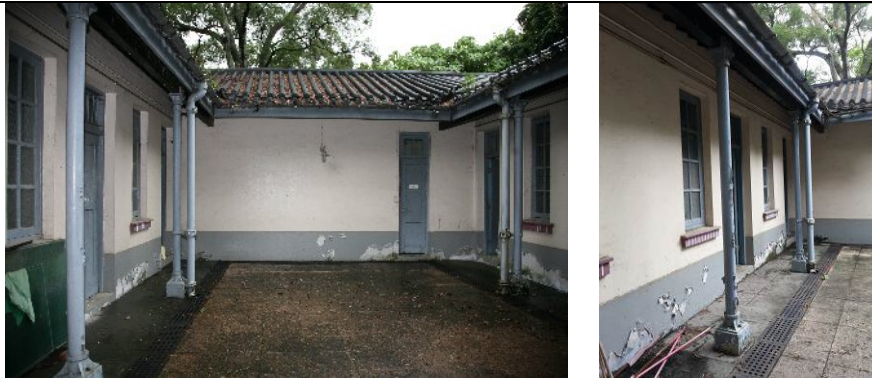
2.8) Open courtyard of the Bungalow including cast iron columns with concrete plinths supporting the roof eaves.

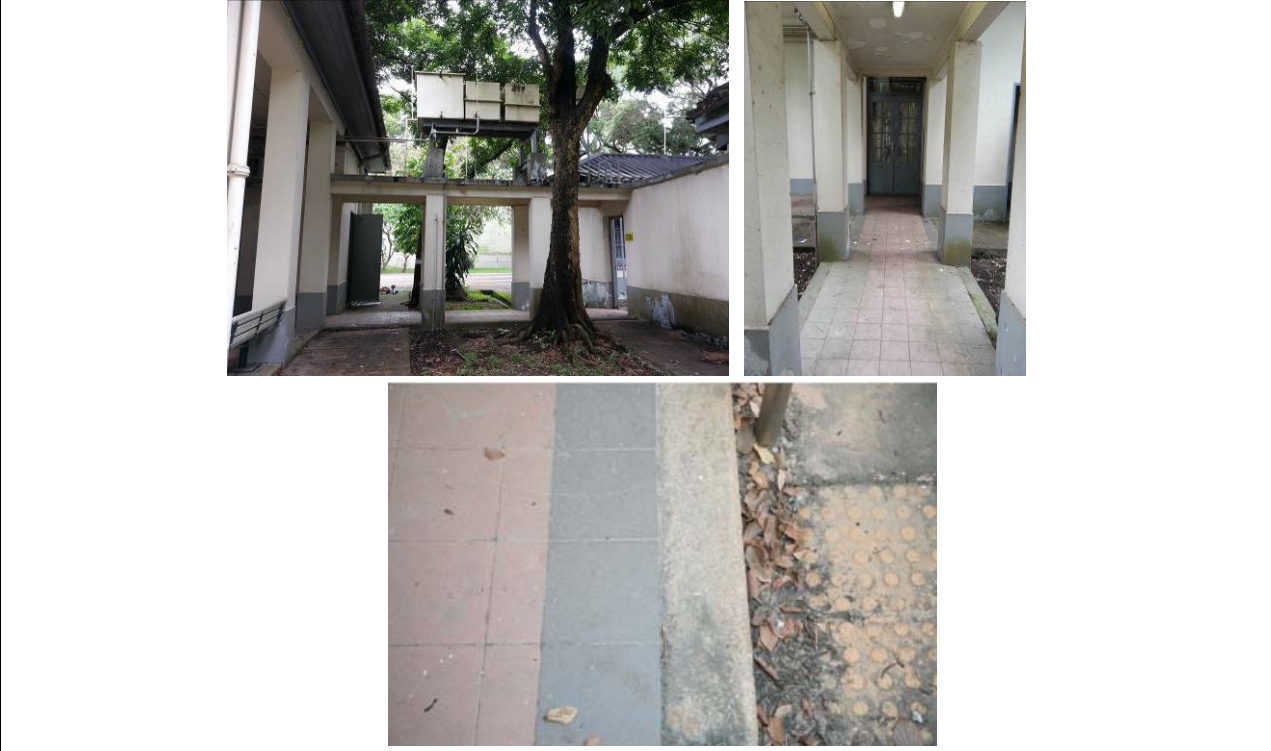
3.1) Covered walkway linking the Main Block and the Bungalow, including concrete square columns and granite edge stones to paving.

Architectural Feature	Required Treatment
3.1) Covered walkway linking the Main Block and the Bungalow, including granite edge stones to paving	The covered walkway should not be enclosed in any way. Repair and repaint as necessary. Remove the water tank, the associated pipes and the supporting plinths on top of the covered walkway. Check waterproofing condition for roof, repair waterproof layer as necessary. The granite edge stones should be retained and be cleaned. If the paving of the covered walkway is to be repaved, the design and materials of new paving should be submitted to AMO for approval.

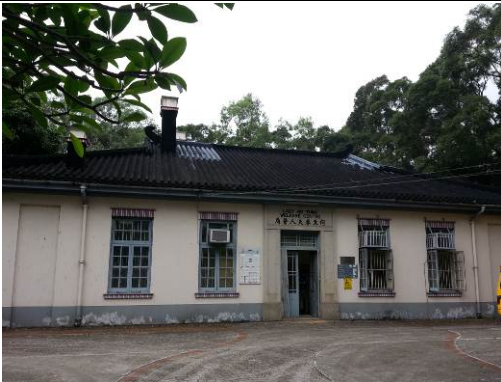
<b>Architectural Feature</b>	<b>Required Treatment</b>
1.1) All elevations with rendered and painted external walls	Repair and repaint the external walls as necessary. The type of paint should match existing and be approved by AMO as appropriate. No alteration to the existing openings or formation of new openings to the elevations is allowed unless approved by AMO.

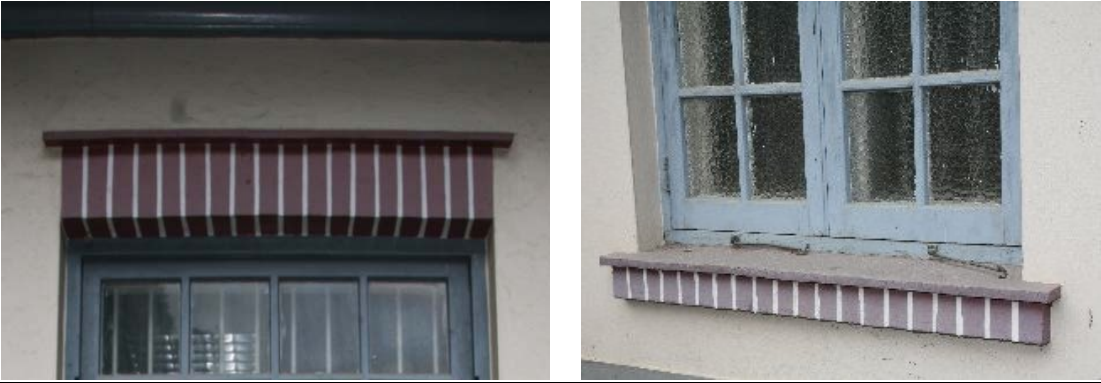
Architectural Feature	Required Treatment
1.4) Window heads and quarry-tiled window sills painted in red with white brick lines	They should be repainted in the same colour scheme.

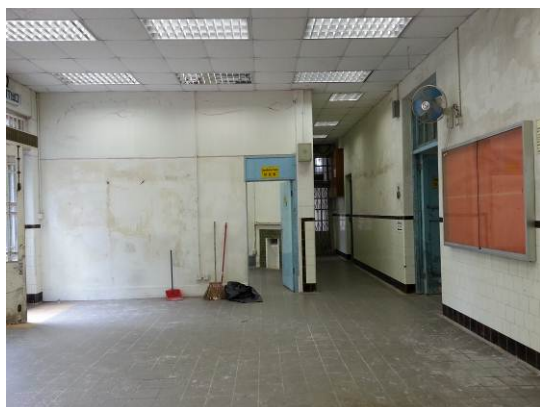
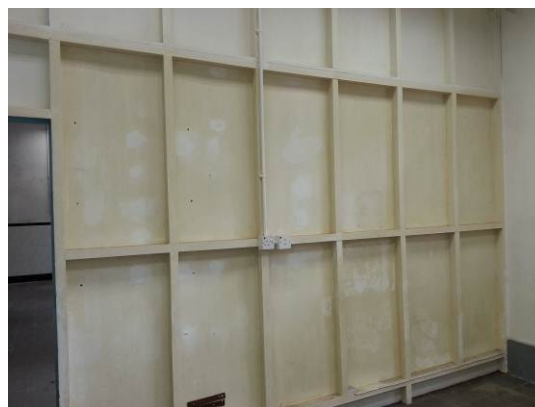
Later-added partition

Architectural Feature	Required Treatment
1.22) Internal walls, floor finishes and suspended ceilings of mineral fibre ceiling tiles	Repair any damage sections of the walls using materials matching existing as necessary. Formation of new openings and alterations to existing openings on load bearing walls may be permitted subject to AMO's approval and Registered Structural Engineer's advice. No objection to the removal of later-added partitions. No specific requirements on floor finishes and suspended ceilings of fibre ceiling tiles.

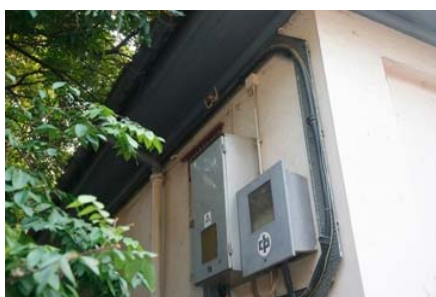
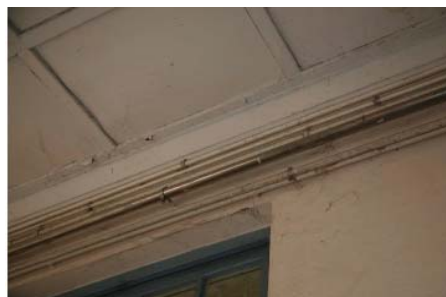
Architectural Feature	Required Treatment
1.23) Redundant cables, old wirings, conduits, disused electrical appliances, and meter boxes	Disconnect and remove redundant cables, old wirings, conduits, disused electrical appliances, and meter boxes. Damage to wall surfaces should be made good to match existing. New cable routes/ conduit routes and pipes should be carefully planned to avoid damage to architectural features and to minimise the intervention to the building fabric.

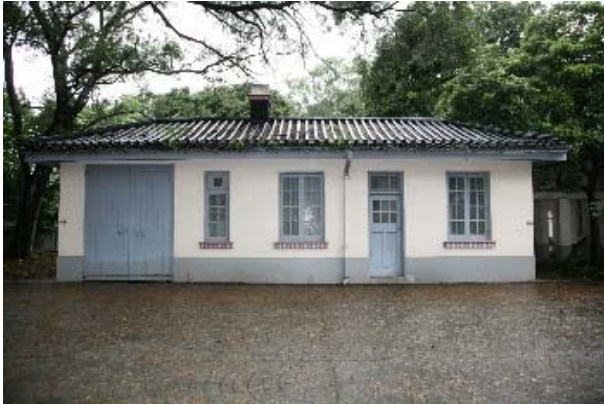
Architectural Feature	Required Treatment
2.1) All elevations with rendered and painted external walls	Repair and repaint the external walls as necessary. The type of paint should match existing and be approved by AMO as appropriate. No alteration to the existing opening or formation of new opening to the elevations is allowed unless approved by AMO.
