**Revitalising Historic Buildings**

**Lady Ho Tung Welfare Centre**

**Resource Kit**

Date: 16 December 2013

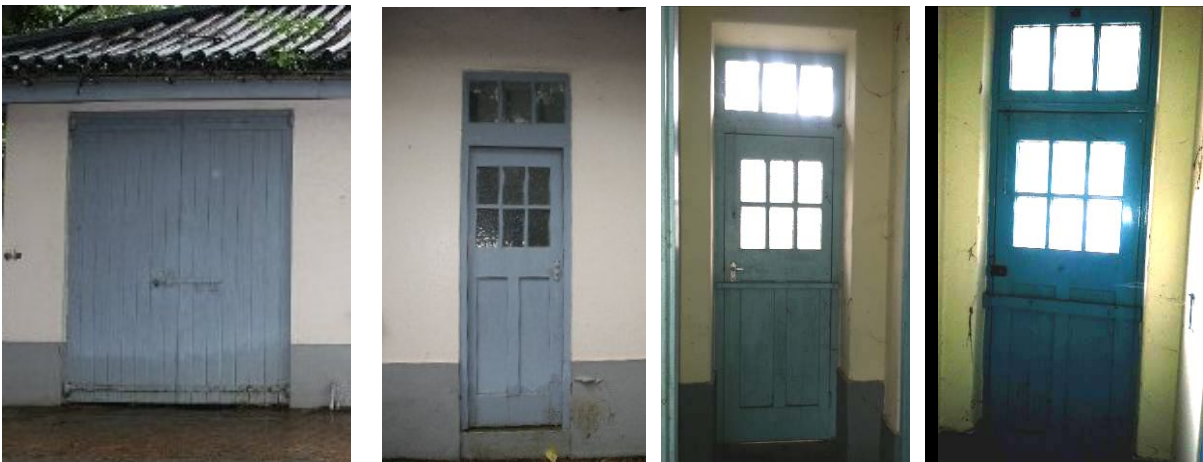
Architectural Feature	Required Treatment
2.2) Timber battened doors of the Garage and all original external timber doors	Ease, adjust and overhaul all doors and fanlights, repair and repaint as necessary. No alteration to the door openings is allowed. The granite threshold should be preserved in-situ and be cleaned. Original glazing scheme of obscure and clear glass should be retained. Original ironmongeries should be overhauled and repaired. New ironmongery installations may be permitted for security reason subject to AMO's approval.

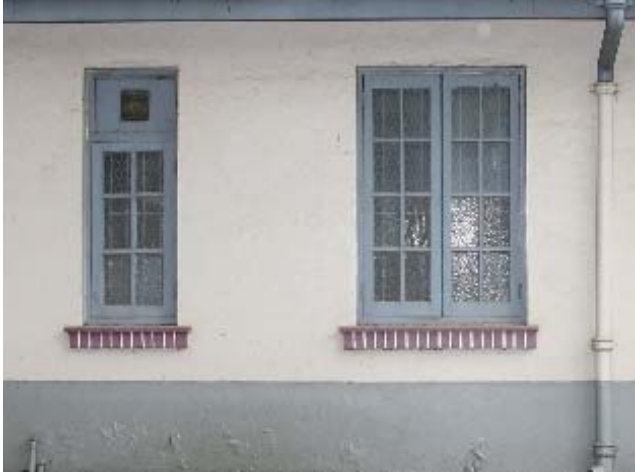
Architectural Feature	Required Treatment
2.3) Quarry-tiled window sills painted in red with white brick lines	They should be repainted in the same colour scheme.

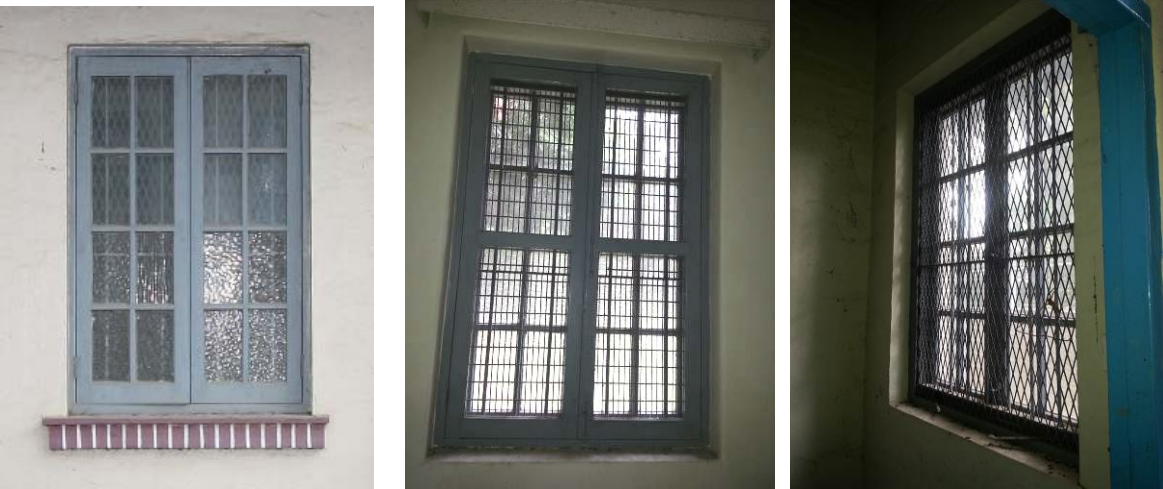
Architectural Feature	Required Treatment
2.4) Timber casement windows	Ease, adjust and overhaul all windows, repair and repaint as necessary. No alteration to window openings is allowed unless approved by AMO. Original ironmongeries should be overhauled and repaired. Original glazing scheme of obscure and clear glass should be retained. No objection to remove the burglar bars and metal grilles installed behind the casement windows.

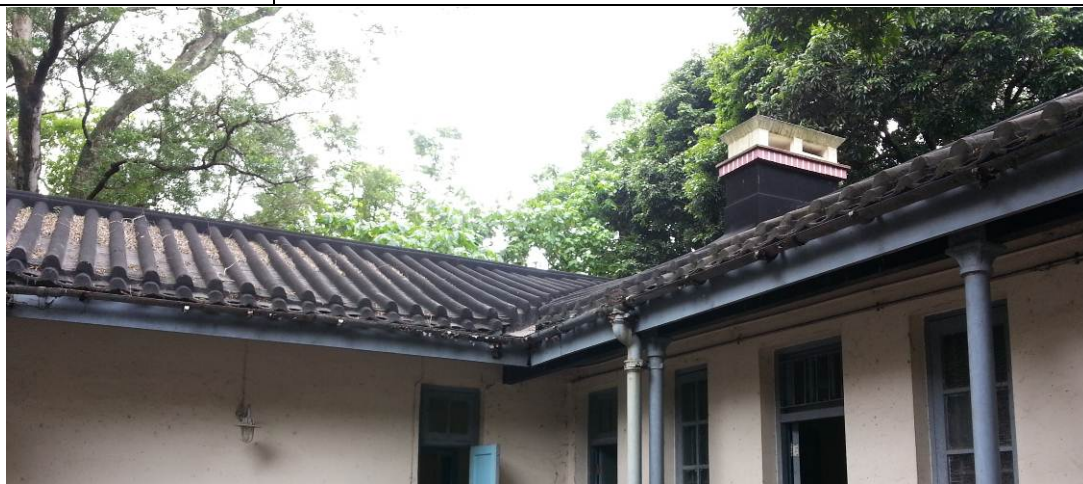
Architectural Feature	Required Treatment
2.5) Chinese pitched roof	Check waterproofing condition. If leaking problem is observed, the roof should be carefully repaired with Chinese pan-and-roll tiles to match existing. Remove any vegetation, leaves, twigs and debris.

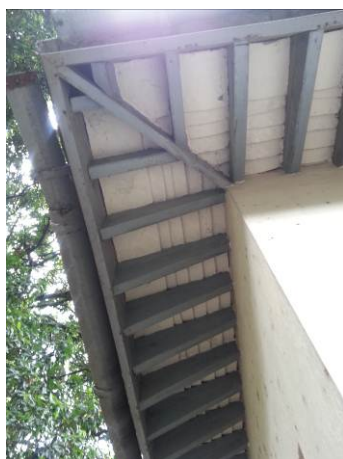
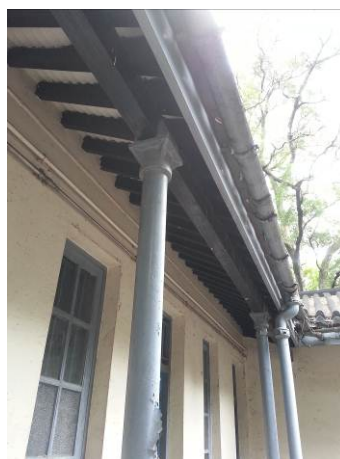
Architectural Feature	Required Treatment
2.6) Over-hanging roof eaves	Check the over-hanging eaves for rot and replace any damaged timber as necessary. Repair and replace rotten fascia boards to match existing. Remove any vegetation, leaves, twigs and debris. Repaint as necessary.

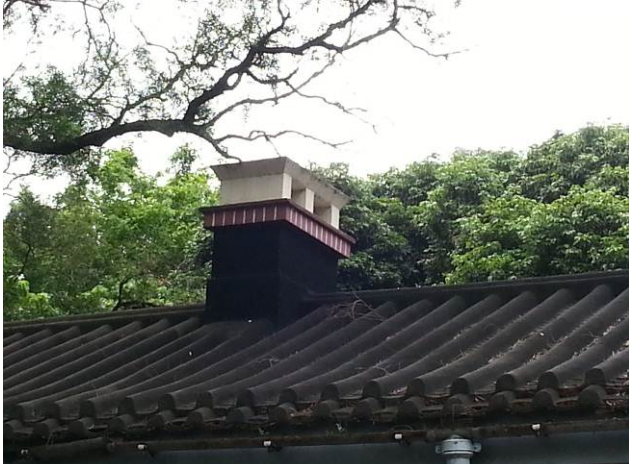
Architectural Feature	Required Treatment
2.7) Chimney stacks with ornamental band painted in red and white brick lines	Retain the ornamental chimney stacks in the original condition which should not be altered in any way. Repair and repaint in the same colour scheme as necessary.

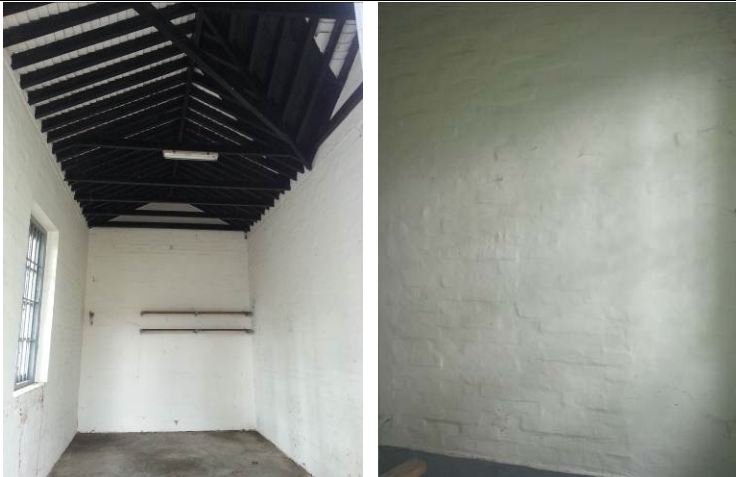
Architectural Feature	Required Treatment
2.12) Internal space of the Garage	The internal space of the Garage should be kept intact, i.e., no alteration to the existing walls or addition of new partitions is allowed unless approved by AMO. Plaster should not be applied to the walls of the Garage. Expose the whole timber roof structure at the Garage for public appreciation.

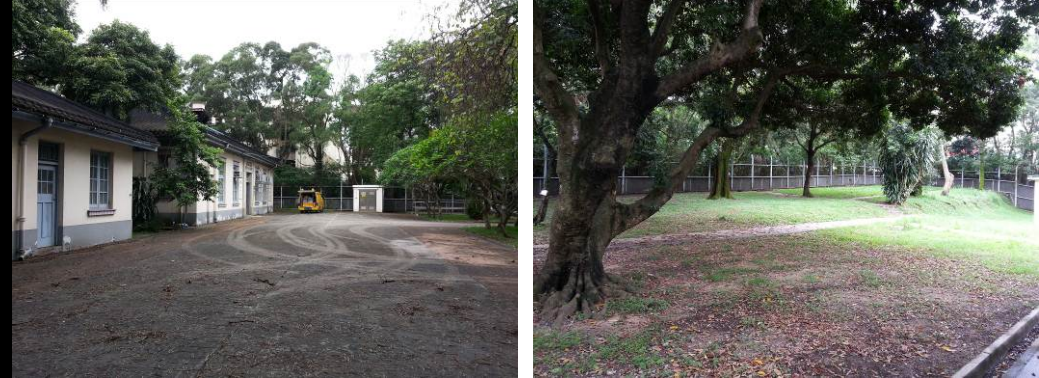
Architectural Feature	Required Treatment
3.2) Open spaces	Any new structure should not cause visual impact to the Main Block and the Bungalow, in particular, the front façades of the buildings should not be blocked.

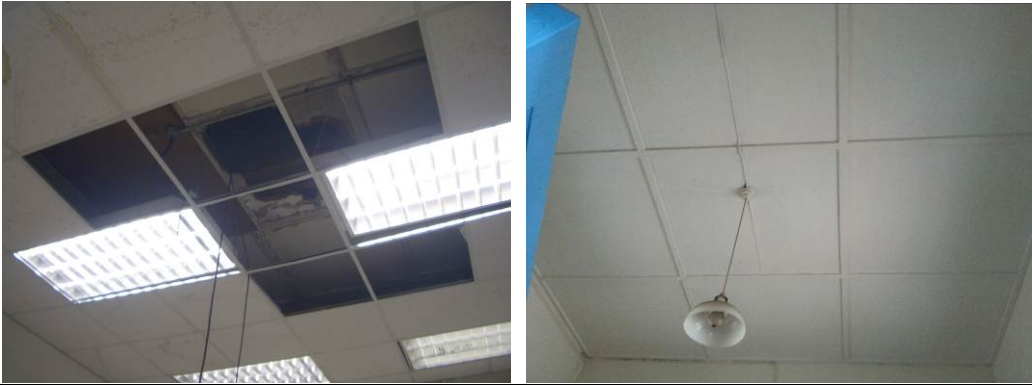
<b>Architectural Feature</b>	<b>Recommended Treatment</b>
1.1) Original suspended timber ceilings	Most of the suspended timber ceilings inside the Main Block are in dilapidated conditions. Those inside the Bungalow are comparatively in better conditions. Since they are an original feature which echoes with the suspended ceilings in the verandah, they are recommended to be retained, repaired or replaced with new timber materials in same design and form as necessary.

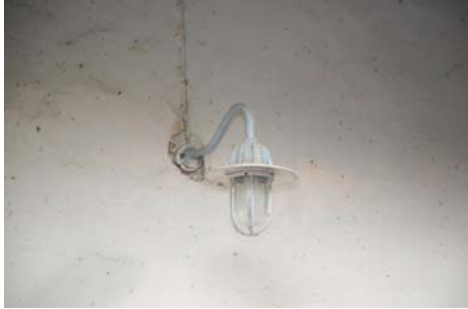
<b>Architectural Feature</b>	<b>Recommended Treatment</b>
1.2) Wall lamp in the courtyard of the Bungalow	Recommended to repair and restore its function if feasible.

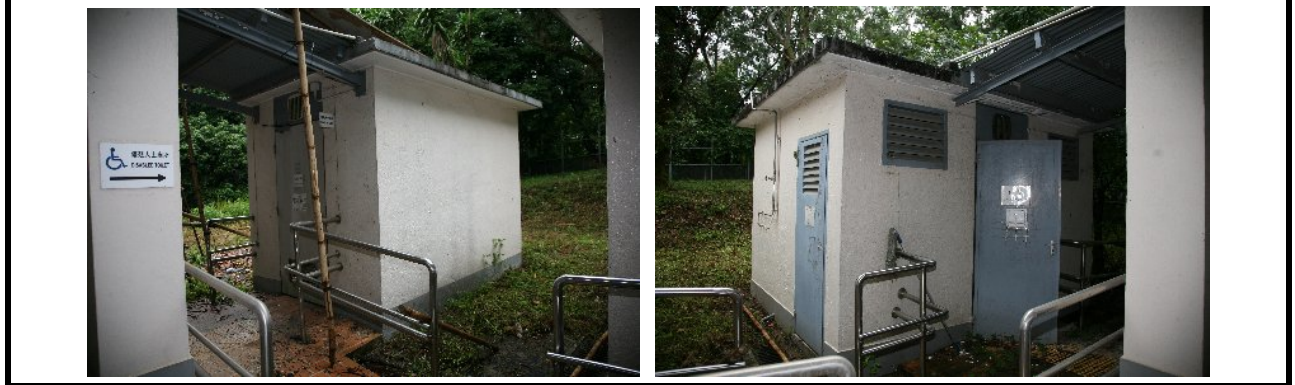
Architectural Feature	Recommended Treatment
2.1) Toilet blocks (2 nos.)	Recommended to remove the toilet blocks as they hinder public appreciation to the rear elevation of the Main Block.

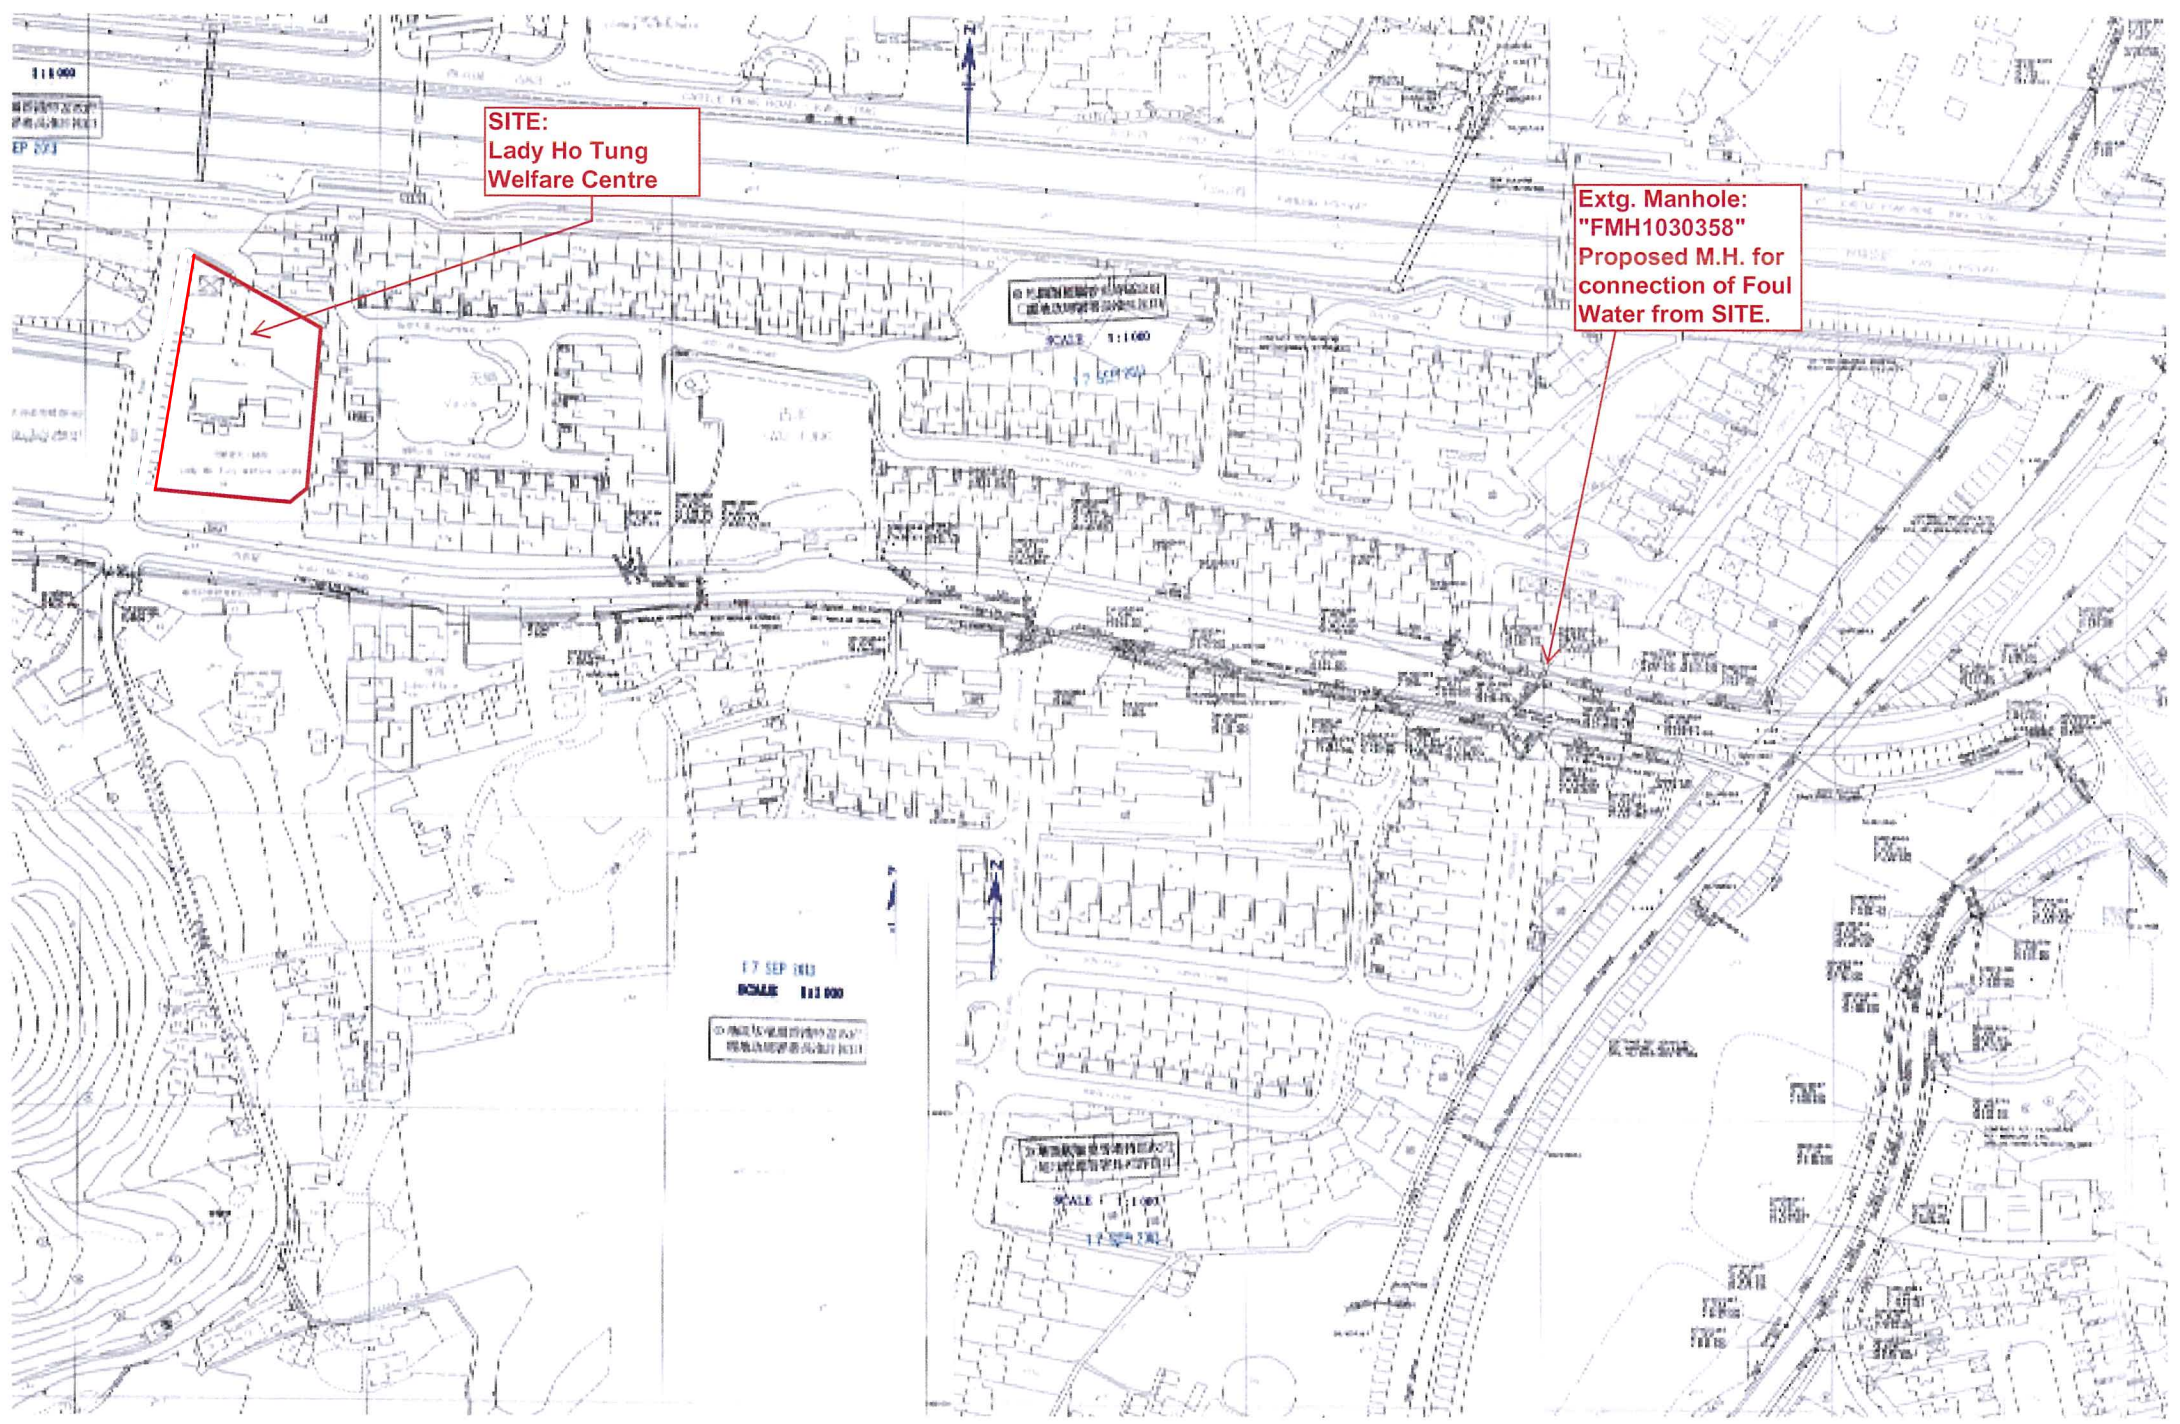
**Record Plan of Drainage Services**

**Extg. Manhole:**  
"FMH1030358"  
Proposed M.H. for  
connection of Foul  
Water from SITE.

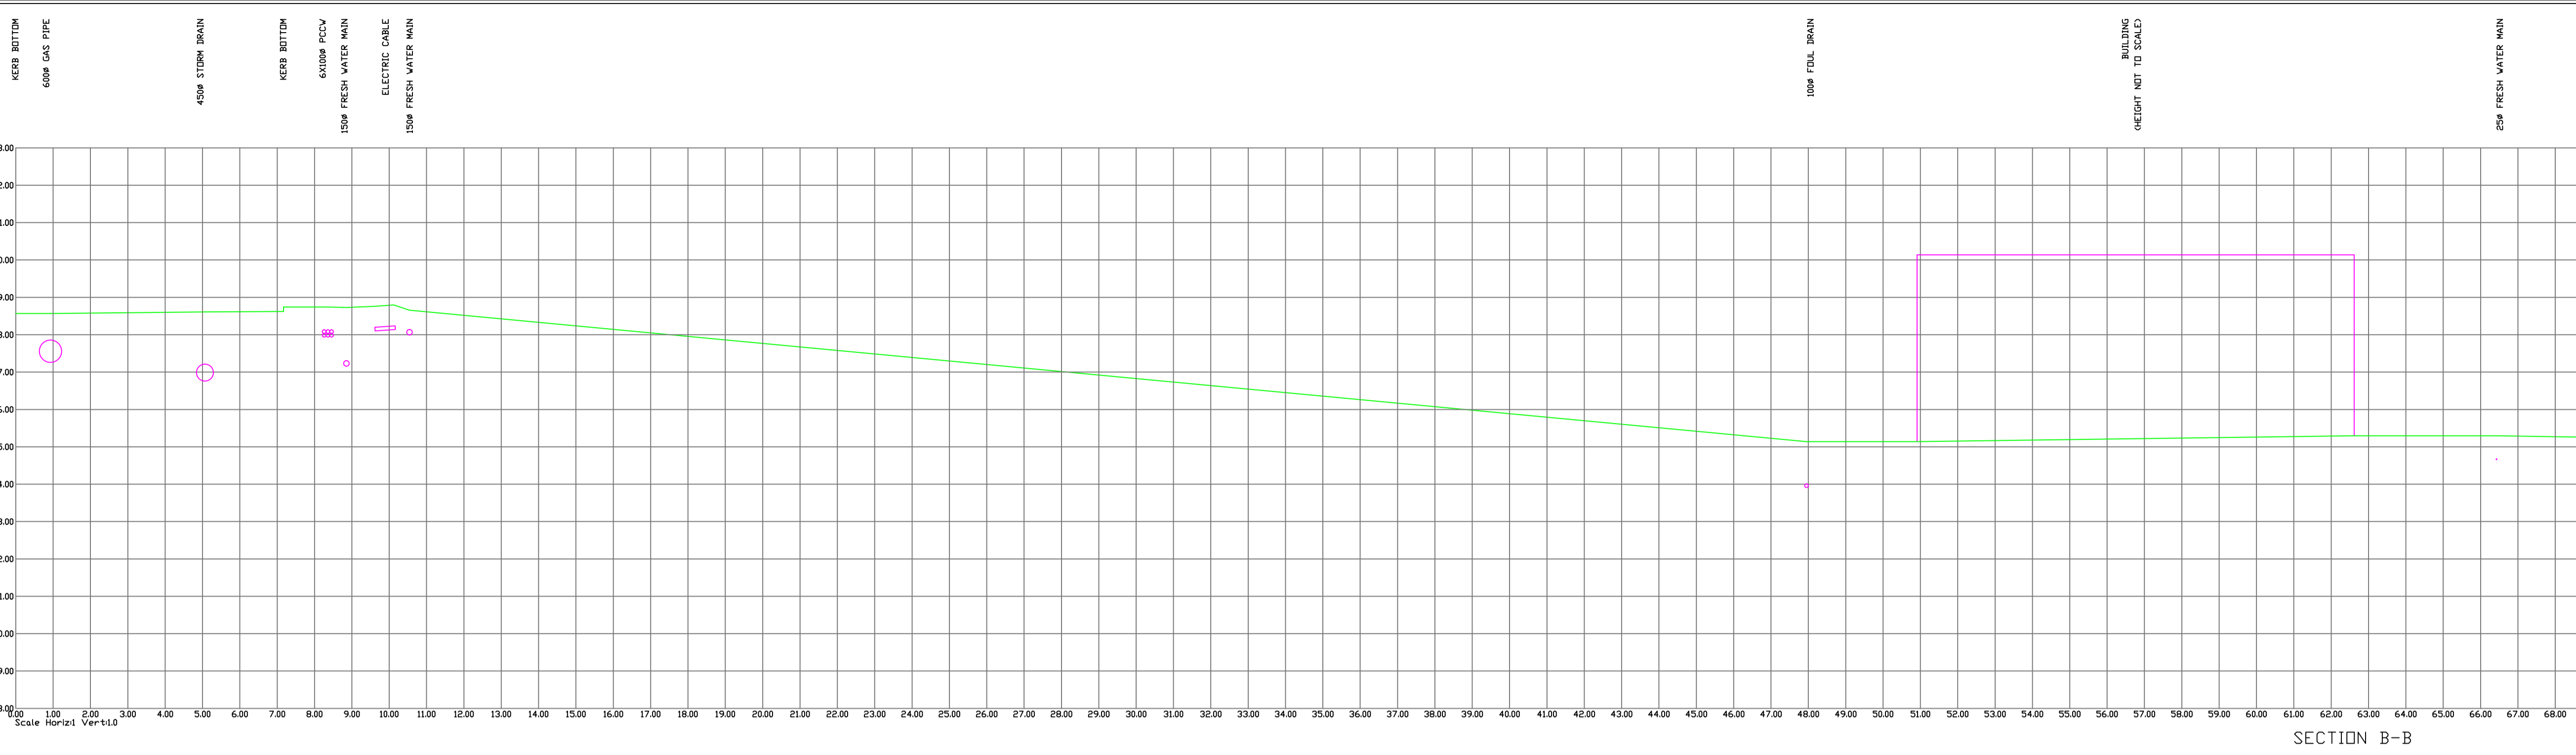
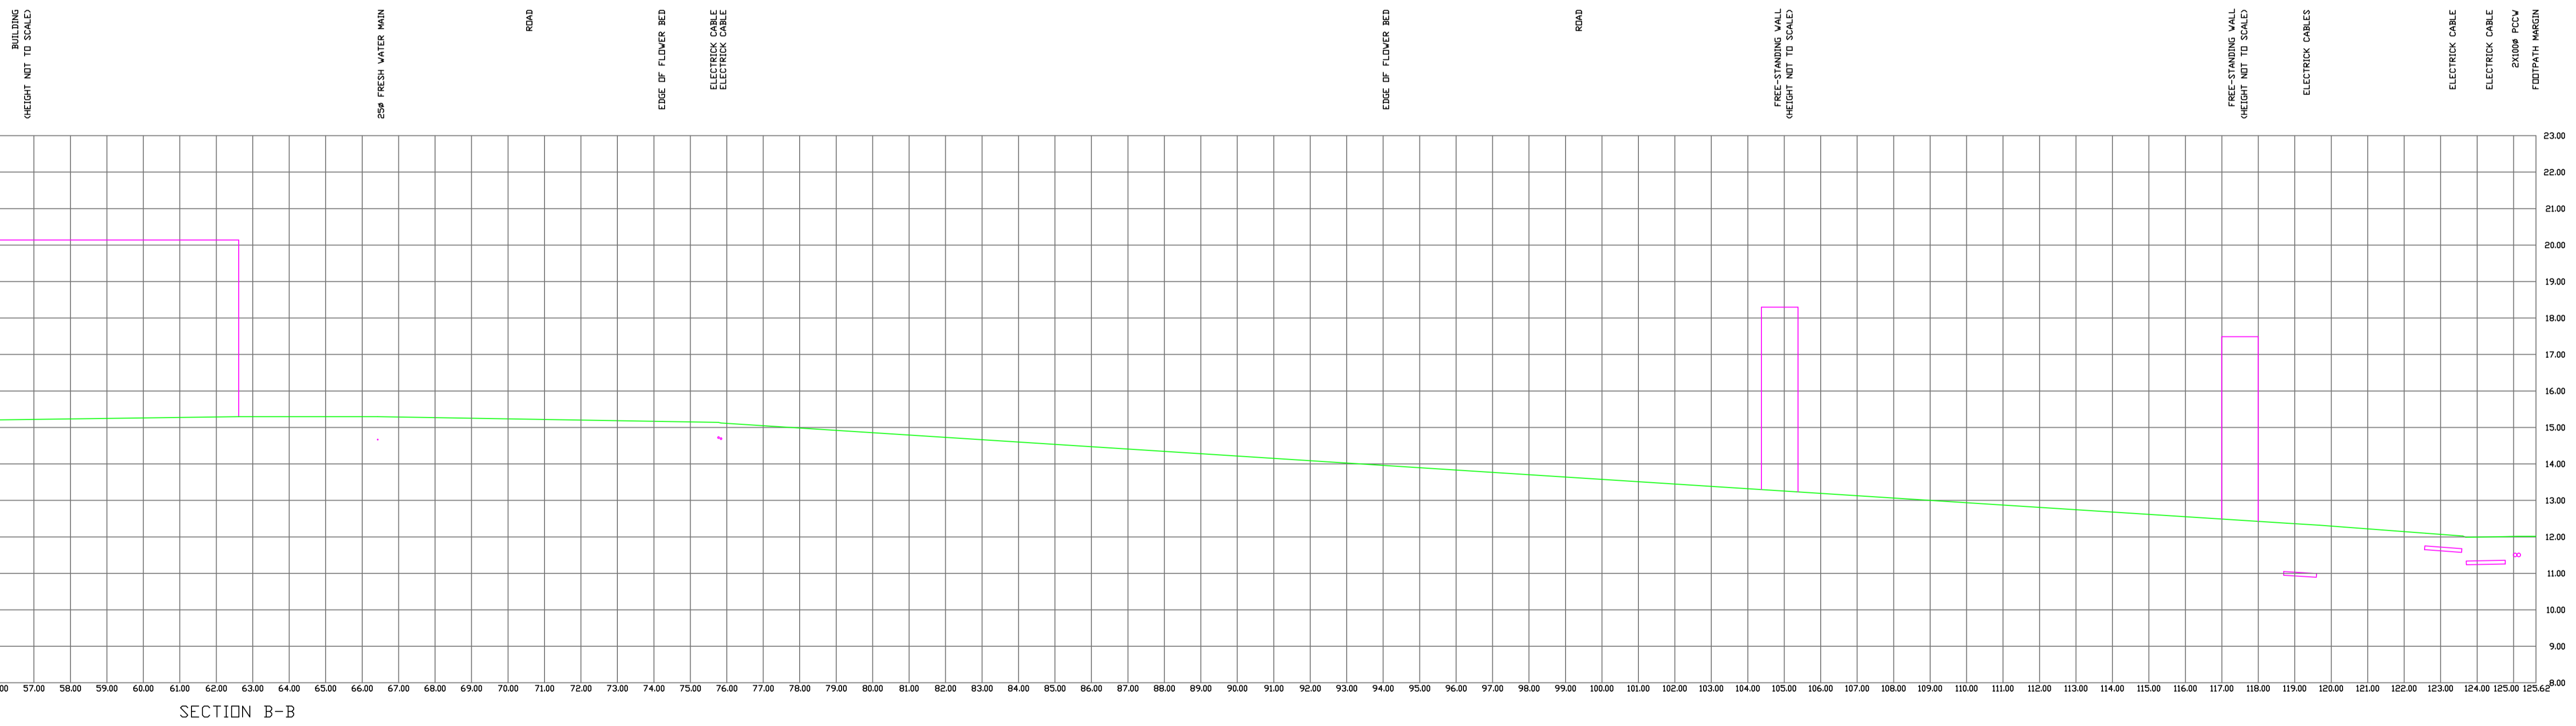
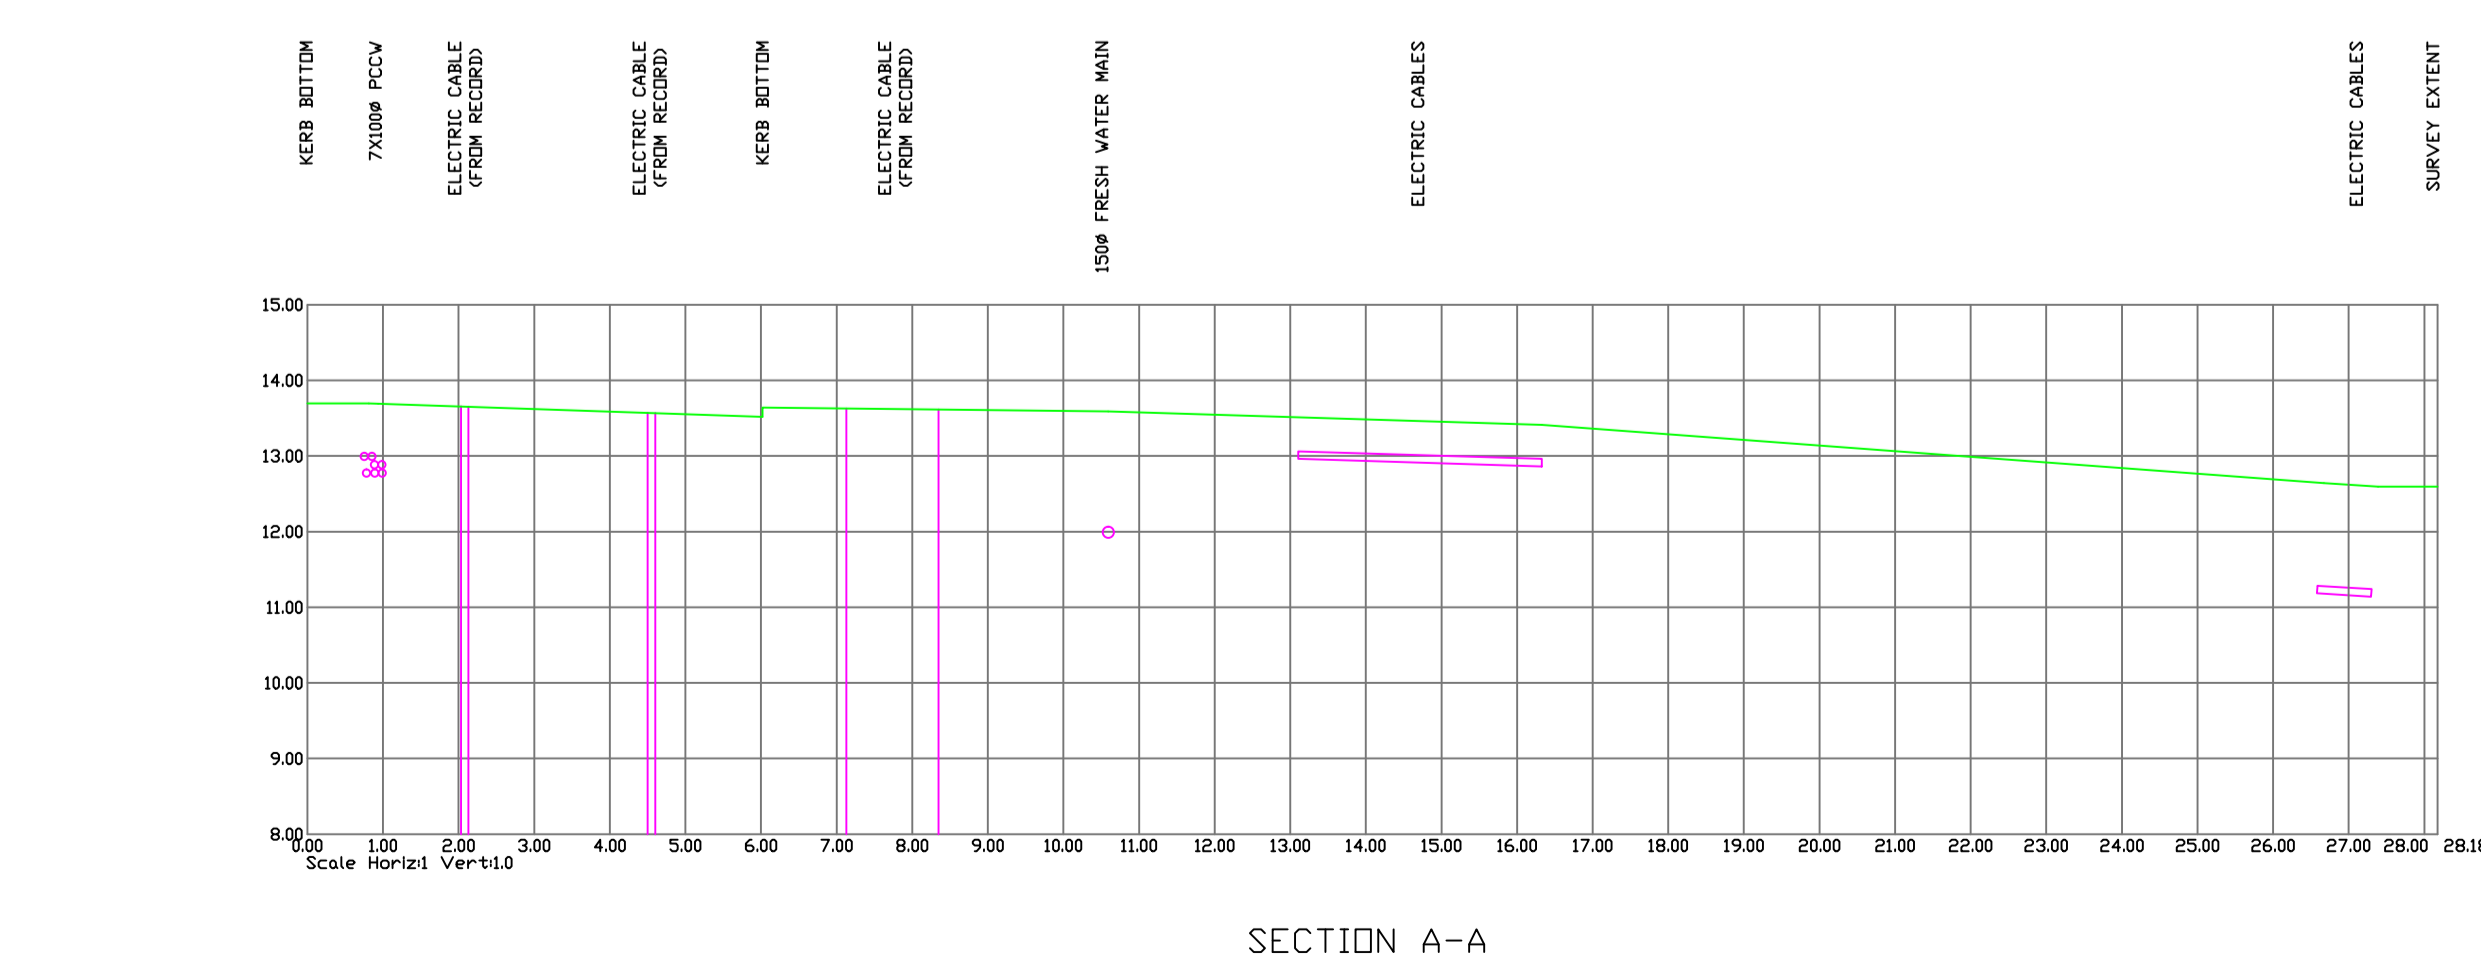
PLAN NO.: 1305799/04/R2  
 PAGE: 4 OF 6  
 SURVEYED BY: CHAU, NGAI KONG CP01235  
 DRAWN BY: YUNG, KWOK KUEN  
 APPROVED BY:

NOTE:  
 1) DIGITAL SURVEY SHEET IS FOR IDENTIFICATION ONLY.  
 2) ALL COORDINATES REFER TO THE HONG KONG 1980 GRID.  
 3) ALL LEVELS REFER TO THE HONG KONG PRINCIPAL DATUM.  
 4) ALL UNITS ARE METRIC.

DRAWING SCALE 1:100  
 DATE OF SURVEY: JUNE 2013
