**Revitalising Historic Buildings
Through Partnership Scheme**

Old Dairy Farm Senior Staff Quarters

Resource Kit

Date: 16 December 2013

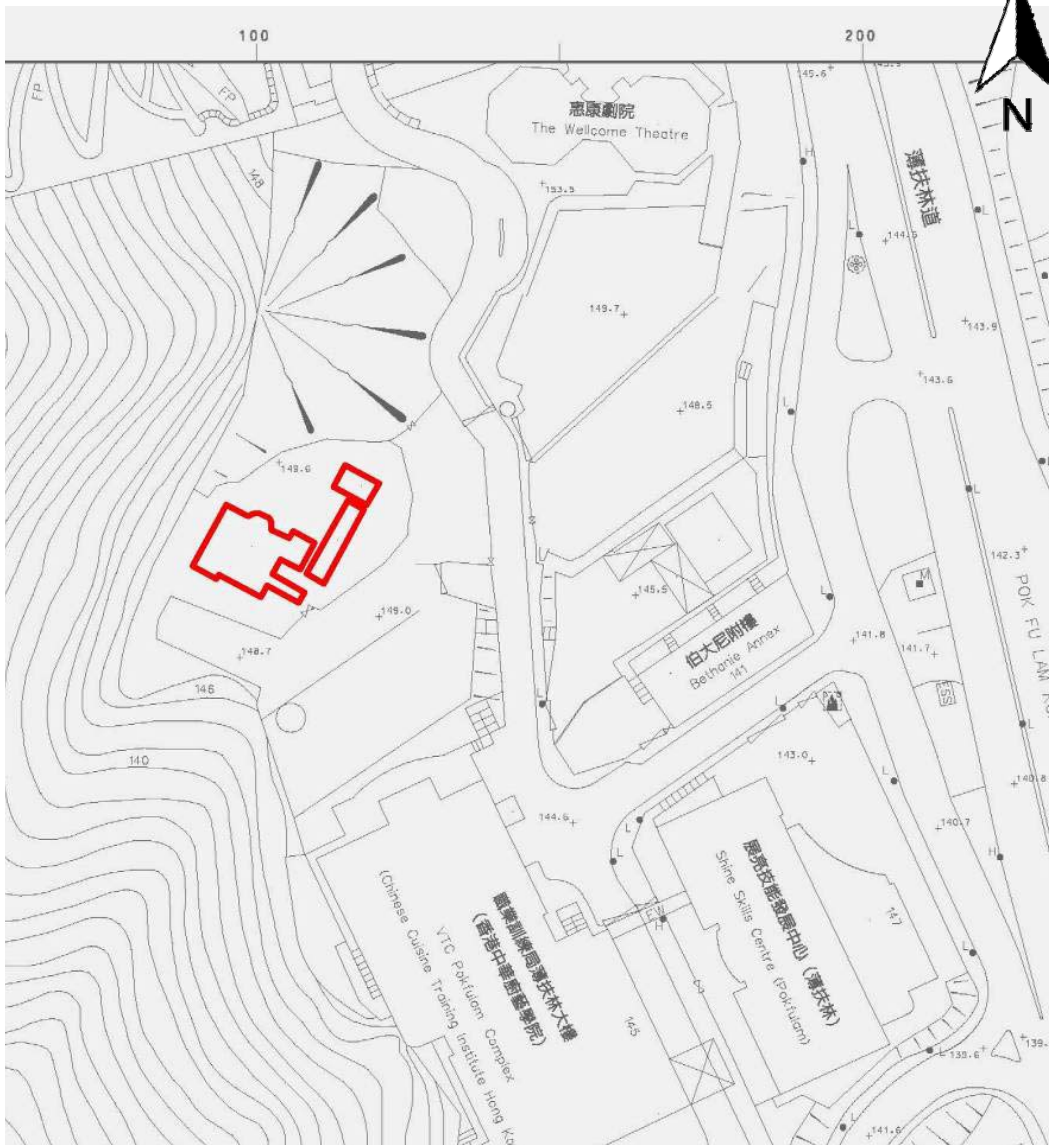
GRADING BOUNDARY	<p style="text-align: center;"> OLD DAIRY FARM SENIOR STAFF QUARTERS 141 POK FU LAM ROAD, HONG KONG </p>	<p> DRAWING NO.: APPENDIX II(B) GRADING BOUNDARY PLAN (as shown) </p>
--	---	--

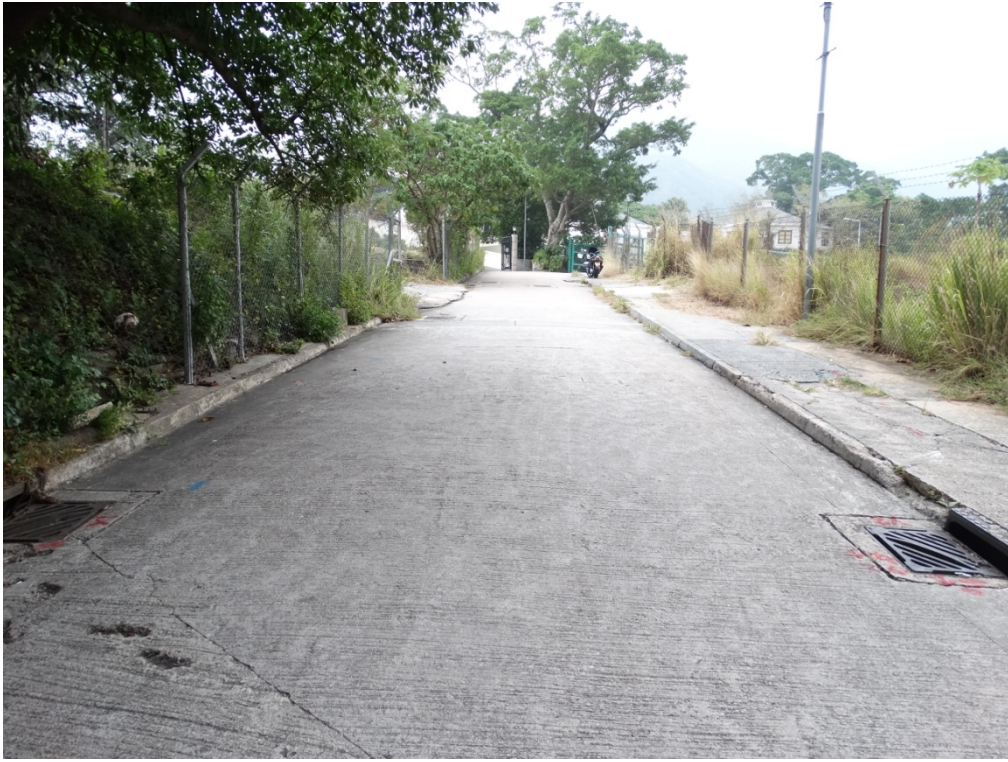
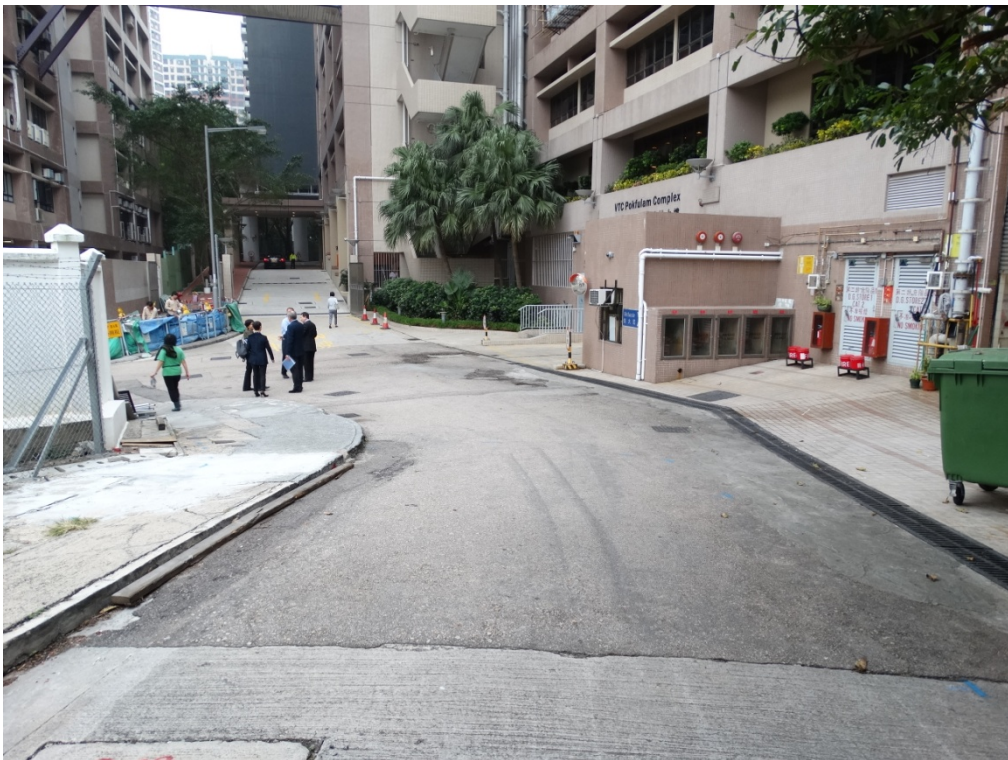
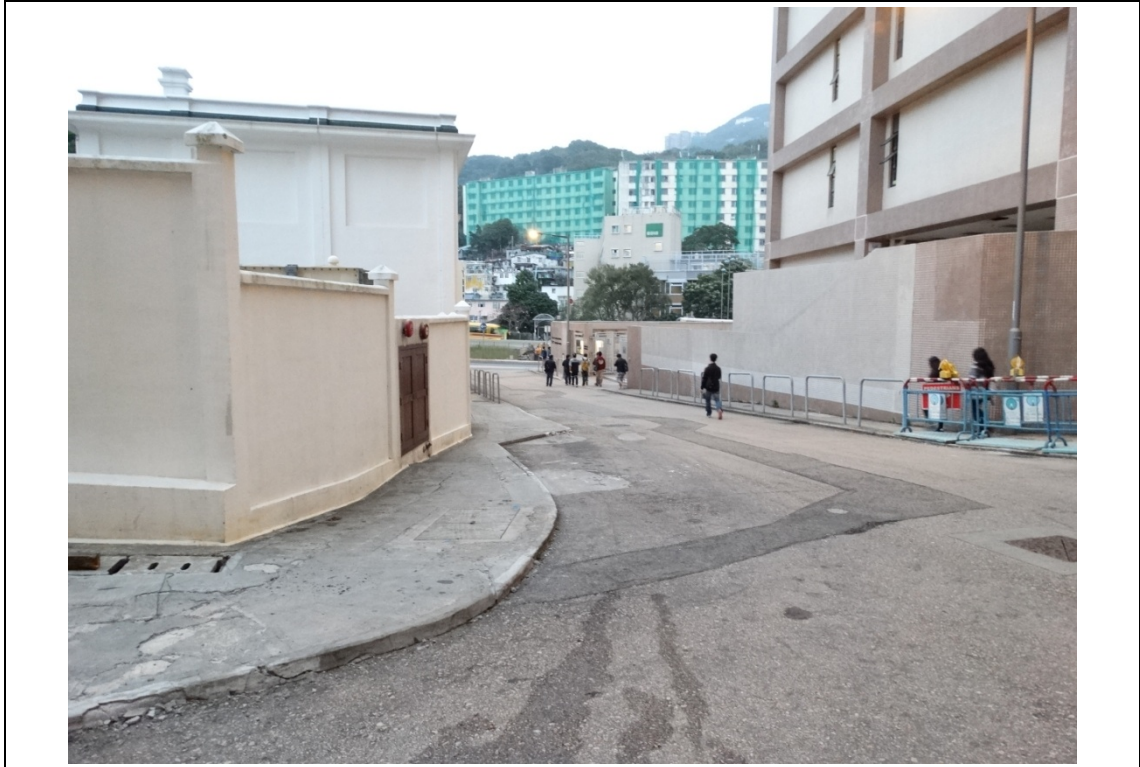
An access road connecting the Site to Pok Fu Lam Road
(currently managed by the VTC)

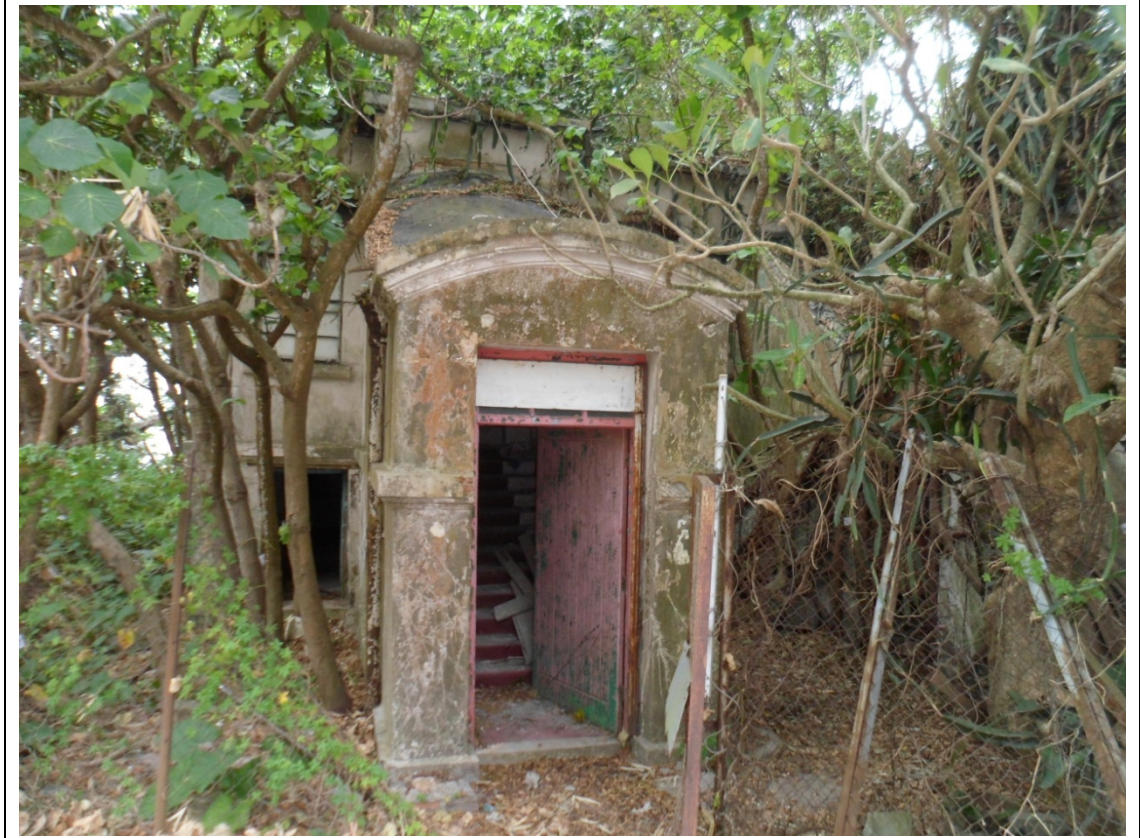
Entrance to 1/F of the Main Building

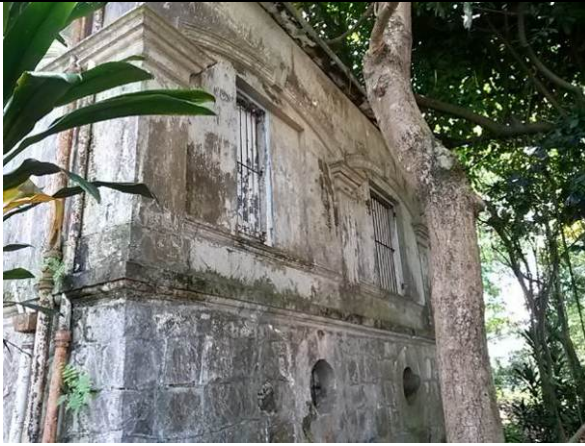
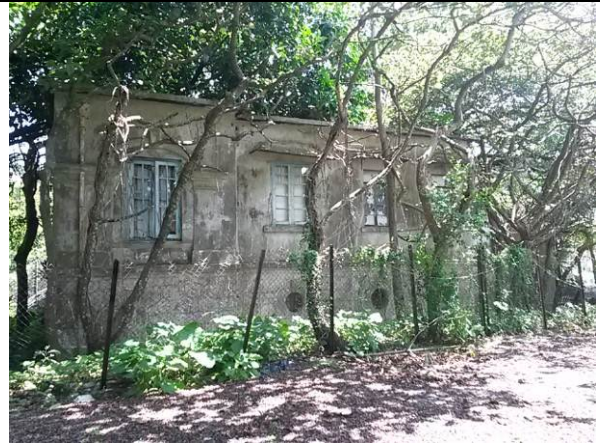
1.1) All elevations with granite block walls at the lower floor and the rendered walls at the upper floor

Architectural Feature	Required Treatment
<p>a) All elevations with granite block walls at the lower floor and the rendered walls at the upper floor</p>	<p>All elevations should be generally kept intact except for alteration or addition for necessary facilities to suit modern day's requirements, provided that they are installed in a less prominent location and subject to the approval of AMO. No window-type air-conditioning units should be installed.</p> <p>Repair the joints at the granite block walls with the materials and style matching existing. Hack off rendering (if any) and clean the granite blocks to sufficient bright by bristle or nylon brushes with clean water. Corrosive cleaning agent should not be used. The granite block surface should be left unpainted.</p> <p>Repair any damage section of the brickworks and the rendered walls using similar materials as existing. No restriction on the proposed colour scheme on the rendered walls provided that it should be compatible to the appearance of the granite block walls and the paint system should be reversible and breathable in nature.</p>

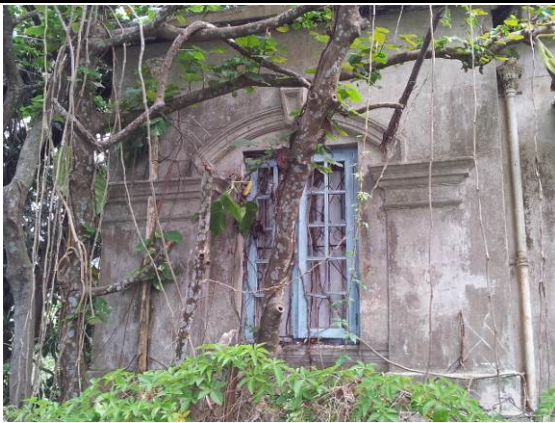
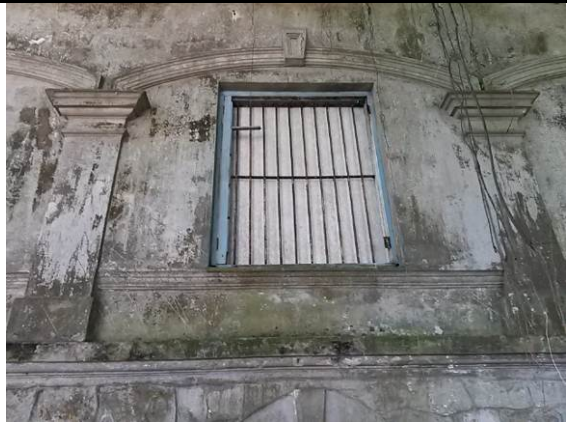
1.2) Classical architectural features on the elevations at the upper floor including columns, window sills, architraves and keystones.

Architectural Feature	Required Treatment
b) Classical architectural features on the elevations at the upper floor including columns, window sills, architraves and keystones	The features should be generally kept intact and should not be covered up. Repair the damaged architectural details following the existing profiles by materials matching existing.

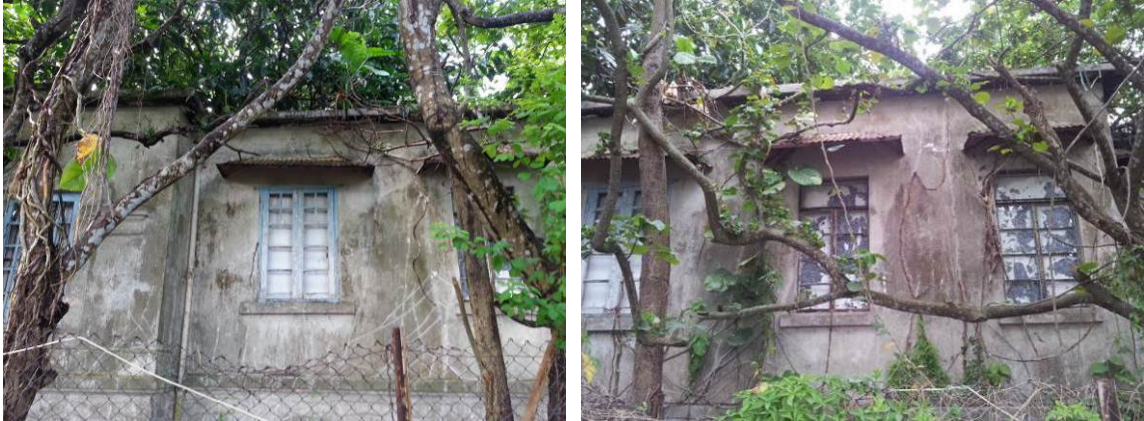
1.3) Window openings at all elevations, including the timber window frames and the window sills (Steel windows and corrugated-sheet canopies are not original)

Architectural Feature	Required Treatment
c) Window openings at all elevations, including the timber window frames and the window sills	No alteration to window openings is allowed unless approved by AMO. Overhaul the existing timber framed windows. Restore the steel framed windows to timber matching the existing style and subdivision. Remove all the corrugated-sheet canopies and other later-added items. Repair the window sills following the existing profiles by materials matching existing.

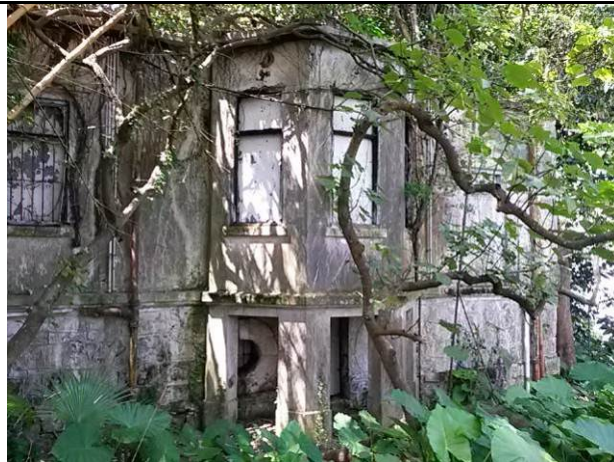
1.4) Bay window at the north-east elevation, including the window openings, the window sills and the supporting columns

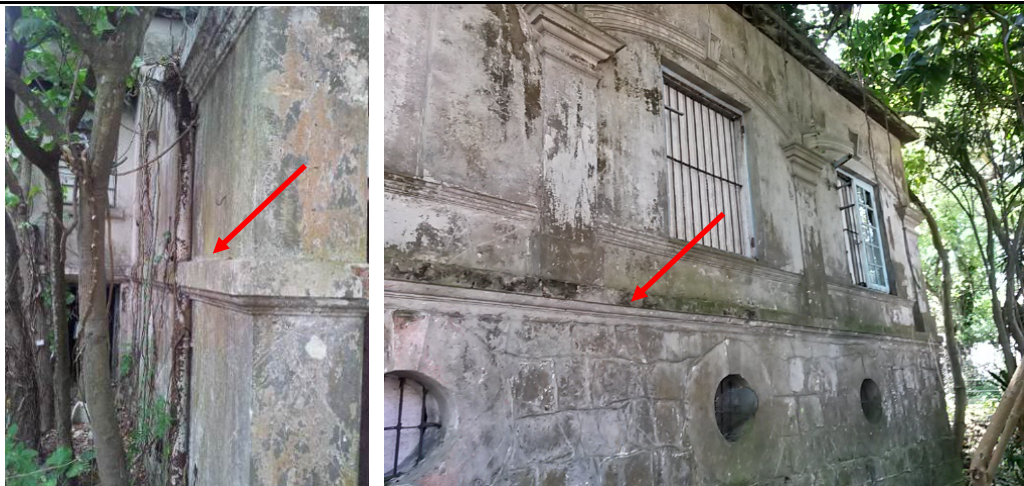
1.5) Horizontal moulded bands aligned with the floor slab

Architectural Feature	Required Treatment
e) Horizontal moulded bands aligned with the floor slab	Repair the feature following the existing profiles by materials matching existing.

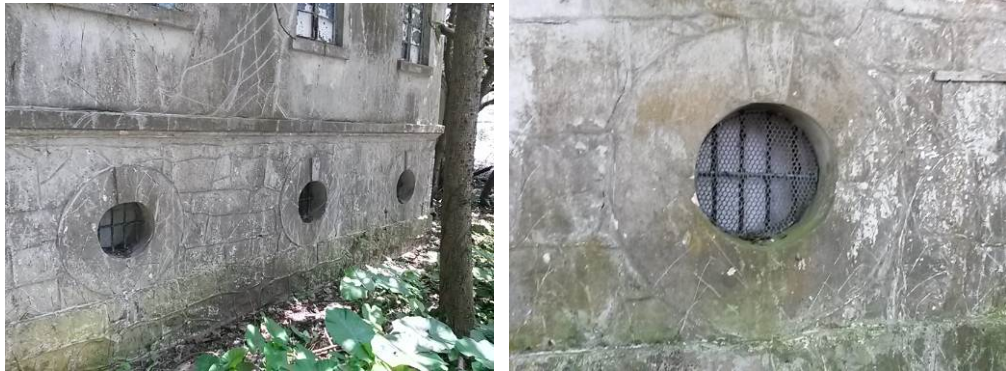
1.6) Circular bull's eye ventilation windows, including the circular surround and the keystone, and the metal grilles and meshes

Architectural Feature	Required Treatment
f) Circular bull's eye ventilation windows, including the circular surround, the keystone, and the metal grilles and meshes	No alteration to circular window openings is allowed. Repair the surround and the keystone following the existing profiles by materials matching existing as necessary. Repair the metal grilles and meshes. Blocking the openings internally by transparent material for operation needs may be permitted subject to AMO's approval.

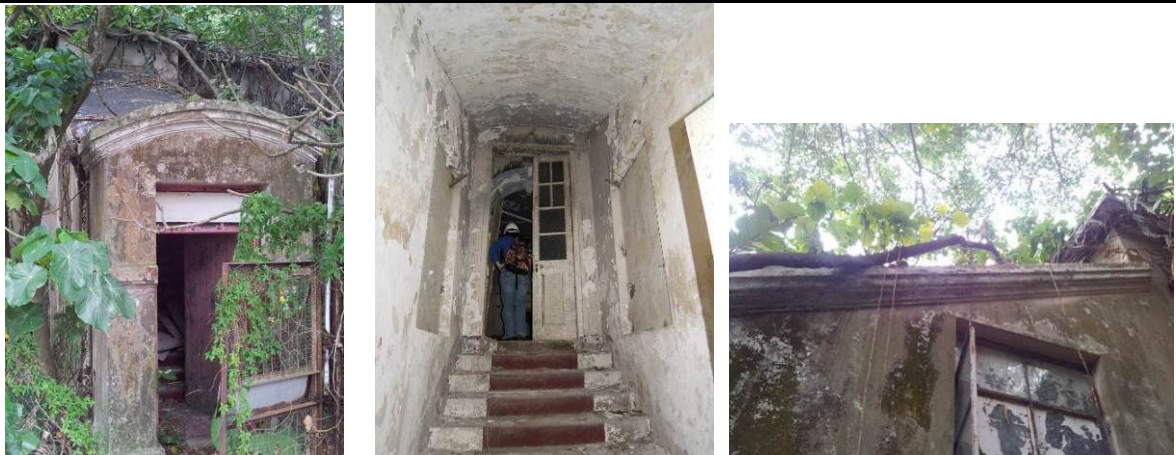
1.7) Main entrance porch to the upper floor, including its form, the arched roof, the stairway leading into the building, and the moulded copings of the roof

Architectural Feature	Required Treatment
g) Main entrance porch to the upper floor, including its form, the arched roof, the stairway leading into the building, and the moulded copings of the roof	The form of the main entrance porch should not be altered. Repair the mouldings following the existing profiles by materials matching existing. Upgrading of the stairway or installation of access facilities to suit the statutory requirements may be permitted provided that the disturbance to the porch should be kept minimum, and the design should be subject to AMO's approval.

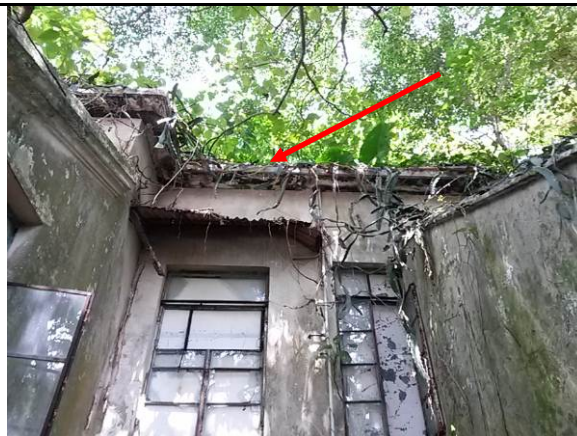
1.8) Projected canopies of the flat roof

Architectural Feature	Required Treatment
h) Projected canopies of the flat roof	Retain and repair as necessary.

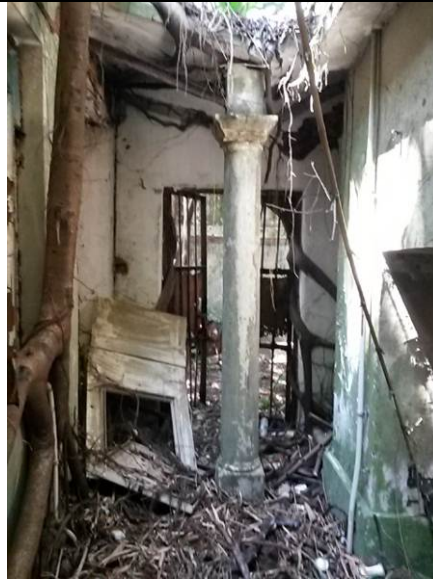
1.9) Covered walkway between the Main Building and the Servants' Quarters supported by a column with moulded details

Architectural Feature	Required Treatment
i) Covered walkway between the Main Building and the Servants' Quarters supported by a column with moulded details	Retain and repair the covered walkway and the moulded details following the existing form and profiles by materials matching existing.

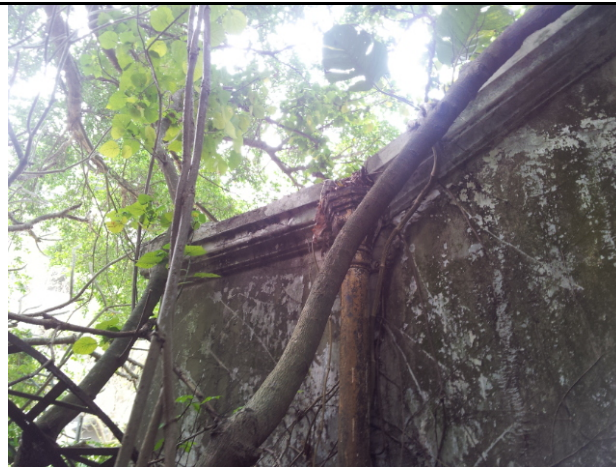
1.10) Cast iron rainwater downpipe with hopper

Architectural Feature	Required Treatment
j) Cast iron rainwater downpipe with hopper	Retain and repair the cast iron rainwater pipes and hopper heads. Restore its function if feasible.

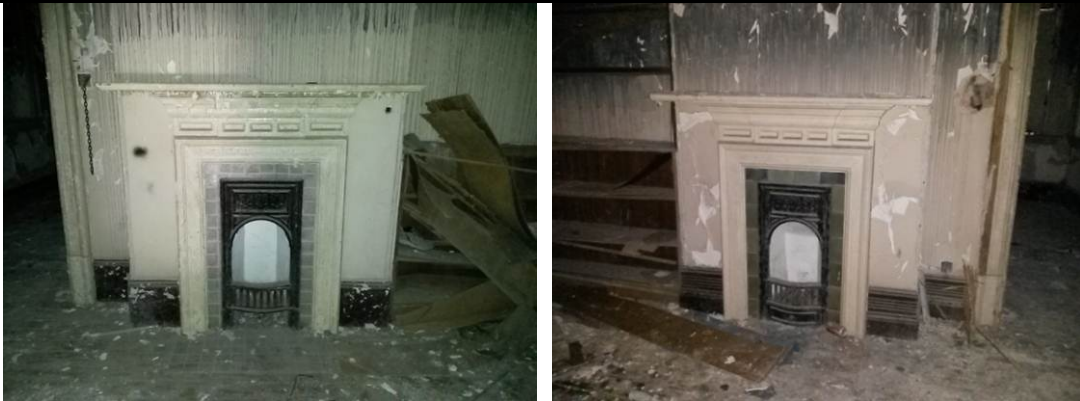
2.1) Fireplaces, including the stack, surrounds, tiling, grates and hearths.

Architectural Feature	Required Treatment
a) Fireplaces, including the stack, surrounds, tiling, grates and hearths	All fireplaces should be preserved in-situ. Do not cover up or enclose the fireplaces. Repair by materials matching existing.

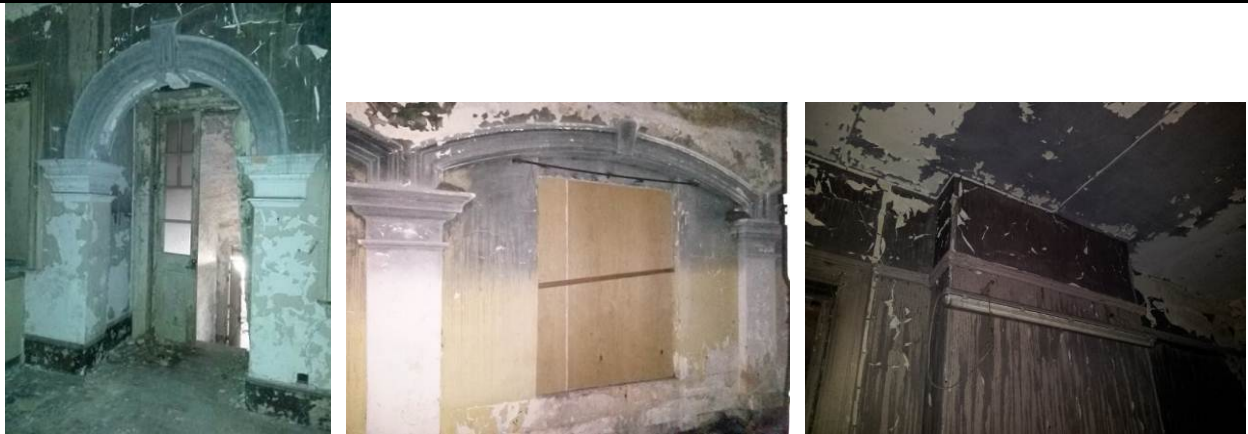
2.2) Classical architectural features including columns, architraves, keystones and mouldings

Architectural Feature	Required Treatment
b) Classical architectural features including columns, architraves, keystones and mouldings	The features should be retained. Repair the damaged architectural details following the existing profiles by materials matching existing. The features should not be covered up.

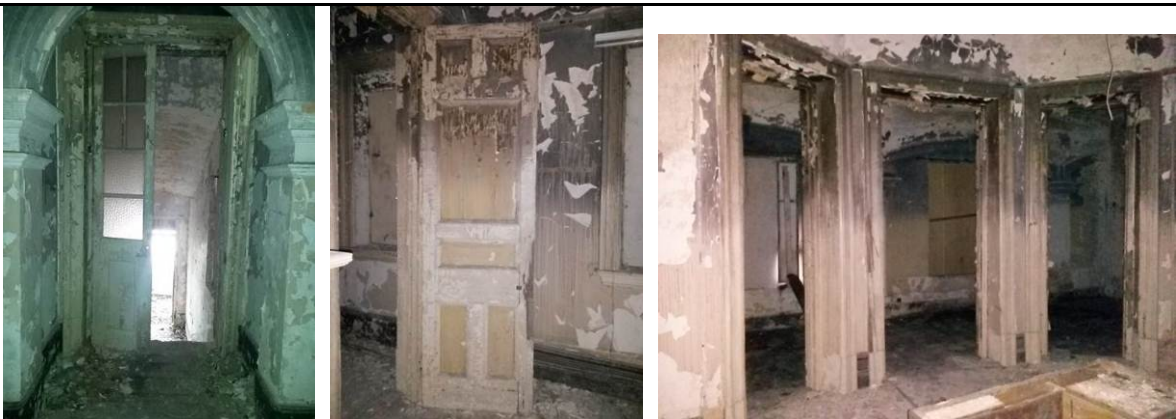
2.3) Door openings, including the timber door panels, glass panels, moulded frame and ironmongeries

Architectural Feature	Required Treatment
c) Door openings, including the timber door panels, glass panels, moulded	Do not alter the door openings. Repair the moulded frames following the existing profiles by materials matching existing. Original panelled doors should be restored and repainted.

frames and ironmongeries	<p>Repair or replace the glass panels with those matching the existing patterns or similar approved by AMO. Original ironmongeries should be preserved in-situ and oiled, adjusted, overhauled and repaired as necessary.</p> <p>No objection to replacement if the elements are beyond repair, but the replacement should be in the material and style matching the existing. Not necessary to re-provide new door if there is already none at the existing openings unless with strong historical evidence or for operational needs.</p>
--------------------------	--

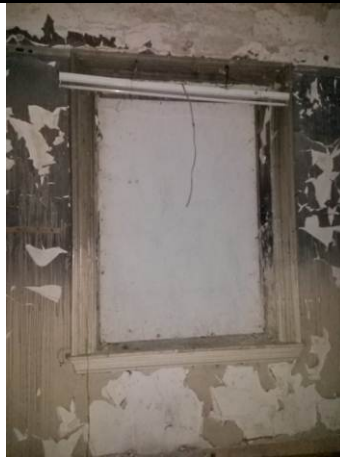
2.4) Window openings, including the moulded window frames

Architectural Feature	Required Treatment
d) Window openings, including the moulded window frames	Do not alter the window openings unless approved by AMO. Repair the moulded frames following the existing profiles by materials matching existing. Restore the window with window frames following the style and materials of the existing.

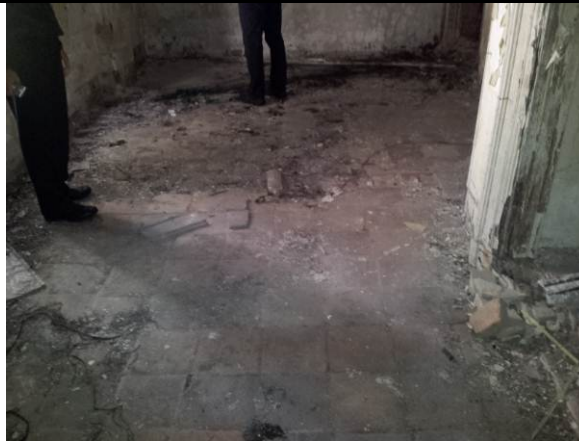
2.5) Floor tiles at the enclosed verandah

Architectural Feature	Required Treatment
e) Floor tiles at the enclosed verandah	Original floor tiles should be preserved in-situ and repaired. New replacement of the tiles is acceptable if the tiles are beyond repair and the replacements should follow the existing style and material. Modification works to the floor slabs for structural strengthening to suit operational needs may be permitted subject to the approval of AMO.

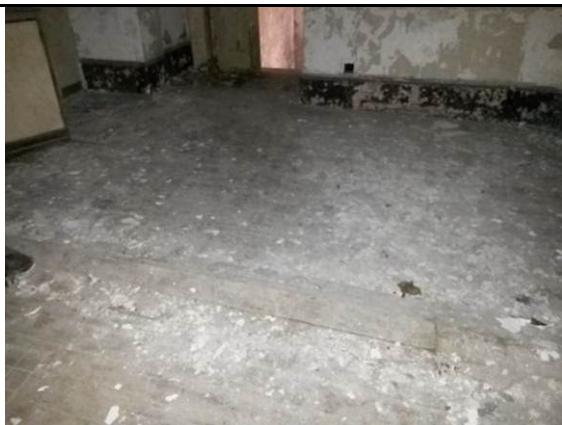
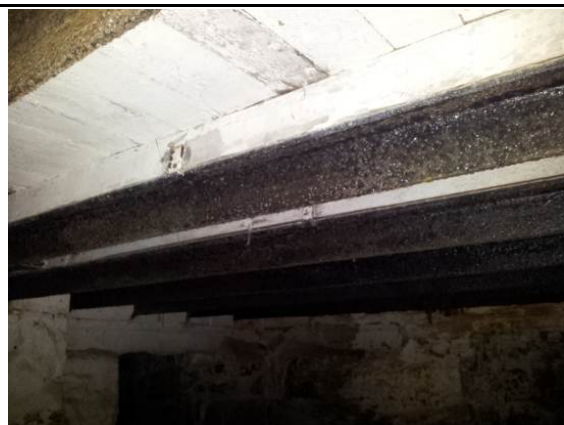
2.6) Timber floor decking

Architectural Feature	Required Treatment
f) Timber floor decking	Timber flooring decking should be preserved in-situ and repaired. New replacement of the elements is acceptable if the elements are beyond repair and the replacements should follow the existing styles and materials. With the advice from a Registered Structural Engineer, the structural system of the timber floor decking could be upgraded to suit modern statutory requirements and operation needs subject to approval from AMO.

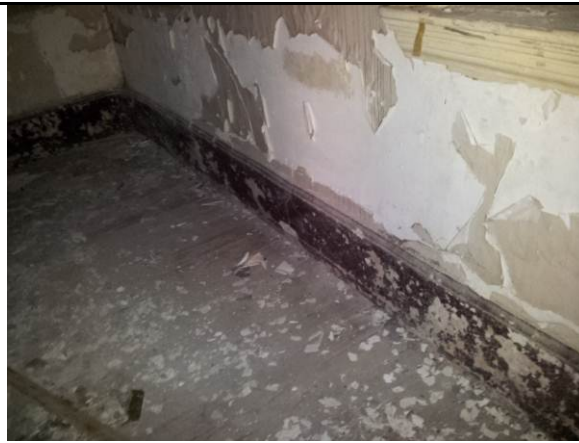
2.7) Wall skirting

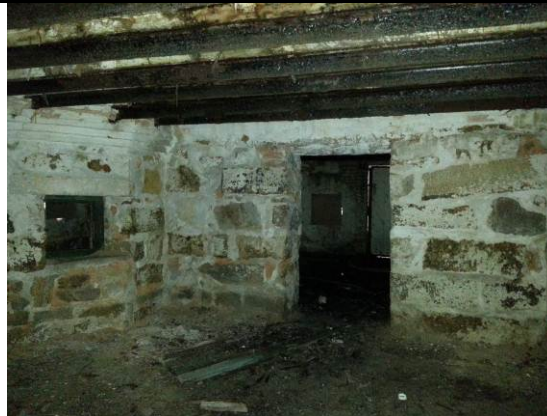
2.8) The lower floor with granite block walls and corbelled mouldings to the steel joists supporting the timber flooring system at the upper floor

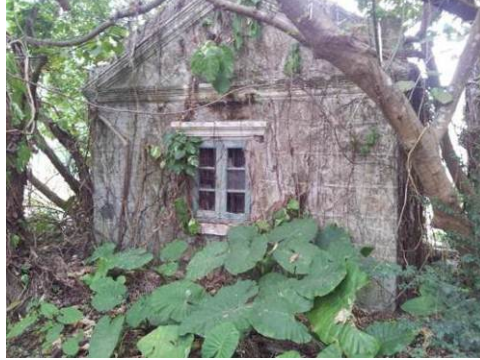
3.1) All elevations of the Garage Block, including the moulded pediments, window hoods and sills, timber windows, and the granite blocks and joints.

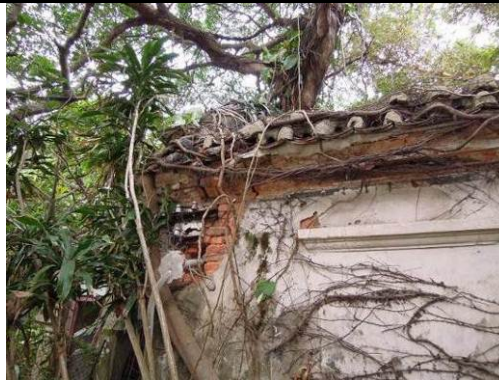
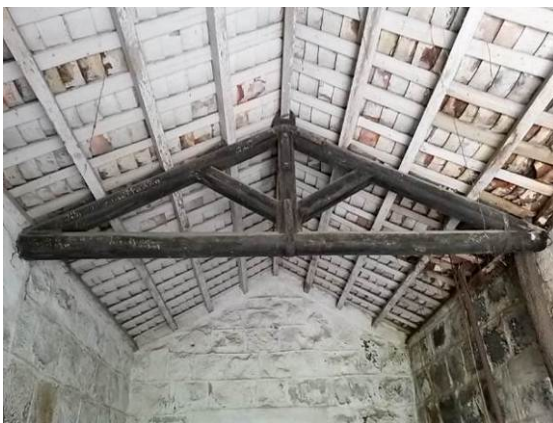
3.2) Pitched roofs with double-roll double-layer Chinese style tiles and the timber roof systems at the Garage Block and the Servants' Quarters

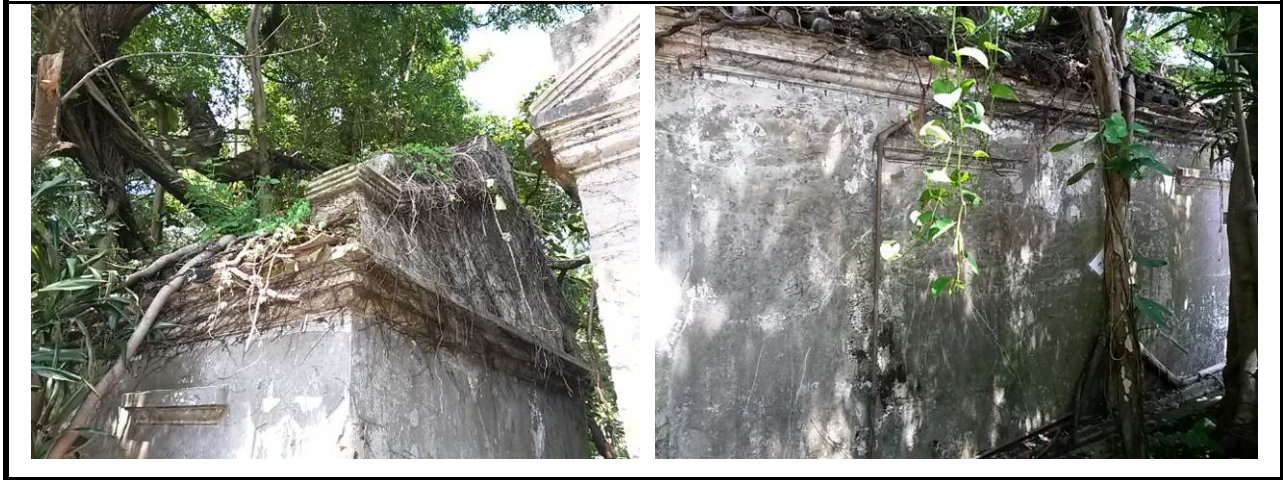
3.3) Moulded copings and horizontal moulded bands to the pitched roof, and the moulded canopies of the blocked door openings at the Servants' Quarters

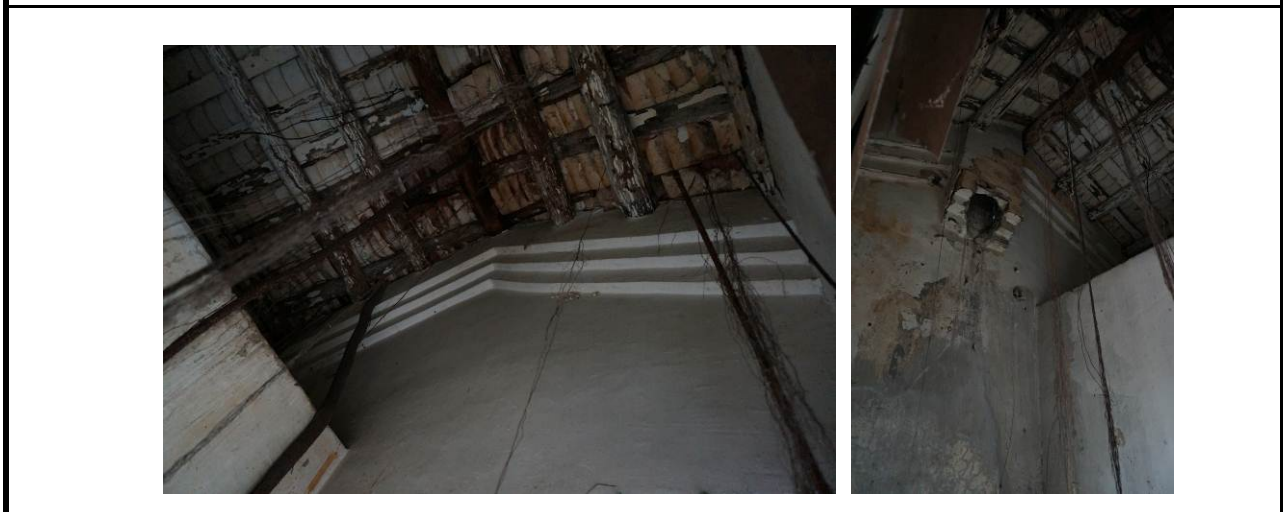
3.4) Corbelled mouldings to the roof and the remains of chimney at the Servants' Quarters

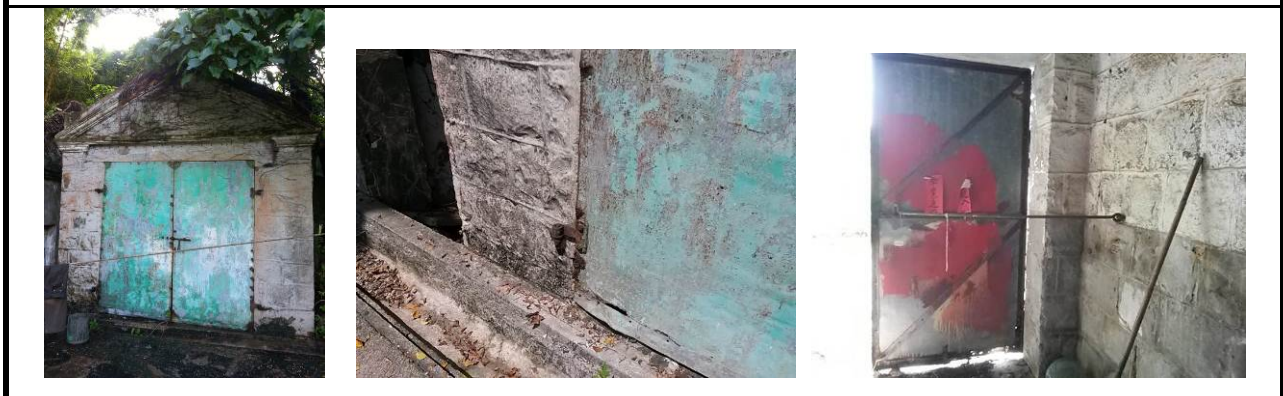
3.5) Door opening at the Garage Block, including the door hinges and the door stay

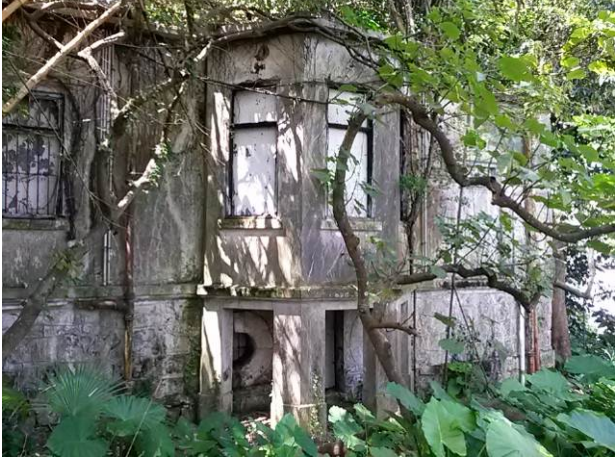
Architectural Feature	Required Treatment
d) Bay window at the north-east elevation, including the window openings, the window sills and the supporting columns	The form of the bay window should not be altered. No alteration to the window openings, the window sills and the supporting columns is allowed. Restore the window openings with timber framed windows matching existing style.

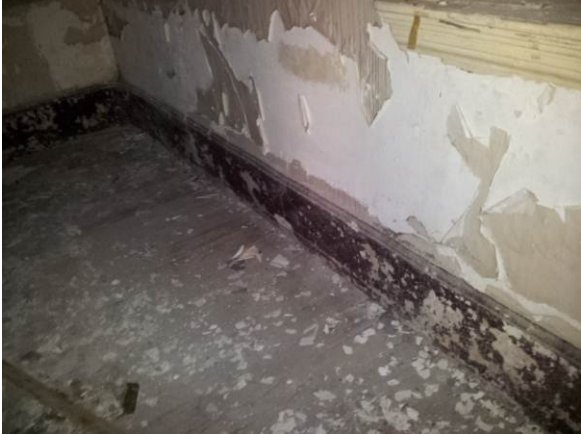
Architectural Feature	Required Treatment
g) Wall skirting	Retain and repair the feature following the existing profiles by materials matching existing. The feature should not be covered up.

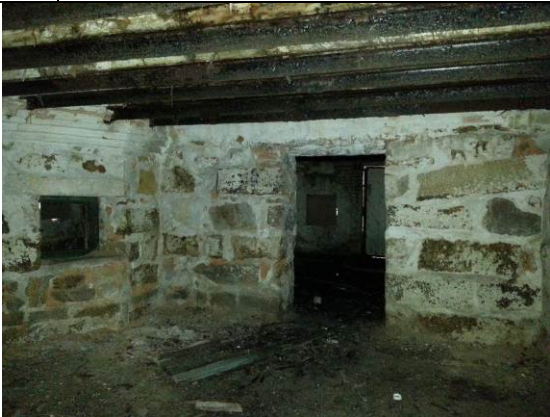
Architectural Feature	Required Treatment
i) The lower floor with granite block walls and corbelled mouldings to the steel joists supporting the floor slabs at the upper floor	The layout of the lower ground floor should not be altered. Repair the joints at the granite blocks as necessary with the material and style matching existing. Clean the granite blocks to sufficient bright by bristle or nylon brushes with clean water. Corrosive cleaning agent should not be used. Repair the corbelled mouldings as necessary following the existing profiles by materials matching existing.

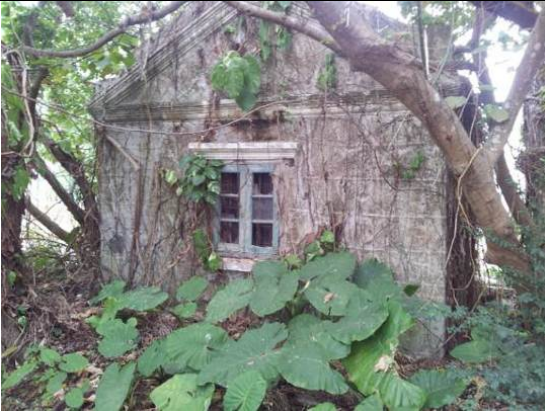
Architectural Feature	Required Treatment
a) All elevations of the Garage Block, including the moulded pediment, granite blocks and joints, window hoods and sills, and timber framed window.	<p>All the elevations should be generally kept intact. Repair the joints at the granite block walls as necessary with the material and style matching existing. Hack off rendering (if any) and clean the granite blocks to sufficient bright by bristle or nylon brushes with clean water. Corrosive cleaning agent should not be used. The granite block surface should be left unpainted.</p> <p>Repair the damaged architectural details, including the moulded pediment, window hoods and sills, following the existing profiles by material matching existing.</p> <p>No alteration to window openings is allowed unless approved by AMO. Overhaul the existing timber framed windows or restore the window following the material and style of the existing window. No replacement by steel or aluminium windows is allowed. No window-type air-conditioning units should be installed.</p>

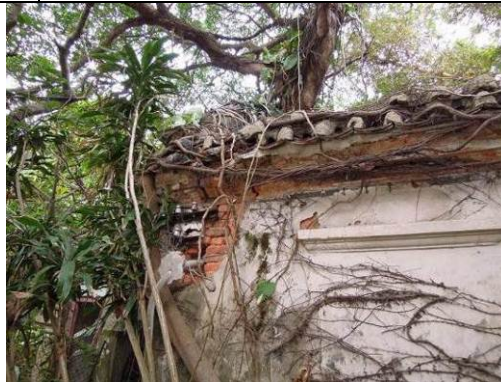
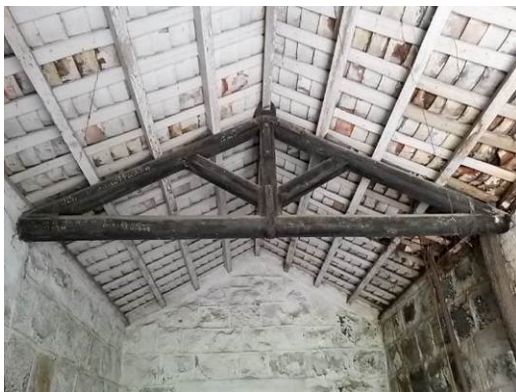
Roof of the Garage Block

Architectural Feature	Required Treatment
b) Pitched roofs with double-roll double-layer Chinese style tiles and the timber roof system at the Garage Block and the Servants' Quarters	Do not change the form and the materials of the roofs. Repair and maintain to be waterproofed. Repair the damaged roofs with the Chinese style tiles matching existing. Check structural condition and repair the defective timber trusses, rafters and purlins as necessary. At least part of the timber structure should be exposed for appreciation. Install termite eradication and monitoring system.

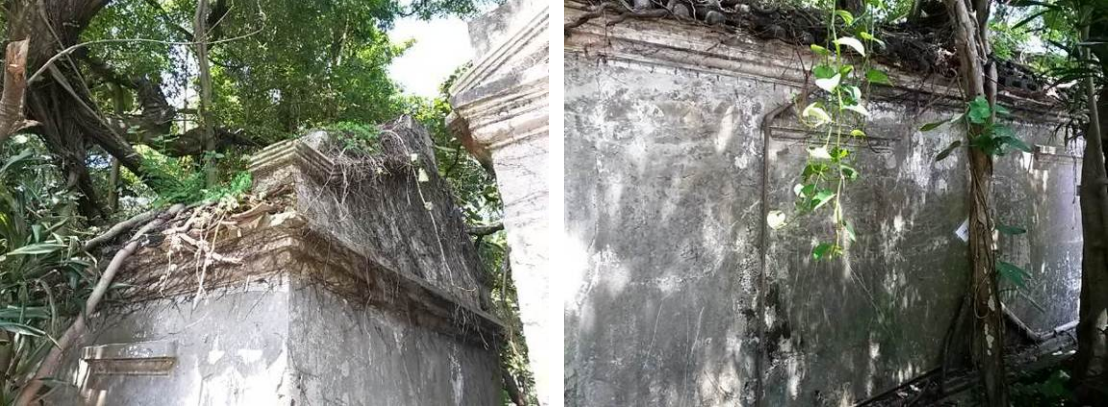
Architectural Feature	Required Treatment
c) Moulded copings and horizontal moulded bands to the pitched roof, and the moulded canopies of the blocked door openings	Repair the damaged architectural details, including the moulded pediment, window hoods and sills, following the existing profiles by materials matching existing.

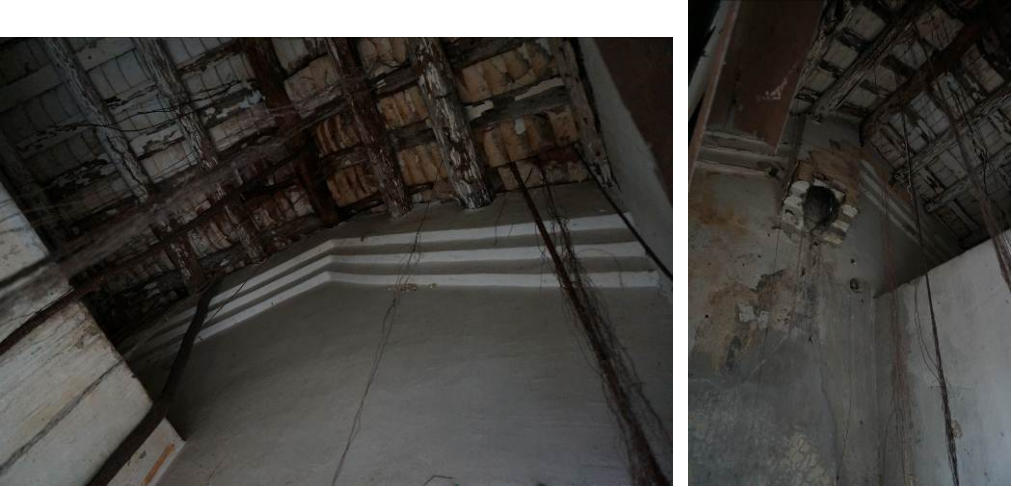
Architectural Feature	Required Treatment
d) Corbelled mouldings to the roof and the remains of the chimney at the Servants' Quarters	Repair the corbelled mouldings and the remains of the chimney as necessary following the existing profiles by materials matching existing. Not necessary to restore the chimney unless with strong historical evidence.

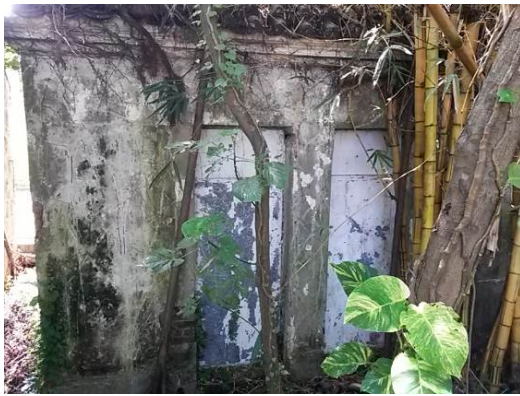
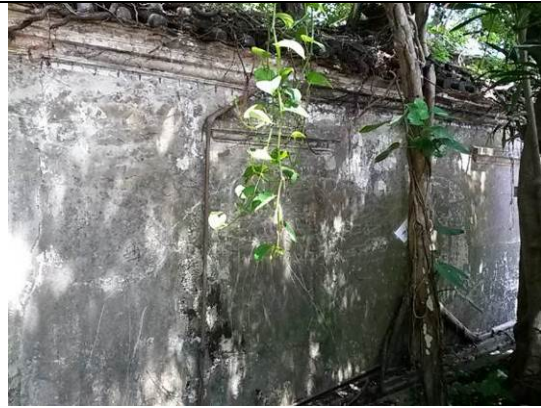
Architectural Feature	Required Treatment
e) Blocked door openings of the Servants' Quarters	<p>Do not alter the size of the existing door openings which are now blocked by steel panels. Replace the steel panels by new doors of style and materials compatible to the existing building design.</p> <p>No specific requirement to the door openings which are already blocked. If they are to be restored to doors, the design of the new door should be compatible to the existing building design. The restored door openings should not wider than their corresponding moulded canopies above. Design of the new door should be submitted to AMO for approval.</p>

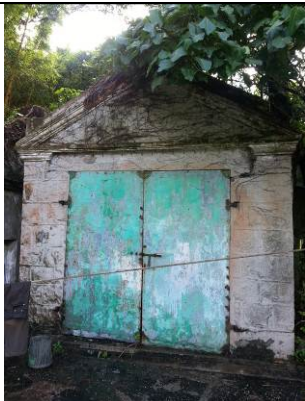
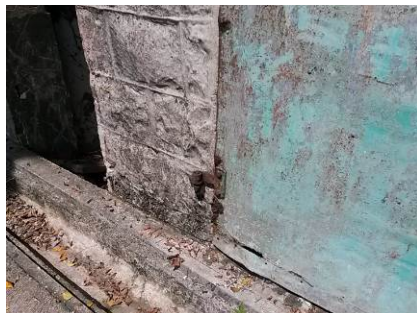
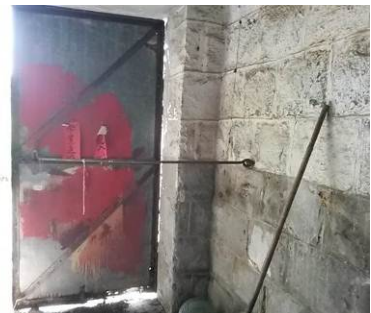
Architectural Feature	Required Treatment
f) Door opening of the Garage Block, including the door hinges and the door stay	<p>Do not alter the size or block the existing door opening. Retain the door hinges and the door stay in-situ, repair, de-rust and repaint them as necessary. No objection to replace the steel door by new door for operational needs, but the new door should be compatible to the existing building design.</p>

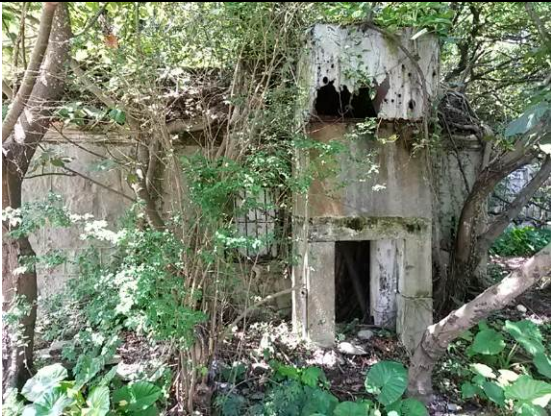
Architectural Feature	Required Treatment
g) Water tank adjacent to the Garage Block	Demolish the structure which hinders appreciation to the side elevation of the Garage Block.

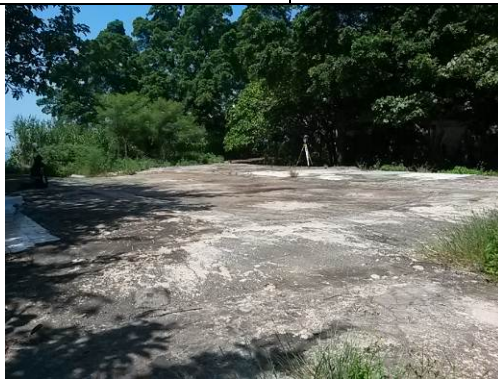
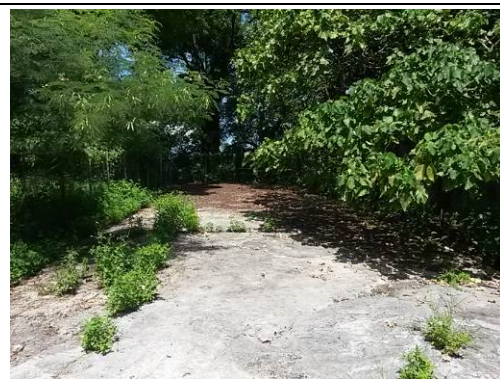
Open Space within the Site

Architectural Feature	Required Treatment
a) Open space	Any new structure should not cause visual impact to the Senior Staff Quarters. In particular, vista from the Senior Staff Quarters to East Lamma Channel, Bethanie, the Cowshed and the Main Office Building of the Old Dairy Farm (these buildings are now re-used by the Hong Kong Academy for Performing Arts) should not be blocked as they possess group value with the Senior Staff Quarters.

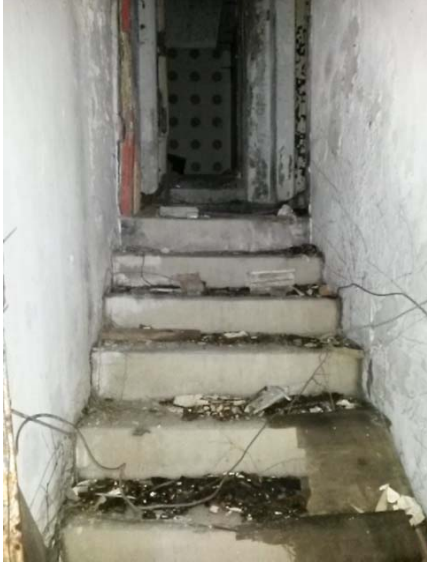
Architectural Feature	Recommended Treatment
a) Side entrance with stairway leading into the Main Building	Retain and upgrade this stairway for circulation purpose.
