**Revitalising Historic Buildings
Through Partnership Scheme**

Old Dairy Farm Senior Staff Quarters

Resource Kit

Date: 16 December 2013

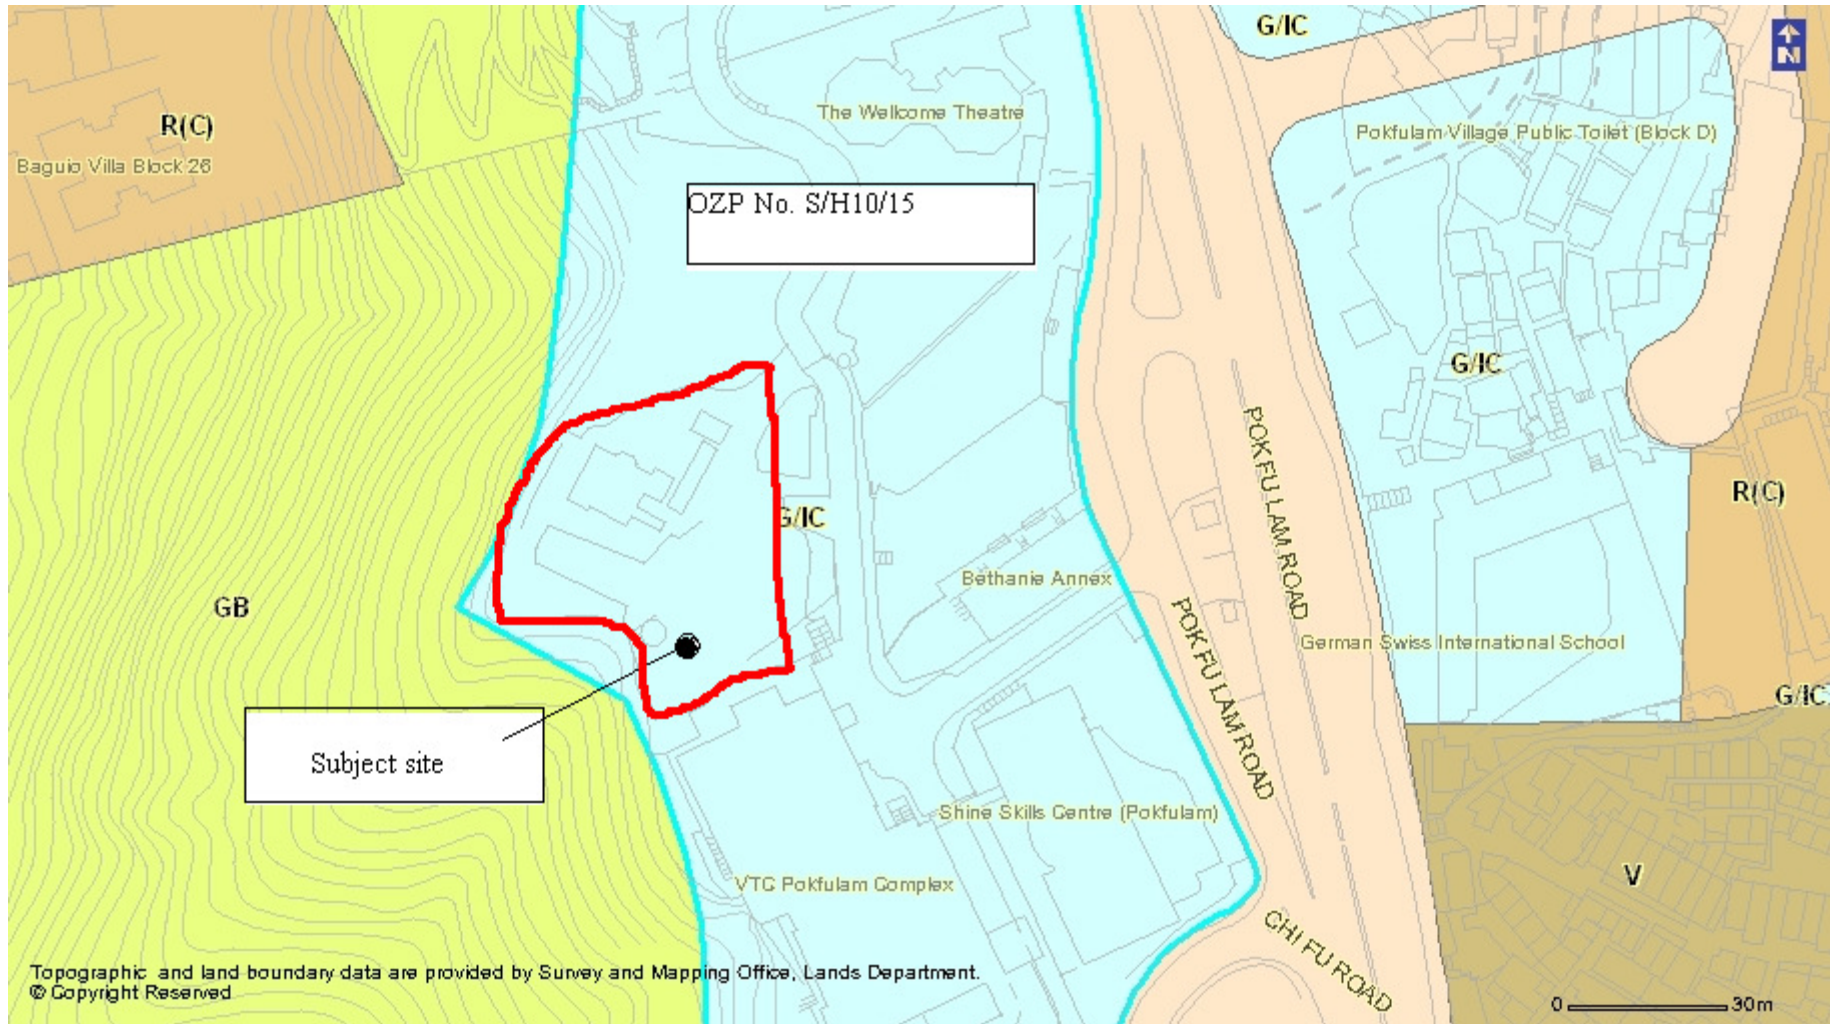
Outline Zoning Plan

GOVERNMENT, INSTITUTION OR COMMUNITY

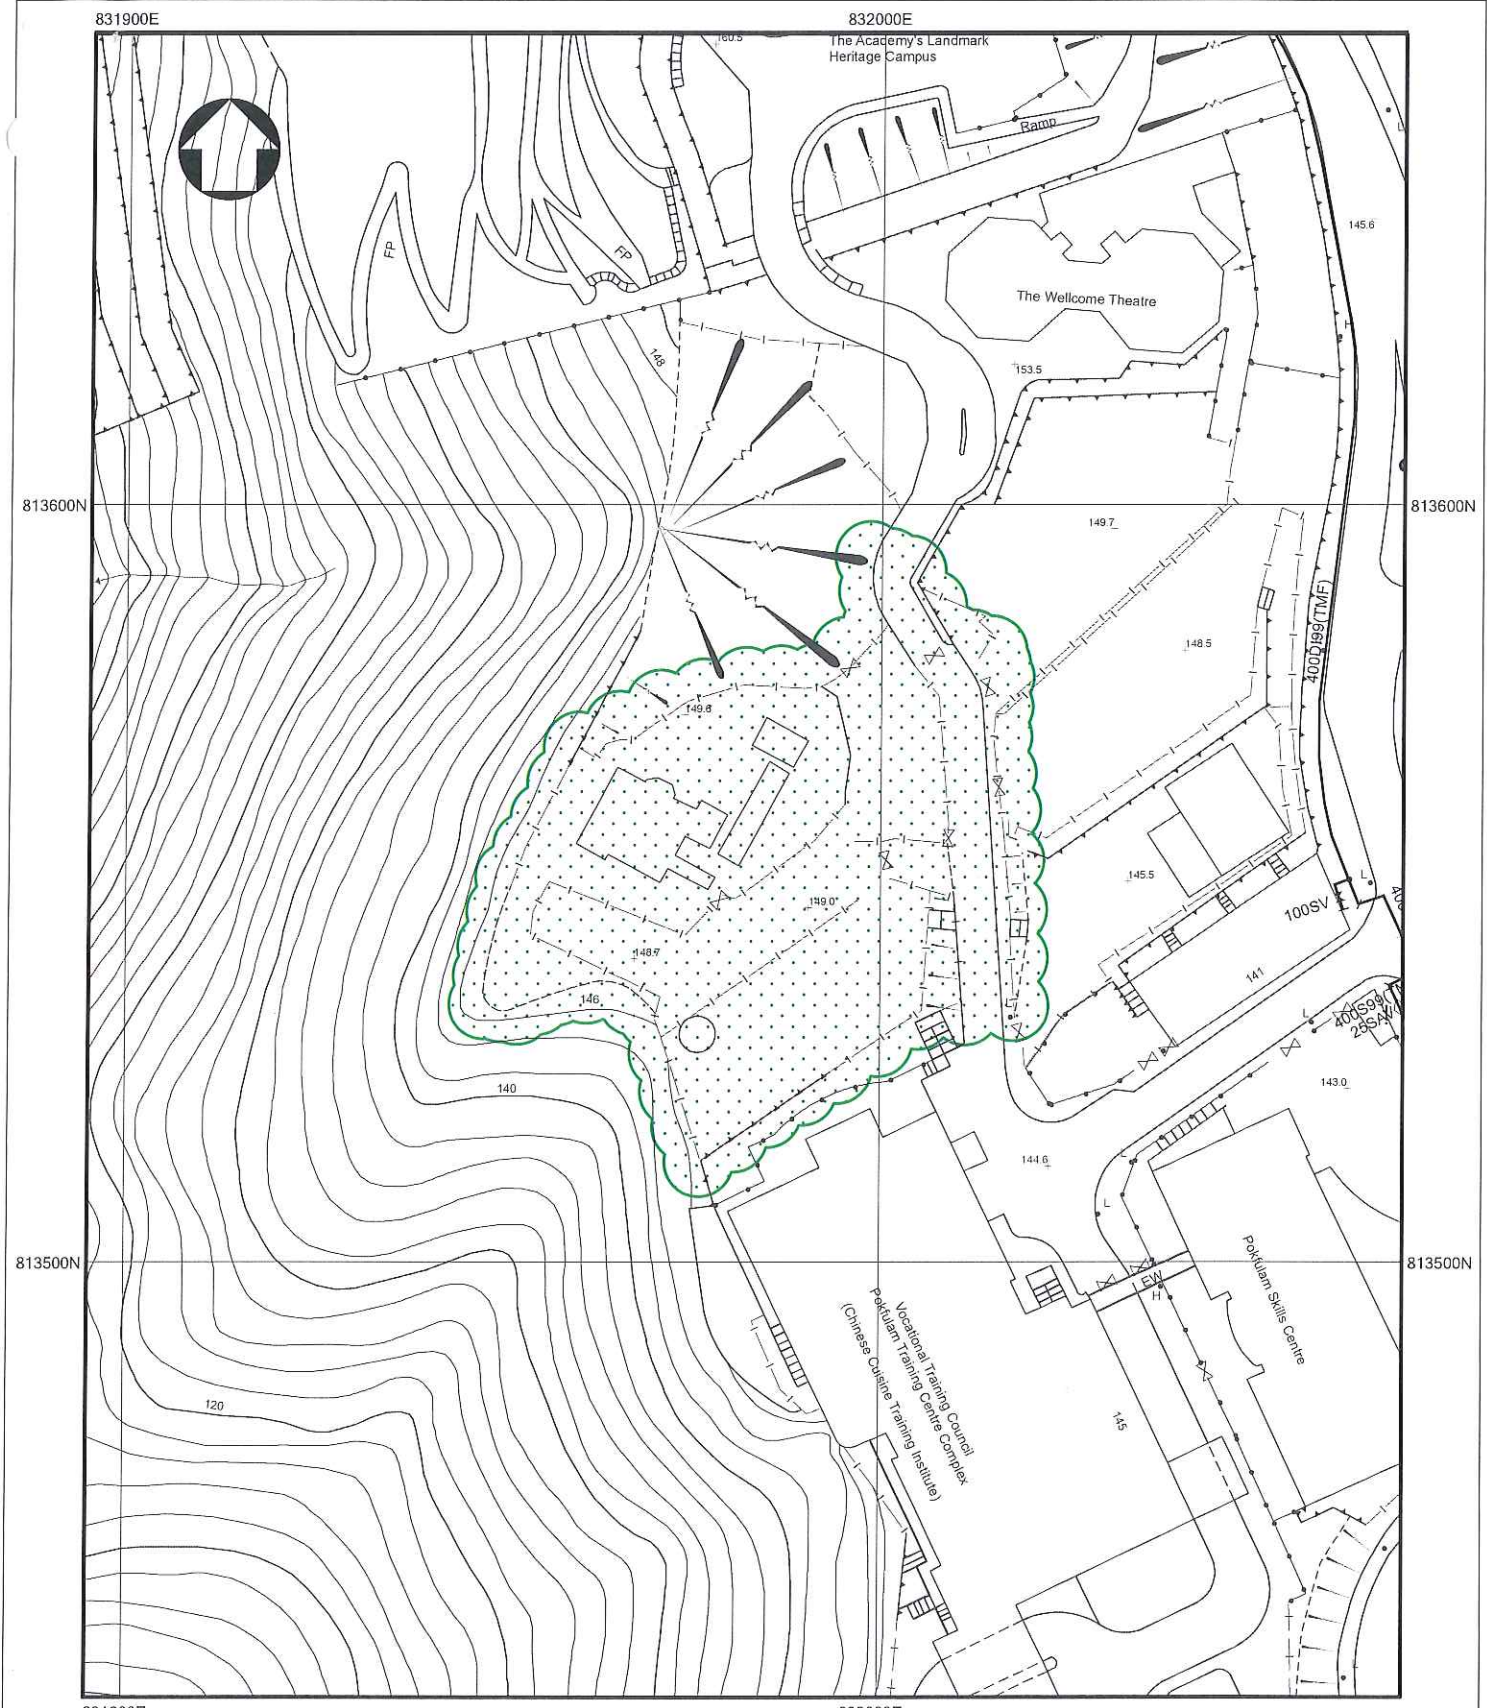
Record Plan of Water Supplies Department

- NOTES:
1. ALL DIMENSIONS ARE IN MILLIMETRES UNLESS OTHERWISE SPECIFIED.
 2. ALL LEVELS ARE IN METRES ABOVE PRINCIPAL DATUM.
 3. INFORMATION ON ALIGNMENT OF MAINS IS OF INDICATIVE VALUE ONLY. WHERE POSITIONAL ACCURACY MAY BE OF IMPORTANCE, DETAILS SHOULD BE SITE CHECKED.
 4. FOR MAINS RECORDS SIGN CONVENTIONS AND DESIGNATIONS SEE SKETCH NO.3988.
 5. NO EXISTING WSD CABLE IN THE VICINITY OF THE SITE.
 6. NO PROPOSED WSD CABLE IN THE VICINITY OF THE SITE.
 7. THE SITE IS NOT WITHIN WSD GATHERING GROUNDS.
 8. NO WSD LAND ALLOCATION / WWR WITHIN THE SITE AREA.
 9. NO WSD SLOPES ARE AFFECTED IN THE VICINITY OF THE SITE.

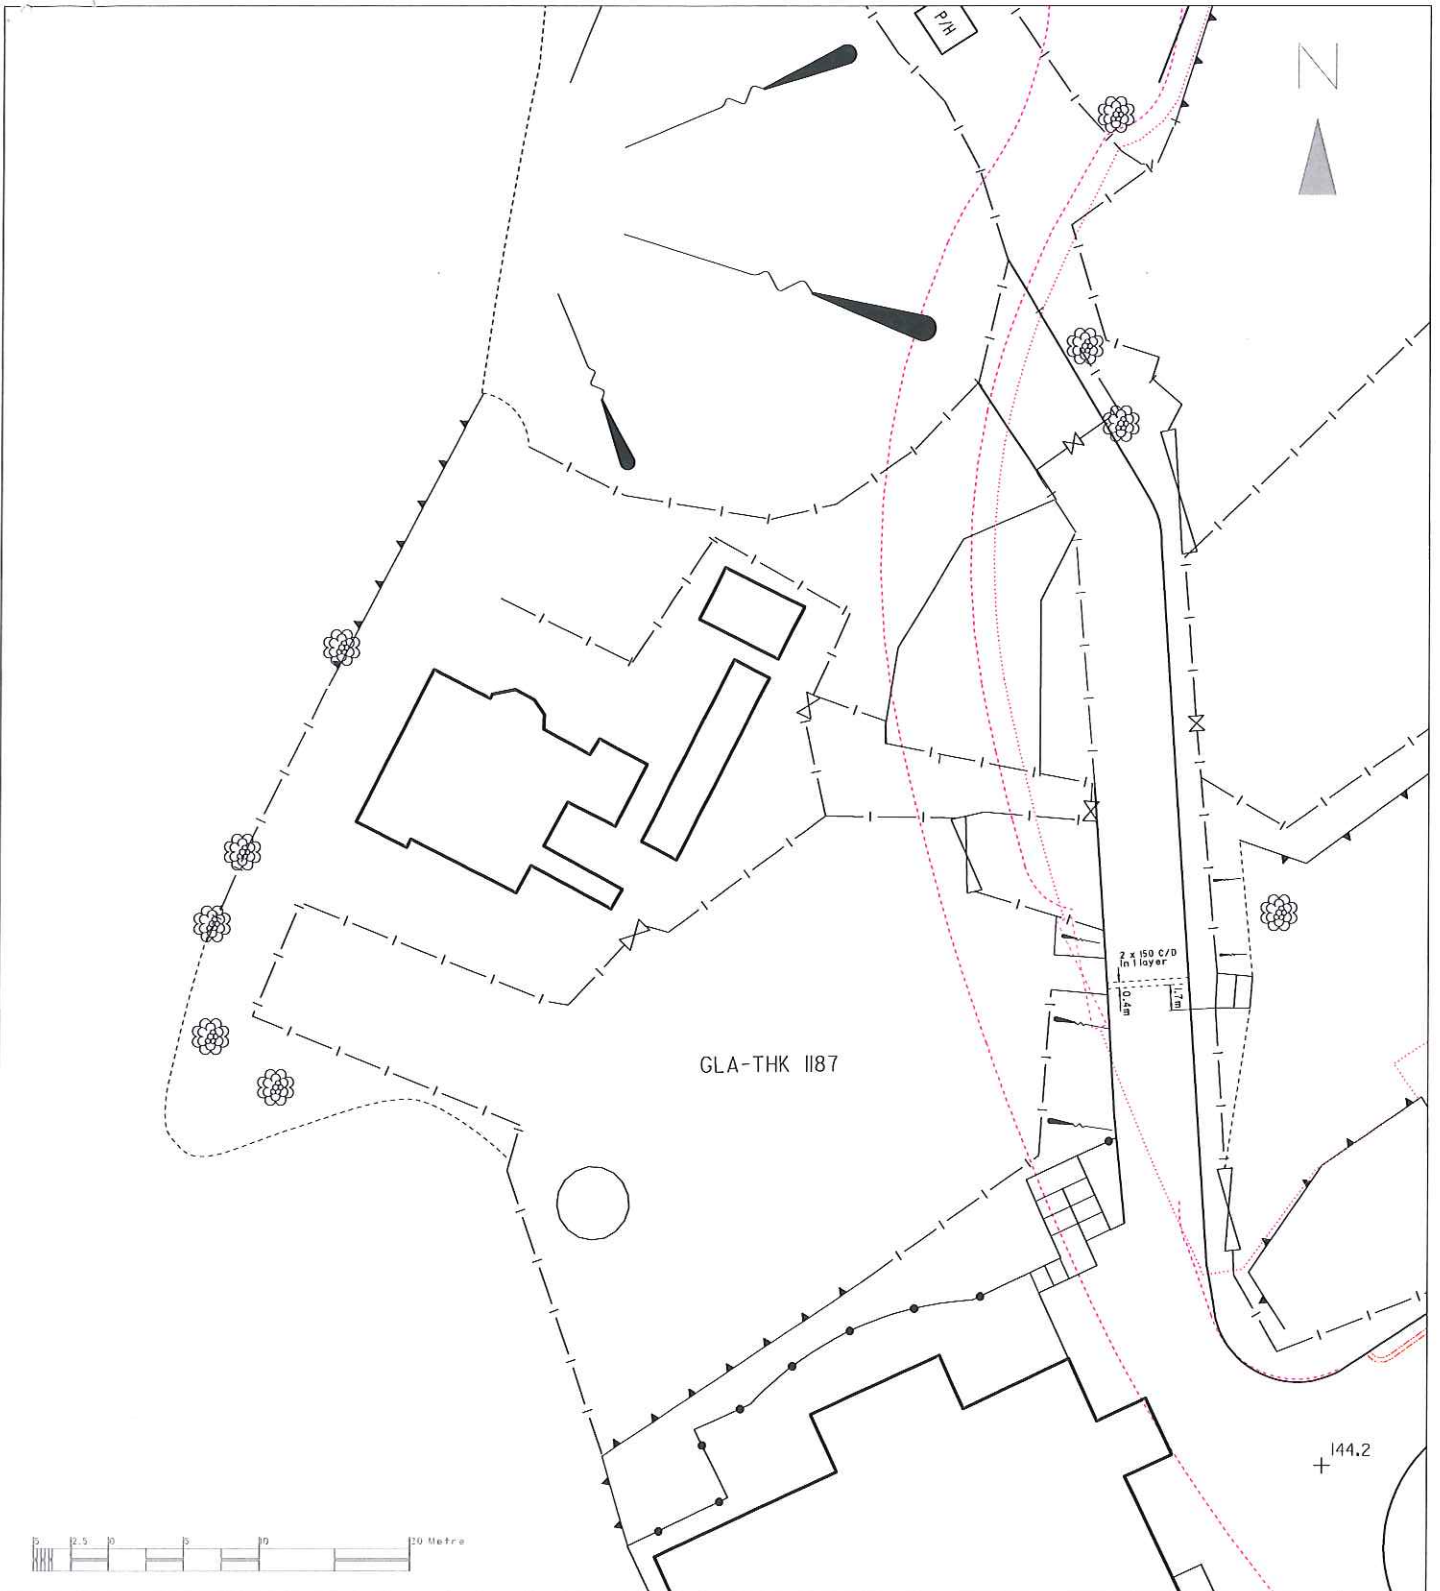
Record Plan of the Hongkong Electric Co. Ltd.

- THIS PLAN SHOULD BE READ IN CONJUNCTION WITH ITEM 4 OF OUR 'GENERAL PRACTICE ON EXECUTION OF EXCAVATION AND CONSTRUCTION WORK NEAR UNDERGROUND ELECTRICITY CABLES'. HEC CABLES WHICH ARE MORE PRONE TO SHALLOW DEPTH MAY BE FOUND AT THE HATCHED AREA MARKED WITH 'SHALLOW DEPTH' AND AT ITS VICINITY AREAS.
