Revitalising Historic Buildings Through Partnership Scheme

King Yin Lei

Resource Kit

Date: 27 November 2019

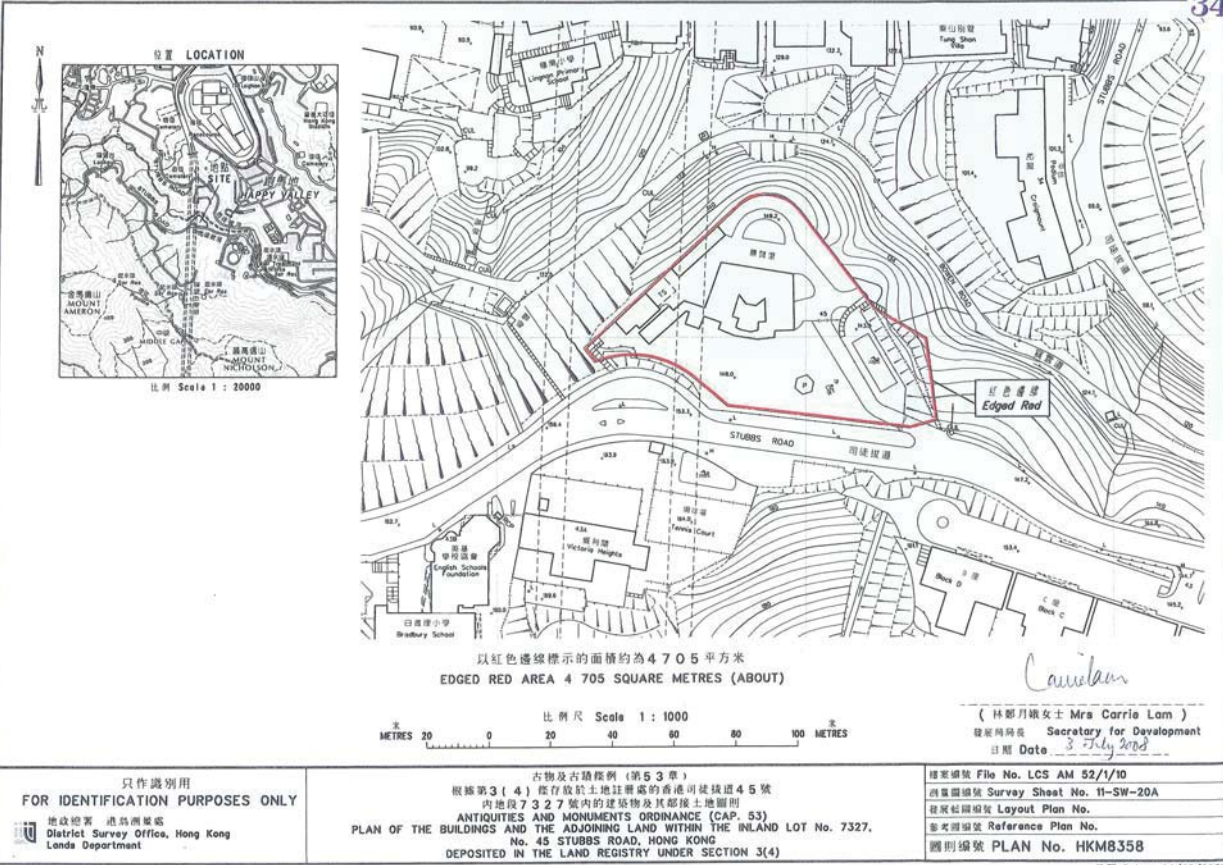
Appendix II (B)
Declared Monument Boundary Plan

古物及古蹟條例 (第53章)
根據第3(4)條存錄於土地註冊處的香港可建地段45號
內地段7327號內的建築物及其鄰接土地圖則
ANTIQUITIES AND MONUMENTS ORDINANCE (CAP. 53)
PLAN OF THE BUILDINGS AND THE ADJOINING LAND WITHIN THE INLAND LOT No. 7327,
No. 45 STUBBS ROAD, HONG KONG
DEPOSITED IN THE LAND REGISTRY UNDER SECTION 3(4)

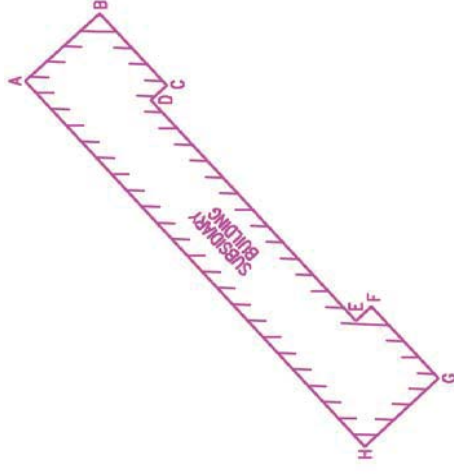
Subsidiary Building				
Building Corner	Northing	Easting	Building Line	Distance(m)
A	814235.754	836671.601	A-B	4.030
B	814232.795	836674.338	B-C	3.960
C	814230.106	836671.431	C-D	0.860
D	814230.737	836670.847	D-E	12.100
E	814222.521	836661.964	E-F	0.860
F	814221.890	836662.548	F-G	3.960
G	814219.201	836659.640	G-H	4.030
H	814222.160	836656.904	H-A	20.020

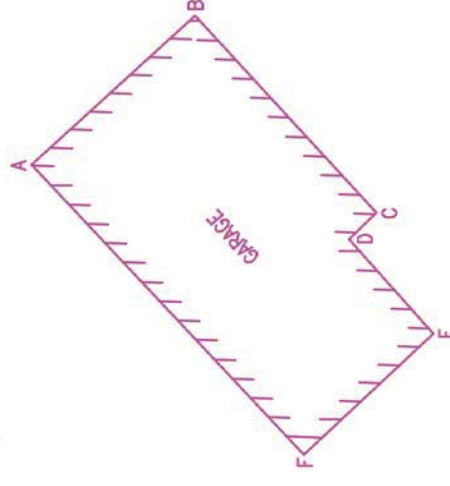
Garage				
Building Corner	Northing	Easting	Building Line	Distance(m)
A	814214.555	836648.595	A-B	7.486
B	814209.033	836653.649	B-C	9.057
C	814202.918	836646.967	C-D	1.288
D	814203.839	836646.067	D-E	4.279
E	814200.988	836642.876	E-F	5.989
F	814205.364	836638.787	F-A	13.442

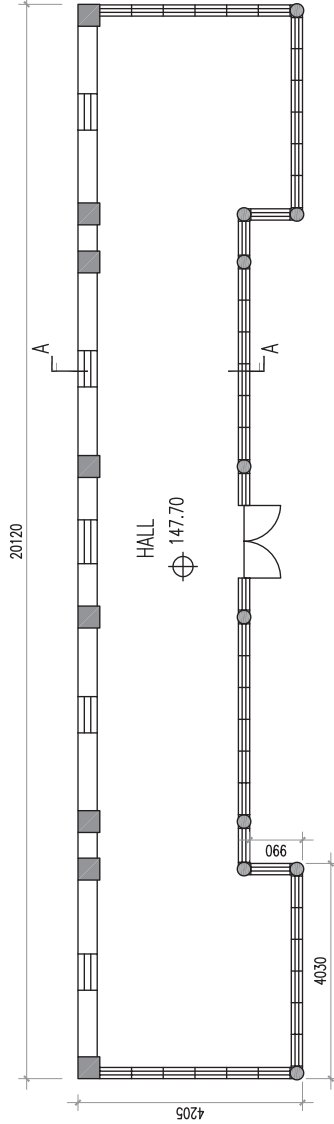
GROUND FLOOR PLAN OF SUBSIDIARY BUILDING

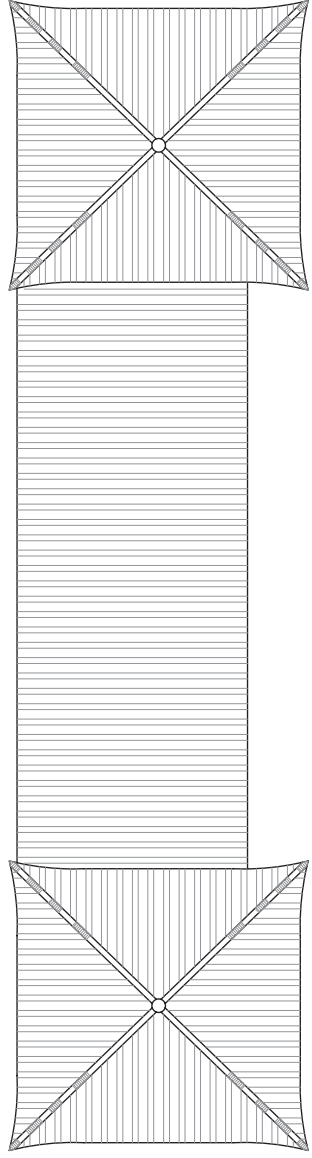
ROOF PLAN OF SUBSIDIARY BUILDING

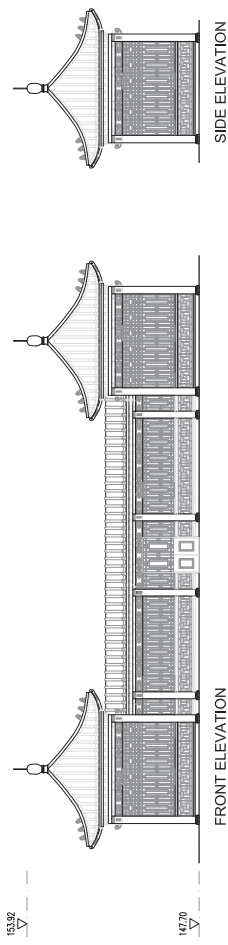
FRONT ELEVATION

SIDE ELEVATION

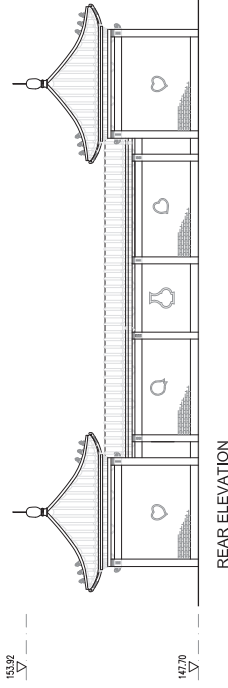
REAR ELEVATION

SECTION A-A

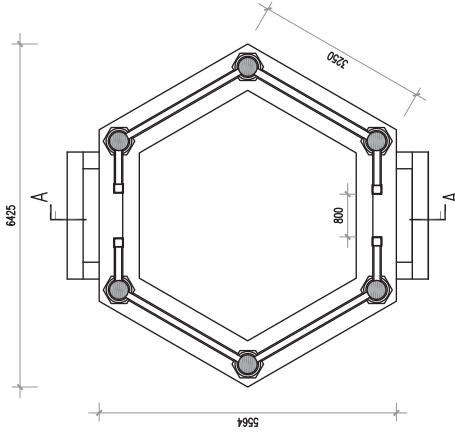
PLAN OF PAVILION

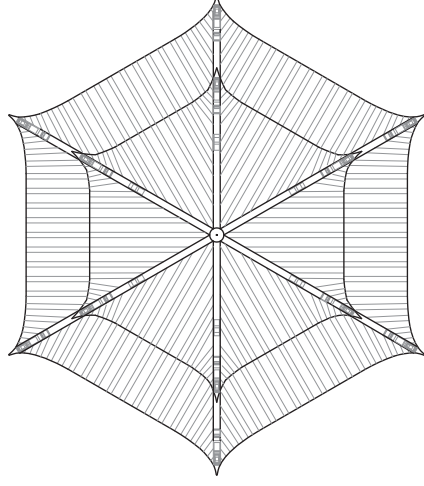
ROOF PLAN OF PAVILION

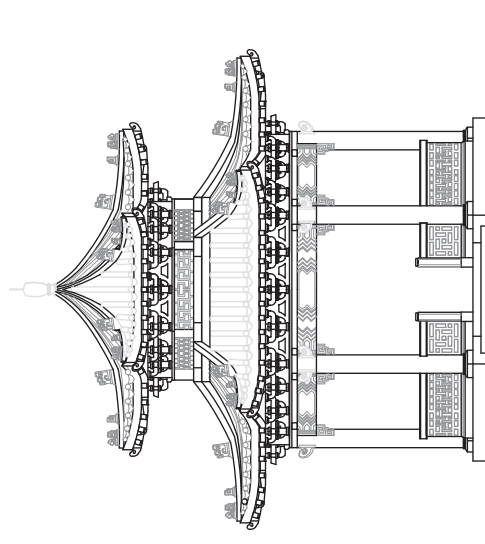
ELEVATION

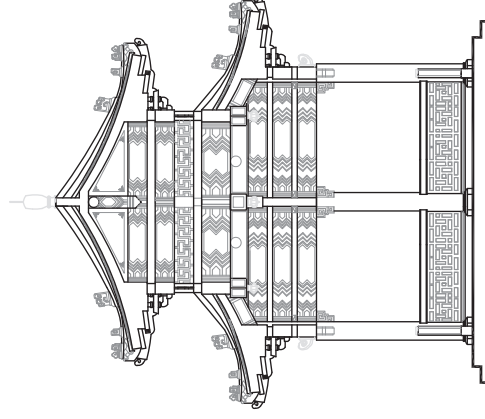
SECTION A-A

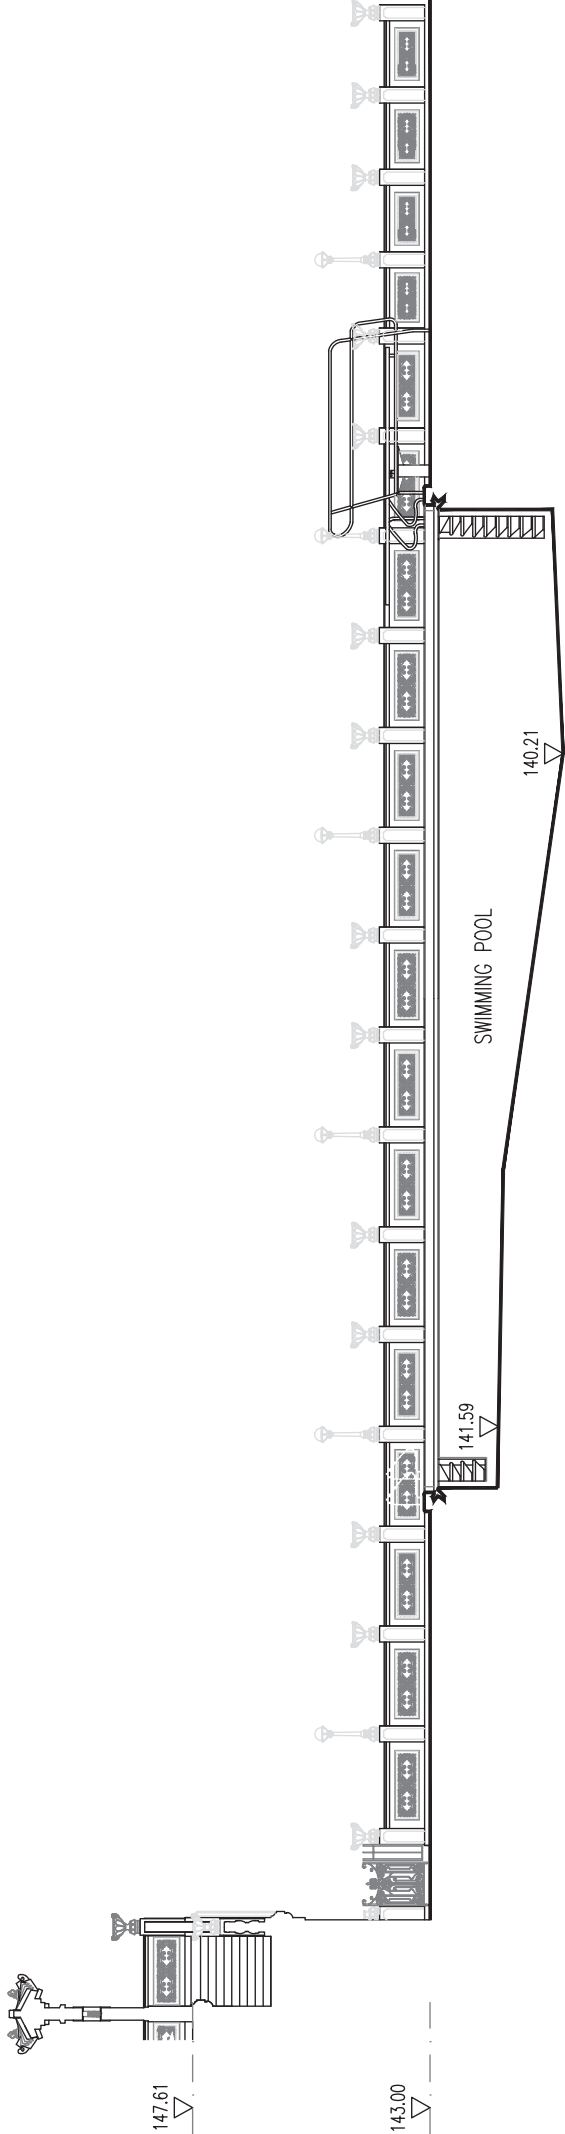
SECTION A-A

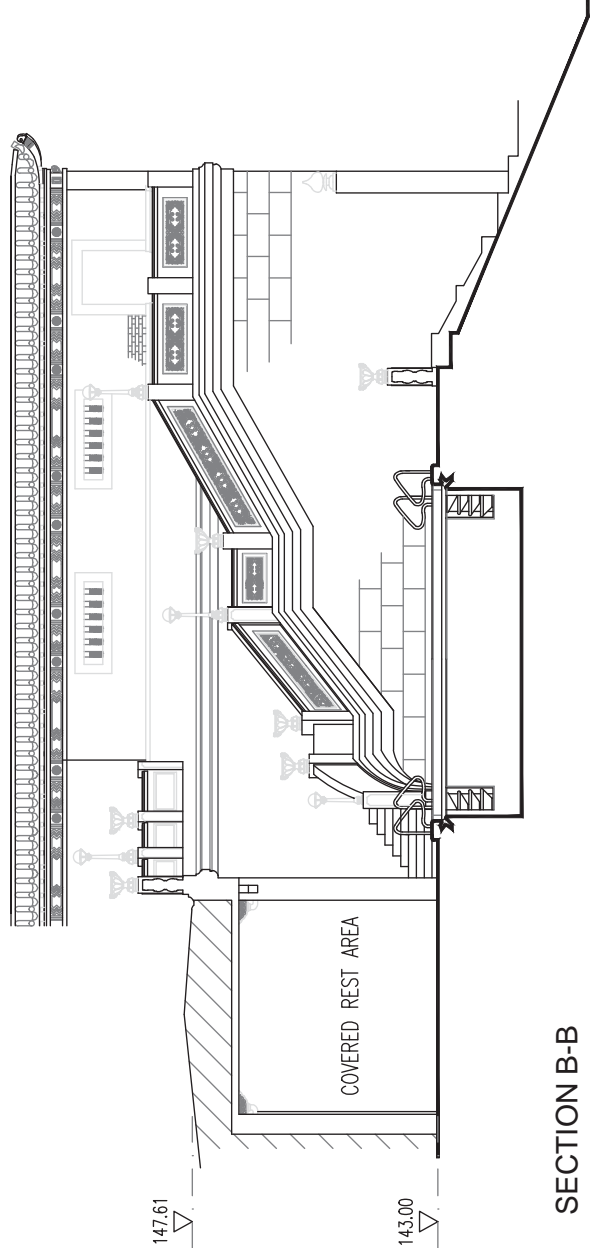
SECTION B-B

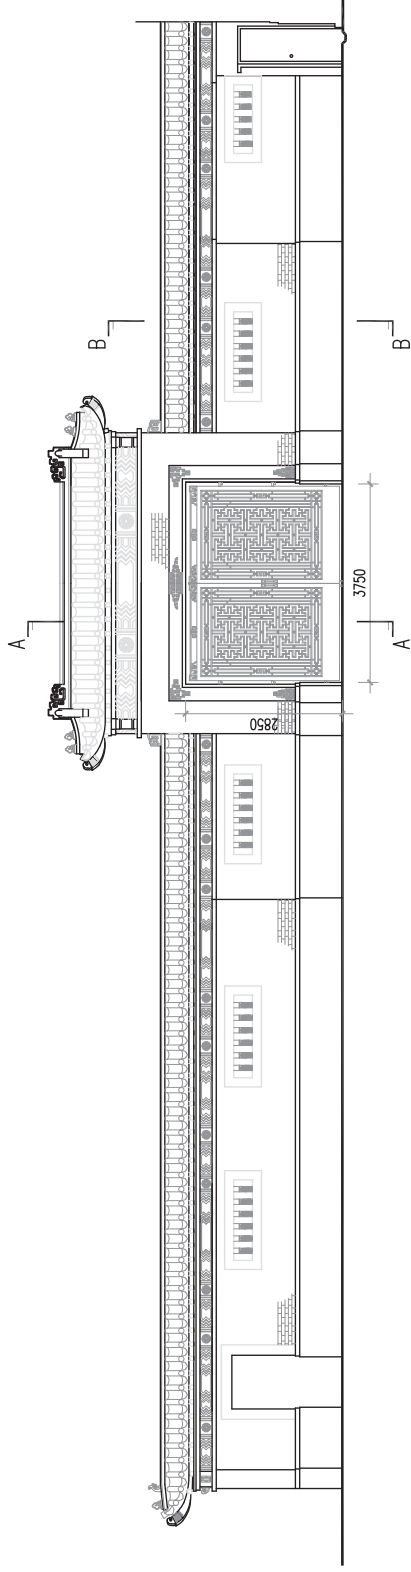
NORTH ELEVATION OF INTERIOR GATEWAY

ROOF PLAN OF INTERIOR GATEWAY

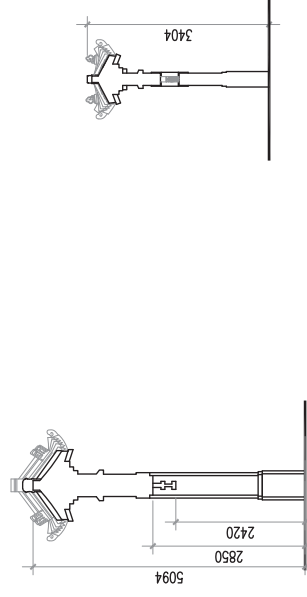
SECTION A-A

SECTION B-B

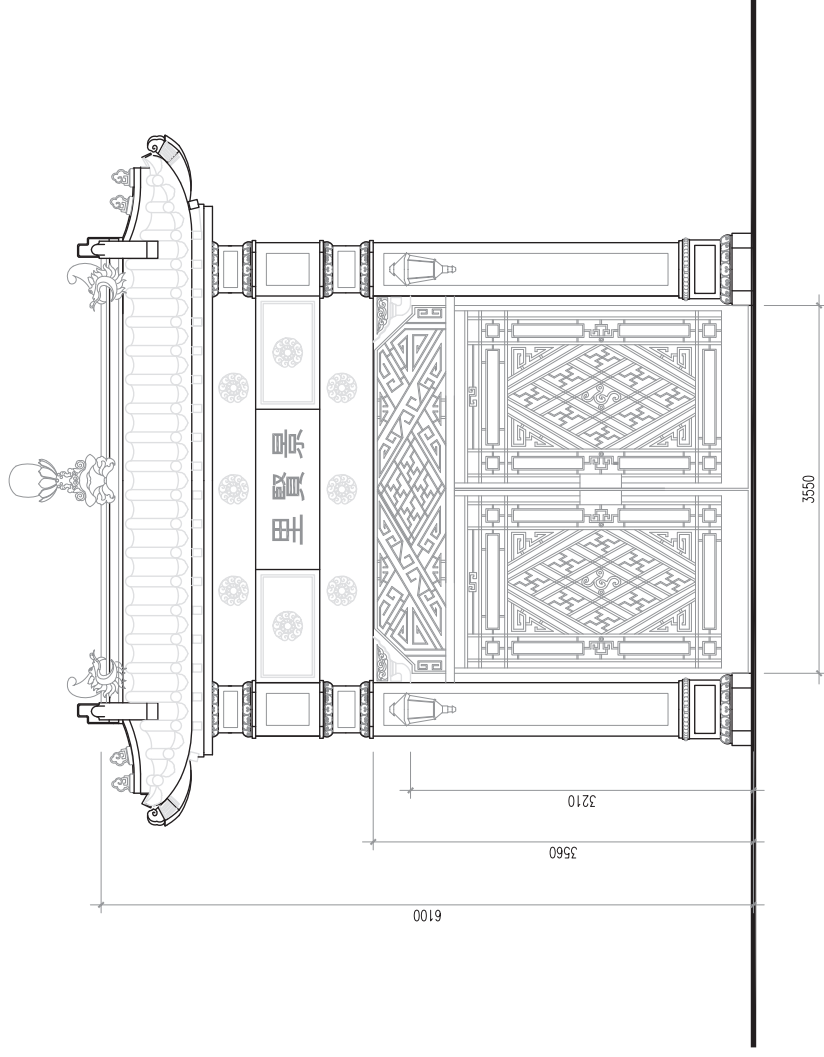
ELEVATION OF EXTERIOR GATEWAY

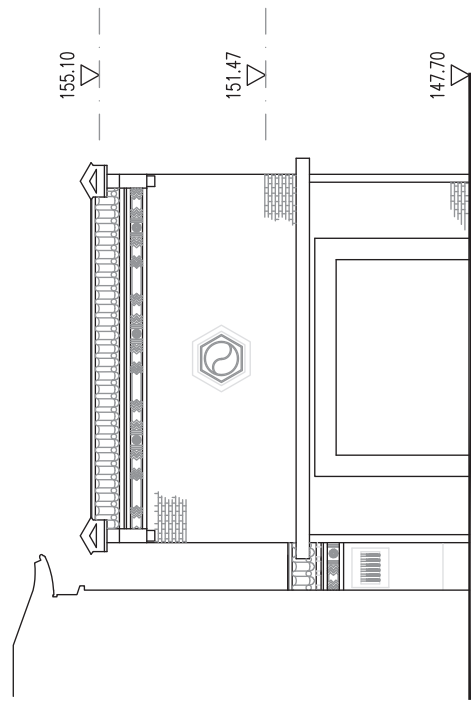
FRONT ELEVATION

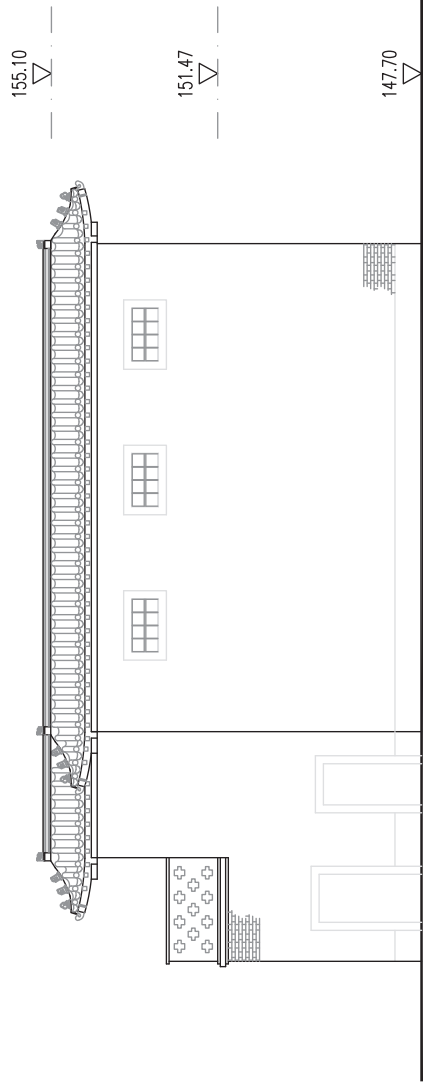
SOUTH EAST ELEVATION

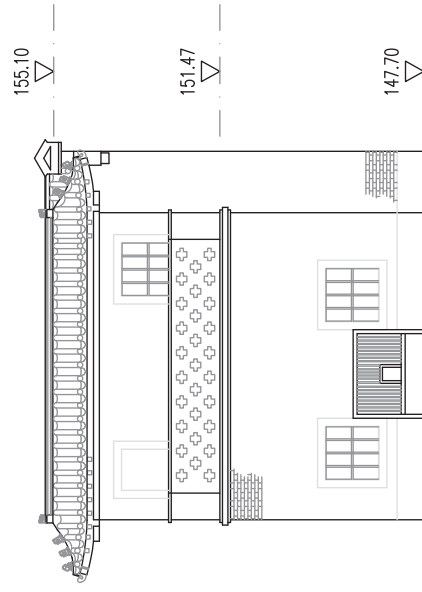
REAR ELEVATION

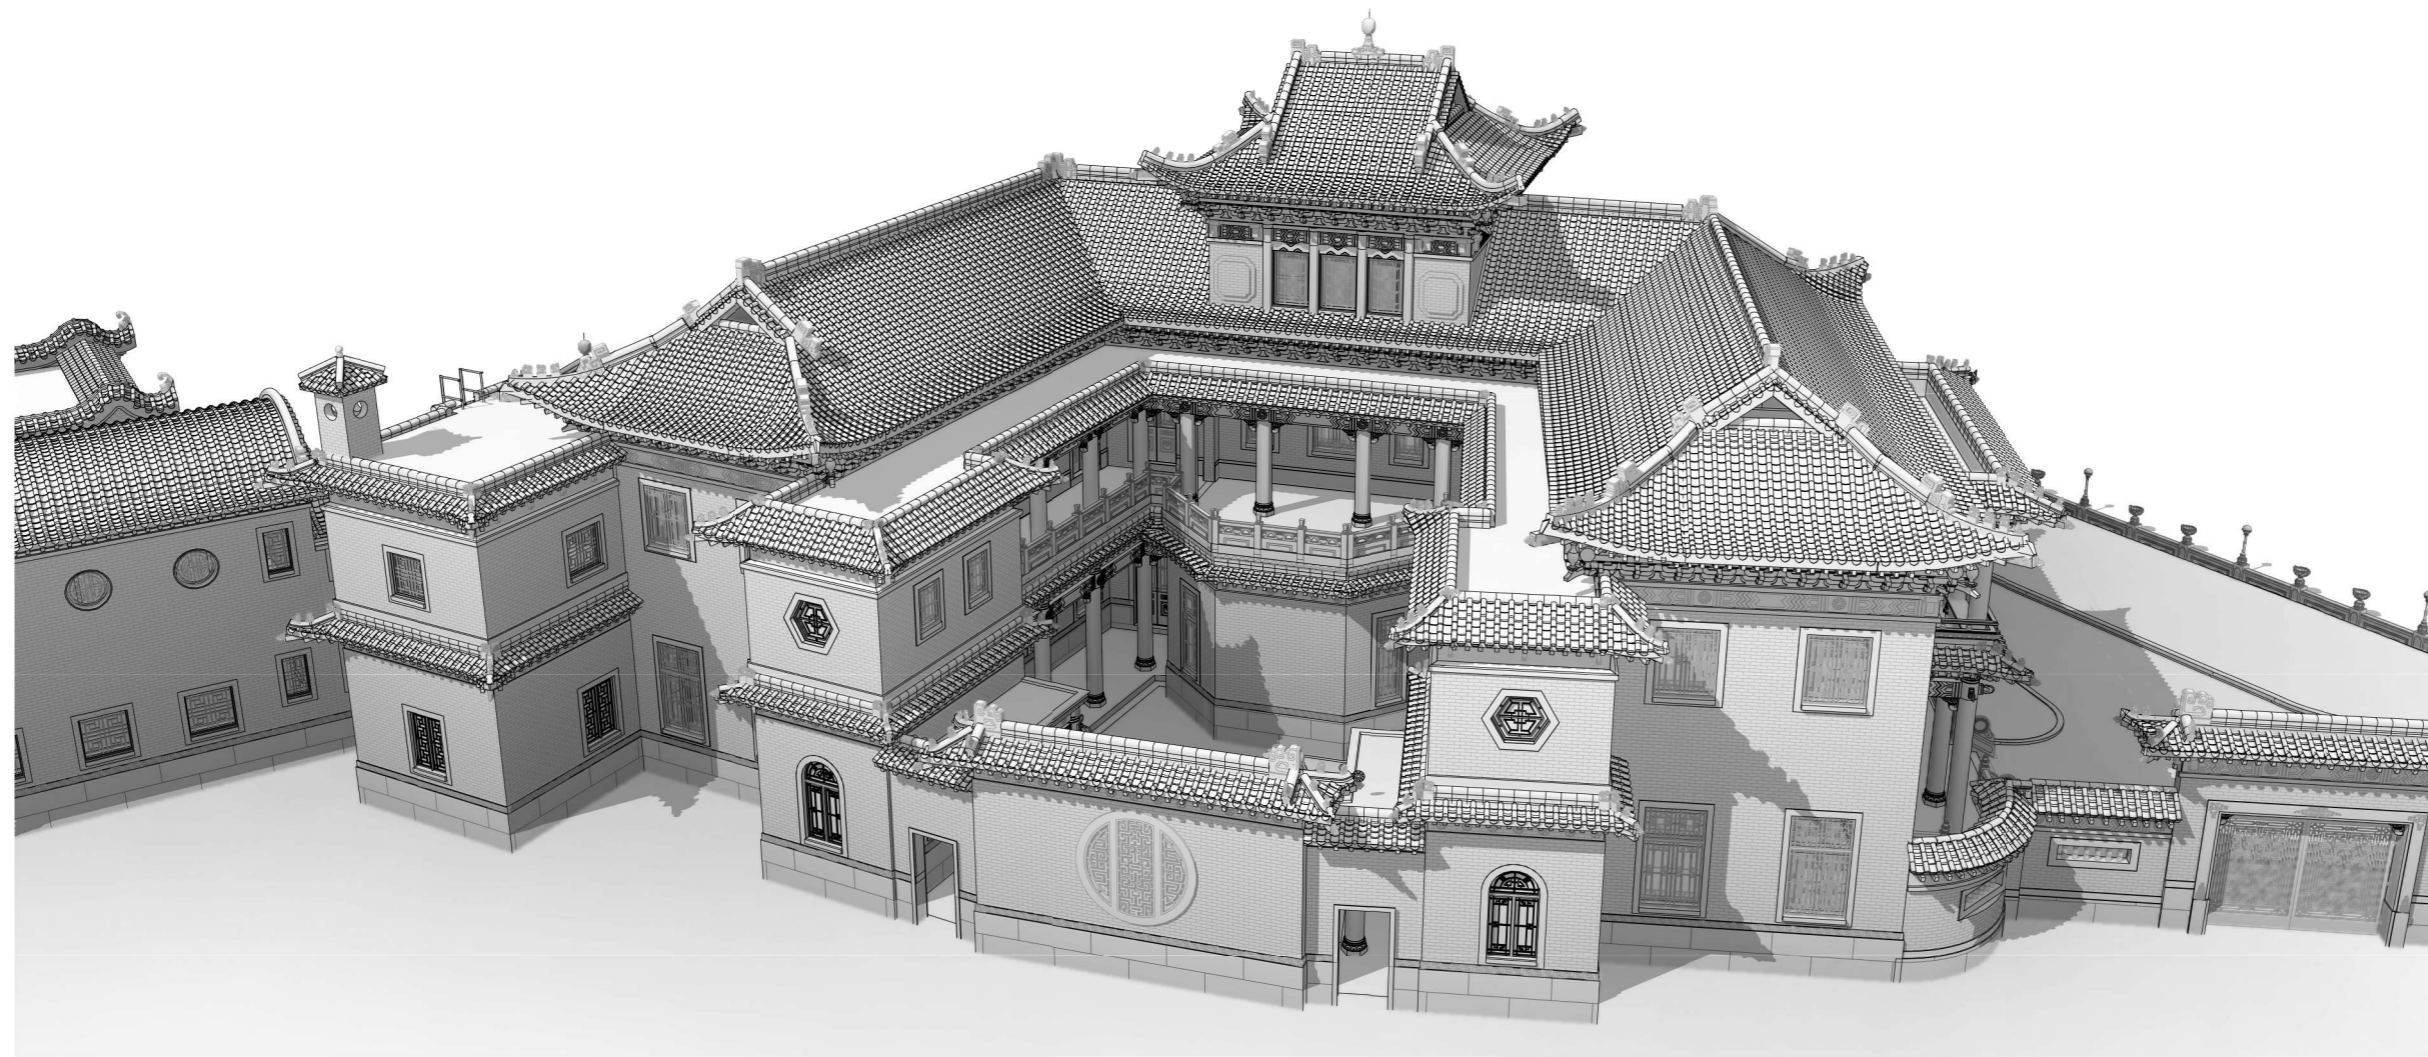
MAKING OF COMPUTER 3D MODELS USING PHOTOGRAMMETRY / 3D LASER SCAN

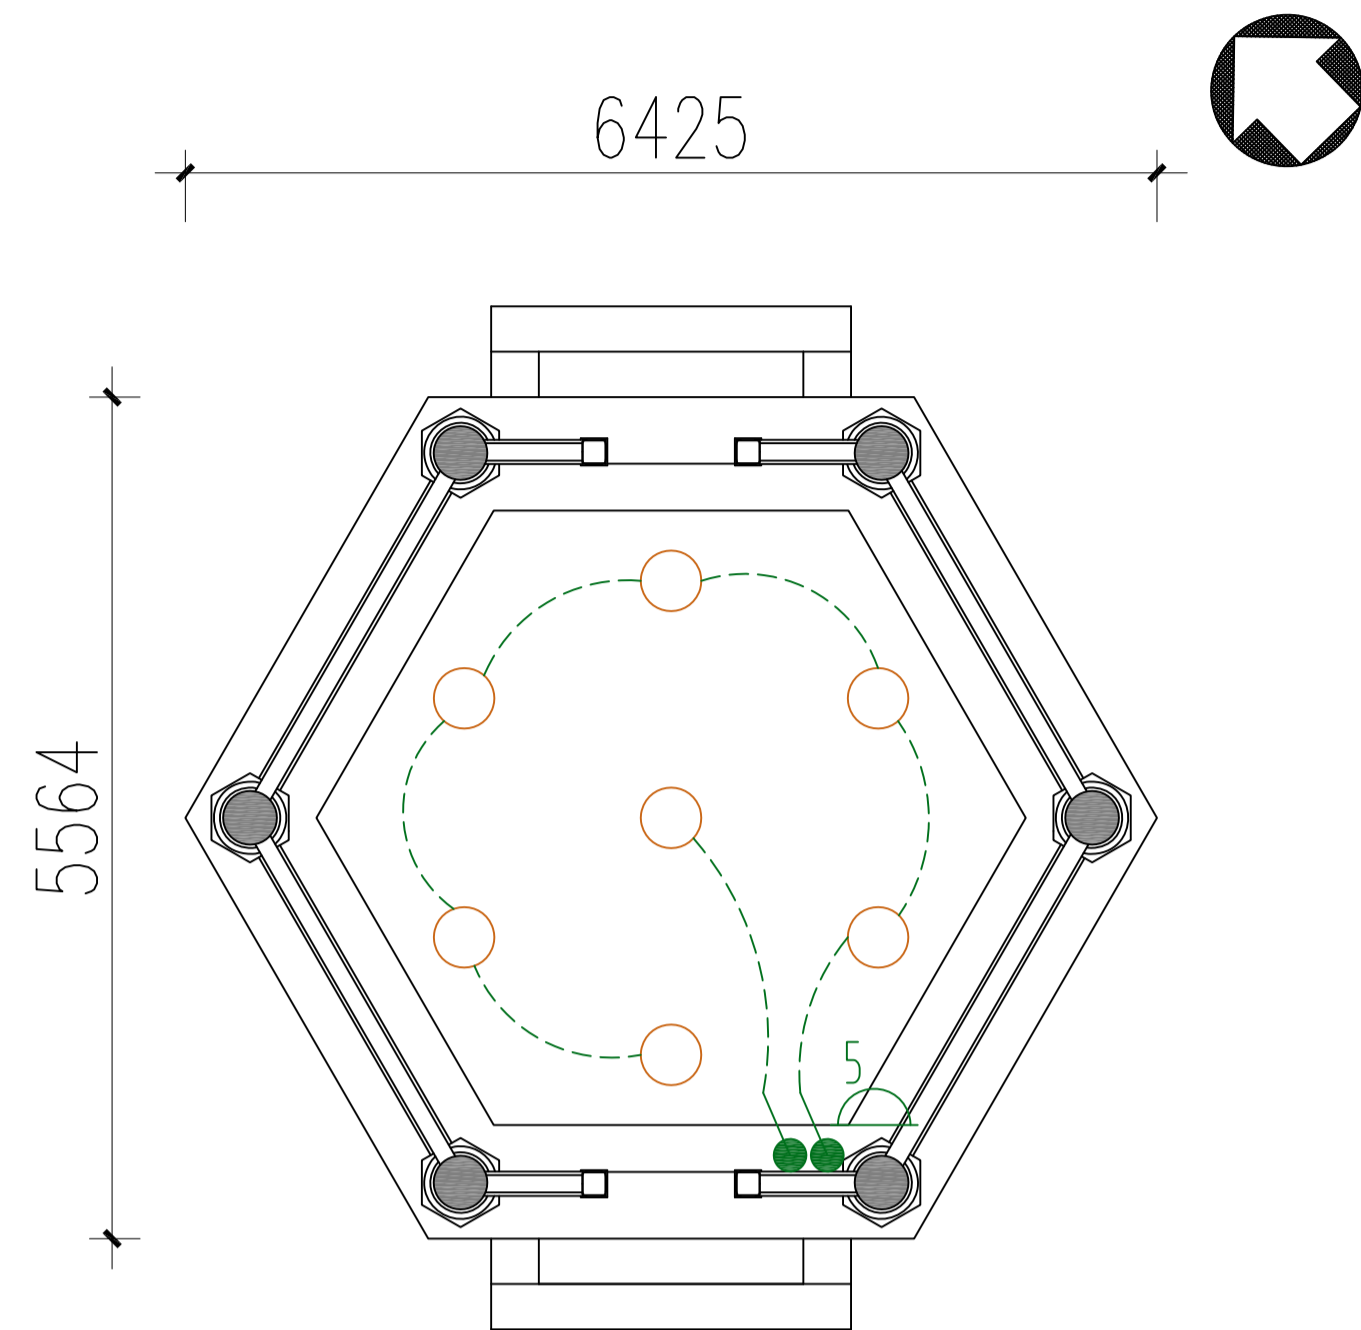
PLAN OF PAVILION (SCALE: 1:50 @A1)

DRAWING TITLE
 SUBSIDIARY BUILDING AND PAVILION
 BUILDING SERVICES LAYOUT

Drawing No.	Drawing Title
1	ME-01	Main Building, Annex Block & Garage Building Service Layout Ground Floor Plan
2	ME -02	Main Building, Annex Block & Garage Building Service Layout First Floor Plan
3	ME -03	Main Building, Annex Block & Garage Building Service Layout Second Floor Plan
4	ME -04	Subsidiary Building and Pavilion Building Service Layout
5	ME -05	Site Plan Building Service Layout
6	ME -06	Swimming Pool, Changing Rooms & Covered Rest Area Building Service Layout
7	ME -07	Existing Electric Schematic Diagram

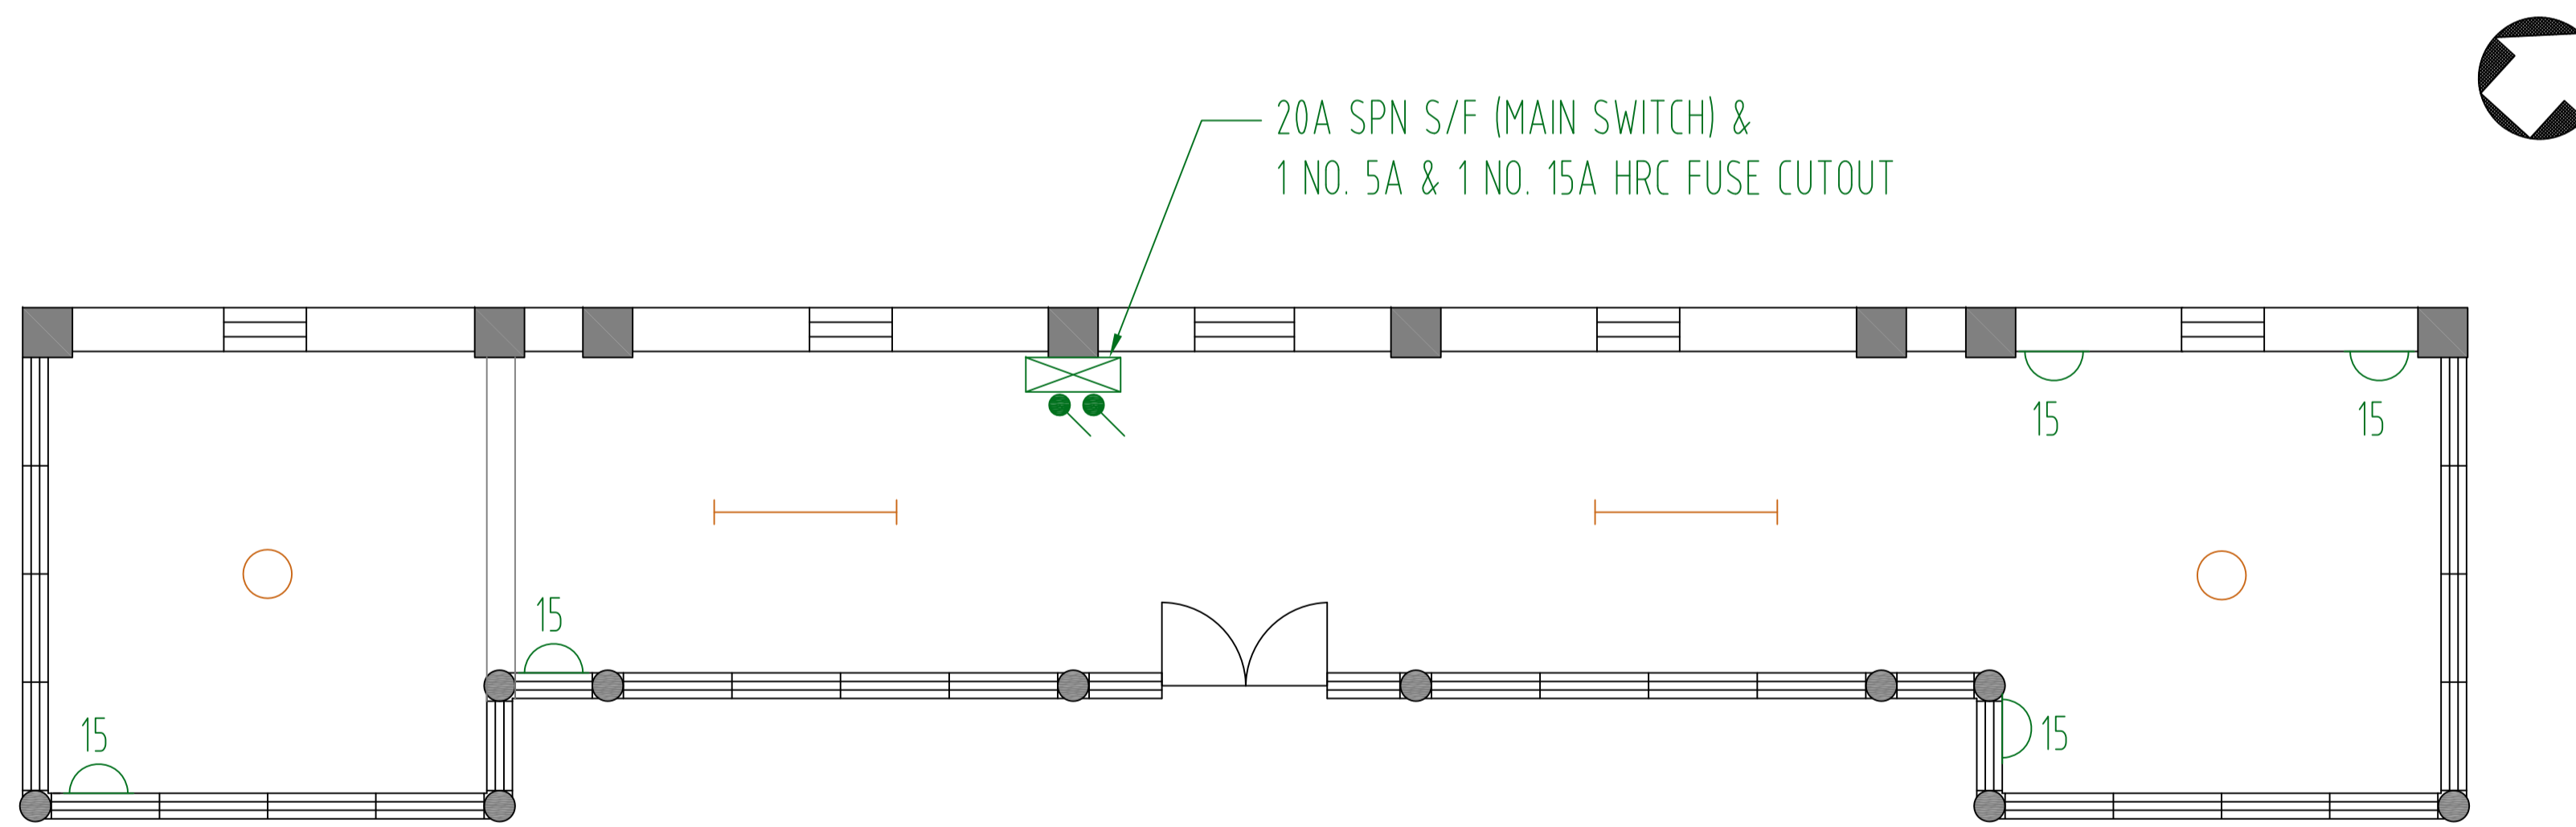
PLAN OF SUBSIDIARY BUILDING (SCALE: 1:50@A1)

- LEGEND**
- CEILING LIGHT POINT
 - POLE TOP FENCE LIGHT
 - WALL MOUNT LIGHT POINT
 - WEATHERPROOF FLUORESCENT FITTING
 - FLOOD LIGHT
 - 5A SOCKET
 - 15A SOCKET
 - 13A SOCKET
 - WEATHERPROOF TYPE SOCKET
 - LIGHT SWITCH
 - WALL MOUNT LIGHT
 - CLEANSING POINT
 - MCB BOARD

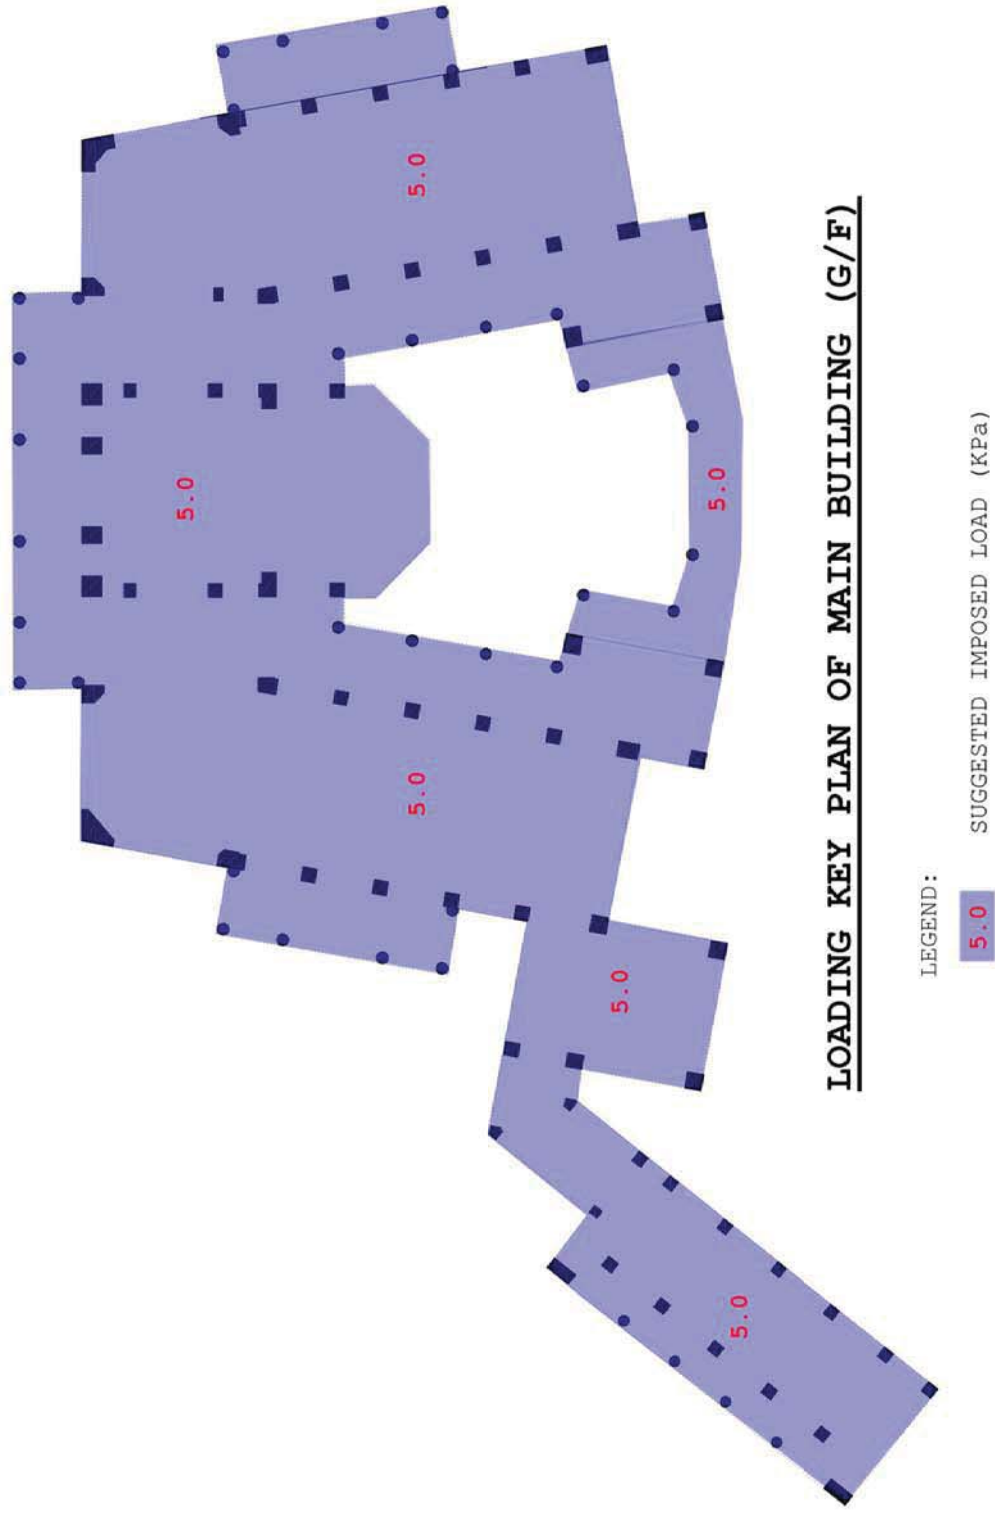
FIGURE 1

Figures of the Suggested Imposed Load on the Buildings

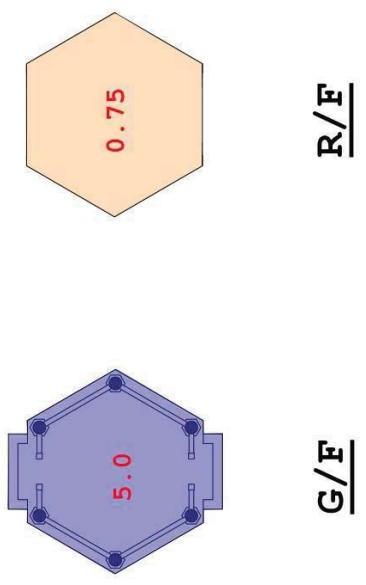
FIGURE 5

LOADING KEY PLAN OF PAVILLION

- LEGEND:
- 5.0 SUGGESTED IMPOSED LOAD (KPa)
 - 0.75 SUGGESTED IMPOSED LOAD (KPa)

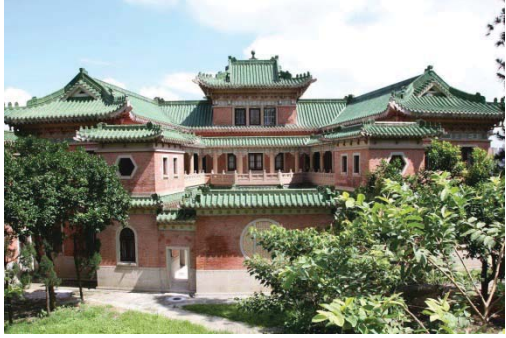
Item	Architectural Features to be Preserved and Conservation Guidelines	Photo
1.1	<p><u>Building Structure</u></p> <p>This is a reinforced concrete framed structure (including roof truss structure) with external and internal walls of red brickworks. The red brickworks appear to be supplementary structure to bear some of the loadings.</p> <p><i>Required Treatment:</i></p> <ul style="list-style-type: none"> ● All structural elements, including columns, beams, structural walls, roof form, roof slab, etc. should be generally kept intact. ● All structural elements should be inspected, repaired and protected. Damaged brickworks beyond repair may be permitted to be replaced, all replaced brickworks should match with the existing and subject to approval by the Antiquities Authority. ● Any necessary structural strengthening works should be unobtrusive to the historic fabric to be preserved. Proposals of strengthening works should be subjected to a Registered Structural Engineer's advice and submitted to AMO for approval by the Antiquities Authority. ● No removal or alteration to the red brickworks are permitted, unless justified by a Registered Structural Engineer and approved by the Antiquities Authority.

<p style="text-align: center;"><u>The reinforced concrete framed structure with walls of red brickwalls</u></p>

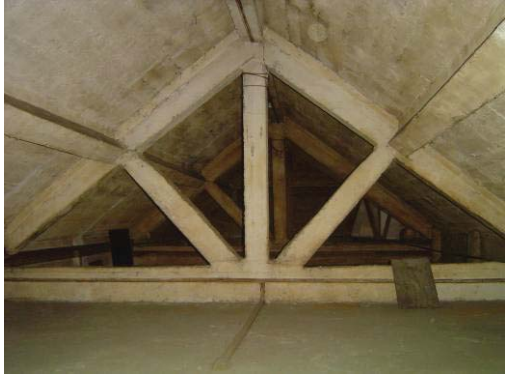
<p style="text-align: center;"><u>Roof truss structure</u></p>

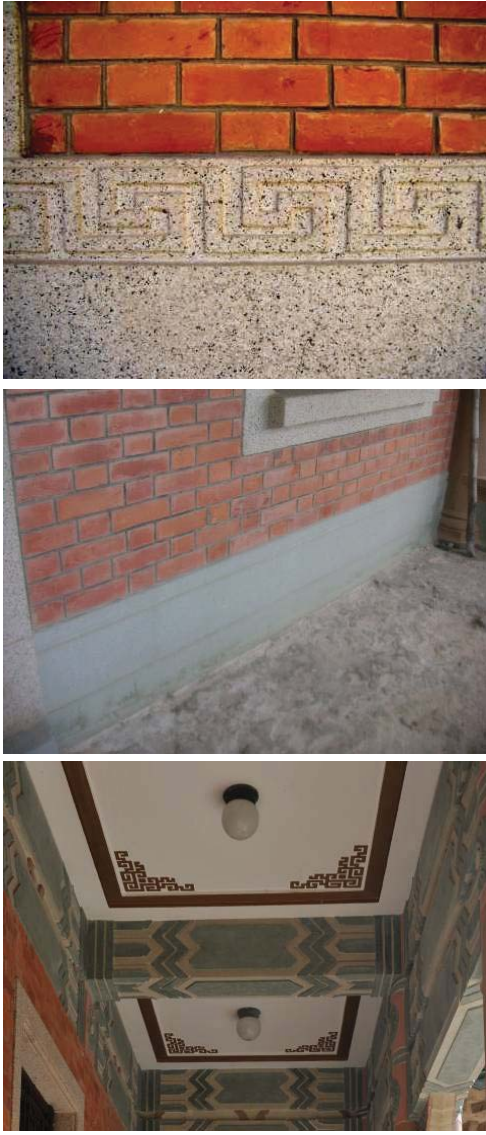
Item	Architectural Features to be Preserved and Conservation Guidelines	Photo
1.2	<p><u>Building façades</u>, with finishes including fair-face brickworks, fair-face granite surfaced dado, shanghai plastering, terrazzo finishes, decorated plastered and painted finishes, granite window and door surrounds, and with architectural features such as Chinese brackets sets (斗拱), beams (額枋), joint brackets (雀替), mouldings or carvings, overhangs, verandahs and the like, etc.</p> <p>Required Treatments:</p> <ul style="list-style-type: none"> ● All elements of building facades should be preserved in-situ. Stains and dirt on the surface should be washed down. ● All granite surfaces shall be cleaned with bristle or nylon brushes and clean water as necessary, and no corrosive cleaning chemical is allowed. No paintings should be applied on all granite surfaces. ● All fair-face brickworks should not be painted, but permeable translucent protective coating for brickworks may be permitted, subject to approval by the Antiquities Authority. ● All shanghai plastering and terrazzo finishes should be preserved and thoroughly cleaned, but no corrosive chemical is allowed. No painting and covering up of these finishes are allowed. ● All decorative plastering works and architectural features should be preserved and no covering up is allowed.

<p>The building facades with different finishes</p>

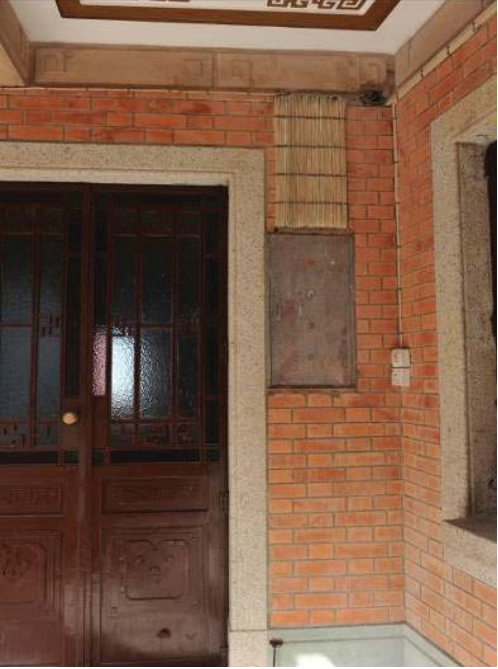
Item	Architectural Features to be Preserved and Conservation Guidelines	Photo
1.2	<p>(Cont'd)</p> <ul style="list-style-type: none">● Repair and repaint the plastered and painted finishes as necessary. Keep existing colour of the paint finishes, or restore their original colour if they are found different from the existing.● Any unsightly and redundant electric conduits, pipework, light fittings and air-conditioning system installations should be relocated and re-routed to less conspicuous location.● No demolition and introduction of openings to the façades are allowed, except small openings on brickwork to facilitate wiring or other E&M services may be permitted subject to Registered Structural Engineer's advice and approval by the Antiquities Authority.

<p><u>Unsightly electric conduits</u></p>

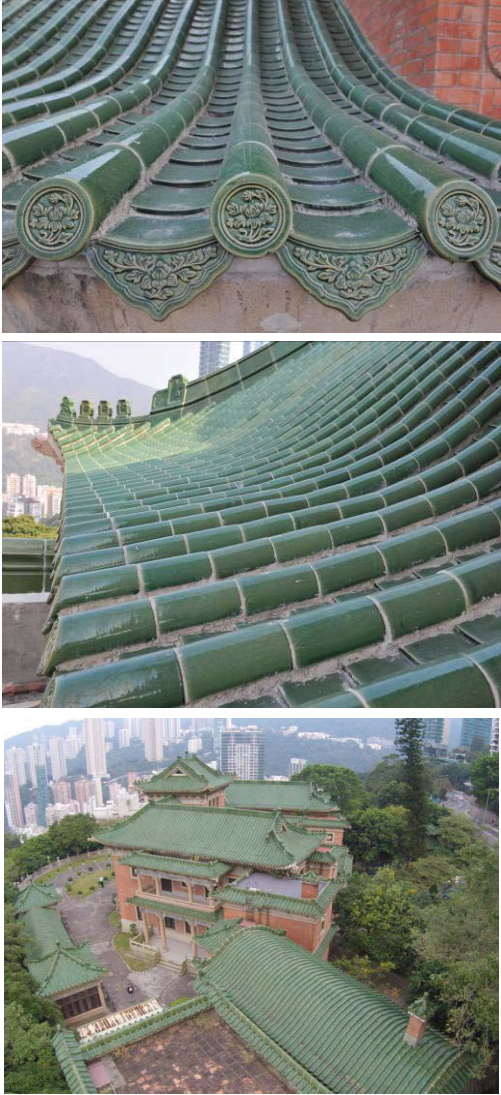
Item	Architectural Features to be Preserved and Conservation Guidelines	Photo
1.3	<p><u>Chinese tiled gable and hip roofs (歇山式屋頂), humpbacked roof (卷棚式屋頂) and eaves</u>, with chimneys, decorative glazed ceramic tiles, roof ornaments in geometric (博古) style on ridges and gables, eaves, eave supports including Chinese brackets set (斗拱), joint brackets (雀替), etc.</p> <p>Required Treatments:</p> <ul style="list-style-type: none"> ● No alteration to the existing roof forms and chimneys is allowed. ● All roof tiles, ornaments, eaves and their supporting features have been restored in 2010 and should be preserved in-situ. Repair of roofing, if necessary, should be carried out in the same manner as the previous restoration. ● The rainwater drainage system for roofs with the associated gutters and ducting should be preserved in-situ. No alteration or covering up of the system is allowed. ● Any damaged glazed tiles shall be carefully removed and replaced with matching colour tile if and only if the tile is beyond repair, and is subjected to approval by the Antiquities Authority. ● Remove foliage, if necessary.

<p style="text-align: center;"><u>Chinese roof tiles</u></p>

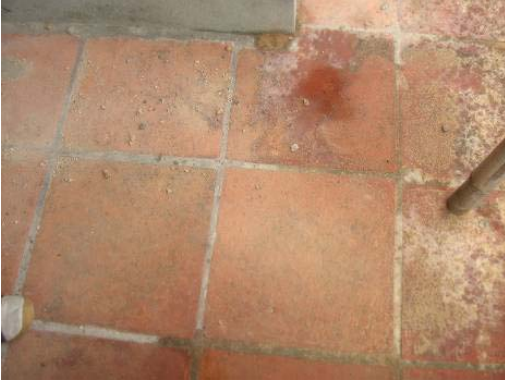
Item	Architectural Features to be Preserved and Conservation Guidelines	Photo
1.4	<p><u>Flat roofs</u> with finishes including Canton tiles</p> <p>Required Treatments:</p> <ul style="list-style-type: none"> ● No alteration to the existing roof forms is allowed. ● All Canton tiles should be preserved in-situ. ● Repair and maintain the waterproofing conditions, install waterproofing layer under the canton tiles may be considered subject to the approval by the Antiquities Authority. ● Repair any defective floor tiles as necessary, with materials match existing, and is subjected to approval by the Antiquities Authority. ● The rainwater drainage system for roofs with the associated dish drains and ducting should be preserved in-situ. No alteration or covering up of the system is allowed.

<p style="text-align: center;"><u>Canton roof tiles</u></p>

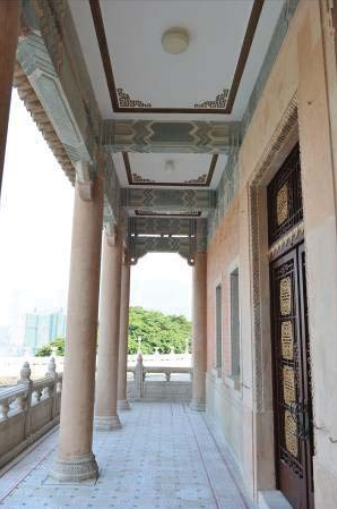
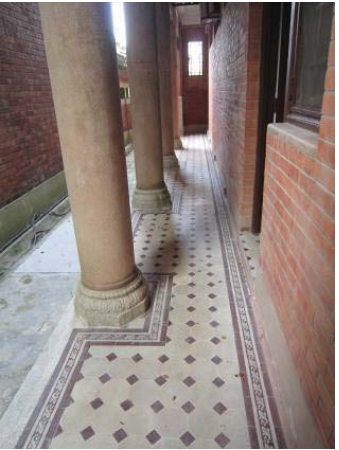
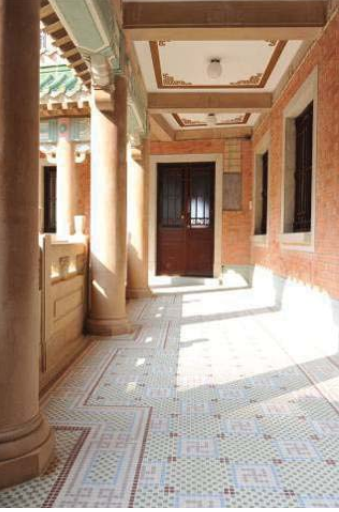
Item No.	Architectural Features to be Preserved and Conservation Guidelines	Photo
1.5	<p><u>Covered outer spaces</u>, including the following 3 types:</p> <p>A. <u>Entrance porches</u> attached to the northern, eastern and western façades of the Main Building on G/F, defined by raised platform, finished by patterned mosaic flooring, led by granite steps from exterior, surrounded by granite balustrade of Chinese style, supported by columns of terrazzo finishes and granite base, and decorated by feature brackets and plastering on beams and soffits, etc.</p> <p>B. <u>Covered walkways</u> attached to eastern and western wings of the Main Building facing the Inner Court on G/F, to the southern screen wall facing the Inner Court on G/F and to the Annex Block on G/F, with architectural features such as granite or mosaic finished steps, patterned mosaic or clay floor tiles, columns of terrazzo finishes and granite/ terrazzo base, decorative brackets and plastering on beams and soffits, etc.</p> <p>C. <u>Verandahs</u> on 1/F of the Main Building and the Annex Block, with architectural features such as terrazzo finished balustrades and sitting benches, ceramic grilles on balustrades, patterned mosaic or clay floor tiles, columns and base of terrazzo finishes, decorative brackets and plastering on beams and soffits, etc.</p>

<p><u>Entrance porch at Main Building</u></p>

<p><u>Covered walkway at Annex Block</u></p>

<p><u>Verandah at Main Building</u></p>

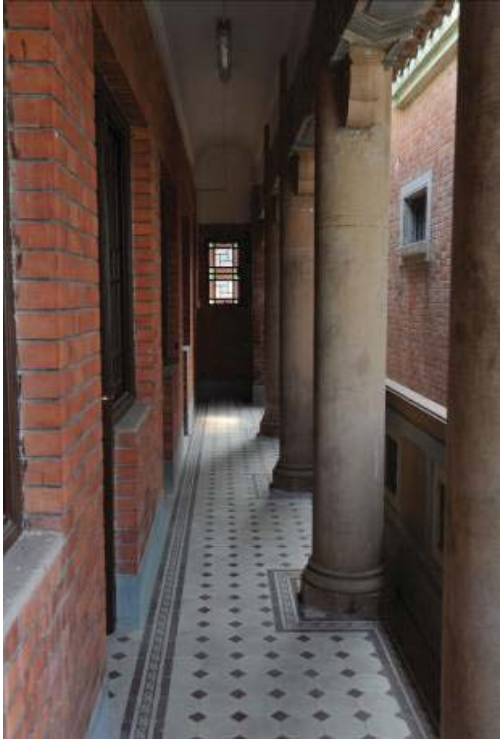
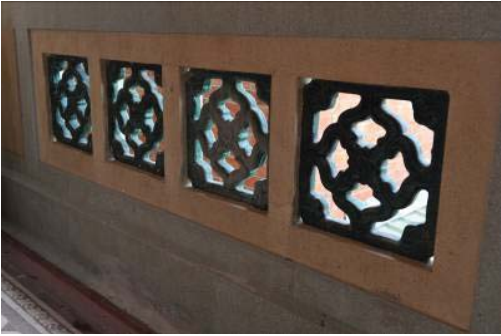
Item	Architectural Features to be Preserved and Conservation Guidelines	Photo
1.5	<p>(Cont'd)</p> <p>Required Treatments:</p> <ul style="list-style-type: none"> ● They should be kept open and no covering up is allowed. ● All architectural features and decorative plastering should be preserved in-situ, repaired as necessary and no covering up is allowed. ● Any carvings and patterns formed on balustrades should not be filled up or blocked. ● All granite surfaces shall be cleaned with bristle or nylon brushes and clean water only; corrosive cleaning chemicals must not be used. No paintings should be applied on the granite surfaces. ● Unsightly and redundant sanitary fitting, E/M equipments and associated ducting & piping should be removed. No objection to remove or replace lighting fittings if necessary. ● Alteration work to the balustrade to suit current regulations and adaptive re-use in a reversible manner may be permitted subject to approval by the Antiquities Authority.

<p style="text-align: center;"><u>Verandah at Annex Block</u></p>

<p style="text-align: center;"><u>Decorative carvings on balustrade</u></p>
