Revitalising Historic Buildings Through Partnership Scheme

King Yin Lei

Resource Kit

Date: 27 November 2019

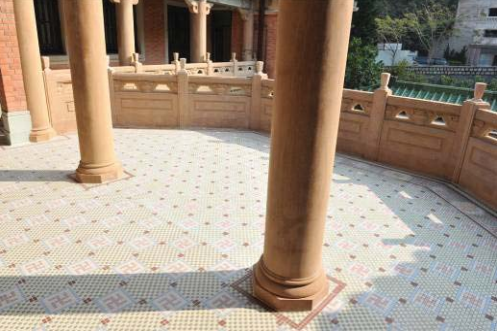
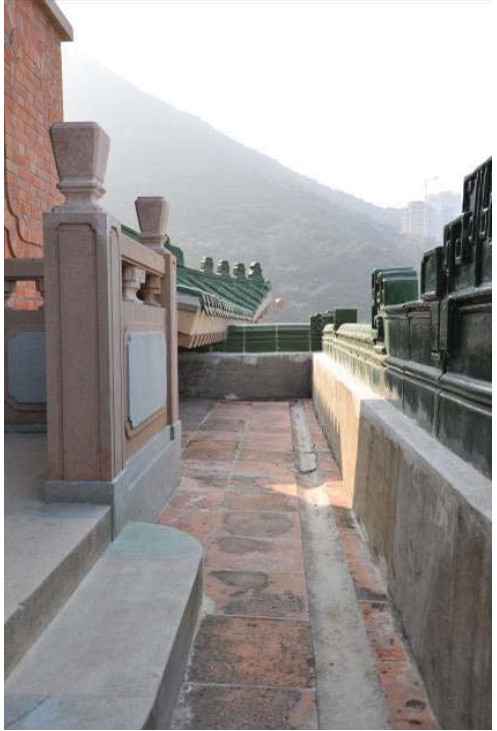
Item	Architectural Features to be Preserved and Conservation Guidelines	Photo
1.6	<p><u>Terraces</u>, including the following two types:</p> <p>A. <u>Octagonal terrace</u> on 1/F above the main hall on G/F of the Main Building, which is half-covered and facing the Inner Court. It is accompanied with patterned mosaic flooring, terrazzo finished balustrades and columns, decorative brackets and plastering on beams and soffits, etc.</p> <p>B. <u>Roof terrace</u> on 2/F of the Main Building facing the Front Garden, which consists of the higher and lower platforms. The higher platform is finished by terrazzo flooring, surrounded by balustrades of terrazzo finish and connected by terrazzo steps to the lower platform with Canton tiled flooring.</p> <p><i>Required Treatments:</i></p> <ul style="list-style-type: none"> ● The terraces should be kept open and no covering is allowed. ● All architectural features and decorative plastering should be preserved in-situ, repaired as necessary and no covering up is allowed. ● Any carvings and patterns formed on balustrades should not be filled up or blocked. ● Alteration work to the balustrades to suit current regulations and adaptive re-use in a reversible manner may be permitted, subject to approval by the Antiquities Authority.

<p><u>Octagonal terrace</u></p>

<p><u>Roof terrace</u></p>

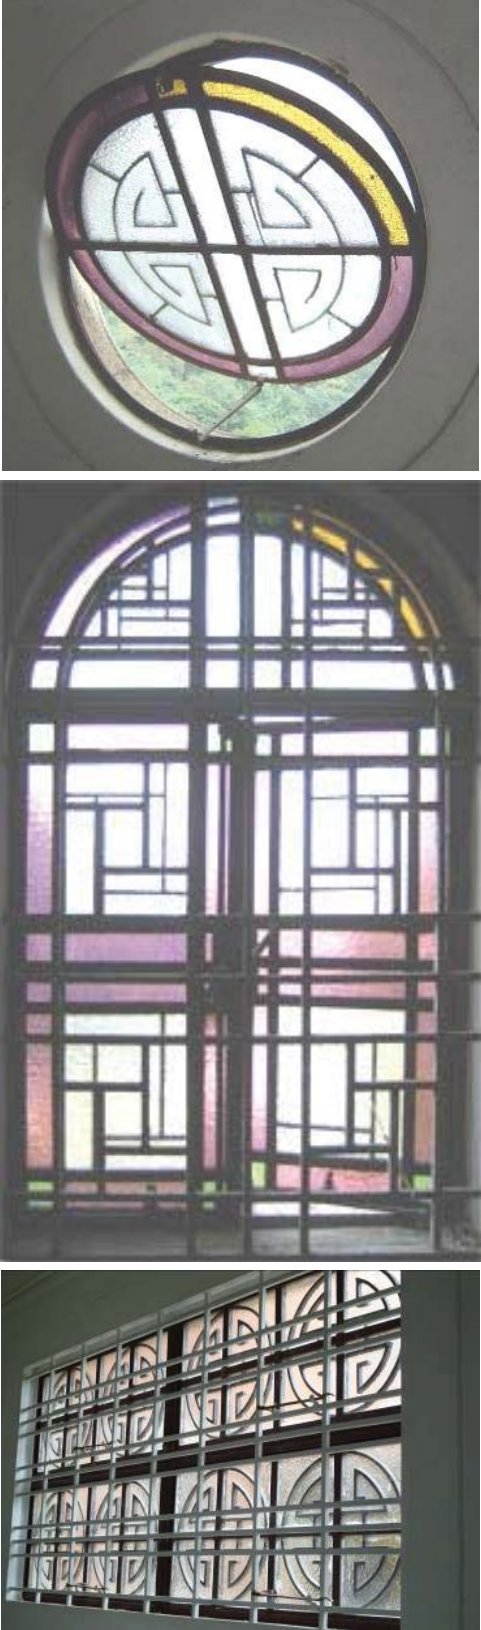
Item	Architectural Features to be Preserved and Conservation Guidelines	Photo
1.7	<p><u>Windows</u> designed in different forms, layers and opening methods, with granite window surrounds, granite, marble or terrazzo threshold, clear, coloured or patterned glazing, metal muntins of Chinese style, metal framed screen and ironmongeries.</p> <p>Required Treatments:</p> <ul style="list-style-type: none"> ● No alteration of window openings is allowed. ● No painting to any granite surface and cleaning by corrosive chemicals are allowed. ● All windows, with glazing layers and metal grille layers, should be preserved in-situ but minor modification works on windows to facilitate wiring or other E&M services may be permitted subject to approval by the Antiquities Authority. ● Repair, de-rust and repaint any defective windows as necessary. ● No objection to remove inner screen window layer if necessary due to operational needs, but original screen windows in good condition are recommended to be preserved. ● Addition of ironmongeries for security reasons to suit operational needs may be permitted subject to approval by the Antiquities Authority. ● No air-conditioning units and any associated ducting and supports attaching to, passing through and disturbing the windows are allowed, unless approved by the Antiquities Authority.

<p style="text-align: center;"><u>Different forms of window</u></p>

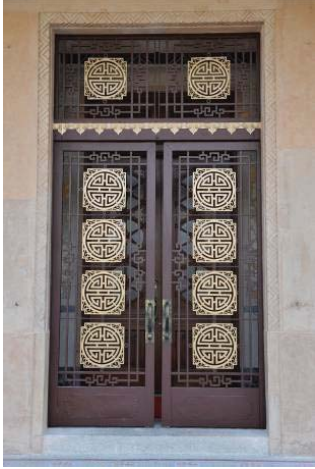
Item	Architectural Features to be Preserved and Conservation Guidelines	Photo
1.8	<p><u>Doors</u> in different dimensions, patterns and opening methods, with ironmongeries, including the following 3 types:</p> <p>A. <u>Triple layered entrance door</u> (三重入口大門) of Main Building, consisted of outermost layer of metal gate, middle layout of sliding door and innermost layout of timber swing door, with terrazzo door surrounds and granite threshold</p> <p>B. <u>Double layered doors</u> (二重門), built with the inner sliding metal gate and the outer layer of metal framed colour glazing door or the timber framed glazed door.</p> <p>C. <u>Single layered timber doors</u> (一重門) consisted of timber solid door, single leaf or double leafs, with or without fanlight.</p> <p>Required Treatments:</p> <ul style="list-style-type: none"> ● No alteration and enlargement of door openings is allowed unless approved by the Antiquities Authority. ● No painting to any granite surface and cleaning by corrosive chemicals are allowed. ● All original doors should be preserved in-situ. ● Check for proper operation and any water ingress, repair as necessary. ● Addition of ironmongeries for security reasons to suit operational needs may be permitted subject to approval by the Antiquities Authority.

<p><u>Triple layered entrance door</u></p>

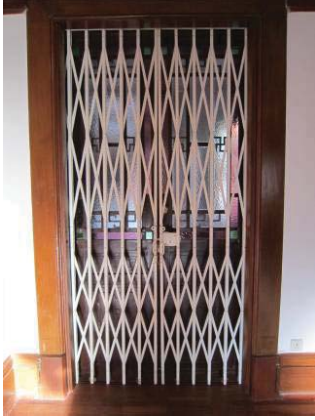
<p><u>Double layered timber door</u></p>

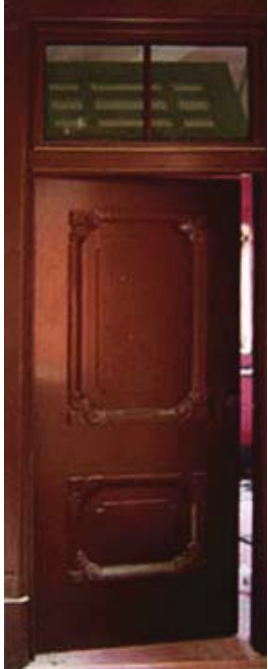
<p><u>Single layered timber door</u></p>

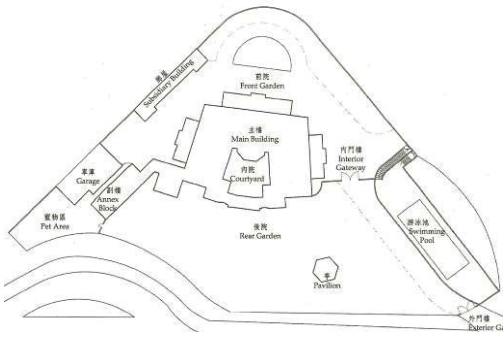
Item	Architectural Features to be Preserved and Conservation Guidelines	Photo
2.1	<p><u>Internal layout</u>, consisting of rooms of different hierarchy separated by internal brick walls.</p> <p>Required Treatments:</p> <ul style="list-style-type: none"> ● No alteration to the internal layout of the Main Building is allowed. ● The original building layout shall be kept intact as far as practicable. ● Alternation to the internal layout and wall openings may be permitted in Annex Block (including the kitchen block) to facilitate the adaptive reuse subject to approval by the Antiquities Authority. ● No demolition and introduction of openings to the walls are allowed but alteration to facilitate wiring or other E&M services or to suit current building requirements may be permitted subject to Registered Structural Engineer's advice and approval by the Antiquities Authority.

<p>The diagram is a site plan of a building complex. It features a central 'Main Building' with an adjacent 'Courtyard'. To the left is a 'Garage' and a 'Pavilion'. To the right is an 'Annex Block' and an 'Interior Gateway'. The plan also shows 'Front Garden', 'Rear Garden', and a 'Swimming Pool'. A 'Pavilion' is located near the rear garden. The entire complex is enclosed by a wall with a 'Gate' at the bottom right. Labels in Chinese and English identify these various components.</p>

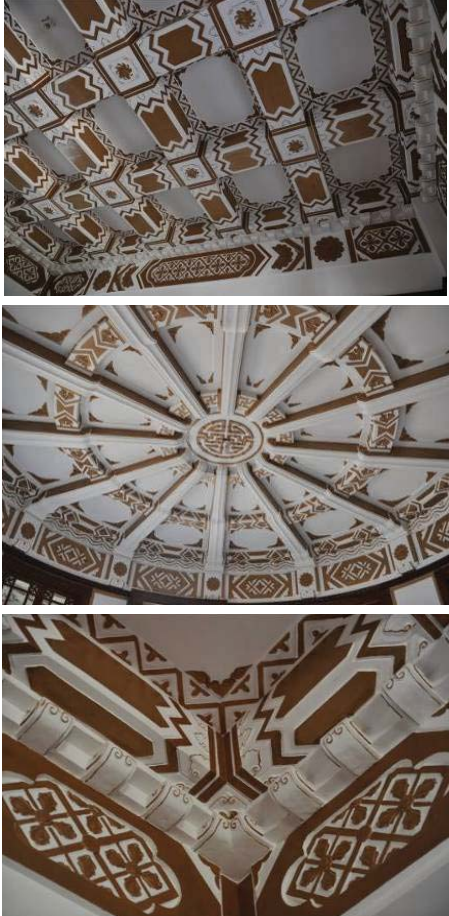
Item	Architectural Features to be Preserved and Conservation Guidelines	Photo
2.2	<p><u>Ceiling, beam, column head</u> with architectural features, including waffle beamed ceilings (井格式樑系) in Main Halls and concentric radiating beamed ceiling (同心圓放射狀樑系) in the circular Dining Hall, ceilings with decorative plastering works on ceiling soffit and cornices (牆簷) of geometric figures symbolizing water (夔紋、水浪紋), floral (菊花), cloud (祥雲) and Chinese character of longevity (壽字) of gold, dark red or other colour paint finishes or coloured terrazzo finishes.</p> <p>Required Treatments:</p> <ul style="list-style-type: none"> ● All ceilings with decorative features, including forms, colours and materials should be preserved intact and no covering up by false ceiling is allowed. ● Repair and repaint the defective plastering surface as necessary. ● Necessary wiring, ducting or E&M facilities should be installed at less conspicuous location and should keep minimal disturbance to any original decorative ceilings.

<p><u>Ceiling, beam, column head with architectural features at Main Building</u></p>

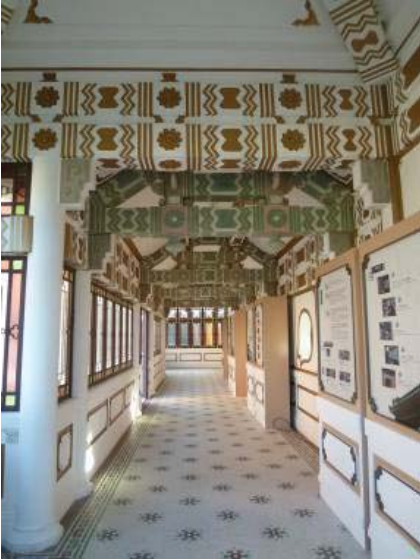
<p><u>Ceiling, beam, column head with architectural features at Subsidiary Building</u></p>

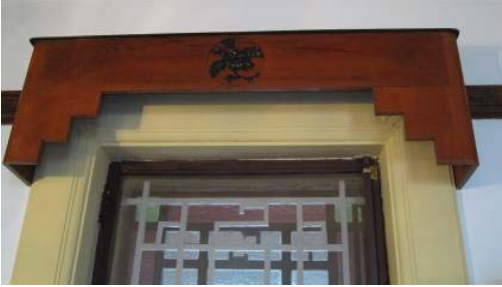
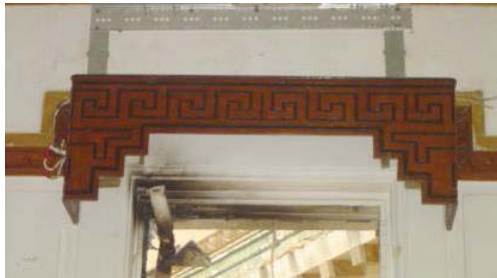
Item	Architectural Features to be Preserved and Conservation Guidelines	Photo
2.3	<p><u>Plastered walls with architectural features</u> such as painted timber cornices in Western style, plastered window surrounds, painted timber or marble window sills, timber pelmet with carvings, decorative plastered dado line, etc.</p> <p><i>Required Treatments:</i></p> <ul style="list-style-type: none"> ● No removal and covering up of any architectural features is allowed. ● No painting and corrosive cleaning chemicals to marble surfaces is allowed. ● Check condition. Repair and repaint to match with existing as necessary. ● Disturbance to the architectural feature by any necessary wiring, ducting or E&M facilities should be kept minimal.

<p><u>Timber pelmet with carvings</u></p>

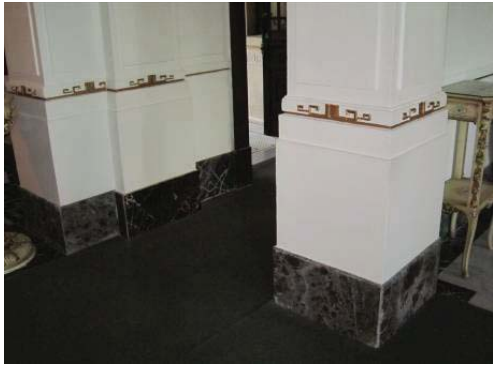
<p><u>Decorative plastered dado line</u></p>

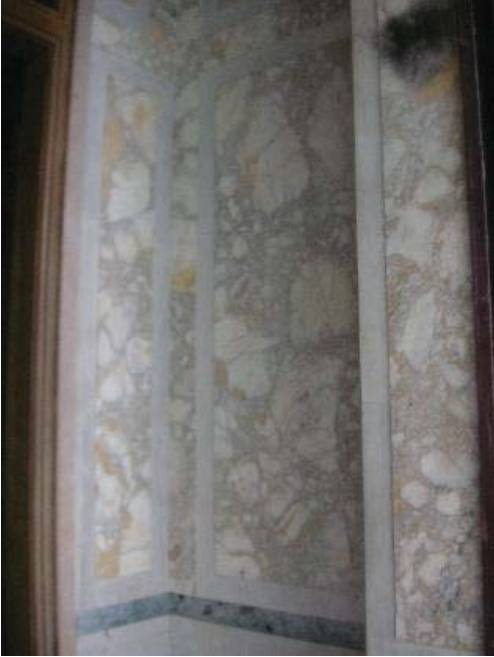
Item	Architectural Features to be Preserved and Conservation Guidelines	Photo
2.4	<p><u>Marble or stone finished walls</u></p> <p>Required Treatments:</p> <ul style="list-style-type: none"> ● No painting and corrosive cleaning chemicals to marble surfaces is allowed.

<p><u>Marble or stone finished walls</u></p>
2.5	<p><u>Floor skirting or dado, including moulded plastered, timber, granolithic, marble or terrazzo finishes.</u></p> <p>Required Treatments:</p> <ul style="list-style-type: none"> ● No objection to re-render or repaint the plastered or painted timber skirting but preservation of their original colours is recommended. ● No covering up of any timber carvings is allowed. ● All skirting or dado of granolithic, marble or terrazzo finish should not be painted.

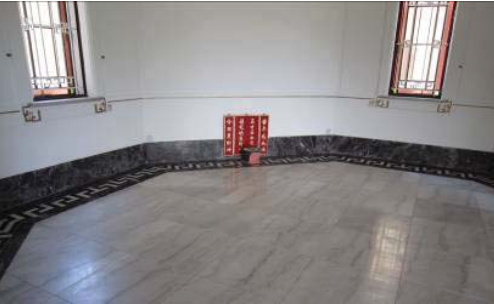
<p><u>Marble skirting</u></p>

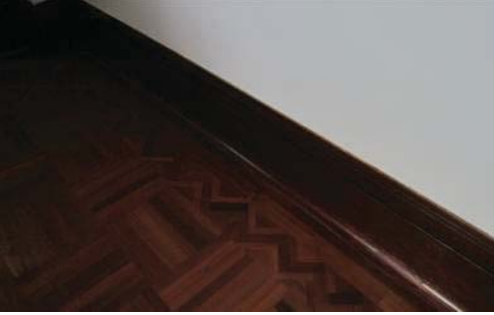
<p><u>Timber skirting</u></p>

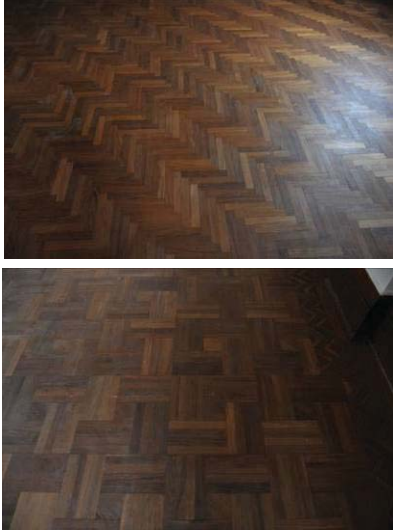
Item	Architectural Features to be Preserved and Conservation Guidelines	Photo
2.7	<p><u>Timber parquet flooring</u>, with patterns.</p> <p>Required Treatments:</p> <ul style="list-style-type: none"> ● All original timber parquet flooring at interiors should be retained in-situ. ● The original timber parquet flooring should only be maintained to matt (non-shiny) surface. ● Rotten and damaged timber parquet blocks shall be carefully taken up and replaced by matching timber blocks in style and material as necessary.

<p><u>Timber parquet flooring laid in special pattern</u></p>

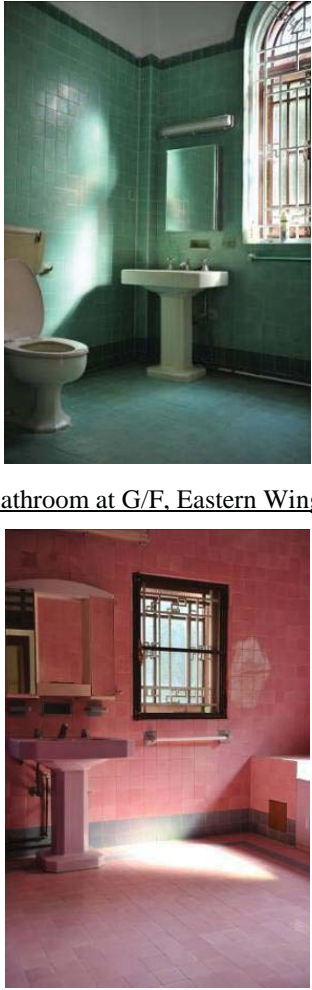
2.8	<p><u>Original glazed coloured ceramic wall, floor and cornice tiles, and sanitary wares, fittings and accessories</u> in bathrooms of G/F eastern wing and 1/F western wing of the Main Building.</p> <p>Required Treatments:</p> <ul style="list-style-type: none"> ● No removal or replacement of the original glazed tiles is allowed. ● All original ceramic sanitary wares, fittings and accessories should be retained in-situ and some could be reused after necessary overhaul and suitable replacement of fittings. No removal or replacement of fittings is permitted unless approved by the Antiquities Authority.

<p><u>Bathroom at G/F, Eastern Wing</u></p> <p><u>Bathroom at 1/F, Western Wing</u></p>

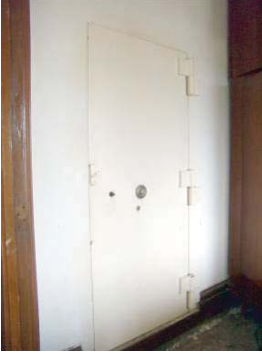
Item	Architectural Features to be Preserved and Conservation Guidelines	Photo
2.10	<p><u>Security room with built-in safe on 1/F</u></p> <p>Required Treatments:</p> <ul style="list-style-type: none"> ● The safe and its door should be preserved in-situ. ● The configuration of the room should not be altered.

<p><u>Security room with built-in safe</u></p>

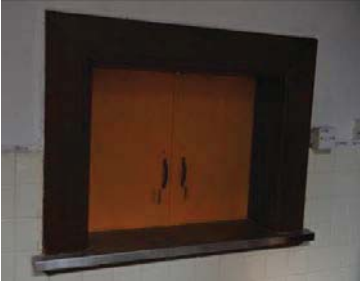
2.11	<p><u>Meal serving opening</u></p> <p>Required Treatments:</p> <ul style="list-style-type: none"> ● The opening shall be generally kept intact. ● Do not permanently block the opening but reversible covering up is allowed.

<p><u>Meal serving opening</u></p>

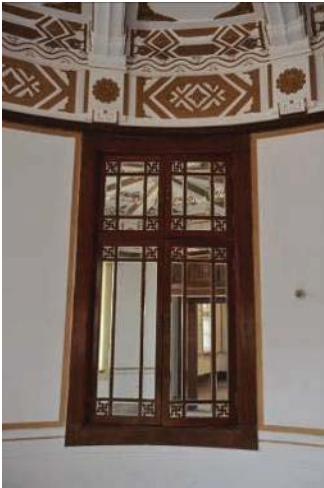
2.12	<p><u>Internal built-in fixtures, including built-in cabinets, fixed mirrors, etc.</u></p> <p>Required Treatments:</p> <ul style="list-style-type: none"> ● All the built-in fixtures should be preserved in-situ. ● Clean, repair and repaint as necessary. ● Some timber works have minor defects and flaking paintwork, and shall be made good by a specialist furniture restorer.

<p><u>Fixed mirror</u></p>

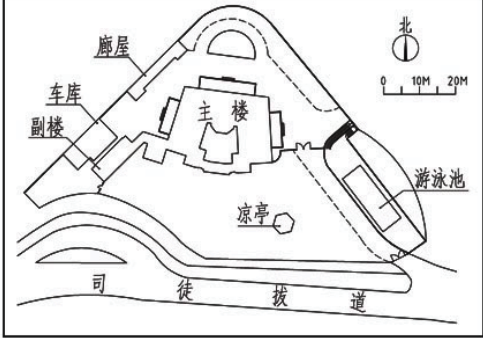
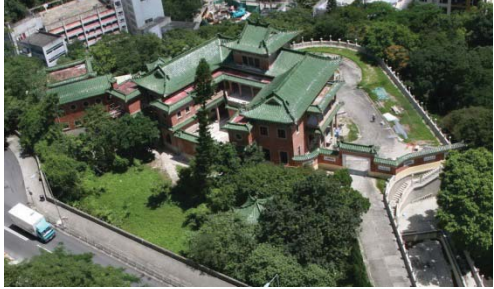
Item	Architectural Features to be Preserved and Conservation Guidelines	Photo
3.1	<p><u>Master layout of buildings and gardens</u> over the whole site, including two zones, namely the inner house zone (內宅區) and the outer garden zone (外院區). The inner house zone consists of the Main Building (主樓) and the Annex Block (副樓), the Garage (車庫), the Subsidiary Building (廊屋), the Front Garden (前院), the Courtyard (內院) and the Pets Area (寵物區), while the outer garden zone consists of the Pavilion (涼亭), the Rear Garden (後院) and the swimming pool.</p> <p>Required Treatments:</p> <ul style="list-style-type: none"> ● Configurations of the “inner house zone” and the “outer garden zone” should be preserved as it reflects planning and spatial concept of traditional Chinese residential architecture. ● No blockage to the view from north of the Main Building over the surroundings. ● The view from Stubbs Road to the Main Building and Annex Block should not be blocked.

<p><u>Master layout of buildings and gardens</u></p>

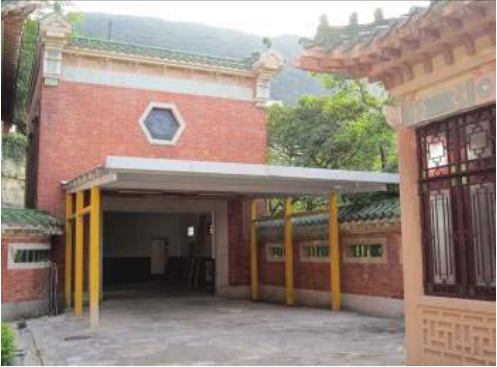
Item	Architectural Features to be Preserved and Conservation Guidelines	Photo
3.3	<p><u>The Garage</u> (車庫) of two storeys (Garage on G/F and living quarter on 1/F), with features such as the classical Chinese <i>luding</i> (盪頂) (a four-sloped roof with a flat central portion), glazed green Chinese ceramic tiles and Canton tiles on roof, verandahs with decorative plastered cornice and ceiling, Chinese bracket sets, beams and joint brackets, perforated red brick parapet wall with terrazzo coping, exterior fair-face red brick walls, metal framed or timber framed windows and doors, timber framed of various shapes, granite window, doors and opening surrounds, coloured clay tile and Canton tile flooring, etc.</p> <p>Required Treatments:</p> <ul style="list-style-type: none"> ● All architectural features should be preserved in-situ. ● No alteration to roof form is allowed but the replacement of roof tiles may be considered for maintenance purpose, and is subjected to approval by the Antiquities Authority. ● Any damaged glazed tiles should be carefully removed and replaced with matching colour tile if and only if the tile is beyond repair, and is subjected to approval by the Antiquities Authority. ● Remove foliage if necessary. ● Repair and maintain the waterproofing conditions of flat roof, install waterproofing layer under the canton tiles may be considered subject to approval by the Antiquities Authority.

<p><u>General view of Garage</u></p>

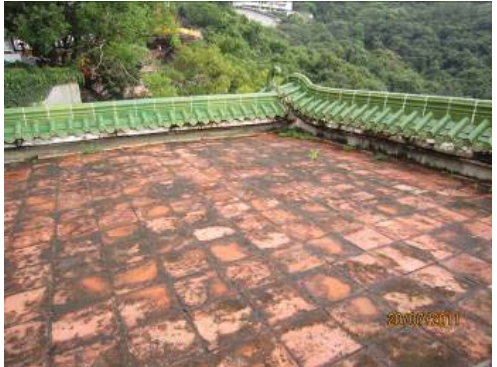
<p><u>The flat roof with classical Chinese <i>luding</i> edging</u></p>

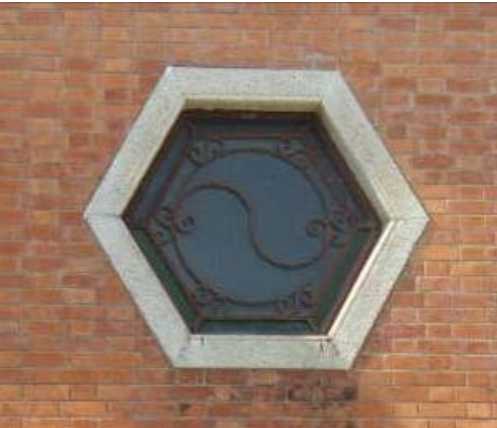
<p><u>Metal framed windows</u></p>

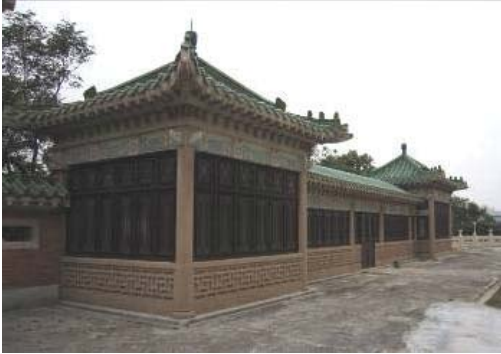
Item	Architectural Features to be Preserved and Conservation Guidelines	Photo
3.4	<p><u>Subsidiary Building</u> (廊屋) of one storey concrete structure with infilled brick walls, with classical Chinese pyramidal roof in quadrangular shape (四角攢尖頂) and humpbacked roof (卷棚式屋頂), connected by corridors (廊) to the square-shaped Pavilions (亭) at both ends, consisted of architectural features including fair-face red brick external wall, terrazzo finished external wall and columns, metal framed windows and French doors with colour glazings, free formed windows with wired glass, internal decorative plastering works to ceiling, cornices, walls and dados, Chinese bracket sets, beams and joint brackets of paint or terrazzo finishes, hexagonal mosaic flooring, granite steps to entrance, etc.</p> <p>Required Treatments:</p> <ul style="list-style-type: none"> ● All architectural features should be preserved in-situ. ● No alteration to roof form is allowed but the replacement of roof tiles may be considered for maintenance purpose, and is subjected to approval by the Antiquities Authority. ● Any damaged glazed tiles should be carefully removed and replaced with matching colour tile if and only if the tile is beyond repair, and is subjected to approval by the Antiquities Authority.

<p><u>General view of Subsidiary Building</u></p>

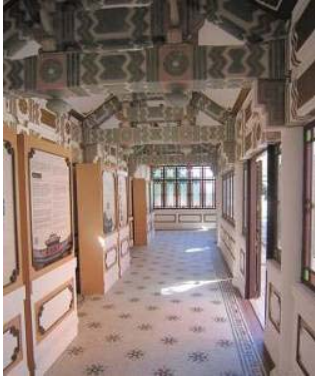
<p><u>Beams and joint brackets of terrazzo finishes</u></p>

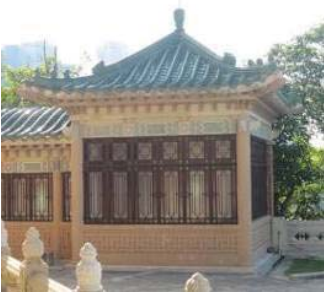
<p><u>Square-shaped Pavilion</u></p>

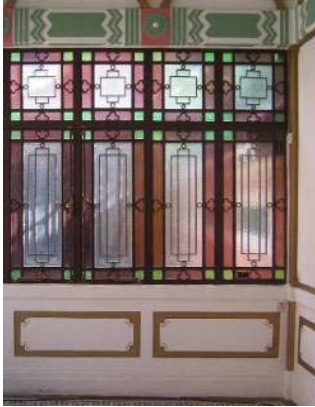
<p><u>Metal frame window with colour glazings</u></p>

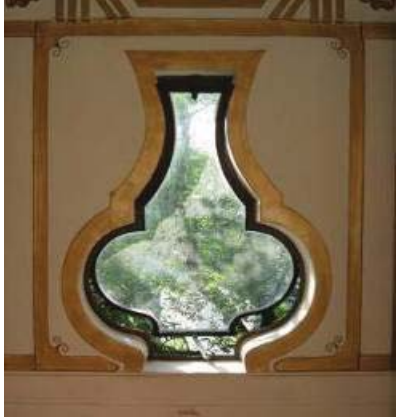
Item	Architectural Features to be Preserved and Conservation Guidelines	Photo
3.4	<p>(Cont'd)</p> <ul style="list-style-type: none"> No introduction of new openings to the external walls is allowed, except those for facilitating wiring and E&M ducting may be permitted subject to Registered Structural Engineer's advice and approval by the Antiquities Authority. Minor modification works on windows to facilitate wiring or other E&M services may be permitted subject to approval by the Antiquities Authority. No painting on fair-face red brick, granite and terrazzo and no covering up of any exterior and interior decorative plastering works and flooring feature is allowed.

<p><u>Free formed windows with wired glass</u></p>

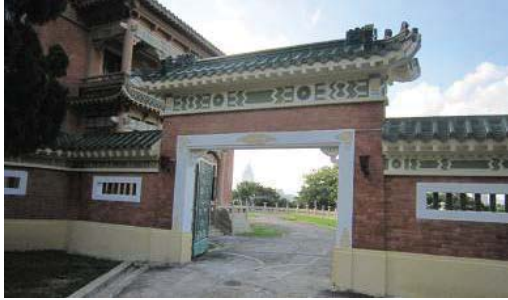
3.5	<p><u>The Front Garden</u> (前院) with “Half Moon Pond” (半月池) of traditional <i>Lingnan</i> (嶺南) style, fair-face red brick fence walls with plastered eave board, dado and opening surrounds, glazed bamboo shaped ceramic grilles, glazed roof tile coping and an entrance metal gate and light fittings separating it from the Rear Garden, and shanghai plastered balustrades to surroundings.</p> <p>Required Treatments:</p> <ul style="list-style-type: none"> The interior gateway, gate, light fitting, “Half Moon Pond” lawn and fence walls with all architectural features should be preserved in-situ.

<p><u>Interior gateway gate</u></p>

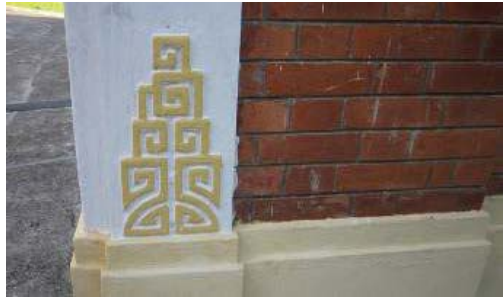
<p><u>Architectural feature at door frame</u></p>

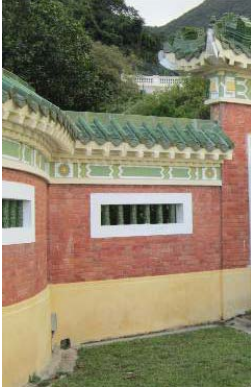
Item	Architectural Features to be Preserved and Conservation Guidelines	Photo
3.5	<p>(Cont'd)</p> <ul style="list-style-type: none"> ● The Front Garden should be kept open and no covering is allowed. No new built structure is allowed to avoid blockage to the view from the Main Building over the surroundings. ● No painting to the fair-face brickworks and shanghai plastered finishes is allowed. ● Alteration to the shanghai plastered balustrade to suit current regulation in a reversible manner may be permitted subject to Registered Structural Engineer's advice and approval by the Antiquities Authority.

<p><u>Fair-face red brick fence wall</u></p>

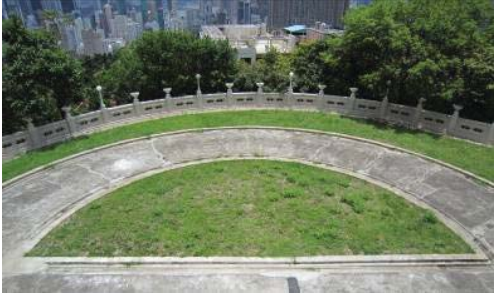
<p><u>"Half Moon Pond" lawn at Front Garden</u></p>

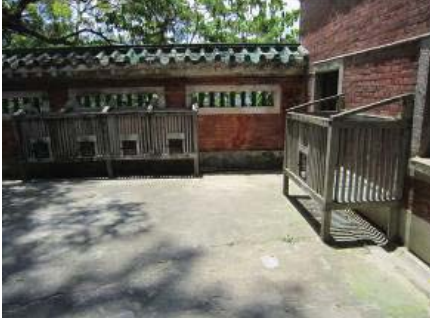
3.6	<p><u>The Pets Area</u>, with doghouse, cages for poultry, a gateway to the Rear Garden and the staircase with cement sand grilled block walls leading up to back entrance of the site, fair-face red brick fence walls with plastered eave board, glazed bamboo shaped ceramic grilles, glazed roof tile coping.</p> <p><i>Required Treatments:</i></p> <ul style="list-style-type: none"> ● The metal gate to the Outer Garden, cages for poultry, doghouse with memorial plaque, staircase with cement sand grilled block walls to back entrance, back entrance portal, and fair-face red brick fence walls with all architectural features should be preserved in-situ.

<p><u>Cages for poultry</u></p>

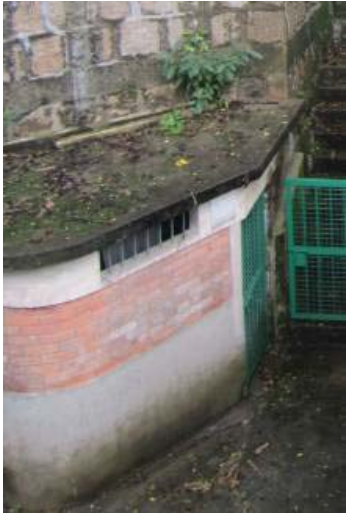
<p><u>Doghouse with memorial plaque</u></p>

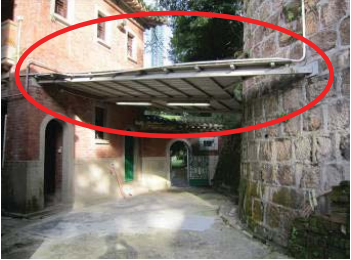
Item	Architectural Features to be Preserved and Conservation Guidelines	Photo
3.6	<p>(Con't)</p> <ul style="list-style-type: none"> ● The later-added metal structure should be removed. Outdoor units for the air-conditioning system, if any, might be considered to accommodate in this passageway to the poultry area, and is subjected to approval by the Antiquities Authority. Appropriate architectural screening to the machinery, if any, should be considered to minimize the visual impact to the historic buildings. ● Any damaged glazed tiles should be carefully removed and replaced with matching colour tile if and only if the tile is beyond repair, and is subjected to approval by the Antiquities Authority. ● Remove foliage if necessary. ● All fair-face brickworks should not be painted, but permeable translucent protective coating for brickworks may be permitted subject to approval by the Antiquities Authority.

<p><u>The later-added metal structure</u></p>

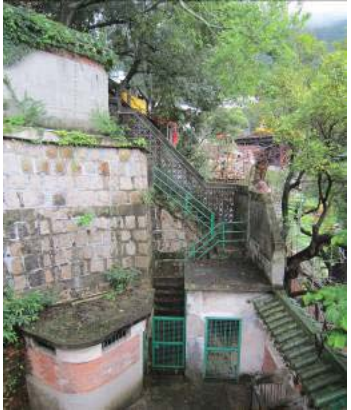
<p><u>Staircase to back entrance</u></p>

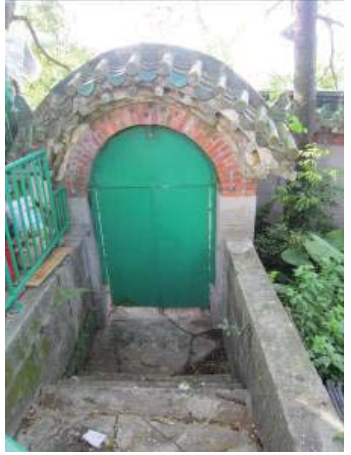
<p><u>Back entrance</u></p>

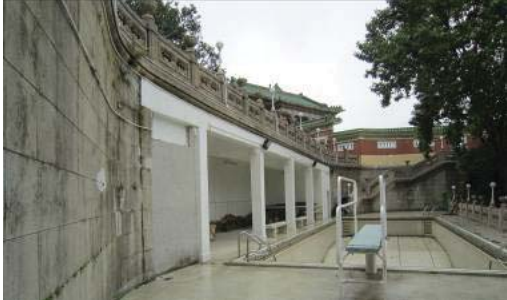
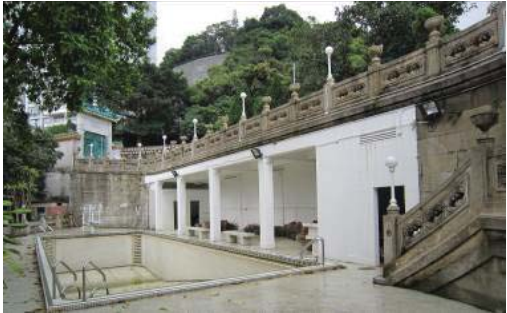
Item	Architectural Features to be Preserved and Conservation Guidelines	Photo
3.7	<p><u>The swimming pool</u> of half sunken configuration and mosaic finishes, with a metal gate and a shanghai plastered access staircase led from the Front Garden, a side covered walkway accommodating a resting area underneath entrance access road, shanghai plastered balustrades with lamps to staircase and east of the pool and metal gates and portals leading to a staircase and then to the surrounding down-slope at east.</p> <p><i>Required Treatments:</i></p> <ul style="list-style-type: none"> ● The swimming pool of half sunken form and profile, with mosaic finishes should be preserved in-situ. Stains and dirt on the surface should be washed down. ● Cracks are found on floor and balustrades next to the pool and part of the balustrades are tilted outwards. Structural and slope condition should be checked. Repair and strengthening works should be carried out as necessary. ● The access doorway and the staircase from the Front Garden to the swimming pool should be preserved in-situ. ● Alteration to balustrades in a reversible manner may be permitted subject to approval by the Antiquities Authority. ● Alteration to the swimming pool, pool deck surface and the nearby area for adaptive reuse in a reversible manner may be permitted subject to approval by the Antiquities Authority.

<p><u>General view of swimming pool</u></p>

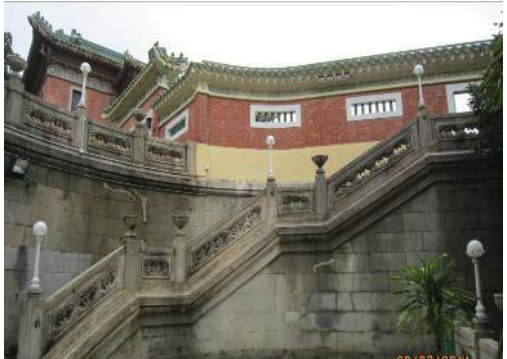
<p><u>Access doorway and staircase to swimming pool</u></p>

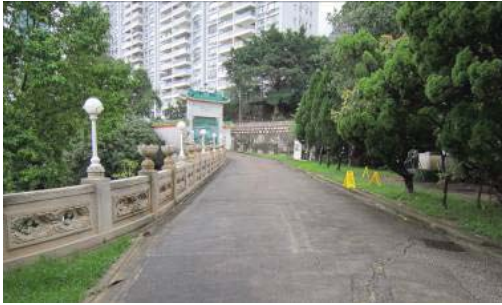
Item	Architectural Features to be Preserved and Conservation Guidelines	Photo
3.8	<p><u>The Rear Garden</u> (後院) with an access road from the main entrance, a terrazzo finished well next to the Pavilion, shanghai plastered balustrades, tailored-made lamp posts and flower pots with Chinese characters. It is bounded by fence walls with fair-face red brick, painted or shanghai plastered surfaces and opening surrounds, bamboo-shaped ceramic grille (竹節筒) and glazed roof tile coping.</p> <p>Required Treatments:</p> <ul style="list-style-type: none"> ● Shanghai plastered balustrades, fence walls, tailored-made lamp posts and terrazzo finished well should be preserved in-situ. ● Alteration works to the balustrades in a reversible manner may be permitted, subject to approval by the Antiquities Authority. ● All shanghai plastering and terrazzo finishes should be thoroughly cleaned, but no corrosive chemical is allowed. ● No painting to the fair-face brickworks and shanghai plaster finishes. ● Preservation and reuse of the tailored-made flower pots with Chinese characters is required.

<p><u>Access road from main entrance</u></p>

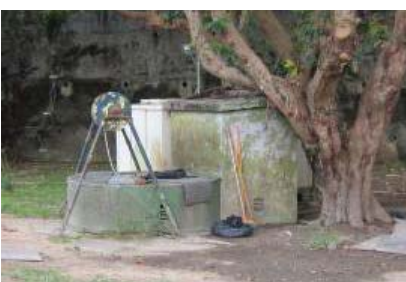
<p><u>Terrazzo finished well</u></p>

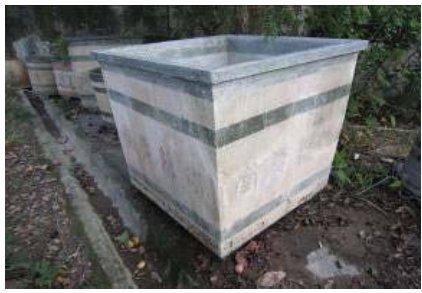
<p><u>Tailored-made flower pot with Chinese characters</u></p>

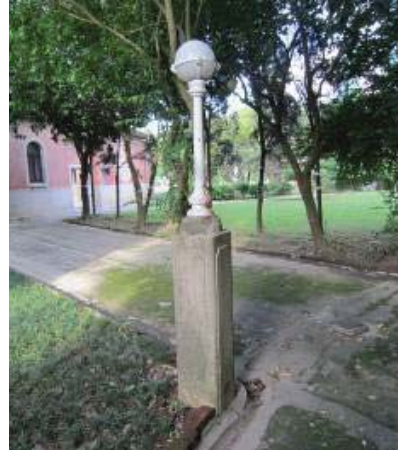
<p><u>Tailored-made lamp post</u></p>

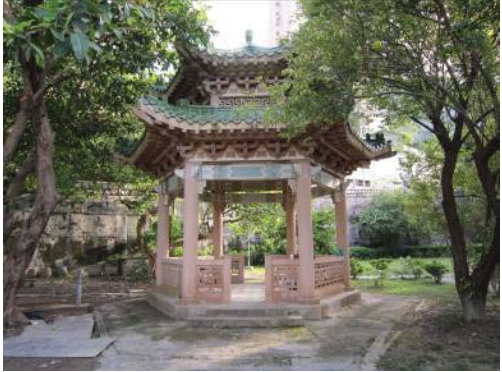
Item	Architectural Features to be Preserved and Conservation Guidelines	Photo
3.9	<p><u>The Pavilion</u> (涼亭) of hexagonal shape, featured by a classical Chinese double-eave pyramidal roof in hexagonal shape (重簷六角攢尖頂), decorative plastering works to ceiling and cornice, columns, Chinese bracket sets (斗拱), beam (額枋) and joint brackets (雀替) of terrazzo finishes, coloured mosaic flooring, granite steps, terrazzo balustrades, etc.</p> <p>Required Treatments:</p> <ul style="list-style-type: none"> ● All architectural features should be preserved in-situ. ● No alteration to roof form, finishes and features is allowed. ● All damaged glazed tiles should be carefully removed and replaced with matching colour tile if and only if the tile is beyond repair, and is subjected to approval by the Antiquities Authority. ● Remove foliage if necessary. ● No painting on fair-face granite, terrazzo and no covering up of any decorative plastering works and flooring feature is allowed. ● Repair and repaint the plastered and painted finishes as necessary. Keep existing colour of the paint finishes, or restore their original colour if they are found different from the existing.

<p data-bbox="1066 696 1209 725"><u>The Pavilion</u></p>

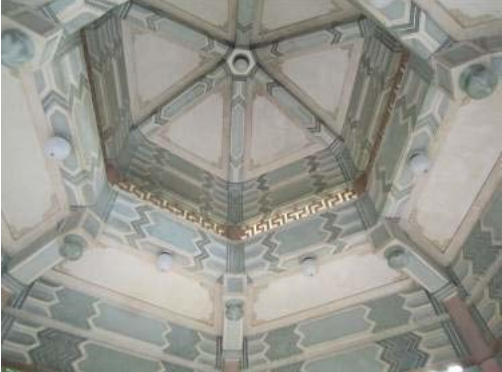
<p data-bbox="951 1167 1326 1196"><u>Pyramidal roof in hexagonal shape</u></p>

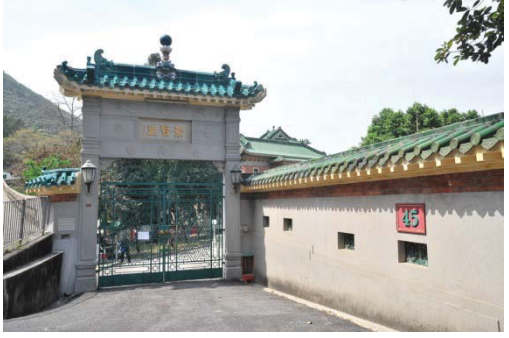
Item	Architectural Features to be Preserved and Conservation Guidelines	Photo
3.10	<p>The Exterior Gateway (外門樓) with shanghai plastered and glazed tile capped entrance portal, the plaque with words “King Yin Lei” over the portal, the patterned metal gate, the plaques with number “45” on the portal and the fence wall next to the portal, light fittings, the earth god shrine and the mail box.</p> <p>Required Treatments:</p> <ul style="list-style-type: none"> ● The Exterior Gateway (外門樓) with the listed features should be preserved in-situ. Stains and dirt on the surface should be washed down. ● All damaged glazed tiles should be carefully removed and replaced with matching colour tile if and only if the tile is beyond repair, and is subjected to approval by the Antiquities Authority. ● Remove foliage if necessary. ● Unsightly and redundant wiring should be removed. ● Check condition of patterned metal gate, de-rust, repair, treat with rust preservation, restore colour and repaint as necessary. ● Repair and repaint the plastered and painted finishes as necessary. ● Alteration of the fence wall to suit current regulations or adaptive re-use may be permitted subject to approval by the Antiquities Authority.

<p><u>The exterior gateway</u></p>

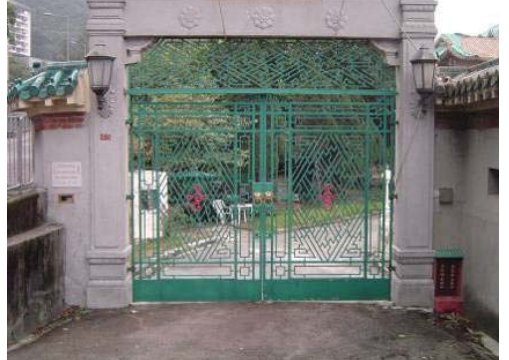
<p><u>Metal gate</u></p>

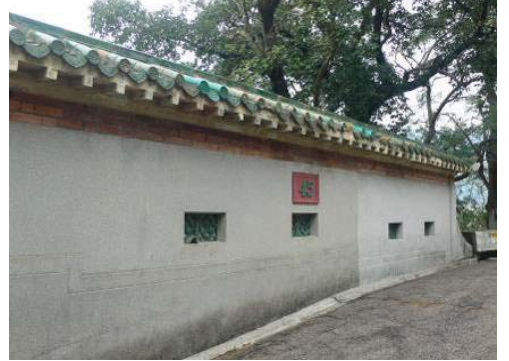
<p><u>Fence wall</u></p>

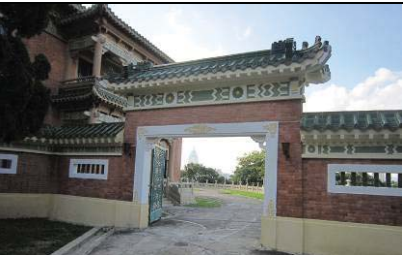
Item	Architectural Features to be Preserved and Conservation Guidelines	Photo
3.11	<p><u>The Interior Gateway (內門樓)</u> with fair-face red brickwall with plastered eave board, painted finishes dado, glazed bamboo shaped ceramic grilles, glazed roof tile coping and an entrance metal gate and light fittings.</p> <p><i>Required Treatments:</i></p> <ul style="list-style-type: none"> ● The Interior Gateway with the listed features should be preserved in-situ. ● All fair-face brickworks should not be painted, but permeable translucent protective coating for brickworks may be permitted, subject to approval by the Antiquities Authority. ● All damaged glazed tiles should be carefully removed and replaced with matching colour tile if and only if the tile is beyond repair, and is subjected to approval by the Antiquities Authority. ● Remove foliage if necessary. ● Check condition of patterned metal gate, de-rust, repair, treat with rust preservation, restore colour and repaint as necessary. ● Repair and repaint the plastered and painted finishes as necessary.

<p style="text-align: center;"><u>The interior gateway</u></p>

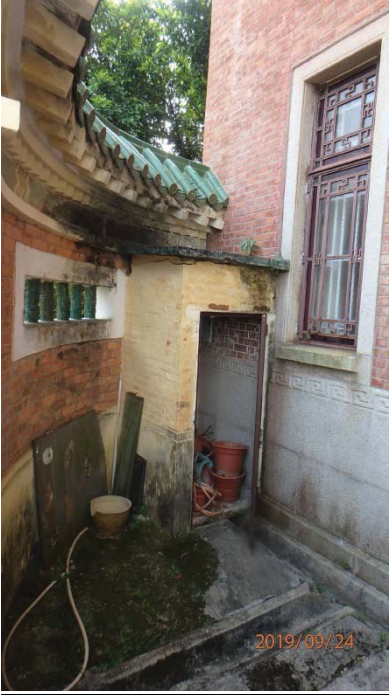
Item	Architectural Features to be Preserved and Conservation Guidelines	Photo
3.11	<p>(Con't)</p> <ul style="list-style-type: none"> ● Outdoor units for the air-conditioning system, if any, might be considered to accommodate in the recess space between the verandah to the Rosewood Hall and the interior gateway, and is subjected to approval by the Antiquities Authority. Removal of the store room to make way for the machinery, if required, might be considered, and is subjected to approval by the Antiquities Authority. The height of the machinery, if any, should not exceed the top level of the glazed tile ridge to minimize the visual impact to the historic buildings. Appropriate architectural screening to the machinery, if any, should be considered to minimize the visual impact to the historic buildings.

<p><u>The store room at this recess space between the verandah to the Rosewood Hall and the interior gateway might be removed if required</u></p>

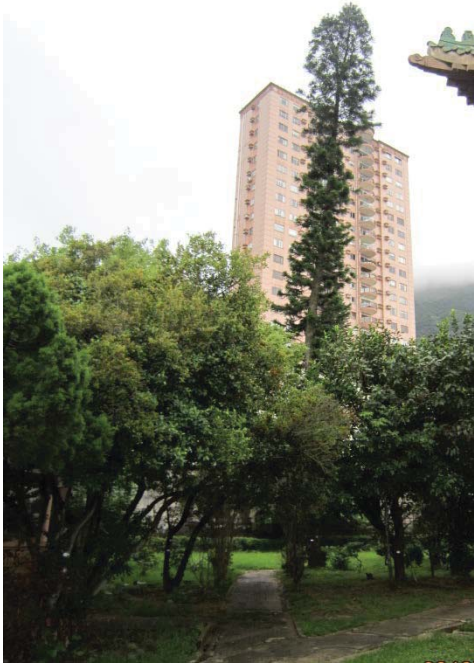
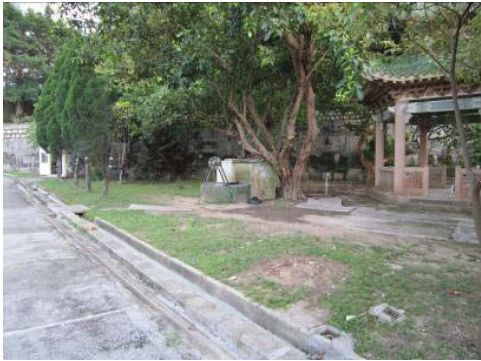
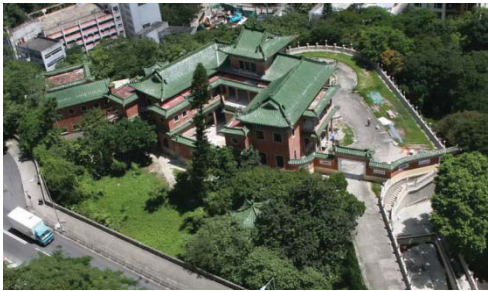
Item	Architectural Features to be Preserved and Conservation Guidelines	Photo
3.12	<p><u>Mature trees and surrounding landscape</u></p> <p><i>Required Treatments:</i></p> <ul style="list-style-type: none"> ● All mature and valuable trees should be preserved, but transplanting to suit operational need may be permitted subject to relevant government authority's approval. ● The surrounding landscape should be preserved and kept its harmony with the context of the site.

<p><u>Mature trees and surrounding landscape</u></p>

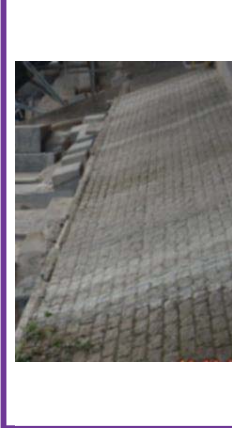
Slope/Retaining Wall Feature 4
SMRIS Slope no.: 11SW-
Responsible Party: IL Lot 9022
(Within IL Lot 9022 and adjacent to Government Land)

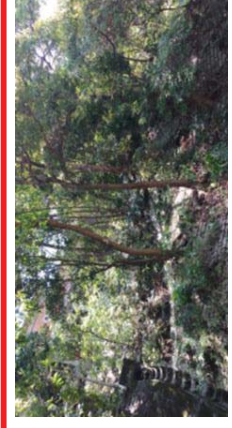
Slope/Retaining Wall Feature 4
SMRIS Slope no.: 11SW-D/FR555(2)
Responsible Party: DEVB
(Partly within IL 9022 and partly on Government land)

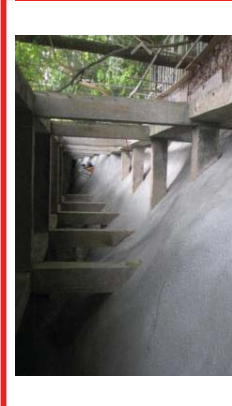
Slope/Retaining Wall Feature 5
SMRIS Slope no.: 11SW-D/FR689
Responsible Party: DEVB
(Within GLA-HK1072)
