**Revitalising Historic Buildings  
Through Partnership Scheme**

**Tai Tam Tuk Raw Water Pumping Station  
Staff Quarters Compound**

**Resource Kit**

**Date: 27 November 2019**

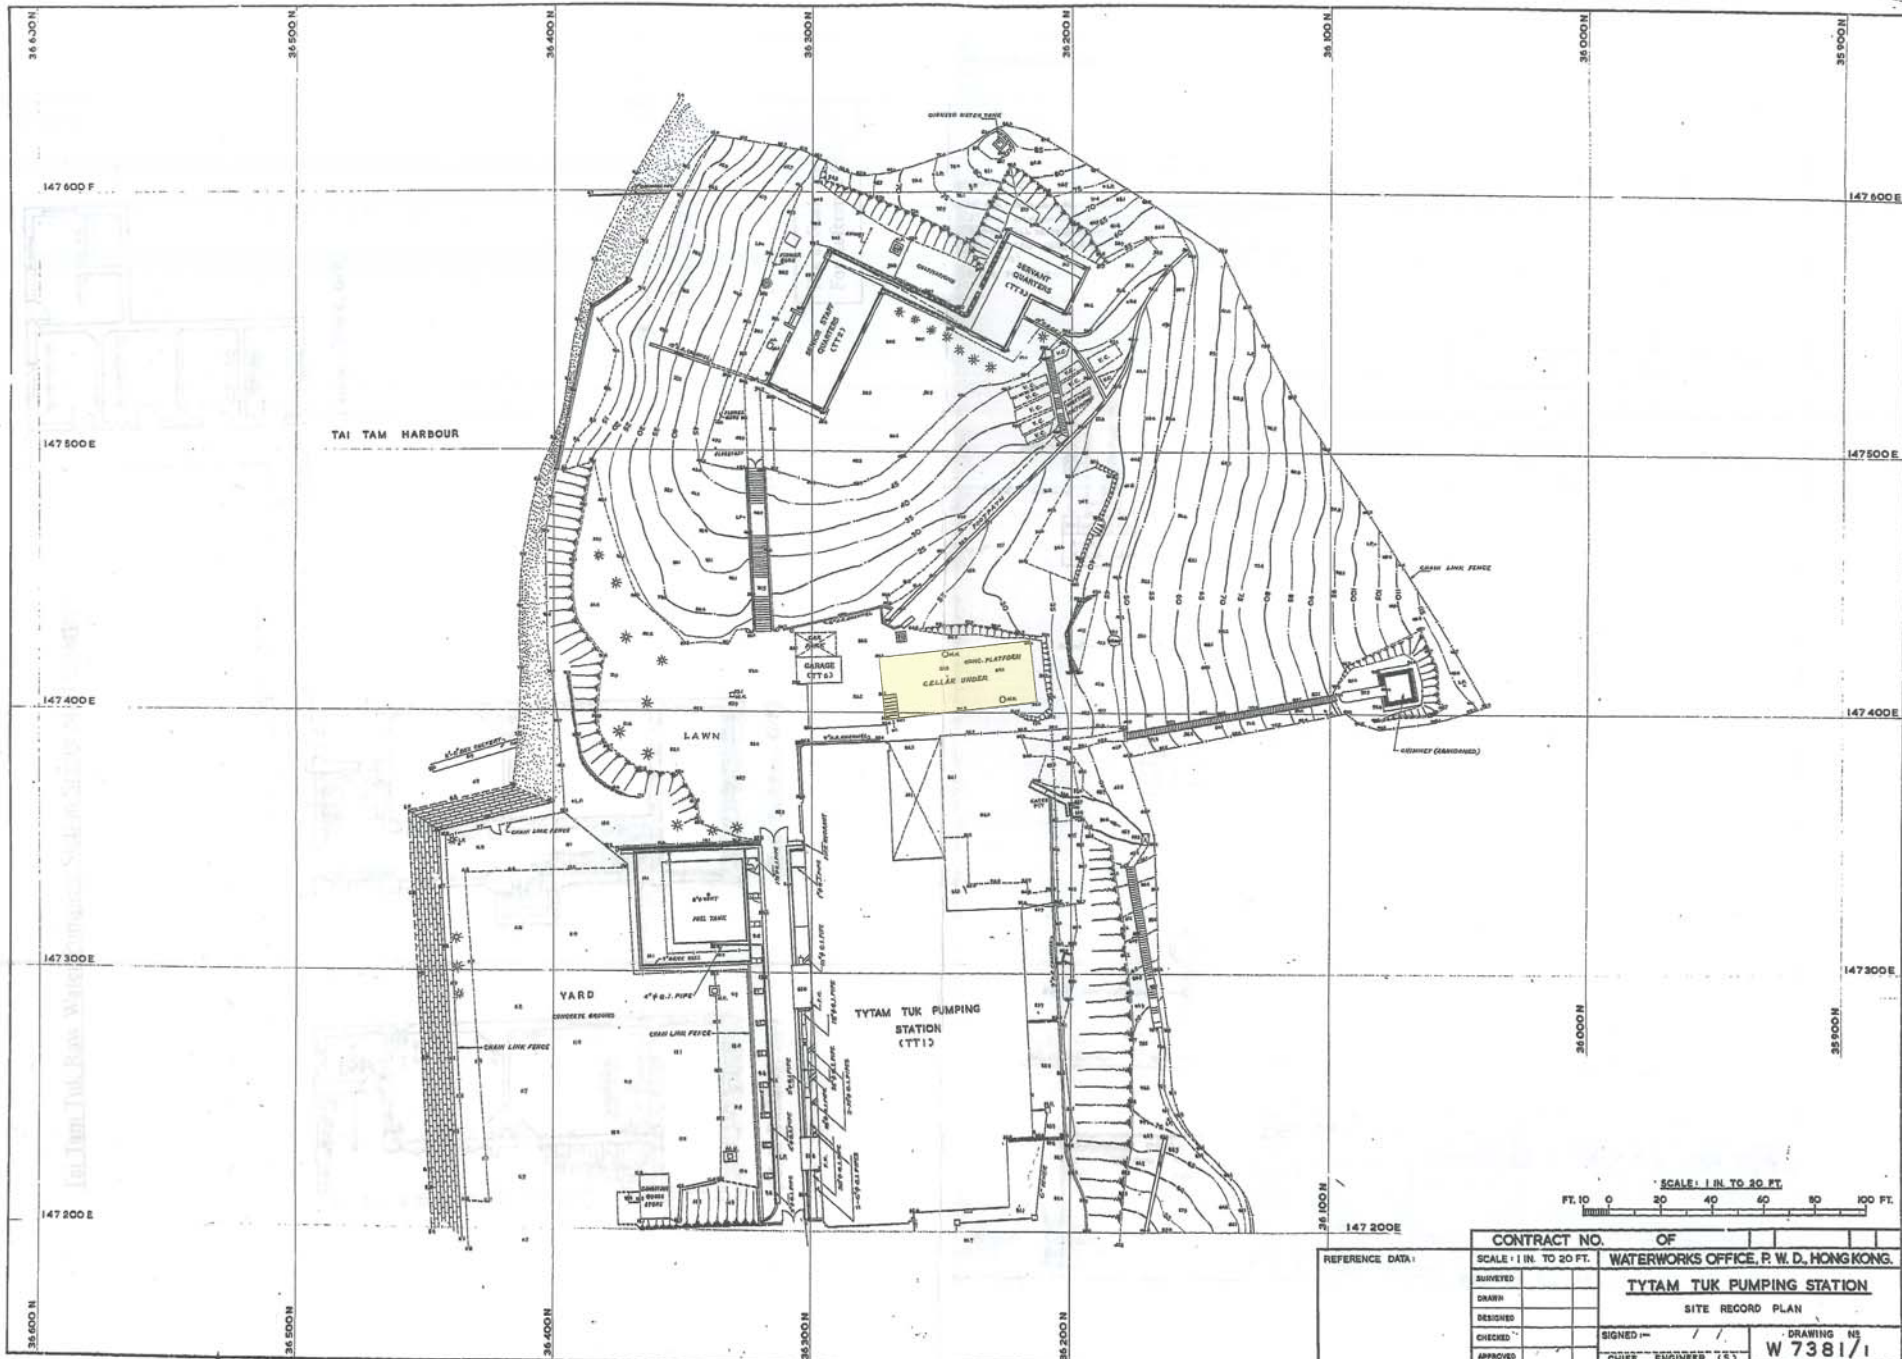
**Appendix IV**  
**Plan for Underground Cellar**

REFERENCE DATA:	CONTRACT NO. _____ OF _____	
	SCALE: 1 IN. TO 20 FT. WATERWORKS OFFICE, P. W. D., HONG KONG.	
	<b>TYTAM TUK PUMPING STATION</b>	
	SITE RECORD PLAN	
	SIGNED: _____	DRAWING NO. <b>W 7381/1</b>
APPROVED: _____	CHIEF ENGINEER (S)

The Underground Cellar appears to be in dilapidated condition. Spalled concrete, rusted reinforcement could be seen within the structure.

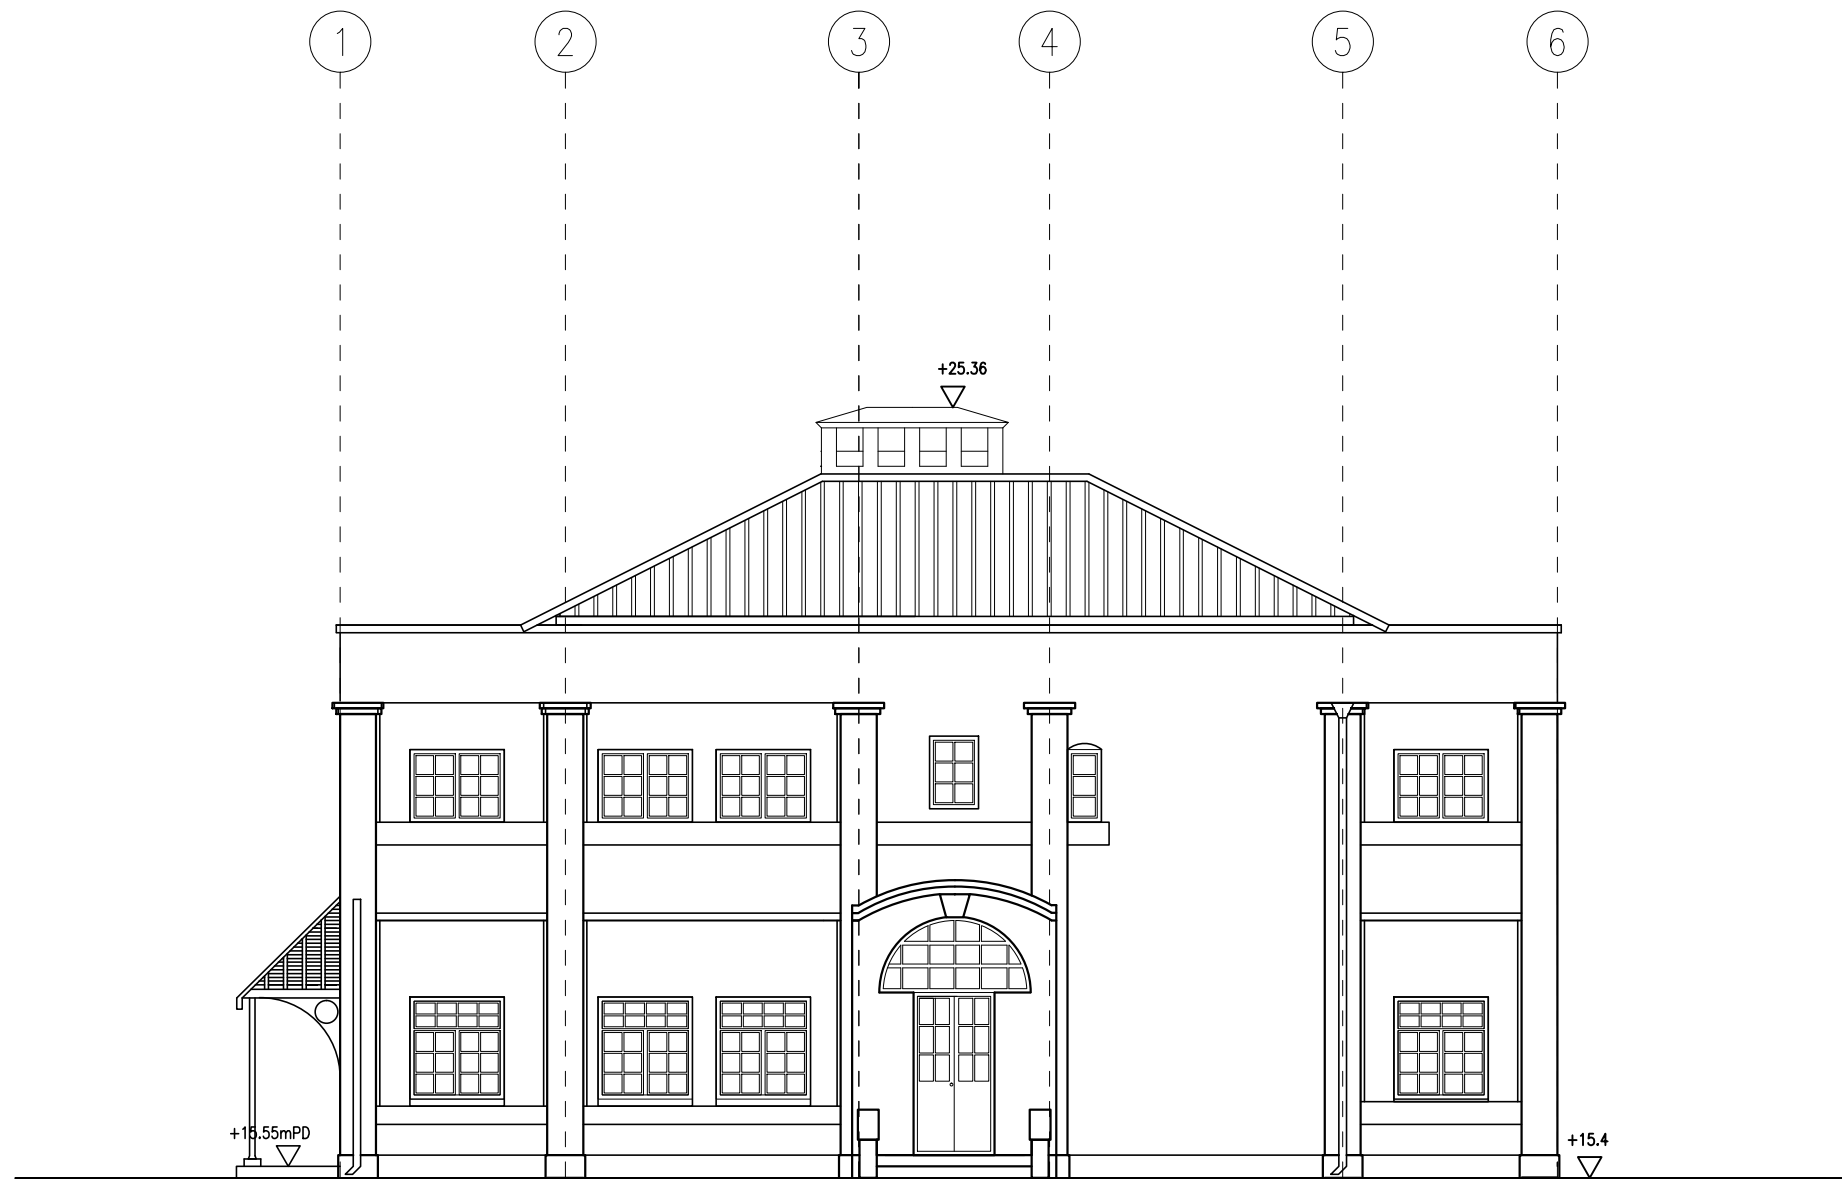
NORTH EAST ELEVATION

JOB NO. <b>HRT-04-2019</b>	Drawing No. <b>TT-04</b>
-------------------------------	-----------------------------

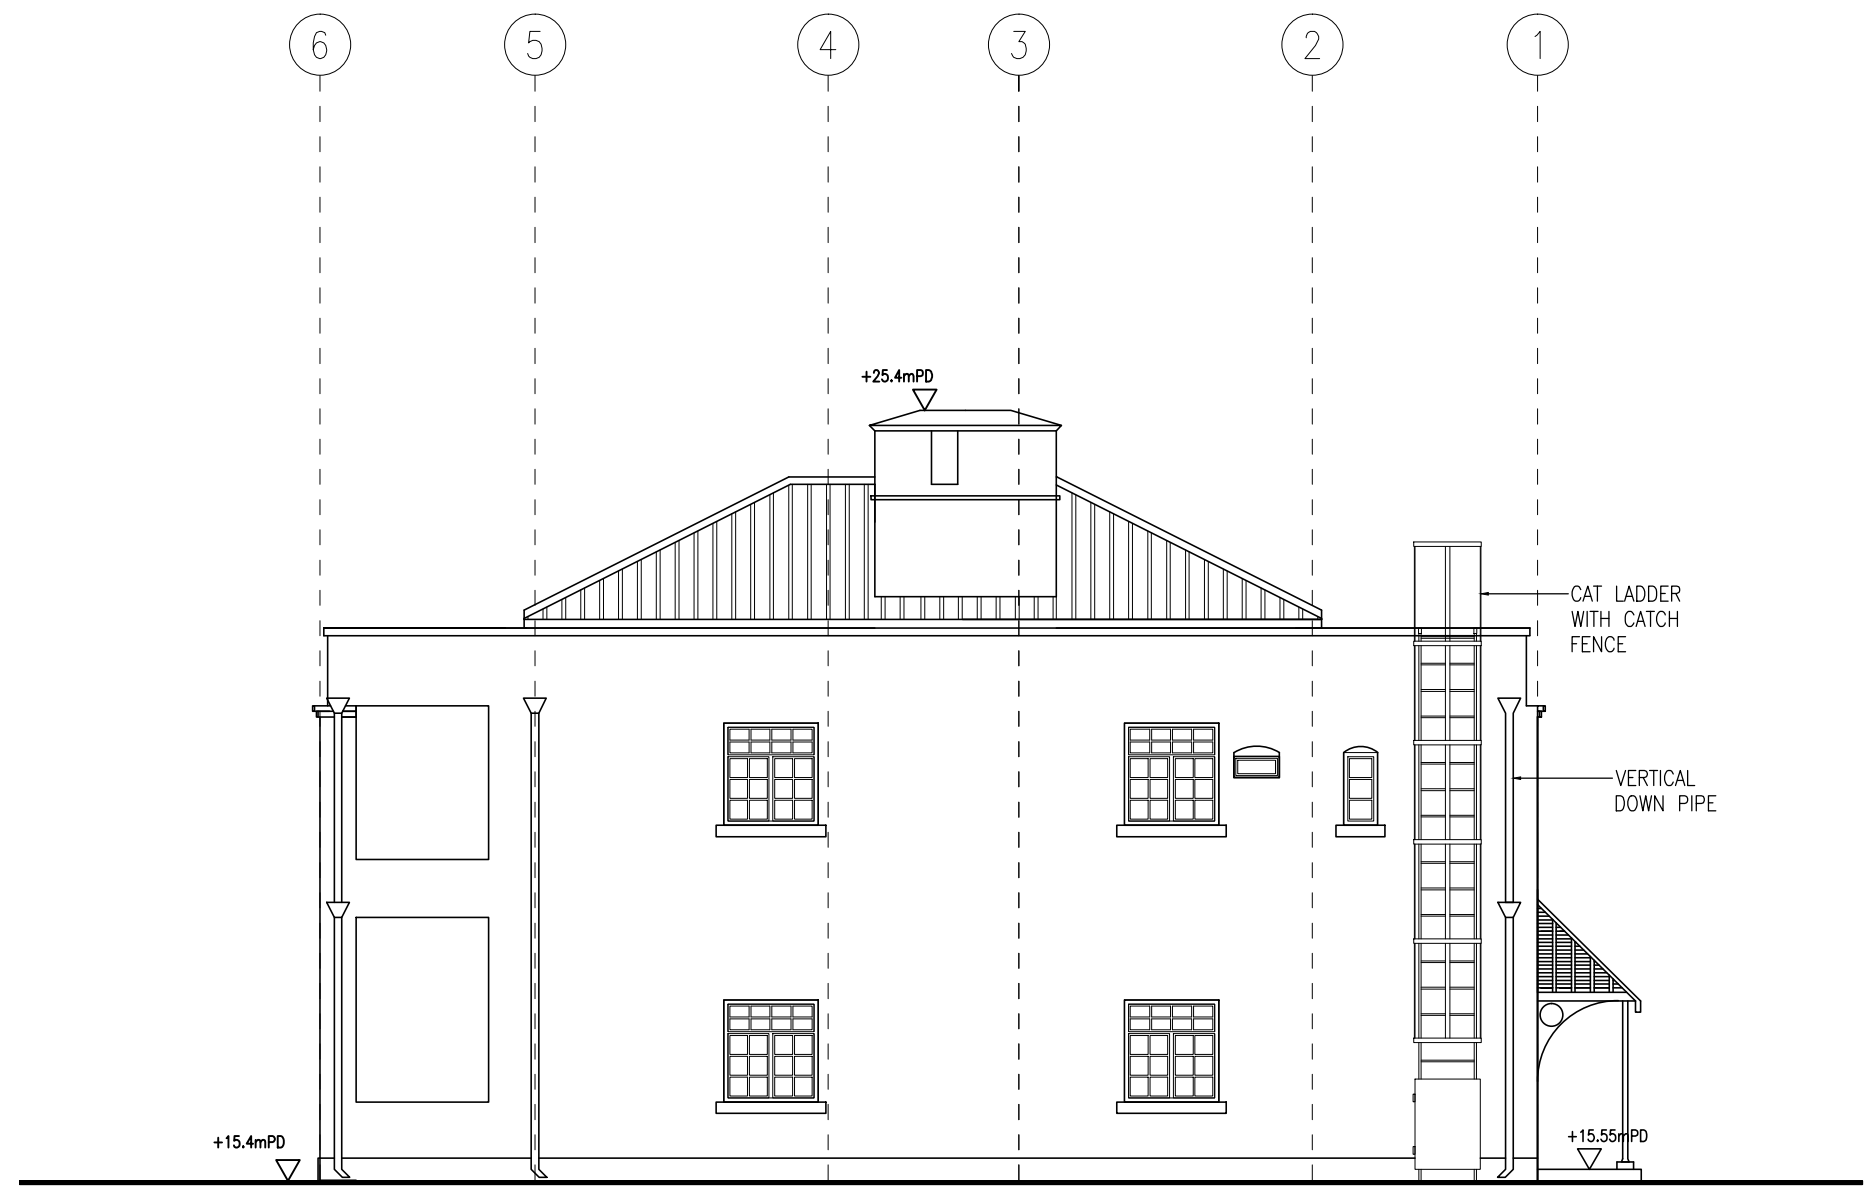
SOUTH WEST ELEVATION

JOB NO. HRT-04-2019	Drawing No. TT-05
------------------------	----------------------

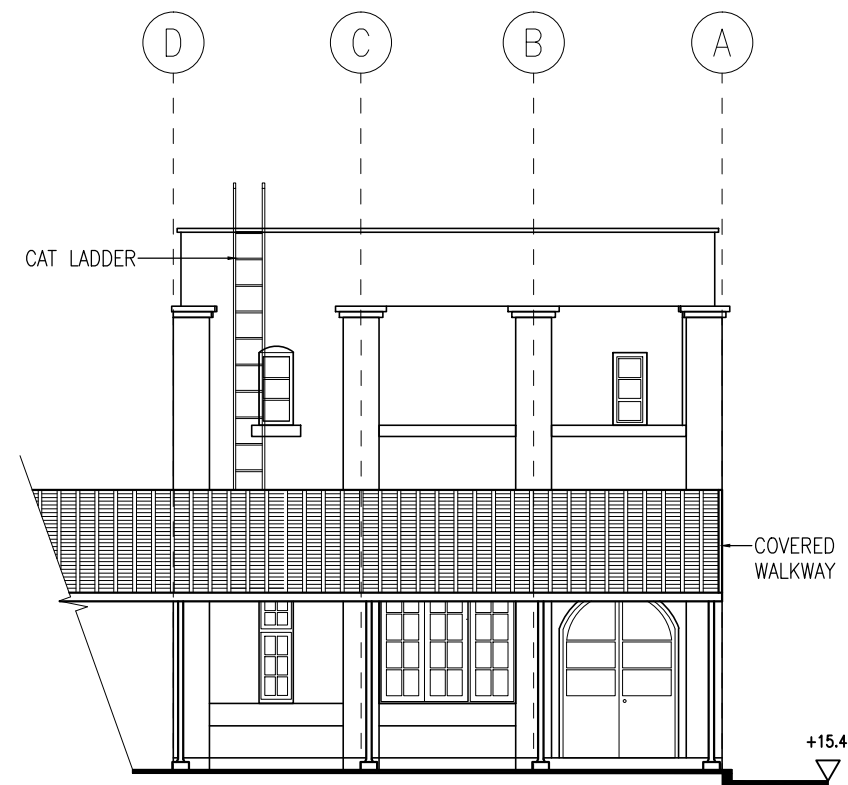
SOUTH EAST ELEVATION

Drawing No.  
TT-06

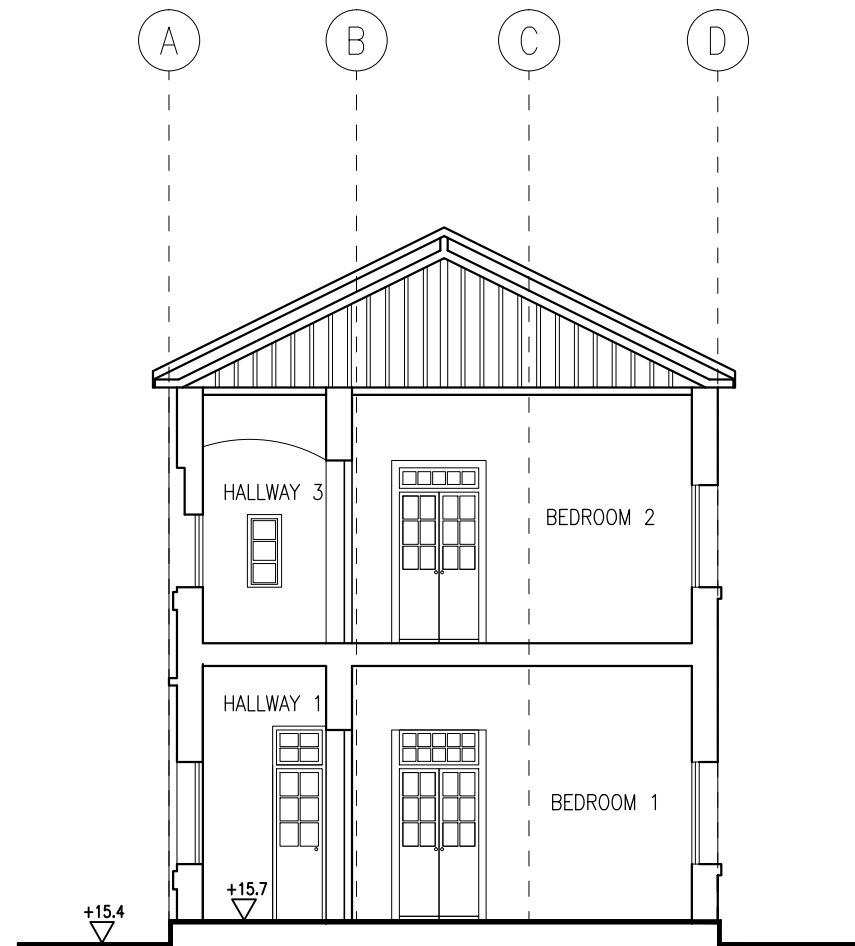
SECTION A-A

Drawing No.  
**TT-08**

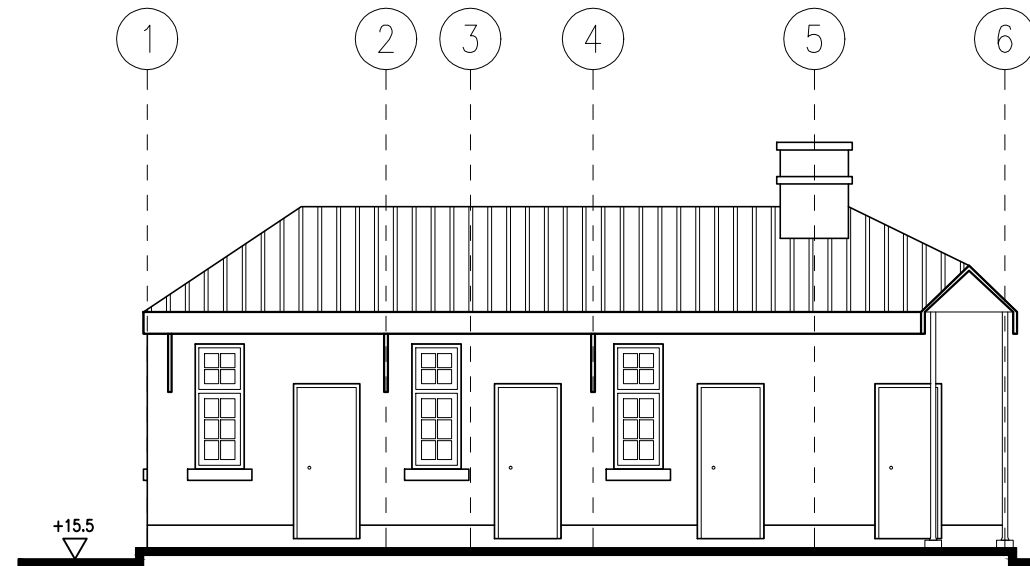
NORTH EAST ELEVATION

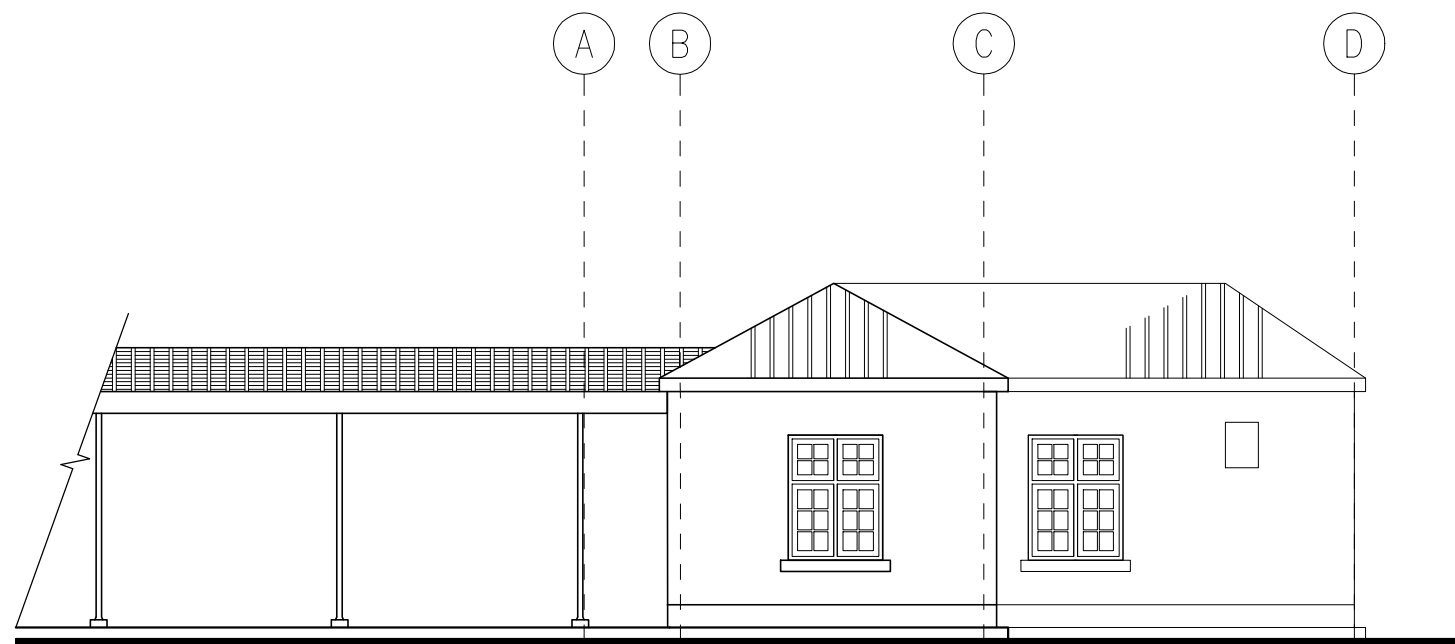
NORTH WEST ELEVATION

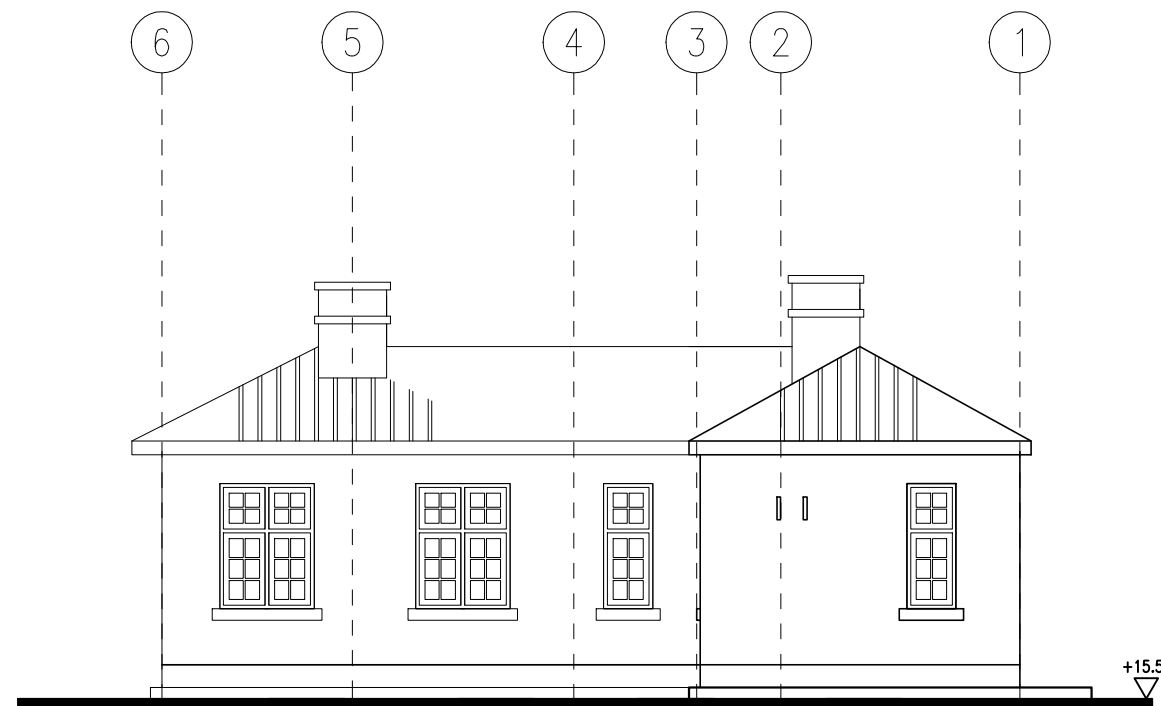
SOUTH WEST ELEVATION

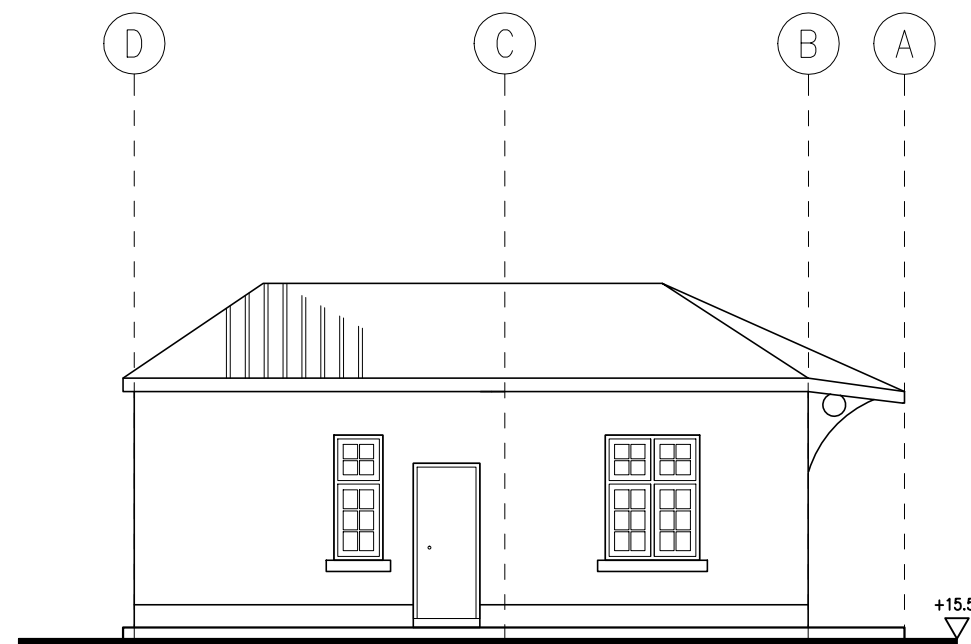
SOUTH EAST ELEVATION

<b>ample</b> SURVEYOR SERVICES LIMITED 安普測量顧問有限公司				
Job Title <b>Resource Kit for Tai Tam Tuk Raw Water Pumping Station and Staff Quarters, Tai Tam Reservoir Road, Tai Tam, Hong Kong</b>				
Drawing Title <b>SOUTH EAST ELEVATION OF SENIOR STAFF QUARTERS - SERVANTS' QUARTERS</b>				
DATE	DRAWN	DESIGNED	CHECKED	SCALE Title
07/08/2019	TC		NL	1:100 (A3)
JOB NO. <b>HRT-04-2019</b>			Drawing No. <b>TT-15</b>	
STATUS :

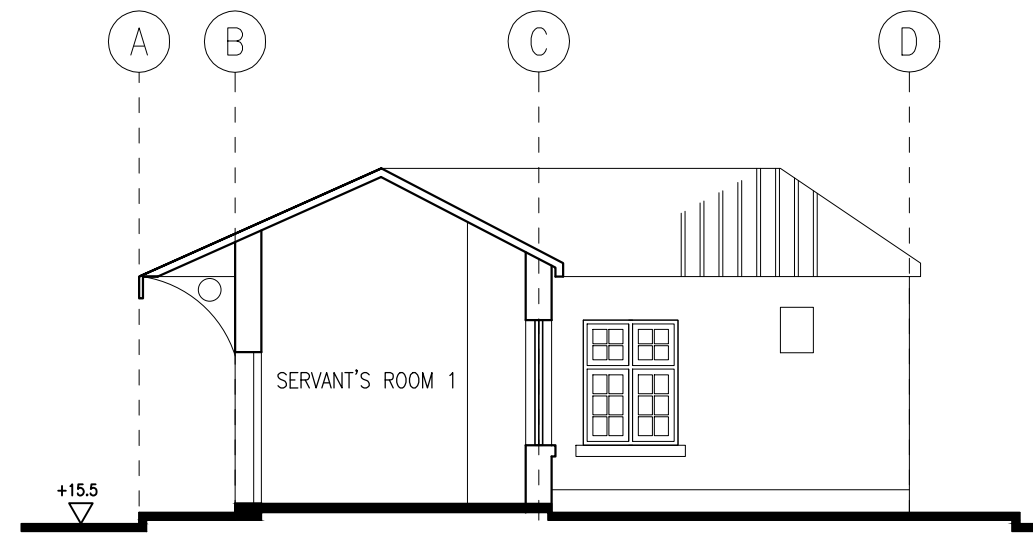
SECTION A-A

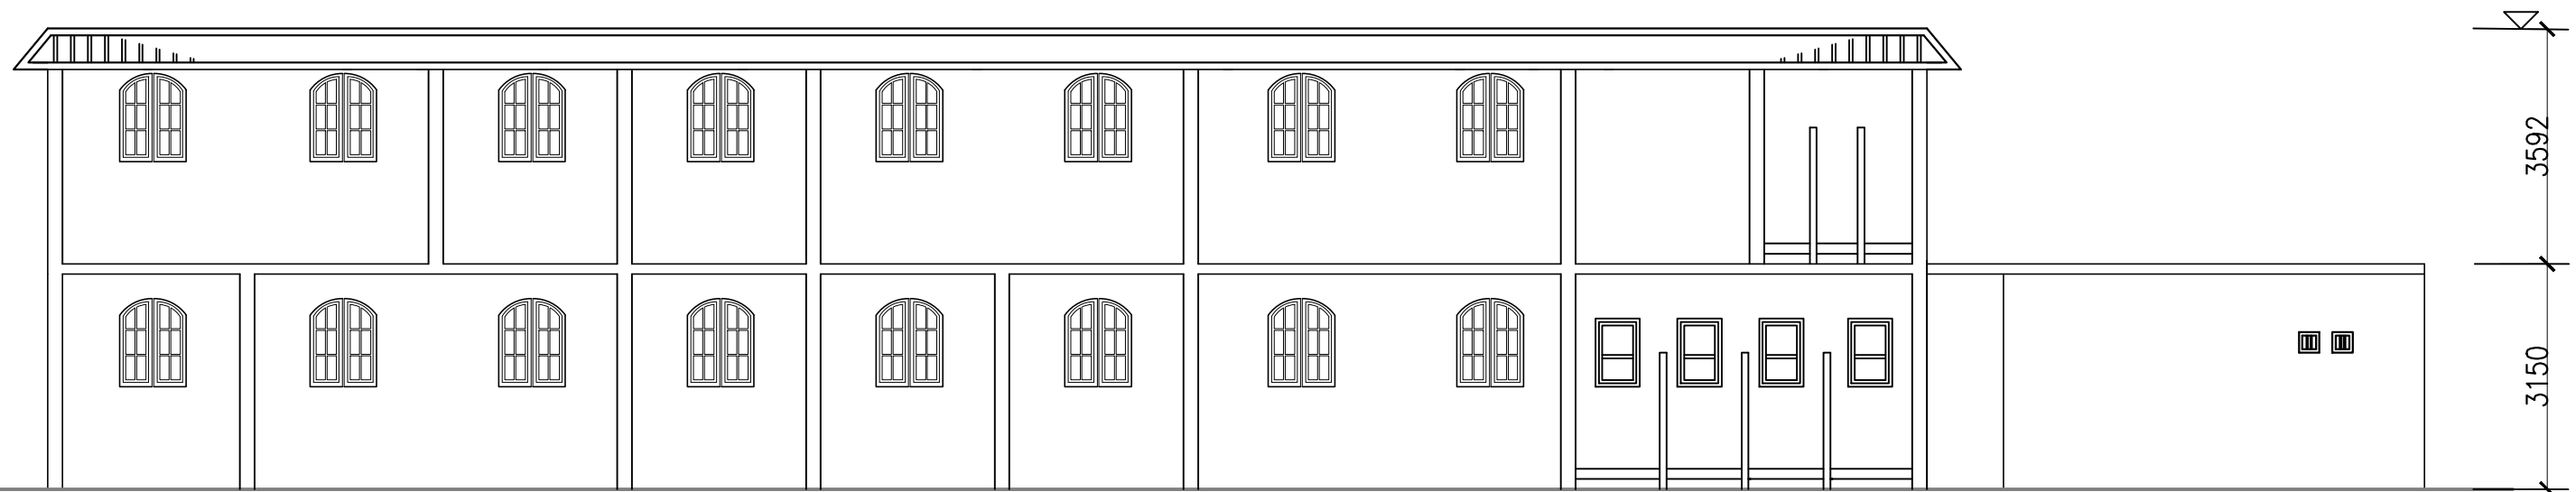
# SECTION A-A

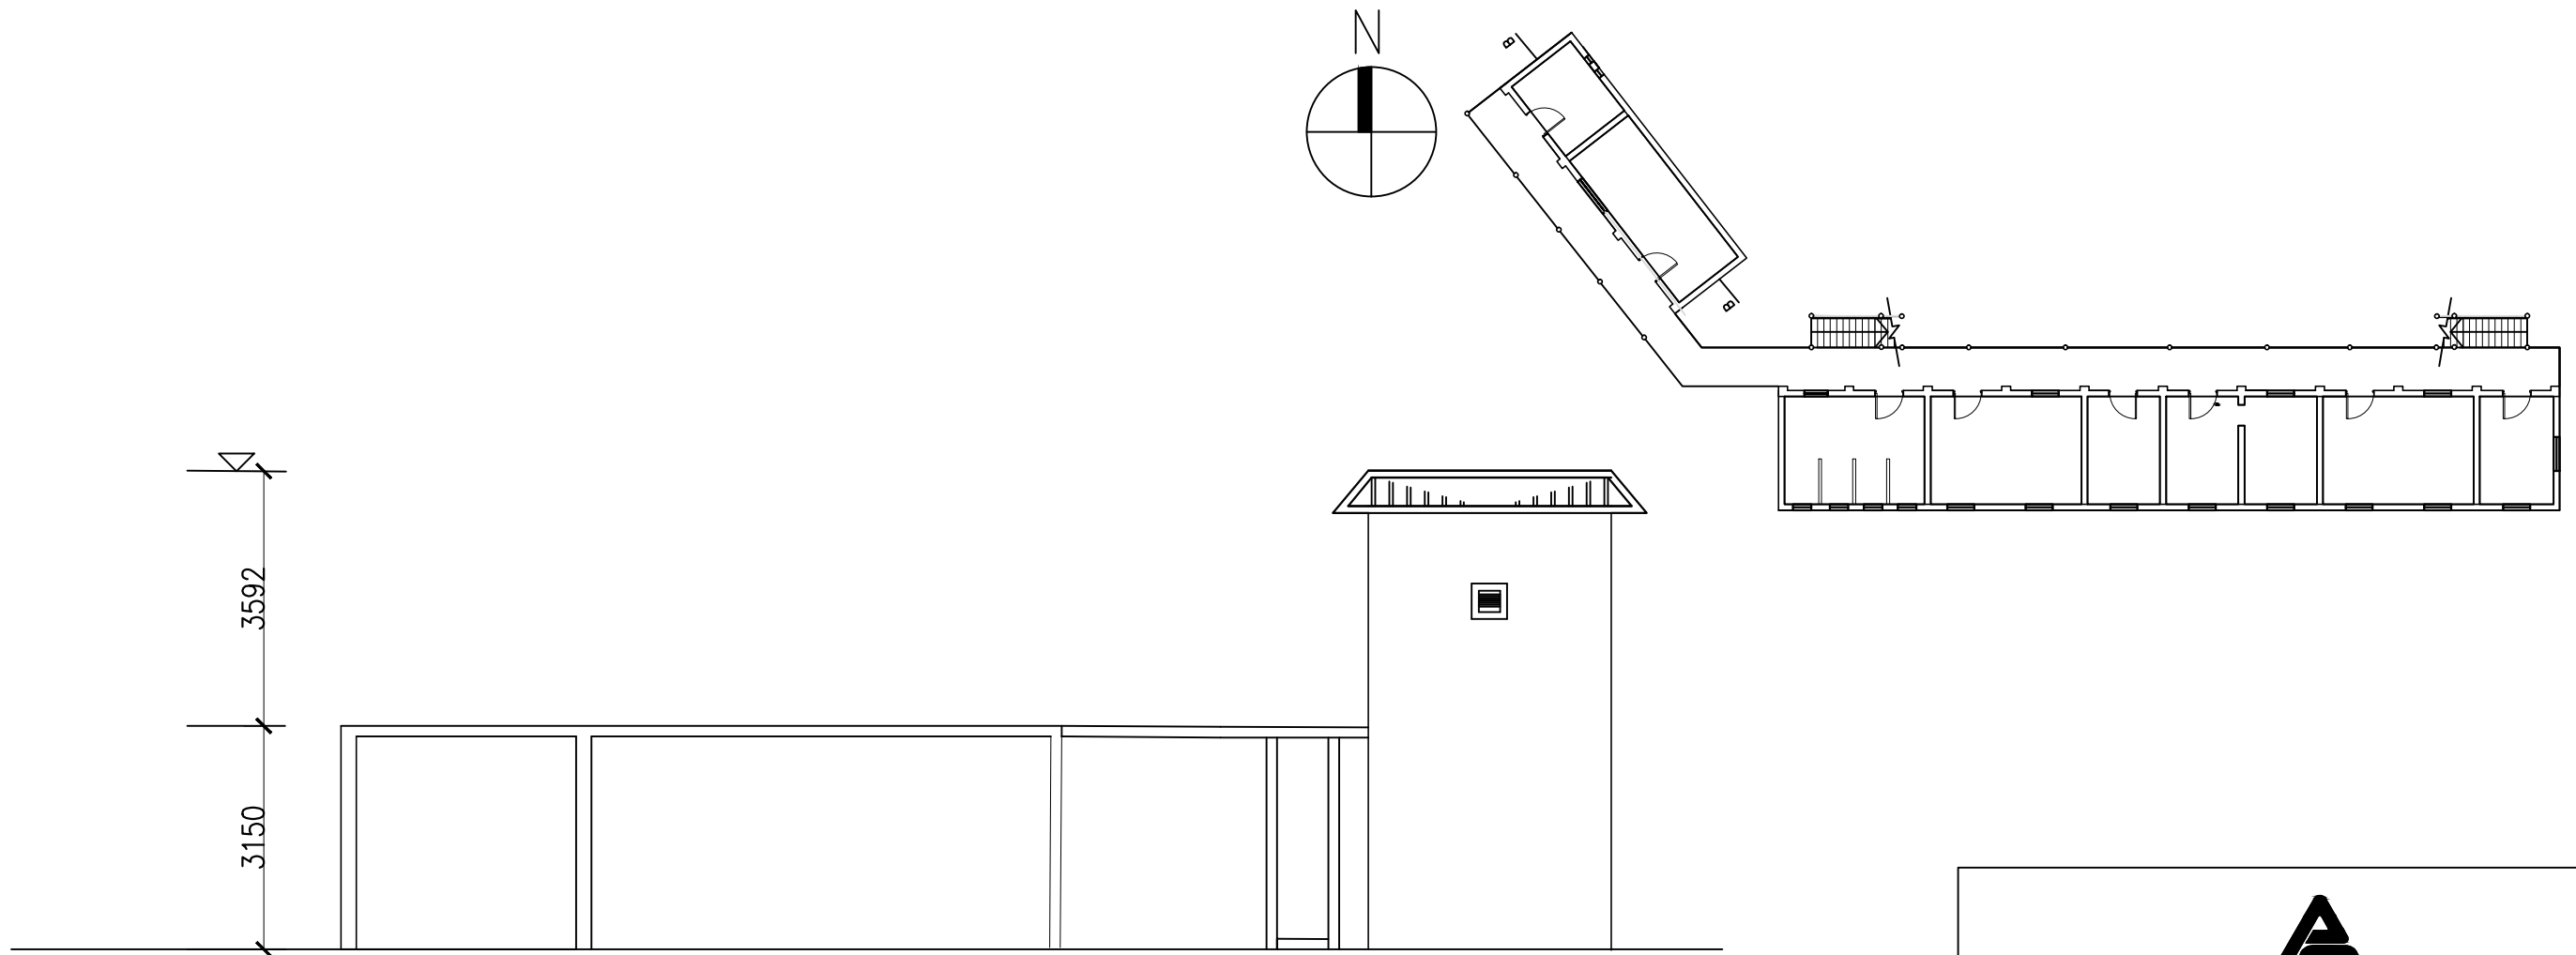
# SECTION B-B

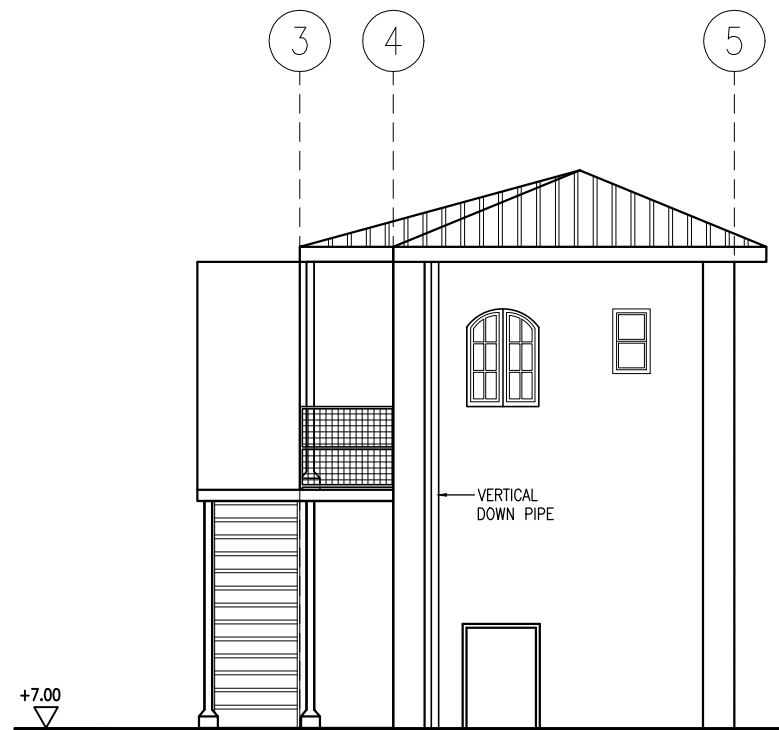
MAIN BUILDING  
EAST ELEVATION

<b>ample</b> SURVEYOR SERVICES LIMITED 安普測量顧問有限公司				
Job Title <b>Resource Kit for Tai Tam Tuk Raw Water Pumping Station and Staff Quarters, Tai Tam Reservoir Road, Tai Tam, Hong Kong</b>				
Drawing Title <b>EAST ELEVATION OF STAFF QUARTER (MAIN BUILDING)</b>				
DATE	DRAWN	DESIGNED	CHECKED	SCALE Title
07/08/2019	TC		NL	1:100 (A3)
JOB NO: <b>HRT-04-2019</b>			Drawing No. <b>TT-21</b>	
STATUS:

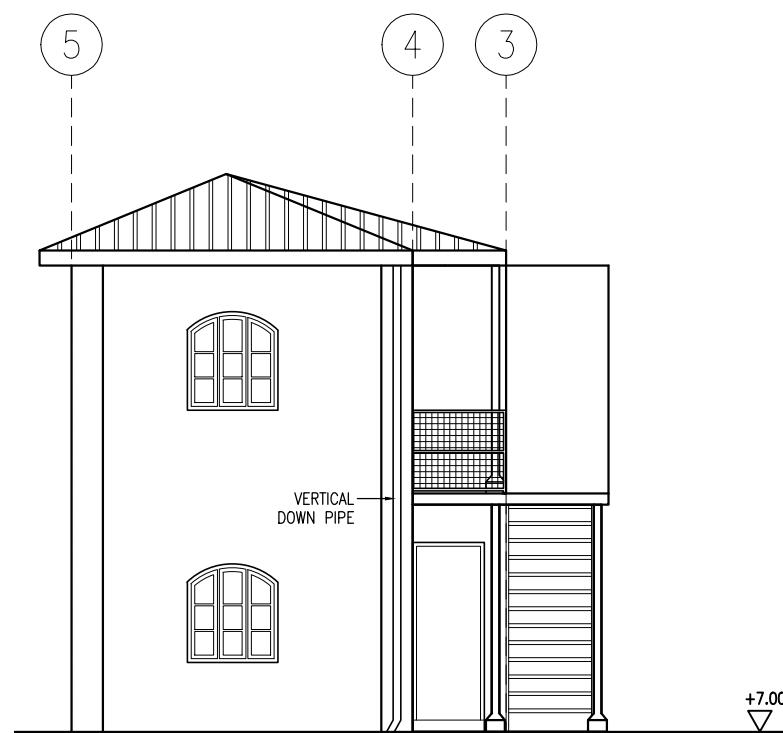
MAIN BUILDING  
WEST ELEVATION

<b>ample</b> SURVEYOR SERVICES LIMITED 安普測量顧問有限公司				
Job Title		Resource Kit for Tai Tam Tuk Raw Water Pumping Station and Staff Quarters, Tai Tam Reservoir Road, Tai Tam, Hong Kong		
Drawing Title WEST ELEVATION OF STAFF QUARTER (MAIN BUILDING)				
DATE	DRAWN	DESIGNED	CHECKED	SCALE Title
07/08/2019	TC		NL	1:100 (A3)
JOB NO: HRT-04-2019			Drawing No. TT-22	
STATUS :

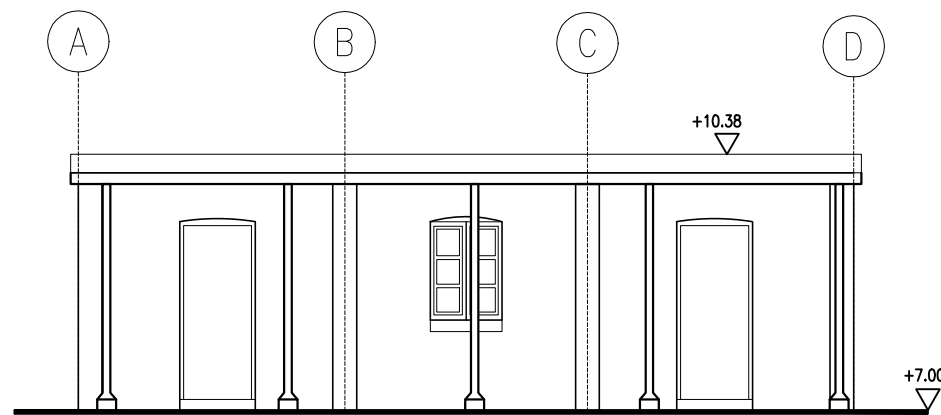
STORE BUILDING  
SOUTH WEST ELEVATION

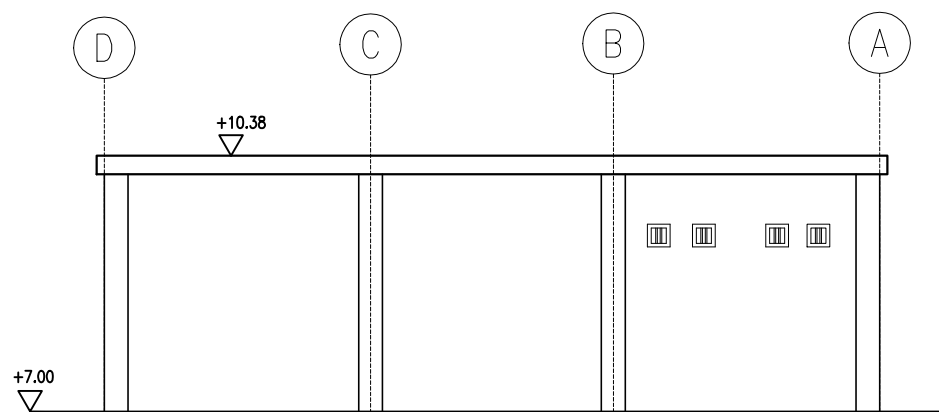
STORE BUILDING  
NORHT EAST ELEVATION

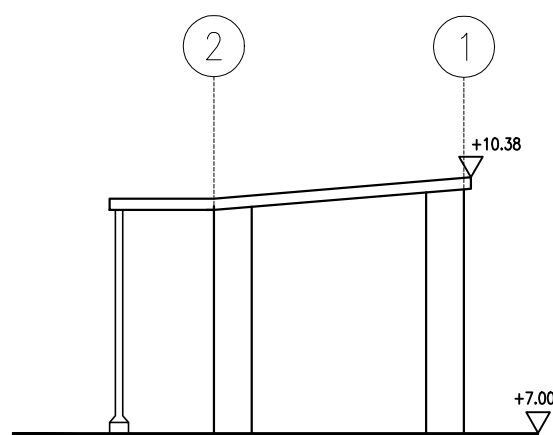
STORE BUILDING  
SOUTH EAST ELEVATION

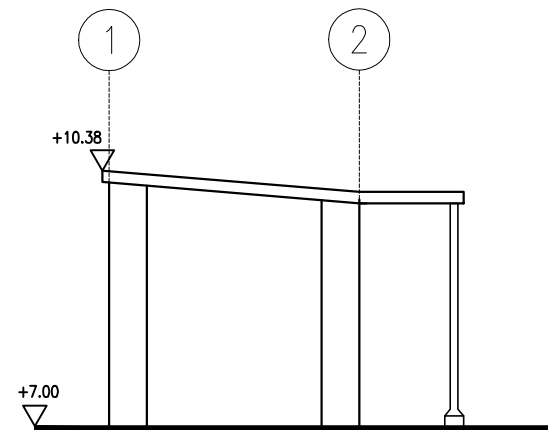
STORE BUILDING  
NORHT WEST ELEVATION

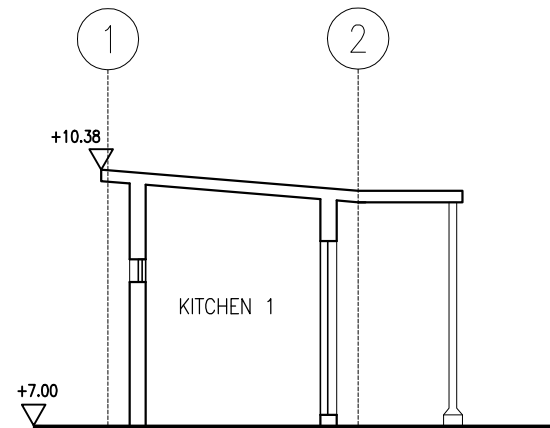
SECTION B-B

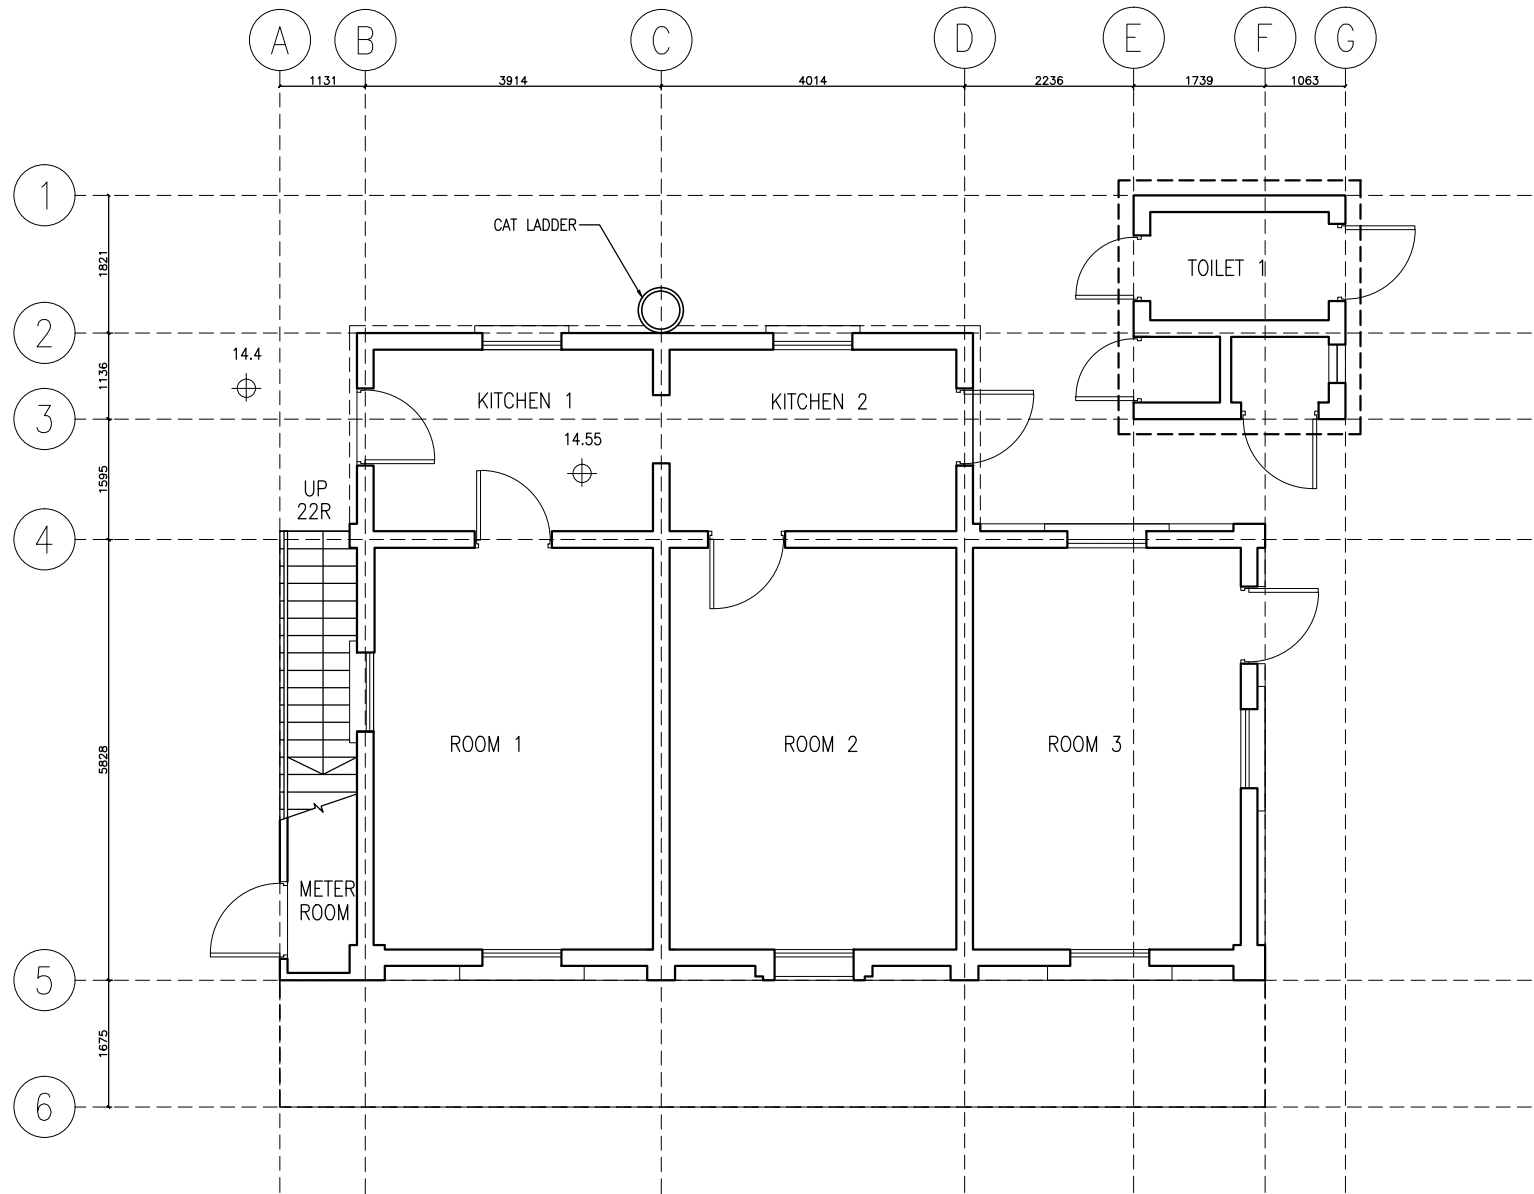
**NO.2 STAFF QUARTERS  
GROUND FLOOR PLAN**

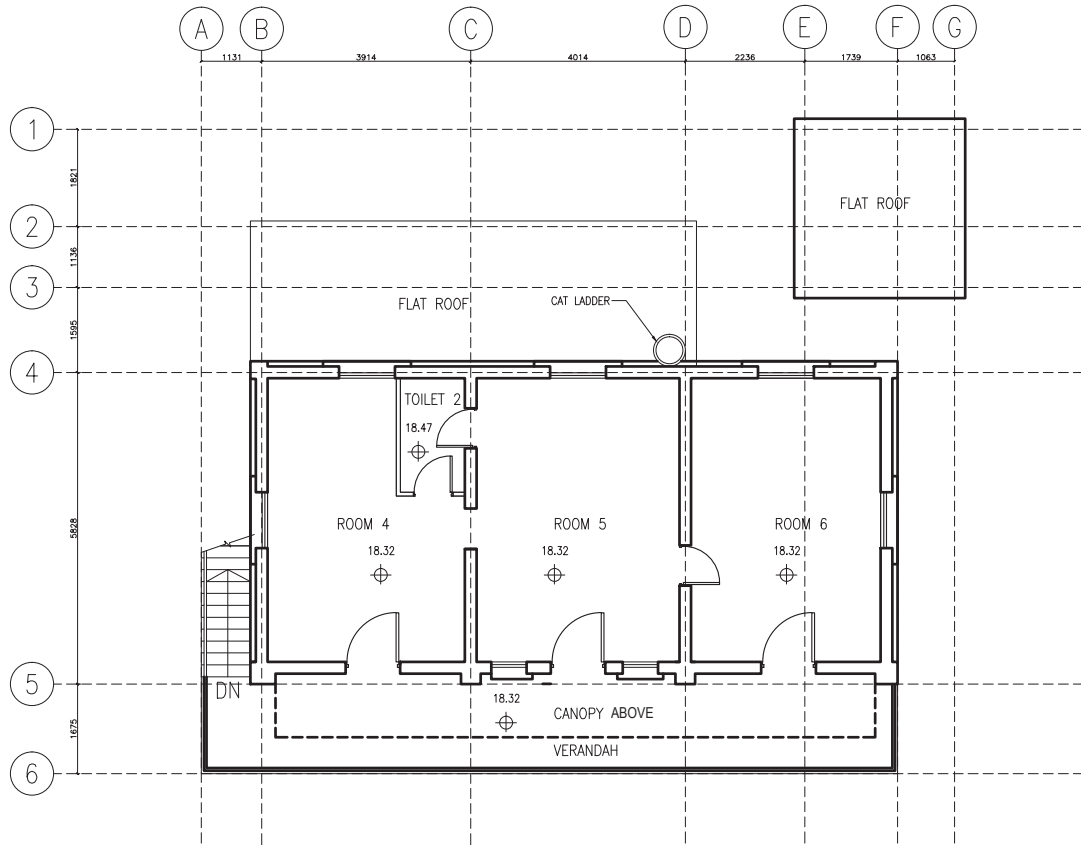
**NO.2 STAFF QUARTERS**  
**FIRST FLOOR PLAN**
