**Revitalising Historic Buildings  
Through Partnership Scheme**

**Tai Tam Tuk Raw Water Pumping Station  
Staff Quarters Compound**

**Resource Kit**

**Date: 27 November 2019**

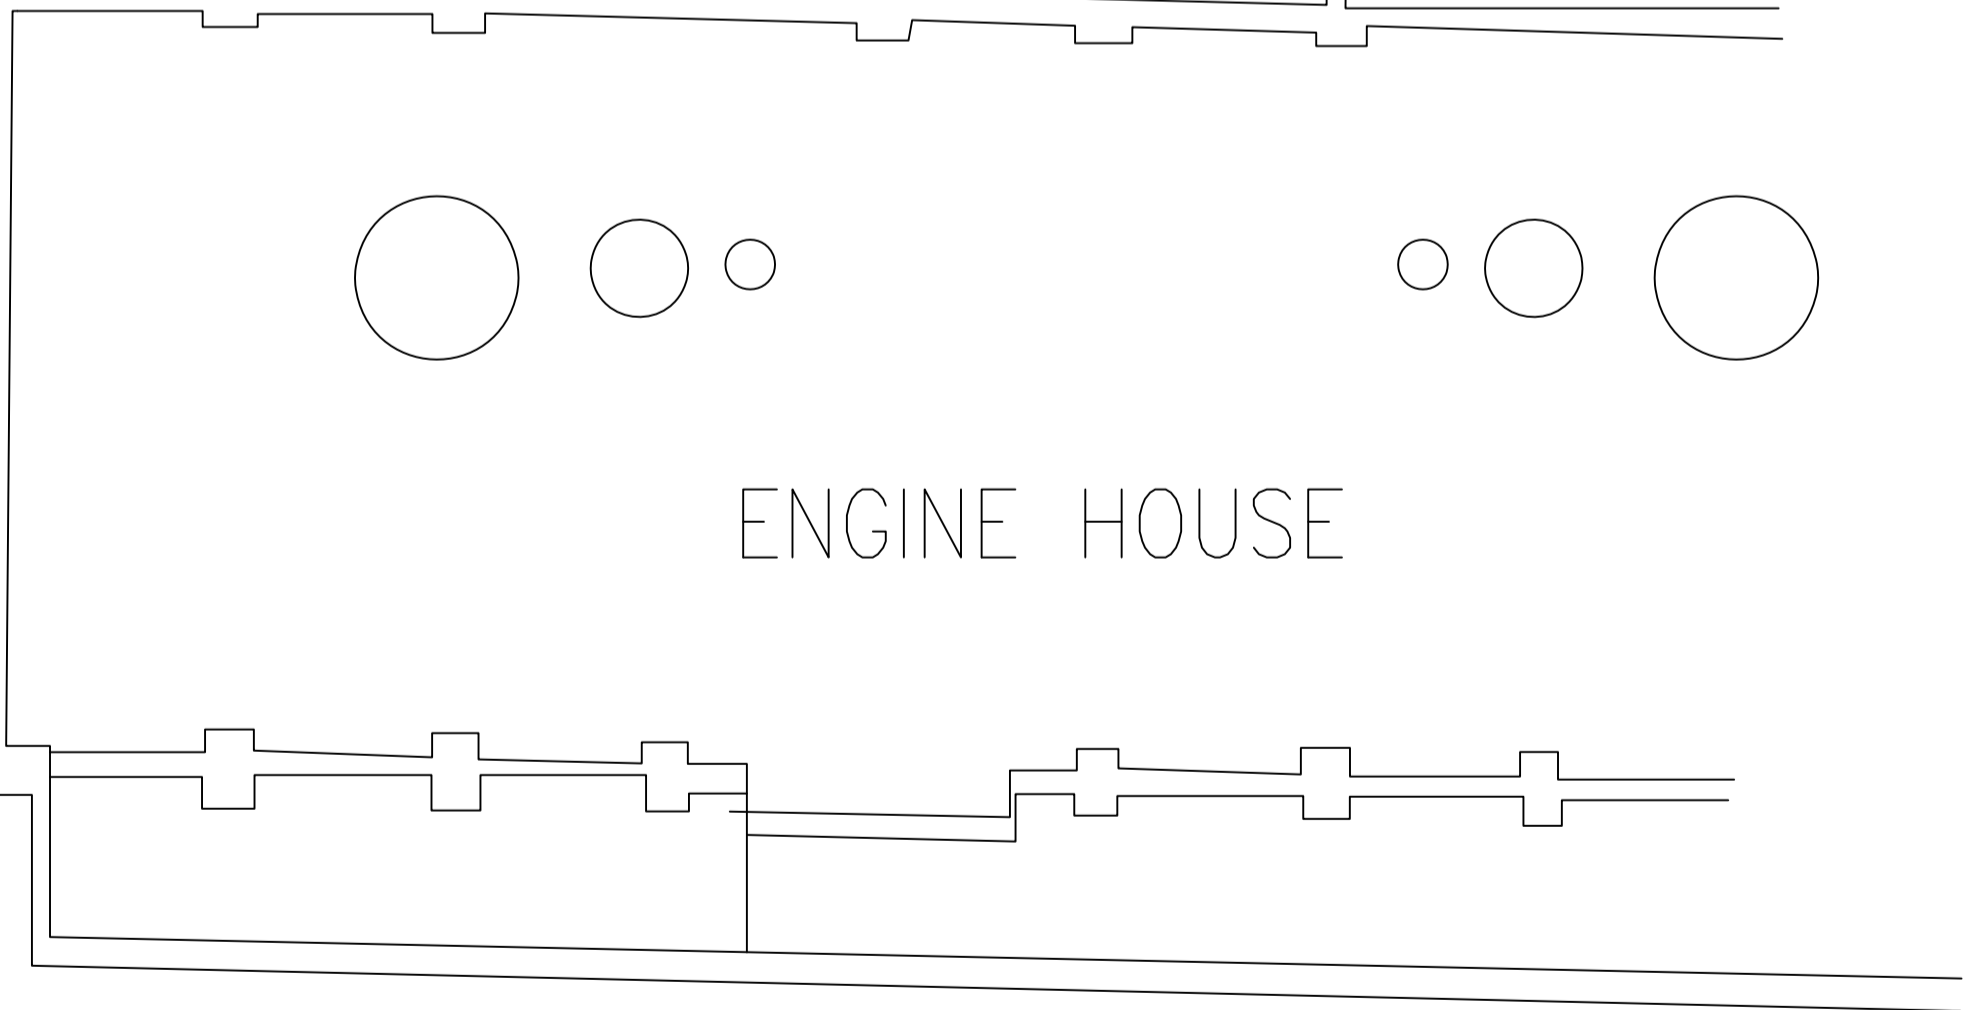
# PLAN PART A

ARCHITECTURAL SERVICES DEPARTMENT				
<b>ample</b> SURVEYOR SERVICES LIMITED 安普測量顧問有限公司				
Job Title Resource Kit for Tai Tam Tuk Raw Water Pumping Station and Staff Quarters, Tai Tam Reservoir Road, Tai Tam, Hong Kong				
Drawing Title PLAN (PART A) OF CHIMNEY SHAFT AND ITS FLUE				
DATE	DRAWN	DESIGNED	CHECKED	SCALE
07/08/2019	TC		NL	1:100 (A1)
JOB No. HRT-04-2019			Drawing No. TT-50	
STATUS:

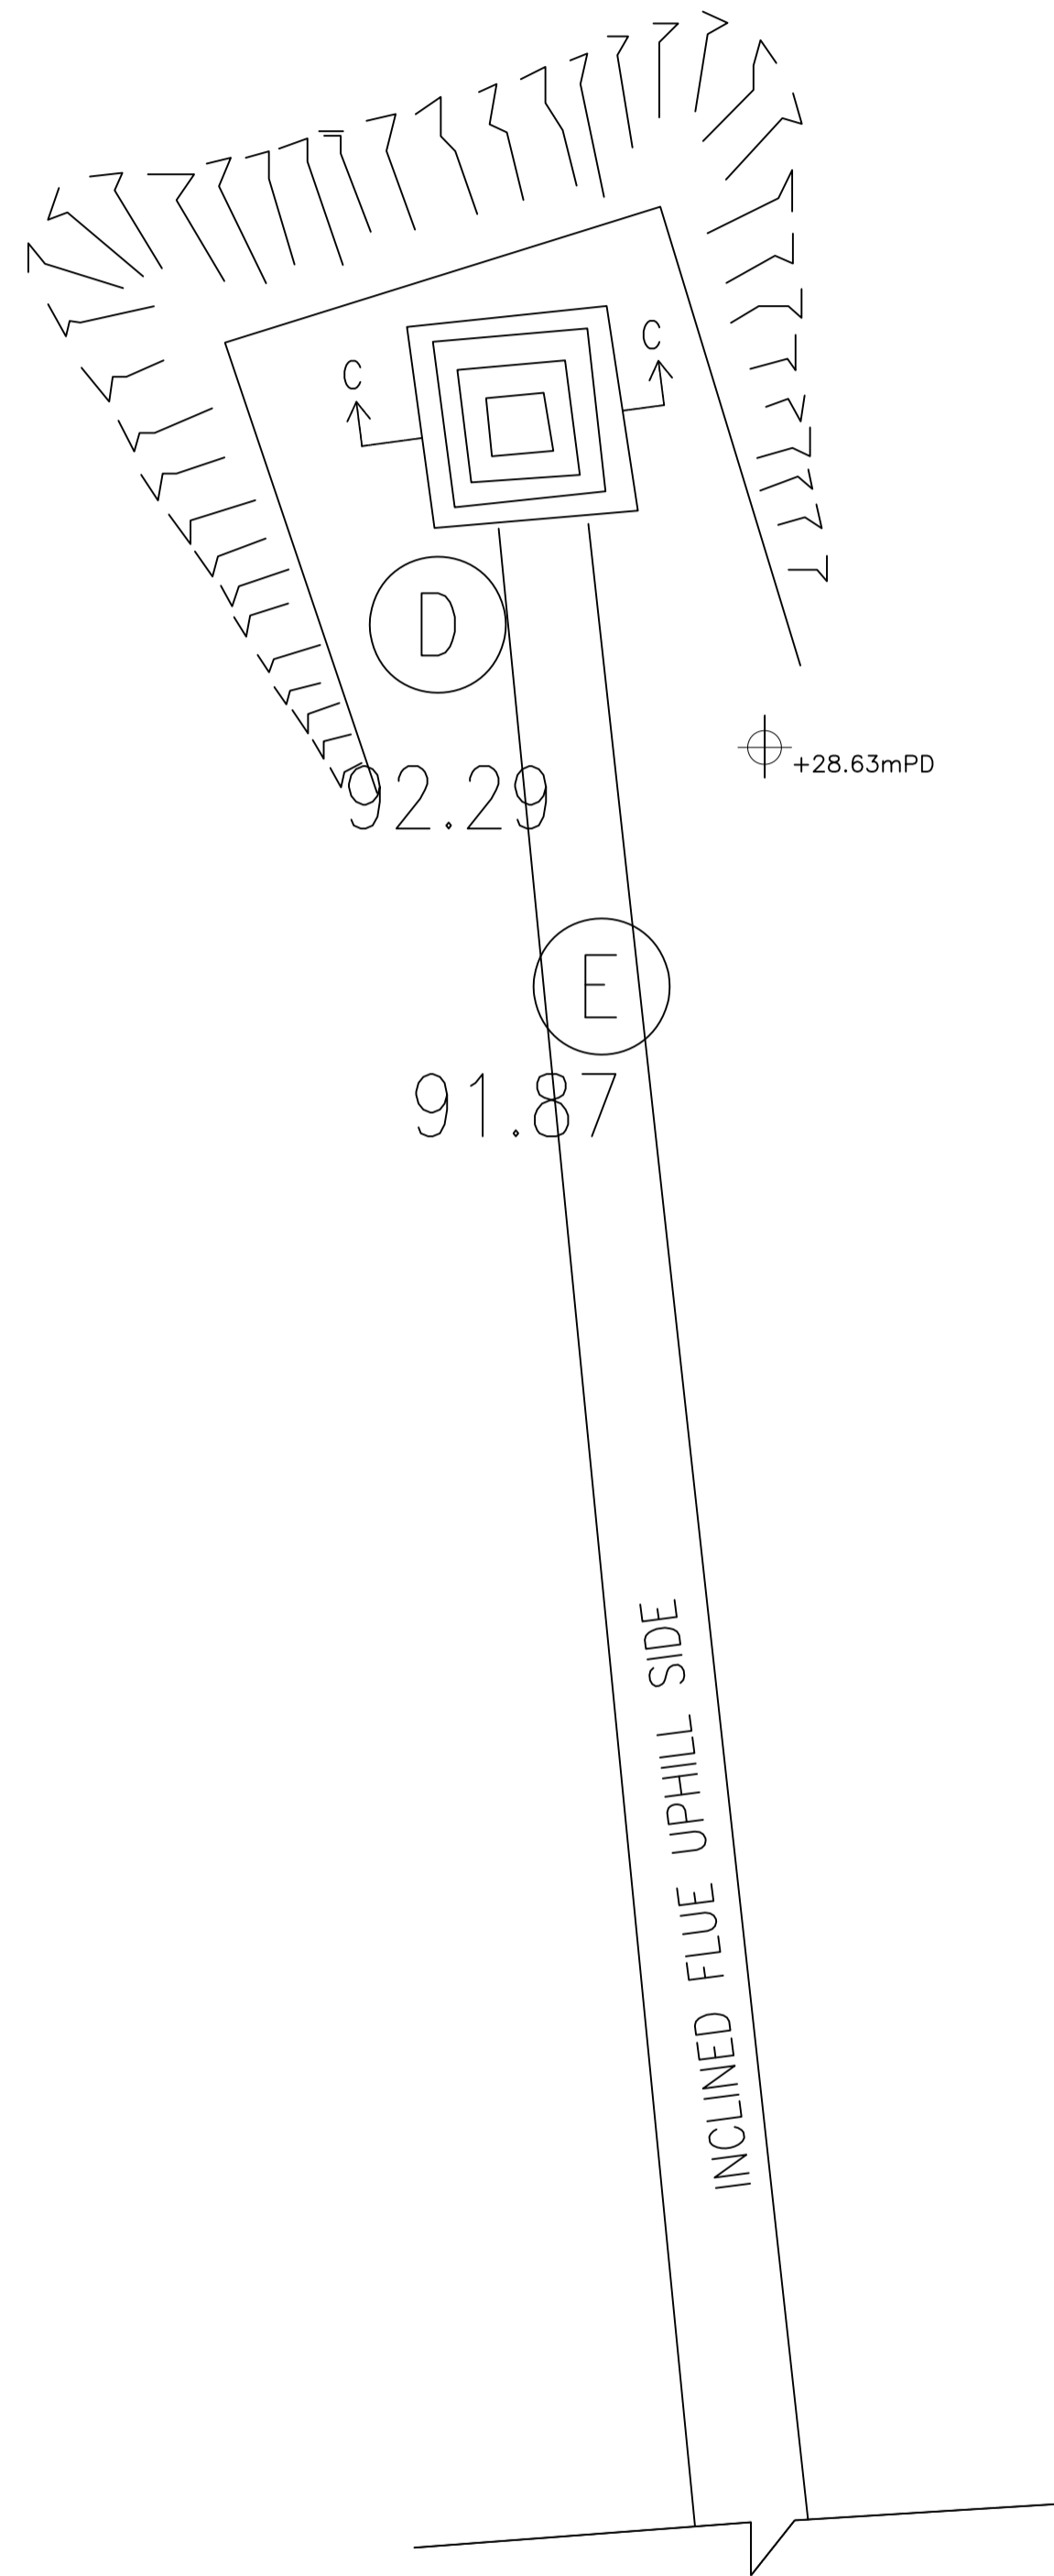
# PLAN PART B

SURVEYOR SERVICES LIMITED 安普測量顧問有限公司				
Job Title Resource Kit for Tai Tam Tuk Raw Water Pumping Station and Staff Quarters, Tai Tam Reservoir Road, Tai Tam, Hong Kong				
Drawing Title PLAN (PART B) OF CHIMNEY SHAFT AND ITS FLUE				
DATE	DRAWN	DESIGNED	CHECKED	
07/08/2019	TC		NL	1:100 (A1)
JOB No. HRT-04-2019			Drawing No. TT-51	
STATUS:

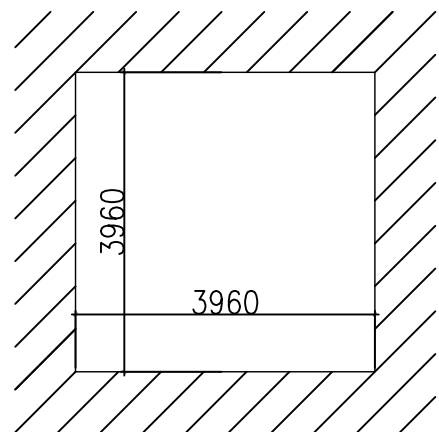
PLAN

CLEAR OPENING OF SHAFT (CHIMNEY) AT BASE

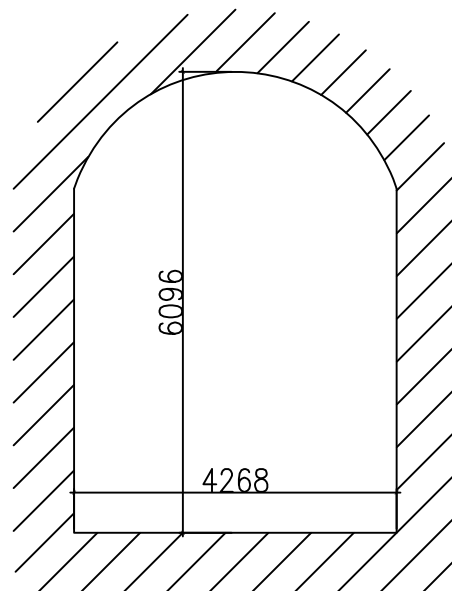
CLEAR OPENING OF FLUE AT SECTION A-A

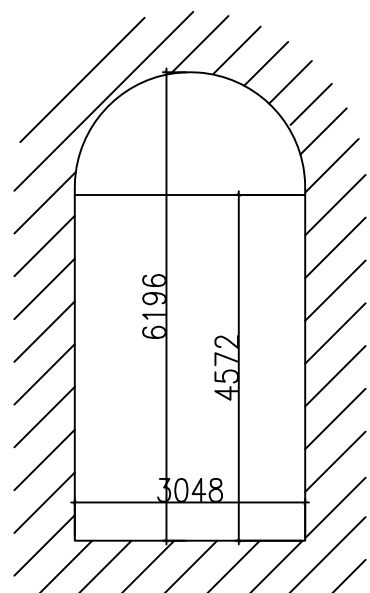
CLEAR OPENING OF FLUE AT SECTION B-B

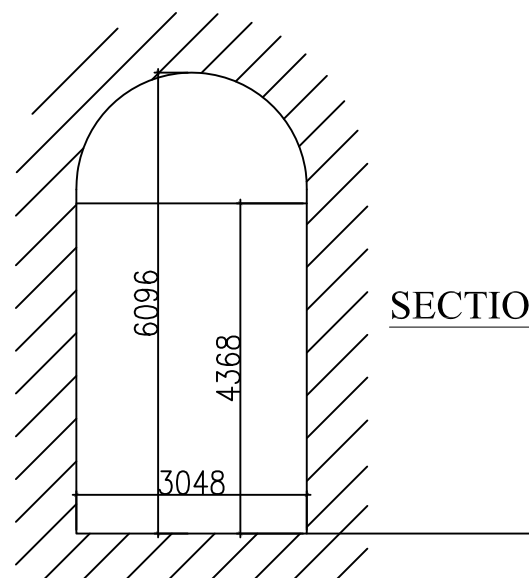
CLEAR OPENING OF FLUE AT SECTION C-C

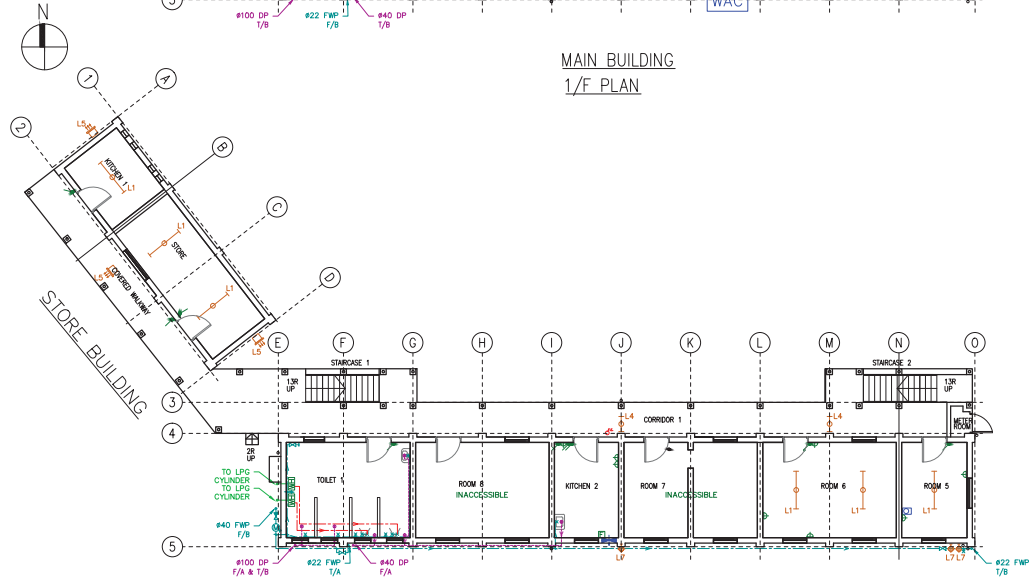
Drawn by TC	Checked by NL	Scale 1:50@A1
Date Issue 23/09/2019	Drawing No. HRT-04-2019 BS-04

MAIN BUILDING  
1/F PLAN

MAIN BUILDING  
G/F PLAN

Drawing No.	Drawing Title
1	BS-01	Senior Staff Quarters – Main Building Building Services Plan G/F and 1/F
2	BS-02	Senior Staff Quarters – Servants' Quarters Building Services Plan G/F
3	BS-03	Staff Quarters (Main Building and Store Building) Building Services Plan G/F and 1/F
4	BS-04	No.2 Staff Quarters Building Services Plan G/F and 1/F
5	BS-05	Garage Building Services Plan
6	BS-06	Underground Cellar Building Services Plan
7	BS-07	Main Building of Pumping Station Building Services Plan

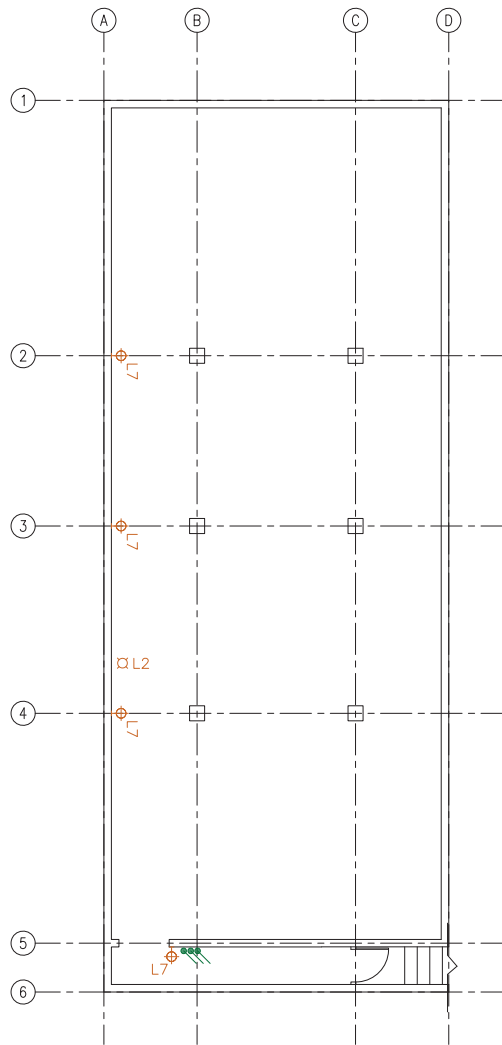
Job No.: HRT-04-2019      Drawing No.: BS-06

PLAN OF UNDERGROUND CELLAR

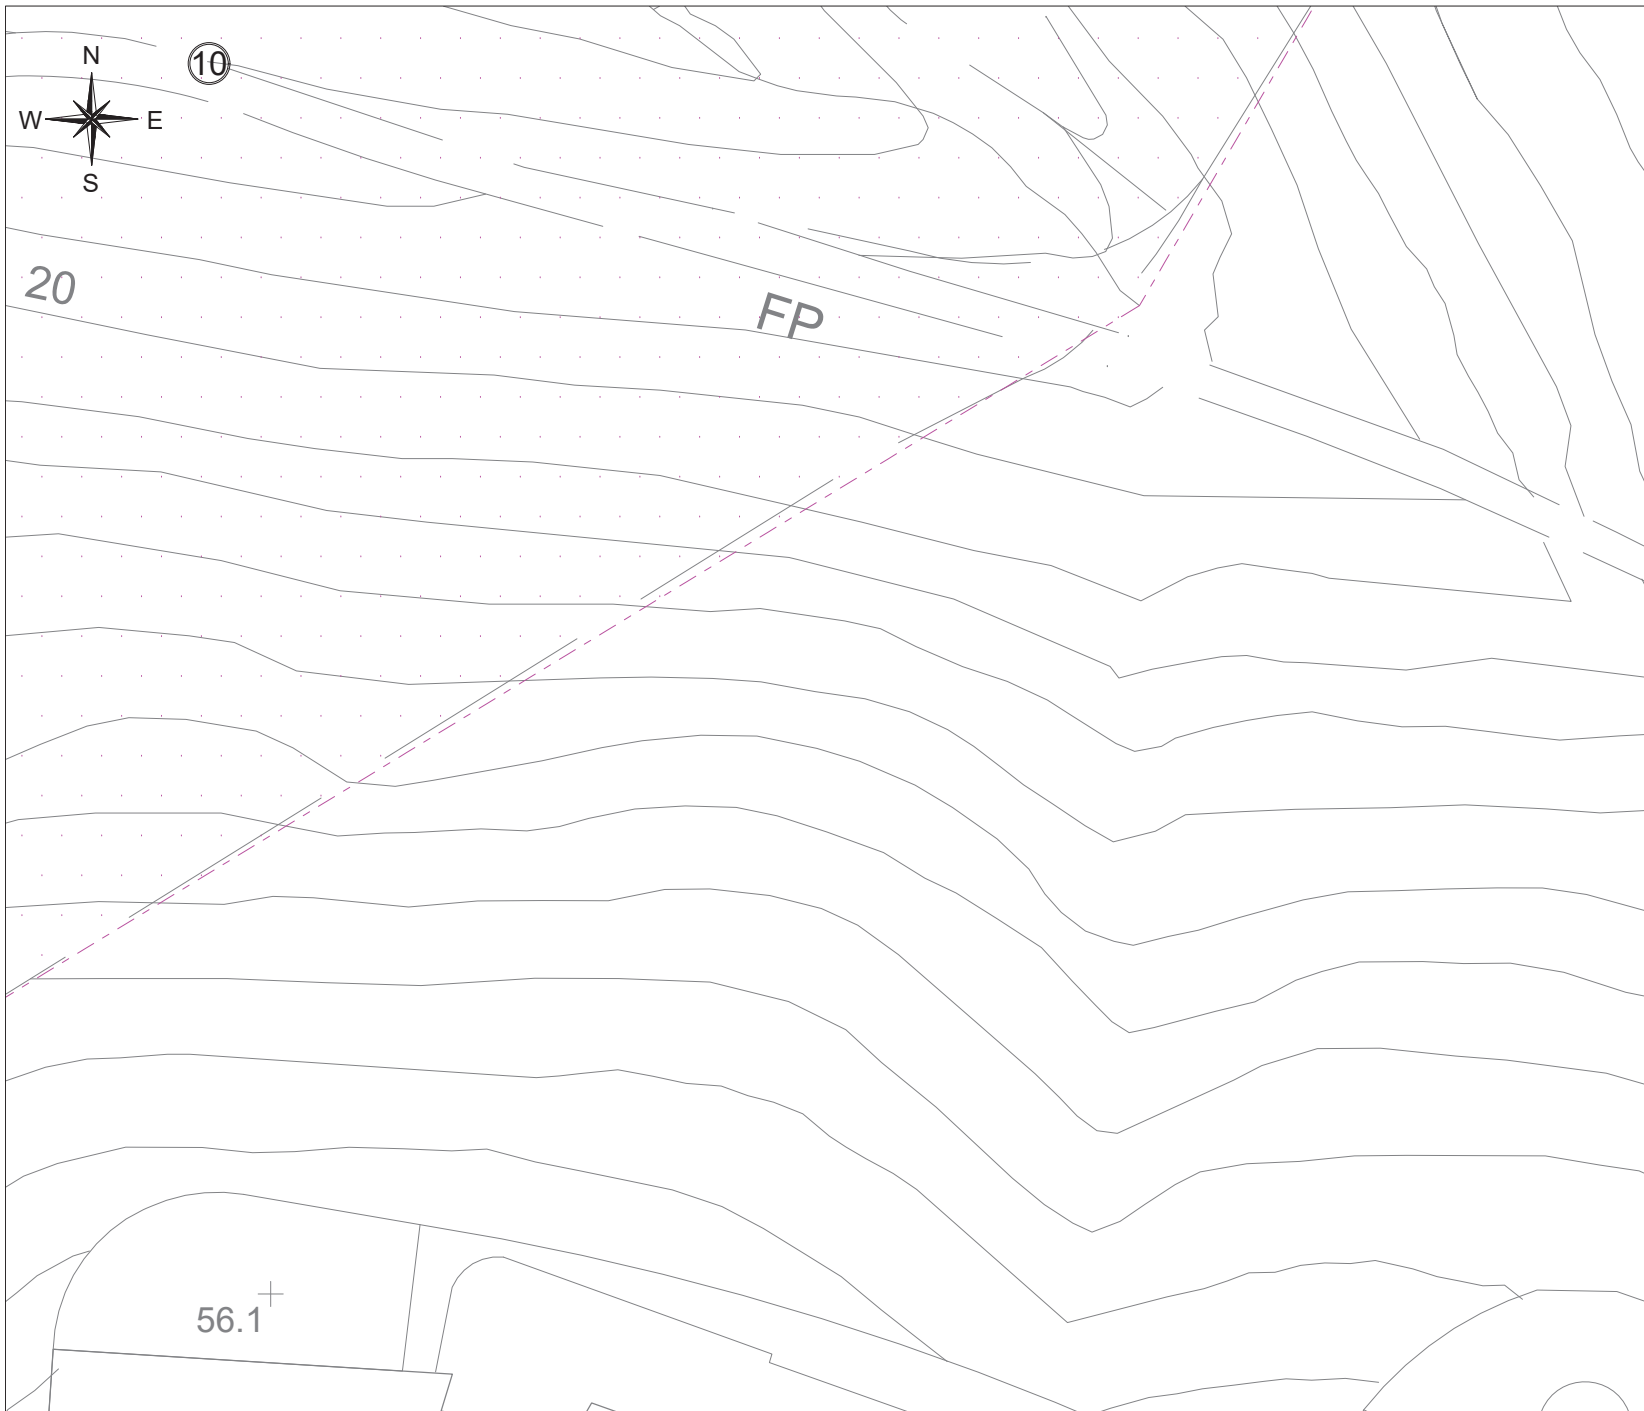
**Drawing No.:** ASSL-TTT-CD-001-DW09

雖合資格人士已用儀器進行有源電纜探測，並探測到供電商的帶電電纜位置，但客戶未有提供相關位置的私人電纜及其他設施圖則，故此客戶在開挖時仍要加倍小心。

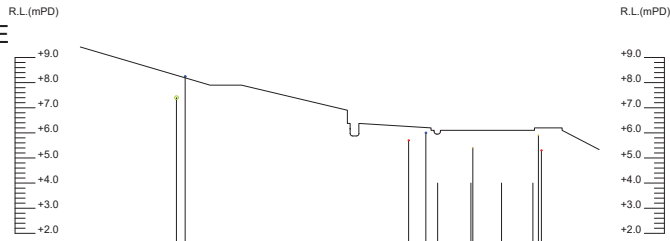
SECTION A-A  
SCALE 1:100

G.L. (mPD)	IL. (mPD)	Depth (m)	Description
8.1	8.1	0.0	UNRELIABLE EXPOSED
8.1	8.1	0.0	UNRELIABLE EXPOSED
6.3	5.7	0.6	1. ELECTRIC CABLE
6.2	6.0	0.2	9. POTABLE WATER PIPE
6.1	UNRELIABLE	UNRELIABLE	16. POTABLE WATER PIPE
6.1	UNRELIABLE	UNRELIABLE	17. POTABLE WATER PIPE
6.1	5.9	0.2	31. PCCW CABLE
6.1	UNRELIABLE	UNRELIABLE	20. POTABLE WATER PIPE
6.1	UNRELIABLE	UNRELIABLE	18. POTABLE WATER PIPE
6.1	5.3	0.8	3. ELECTRIC CABLE

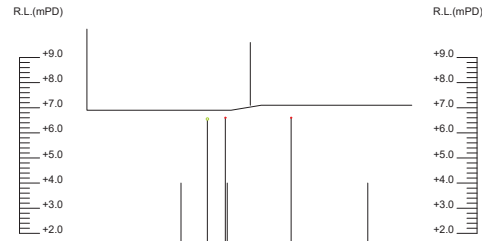
SECTION B-B  
SCALE 1:100

G.L. (mPD)	IL. (mPD)	Depth (m)	Description
6.9	UNRELIABLE	UNRELIABLE	24. POTABLE WATER PIPE
6.9	6.5	0.4	43. EQUI. WATER PIPE
6.9	6.6	0.3	1. ELECTRIC CABLE
6.9	UNRELIABLE	UNRELIABLE	26. POTABLE WATER PIPE
7.1	6.6	0.5	3. ELECTRIC CABLE
7.1	UNRELIABLE	UNRELIABLE	27. POTABLE WATER PIPE

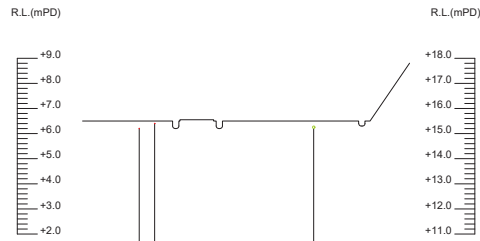
SECTION C-C  
SCALE 1:100

G.L. (mPD)	IL. (mPD)	Depth (m)	Description
15.5	15.5	0.0	5. ELECTRIC CABLE
15.5	15.4	0.1	4. ELECTRIC CABLE
15.5	15.2	0.3	51. EQUI. WATER PIPE

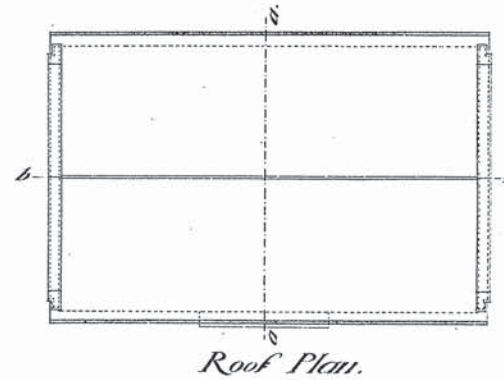
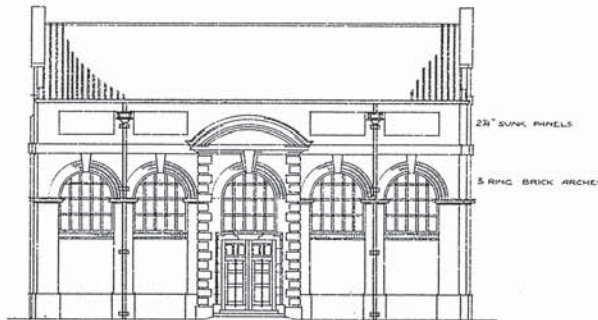
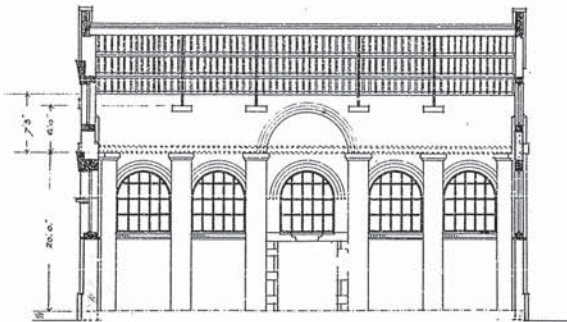
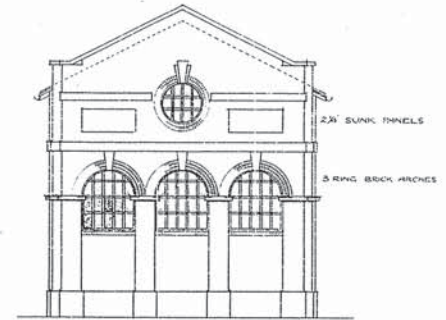
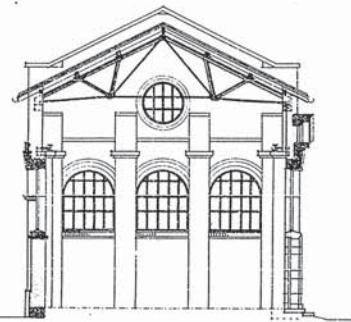
Drawing No. 1  
Contract No. 23 of 1904.

PUMPING STATION AT TYTAM TUK :

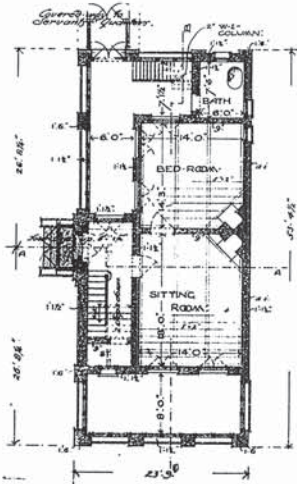
GROUND-FLOOR PLAN.

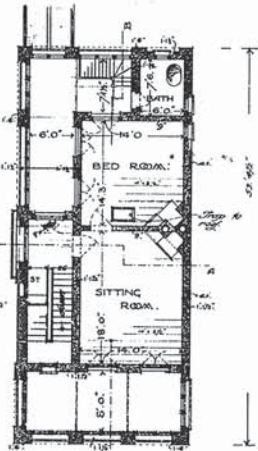
FIRST-FLOOR PLAN.

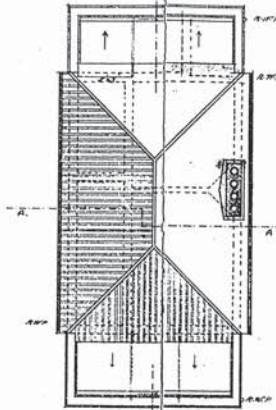
ROOF PLAN.

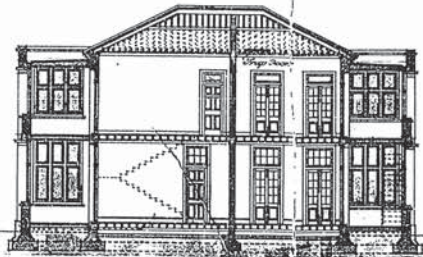
SECTION 'BB'

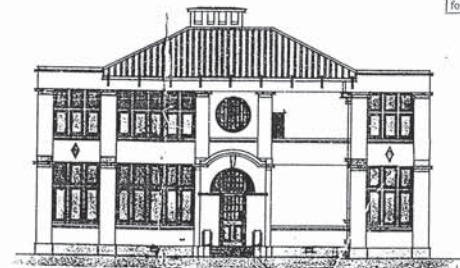
N-EAST FRONT.

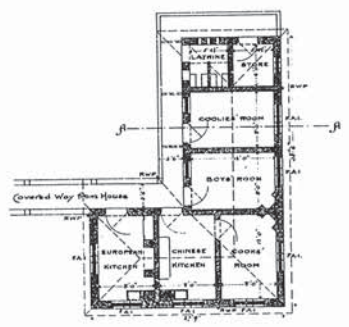
— Ground Floor Plan —

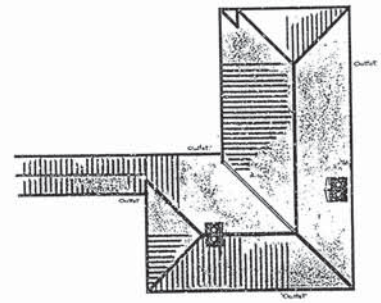
— Roof Plan —

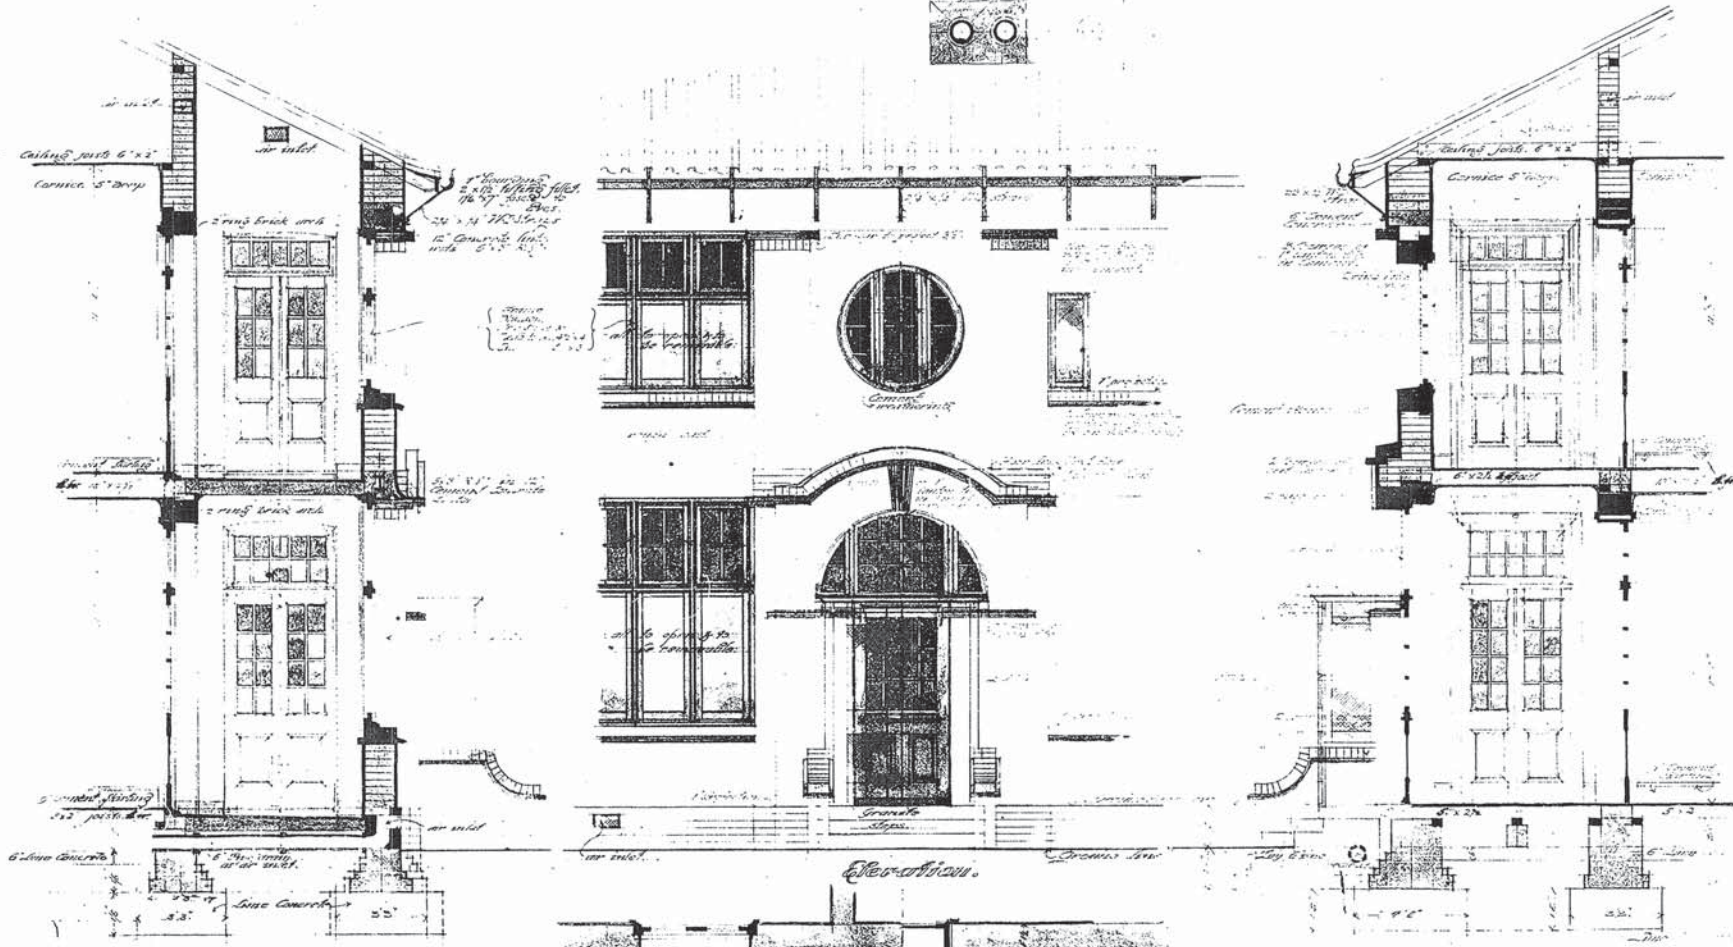
Section thro' the window

Elevation

Section thro' the doorway

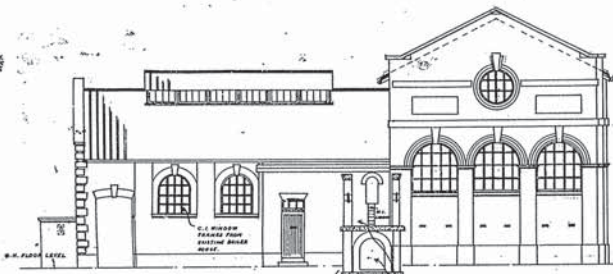
END ELEVATION AT C.C!

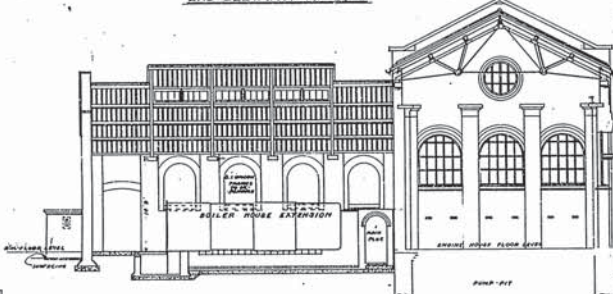
CROSS SECTION AT D.D!

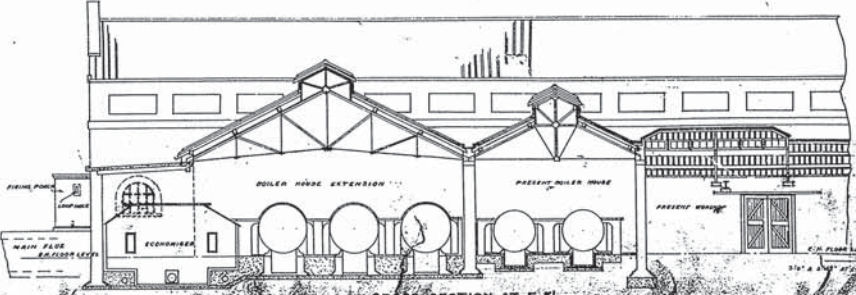
CROSS SECTION AT F.F!

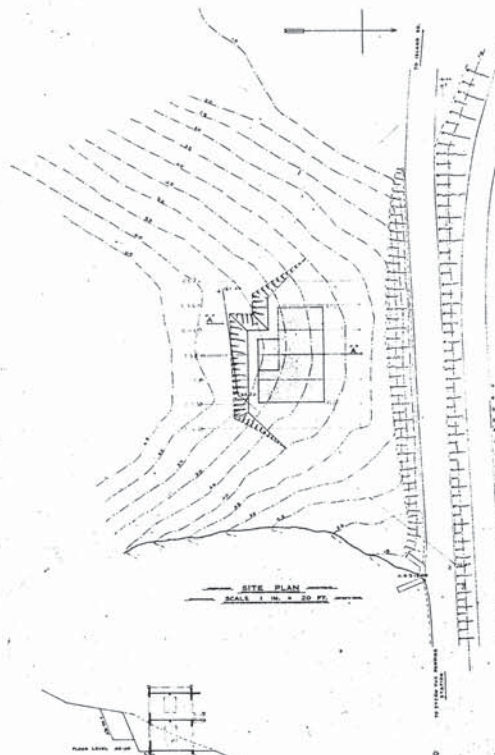
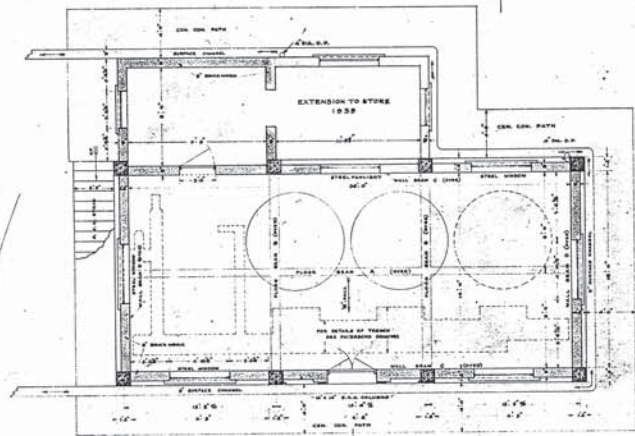
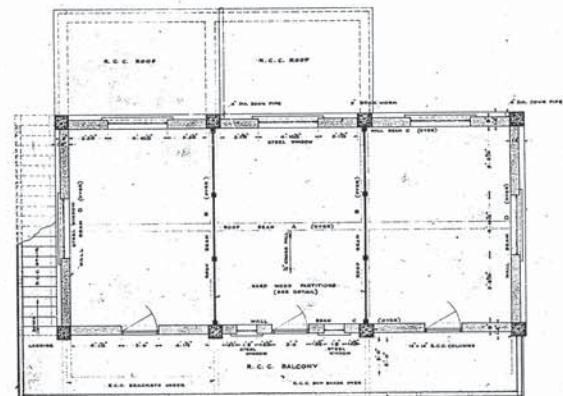
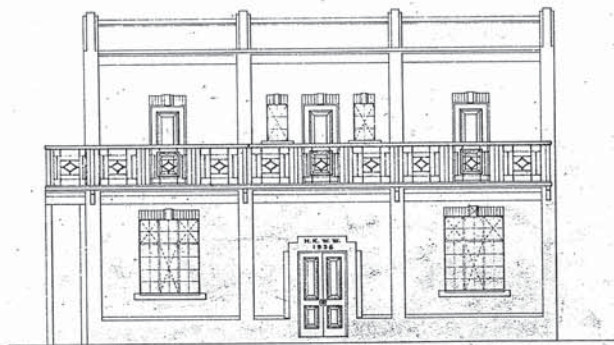
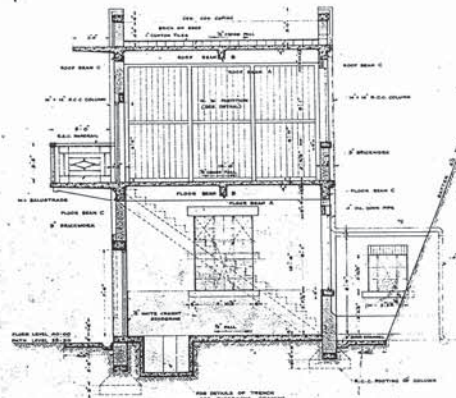
**HONG KONG WATER WORKS**  
**STANLEY SUPPLY**  
**PRESSURE FILTER HOUSE**  
**SCALE 1 IN. = 4 FT.**

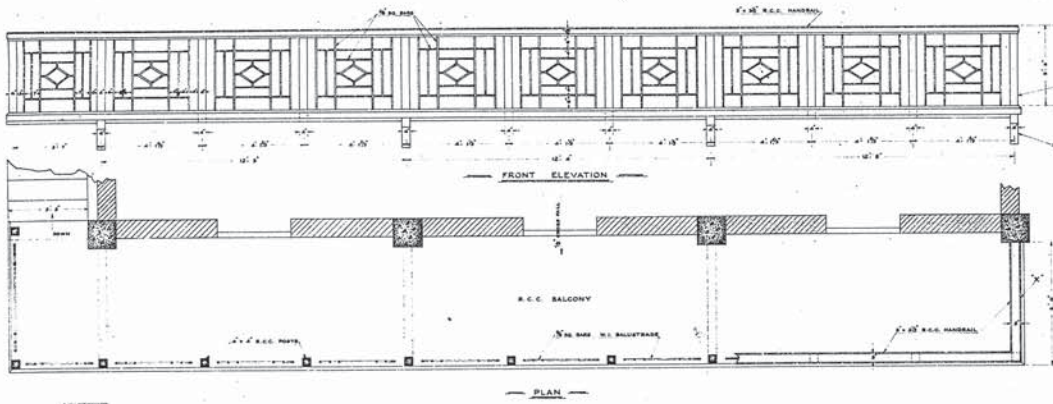
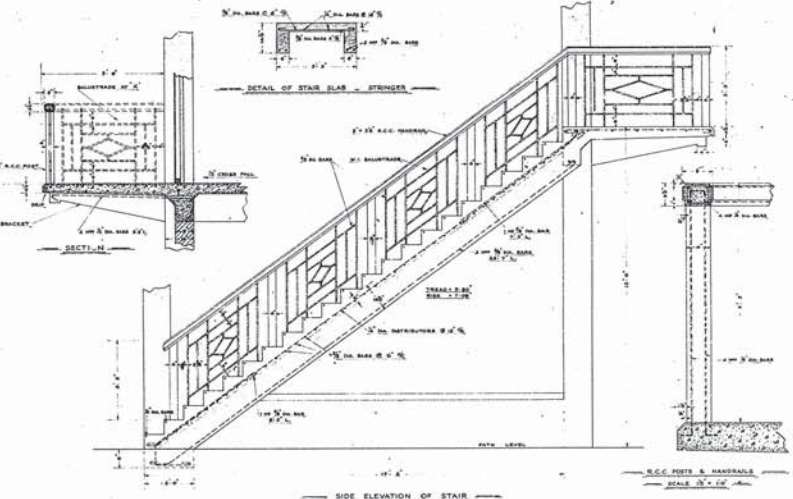
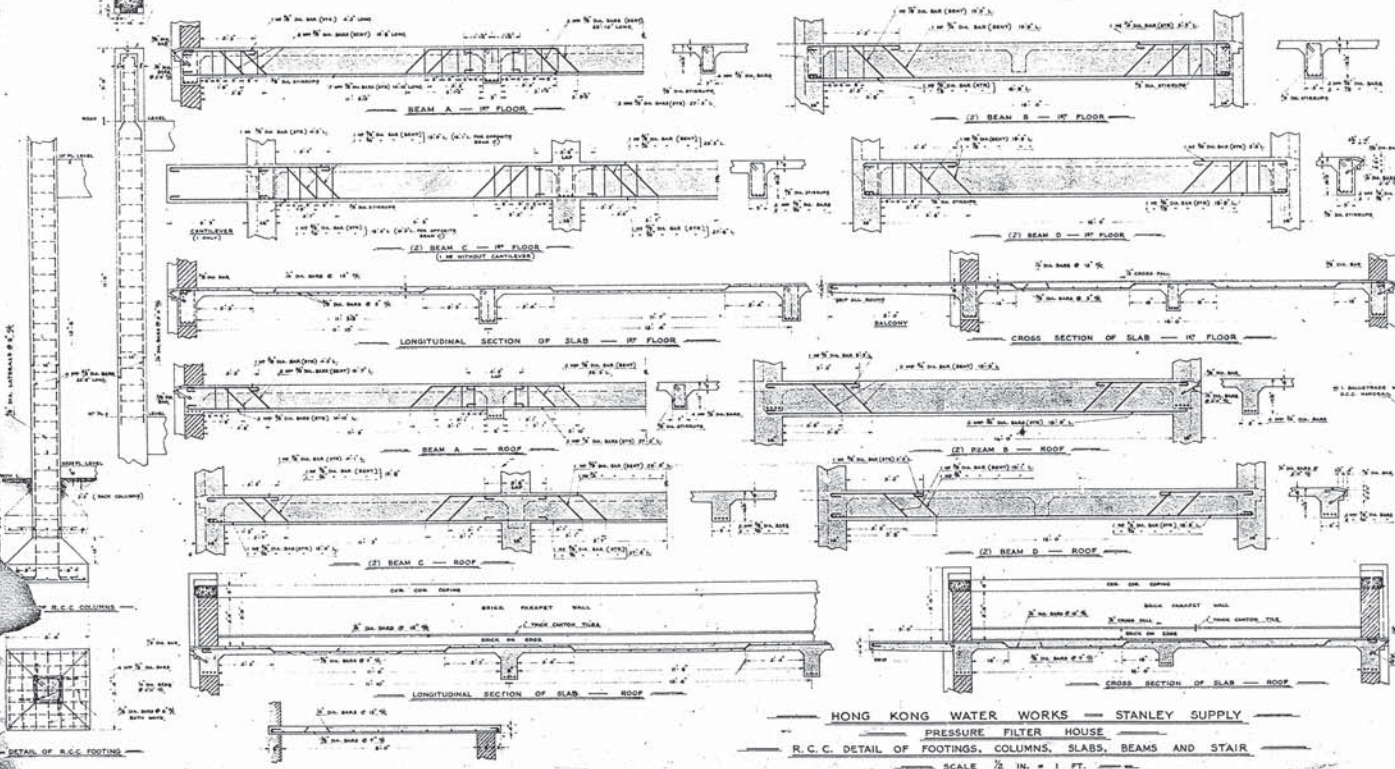
CONTRACT NO 46 OF 1936  
 DRAWING NO 2  
 DRAWER T. DRG W 426

HONG KONG WATER WORKS - STANLEY SUPPLY  
 PRESSURE FILTER HOUSE  
 R.C.C. DETAIL OF FOOTINGS, COLUMNS, SLABS, BEAMS AND STAIR  
 SCALE 1/2 IN. = 1 FT.

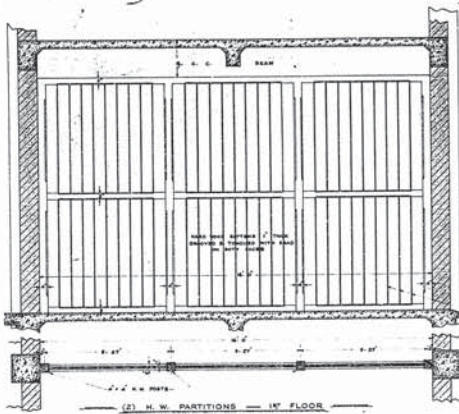
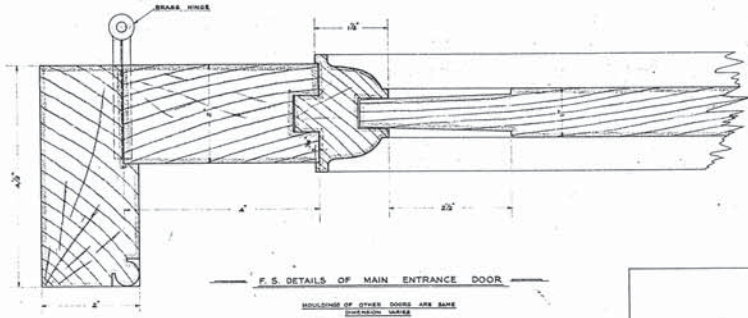
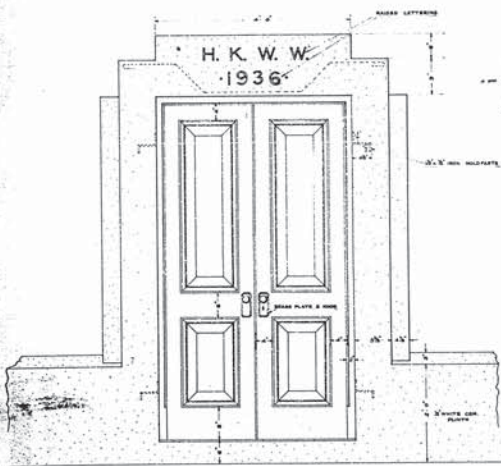
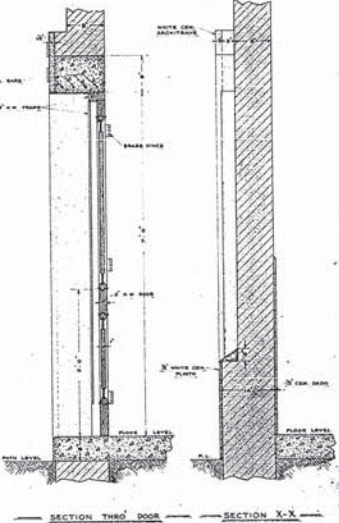
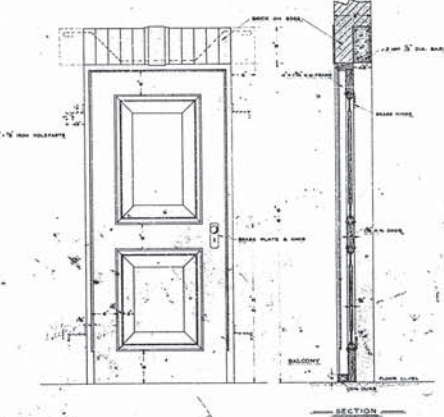
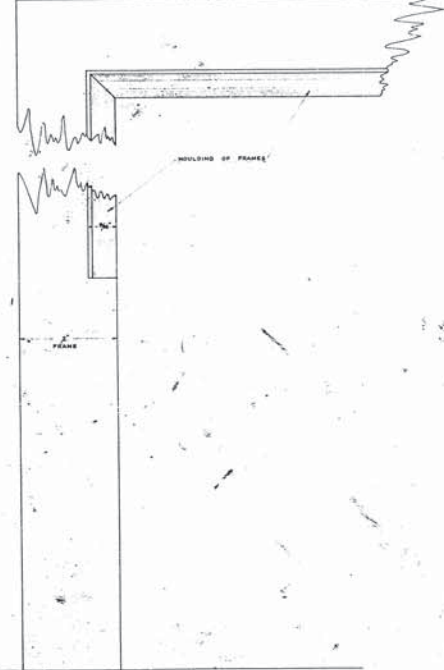
**HONG KONG WATER WORKS**  
**STANLEY SUPPLY**  
**PRESSURE FILTER HOUSE**  
**DETAIL OF WOODEN DOORS & PARTITIONS**  
**SCALE 1 IN. = 1 FOOT**

- (3) DOORS - 1ST FLOOR
- (2) DOOR OF ASP.
- (1) DOOR OF ASP.

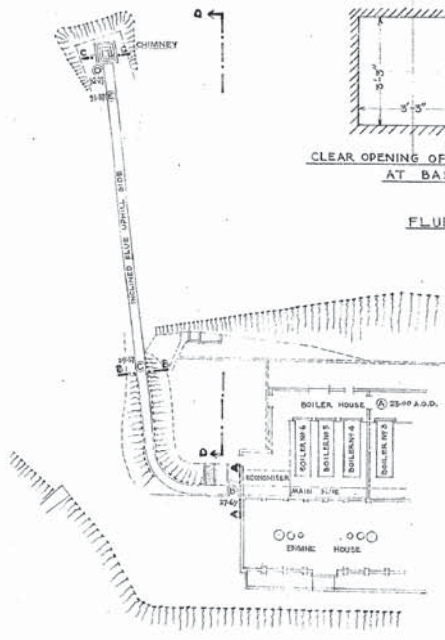
T. T. M. No 2

FLUE INTERNAL MEASUREMENTS  
SCALE 1/2" TO 1 FT.

LEVEL	REMARKS
A	23.00 BOILER HOUSE FLOOR LEVEL
B	27.69
C	29.67
D	92.29 BOTTOM OF CHIMNEY
E	91.87 K&C LEVEL ON CONCRETE STEP

SLOPE DISTANCE	REMARKS
B	735'-0"
C	139'-0"
E	20'-9"
D	232'-9"
	TOTAL FOOTAGE

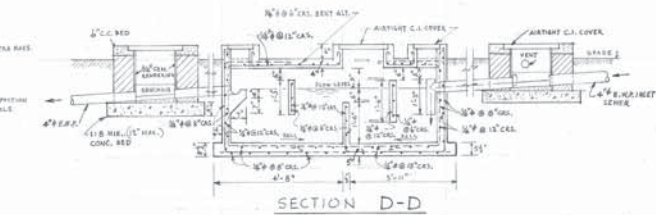
SECTION D-D

SECT. E-E

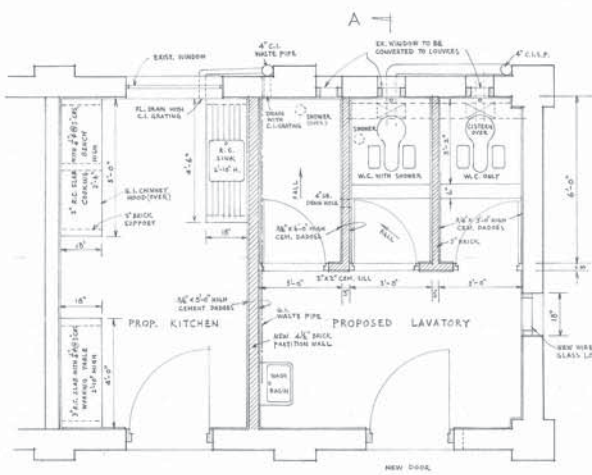
FIRST FLOOR PLAN

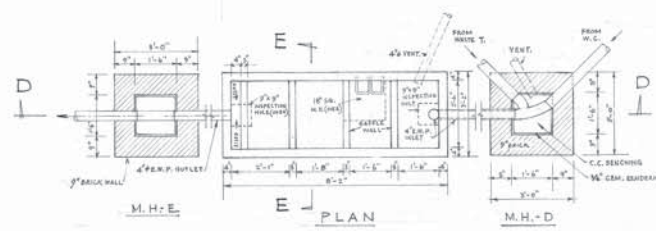
DETAILS OF R.C. SEPTIC TANK TYPE B

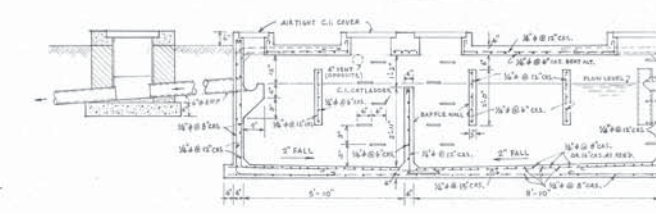
SECTION B-B

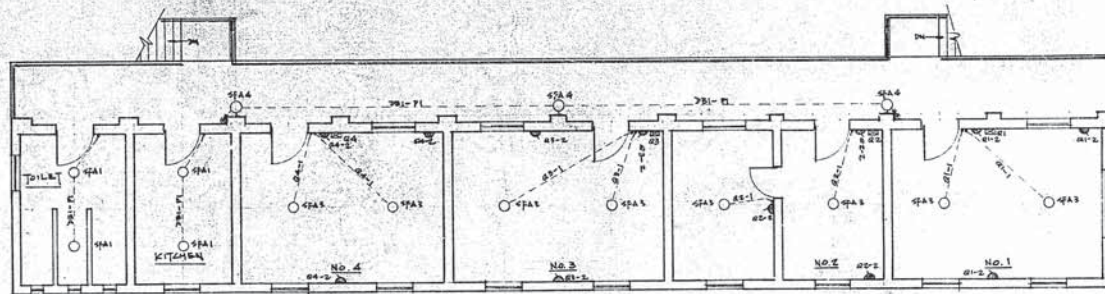
FIRST FLOOR PLAN

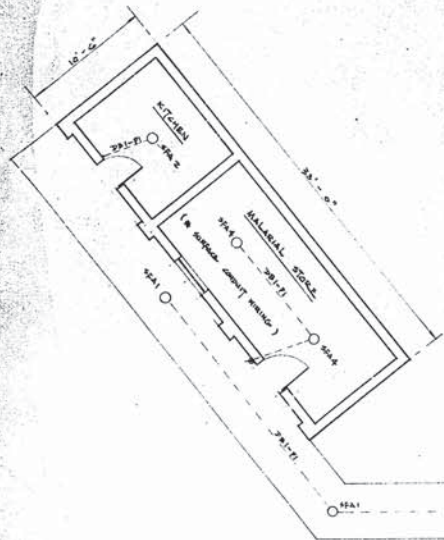
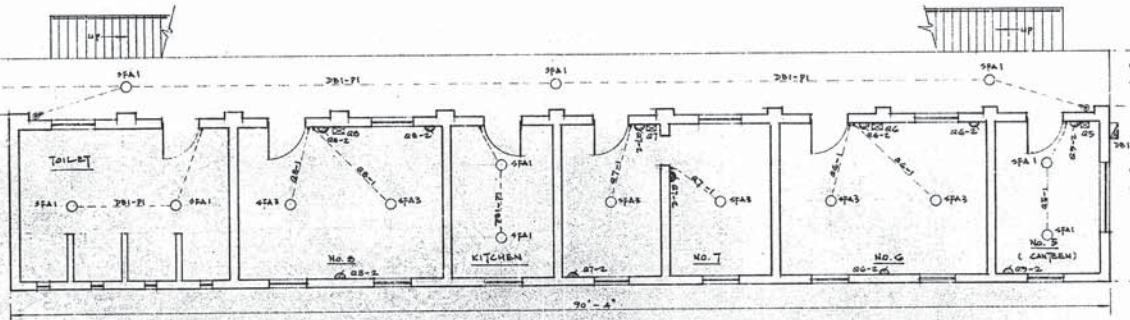
GROUND FLOOR PLAN

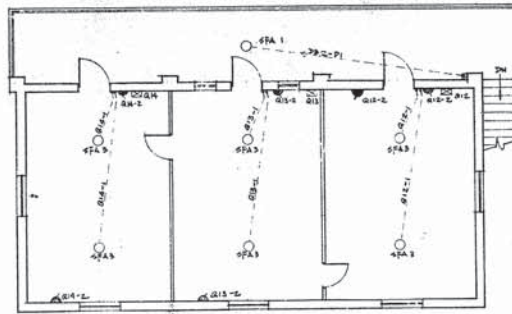
FIRST FLOOR PLAN  
SCALE: 3/16" = 1'-0"

- 1) THE INTERNAL ELECTRICAL INSTALLATION SHALL BE CARRIED OUT WITH SURFACE CONDUIT WIRING SYSTEM (INCLUDING INSTALLATION IN KITCHENS).
- 2) THE INTERNAL ELECTRICAL INSTALLATION SHALL BE CARRIED OUT WITH PVC MULTI-CORE CABLES RUN ON THE SURFACE.
- 3) WHEREVER POSSIBLE, SOCKETS & LIGHTING SWITCHES SHALL BE FLUSH MOUNTED.
- 4) FOR SCHEMATIC WIRING DIAGRAM, SEE DRG. NO. W 7129/1-A.

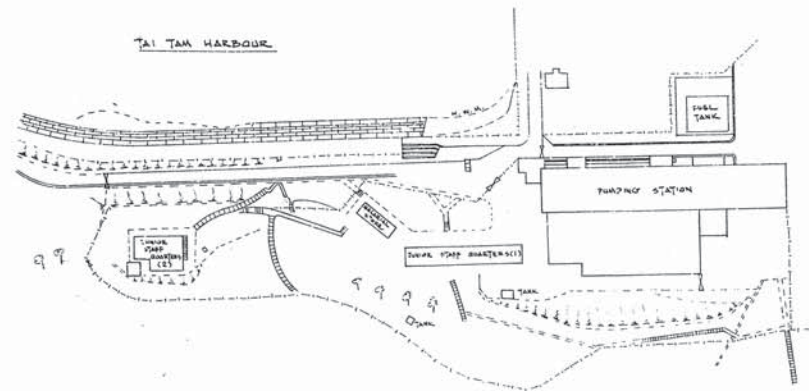
SITE PLAN

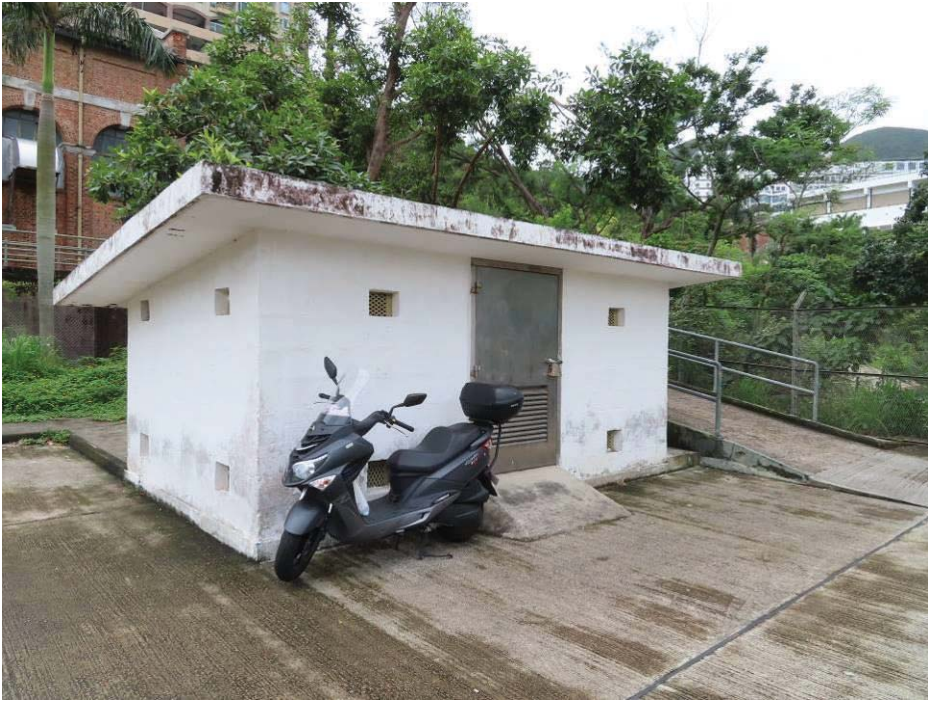
8.1 View of Dangerous Goods Store

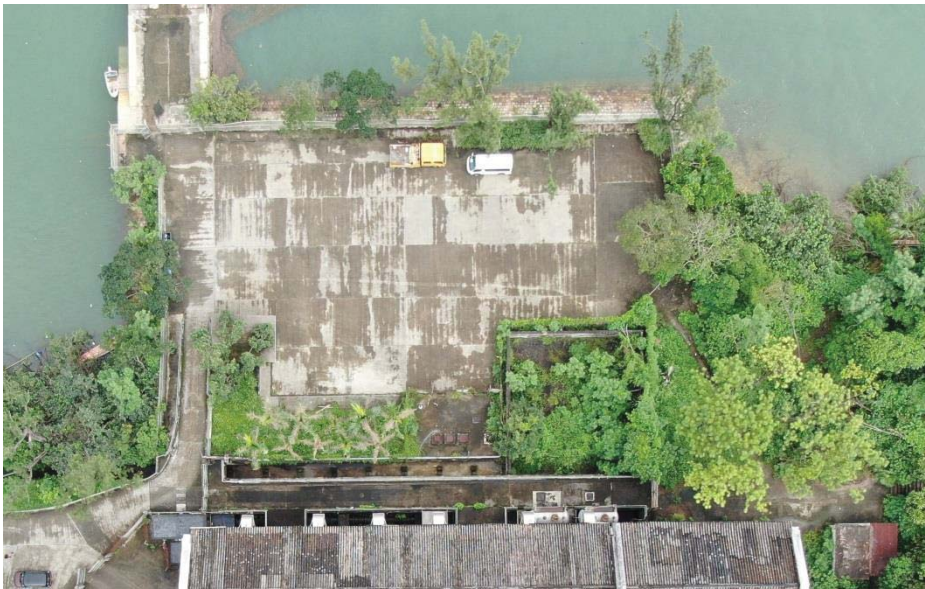
9.2 Aerial view of Yard
