**Revitalising Historic Buildings  
Through Partnership Scheme**

**Tai Tam Tuk Raw Water Pumping Station  
Staff Quarters Compound**

**Resource Kit**

**Date: 27 November 2019**

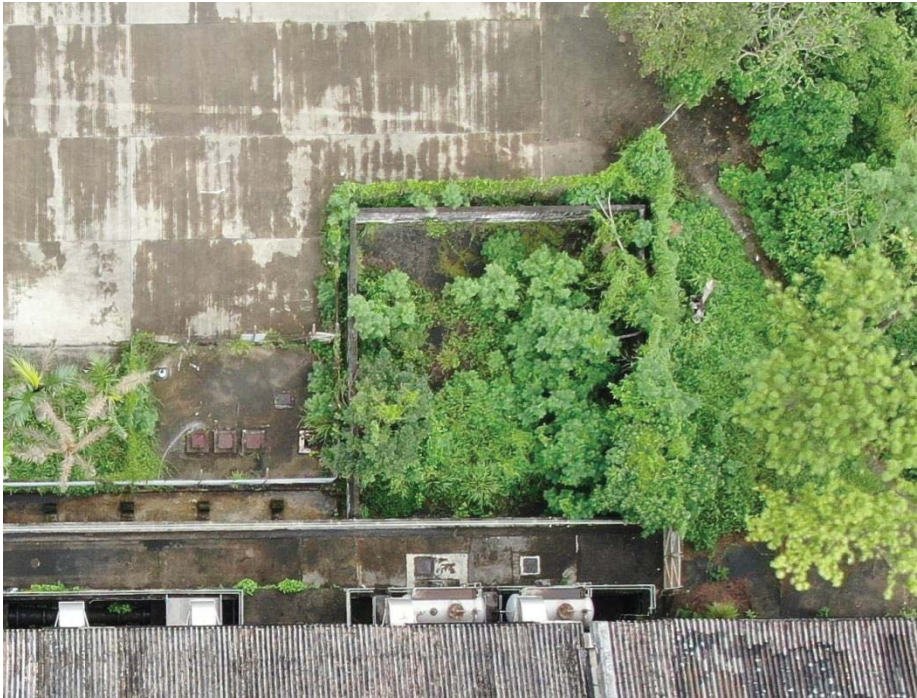
10.1 Aerial view of Fuel Tank

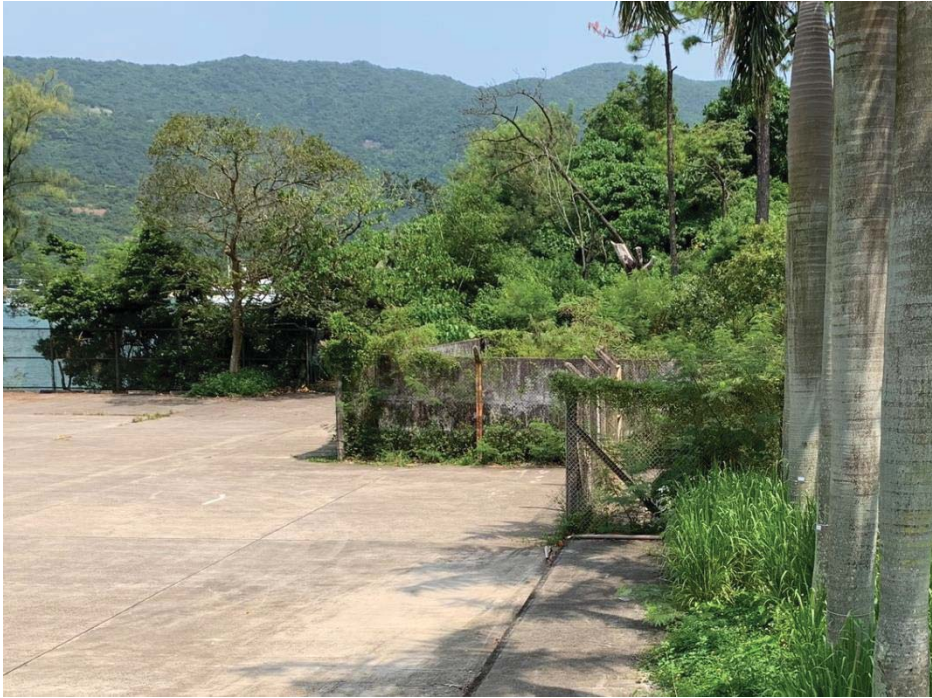
10.2 View of Fuel Tank

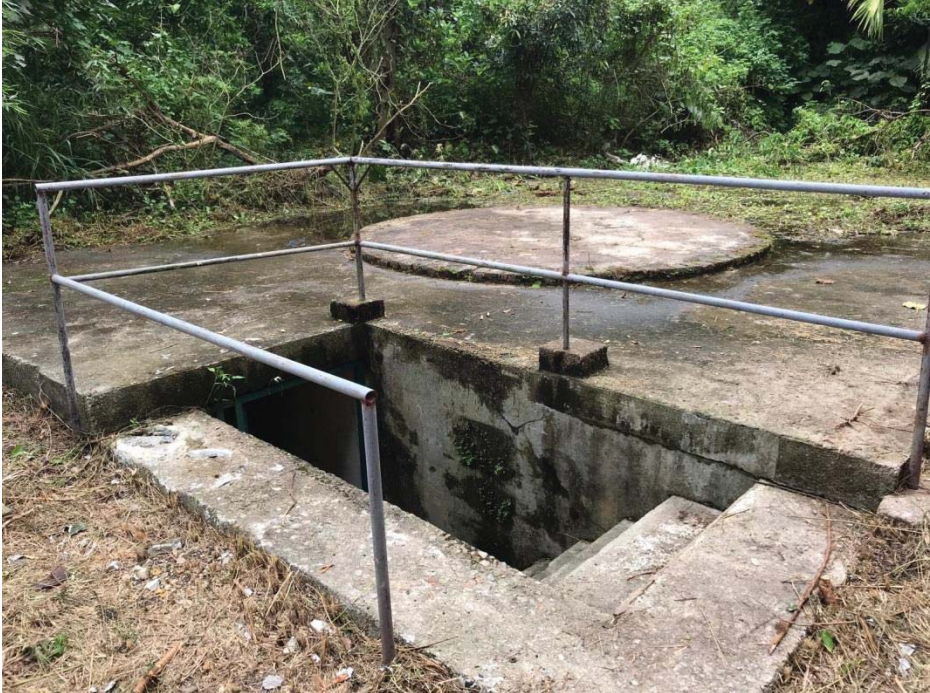
12.1 View of Entrance of Underground Cellar

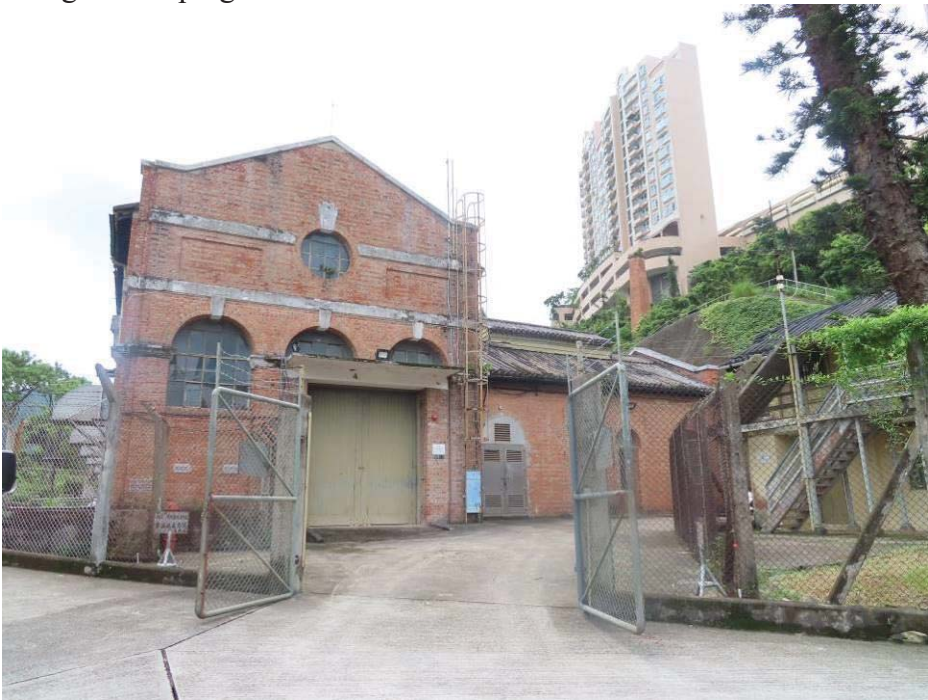
13.1 View of Pumping Station

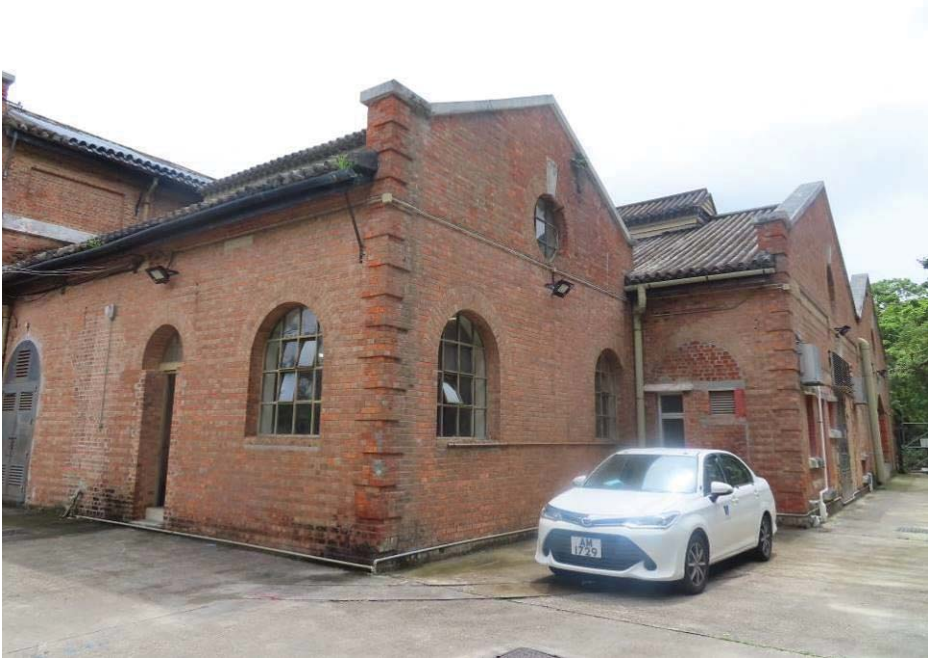
13.2 View of Pumping Station

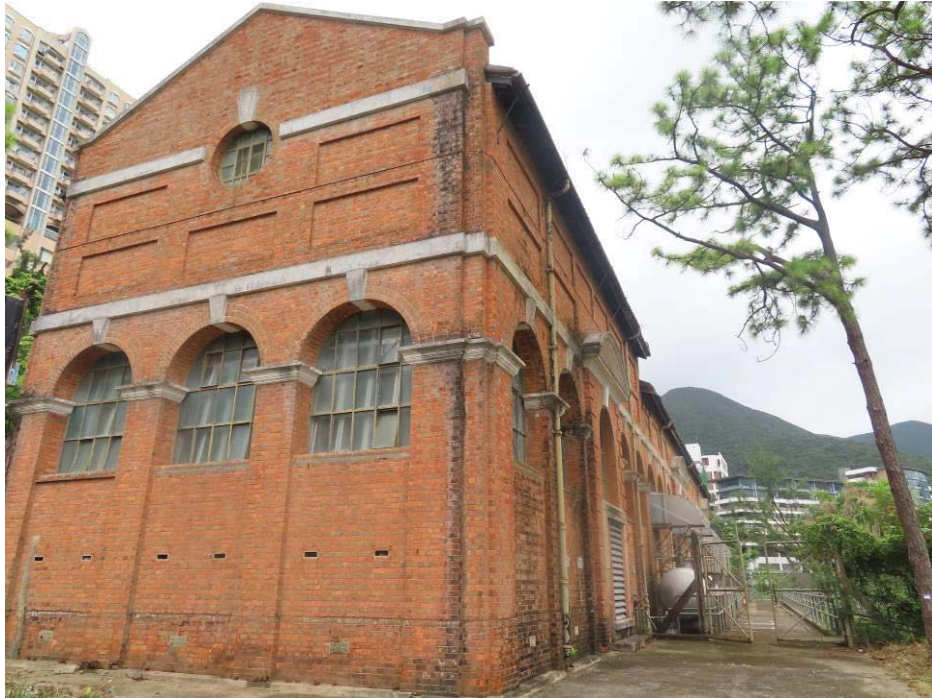
13.3 View of Pumping Station

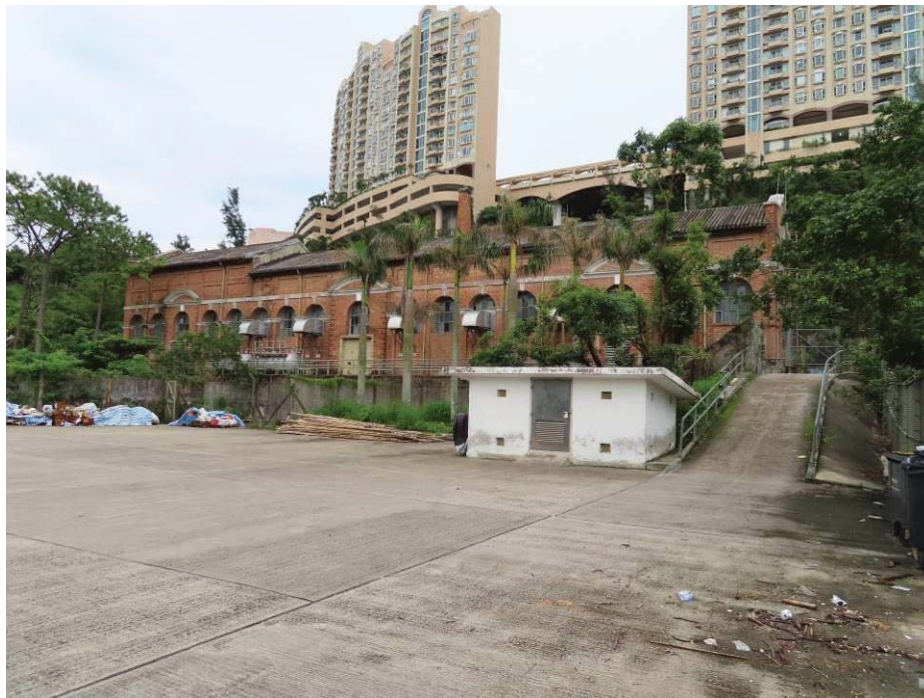
13.4 View of Pumping Station

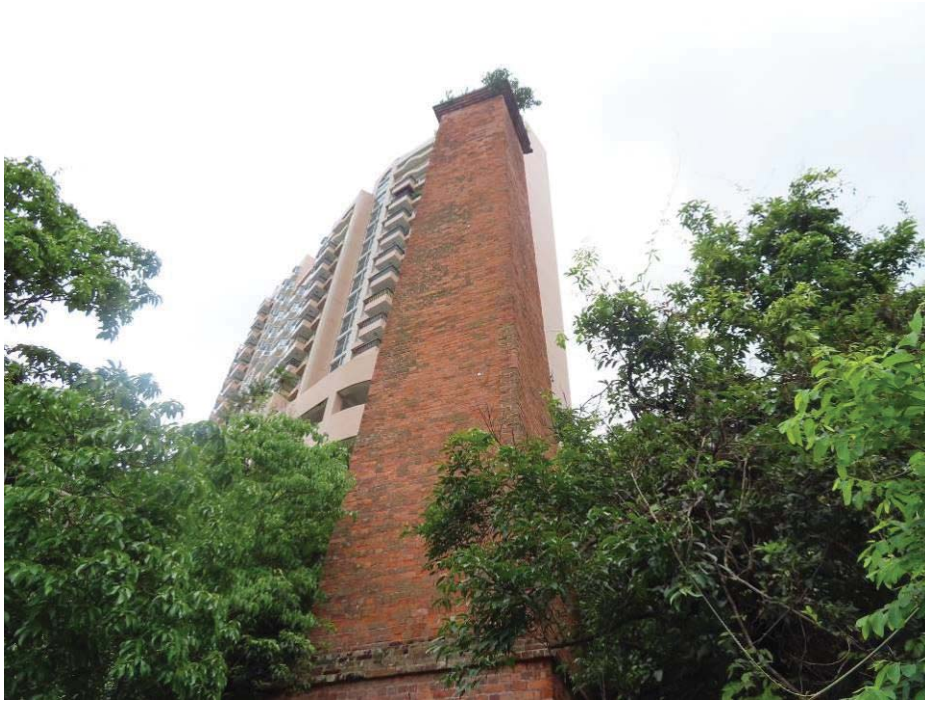
14.1 View of Chimney Shaft

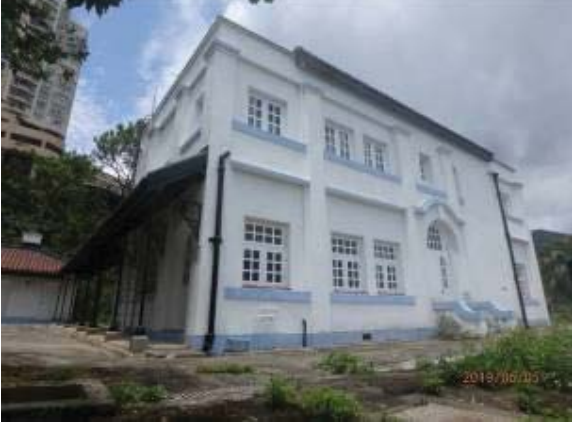
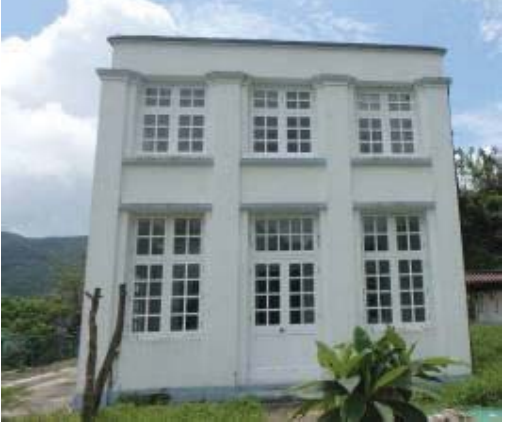
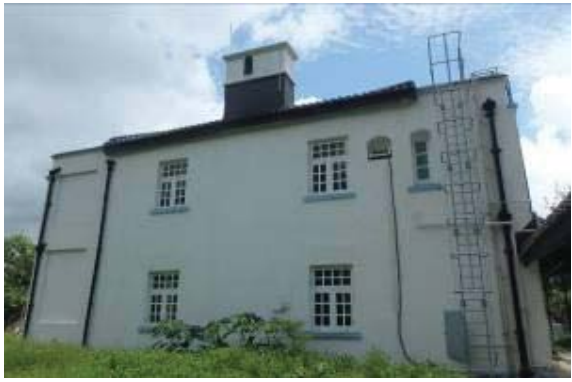
Item	Architectural Feature
1A.1	<p><u>Building Facades</u>            All building facades in symmetrical design with rendered walls painted in white and with horizontal features highlighted, including all classical architectural features such as pilasters, centrally placed entrance porch and doorway with semi-circular arched fanlight above and arched windows etc.</p>
	<div style="display: flex; justify-content: space-around;"> <div style="text-align: center;">

<p>North-east elevation</p> </div> <div style="text-align: center;">

<p>North-west elevation</p> </div> </div>
	<div style="display: flex; justify-content: space-around;"> <div style="text-align: center;">

<p>South-west elevation</p> </div> <div style="text-align: center;">   <p>South-east elevation</p> </div> </div>

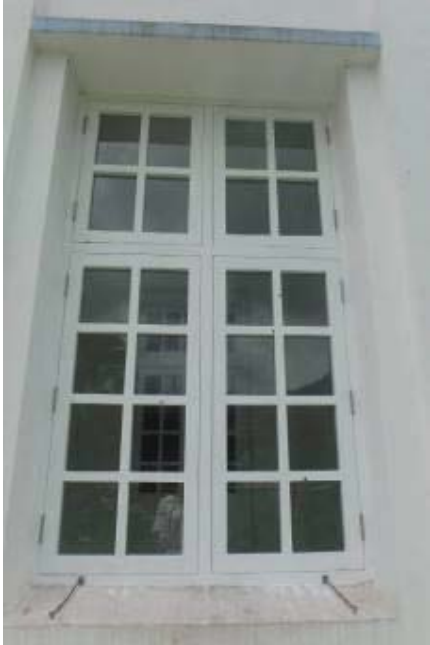
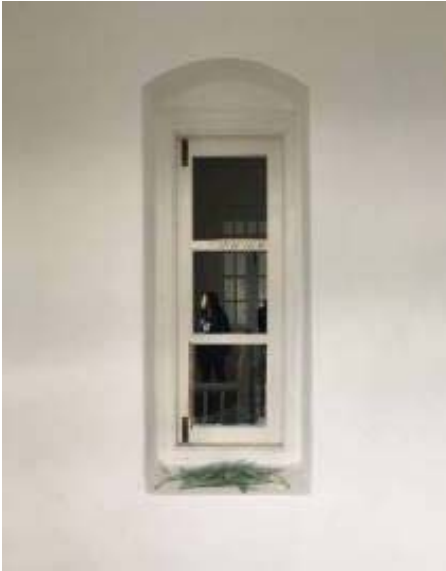
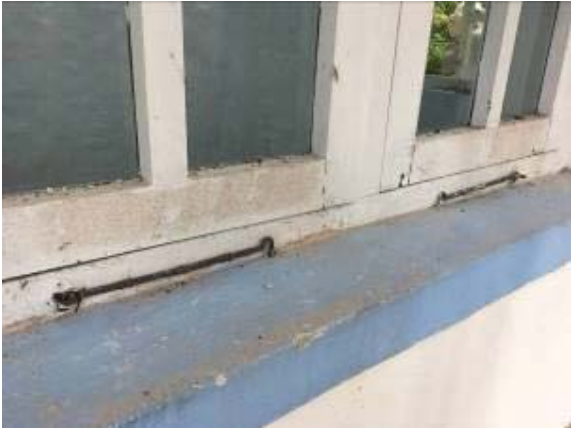
Item	Architectural Feature
1A.2	<p data-bbox="332 226 560 256"><u>Wooden Windows</u></p> <p data-bbox="332 262 1453 361">Wooden casement windows and arched windows, including the original openings, window frames with mouldings at interior, grid glazing patterns, original ironmongeries, protruded window heads and window sills. (Some of the windows openings have been altered.)</p> <div style="text-align: center;">

<p data-bbox="732 1066 1052 1096">Wooden casement window</p> </div> <div style="display: flex; justify-content: space-around; margin-top: 20px;"> <div style="text-align: center;">

<p data-bbox="500 1703 693 1732">Arched window</p> </div> <div style="text-align: center;">

<p data-bbox="1013 1703 1295 1732">Original ironmongeries</p> </div> </div>

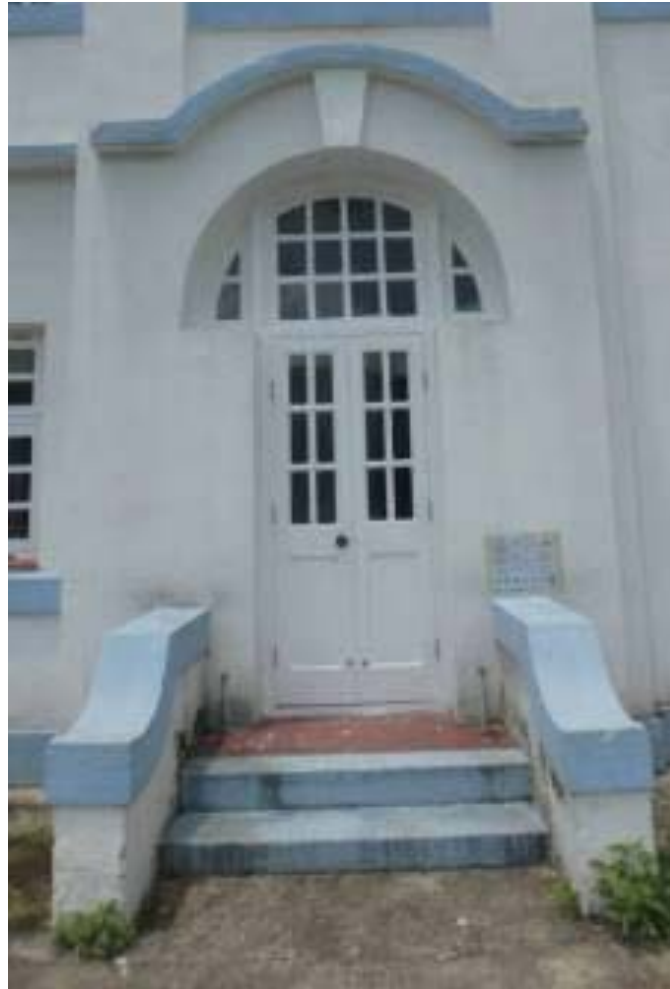
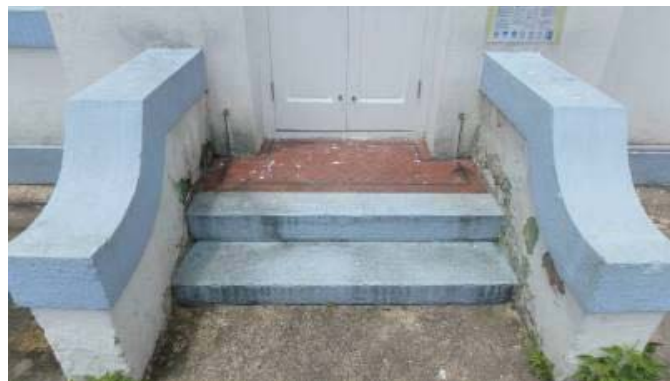
Entrance Porch and Main Entrance Door

The entrance porch and main entrance door including the steps and the patterned floor finishes, door threshold, the parapet walls, the arched fin and the keystone. The original wooden French door with semi-circular arched fanlight including the door frame, grid glazing patterns and the original ironmongeries.

Item	Architectural Feature	Required Treatments
1A.3	<u>Entrance Porch and Main Entrance Door</u>	<ul style="list-style-type: none"> <li>a. The entrance porch and main entrance door including the steps and the patterned floor finishes, door threshold, the parapet walls, the arched fin and the keystone should be preserved in-situ.</li> <li>b. The original wooden French door with semi-circular arched fanlight including the door frame, grid glazing patterns and the original ironmongeries should be preserved in-situ.</li> <li>c. Any defective floor finishes, parapet walls, steps are to be repaired as necessary to match existing.</li> <li>d. If the wooden French door are beyond repair, they are to be replaced with new wooden door and ironmongeries based on existing design, subjected to Antiquities Authority's approval.</li> <li>e. Wood preservative treatment to all the timber elements is to be provided.</li> </ul>

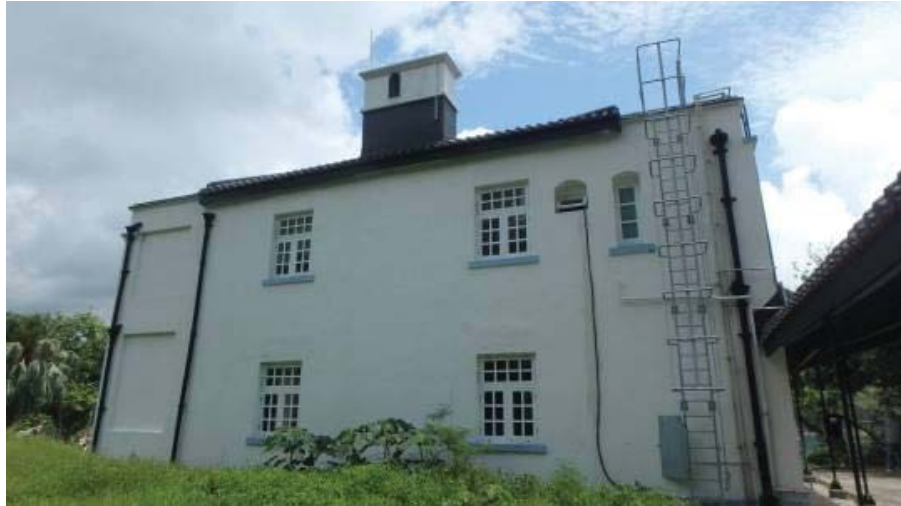
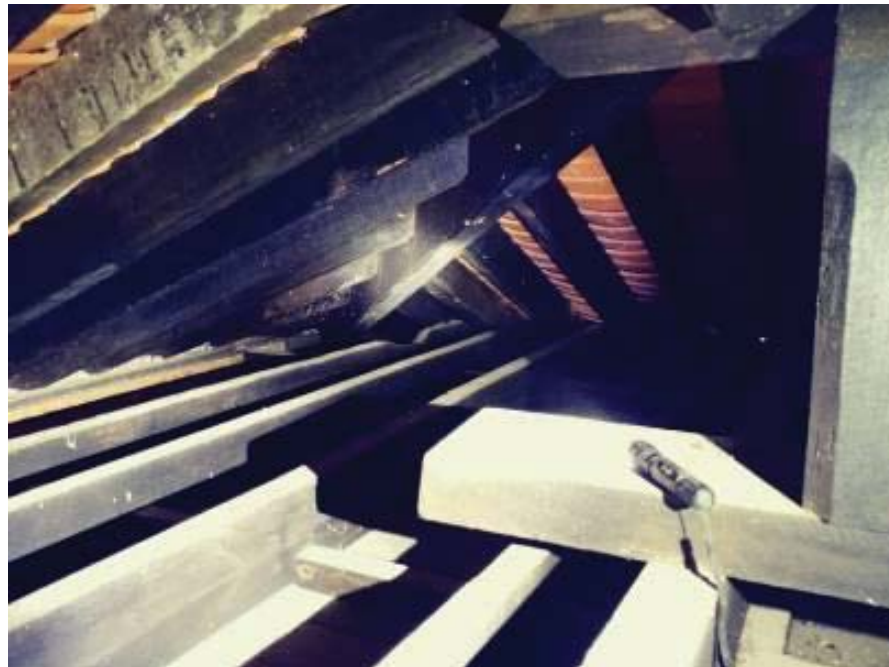
1A.5	<p><u>Hipped Roof at the Middle and Flat Roof at the Sides</u>            Flat roofs at two sides with parapet walls. Hipped roof structure at the middle laid with double-layered Chinese pan and roll tiles including all timber rafter and fascia boards.</p>
------	--

Hipped roof at the central and flat roofs at two sides

Timber rafter

Item	Architectural Feature	Required Treatments
1A.5	<u>Hipped Roof at the Middle and Flat Roof at the Sides</u>	<ul style="list-style-type: none"> <li>a. The form and the materials of the roofs are not to be changed.</li> <li>b. The hipped roof with the double-layered Chinese pan and roll tiles are to be checked and repaired as necessary to maintain waterproof matching with existing.</li> <li>c. The structural condition is to be checked, the defective timber trusses, rafters and purlins are to be repaired as necessary. New replacement of the timber elements is acceptable if the elements are beyond repair and the replacements should follow the existing materials and design.</li> <li>d. Termite eradication and monitoring system is to be installed.</li> <li>e. The defective roofing membrane at flat roof is to be repaired as necessary.</li> <li>f. No construction of additional storey at roof is permitted.</li> <li>g. Installation of building services equipment, ductwork, pipeworks, etc. on the flat roof could be considered, provided that the new installations should be setback from the facades with no visual impact created to the declared monument and subjected to Registered Structural Engineer's confirmation that no structural strengthening works is necessary, and is subjected to Antiquities Authority's approval.</li> </ul>

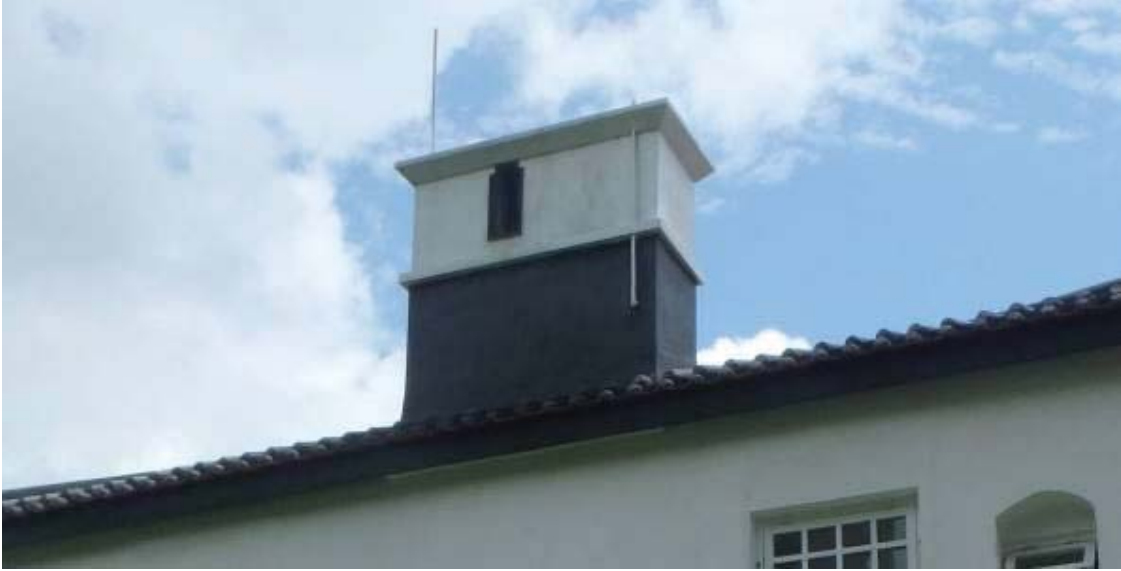
Item	Architectural Feature
1A.6	<p><u>Chimney Stack</u> The Chimney stack at both exterior and interior connecting to the fireplaces at the rooms of G/F and 1/F.</p>

Item	Architectural Feature	Required Treatments
1A.6	<u>Chimney Stack</u>	<ul style="list-style-type: none"> <li>a. The chimneys on roof together with the chimney stack in the interior should be preserved in-situ</li> <li>b. Any defective brickworks are to be repaired as necessary and repaint to match existing.</li> <li>c. Blocking the openings of chimney at roof to prevent water seepage in a reversible manner may be considered provided that the appearance of the chimney is not affected.</li> </ul>

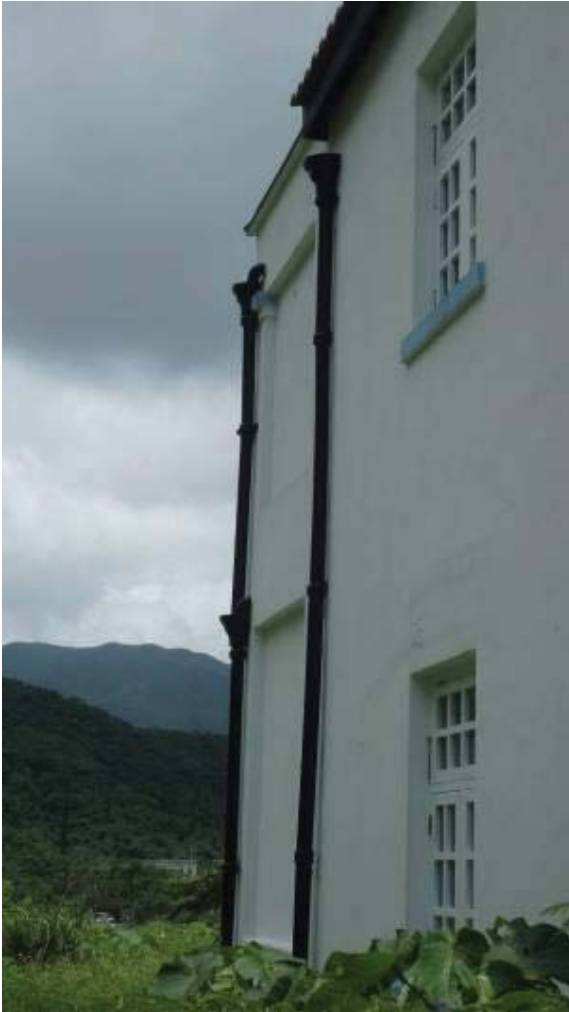
Item	Architectural Feature
1A.7	<p data-bbox="329 254 743 285"><u>Original Cast Iron Rainwater pipe</u></p> <p data-bbox="329 285 1455 352">All historical cast iron rainwater pipes including hopper, pipe works and their associated parts.</p>

Item	Architectural Feature	Required Treatments
1A.7	<u>Original Cast Iron Rainwater pipe</u>	<ul style="list-style-type: none"> <li>a. All historical cast iron rainwater pipes, including hopper, pipe works and their associated parts, should be preserved in-situ as far as practical.</li> <li>b. Any defective part(s) of the drainage system are to be repaired and replaced as necessary. Any blockage in the drainage system is to be cleared to restore its function.</li> <li>c. If defective pipework is beyond repair, they should be replaced with cast iron pipework and to be painted to match existing.</li> </ul>

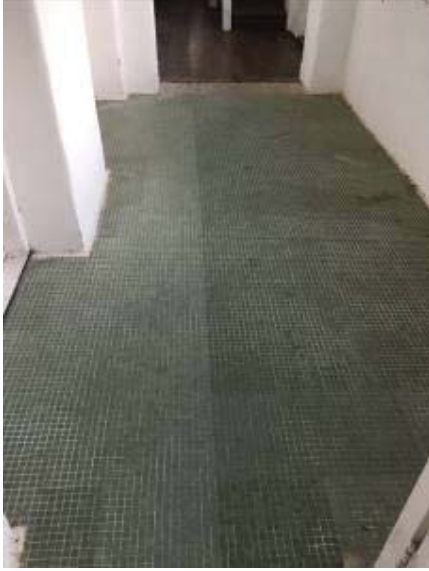
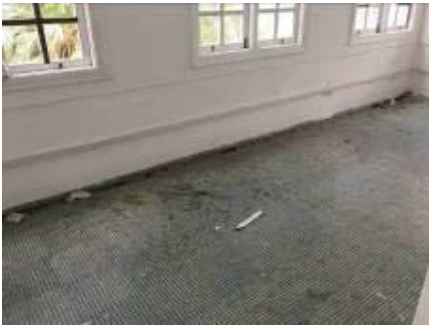
Item	Architectural Feature
1A.10	<p><u>Mosaic Tiled Finishes</u> Original mosaic tiled finishes at the original hallways at G/F and 1/F including the drainage channels.</p>
<div style="display: flex; flex-wrap: wrap; justify-content: space-around;"> <div style="text-align: center; width: 45%;">

<p>Hallway 1 on G/F</p> </div> <div style="text-align: center; width: 45%;">   <p>Hallway 3 on 1/F</p> </div> <div style="text-align: center; width: 45%;">   <p>Hallway 2 on G/F</p> </div> <div style="text-align: center; width: 45%;">

<p>Hallway 4 on 1/F</p> </div> </div>

Item	Architectural Feature	Required Treatments
1A.10	<u>Mosaic Tiled Finishes</u>	<ul style="list-style-type: none"> <li>a. The green mosaic tiles including the drainage channels should be preserved in situ.</li> <li>b. The mosaic tiled finishes are to be cleaned and defective tiles are to be repaired as necessary for public appreciation.</li> </ul>

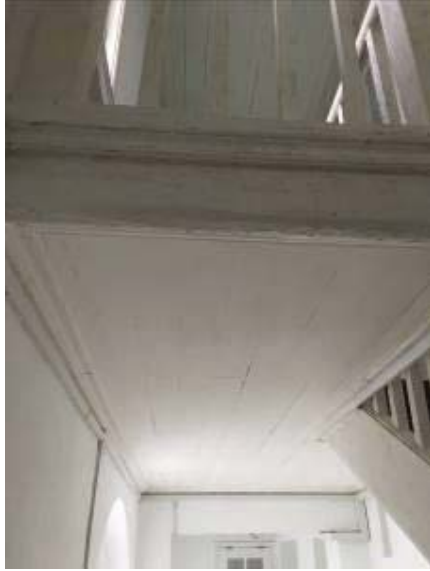
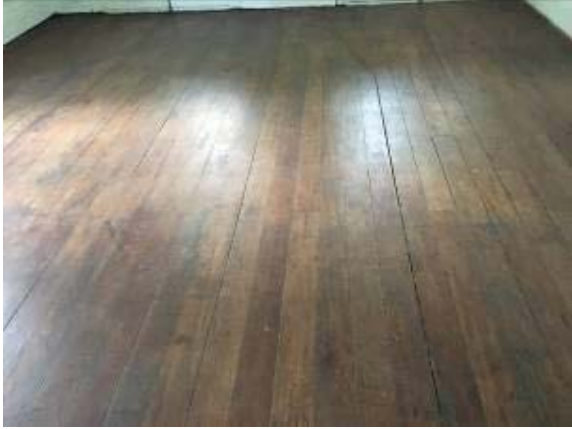
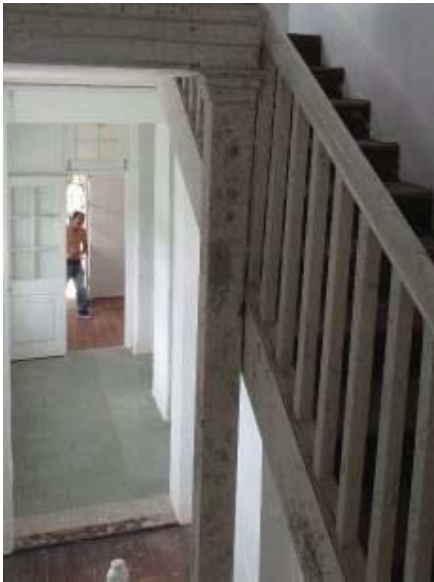
Item	Architectural Feature
1A.12	<p data-bbox="349 241 609 273"><u>Timber Floor System</u></p> <p data-bbox="349 273 1453 346">Timber floor system including timber floor joists hidden above the suspended ceiling, timber column, timber floor finishes and mouldings at the side.</p> <div style="display: flex; justify-content: space-around; align-items: flex-start; padding: 20px;"> <div style="text-align: center;">

<p data-bbox="462 1008 722 1045">Mouldings at the side</p> </div> <div style="text-align: center;">

<p data-bbox="1019 1008 1279 1045">Timber floor finishes</p> </div> </div> <div style="text-align: center; margin-top: 20px;">

<p data-bbox="500 1654 690 1690">Timber column</p> </div>

Item	Architectural Feature	Required Treatments
1A.12	<u>Timber Floor System</u>	<ul style="list-style-type: none"> <li>a. The timber floor system including the timber floor joists, timber column and timber floor finishes should be preserved in-situ.</li> <li>b. The timber floor system is to be repaired as necessary and wood preservative treatment is to be provided to all the timber elements.</li> <li>c. New replacement of the elements is acceptable if the elements are beyond repair and the replacements should follow the existing structural systems and materials.</li> <li>d. Upgrading of timber floor system to suit modern statutory requirements and operation needs in a reversible manner may be permitted, subjected to the advice from the Registered Structural Engineer, and is subjected to Antiquities Authority's approval.</li> <li>e. Covering the timber floor finishes in a reversible manner may be considered, and is subjected to Antiquities Authority's approval.</li> </ul>

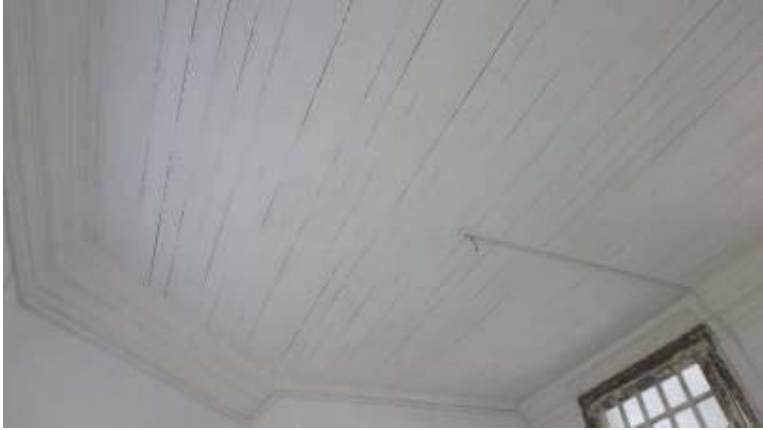
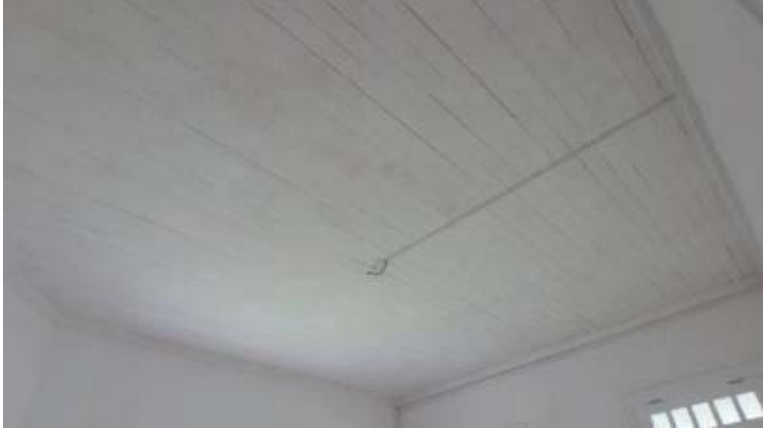
Item	Architectural Feature
1A.13	<p data-bbox="349 191 673 222"><u>Timber Suspended Ceiling</u></p> <p data-bbox="349 224 1133 256">Timber suspended ceiling with crown mouldings on G/F and 1/F.</p> <div data-bbox="521 346 1279 772">

A photograph showing a close-up view of a white-painted timber suspended ceiling. The ceiling features a decorative crown moulding at the junction with the walls. The timber planks are arranged in a grid pattern. A portion of a window with a dark frame is visible in the lower right corner.</div> <p data-bbox="602 789 1198 821">Crown moulded timber suspended ceiling on G/F</p> <div data-bbox="521 840 1279 1266">

A photograph showing a close-up view of a white-painted timber suspended ceiling, similar to the one on the ground floor. It features a decorative crown moulding at the junction with the walls. The timber planks are arranged in a grid pattern. A portion of a window with a dark frame is visible in the lower right corner.</div> <p data-bbox="602 1283 1198 1314">Crown moulded timber suspended ceiling on 1/F</p>

Item	Architectural Feature	Required Treatments
1A.13	<u>Timber Suspended Ceiling</u>	<ul style="list-style-type: none"> <li>a. The timber suspended ceiling including crown moulding on G/F and 1/F should be preserved in-situ.</li> <li>b. The timber suspended ceiling is to be repaired as necessary and wood preservative treatment is to be provided to all the timber elements.</li> <li>c. New replacement of the elements is acceptable if the elements are beyond repair and the replacements should follow the existing materials and design.</li> <li>d. If upgrading works of 1/F timber floor system is necessary upon the advice from the Registered Structural Engineer, dismantle and reinstatement of the timber suspended ceiling for the upgrading works may be permitted, subjected to Antiquities Authority's approval.</li> </ul>

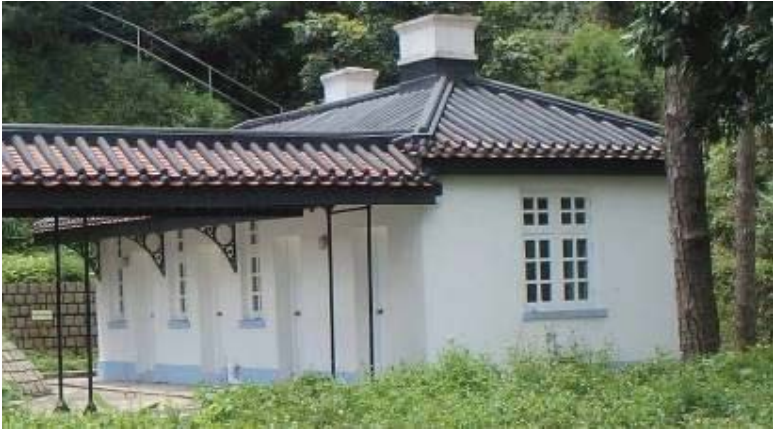
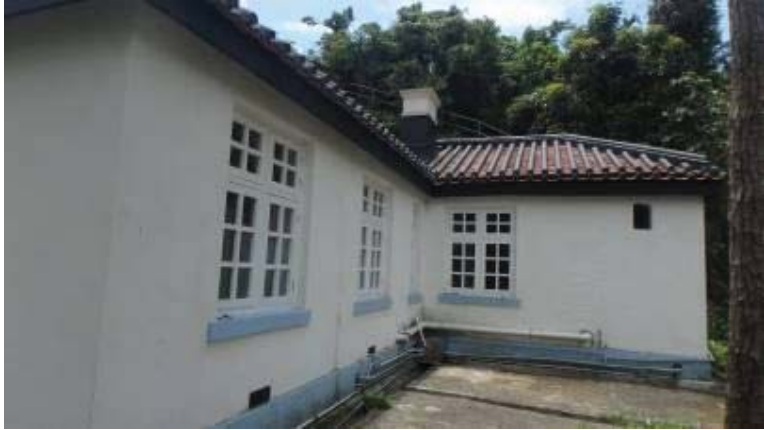
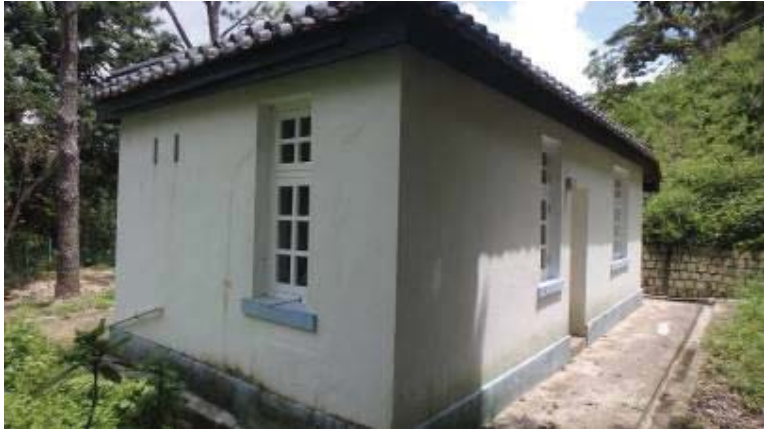
Item	Architectural Feature
1B.1	<p data-bbox="329 302 922 365"><u>Building Facades</u> All building facades with painted rendered walls.</p>

<p data-bbox="667 898 1110 930">North-east and north-west elevations</p>

<p data-bbox="662 1392 1115 1423">South-west and north-west elevations</p>

<p data-bbox="670 1885 1107 1917">Southwest and south-east elevations</p>

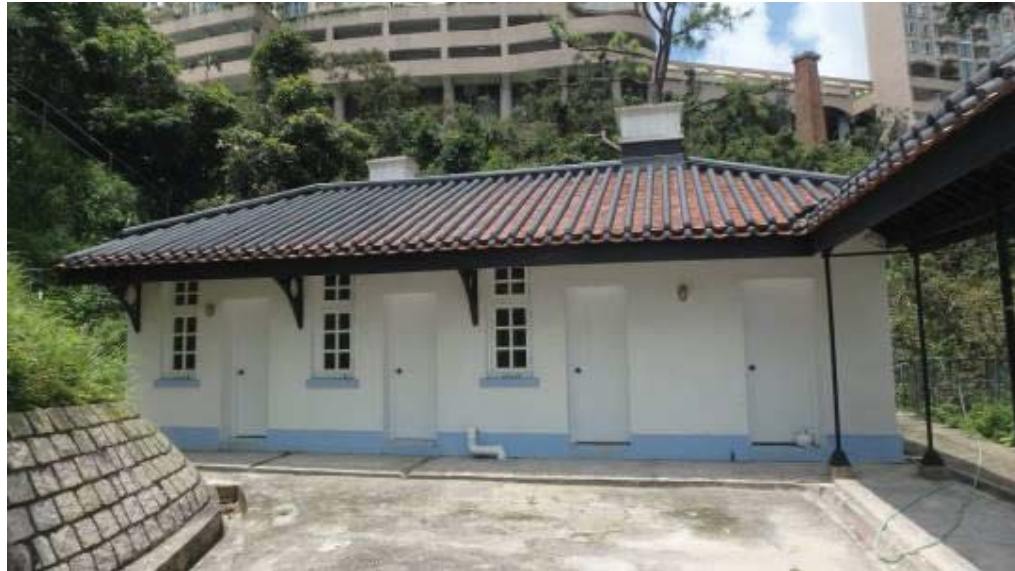
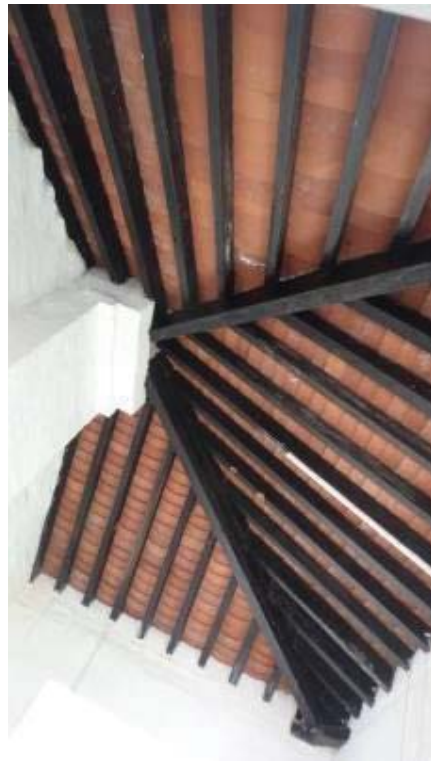
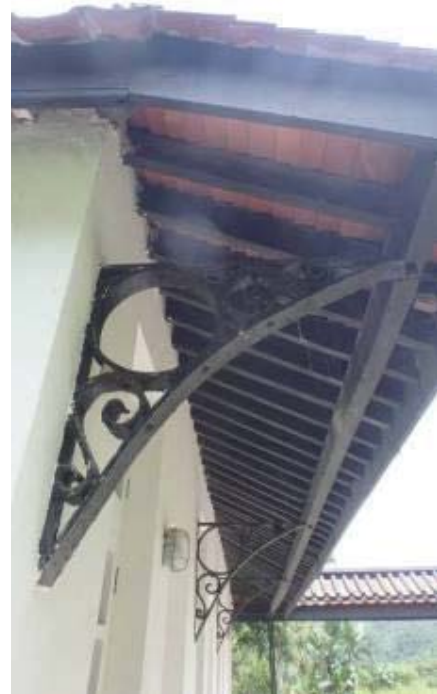
1B.3	<u>Hipped Roof with Double-layered Chinese Pan and Roll tiles</u> Hipped roof laid with double-layered Chinese pan and roll tiles including all timber rafter, fascia boards and ornamental cast iron brackets.
------	--

Hipped roof laid with double-layered pan and roll tiles

Timber rafter

Cast Iron brackets

Item	Architectural Feature	Required Treatments
1B.3	<u>Hipped Roof with Double-layered Chinese Pan and Roll tiles</u>	<ul style="list-style-type: none"> <li>a. The form and the materials of the roofs are not to be changed.</li> <li>b. The hipped roofs with the double-layered Chinese pan and roll tiles are to be checked and repaired to maintain waterproof matching existing.</li> <li>c. Structural condition is to be checked and the defective timber trusses, rafters and purlins are to be repaired as necessary.</li> <li>d. The ornamental cast iron brackets are to be repaired and repainted as necessary.</li> <li>e. Wood preservative treatment is to be provided to all the timber elements and termite eradication and monitoring system is to be installed.</li> <li>f. At least part of the timber structure should be exposed for public appreciation.</li> </ul>

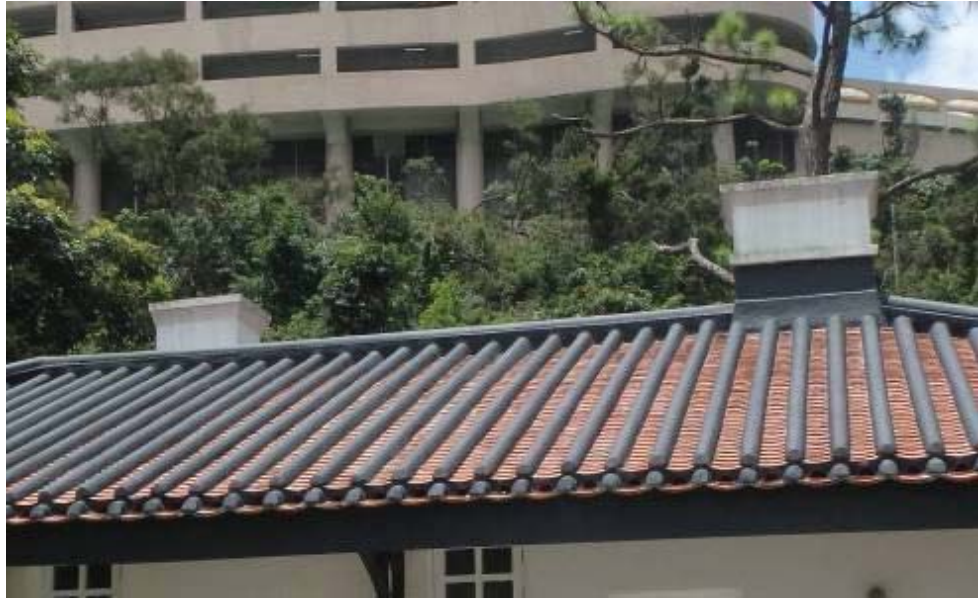
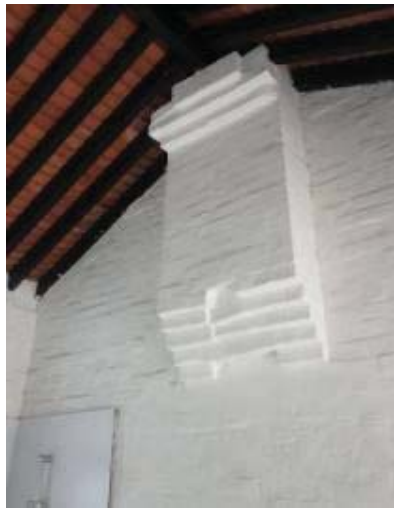
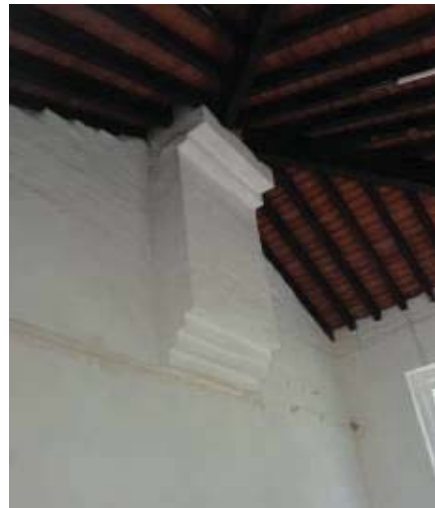
1B.4	<p><u>Chimney Stacks</u> Chimney stacks at both exterior and interior connecting to the fireplace and the remains of chimney stacks at interior.</p>
------	--

Chimney stacks at roof

Remains of chimney stacks at interior

Item	Architectural Feature	Required Treatments
1B.4	<u>Chimney Stacks</u>	<ul style="list-style-type: none"> <li>a. The chimneys on roof together with the chimney stack in the interior connecting to fireplace and the remains should be preserved in-situ.</li> <li>b. Any defective brickworks are to be repaired as necessary and repaint to match existing.</li> <li>c. Blocking the openings of chimney at roof to prevent water seepage in a reversible manner may be considered provided that the appearance of the chimney is not affected.</li> </ul>
<div style="text-align: center;">

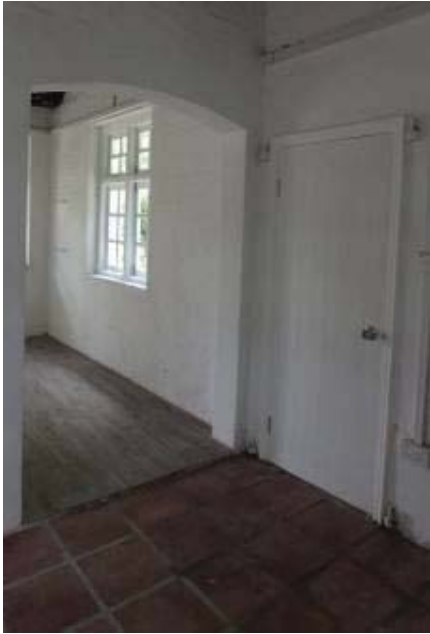
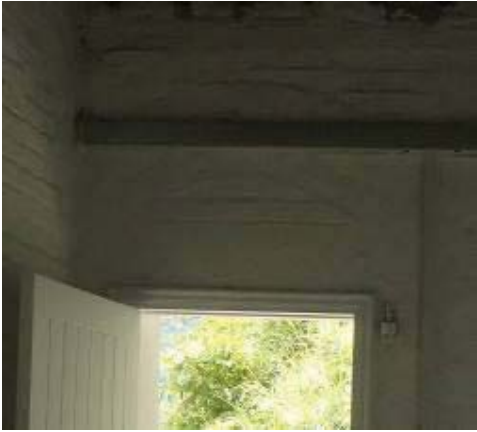
Item	Architectural Feature
1B.7	<p data-bbox="329 243 1453 348"><u>Internal Arched doorway</u> The original segmental arched doorways and the segmental arched brickworks remains at walls.</p> <div data-bbox="397 436 824 1066">

</div> <p data-bbox="446 1081 776 1117">Segmental arched doorway</p> <div data-bbox="932 436 1406 865">

</div> <p data-bbox="938 1081 1399 1117">Segmental arched brickworks remains</p>

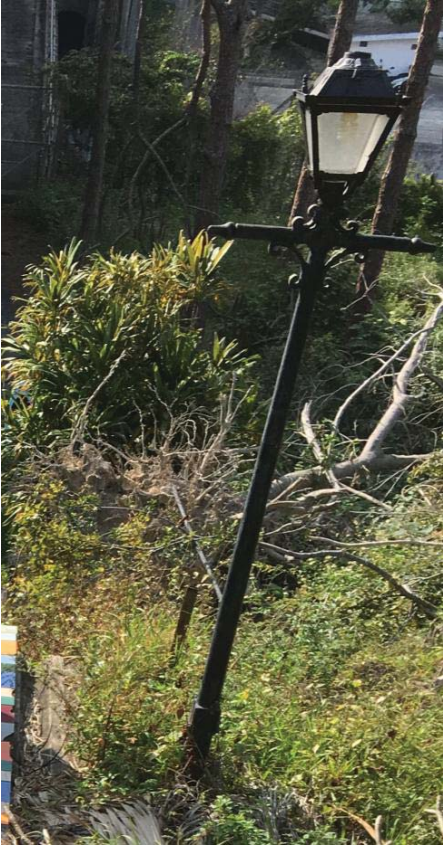
Item	Architectural Feature
1D.2	<p data-bbox="331 247 1328 315"><u>Classic cast iron lamp post</u> The classic cast iron lamp post beside the access stairs to the Senior Staff Quarters.</p>

<b>Item</b>	<b>Architectural Feature</b>	<b>Required Treatments</b>
1D.2	<u>Classic cast iron lamp post</u>	<p>a. The classic cast iron lamp post should be preserved in-situ.</p> <p>b. The cast iron lamp post is to be repaired and its function is to be restored as far as practicable.</p>

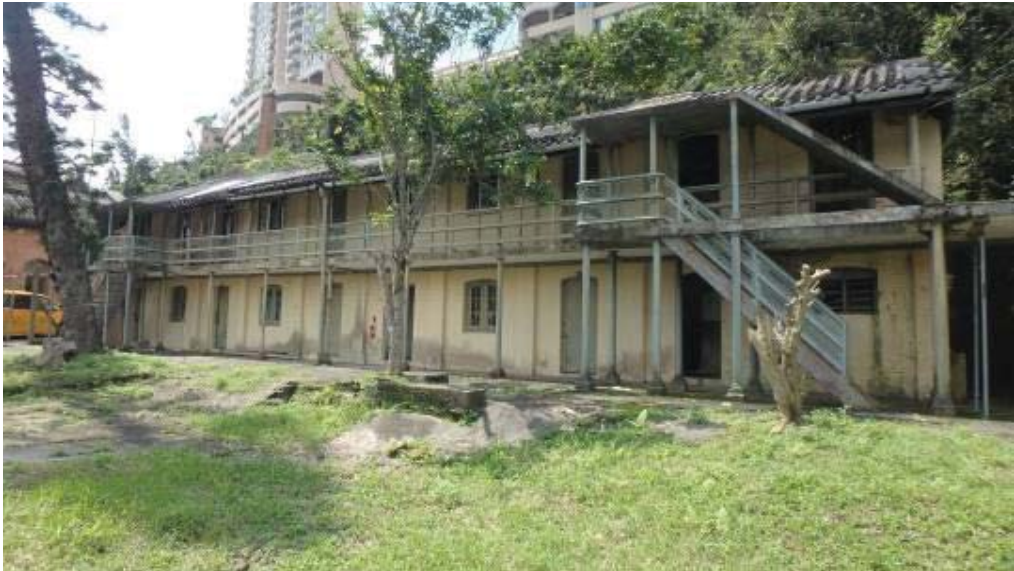
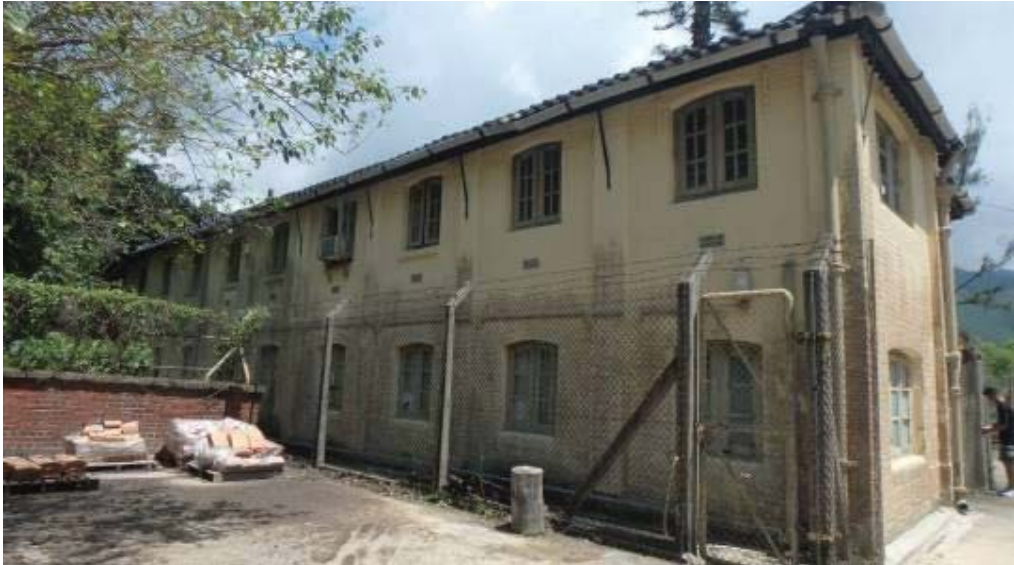
Item	Architectural Feature
2A.1	<p><u>Building Facades</u> All building facades with exposed columns and paint applied directly on brick walls.</p>

A photograph showing the north elevation of a two-story building. The building has a light-colored facade with exposed columns and a balcony on the upper floor. The ground in front is grassy with some trees and a yellow vehicle visible in the background.	
<p>North elevation</p>

A photograph showing the south elevation of the main building. The building has a light-colored facade with exposed columns and a balcony on the upper floor. The ground in front is paved and there are some construction materials (bags of cement) visible in the foreground.	
<p>South elevation</p>

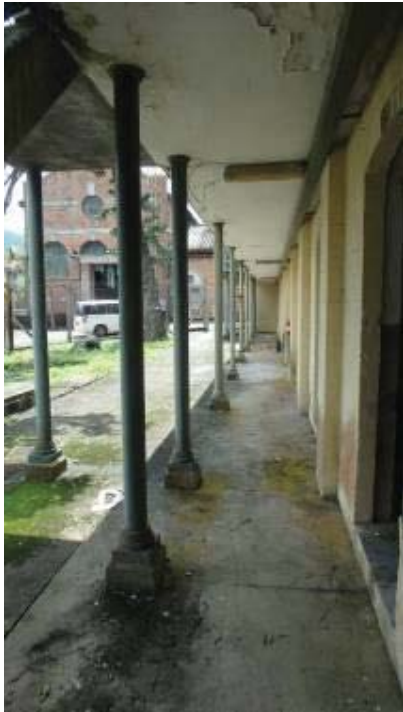
Item	Architectural Feature
2A.2	<p><u>Verandahs on the North Elevation</u> Open verandahs supported by cast iron round columns on G/F and 1/F including granite stones bases on G/F, concrete slab and tubular metal balustrades on 1/F.</p>
	<div data-bbox="410 422 810 1129">

A photograph showing a long, covered walkway on the ground floor. The walkway is supported by a series of dark, cylindrical cast iron columns. The ground is paved with concrete slabs. In the background, a white van is parked on a grassy area.</div> <p data-bbox="505 1150 711 1178">Verandah on G/F</p> <div data-bbox="902 422 1435 1129">

Item	Architectural Feature	Required Treatments
2A.2	<u>Verandahs on North Elevation</u>	<ul style="list-style-type: none"> <li>a. The open verandahs including the cast iron metal round columns on G/F and 1/F and granite stones bases should be preserved in-situ.</li> <li>b. No enclosure of the verandah, wholly or partially is permitted.</li> <li>c. The existing slab is to be repaired based on existing structural system as necessary.</li> <li>d. The existing tubular metal balustrade should be preserved as far as practicable, upgrading of existing balustrade to meet current statutory requirements in a reversible manner and with minimum disturbance to the balustrades may be considered, subjected to the Antiquities Authority's approval.</li> <li>e. A research study on the authenticity of the existing metal balustrade is to be conducted. The study should be based on archival research and site investigations, and supplemented with photos, drawings, etc. for AMO's record. If sufficient evidence could be provided that the balustrade is not original, replacement of balustrade with similar design of simple tubular metal balustrade which is compatible with the building design may be considered, subjected to the Antiquities Authority's approval.</li> </ul>

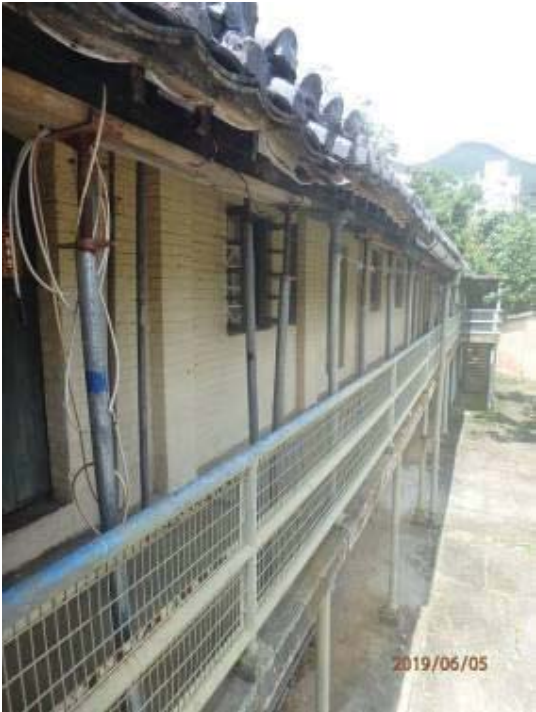
A photograph showing a verandah on the first floor. The verandah has a concrete slab floor and is enclosed by a tubular metal balustrade. The building has a tiled roof and a yellowish wall. A date stamp '2019/06/05' is visible in the bottom right corner of the image.</div> <p data-bbox="1068 1150 1274 1178">Verandah on 1/F</p>
