**Revitalising Historic Buildings  
Through Partnership Scheme**

**Tai Tam Tuk Raw Water Pumping Station  
Staff Quarters Compound**

**Resource Kit**

**Date: 27 November 2019**

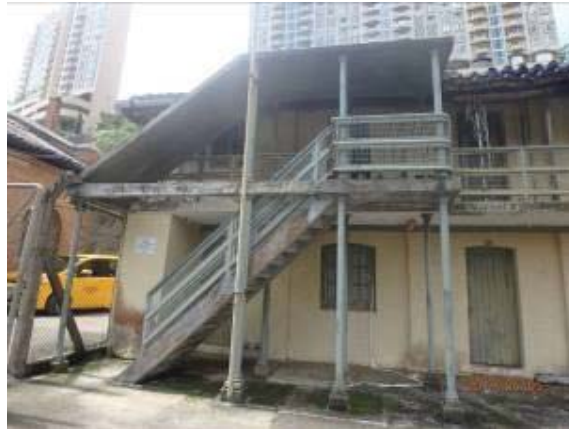
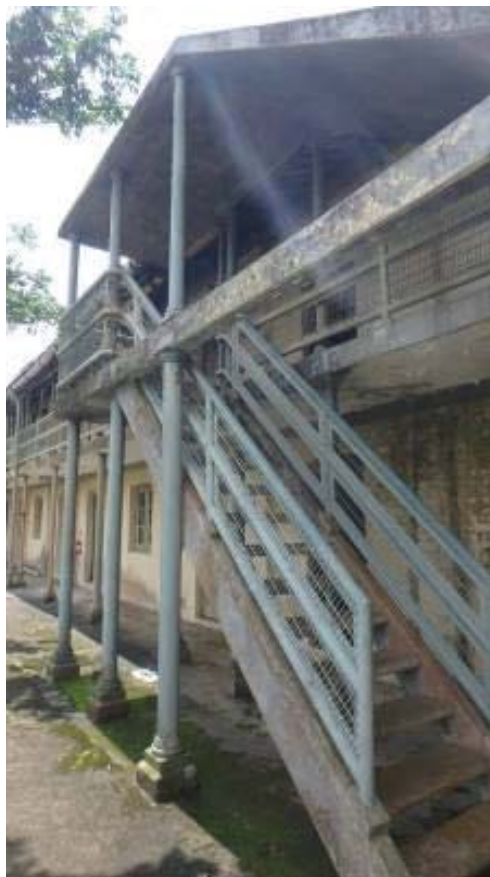
2A.3	<p><u>Open Staircases</u> Open Staircases at east and west ends of the north elevation, connecting to the verandahs on 1/F including the cast iron round columns, concrete roof slabs, steps with granolithic finishes and tubular metal balustrades</p>
------	--

Open staircase on the east end

Open staircase on the west end

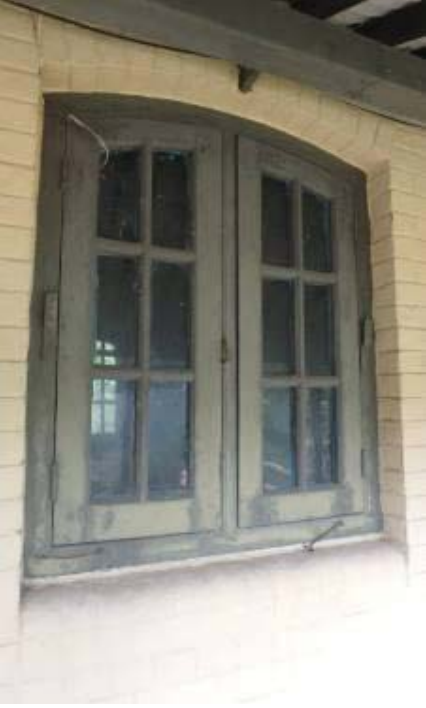
Item	Architectural Feature
2A.4	<p><u>Segmental Arched Wooden Casement Windows</u> All original segmental arched wooden casement windows including the segmental arched brickworks, grid glazing patterns, rounded edge window sills and all ironmongeries.</p>

Item	Architectural Feature	Required Treatments
2A.4	<u>Segmental Arched</u> <u>Wooden Casement</u> <u>Windows</u>	<ul style="list-style-type: none"> <li>a. All original segmental arched wooden casement windows including the segmental arched brickworks, grid glazing patterns, rounded edge window sills and all ironmongeries should be preserved in-situ.</li> <li>b. The wooden windows are to be repaired to match existing as necessary. If the wooden windows and ironmongeries are beyond repair, replace the windows with new wooden windows and ironmongeries following the existing design, subjected to Antiquities Authority's approval.</li> <li>c. Wood preservative treatment is to be provided to all the timber elements.</li> <li>d. Modification of the window openings into door openings to meet the current statutory requirements may be considered, provided that the modification works would be carried out at the rear side of the Main Building at less prominent area, and is subjected to the Antiquities Authority's approval.</li> </ul>

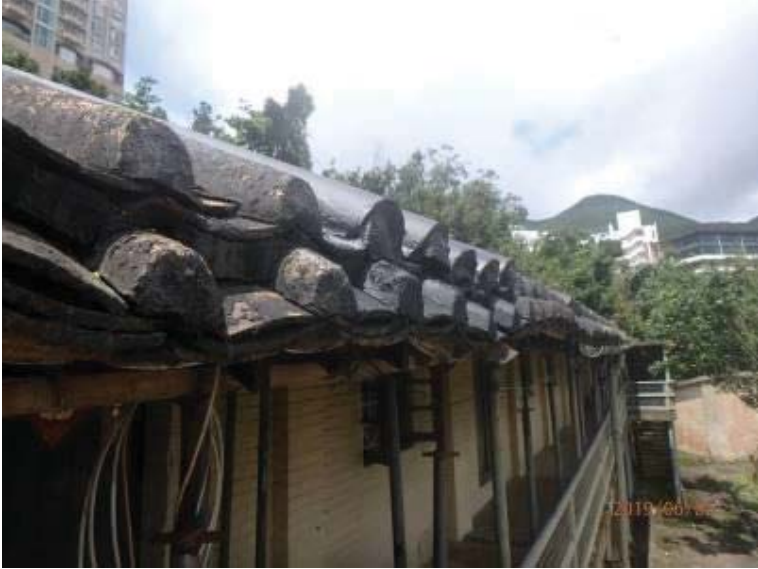
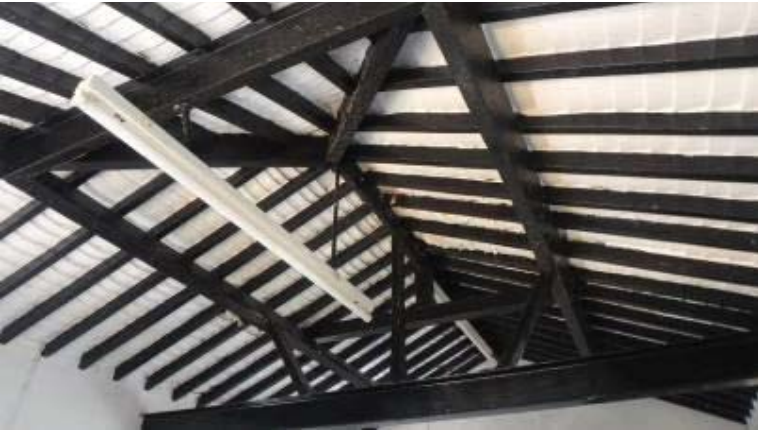
Item	Architectural Feature
2A.6	<p data-bbox="332 239 1071 273"><u>Hipped Roof with Double-layered Chinese Pan and Roll tiles</u></p> <p data-bbox="332 275 1455 340">Hipped roof laid with double-layered Chinese pan and roll tiles including all timber rafter, timber trusses, timber purlins, metal beams and bracings, and timber fascia boards.</p> <div data-bbox="516 409 1269 974">

A photograph showing the exterior of a building with a hipped roof. The roof is covered with two layers of dark grey Chinese pan and roll tiles. The structure is supported by dark wooden rafters and trusses. In the background, there are green trees and a hillside under a cloudy sky. A small orange timestamp '2019/06/15' is visible in the bottom right corner of the image.</div> <p data-bbox="643 993 1143 1026">Double-layered Chinese pan and roll tiles</p> <div data-bbox="516 1041 1269 1470">

A photograph showing the interior of the roof structure. It features a complex arrangement of dark wooden timber trusses and rafters. A prominent white steel beam runs diagonally across the structure. The roof is supported by a network of dark wooden beams and bracings.</div> <p data-bbox="659 1486 1127 1520">Timber truss, steel beams and bracings</p>

Item	Architectural Feature	Required Treatments
2A.6	<u>Hipped Roof with Double-layered Chinese Pan and Roll tiles</u>	<ul style="list-style-type: none"> <li>a. The form and the materials of the roofs are not to be changed.</li> <li>b. The hipped roofs are to be checked and repaired with the double-layered pan and roll tiles to maintain waterproof matching existing.</li> <li>c. Structural condition is to be checked and the defective timber trusses, rafters, purlins and metal beams and bracings are to be repaired as necessary to match existing. Termite eradication and monitoring system is to be installed.</li> </ul>
<div style="display: flex; flex-direction: column; align-items: center;">

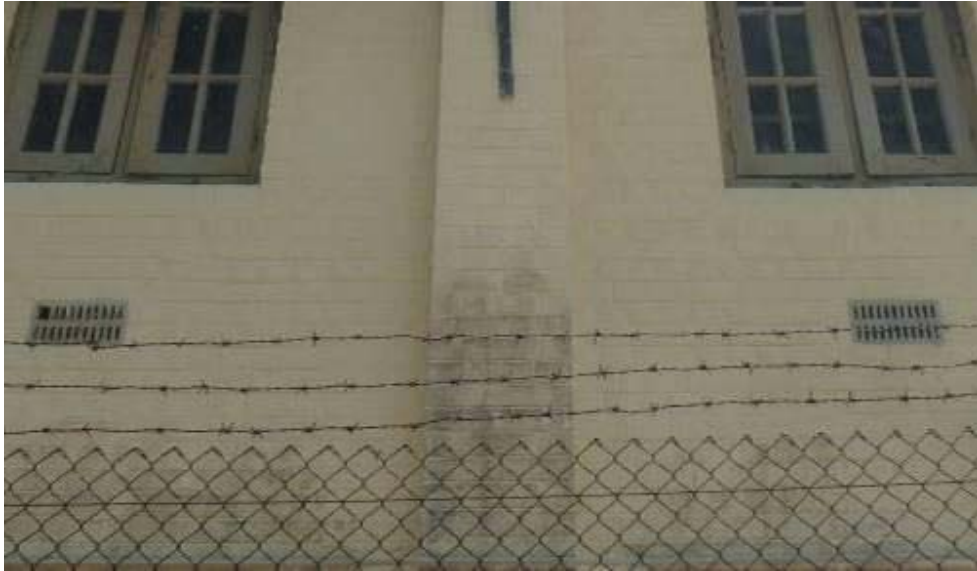
Item	Architectural Feature
2A.7	<p data-bbox="332 233 665 268"><u>Original Ventilation Grilles</u></p> <p data-bbox="332 268 1006 304">All historical cast iron ventilation grilles at G/F and 1/F.</p>

<b>Item</b>	<b>Architectural Feature</b>	<b>Required Treatments</b>
2A.7	<u>Original Ventilation Grilles</u>	<ul style="list-style-type: none"><li>a. All original ventilation grilles should be preserved in-situ.</li><li>b. The grilles should not be blocked to maintain its function.</li><li>c. Repair, de-rust and repaint any defective grilles as necessary.</li></ul>

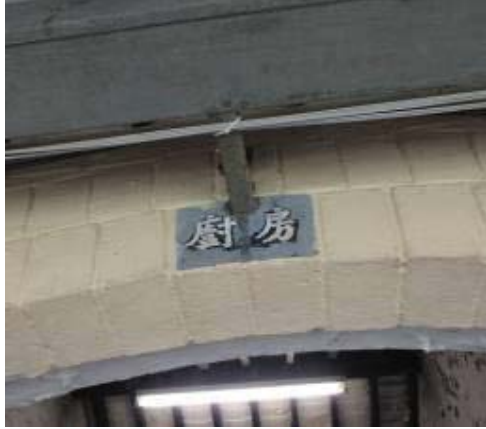
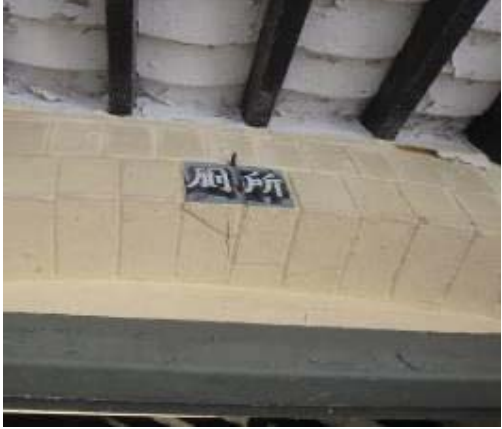
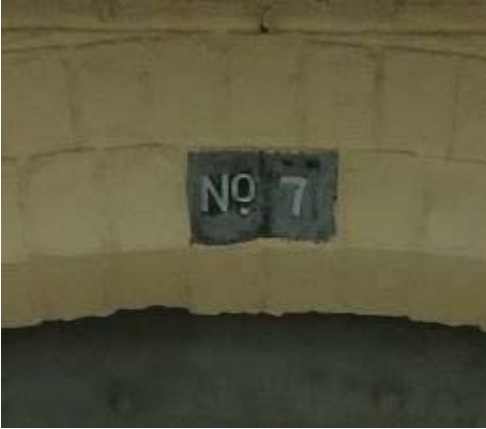
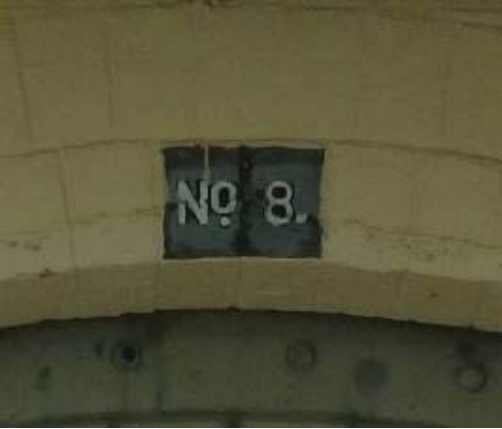
Item	Architectural Feature
2A.8	<p data-bbox="332 241 576 273"><u>Stencilled Signages</u></p> <p data-bbox="332 277 1453 340">All stencilled signages at external walls including those above or beside door openings showing the room nos. and the usage of the rooms.</p> <div data-bbox="370 409 852 835">

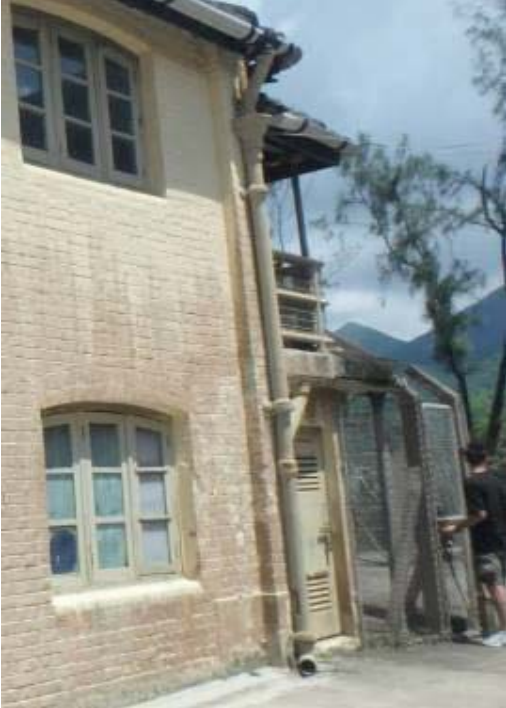
Item	Architectural Feature
2A.9	<p><u>Original Cast Iron Rainwater Pipe</u> All historical cast iron rainwater pipes including hopper, pipe works and their associated parts.</p>

Item	Architectural Feature	Required Treatments
2A.9	<u>Original Cast Iron Rainwater Pipe</u>	<ul style="list-style-type: none"> <li>a. Some of the rainwater pipes and the gutters have been altered or replaced with new materials. A research study on the original rainwater drainage system is to be conducted and the drainage system is to be restored by using the materials of the period as far as practicable.</li> <li>b. All historical cast iron rainwater pipes, including hopper, pipe works and their associated parts, should be preserved in-situ as far as practicable.</li> <li>c. Historical cast iron rainwater pipes and any defective part(s) of are to be repaired to restore its function. If defective pipework is beyond repair, the replacement pipework should be cast iron and painted to match existing.</li> </ul>

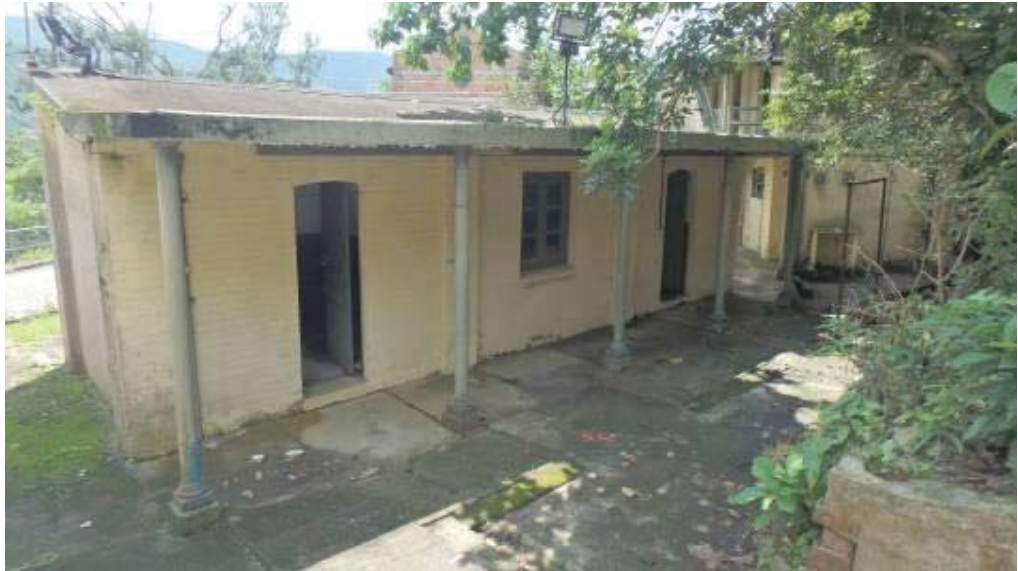
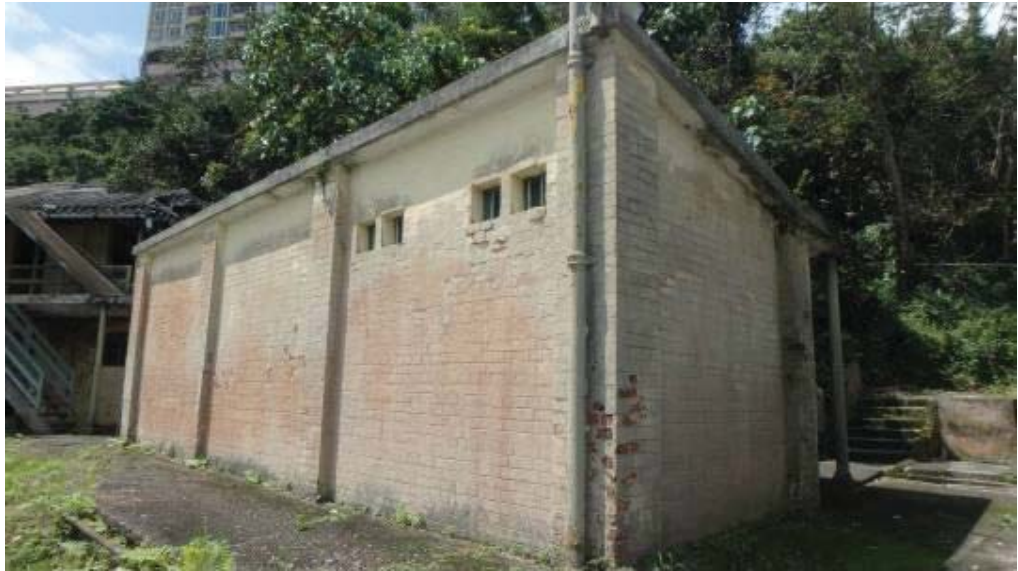
Item	Architectural Feature
2B.1	<p><u>Building Facades</u> All building facades with exposed columns and paint applied directly on brick walls.</p>

A photograph showing the south-west elevation of a single-story brick building. The building has a flat roof and is supported by several vertical concrete columns. The walls are painted a light yellowish-tan color. There are several doorways and windows visible. The building is situated outdoors with trees and a paved area in the foreground.	
<p>South-west elevation</p>

A photograph showing the north-east and north-west elevations of the same brick building. The building is a simple rectangular structure with a flat roof. The walls are made of brick and are painted a light tan color. There are several small, square windows near the roofline. The building is surrounded by trees and a paved area.	
<p>North-east and North-west elevations</p>

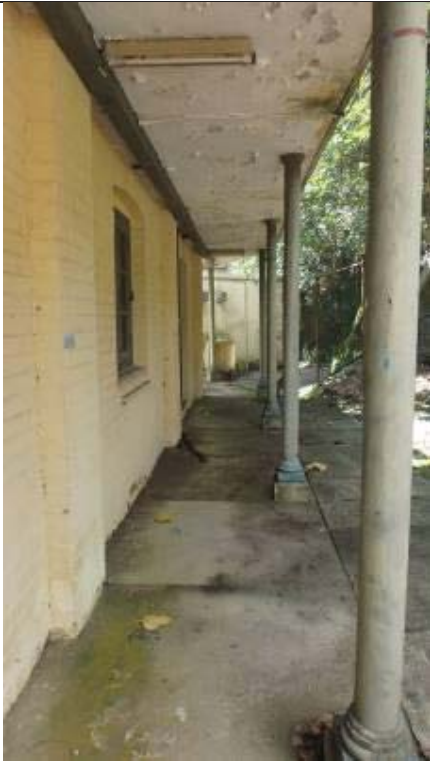
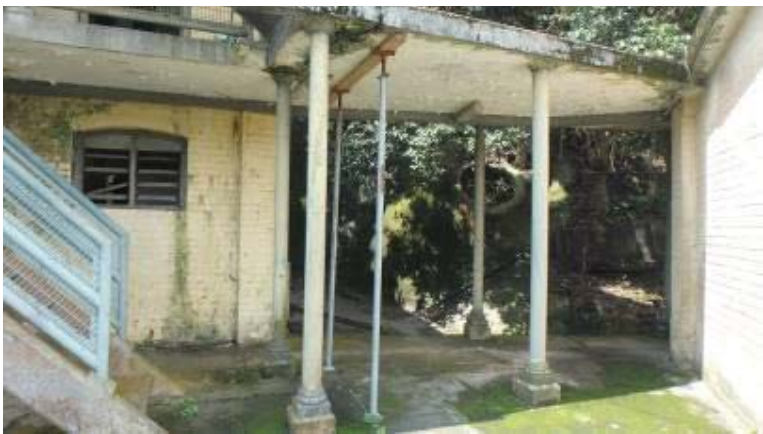
Item	Architectural Feature
2B.2	<p><u>Verandah on South-west Elevation and Covered walkway</u> Open verandah and covered walkway linking the Store Building and the Main Building supported by metal round columns with granite stones bases.</p>

<p>Verandah on the South-west elevation</p>

<p>Covered Walkway linking the Store and the Main Building</p>

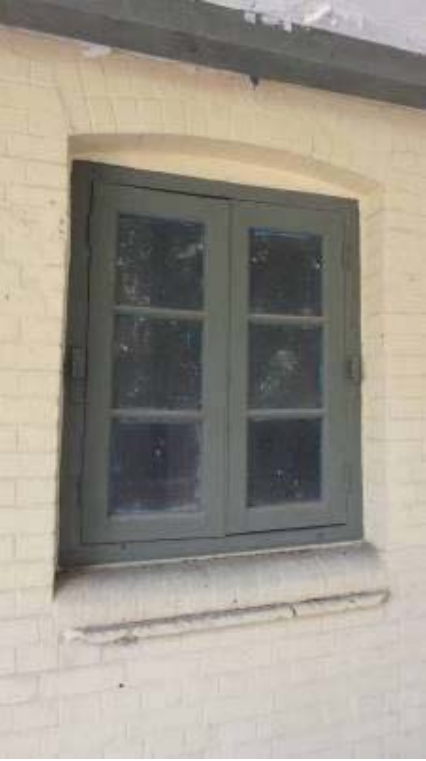
Item	Architectural Feature
2B.3	<p data-bbox="329 243 914 275"><u>Segmental Arched Wooden Casement Windows</u></p> <p data-bbox="329 279 1451 342">All original segmental arched wooden casement windows including the segmental arched brickworks, grid glazing patterns, rounded edge window sills and all ironmongeries.</p>

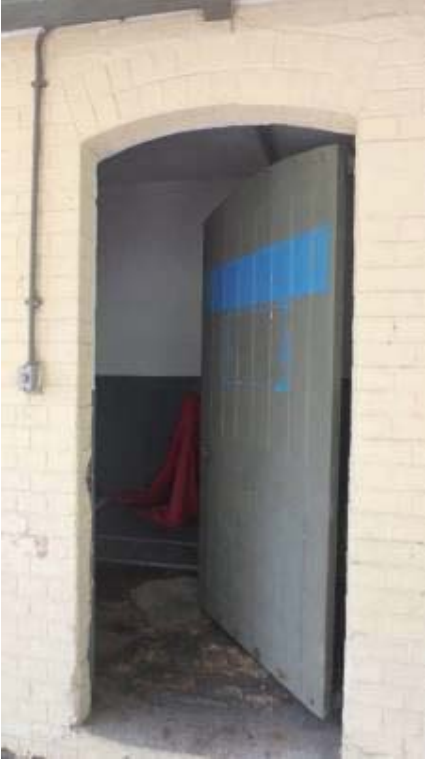
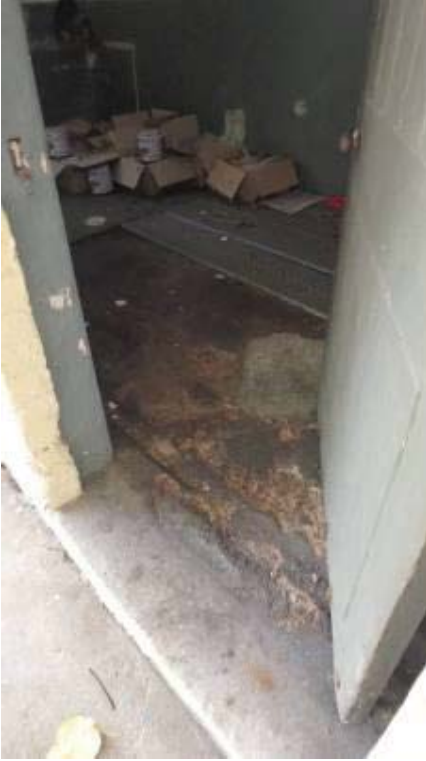
Item	Architectural Feature
2B.4	<p><u>Segmental Arched Wooden Doors</u> All original segmental arched wooden panel door including the original ironmongery, the segmental arched brickworks, and granite stones for the fixing of the hinges and granite thresholds.</p>
	<div data-bbox="402 443 824 1199">

</div> <p data-bbox="415 1220 812 1251">Segmental Arched Wooden Door</p> <div data-bbox="959 443 1382 1199">

</div> <p data-bbox="1065 1220 1276 1251">Granite threshold</p>

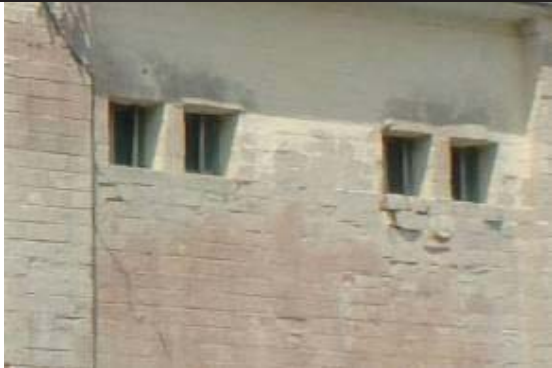
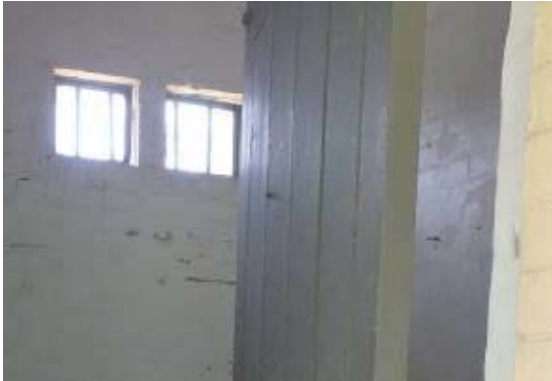
Item	Architectural Feature
2B.5	<p data-bbox="332 233 1177 304"><u>Ventilation Openings</u> All ventilation openings on the north-east elevation with metal grilles.</p>

<p data-bbox="651 724 1133 758">Ventilation openings view from exterior</p>

<p data-bbox="651 1171 1133 1205">Ventilation openings view from interior</p>

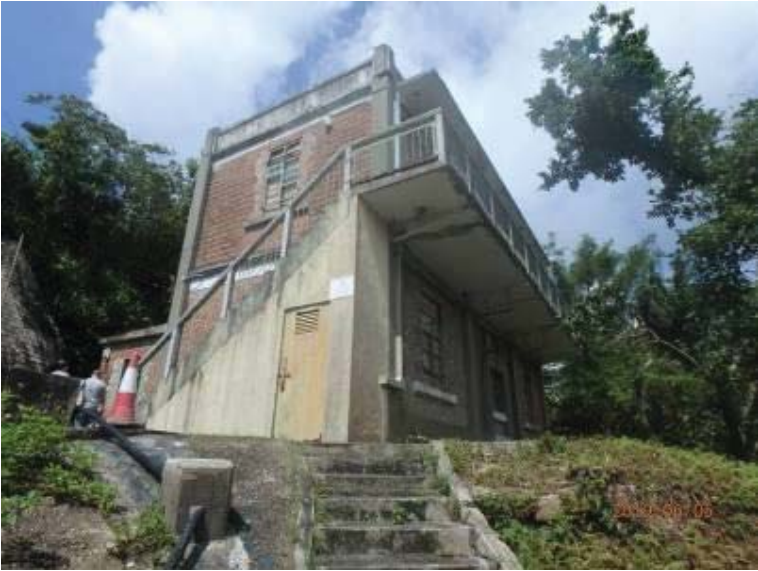
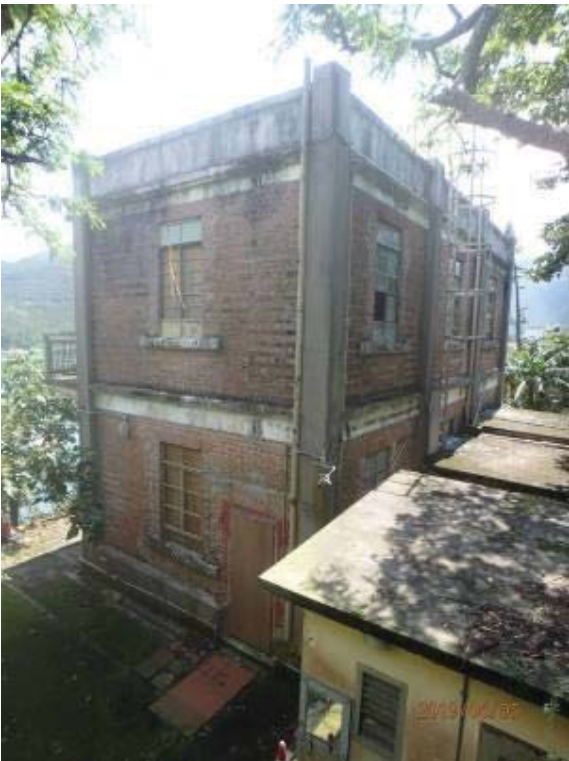
Item	Architectural Feature
3.1	<p data-bbox="332 289 548 319"><u>Building Facades</u></p> <p data-bbox="332 323 1437 390">All elevations including fair-faced red bricks, Shanghai plaster finishes on exposed columns and along the bottom of walls.</p> <div data-bbox="516 457 1269 1024">

A photograph showing the North and East elevations of the building. The structure is a two-story building with a prominent concrete balcony on the upper level. The facade is primarily composed of red bricks, with concrete elements around the balcony and entrance. A set of stone steps leads up to the entrance. The building is situated on a hillside with lush green trees in the background under a blue sky with scattered clouds.</div> <p data-bbox="734 1041 1052 1071">North and East Elevations</p> <div data-bbox="610 1087 1175 1843">

A photograph showing the South and West elevations of the building. This view highlights the brickwork and the concrete columns that support the balcony. The building is surrounded by trees, and a portion of a yellow structure is visible in the foreground. The sky is bright and clear.</div> <p data-bbox="734 1860 1052 1890">South and West Elevations</p>

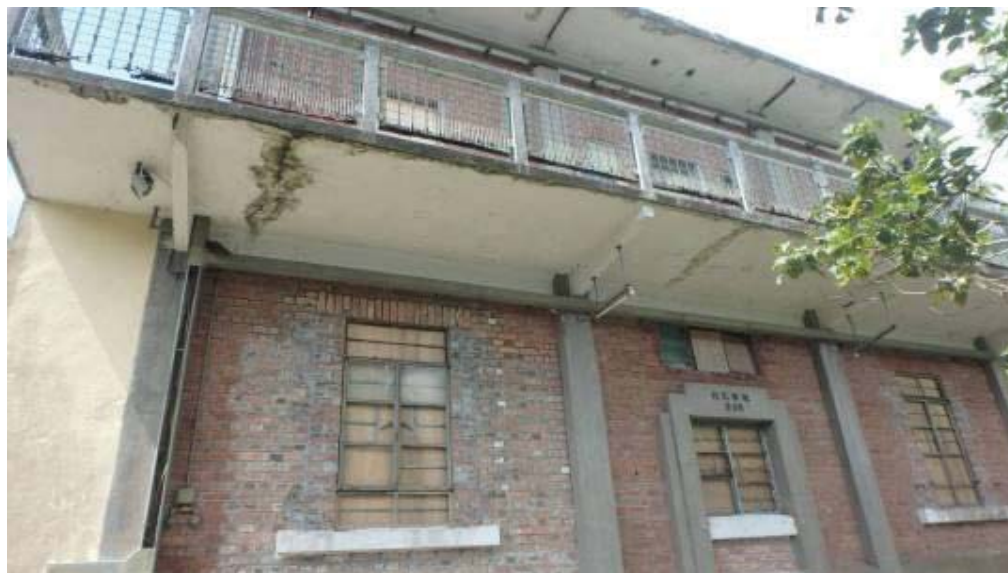
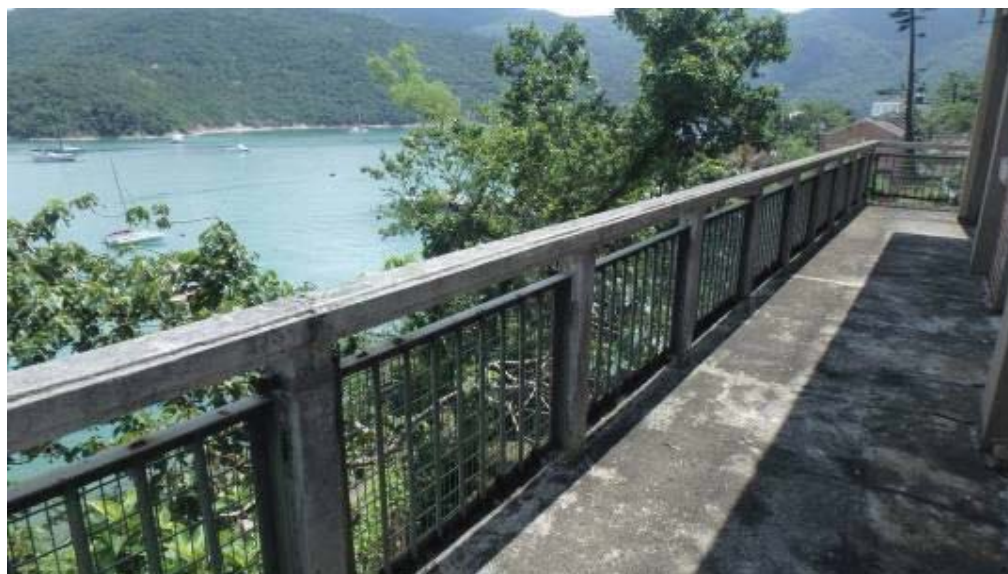
Open verandah including the concrete railings and posts of balustrades, the cantilevered slab and the concrete canopy.

Open verandah at 1/F

Metal balustrades with concrete railings and posts

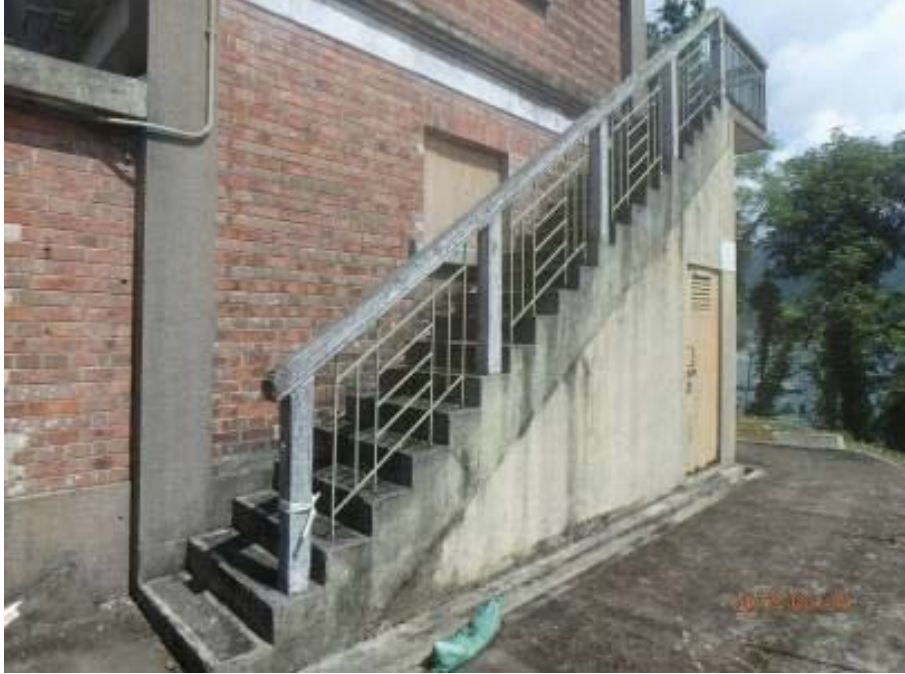
Item	Architectural Feature
3.3	<p><u>Open Staircase</u> Concrete open staircase connecting to the verandah on 1/F including the stairs, balustrade with concrete posts and railings and granolithic floor finishes.</p>

A photograph showing an external concrete staircase with metal railings and concrete posts. The stairs lead up to a verandah on the first floor of a brick building. The ground is paved with granolithic floor finishes. A small green object is visible on the ground near the base of the stairs.

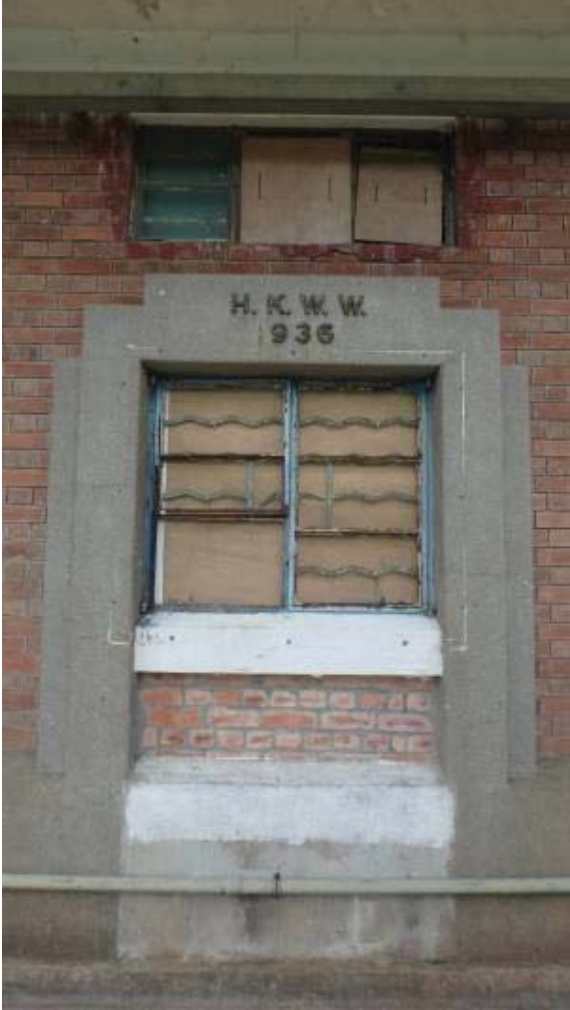
Item	Architctural Feature
3.4	<p><u>Doorcase of Original Main Entrance</u> Geometric doorcase of the original main entrance, including the Shanghai plaster finishes, and the signs of “H.K.W.W.” and “1936”.</p>

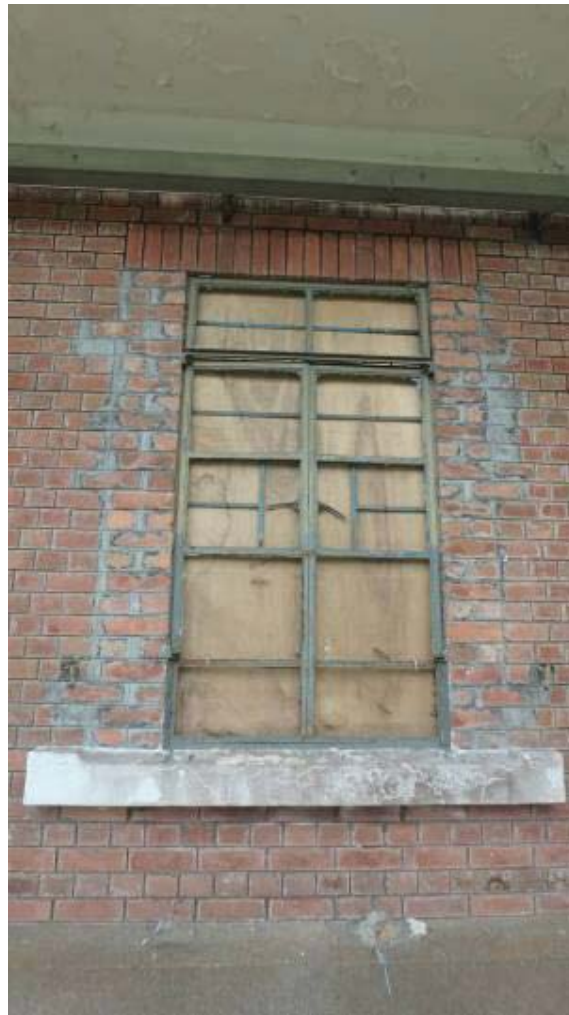
Window Head and Window Sill.

Brick window head and concrete window sill including the old ironmongeries at the sides. (The openings of the windows have been altered.)

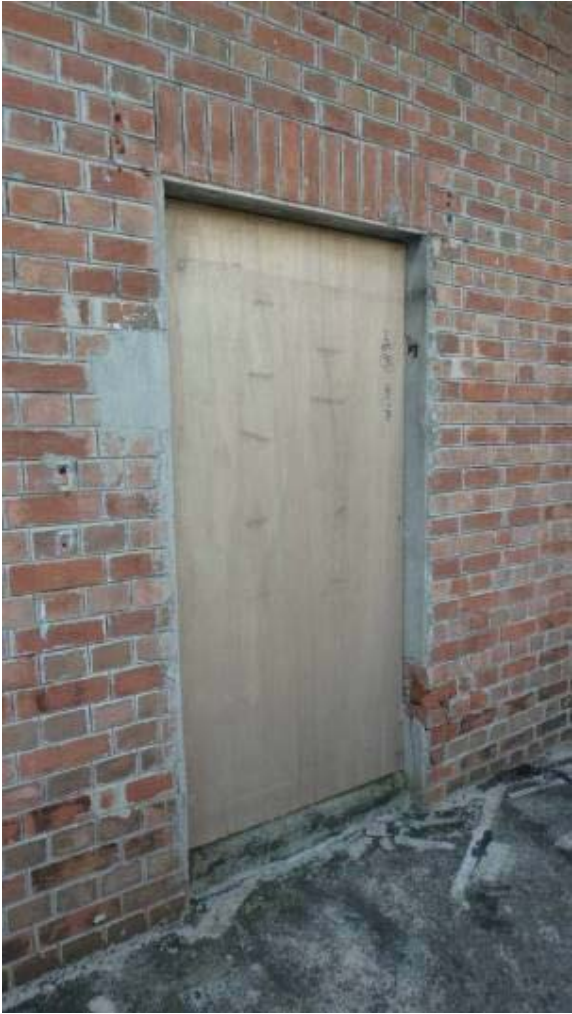
Item	Architectural Feature
3.6	<p data-bbox="332 233 836 304"><u>Door Openings</u> Door openings with brick door heads on 1/F.</p>

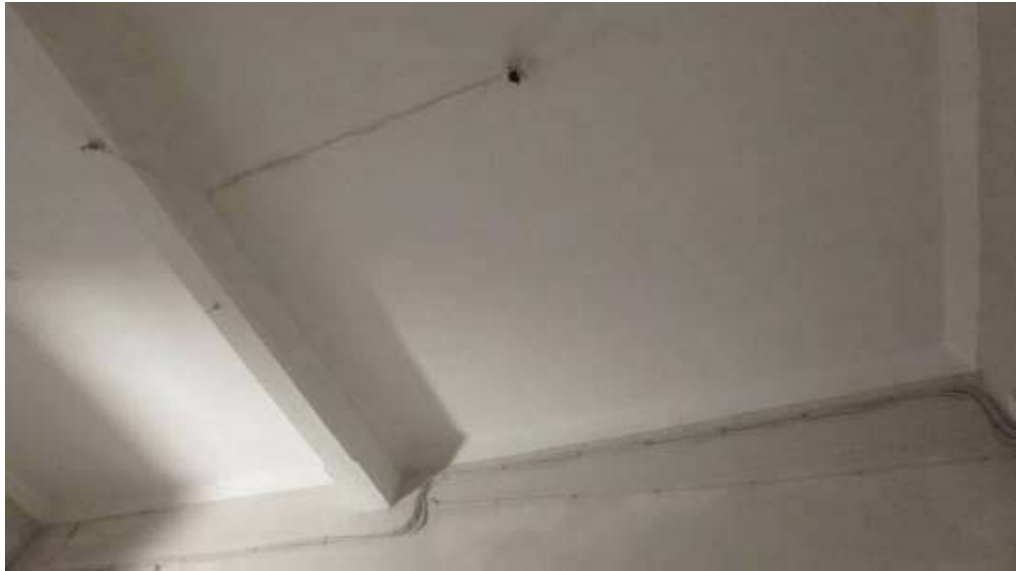
Item	Architectural Feature
3.8	<u>Coved Ceiling</u> All coved ceilings on G/F and 1/F.

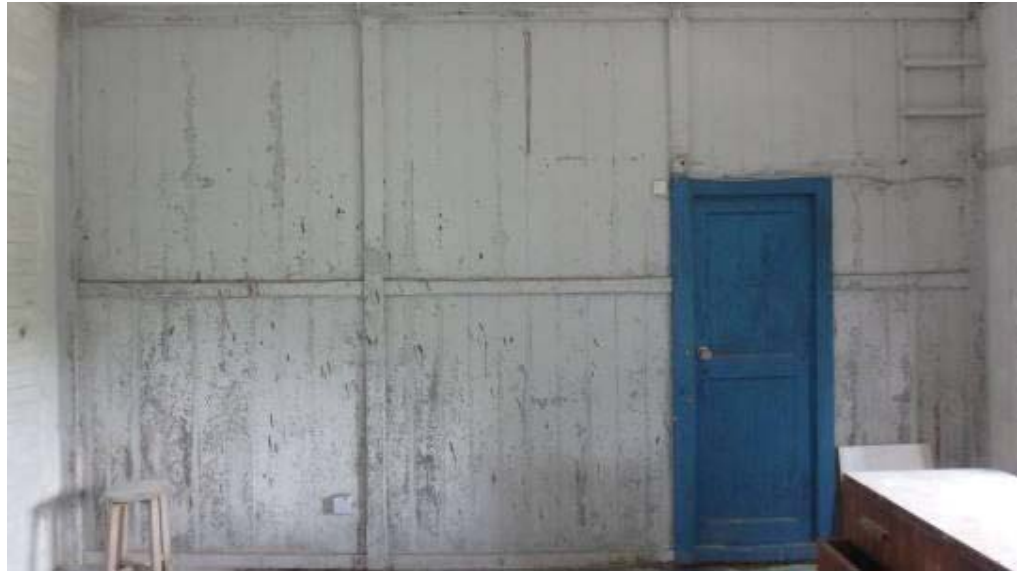
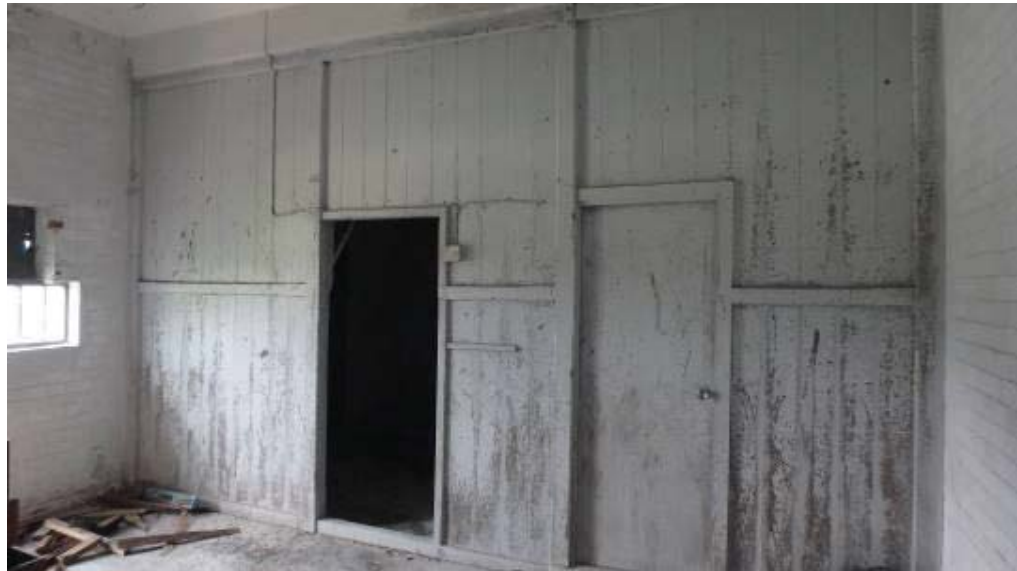
3.9

Wooden partitions on 1/F  
Wooden partitions on 1/F.

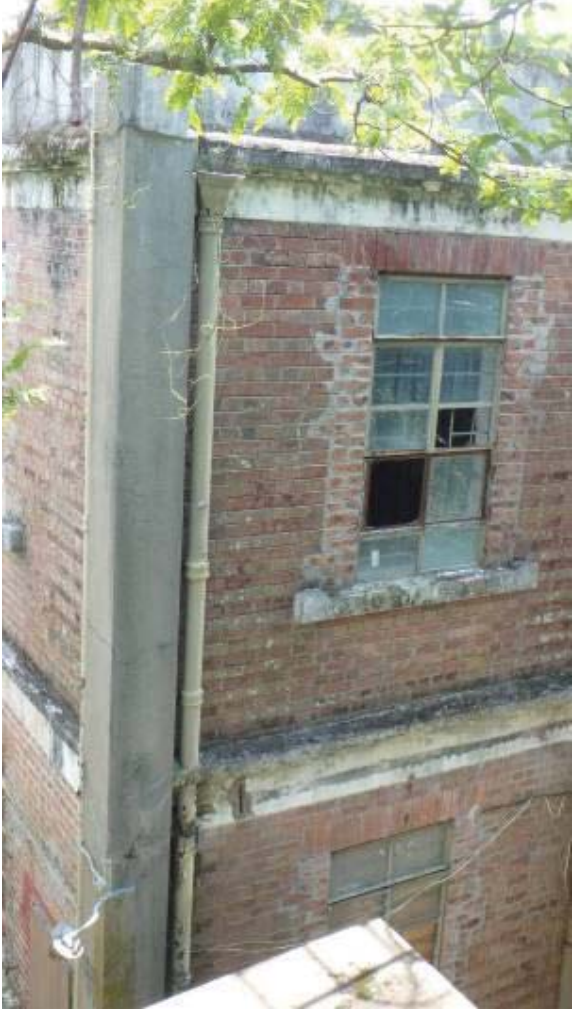
Item	Architectural Feature
3.10	<p><u>Original Cast Iron Rainwater Pipe</u> All historical cast iron rainwater pipes including hopper, pipe works and their associated parts.</p>

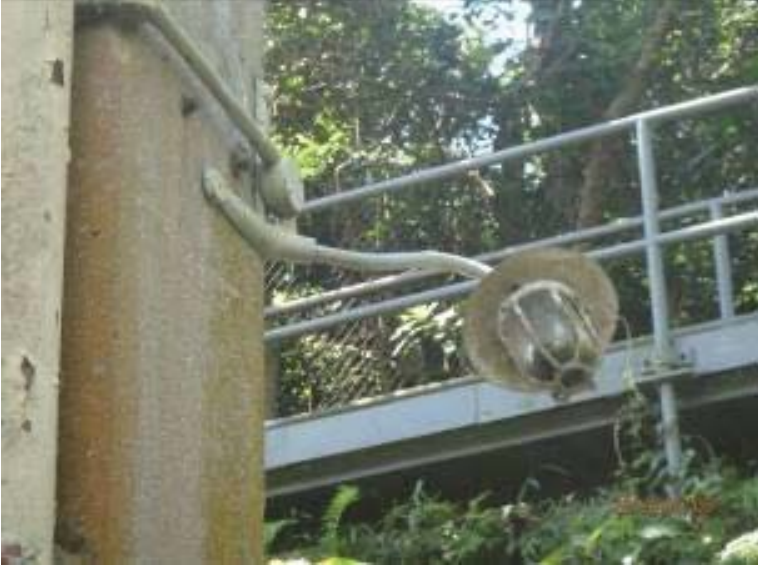
Item	Architectural Feature
3.11	<p data-bbox="332 239 581 268"><u>Historical wall lamp</u></p> <p data-bbox="332 275 829 304">The historical wall lamp at external wall.</p>

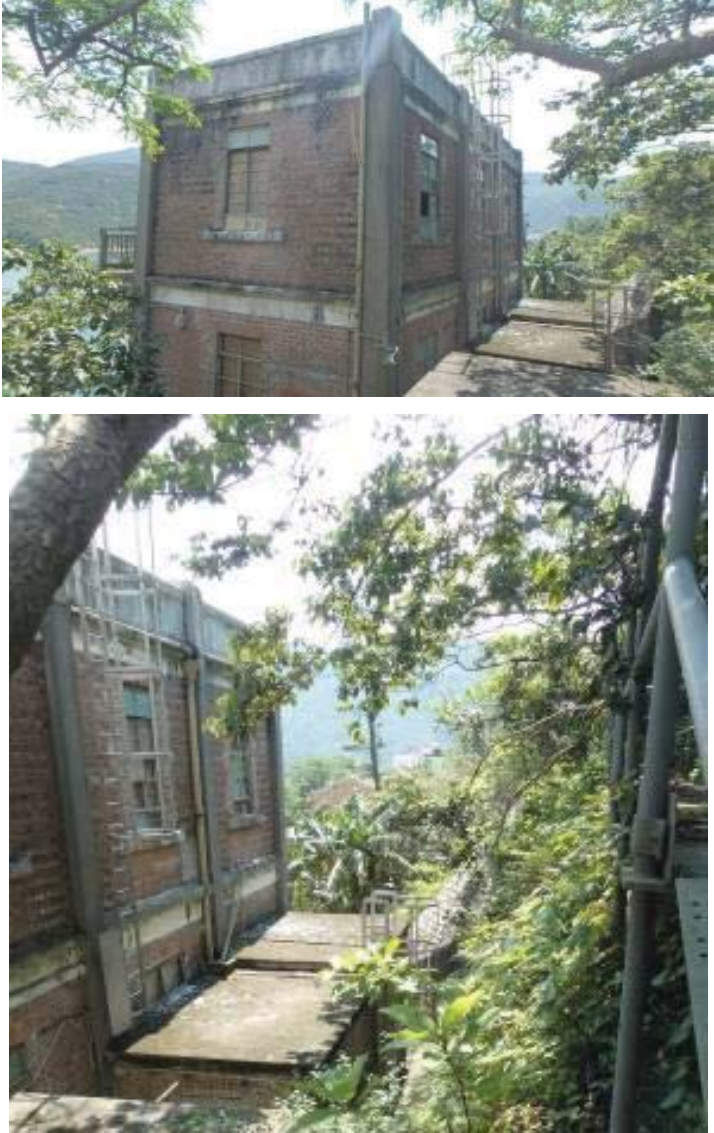
Item	Architectural Feature
3.12	<u>Flat Roofs</u> All flat roofs.

<p>The top photograph shows a two-story brick building with a flat roof, situated on a hillside. The building has several windows and a concrete walkway leading to it. The bottom photograph shows a similar view of the building from a different angle, highlighting the flat roof and the surrounding greenery.</p>

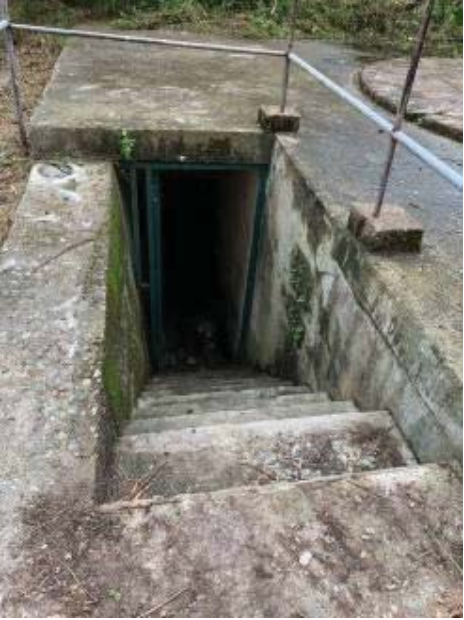
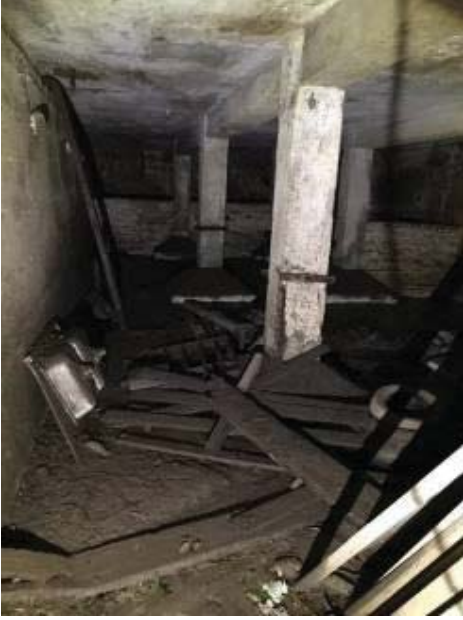
Item	Architectural Feature
4.1	<p><u>Existing Underground Cellar/ Air Raid Shelters</u> The existing Underground Cellar/ air raid shelters and all the associated staircase and tunnels, if any.</p>
	<div data-bbox="386 457 846 1073">

</div> <p data-bbox="407 1094 821 1125">Access to the Underground Cellar</p> <div data-bbox="943 457 1403 1073">

</div> <p data-bbox="964 1094 1382 1125">Interior of the Underground Cellar</p>

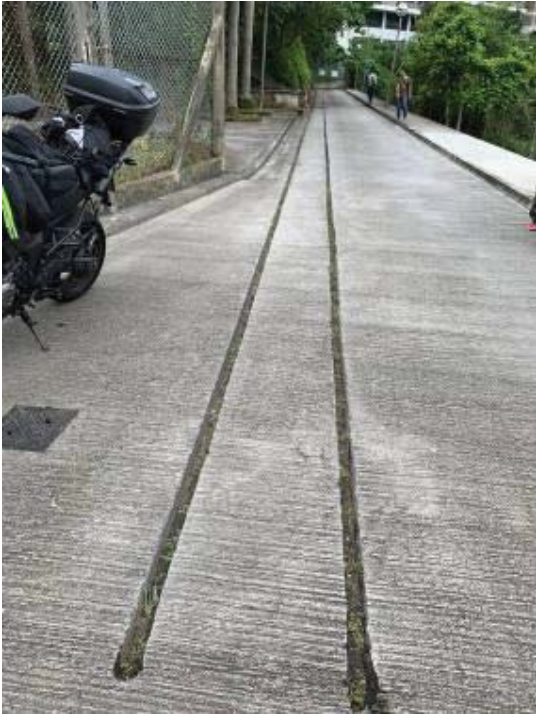
Item	Architectural Feature
4.2	<u>Old tracks</u> The old tracks for transportation of coal.

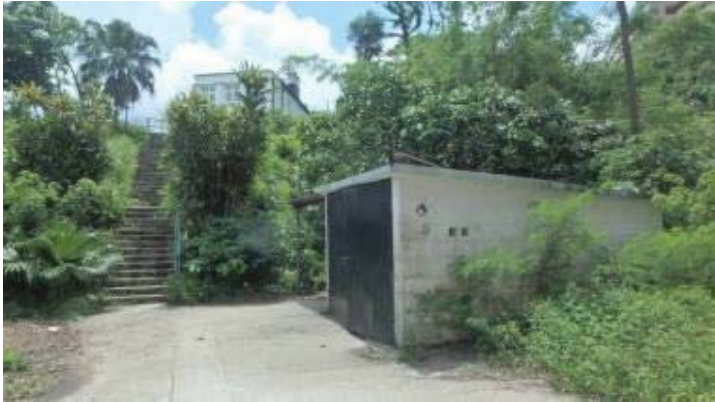
Item	Architectural Feature
4.3	<u>Garage</u> The garage building beside the Pumping Station including the shelter.

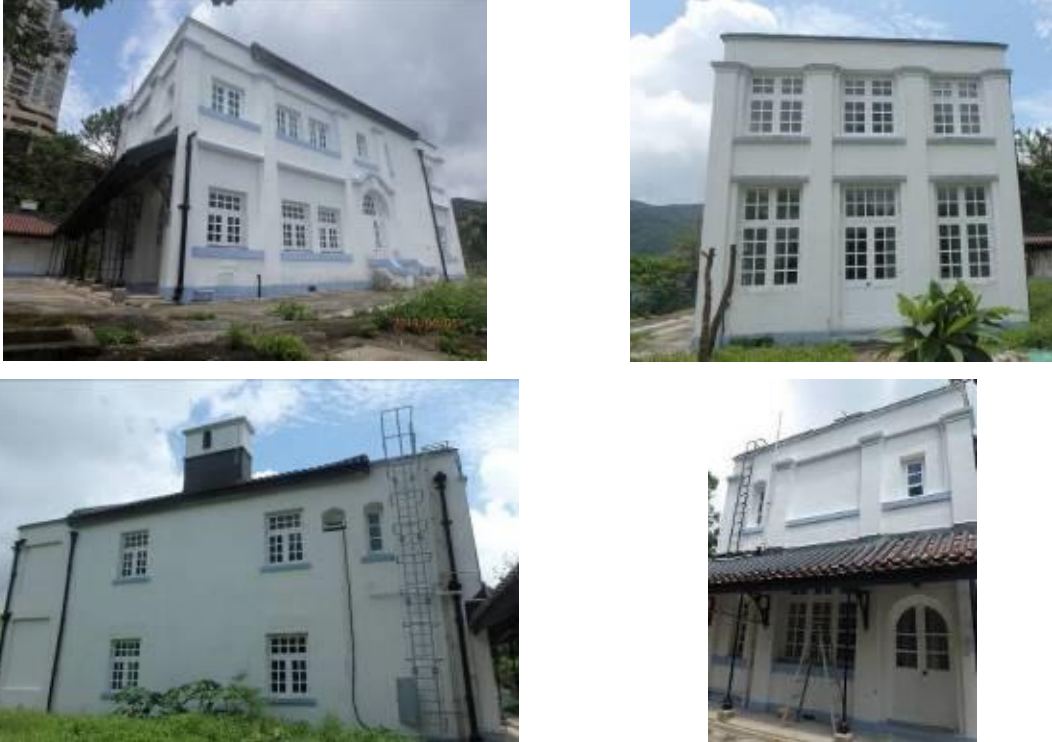
<b>Item</b>	<b>Architectural Feature</b>	<b>Required Treatments</b>
1A.1	<u>Building Facades</u>	<ul style="list-style-type: none"> <li>a. All elevations including classical architectural features should be generally kept intact except for restoration works and necessary alteration and addition works to meet current statutory requirements, subjected to Antiquities Authority's approval.</li> <li>b. Any restoration works should be based on further research and/or site investigations with sufficient evidence.</li> <li>c. Any alteration and addition works should be fully justified and carried out at less prominent area at the rear side in order to keep their visual impact on the declared monument and the landscape nearby to minimal and subjected to AMO and/or Antiquities Authority's approval as necessary if the Declared Monument is affected.</li> <li>d. Apart from Item 1A.1 b &amp; 1A.1 c, no new structures, awning, additional shading fins, equipment etc. should be installed on the building facades.</li> <li>e. Installation of new signage on the facade may be permitted provided that it will not overwhelm the existing elevation design and should be submitted to Antiquities Authority for approval.</li> <li>f. No alteration to the existing opening or blockage to openings or formation of new opening should be made unless approved by Antiquities Authority.</li> <li>g. Rendered walls and the features are to be repaired as necessary to match existing and repaint with reversible painting system and colour approved by Antiquities Authority.</li> </ul>

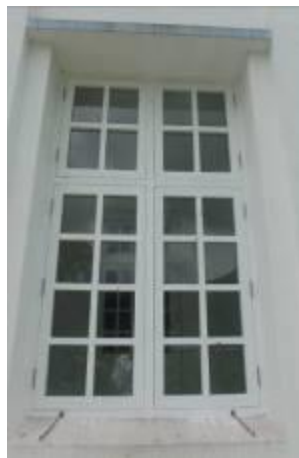
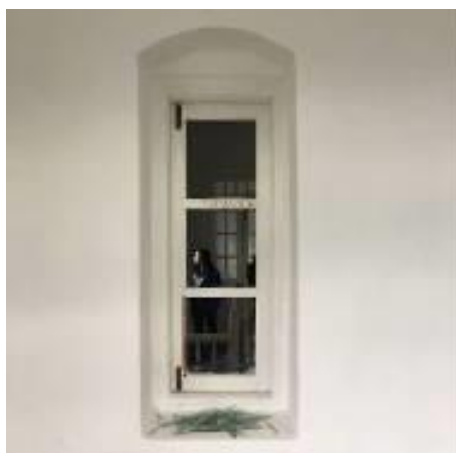
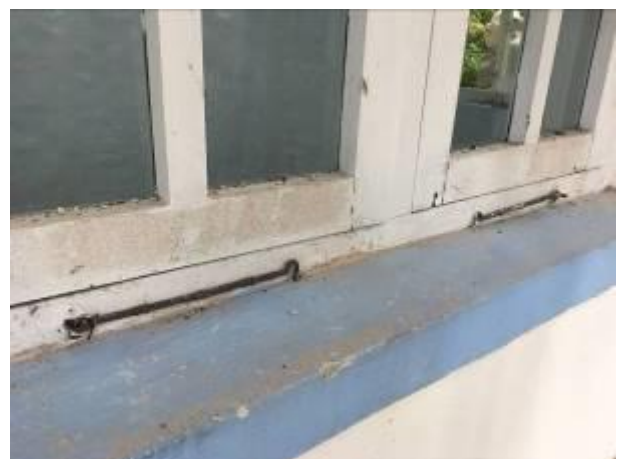
Item	Architectural Feature	Required Treatments
1A.2	<u>Wooden Windows</u>	<ul style="list-style-type: none"> <li>a. A research study on the window openings is to be conducted to find out if some of the window openings has been altered and the original design of the wooden windows. The study should be based on archival research and site investigations, and supplemented with photos, drawings, etc. for AMO's record.</li> <li>b. The window openings which have been altered should be restored to the original size with new wooden windows following the original design or similar design of the period, subjected to Antiquities Authority's approval.</li> <li>c. Other wooden windows with original openings including the window frames with mouldings at interior, grid glazing patterns, original ironmongeries, protruded window heads and window sills should be preserved in-situ as far as practicable with necessary repair works to match existing. If the wooden windows and ironmongeries are beyond repair, they are to be replaced with new wooden windows and ironmongeries based on the existing design, subjected to Antiquities Authority's approval.</li> <li>d. Wood preservative treatment are to be provided to all the timber elements.</li> </ul>

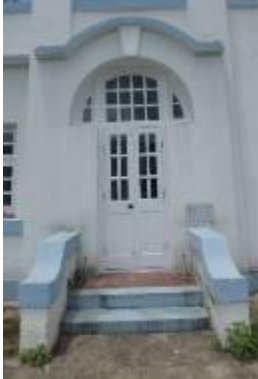
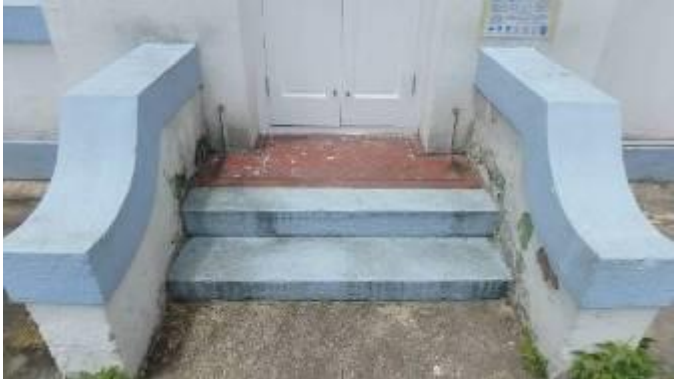
Item	Architectural Feature	Required Treatments
1A.3	<u>Entrance Porch and Main Entrance Door</u>	<ul style="list-style-type: none"> <li>a. The entrance porch and main entrance door including the steps and the patterned floor finishes, door threshold, the parapet walls, the arched fin and the keystone should be preserved in-situ.</li> <li>b. The original wooden French door with semi-circular arched fanlight including the door frame, grid glazing patterns and the original ironmongeries should be preserved in-situ.</li> <li>c. Any defective floor finishes, parapet walls, steps are to be repaired as necessary to match existing.</li> <li>d. If the wooden French door are beyond repair, they are to be replaced with new wooden door and ironmongeries based on existing design, subjected to Antiquities Authority's approval.</li> <li>e. Wood preservative treatment to all the timber elements is to be provided.</li> </ul>
