**Revitalising Historic Buildings  
Through Partnership Scheme**

**Tai Tam Tuk Raw Water Pumping Station  
Staff Quarters Compound**

**Resource Kit**

**Date: 27 November 2019**

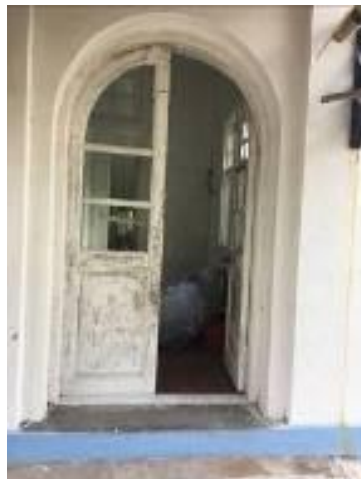
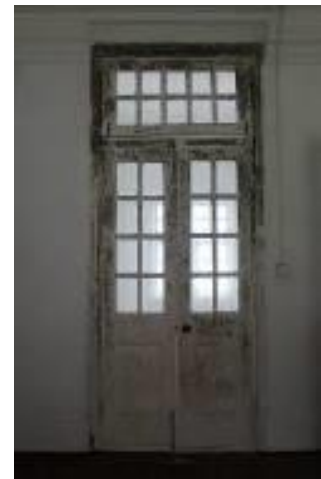
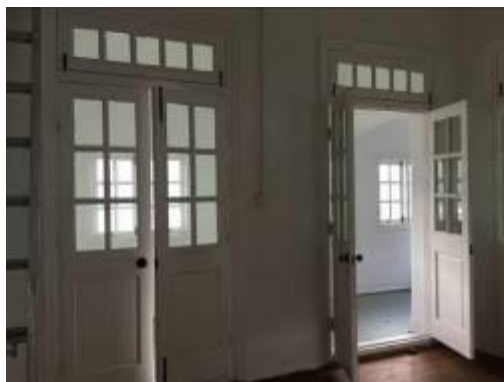
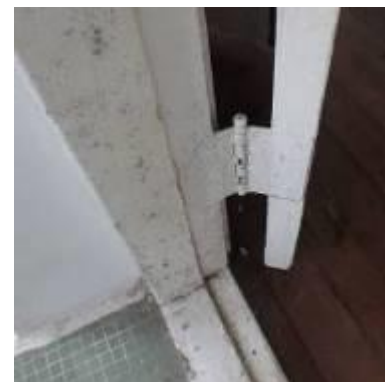
Item	Architectural Feature	Required Treatments
1A.4	<u>Side Entrance Door and Internal French Doors</u>	<ul style="list-style-type: none"> <li>a. A research study on the original door openings and the original French door design is to be conducted. The study should be based on archival research and site investigations, and supplemented with photos, drawings, etc. for AMO's record.</li> <li>b. For external doors, any later formed door openings at the external walls and any French doors replaced with altered design should be restored as far as practicable based on the research.</li> <li>c. For internal doors, the original French doors with original design door panels including the grid glazing patterns, door frames, top hung fanlight, original ironmongeries and arched opening should be preserved in-situ, while the French doors which have been replaced with altered design at original openings should be restored to the original design as far as practicable.</li> <li>d. If the wooden French doors are beyond repair, they are to be replaced with new wooden doors and ironmongeries based on the original design as far as practicable and subjected to Antiquities Authority's approval.</li> <li>e. Wood preservative treatment is to be provided to all the timber elements.</li> </ul>

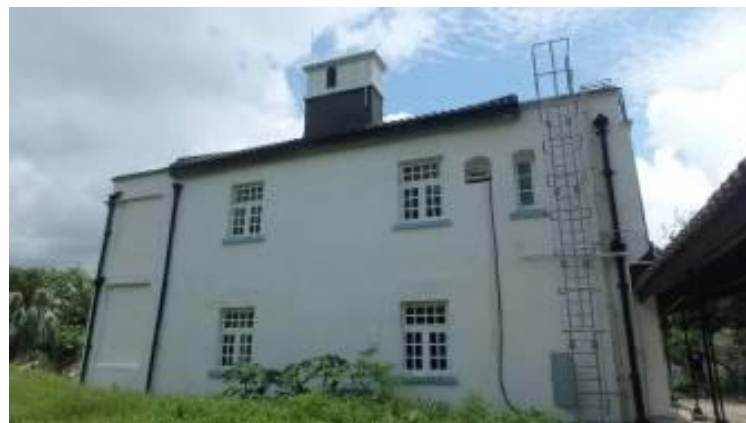
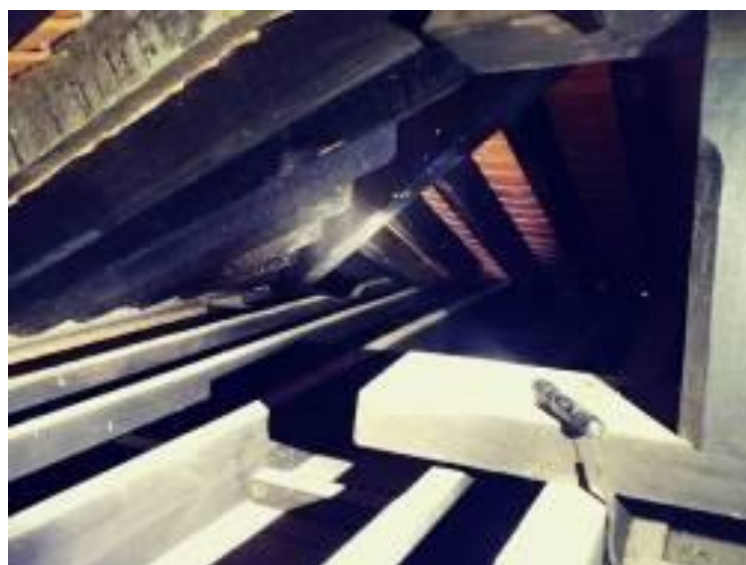
Item	Architectural Feature	Required Treatments
1A.5	<u>Hipped Roof at the Middle and Flat Roof at the Sides</u>	<ul style="list-style-type: none"> <li>a. The form and the materials of the roofs are not to be changed.</li> <li>b. The hipped roof with the double-layered Chinese pan and roll tiles are to be checked and repaired as necessary to maintain waterproof matching with existing.</li> <li>c. The structural condition is to be checked, the defective timber trusses, rafters and purlins are to be repaired as necessary. New replacement of the timber elements is acceptable if the elements are beyond repair and the replacements should follow the existing materials and design.</li> <li>d. Termite eradication and monitoring system is to be installed.</li> <li>e. The defective roofing membrane at flat roof is to be repaired as necessary.</li> <li>f. No construction of additional storey at roof is permitted.</li> <li>g. Installation of building services equipment, ductwork, pipeworks, etc. on the flat roof could be considered, provided that the new installations should be setback from the facades with no visual impact created to the declared monument and subjected to Registered Structural Engineer's confirmation that no structural strengthening works is necessary, and is subjected to Antiquities Authority's approval.</li> </ul>

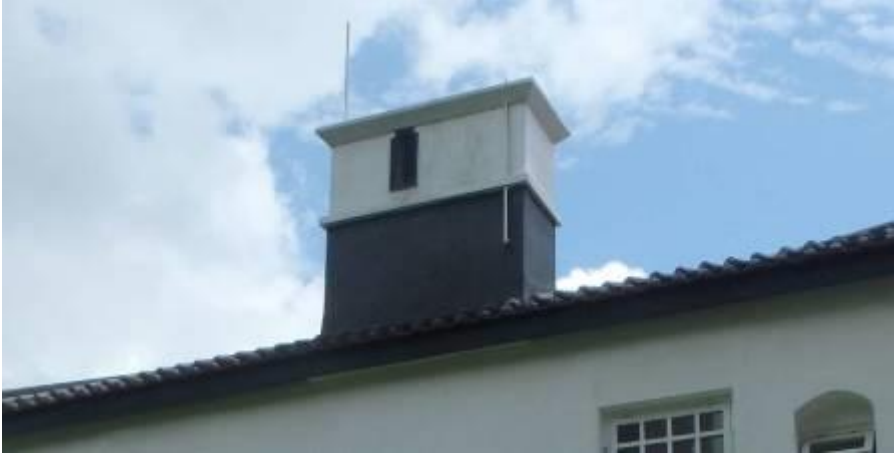
Item	Architectural Feature	Required Treatments
1A.6	<u>Chimney Stack</u>	<ul style="list-style-type: none"> <li>a. The chimneys on roof together with the chimney stack in the interior should be preserved in-situ</li> <li>b. Any defective brickworks are to be repaired as necessary and repaint to match existing.</li> <li>c. Blocking the openings of chimney at roof to prevent water seepage in a reversible manner may be considered provided that the appearance of the chimney is not affected.</li> </ul>

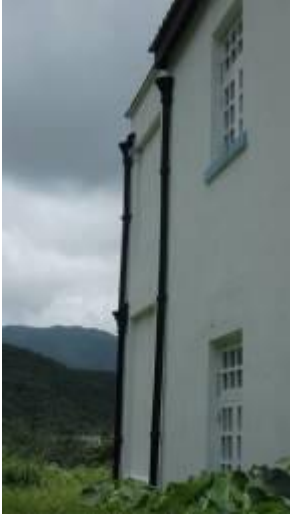
Item	Architectural Feature	Required Treatments
1A.7	<u>Original Cast Iron Rainwater pipe</u>	<ul style="list-style-type: none"> <li>a. All historical cast iron rainwater pipes, including hopper, pipe works and their associated parts, should be preserved in-situ as far as practical.</li> <li>b. Any defective part(s) of the drainage system are to be repaired and replaced as necessary. Any blockage in the drainage system is to be cleared to restore its function.</li> <li>c. If defective pipework is beyond repair, they should be replaced with cast iron pipework and to be painted to match existing.</li> </ul>

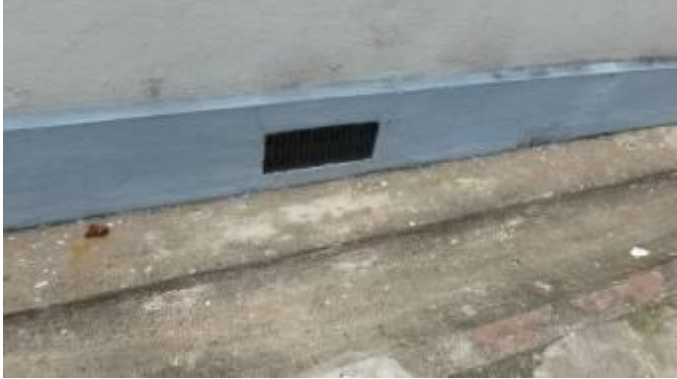
Item	Architectural Feature	Required Treatments
1A.8	<u>Original ventilation grilles</u>	<ol style="list-style-type: none"><li>a. All original ventilation grilles should be preserved in-situ.</li><li>b. The grilles should not be blocked to maintain its function.</li><li>c. Any defective grilles are to be repaired, de-rusted and repainted as necessary.</li></ol>

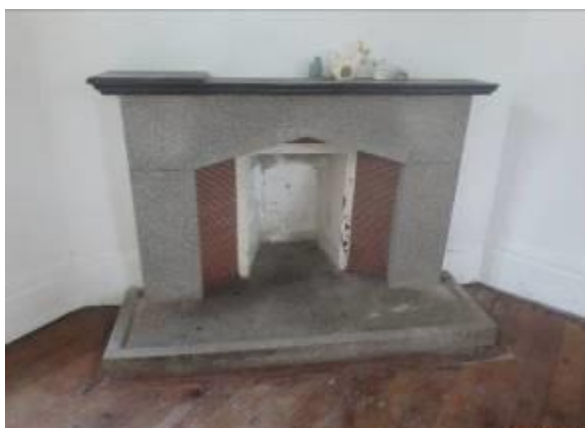
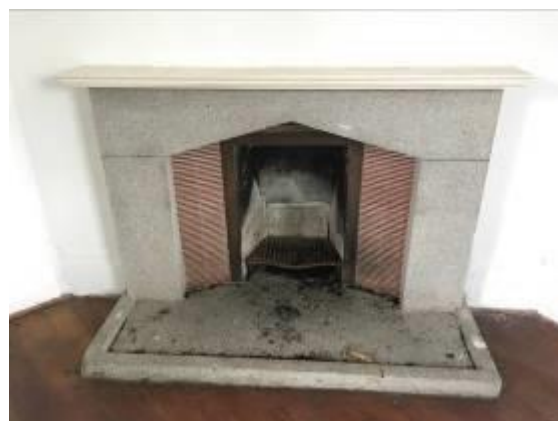
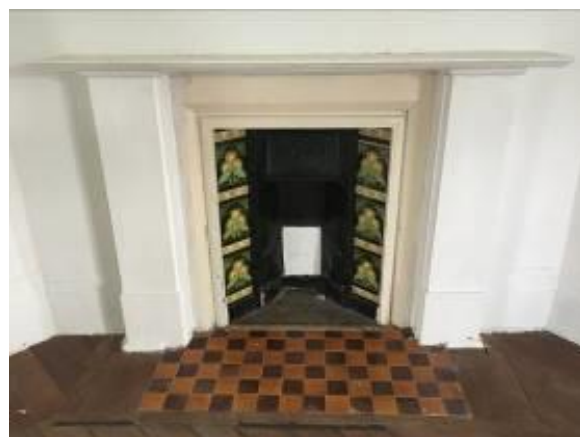
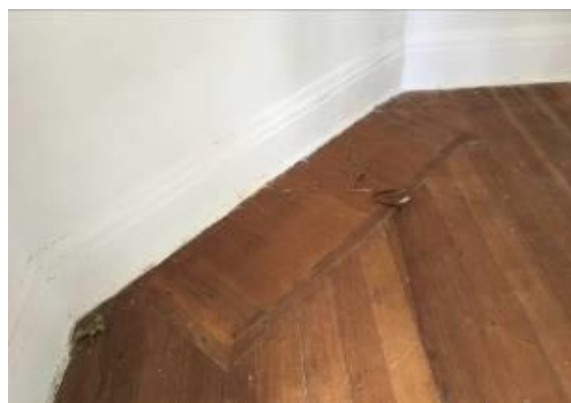
Item	Architectural Feature	Required Treatments
1A.9	<u>Fireplaces</u>	<ul style="list-style-type: none"> <li>a. The existing fireplaces including the tiling, shanghai plaster finishes, surrounds, grates, hearths and mantel shelves should be preserved in-situ and exposed to public for appreciation.</li> <li>b. The old fireplace mark on timber floor finishes should be preserved in-situ.</li> <li>c. Restoration of the fireplaces may be considered if sufficient evidence of the original design and appearance could be provided, subjected to the Antiquities Authority's approval.</li> <li>d. The fireplace is to be repaired as necessary and wood preservative treatment is to be provided to all the timber elements.</li> </ul>

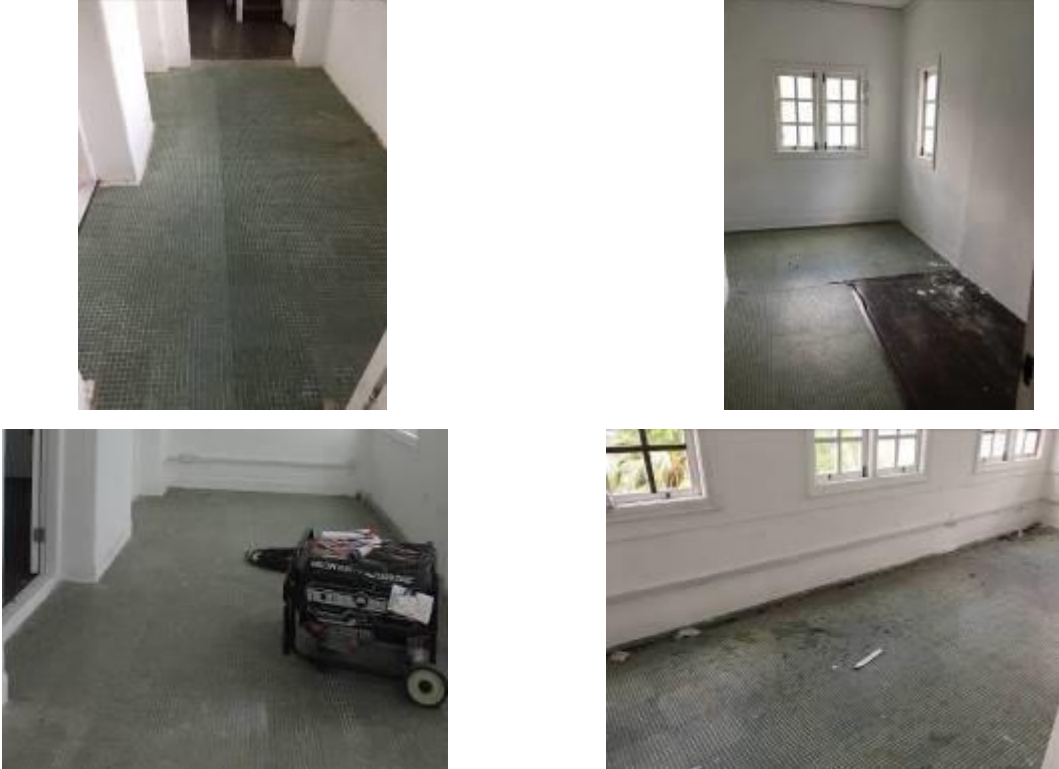
Item	Architectural Feature	Required Treatments
1A.10	<u>Mosaic Tiled Finishes</u>	<ul style="list-style-type: none"> <li>a. The green mosaic tiles including the drainage channels should be preserved in situ.</li> <li>b. The mosaic tiled finishes are to be cleaned and defective tiles are to be repaired as necessary for public appreciation.</li> </ul>

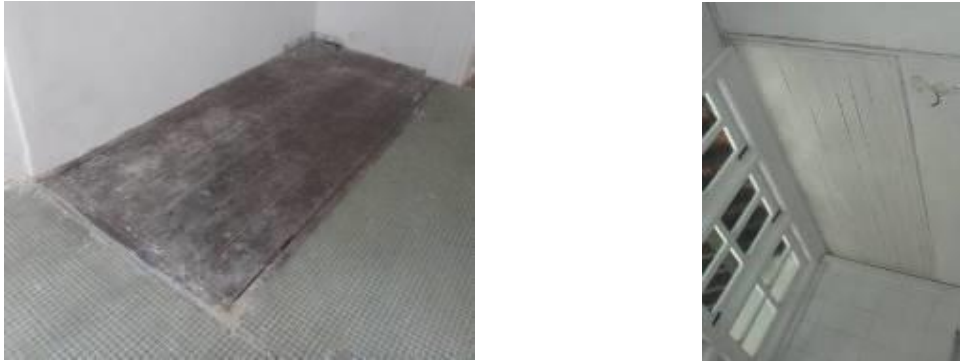
Item	Architectural Feature	Required Treatments
1A.11	<u>Timber Floor Cover</u>	<ul style="list-style-type: none"> <li>a. The timber floor cover should be preserved in-situ as far as practicable.</li> <li>b. The timber floor cover is to be repaired and wood preservative treatment is to be provided to all the timber elements and the existing defective elements is to be replaced based on the existing materials as necessary.</li> <li>c. Covering the timber floor cover in a reversible manner may be permitted, subjected to Antiquities Authority's approval.</li> </ul>

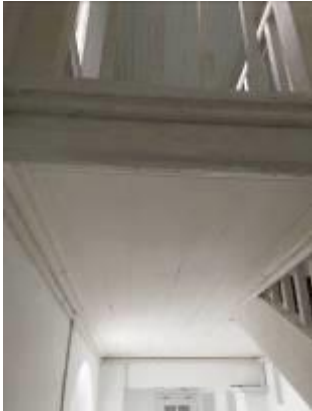
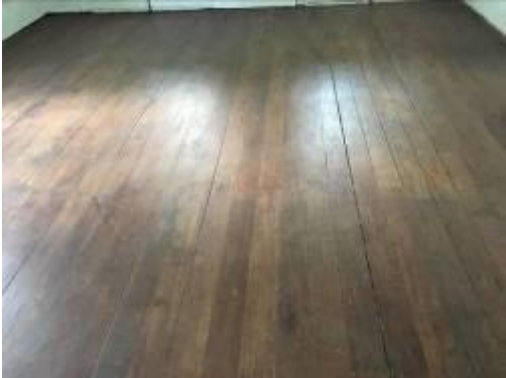
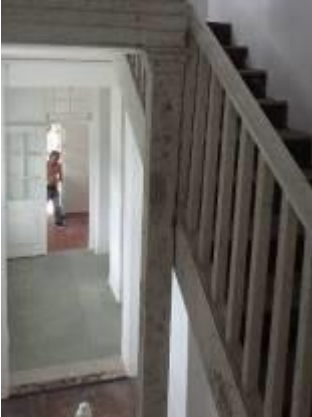
Item	Architectural Feature	Required Treatments
1A.12	<u>Timber Floor System</u>	<ul style="list-style-type: none"> <li>a. The timber floor system including the timber floor joists, timber column and timber floor finishes should be preserved in-situ.</li> <li>b. The timber floor system is to be repaired as necessary and wood preservative treatment is to be provided to all the timber elements.</li> <li>c. New replacement of the elements is acceptable if the elements are beyond repair and the replacements should follow the existing structural systems and materials.</li> <li>d. Upgrading of timber floor system to suit modern statutory requirements and operation needs in a reversible manner may be permitted, subjected to the advice from the Registered Structural Engineer, and is subjected to Antiquities Authority's approval.</li> <li>e. Covering the timber floor finishes in a reversible manner may be considered, and is subjected to Antiquities Authority's approval.</li> </ul>

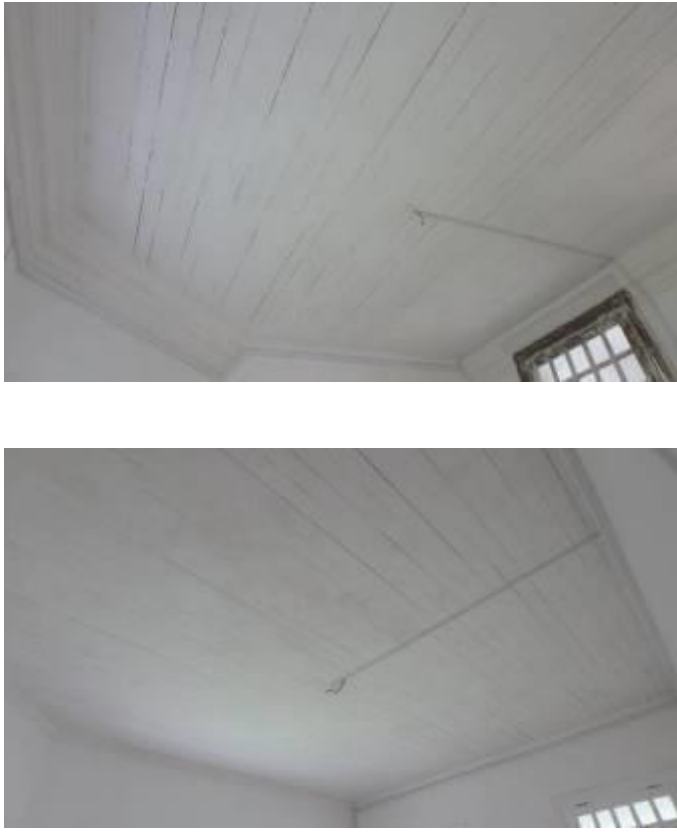
Item	Architectural Feature	Required Treatments
1A.13	<u>Timber Suspended Ceiling</u>	<ul style="list-style-type: none"> <li>a. The timber suspended ceiling including crown moulding on G/F and 1/F should be preserved in-situ.</li> <li>b. The timber suspended ceiling is to be repaired as necessary and wood preservative treatment is to be provided to all the timber elements.</li> <li>c. New replacement of the elements is acceptable if the elements are beyond repair and the replacements should follow the existing materials and design.</li> <li>d. If upgrading works of 1/F timber floor system is necessary upon the advice from the Registered Structural Engineer, dismantle and reinstatement of the timber suspended ceiling for the upgrading works may be permitted, subjected to Antiquities Authority's approval.</li> </ul>

<p>The image contains two photographs of a timber suspended ceiling. The top photograph shows a close-up view of the ceiling with a decorative crown moulding at the junction of the ceiling and the wall. The bottom photograph shows a wider view of the same ceiling, highlighting the parallel wooden slats and the crown moulding.</p>

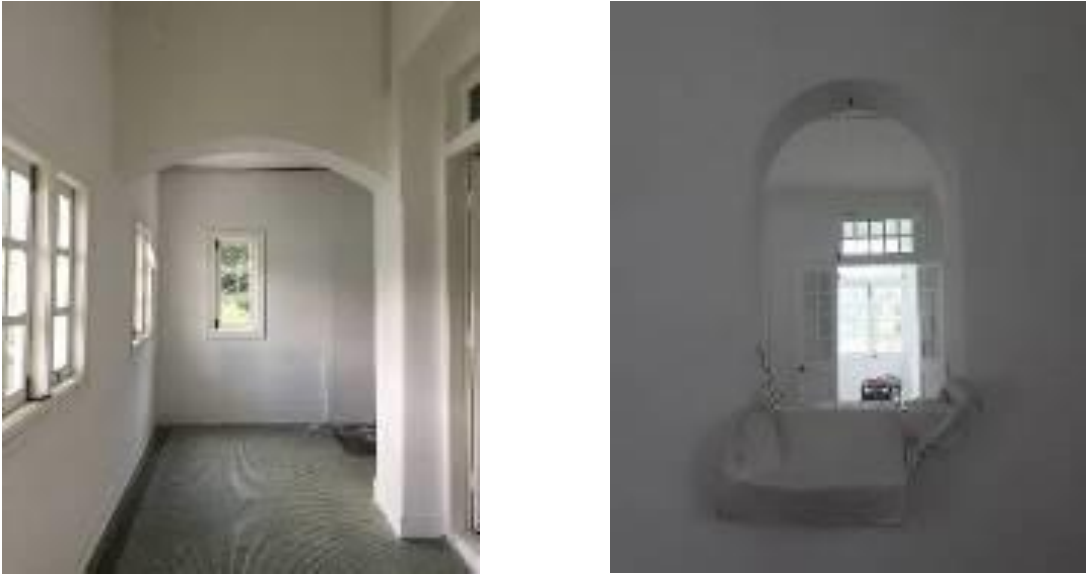
Item	Architectural Feature	Required Treatments
1A.15	<u>Internal Arched Doorway and Opening</u>	<p>a. The segmental arched doorway at Hallway 3 on 1/F and arched opening between Bedroom 1 and Sitting Room 1 on G/F are not to be altered.</p> <p>b. Blocking of the opening by glass door or glass panel in a reversible manner to suit operation needs may be permitted, subjected to Antiquities Authority's approval.</p>

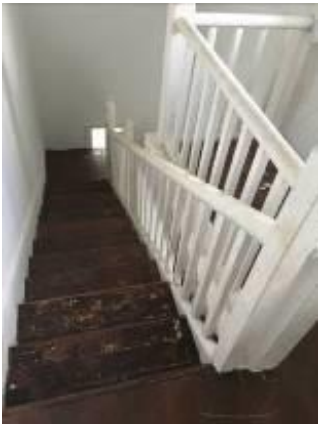
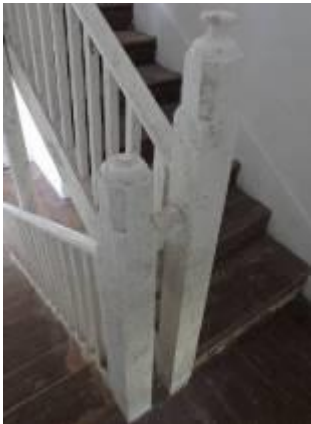
Item	Architectural Feature	Required Treatments
1A.16	<u>Original Timber Staircase</u>	<ul style="list-style-type: none"> <li>a. The original timber staircase, including the timber balustrades, railings and steps, should be preserved in-situ.</li> <li>b. The original timber staircase is to be repaired as necessary and wood preservative treatment is to be provided to all the timber elements.</li> <li>c. New replacement of the elements is acceptable if the elements are beyond repair and the replacements should follow the existing materials and design.</li> <li>d. Upgrading works to the existing handrails and balustrades as required by statutory requirements that are installed in a reversible manner may be considered. The design should be distinguishable from and compatible with the existing handrails and balustrades and is subjected to Antiquities Authority's approval.</li> </ul>
<div style="display: flex; justify-content: space-around;">

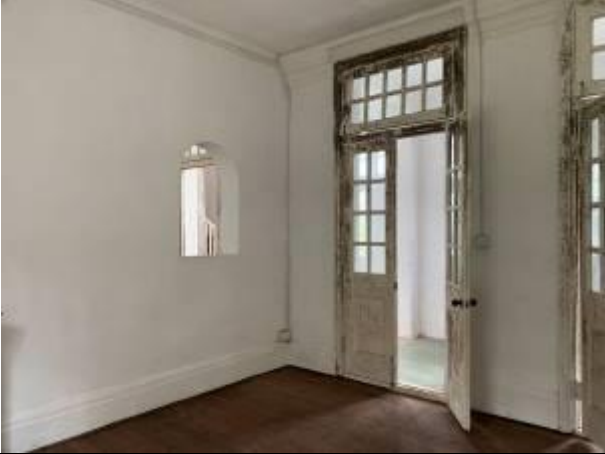
<b>Item</b>	<b>Architectural Feature</b>	<b>Required Treatments</b>
1A.18	<u>Internal walls</u>	<p>a. Any damage sections of the walls is to be repaired by using materials matching existing as necessary.</p> <p>b. The existing interior planning should be kept intact in general. Alteration to the existing walls or addition of new partitions is not allowed unless approved by Antiquities Authority, and is subjected to the advice of a Registered Structural Engineer.</p>

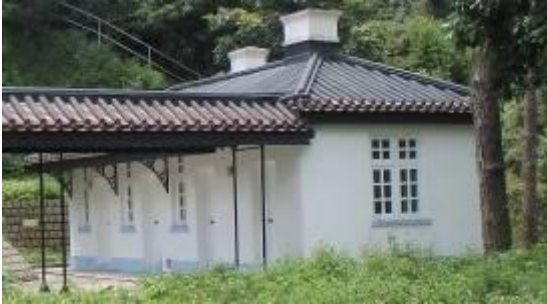
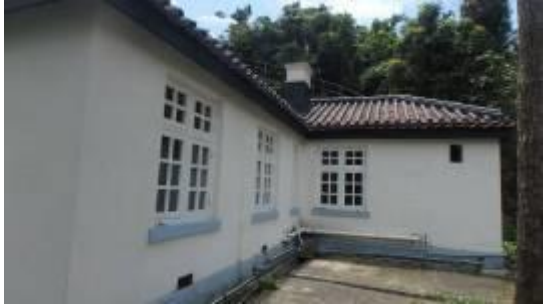
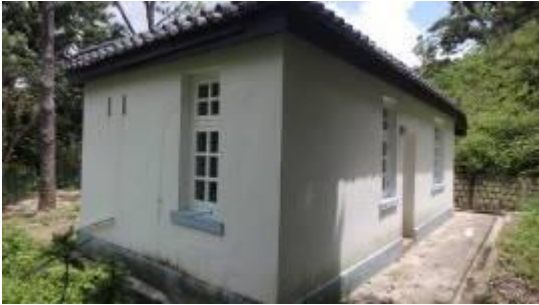
Item	Architectural Feature	Required Treatments
1B.1	<u>Building Facades</u>	<ul style="list-style-type: none"> <li>a. All elevations with painted rendered walls should be generally kept intact except for restoration works, subjected to Antiquities Authority’s approval.</li> <li>b. Any restoration works should be based on further research and/or site investigations with sufficient evidence.</li> <li>c. No new structures, awning, additional shading fins, equipment etc. should be installed on the building facades.</li> <li>d. Installation of new signage on the facade may be permitted provided that it will not overwhelm the existing elevation design and should be submitted to Antiquities Authority for approval.</li> <li>e. No alteration to the existing opening or blockage to openings or formation of new opening should be made unless approved by Antiquities Authority.</li> <li>f. The rendered walls and the features are to be repaired as necessary to match existing and to be repainted with reversible painting system and colour approved by Antiquities Authority.</li> </ul>

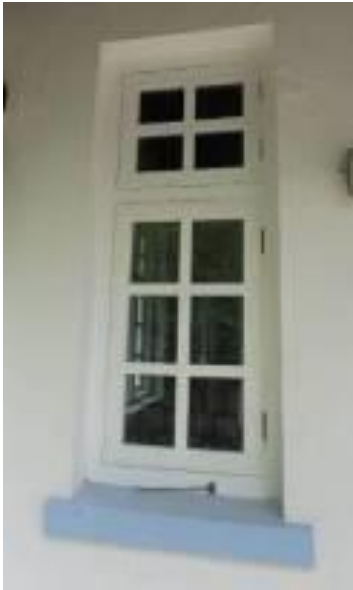
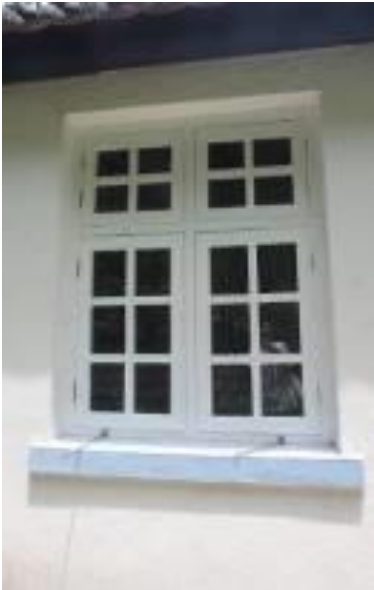
Item	Architectural Feature	Required Treatments
1B.2	<u>Wooden Casement Windows</u>	<ul style="list-style-type: none"> <li>a. All wooden windows with original openings including all window frames, ironmongeries, grid glazing patterns and protruded windows sills should be preserved in-situ as far as practical with necessary repair works to match existing.</li> <li>b. If the wooden windows and ironmongeries are beyond repair, they are to be replaced with new wooden windows and ironmongeries based on the existing design, subjected to Antiquities Authority's approval.</li> <li>c. Wood preservative treatment is to be provided to all the timber elements.</li> </ul>
<div style="display: flex; justify-content: space-around; align-items: center;">

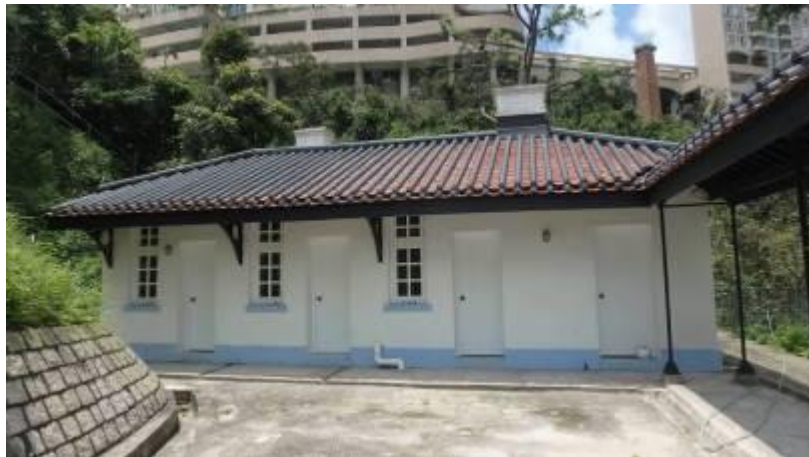
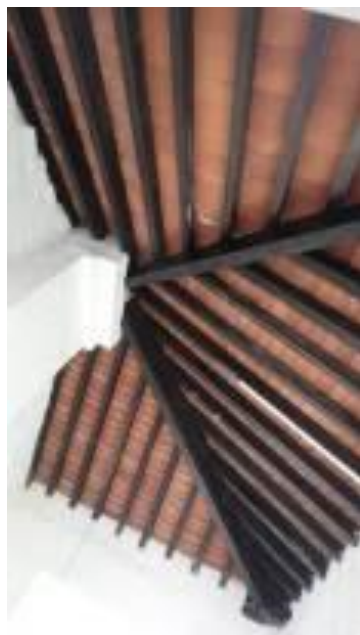
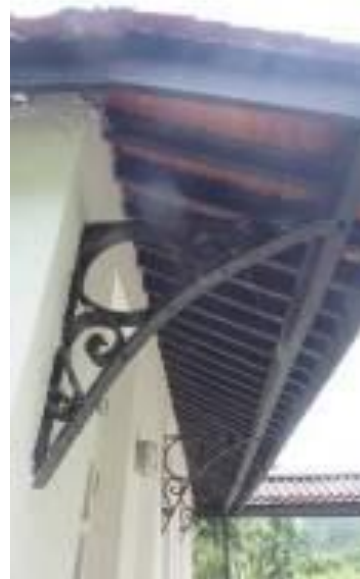
Item	Architectural Feature	Required Treatments
1B.3	<u>Hipped Roof with Double-layered Chinese Pan and Roll tiles</u>	<ul style="list-style-type: none"> <li>a. The form and the materials of the roofs are not to be changed.</li> <li>b. The hipped roofs with the double-layered Chinese pan and roll tiles are to be checked and repaired to maintain waterproof matching existing.</li> <li>c. Structural condition is to be checked and the defective timber trusses, rafters and purlins are to be repaired as necessary.</li> <li>d. The ornamental cast iron brackets are to be repaired and repainted as necessary.</li> <li>e. Wood preservative treatment is to be provided to all the timber elements and termite eradication and monitoring system is to be installed.</li> <li>f. At least part of the timber structure should be exposed for public appreciation.</li> </ul>

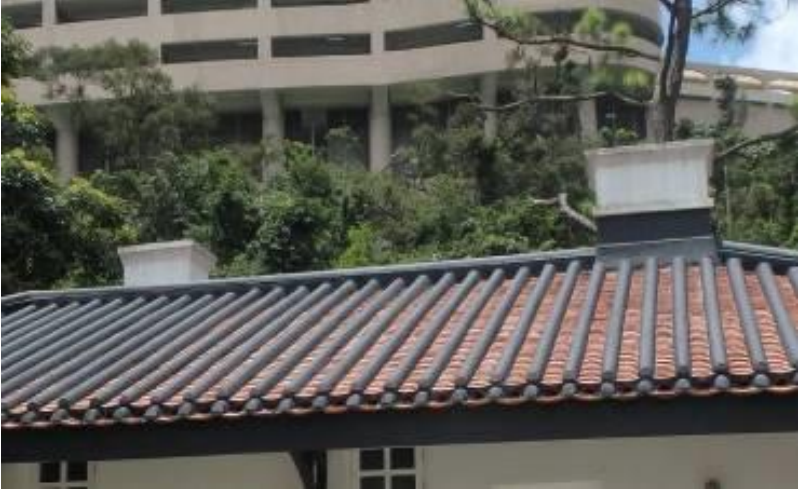
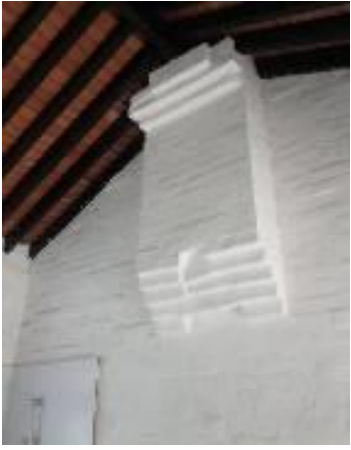
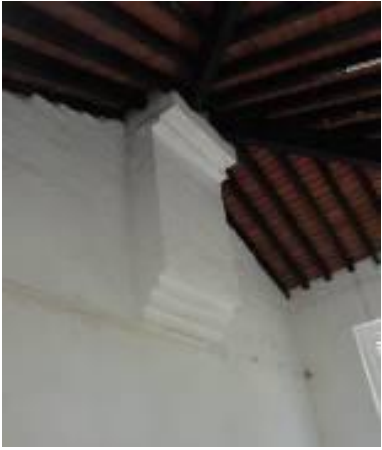
Item	Architectural Feature	Required Treatments
1B.4	<u>Chimney Stacks</u>	<ul style="list-style-type: none"> <li>a. The chimneys on roof together with the chimney stack in the interior connecting to fireplace and the remains should be preserved in-situ.</li> <li>b. Any defective brickworks are to be repaired as necessary and repaint to match existing.</li> <li>c. Blocking the openings of chimney at roof to prevent water seepage in a reversible manner may be considered provided that the appearance of the chimney is not affected.</li> </ul>
<div style="text-align: center;">

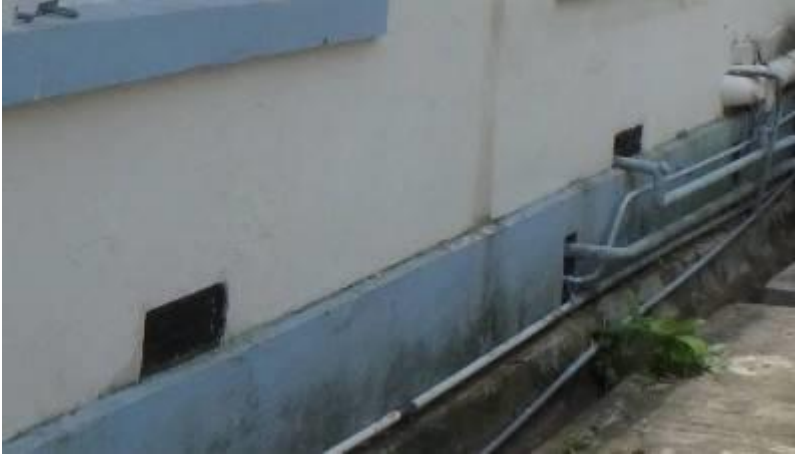
Item	Architectural Feature	Required Treatments
1B.5	<u>Original Ventilation Grilles</u>	<ul style="list-style-type: none"> <li>a. All original ventilation grilles should be preserved in-situ.</li> <li>b. The grilles should not be blocked to maintain its function.</li> <li>c. Any defective grilles are to be repaired, de-rusted and repainted as necessary.</li> </ul>

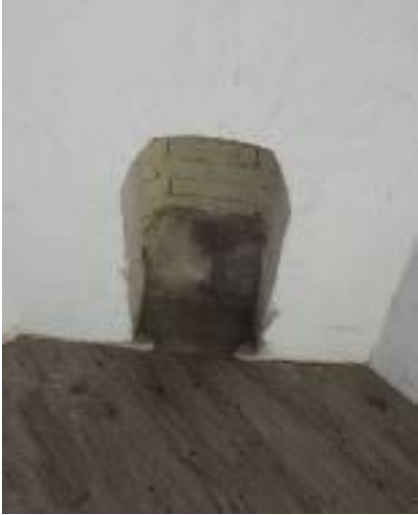
Item	Architectural Feature	Required Treatments
1B.6	<u>Fireplace</u>	<ul style="list-style-type: none"> <li>a. The existing fireplaces including brickwork surrounds and the cement hearth should be preserved in-situ and exposed to public for appreciation.</li> <li>b. Restoration of the fireplaces may be considered if sufficient evidence of the original design and appearance could be provided, subjected to the Antiquities Authority's approval.</li> </ul>

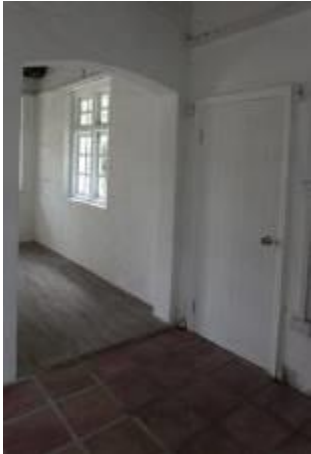
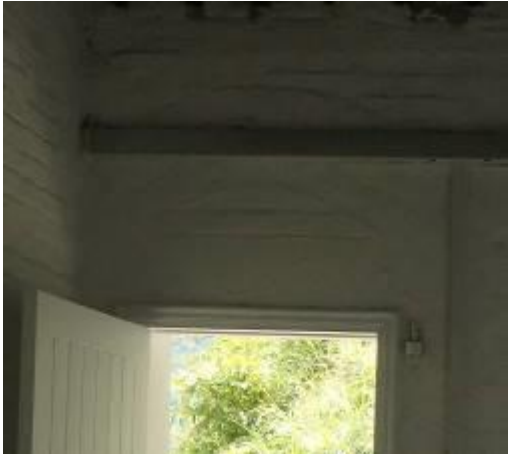
Item	Architectural Feature	Required Treatments
1B.7	<u>Internal Arched Doorway</u>	<ul style="list-style-type: none"> <li>a. The segmental arched doorway are not to be altered.</li> <li>b. All segmental arched brickworks remains at walls should be preserved in-situ</li> <li>c. Blocking of the opening by glass door or glass panel in a reversible manner to suit operation needs may be permitted, subjected to Antiquities Authority's approval.</li> </ul>
<div style="display: flex; justify-content: space-around; align-items: center;">

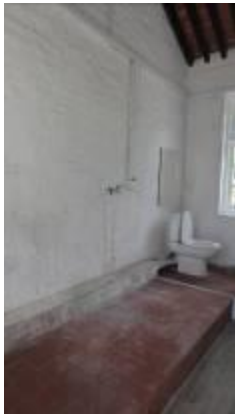
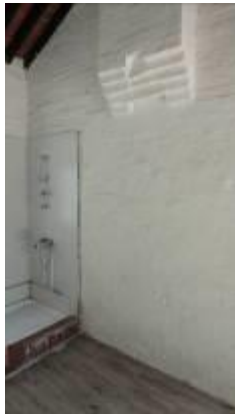
Item	Architectural Feature	Required Treatments
1B.8	<u>Internal Walls</u>	<ul style="list-style-type: none"> <li>a. Any damage sections of the walls are to be repaired by using materials matching existing as necessary.</li> <li>b. The existing interior planning should be kept intact in general. Alteration to the existing walls or addition of new partitions is not allowed unless approved by Antiquities Authority, and is subjected to the advice of a Registered Structural Engineer.</li> <li>c. Plaster should not be applied on walls.</li> </ul>
<div style="display: flex; justify-content: space-around; align-items: center;">

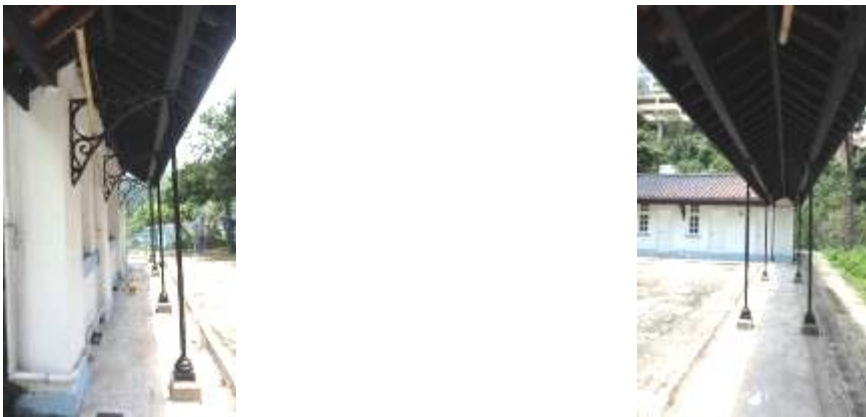
Item	Architectural Feature	Required Treatments
1C.1	<u>Structure and Extent of Covered Walkway</u>	<ol style="list-style-type: none"> <li>The form and the materials of the covered walkway are not to be altered.</li> <li>The covered walkway should maintain open at the sides.</li> <li>All the structural elements including the cast iron columns with granite stone bases, ornamental cast iron brackets and cast iron bracings and rods should be preserved in-situ, repaired and repainted as necessary.</li> </ol>

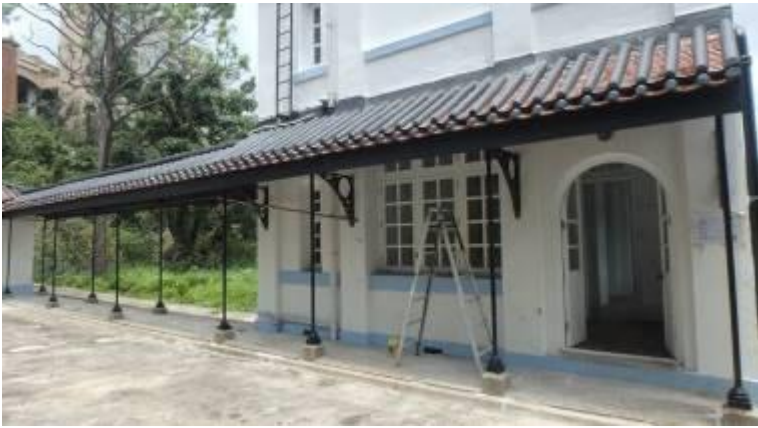
Item	Architectural Feature	Required Treatments
1C.2	<u>Pitched roof with Double-layered Chinese Pan and Roll Tiles</u>	<ol style="list-style-type: none"> <li>The pitched roofs is to be checked and repaired with the double-layered Chinese pan and roll tiles to maintain waterproof matching existing.</li> <li>Structural condition is to be checked and the defective timber trusses, rafters and purlins are to be repaired as necessary.</li> <li>The ornamental cast iron brackets are to be repaired and repainted as necessary.</li> <li>Wood preservative treatment is to be provided to all the timber elements and termite eradication and monitoring system is to be installed.</li> </ol>

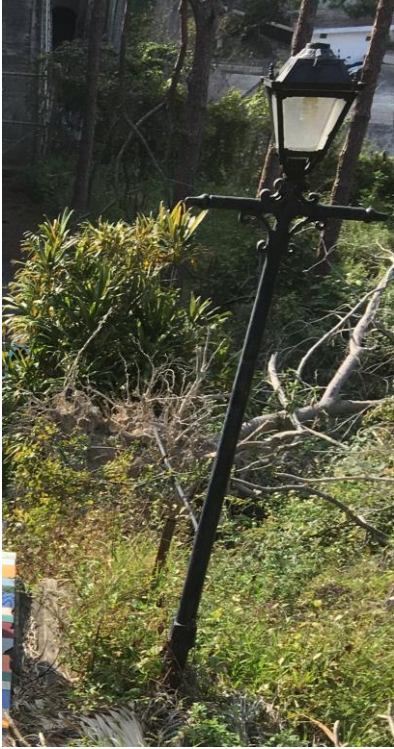
<b>Item</b>	<b>Architectural Feature</b>	<b>Required Treatments</b>
1D.2	<u>Classic cast iron lamp post</u>	<p>a. The classic cast iron lamp post should be preserved in-situ.</p> <p>b. The cast iron lamp post is to be repaired and its function is to be restored as far as practicable.</p>

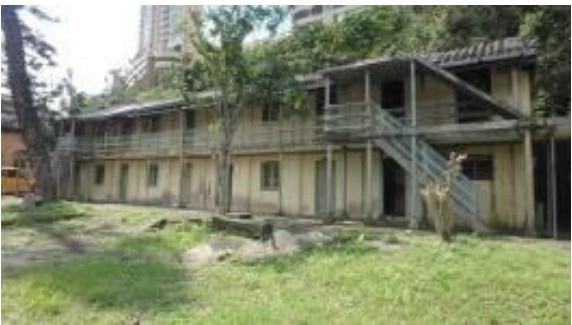
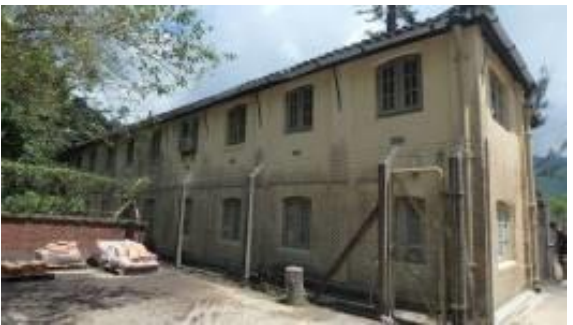
Item	Architectural Feature	Required Treatments
2A.1	<u>Building Facades</u>	<ul style="list-style-type: none"> <li>a. All elevations with exposed columns should be generally kept intact except for restoration works and necessary alteration and addition works to meet current statutory requirements, subjected to Antiquities Authority's approval.</li> <li>b. Any restoration works should be based on further research and/or site investigations with sufficient evidence.</li> <li>c. Any alteration and addition works should be carried out at less prominent area at the rear side in order to keep their visual impact on the Main Building and the Store Building to minimal.</li> <li>d. Apart from Item 2A.1b &amp; 2A.1c no new structures, awning, additional shading fins, equipment etc. should be installed on the building facades.</li> <li>e. Installation of new signage on the facade may be permitted provided that it will not overwhelm the existing elevation design and should be submitted to Antiquities Authority for approval.</li> <li>f. No alteration to the existing opening or blockage to openings or formation of new opening should be made unless approved by Antiquities Authority.</li> <li>g. The rendered walls and the features are to be repaired as necessary to match existing and repaint with reversible painting system and colour approved by Antiquities Authority.</li> <li>h. No plaster should be applied on walls.</li> </ul>

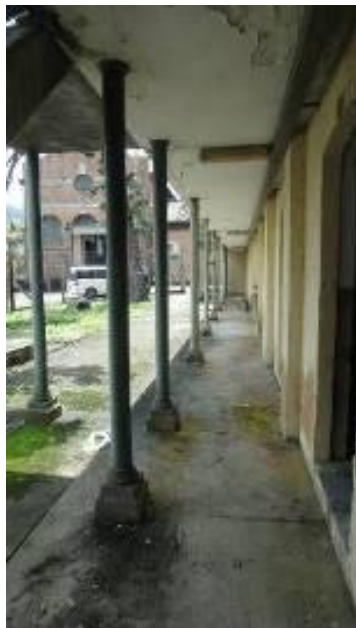
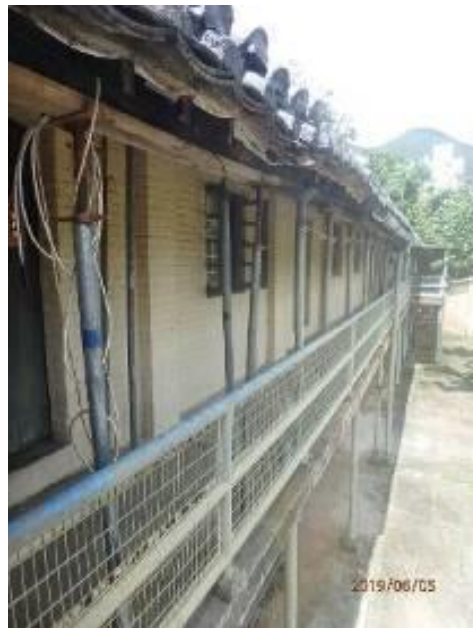
Item	Architectural Feature	Required Treatments
2A.2	<u>Verandahs on North Elevation</u>	<ul style="list-style-type: none"> <li>a. The open verandahs including the cast iron metal round columns on G/F and 1/F and granite stones bases should be preserved in-situ.</li> <li>b. No enclosure of the verandah, wholly or partially is permitted.</li> <li>c. The existing slab is to be repaired based on existing structural system as necessary.</li> <li>d. The existing tubular metal balustrade should be preserved as far as practicable, upgrading of existing balustrade to meet current statutory requirements in a reversible manner and with minimum disturbance to the balustrades may be considered, subjected to the Antiquities Authority's approval.</li> <li>e. A research study on the authenticity of the existing metal balustrade is to be conducted. The study should be based on archival research and site investigations, and supplemented with photos, drawings, etc. for AMO's record. If sufficient evidence could be provided that the balustrade is not original, replacement of balustrade with similar design of simple tubular metal balustrade which is compatible with the building design may be considered, subjected to the Antiquities Authority's approval.</li> </ul>

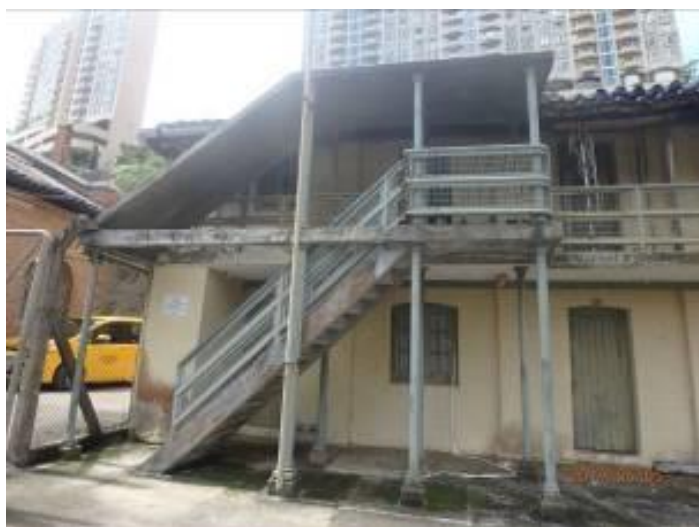
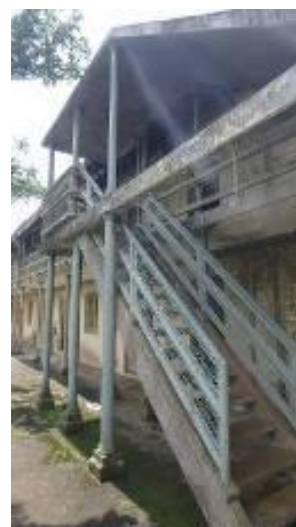
Item	Architectural Feature	Required Treatments
2A.3	<u>Open Staircases</u>	<ul style="list-style-type: none"> <li>a. The open staircases including the cast iron round columns, concrete roof slabs and steps with granolithic finishes should be preserved in situ.</li> <li>b. The staircase should be kept open, no enclosure of open staircase is permitted.</li> <li>c. The existing tubular metal balustrade should be preserved as far as practicable, upgrading of existing balustrade to meet current statutory requirements in a reversible manner and with minimum disturbance to the balustrades may be considered, subjected to the Antiquities Authority's approval.</li> <li>d. A research study on the authenticity of the existing metal balustrade is to be conducted. The study should be based on archival research and site investigations, and supplemented with photos, drawings, etc. for AMO's record. If sufficient evidence could be provided that the balustrade is not original, replacement of balustrade with similar design of simple tubular metal balustrade which is compatible with the building design may be considered, subjected to the Antiquities Authority's approval.</li> </ul>

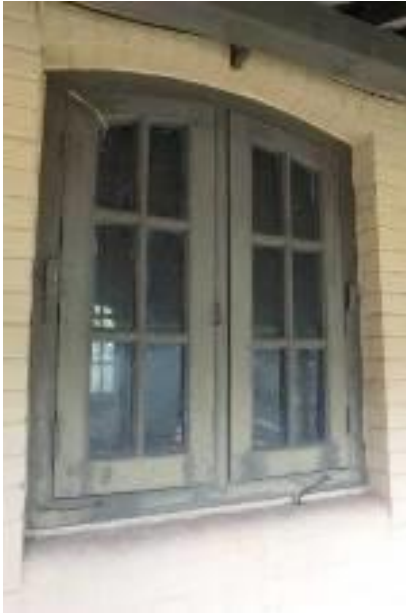
Item	Architectural Feature	Required Treatments
2A.4	<u>Segmental Arched</u> <u>Wooden Casement</u> <u>Windows</u>	<ul style="list-style-type: none"> <li>a. All original segmental arched wooden casement windows including the segmental arched brickworks, grid glazing patterns, rounded edge window sills and all ironmongeries should be preserved in-situ.</li> <li>b. The wooden windows are to be repaired to match existing as necessary. If the wooden windows and ironmongeries are beyond repair, replace the windows with new wooden windows and ironmongeries following the existing design, subjected to Antiquities Authority's approval.</li> <li>c. Wood preservative treatment is to be provided to all the timber elements.</li> <li>d. Modification of the window openings into door openings to meet the current statutory requirements may be considered, provided that the modification works would be carried out at the rear side of the Main Building at less prominent area, and is subjected to the Antiquities Authority's approval.</li> </ul>

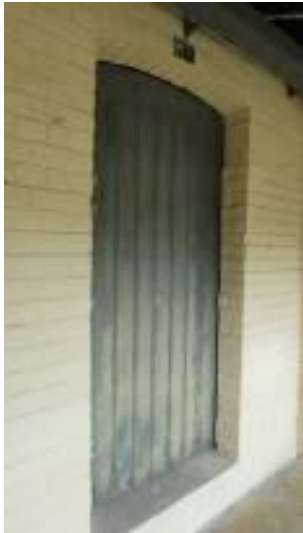
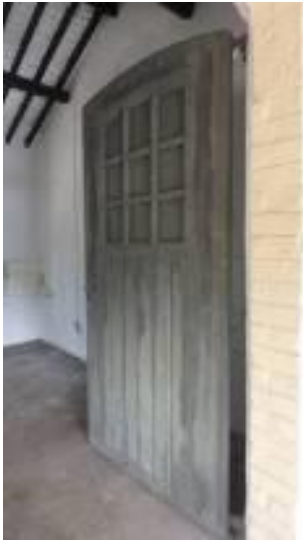
Item	Architectural Feature	Required Treatments
2A.5	<u>Segmental Arched Wooden Doors</u>	<ul style="list-style-type: none"> <li>a. All original segmental arched wooden panel door including the original ironmongeries, the grid glazing pattern, the segmental arched brickworks, and granite stones for the fixing of the hinges and granite thresholds should be preserved in-situ.</li> <li>b. The wooden doors are to be repaired to match existing as necessary. If the wooden windows and ironmongeries are beyond repair, they are to be replaced with new wooden doors and ironmongeries based on the existing design, subjected to Antiquities Authority's approval.</li> <li>c. Wood preservative treatment is to be provided to all the timber elements.</li> </ul>
<div style="display: flex; justify-content: space-around; align-items: center;">

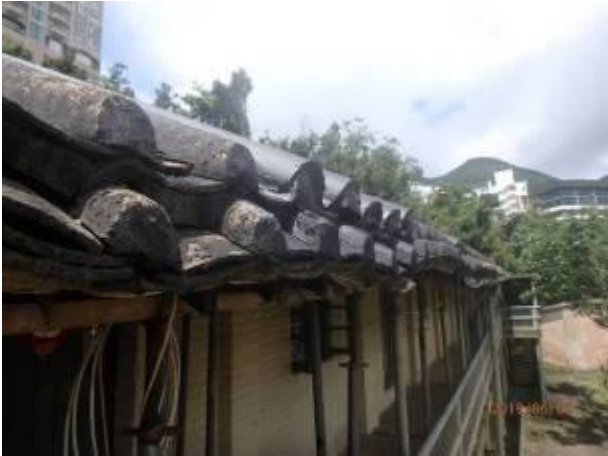
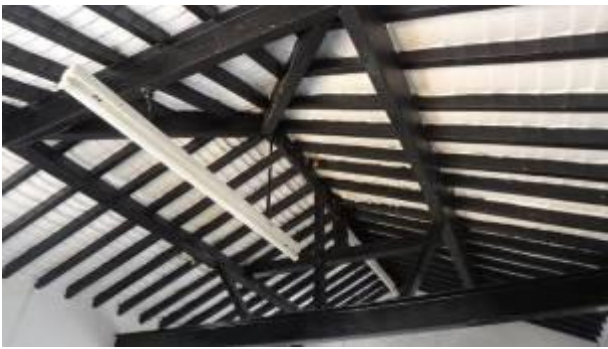
Item	Architectural Feature	Required Treatments
2A.6	<u>Hipped Roof with Double-layered Chinese Pan and Roll tiles</u>	<ul style="list-style-type: none"> <li>a. The form and the materials of the roofs are not to be changed.</li> <li>b. The hipped roofs are to be checked and repaired with the double-layered pan and roll tiles to maintain waterproof matching existing.</li> <li>c. Structural condition is to be checked and the defective timber trusses, rafters, purlins and metal beams and bracings are to be repaired as necessary to match existing. Termite eradication and monitoring system is to be installed.</li> </ul>
<div style="display: flex; flex-direction: column; align-items: center;">

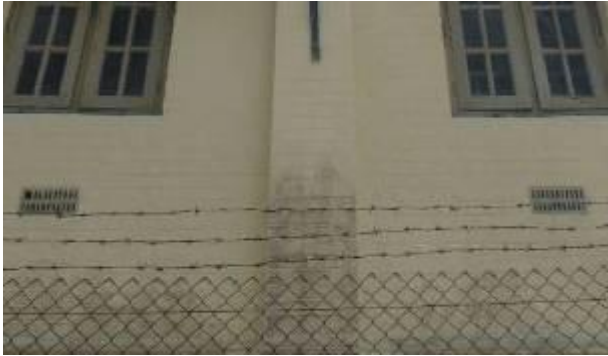
<b>Item</b>	<b>Architectural Feature</b>	<b>Required Treatments</b>
2A.7	<u>Original Ventilation Grilles</u>	<ul style="list-style-type: none"><li>a. All original ventilation grilles should be preserved in-situ.</li><li>b. The grilles should not be blocked to maintain its function.</li><li>c. Repair, de-rust and repaint any defective grilles as necessary.</li></ul>

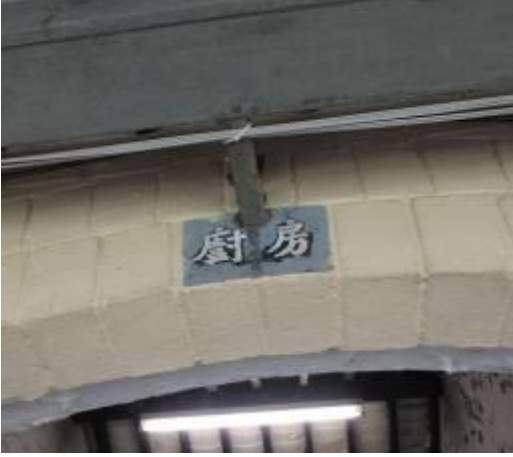
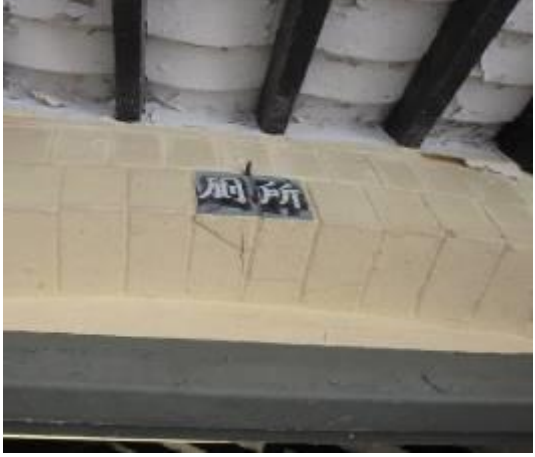
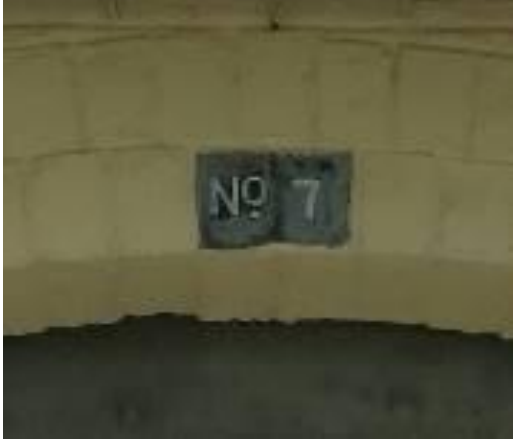
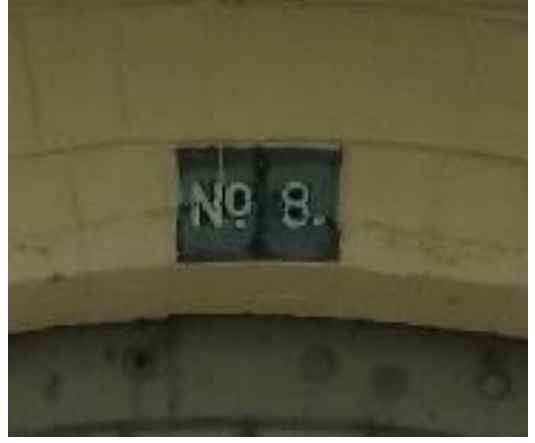
Item	Architectural Feature	Required Treatments
2A.8	<u>Stencilled Signages</u>	a. All stencilled signages at external walls including those above or beside door openings showing the room nos. and the function of the rooms should be preserved in-situ. b. The stencilled signage are not to be covered and should be displayed for public appreciation.
<div style="display: flex; flex-wrap: wrap; justify-content: space-around;">

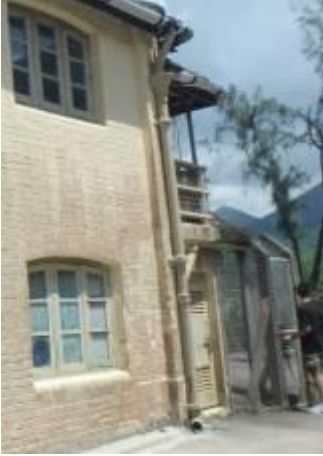
Item	Architectural Feature	Required Treatments
2A.9	<u>Original Cast Iron Rainwater Pipe</u>	<ul style="list-style-type: none"> <li>a. Some of the rainwater pipes and the gutters have been altered or replaced with new materials. A research study on the original rainwater drainage system is to be conducted and the drainage system is to be restored by using the materials of the period as far as practicable.</li> <li>b. All historical cast iron rainwater pipes, including hopper, pipe works and their associated parts, should be preserved in-situ as far as practicable.</li> <li>c. Historical cast iron rainwater pipes and any defective part(s) of are to be repaired to restore its function. If defective pipework is beyond repair, the replacement pipework should be cast iron and painted to match existing.</li> </ul>

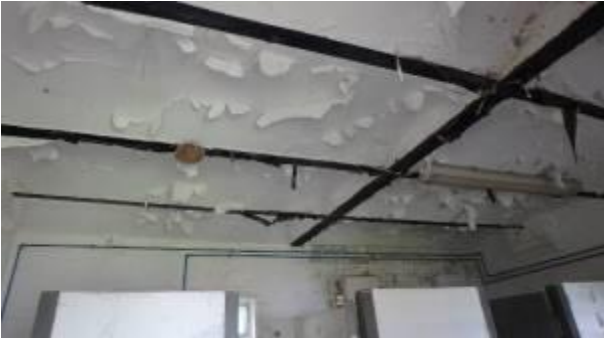
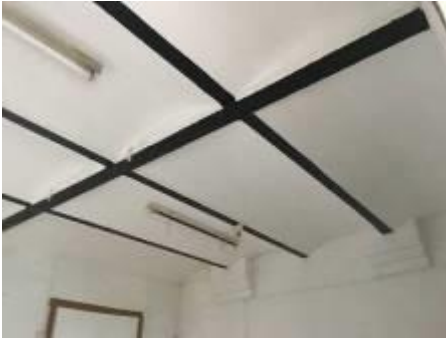
Item	Architectural Feature	Required Treatments
2A.10	<u>Jack Arch slabs</u>	<ul style="list-style-type: none"> <li>a. The jack arch slabs on 1/F with bottom of metal beams exposed and the supporting brick corbels should be preserved in-situ.</li> <li>b. The condition of the Jack arch slabs are to be checked and they are to be repaired as necessary following the existing structural system. New replacement of the elements is acceptable if the elements are beyond repair and the replacements should follow the existing structural system, materials and design.</li> <li>c. If upgrading works of the slab to meet current statutory requirements is necessary upon the advice from the Registered Structural Engineer, upgrading works may be permitted, subjected to Antiquities Authority's approval.</li> <li>d. Any upgrading works should be reversible in manner with the metal beams and arched ceiling to be exposed for public appreciation as far as practicable.</li> </ul>
