**Revitalising Historic Buildings  
Through Partnership Scheme**

**Tai Tam Tuk Raw Water Pumping Station  
Staff Quarters Compound**

**Resource Kit**

**Date: 27 November 2019**

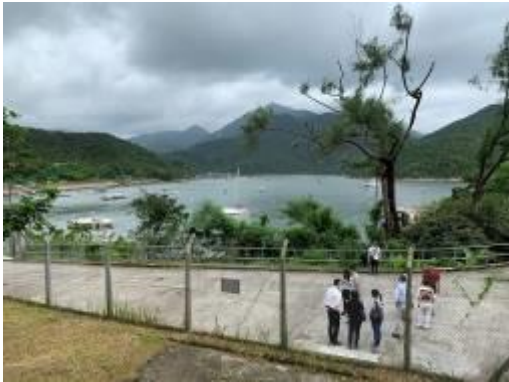
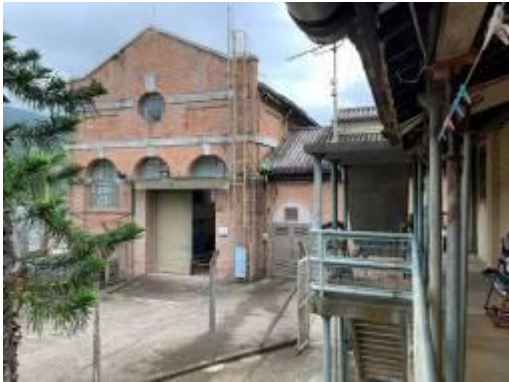
Item	Architectural Feature	Required Treatments
2A.11	<u>Vistas to the Tai Tam Harbour</u>	<ul style="list-style-type: none"> <li>a. The vistas from the Staff Quarters to the Tai Tam Harbour and the Pumping Station should be maintained.</li> <li>b. Erection of new structure at the north side in front of the Staff Quarters and at the east side between the Staff Quarters and the Pumping Station should be avoided.</li> </ul>
<div style="display: flex; justify-content: space-around;">

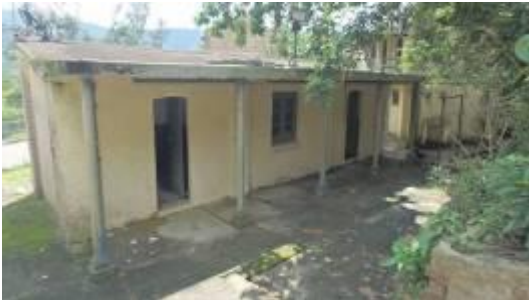
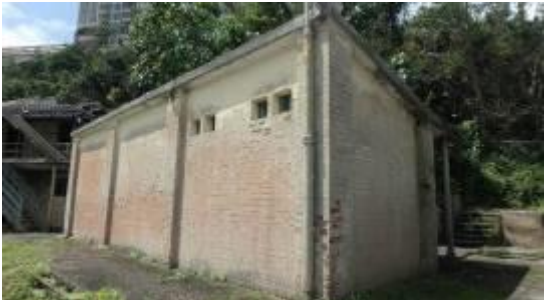
Item	Architectural Feature	Required Treatments
2B.1	<u>Building Facades</u>	<ul style="list-style-type: none"><li>a. All elevations with exposed columns should be generally kept intact, subjected to Antiquities Authority's approval.</li><li>b. No new structures, awning, additional shading fins, equipment etc. should be installed on the building facades.</li><li>c. Installation of new signage on the facade may be permitted provided that it will not overwhelm the existing elevation design and should be submitted to AMO for approval.</li><li>d. No alteration to the existing opening or blockage to openings or formation of new opening should be made unless approved by AMO.</li><li>e. The rendered walls and the features are to be repaired as necessary to match existing and repaint with reversible painting system and colour approved by AMO.</li><li>f. No plaster should be applied on walls.</li></ul>

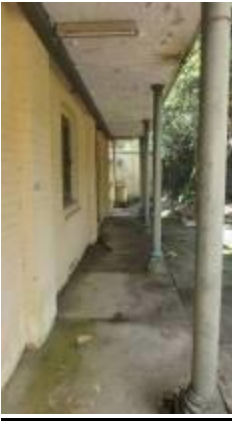
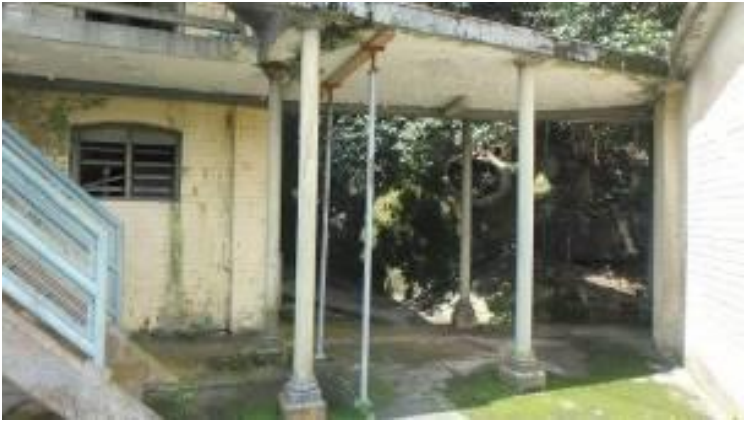
Item	Architectural Feature	Required Treatments
2B.2	<u>Verandah on South-west Elevation and Covered walkway</u>	<ul style="list-style-type: none"> <li>a. The open verandah and the covered walkway linking the Store Building and the Main Building including the cast iron metal round columns with granite stones bases should be preserved in-situ.</li> <li>b. No enclosure of the verandah, wholly or partially is permitted.</li> <li>c. The existing roof slab is to be repaired following existing structural system as necessary.</li> </ul>

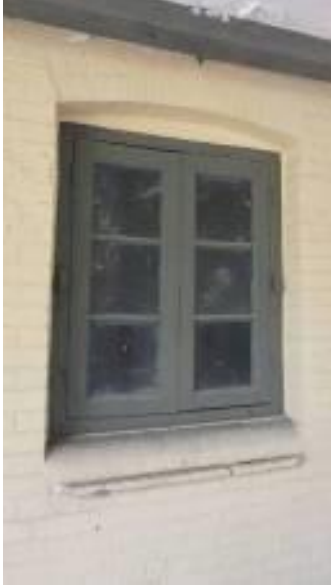
Item	Architectural Feature	Required Treatments
2B.3	<u>Segmental Arched Wooden Casement Windows</u>	<ul style="list-style-type: none"><li>a. All original segmental arched wooden casement windows including the segmental arched brickworks, grid glazing patterns, rounded edge window sills and all ironmongeries should be preserved in-situ.</li><li>b. The wooden windows are to be repaired to match existing as necessary. If the wooden windows and ironmongeries are beyond repair, they are to be replaced with new following the existing design.</li><li>c. Wood preservative treatment is to be provided to all the timber elements.</li></ul>

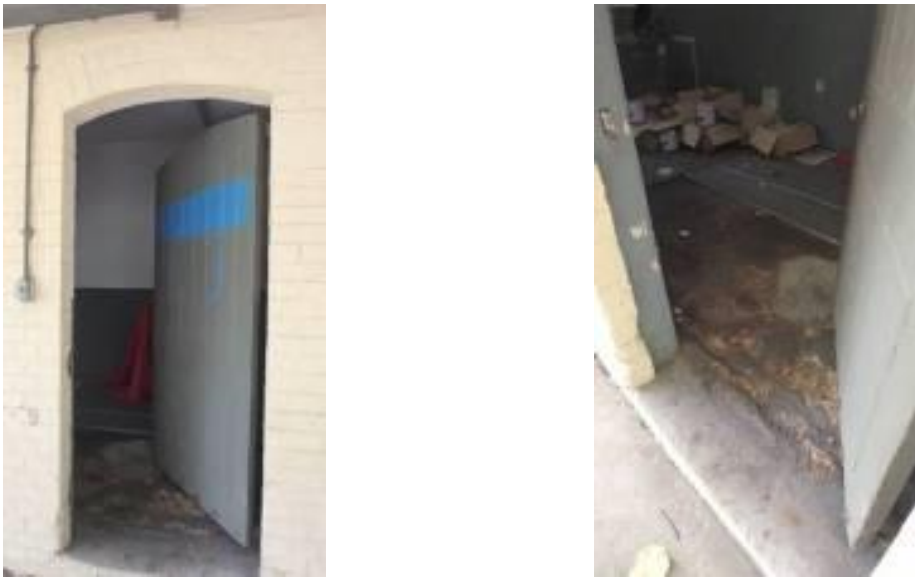
Item	Architectural Feature	Required Treatments
2B.4	<u>Segmental Arched Wooden Doors</u>	<ul style="list-style-type: none"><li>a. All original segmental arched wooden panel door including the original ironmongeries, the segmental arched brickworks, and granite stones for the fixing of the hinges and granite thresholds should be preserved in-situ.</li><li>b. The wooden doors are to be repaired to match existing as necessary. If the wooden windows and ironmongeries are beyond repair, they are to be replaced with new following the existing design.</li><li>c. Wood preservative treatment is to be provided to all the timber elements.</li></ul>

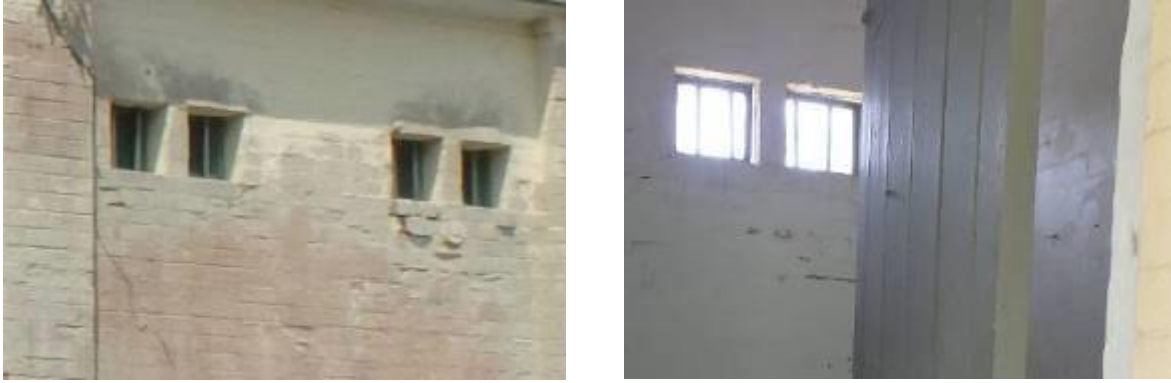
Item	Architectural Feature	Required Treatments
2B.5	<u>Ventilation Openings</u>	<ul style="list-style-type: none"> <li>a. The wall openings on the north-east elevation with metal grilles should be preserved in-situ.</li> <li>b. Blockage of the openings in a reversible manner may be considered to meet statutory requirement, and is subjected to AMO's approval.</li> </ul>

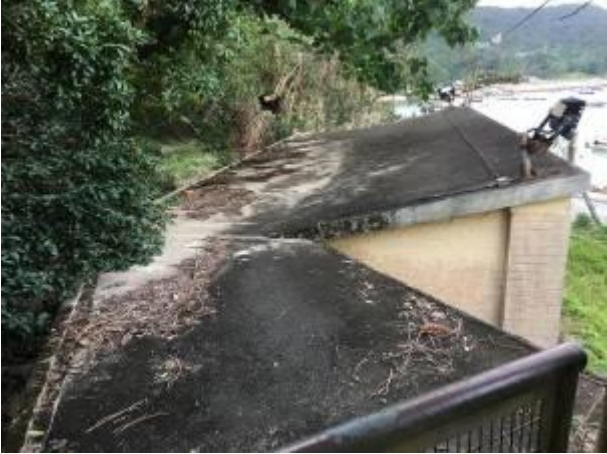
Item	Architectural Feature	Required Treatments
2B.6	<u>Mono-pitched Roof</u>	<ul style="list-style-type: none"> <li>a. The form and the materials of the roof are not to be changed.</li> <li>b. The roof slab is to be checked and repaired following existing material and design as necessary.</li> <li>c. Roofing membrane at flat roof is to be applied in a reversible-manner to improve the waterproof as necessary.</li> </ul>

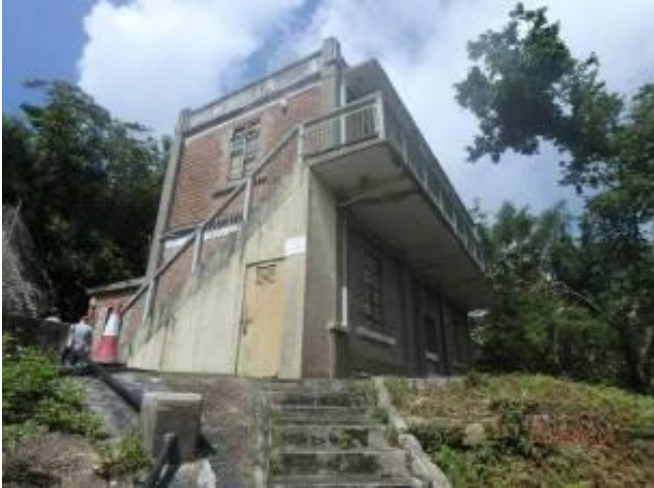
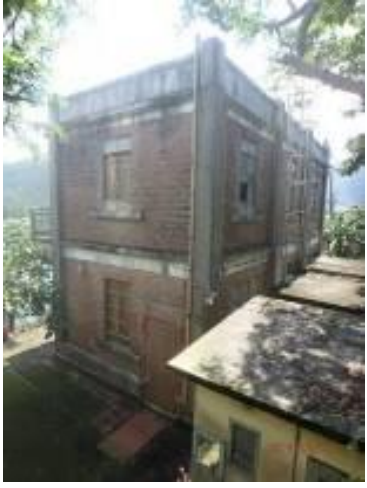
Item	Architectural Feature	Required Treatments
3.1	<u>Building Facades</u>	<ul style="list-style-type: none"> <li>a. All elevations including fair-faced red bricks, Shanghai plaster finishes on exposed columns and along the bottom of walls should be generally kept intact except for restoration works and necessary alteration and addition works to meet current statutory requirements, subjected to Antiquities Authority's approval.</li> <li>b. Any restoration works should be based on further research and/or site investigations with sufficient evidence.</li> <li>c. Any alteration and addition works should be carried out at less prominent area at the south and west side of building in order to keep their visual impact on the declared monument to minimal.</li> <li>d. Apart from Item 3.1b &amp; 3.1c, no new structures, awning, additional shading fins, equipment etc. should be installed on the building facades.</li> <li>e. Installation of new signage on the facade may be permitted provided that it will not overwhelm the existing elevation design and should be submitted to Antiquities Authority for approval.</li> <li>f. No alteration to the existing opening or blockage to openings or formation of new opening should be made unless approved by Antiquities Authority.</li> <li>g. The walls and the finishes are to be repaired as necessary to match existing.</li> <li>h. No painting should be applied on walls.</li> </ul>

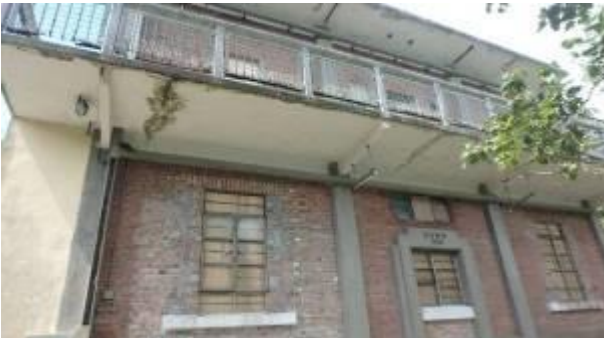
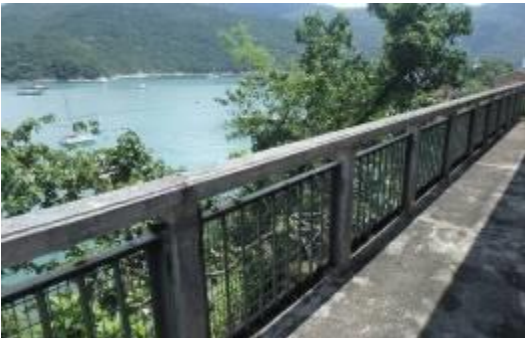
Item	Architectural Feature	Required Treatments
3.2	<u>Verandahs on North Elevation</u>	<ul style="list-style-type: none"> <li>a. The open verandahs including the concrete railings and posts of balustrades should be preserved in-situ.</li> <li>b. No enclosure of the verandah, wholly or partially is permitted.</li> <li>c. The existing slab and canopy is to be repaired following existing structural system as necessary.</li> <li>d. The existing metal balustrade is not original. A research study on the original design of the metal balustrade is to be conducted and the metal balustrade is to be restored to the original design. The study should be based on archival research and site investigations, and supplemented with photos, drawings, etc. for AMO's record.</li> <li>e. Upgrading of the balustrade to meet current statutory requirements in a reversible manner and with minimum disturbance to the concrete railings and posts of balustrades may be considered, subjected to the Antiquities Authority's approval.</li> </ul>

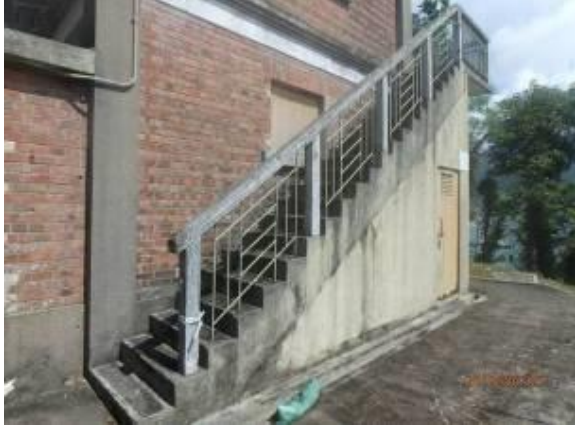
Item	Architectural Feature	Required Treatments
3.3	<u>Open Staircase</u>	<ul style="list-style-type: none"> <li>a. The concrete open staircase connecting to the verandah on 1/F should be preserved in-situ.</li> <li>b. The existing metal balustrade is not original. A research study is to be conducted on the original design of the metal balustrade and the metal balustrade is to be restored to the original design. The study should be based on archival research and site investigations, and supplemented with photos, drawings, etc. for AMO's record.</li> <li>c. Upgrading of the balustrade to meet current statutory requirements in a reversible manner and with minimum disturbance to the concrete railings and posts of balustrades may be considered, subjected to the Antiquities Authority's approval.</li> </ul>

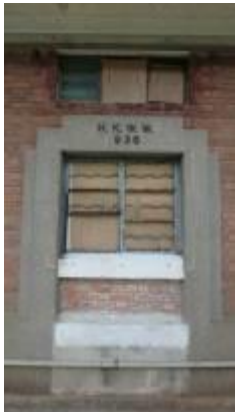
Item	Architectural Feature	Required Treatments
3.4	<u>Doorcase of Original Main Entrance</u>	<ul style="list-style-type: none"> <li>a. The geometric doorcase of the original main entrance including the shanghai plaster finishes and the signs of "H.K.W.W." and "1936" should be preserved in-situ.</li> <li>b. The original door opening which have been altered into window opening should be restored and the surrounding should be made good.</li> <li>c. The doorcase Shanghai plaster finishes is to be repaired to match existing as necessary.</li> </ul>

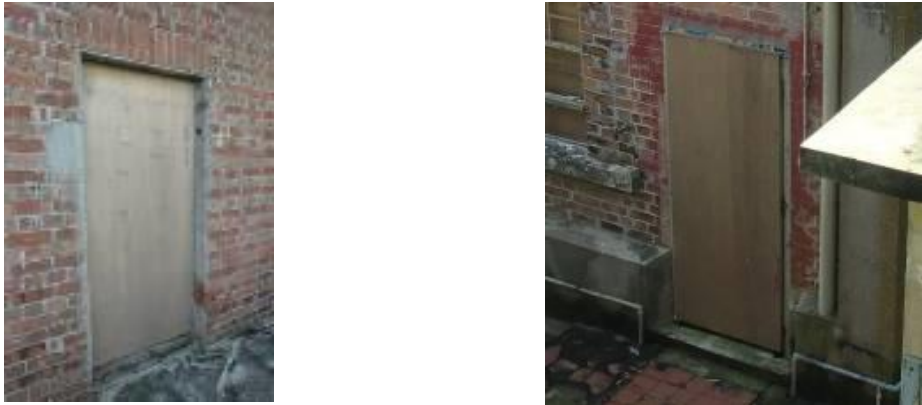
Item	Architectural Feature	Required Treatments
3.6	<u>Door Openings</u>	<ul style="list-style-type: none"> <li>a. A research study and site investigation is to be conducted to identify the original door openings and later-formed door openings, and the original design of the doors. The study should be based on archival research and site investigations, supplemented with photos, drawings, etc. for AMO's record.</li> <li>b. The brick door heads on 1/F should be preserved in-situ and repaired as necessary.</li> <li>c. The original door openings are to be restored with new doors following the original design or the design of the period.</li> <li>d. Altered door openings or later-formed door openings should be restored to window openings or reinstated with brickworks to match with existing walls, unless with justifications approved by the Antiquities Authority.</li> </ul>

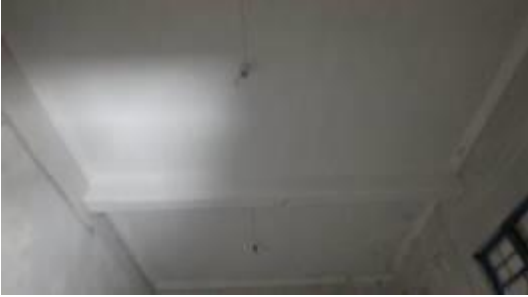
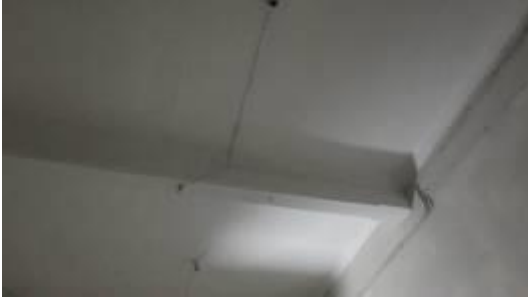
Item	Architectural Feature	Required Treatments
3.7	<u>Concrete Beams</u>	<ul style="list-style-type: none"> <li>a. All concrete beams with sloping corners on G/F and 1/F should be preserved in-situ and be exposed for public appreciation as far as practicable.</li> <li>b. The concrete beams are to be repaired as necessary following the existing profile.</li> </ul>
<div style="display: flex; justify-content: space-around;">

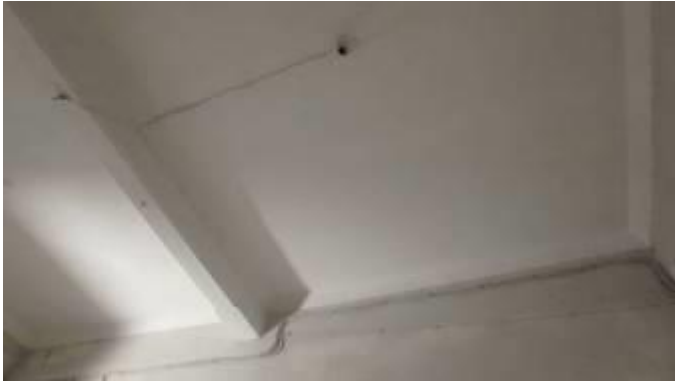
Item	Architectural Feature	Required Treatments
3.8	<u>Coved Ceiling</u>	<ul style="list-style-type: none"> <li>a. All coved ceiling on G/F and 1/F should be preserved in-situ and be exposed for public appreciation as far as practicable.</li> <li>b. The coved moulding is to be reinstated to match existing after any ceiling repair work as necessary.</li> </ul>
<div style="text-align: center;">

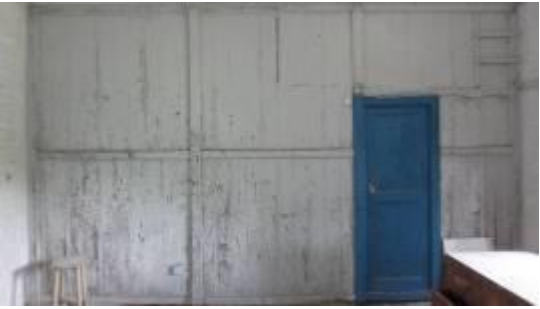
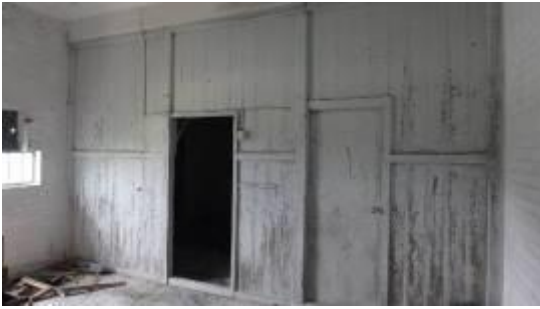
Item	Architectural Feature	Required Treatments
3.9	<u>Wooden Partitions on 1/F</u>	<ul style="list-style-type: none"> <li>a. The wooden partitions on 1/F, though have been altered, should be preserved as far as practicable.</li> <li>b. The defective elements of wooden partitions are to be repaired and replaced with new following the existing design and materials as necessary. Wood preservative treatment is to be provided to all the timber elements.</li> </ul>
<div style="display: flex; justify-content: space-around;">

Item	Architectural Feature	Required Treatments
2.2	<u>Wooden partitions on 1/F</u>	a. The altered wooden partitions are to be restored to original design without door openings.
  <p>The two photographs show the interior of a room with wooden partitions. The left photo shows a blue door set within a partition wall. The right photo shows a doorway where a partition wall has been removed, creating an opening. The wood appears aged and worn.</p>

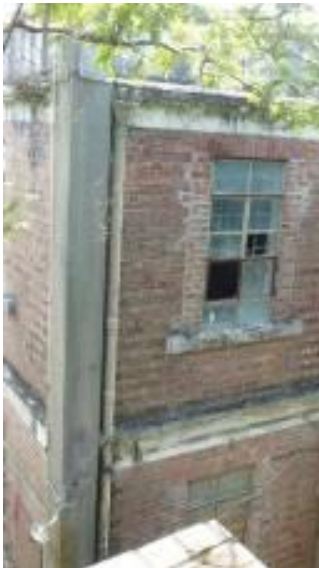
Item	Architectural Feature	Required Treatments
3.10	<u>Original Cast Iron Rainwater Pipe</u>	<ul style="list-style-type: none"> <li>a. All historical cast iron rainwater pipes, including hopper, pipe works and their associated parts, should be preserved in-situ as far as practicable.</li> <li>b. Any defective part(s) of the drainage system are to be repaired and replaced with new as necessary. Clear any blockage in the drainage system to restore its function.</li> <li>c. If defective pipework is beyond repair, the replacement pipework should be cast iron and painted to match existing.</li> </ul>
<div style="text-align: center;">

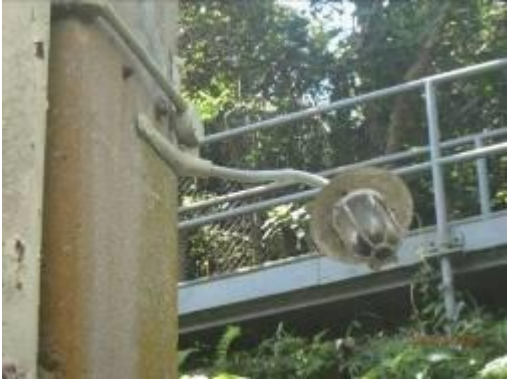
Item	Architectural Feature	Required Treatments
3.11	<u>Historical Wall Lamp</u>	<ul style="list-style-type: none"> <li>a. The historic wall lamp should be preserved in-situ.</li> <li>b. It is to be repaired and its function is to be restored as far as practicable.</li> </ul>

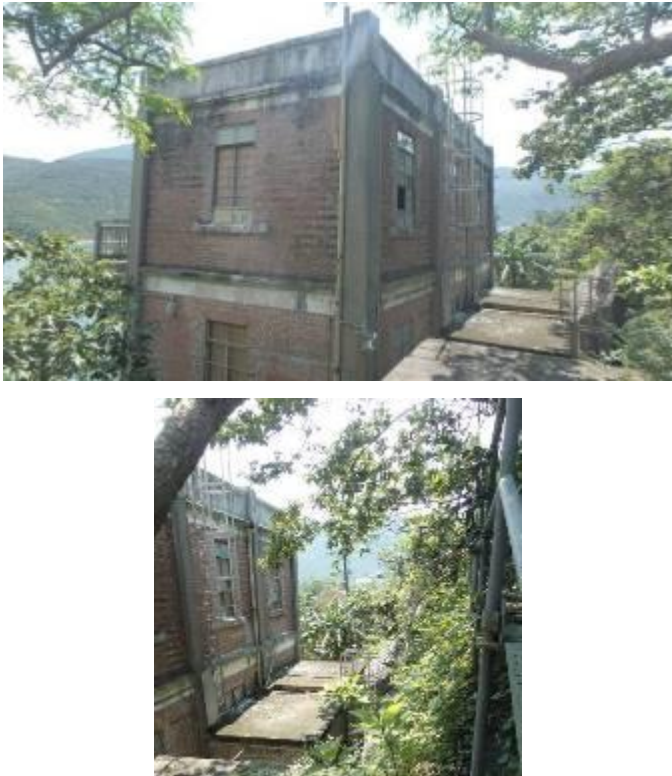
Item	Architectural Feature	Required Treatments
3.12	<u>Flat Roofs</u>	<ul style="list-style-type: none"> <li>a. The form and the materials of the roof are not to be changed</li> <li>b. The roof slab is to be checked and repaired following existing material and design as necessary.</li> <li>c. Roofing membrane at flat roof is to be applied in a reversible-manner to improve the waterproof as necessary.</li> </ul>

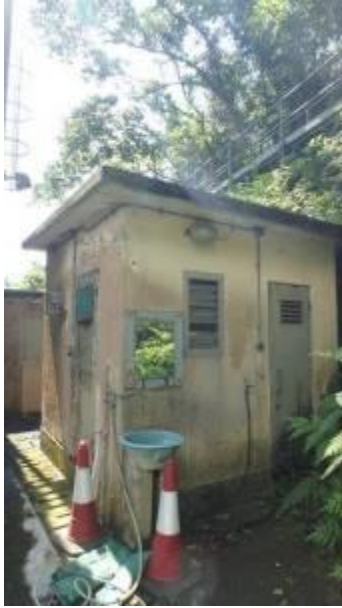
Item	Architectural Feature	Required Treatments
3.14	<u>Outbuilding</u>	a. The outbuilding (used as bathroom) at the southern side of the No. 2 Staff Quarters is a later addition. b. No objection to demolish to make way for new access facilities if necessary, subjected to the approval by the AMO.

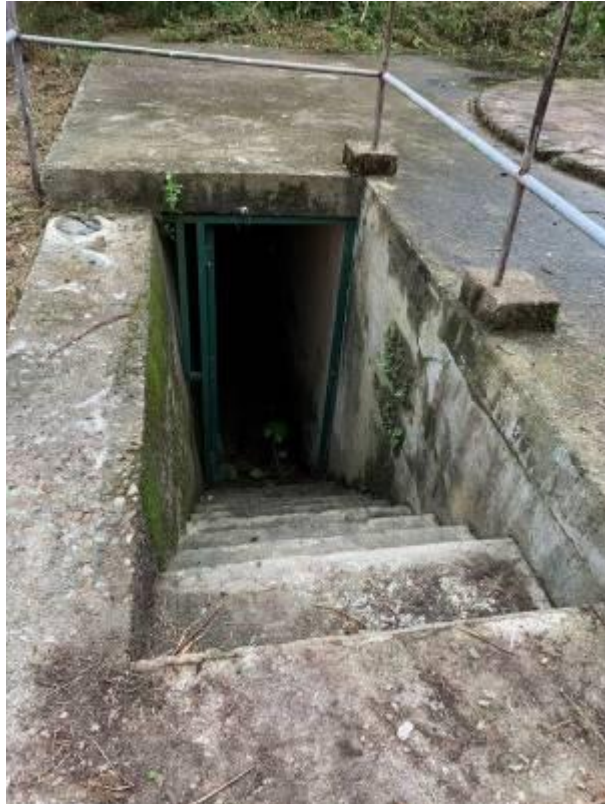
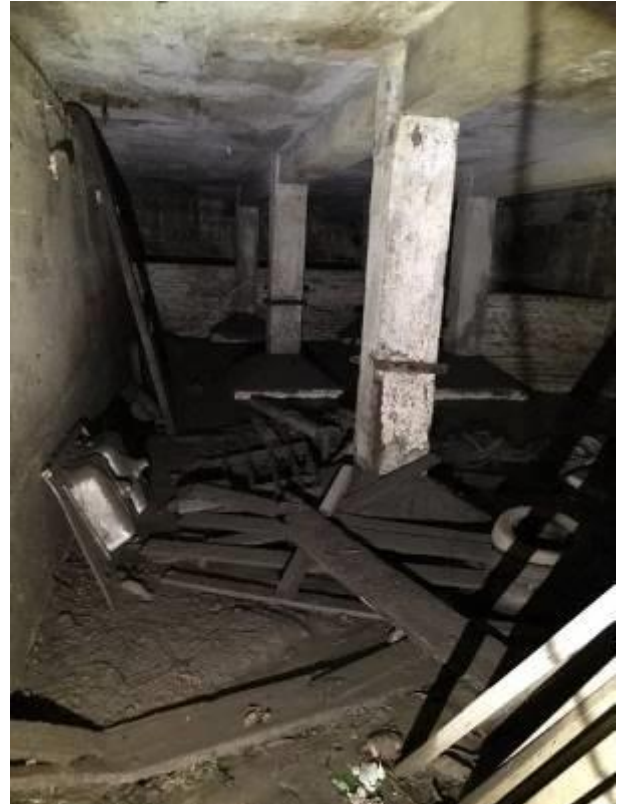
Item	Architectural Feature	Required Treatments
4.1	<u>Underground Structures within the Site</u>	<ul style="list-style-type: none"> <li>a. A research study and site investigation are to be conducted on the Underground Cellar/ air raid shelter to find out the extent and locations of the air raid shelter and the associated staircase (and tunnels if any). The study should be based on archival research and site investigations, supplemented with photos, drawings, etc. for AMO's record.</li> <li>b. All the Underground Cellar/ air raid shelter (and tunnels if any) should be preserved in-situ and repaired with materials matching existing as necessary.</li> <li>c. No erection of new structure at the land above the existing Underground Cellar except for lift facilities as mentioned in Item 4.5 below will be permitted. Any new structure or strengthening works for proposed new use of the land above should not cause any damage on the underground structures.</li> <li>d. All new above-ground or underground structure, alteration works or strengthening works to the existing underground structures should be subjected to the advice from a Registered Structural Engineer and is subjected to the Antiquities Authority's approval.</li> <li>e. The Underground Cellar is to be re-used as far as practicable. Any formation of new openings to the Underground Cellar should be approved by the AMO.</li> </ul>

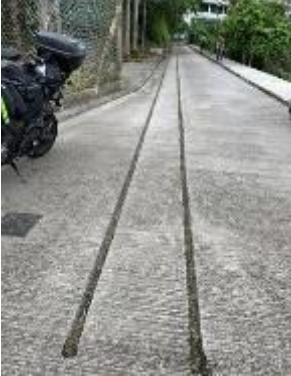
Item	Architectural Feature	Required Treatments
4.2	<u>Old Tracks</u>	a. The old tracks along the road should be preserved in-situ and exposed for public appreciation.

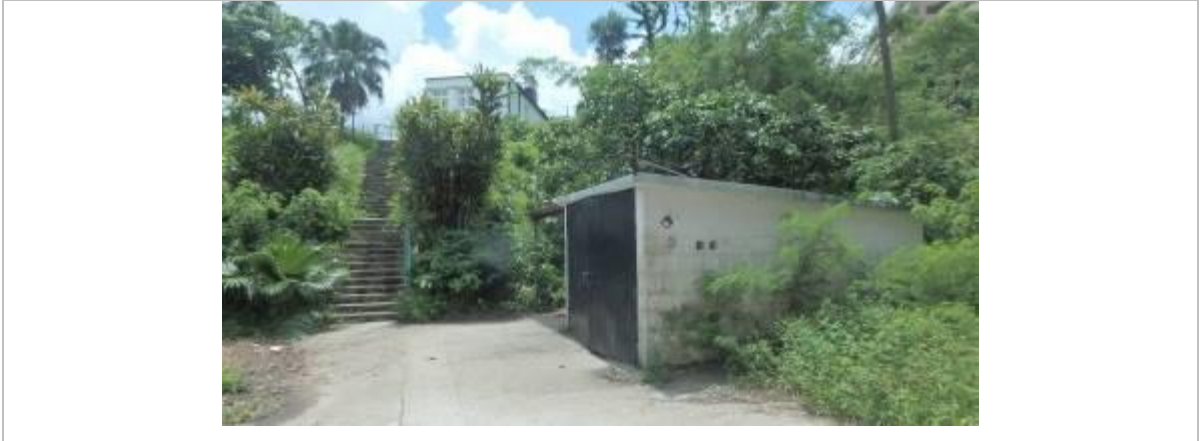
Item	Architectural Feature	Required Treatments
4.3	<u>Garage</u>	<p>a. A research study on the Garage to be conducted to find out its history. The study should be based on archival research and site investigations, supplemented with photos, drawings, etc. for AMO's record.</p> <p>b. The Garage and the shelter should be preserved in-situ.</p> <p>c. The Garage and the shelter is to be repaired and repainted to match existing and is to be reused as far as practicable.</p> <p>d. Roofing membrane is to be applied at flat roof in a reversible-manner to improve the waterproof as necessary.</p>

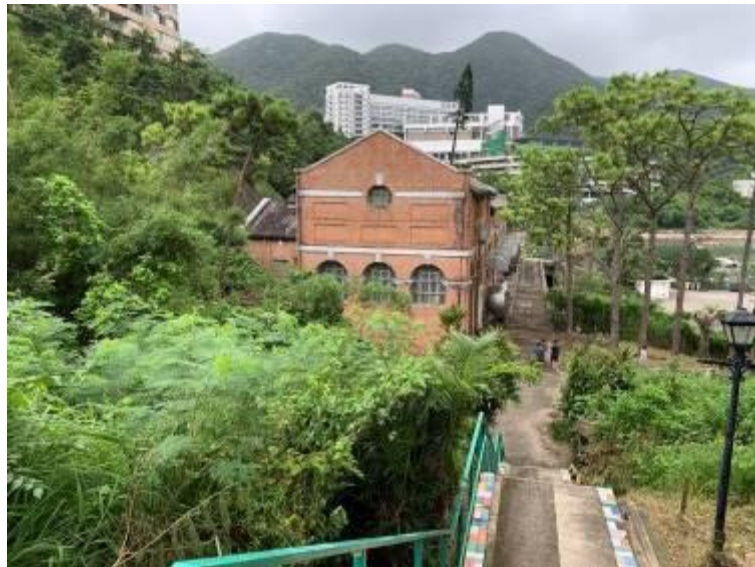
Item	Architectural Feature	Required Treatments
4.5	<u>Slopes at the West Side of Senior Staff Quarters and Slopes/ Retaining Walls at the North Side of No. 2 Staff Quarters</u>	<ul style="list-style-type: none"> <li>a. For provision of barrier free access, construction of ramp(s) or lift facilities may be required from the vehicular road level to the higher platforms of the Senior Staff Quarters and the No. 2 Staff Quarters.</li> <li>b. Construction of ramp(s) or lift facilities should match the existing topography as far as practicable in order to keep the overall visual impact to a minimum.</li> <li>c. The lift facilities if any should be of minimal size, and the design should be compatible and distinguishable from the declared monuments to minimize the visual impact on the declared monuments.</li> <li>d. The design and materials of the ramp(s), lift facilities if any and related landscaping or sloping works should be submitted to AMO for approval.</li> </ul>

Slope at the west side of Senior Staff Quarters

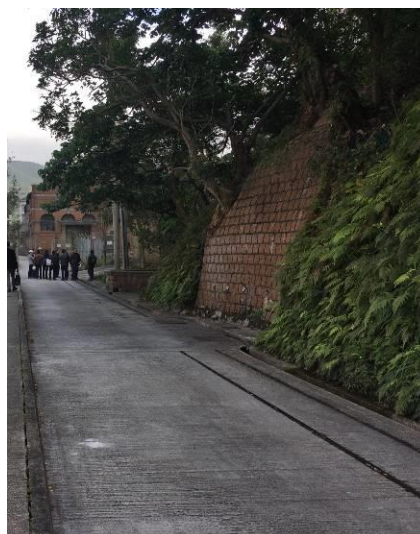
Slopes/ retaining walls at the north side of No. 2 Staff Quarters

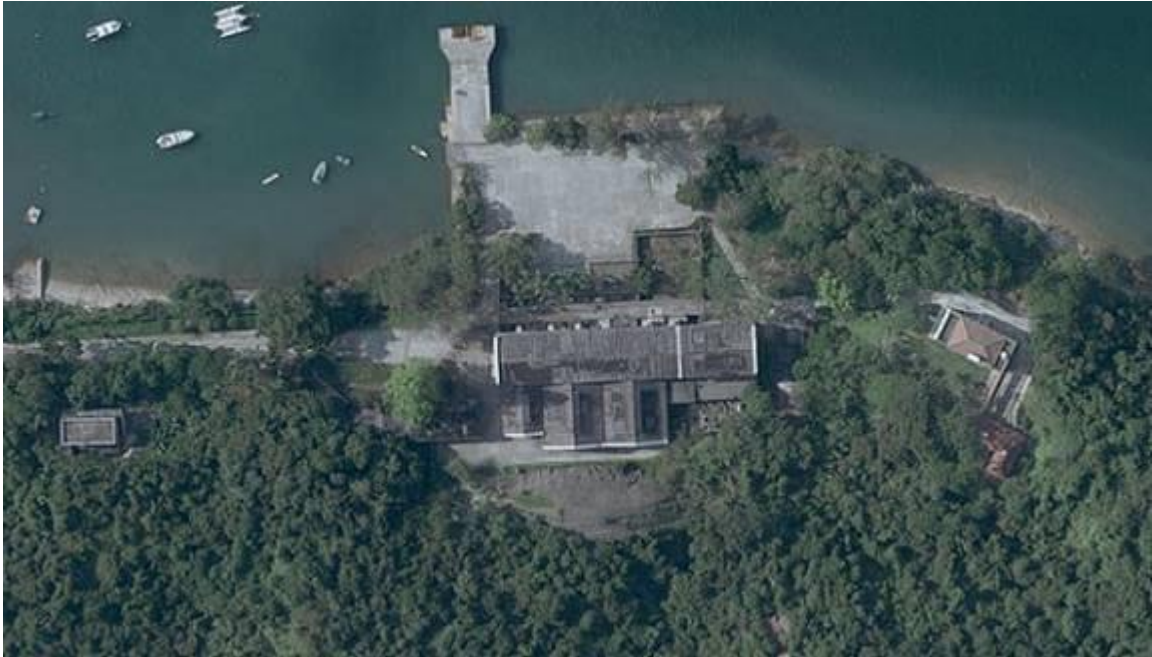
Item	Architectural Feature	Required Treatments
4.6	<u>Natural Landscape and Natural Terrain of the Surrounding Areas</u>	a. The existing natural landscape and natural terrain at the surrounding areas should be maintained. Any proposed improvement works at the surrounding areas of declared monuments should be made compatible with the existing natural landscape and natural terrain to avoid creating adverse visual impact on the natural environment.

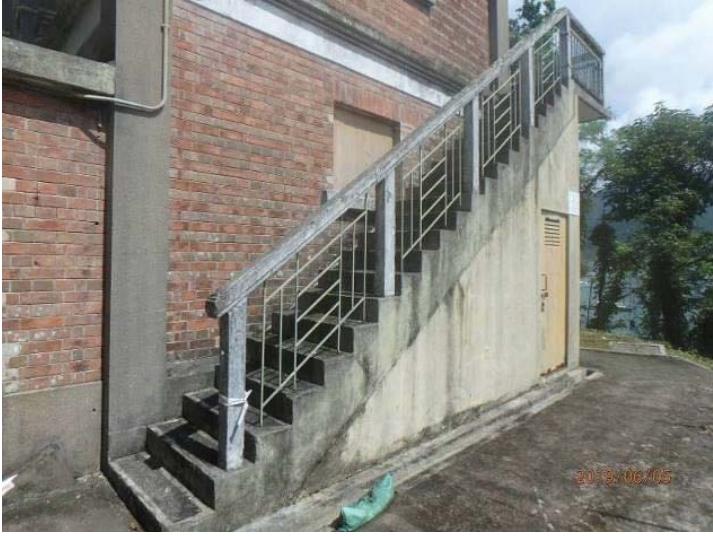
Item	Architectural Feature	Recommended Treatments
2.1	Room under Open Staircase	b. The room under the open staircase is later-addition. The later-added room is to be demolished to restore the appearance of the side elevation of Building.

<p>The photograph shows the exterior of a brick building. A concrete staircase with a metal railing leads up to a second-story level. Below the staircase, there is a small, enclosed room with a yellow door. The brickwork is red, and the concrete elements are grey. The ground in front is a dark, paved area.</p>

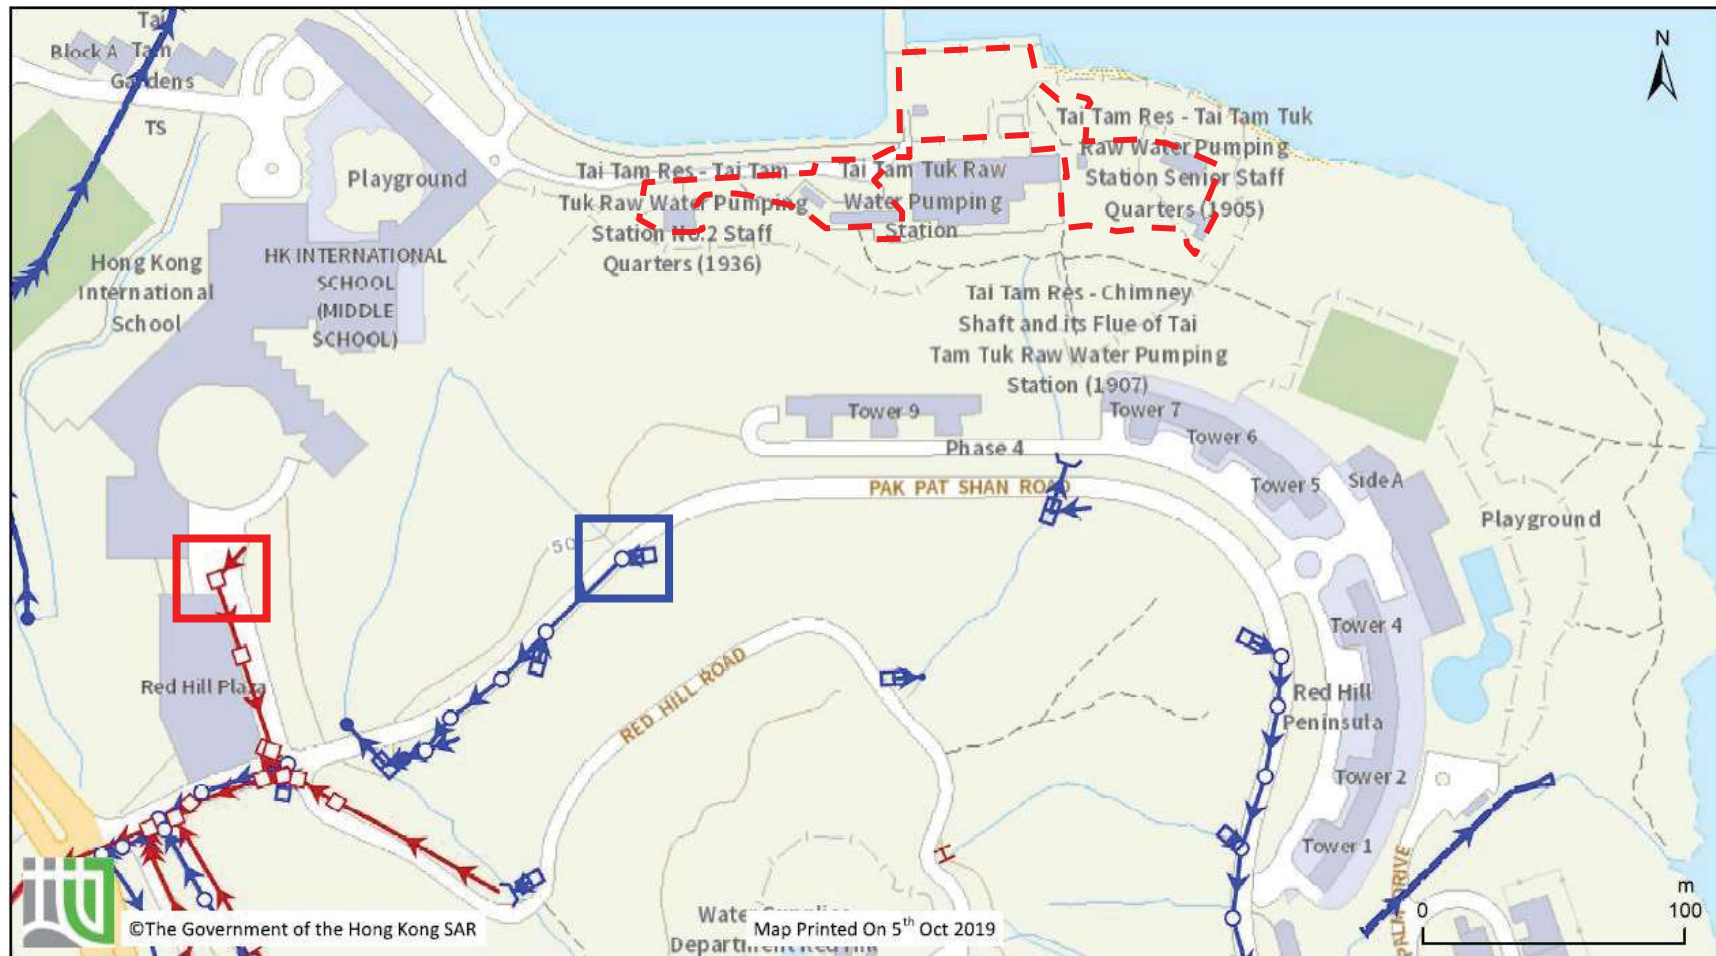
**Location of Nearest Public Storm Water Manhole and Sewer Manhole**

(DSD's record extracted from GeolInfo Map)
