活化歷史建筑伙伴计划

第 48 区前哥顿军营

Watervale House

资料册

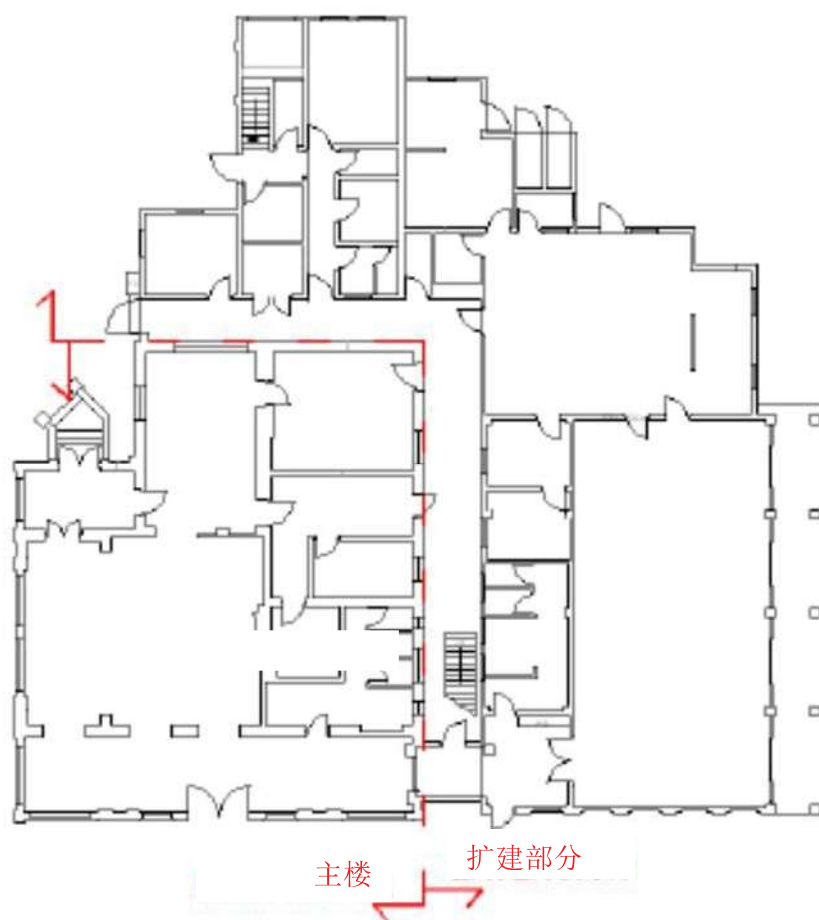
主楼和扩建部分的划分图

Watervale House 由两个部分组成。原建筑 (以下简称「主楼」) 约4.5米高, 是战前建成的单层住宅, 有长屋檐环绕。如下划分图所示, 主楼的东面和北面由L形的扩建部分 (以下简称「扩建部分」) 所包围。Watervale House 的建筑图则, 包括位置图、平面图、立面图和剖面图均载于附录V。这些建筑图则按粗略实地测量绘制, 需进一步核实。

扩建部分包括地下(G/F)的餐饮设施和地下(G/F)及一楼(1/F)的员工宿舍。部分主楼的长屋檐因兴建员工宿舍而被拆除。主楼和扩建部分之间有天井分隔。

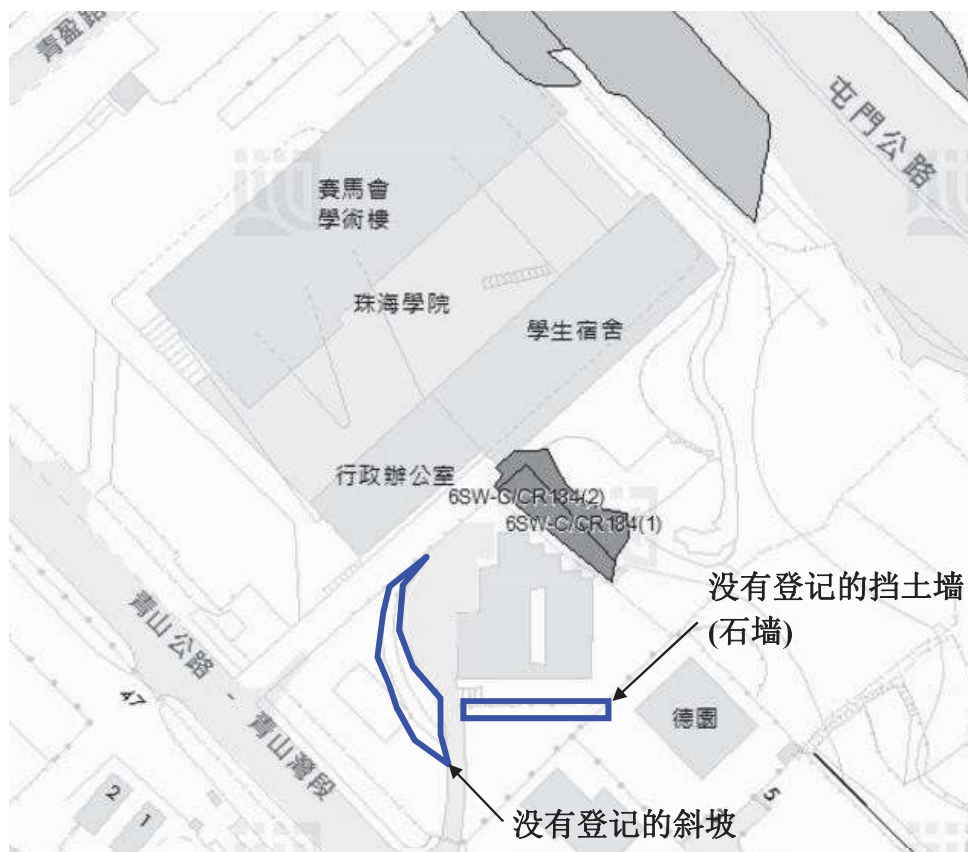
用地内有并不包括在SMRIS系统内的一幅斜坡及一幅挡土墙（这些斜坡及挡土墙显示于下图，以下简称为「没有登记的斜坡」及「没有登记的挡土墙」）。

没有登记的挡土墙有些变形及在其旁边的混凝土梯级有些轻微移位。

获选机构日后须负责这些没有登记的斜坡及没有登记的挡土墙之维修和保养，并支付所需费用。

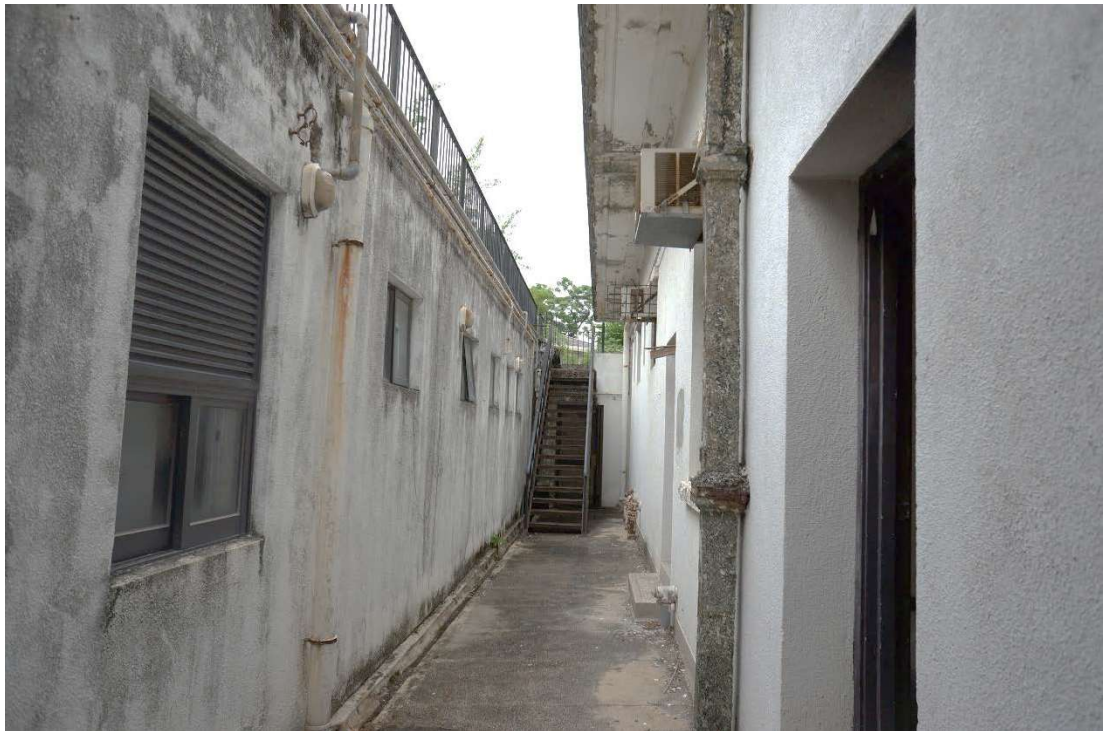
位于主楼与扩建部分中间的天井

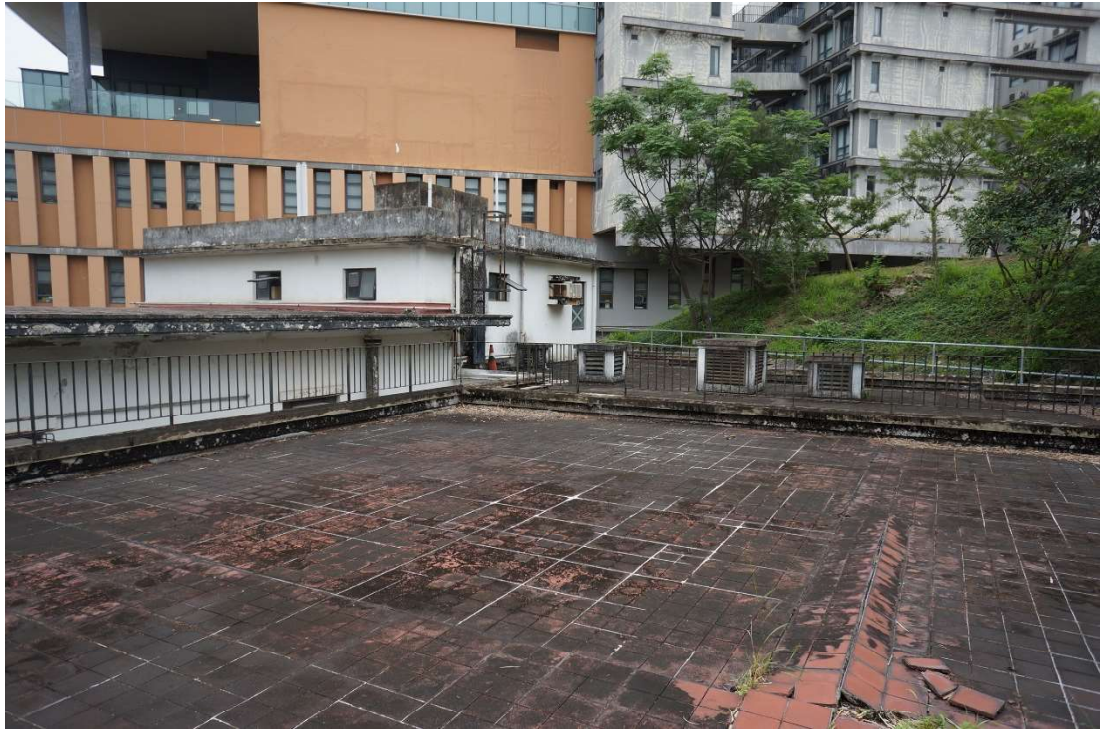
扩建部分天台的视图

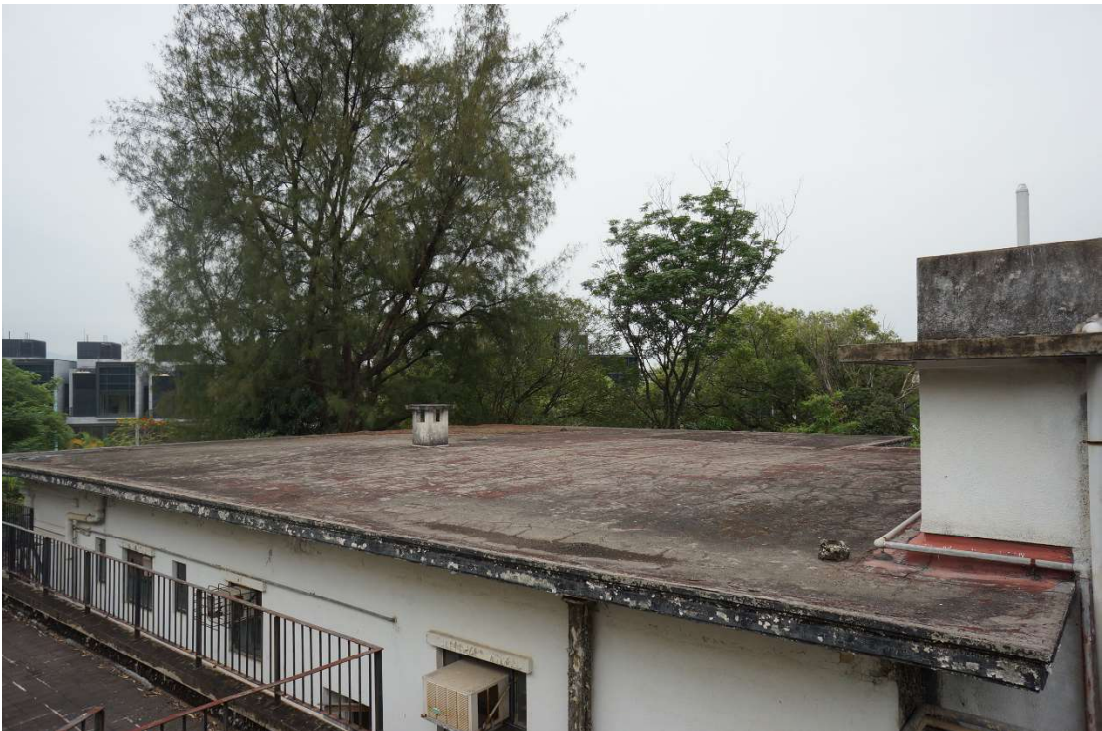
主楼天台的视图

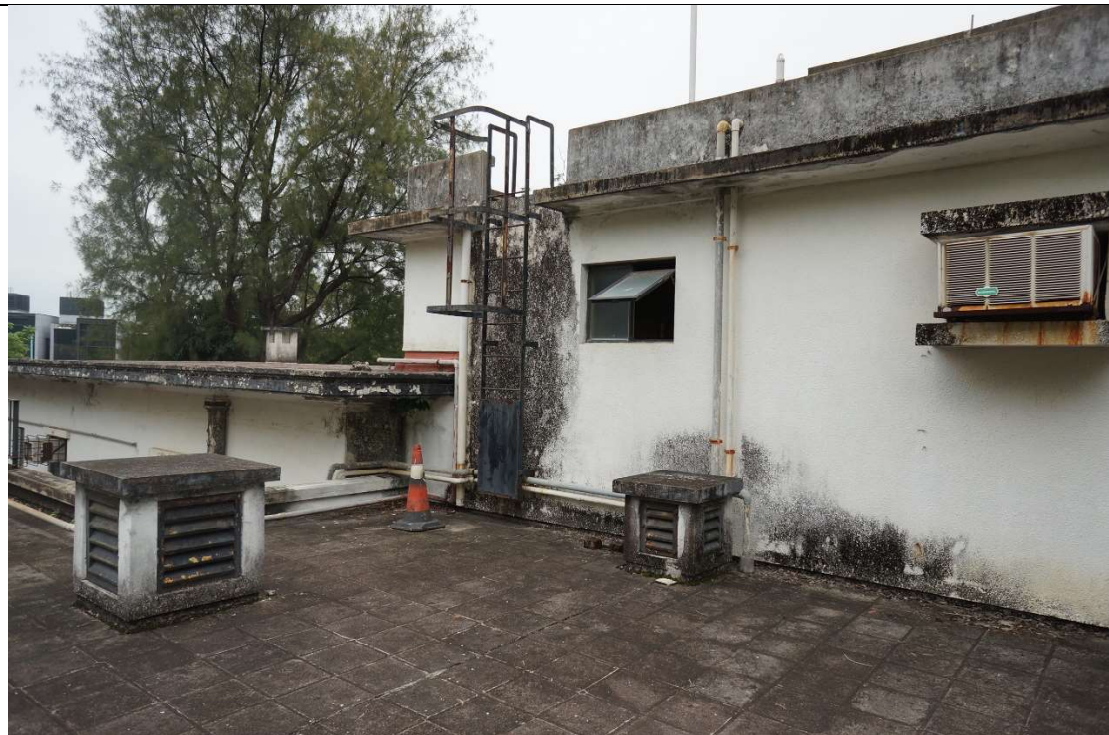
由扩建部分平台通往天台的猫梯视图

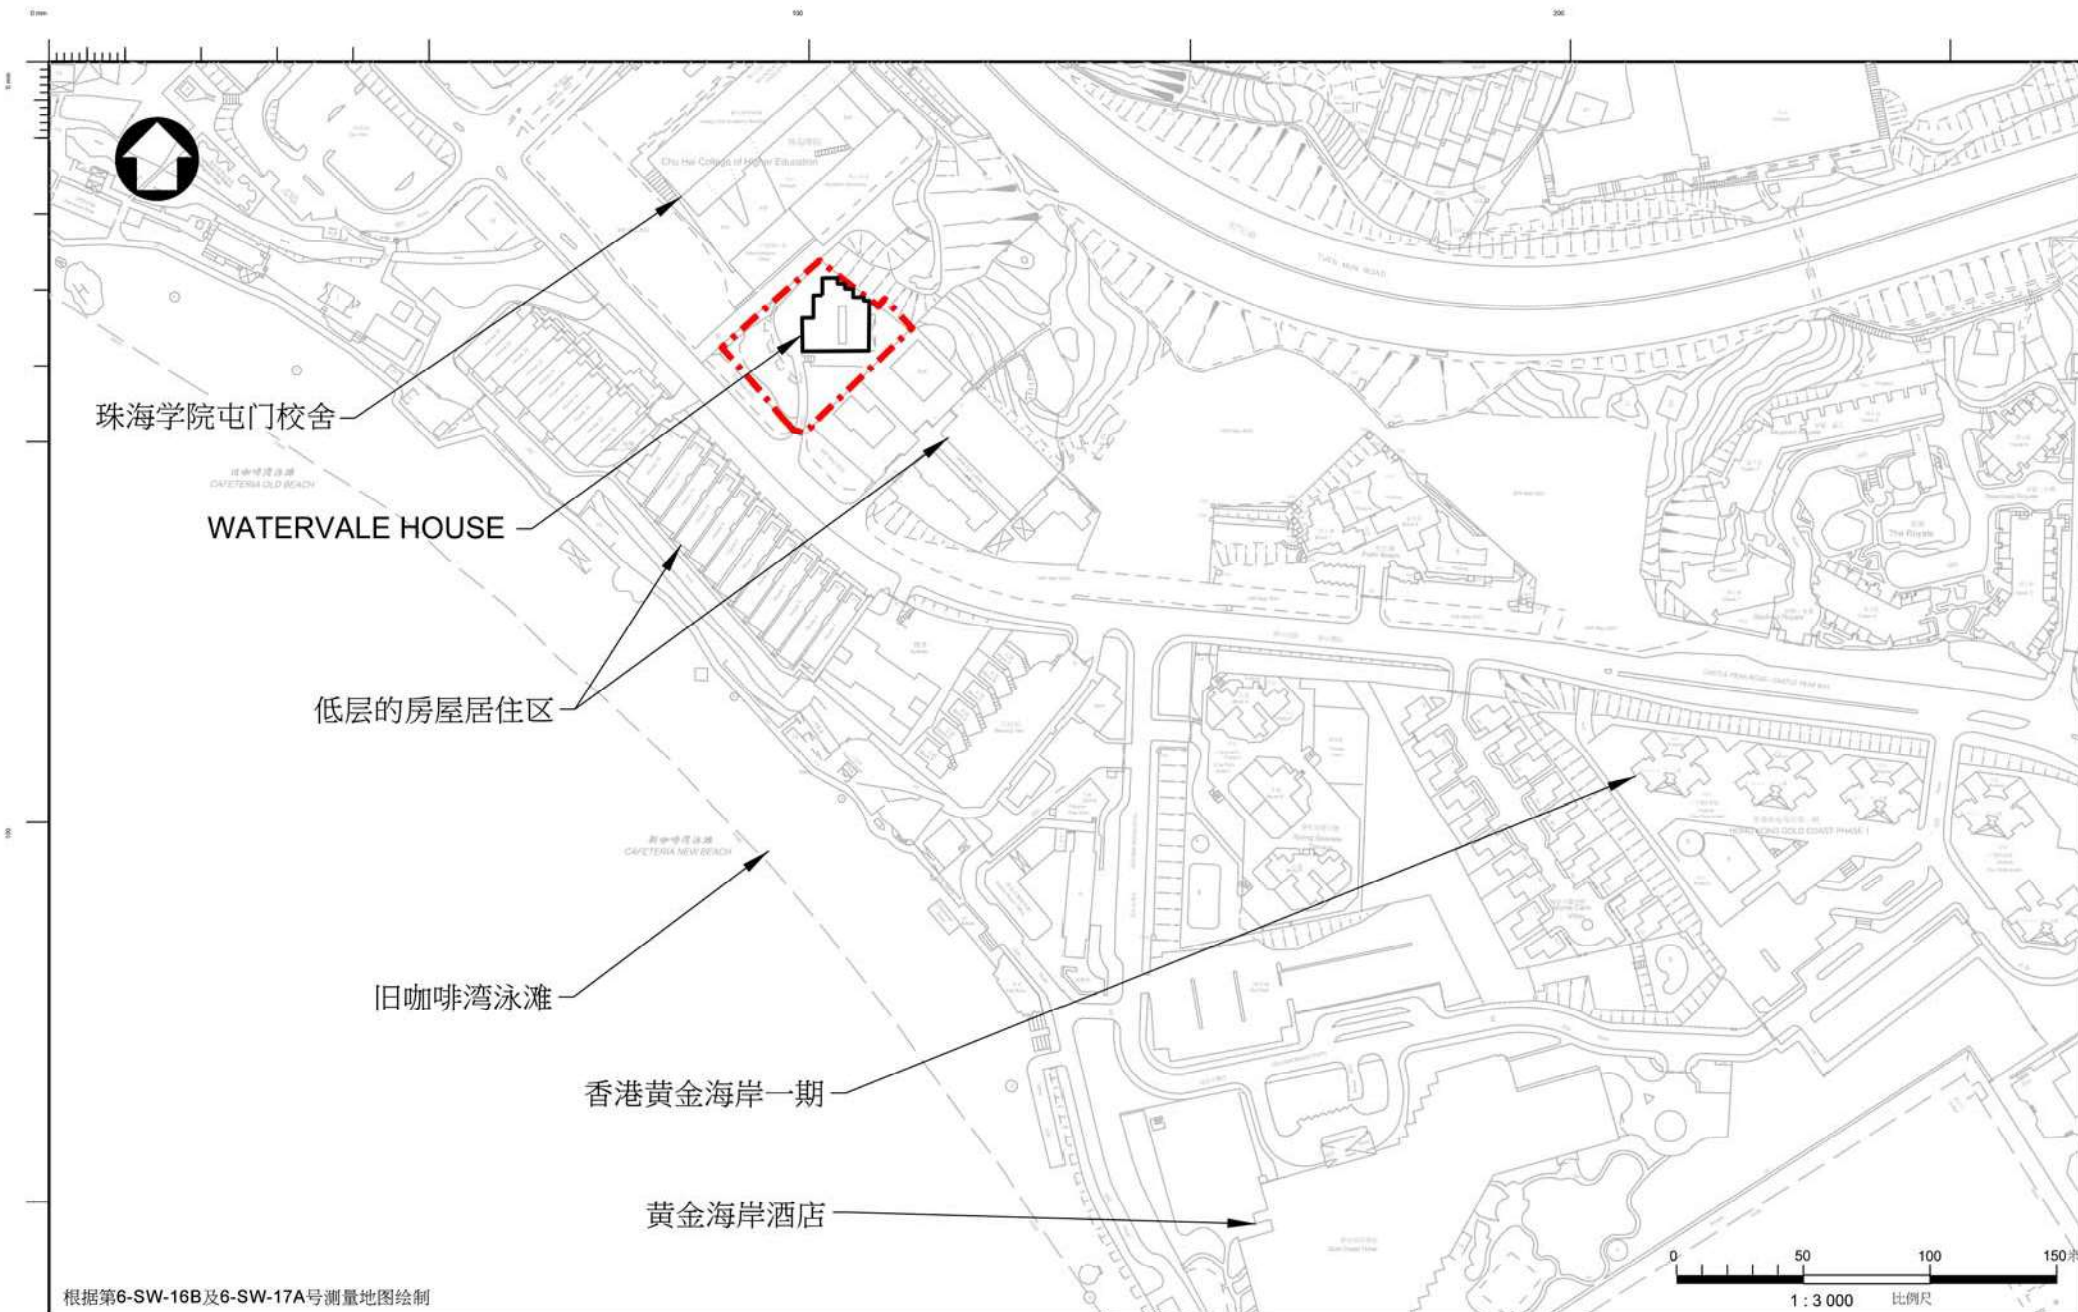
图则编号:
附录 VII 显示毗邻环境的图则

根据第6-SW-16B及6-SW-17A号测量地图绘制

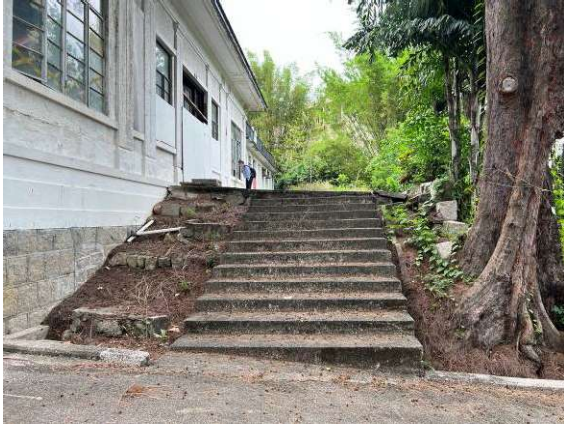
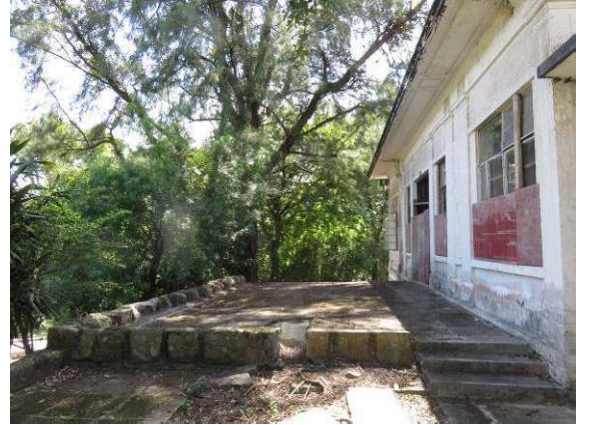
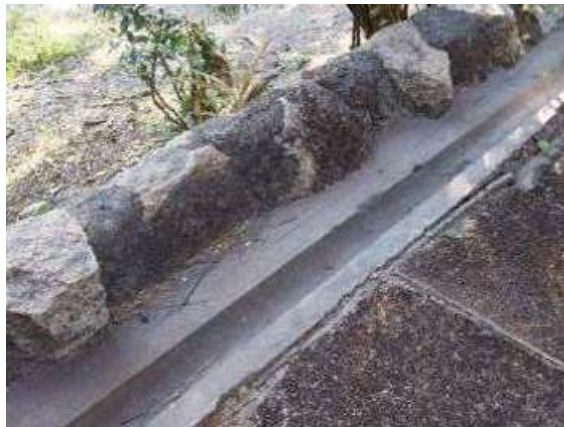
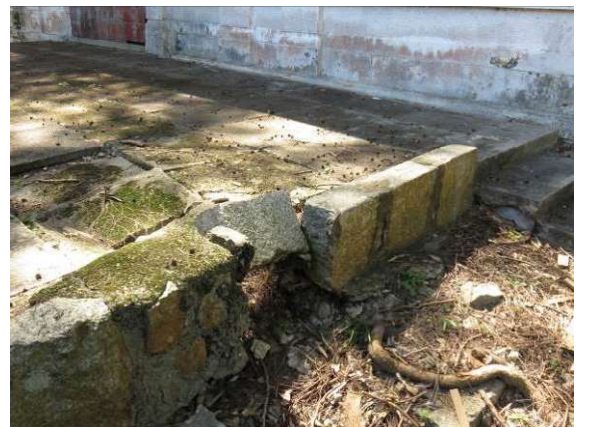
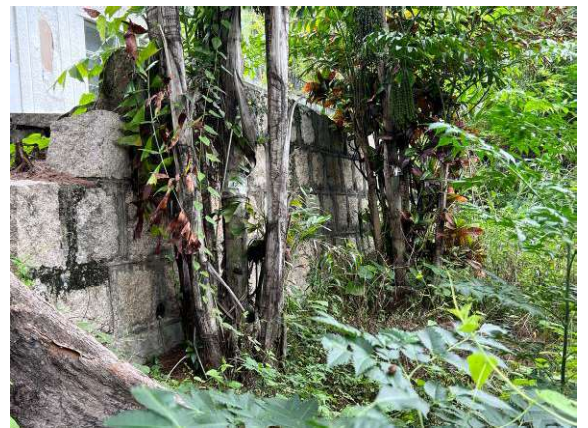
南面现存的平台，包括通往行车道和相连平台的梯级、石米饰面（地砖及梯级面）、矮毛石路缘及石砌面墙。

项目	建筑特色	规定处理方法
1.3	平台	<ul style="list-style-type: none"> a. 南面现存的平台，包括通往行车道和相连平台的梯级、石米饰面（地砖及梯级面）、矮毛石路缘及石砌面墙应大致保持原状。 b. 检查平台的排水设计，确保雨水不影响主楼。 c. 视乎需要，参照现有式样修葺损坏的梯级，重新铺砌不平的地台和花岗石路缘，替换损坏的石米饰面地砖及松脱的石块。 d. 检查平台下方的挡土墙是否稳固，如须进行改善工程，应保留石砌面并参照现有式样还原。 e. 参照现有式样，还原受挡土墙改善工程影响的石米饰面和路缘。

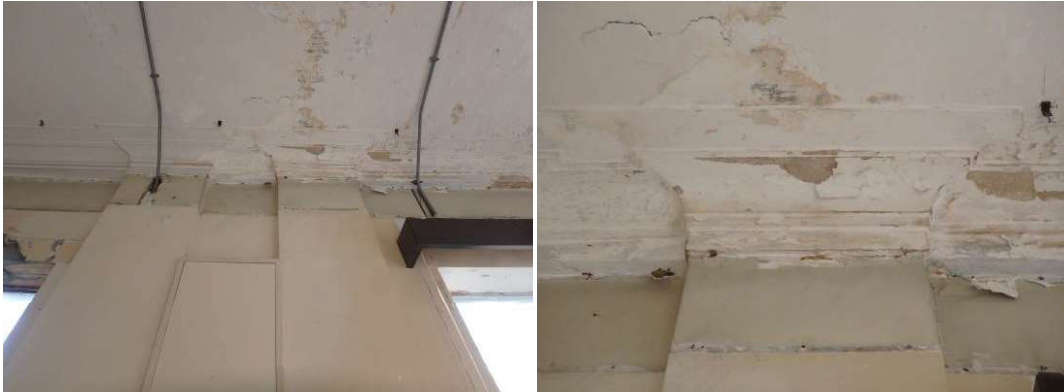
项目	建筑特色
3.5	<p data-bbox="331 277 496 353"><u>内部壁柱</u> 所有壁柱。</p> <div data-bbox="365 376 1434 766">

项目	建筑特色	规定处理方法
3.5	内部壁柱	<p>a. 在保存范围内所有壁柱应原位保存。</p> <p>b. 视乎需要修复损坏的饰面。</p>

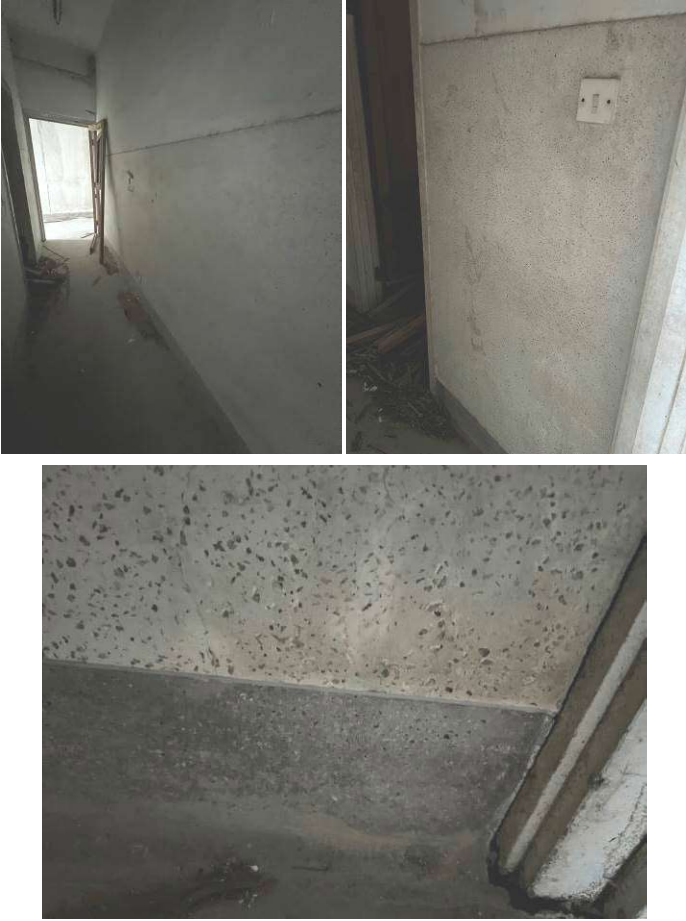
项目	建筑特色
5.2	<p data-bbox="331 277 1246 353"><u>走廊水磨石饰面</u> 扩建部分内的墙裙及走廊至梯间墙脚在线的水磨石饰面。</p> <div data-bbox="557 394 1246 1312">

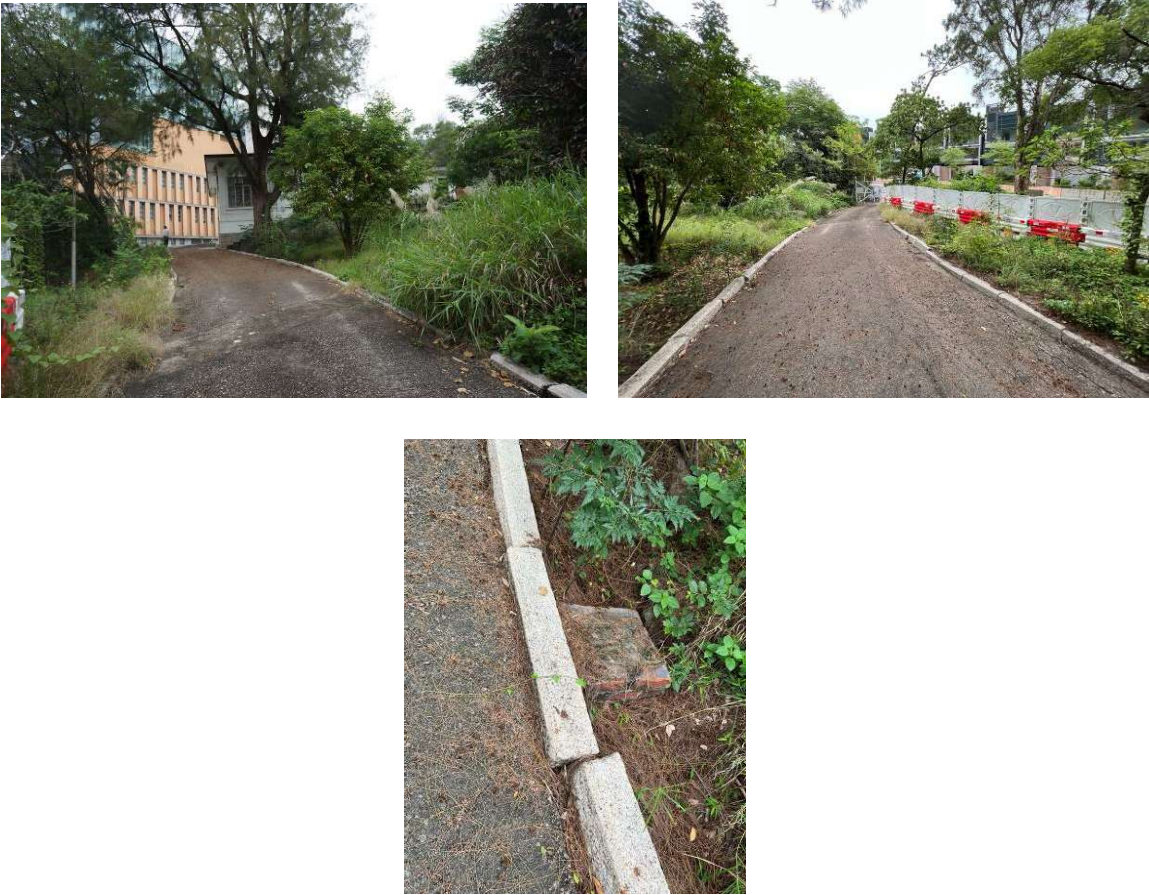
项目	建筑特色	规定处理方法
1.1	布局 / 四周范围	<ul style="list-style-type: none">a. 整体的地形、现有的花木以及通往主楼入口处的行车道，均应大致保持原状。b. 除非这些花木对公众及主楼构成危险，否则不得移除。c. 应原位保存沿着行车道的花岗石路缘。d. 视乎需要修复该处的排水设施、行车道路面及路缘。

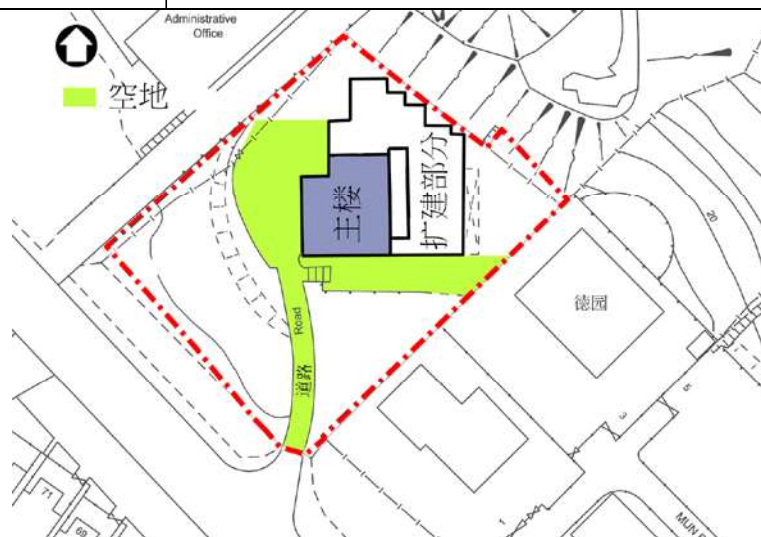
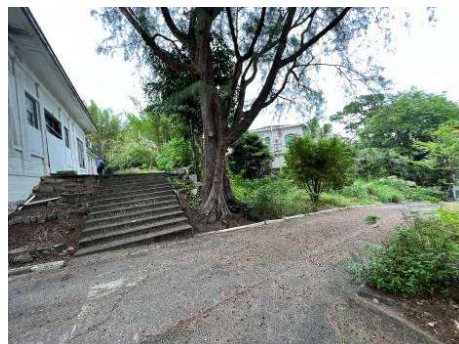
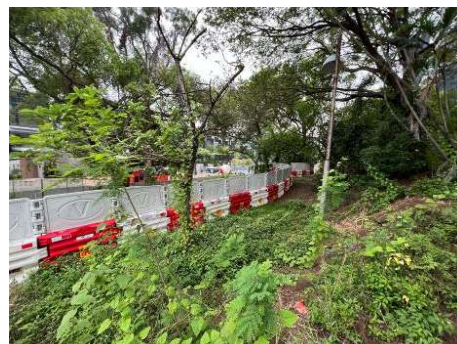
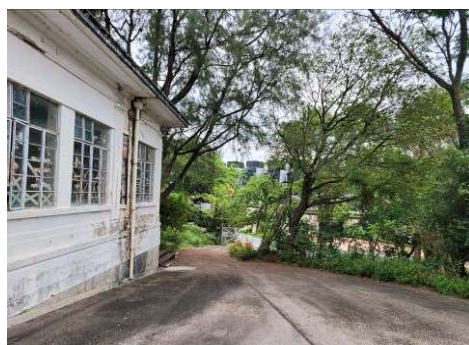
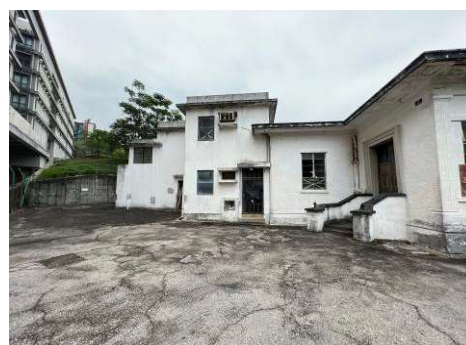
项目	建筑特色	规定处理方法
1.2	主樓外面空地	<p>a. 主樓东、西及南立面的景观十分重要，应予保留，让公众欣赏该建筑物时不受遮挡。</p> <p>b. 为减少对建筑物立面外观的影响，毗邻主楼的空地(見下图)应予保留。</p> <p>c. 为符合法定要求而在上述空地以外位置加建建筑物或构筑物作主楼的附属用途(拟议工程)，是可获考虑，惟须获古迹办批准。</p> <p>d. 拟议工程应为独立建筑物，施工地点须尽量远离主樓。</p> <p>e. 拟议工程不应对主樓的结构造成不良影响。</p> <p>f. 拟议工程的设计应与主樓兼容，亦易于区分。</p> <p>g. 拟议工程的最终高度须低于主樓的屋檐水平。</p>

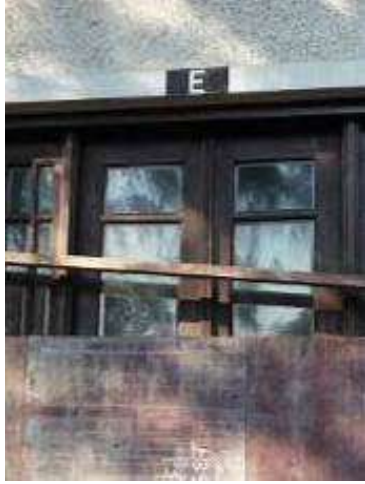
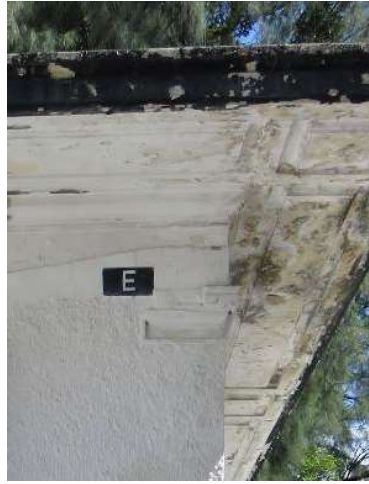
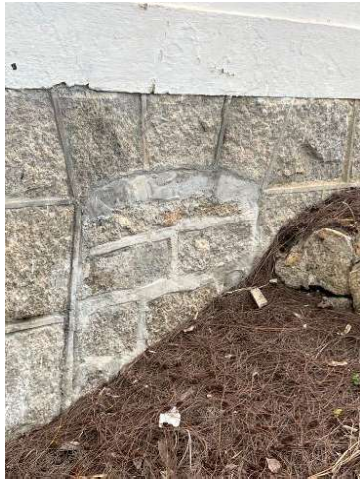
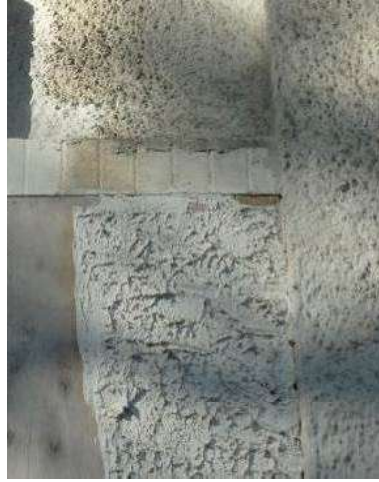
项目	建筑特色	规定处理方法
2.1	建筑物外立面	<ul style="list-style-type: none"> a. 应原位保存建筑物所有外立面，包括花岗石基座；批荡面(光滑面及粗灰泥面)；砖砌门楣、窗楣、门坎、窗台及砖砌装饰带。 b. 在平台木门砖楣及近主入口处屋檐下髹上的黑底白色「E」字，应原位保存，施工期间必须保护周全。 c. 不得在建筑物的立面加设新构筑物、空调设备、遮篷、鳍状遮挡等。 d. 不得改动立面现有的开口或增加开口。 e. 为外立面、钢窗、入口处木门及平台木门連侧窗的原本颜色进行研究及涂料分析，并向古迹办汇报研究结果及提交建筑物的配色方案，以供审批。 f. 使用获批准的去除涂料方法，除去批荡及砖块上的涂料。 g. 研究在南面立面花岗石基座上二个已围封的窗户的改动及原本的功能，向古迹办汇报研究结果，并视乎需要提出改善工程的建议。 h. 视乎需要修葺损坏的批荡，参照旁边批荡的式样重修饰面。 i. 使用获批准的可还原涂料及颜色重髹所有批荡。 j. 所有砖砌门楣、窗楣、门坎、窗台及砖砌装饰带一律保持清水饰面。视乎需要修葺损坏的砖块及砖缝。 k. 所有花岗石构件一律保持清水饰面。清除所有花岗石上的青苔及污渍，视乎需要修復石缝。

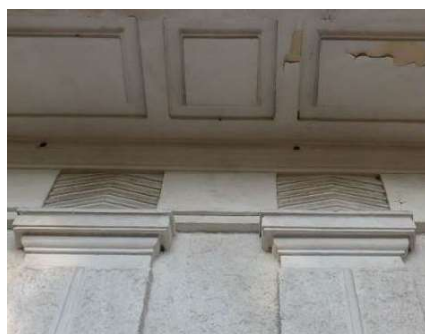
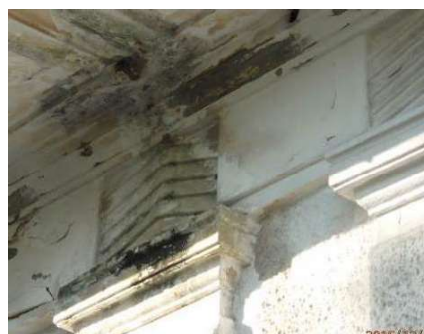
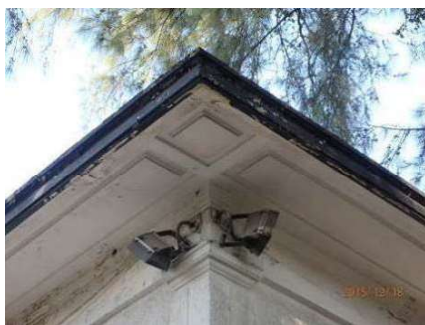
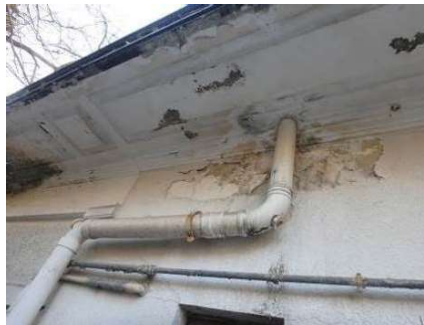
项目	建筑特色	规定处理方法
2.3	外墙檐壁	<p>a. 应原位保存所有外墙檐壁連飞檐及立体几何纹饰。</p> <p>b. 拆除西、南两个立面檐壁上的灯具、管道等。</p> <p>c. 使用获批准的方法除去旧涂料，然后使用获批准的可还原涂料及颜色重新髹漆。</p> <p>d. 视乎需要，参照现有式样修復破损的纹饰，以及修葺损坏的批荡。</p>

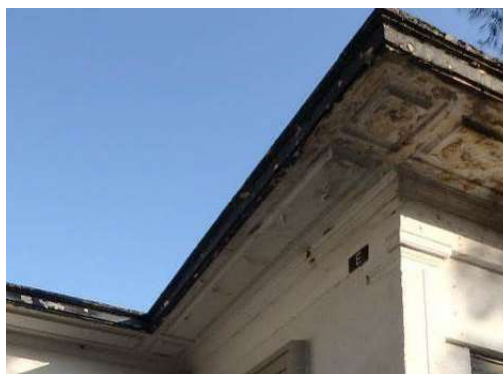
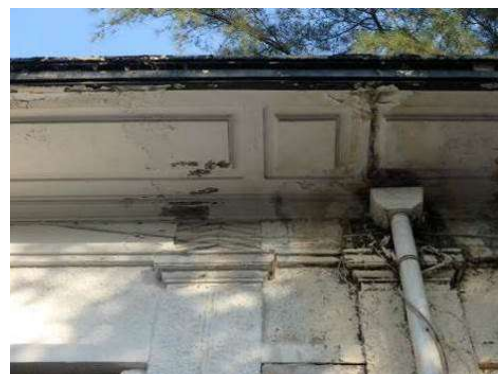
项目	建筑特色	规定处理方法
2.4	檐底纹饰	<p>a. 应原位保存檐底所有立体几何纹饰。</p> <p>b. 使用获批准的方法除去旧涂料，然后使用获批准的可还原涂料及颜色重新髹漆。</p> <p>c. 视乎需要，参照现有式样修復破损的纹饰，修葺损坏的批荡。</p>

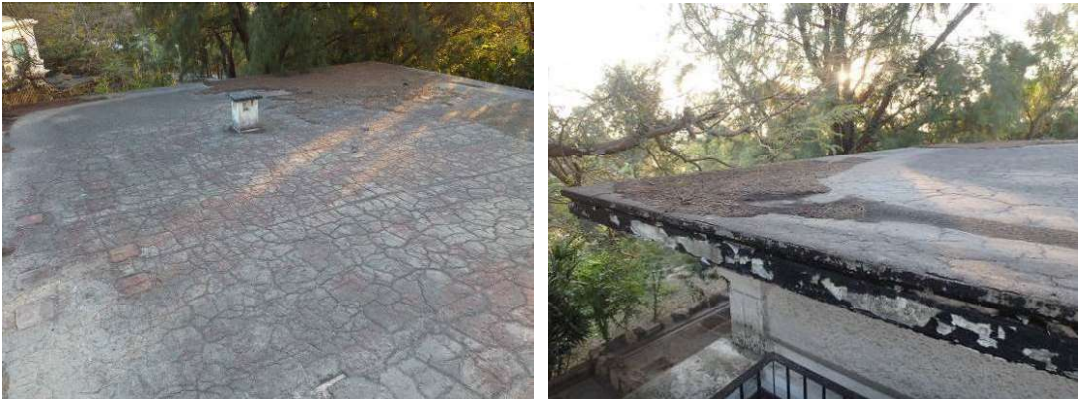
项目	建筑特色	规定处理方法
2.6	平屋顶	<ul style="list-style-type: none"> a. 平屋顶连凸出的屋檐均应大致保持原状。 b. 屋顶不得加建楼层。 c. 屋顶不得加装屋宇设备、风喉、管道等。 d. 修葺损坏的天面及防水层，并视乎需要更换损坏的天面物料。 e. 在修葺屋顶前，视乎需要修葺损坏的屋顶楼板。 f. 视乎需要更换损坏的檐口板，然后重新髹漆。 g. 尽量避免在主楼屋顶安装防护栏。

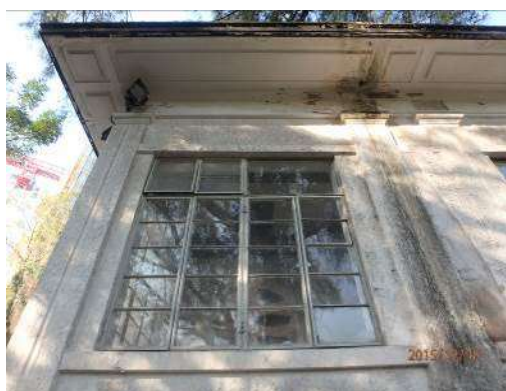
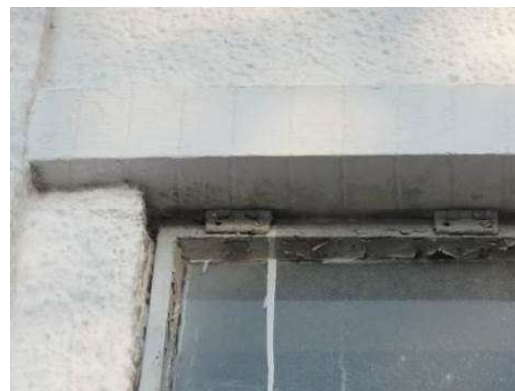
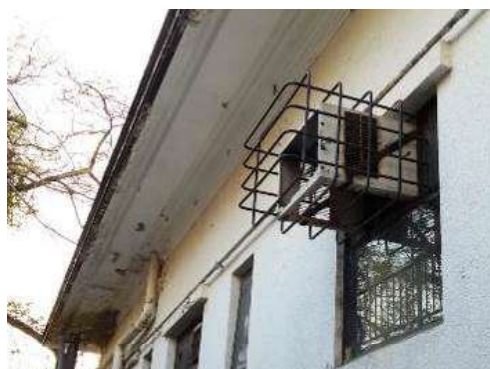
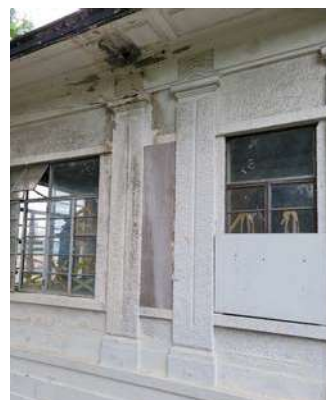
项目	建筑特色	规定处理方法
2.9	钢窗	<ul style="list-style-type: none"> a. 南和西两个立面的所有现存钢窗及金属部件如状况良好，仍能使用，应尽量原位保存。 b. 应把东立面的其他铝窗更换成新钢窗。新窗的设计及金属部件须获古迹办批准。 c. 拆除所有窗口的金属格栅 / 罩。 d. 拆除围封窗户的木板，并把钢窗修复至原有设计及功能。 e. 检查南和西两个立面的钢窗系统状况，包括但不限于窗框、玻璃、接缝料、金属部件及开关的状况，并进行渗水测试。 f. 清除钢窗上的锈渍。视乎需要修葺损坏的钢框，参照现有式样更换损坏的金属部件及玻璃。更换所有玻璃压条及接缝料。为所有窗框髹上防锈剂，然后重新髹漆。 g. 拆走冷气机，修复受影响的窗框。 h. 如钢窗已无法修葺而必须更换，新换的窗及金属部件的设计及饰面须与现有的相同，并须获古迹办批准。

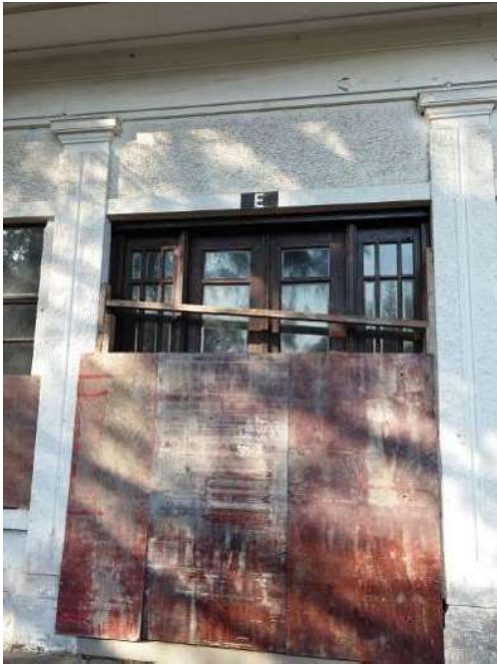
项目	建筑特色	规定处理方法
2.10	平台木门連側窗	<ul style="list-style-type: none">a. 应原位保存通往平台的一对法式木门連側窗及金属部件。b. 检查木门系统的状况，包括但不限于木门框、玻璃、接缝料、金属部件及开关的状况。c. 视乎需要修葺木门及金属部件，并参照现有式样更换损坏的玻璃。d. 如金属部件必须更换，新换的部件的设计及饰面须与现有的相同，并须获古迹办批准。e. 除去木门、木框及窗棂上的旧涂料，髹上木材防腐剂，以及使用获批准的方法及物料，重新髹上透明哑光漆。

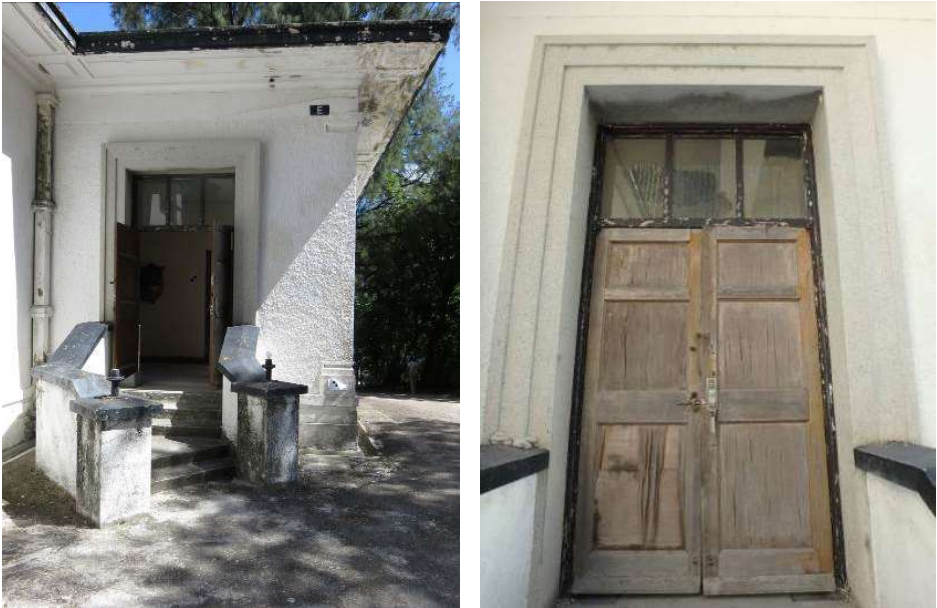
项目	建筑特色	规定处理方法
2.11	入口处的木门連楣窗	<ul style="list-style-type: none"> a. 尽量保存现存的门框連楣窗。 b. 修葺木门及上方楣窗损坏的木框。如现存的木框已无法修葺，应换上木料相同的新框。 c. 更换主入口处的木门及门底挡缝条，木料及设计须与现有的相同，并髹上透明哑光漆。新换木门的设计、饰面及金属部件须获古迹办批准。 d. 门楣及门底挡缝条明显因渗水受到损坏，应考虑进行改善工程，避免日后门楣再现水渍，门底挡缝条再受渗水影响。拟议改善工程须获古迹办批准。

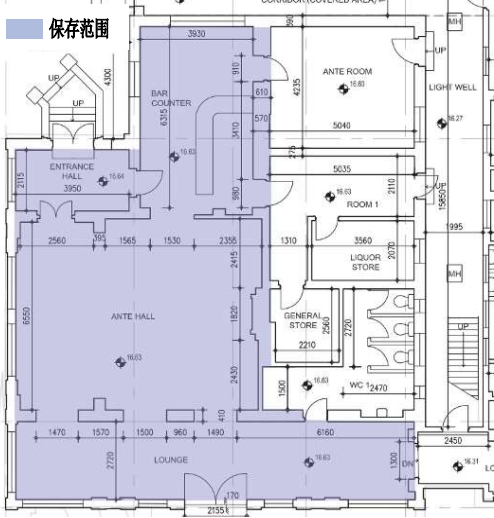
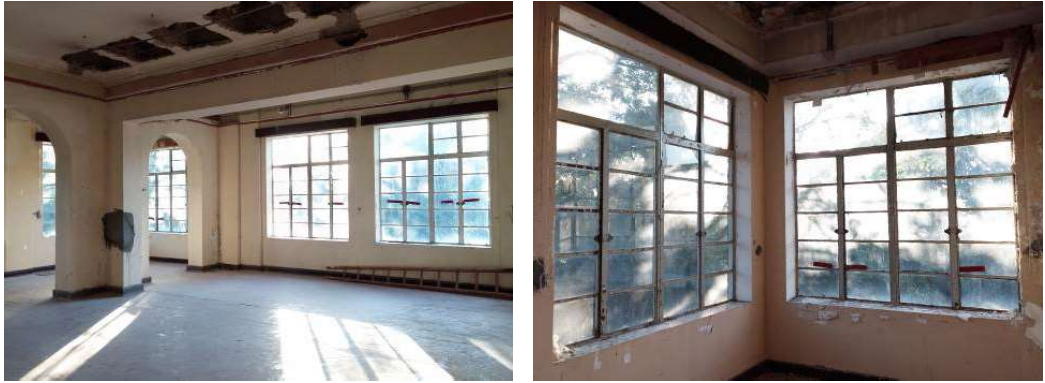
項目	建築特色	規定處理方法
3.1	空間布局	<p>a. 門窗闊大，把大自然帶入室內，營造整體空間開闊的氛圍；木制地板、牆腳線、窗簾盒等有助營造暖意的室內飾面；以及天花線、拱門及壁柱等帶有古典風味的裝飾均應大致保持原狀。</p> <p>b. 除非獲古蹟辦批准，否則不得在保存範圍內（見下图）加建新結構、間隔或其他永久裝置。</p> <p>c. 可考慮改動在保存範圍以外地方的內部間隔，以進行內部改裝和加建工程，惟須獲古蹟辦批准。</p> <p>d. 可考慮在建築物裝設空調系統，惟室外機組及設備須安裝在不顯眼處。空調系統的設計及布局須獲古蹟辦批准。</p> <p>e. 視乎需要，參照現有式樣修復早前凿開的地方和損壞的批蕩。</p> <p>f. 研究主樓內部原本採用的顏色及飾面，然後向古蹟辦提交調查結果、測試結果、照片、繪圖、調查摘要等，以供存檔。</p> <p>g. 修葺損壞的飾面，使用獲批准的可還原塗料及顏色重鬆建築物內部的整個空間。</p>

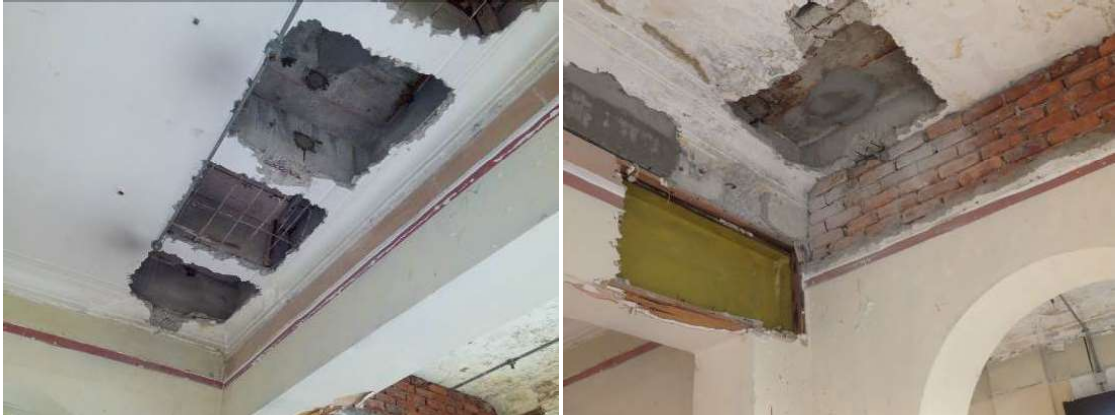
项目	建筑特色	规定处理方法
3.2	建筑结构	<p>a. 所有原有的结构构件(包括支柱、横梁、结构墙、拱形开口及屋顶原有的隐蔽式肋梁结构楼板等)应大致保持原状。</p> <p>b. 不得在结构上凿开新孔或加设开口。</p> <p>c. 在结构任何部分进行加固或重建工程以符合法定要求，是获可考虑，惟须先征询注册结构工程师的意见，并获古迹办批准。</p> <p>d. 在保存范围内后来加建的钢梁，与原有混凝土结构不协调，因此应予拆除。翻查历史记录，并按原有的设计及位置，还原有关支柱及拱门。</p> <p>e. 参照现有物料及设计，把原有隐蔽式肋梁结构楼板的所有凿开和损坏的地方还原。在可行情况下尽量拆除留在原有隐蔽式肋梁结构楼板内的木模板。</p> <p>f. 视乎需要，修葺所有剥落的混凝土以及其他损坏的地方。</p>

获选机构须进行全面的结构评估，包括详细的现场勘测及进行适当的现场及实验室检测，核实和确认结构组件的数据和状况及楼宇结构能力，以设计所提议的活化用途。须特别注意钢筋混凝土肋形楼板的底板，因这些底板可能阻碍检测空隙内有否结构上的缺陷和有关修复工作。

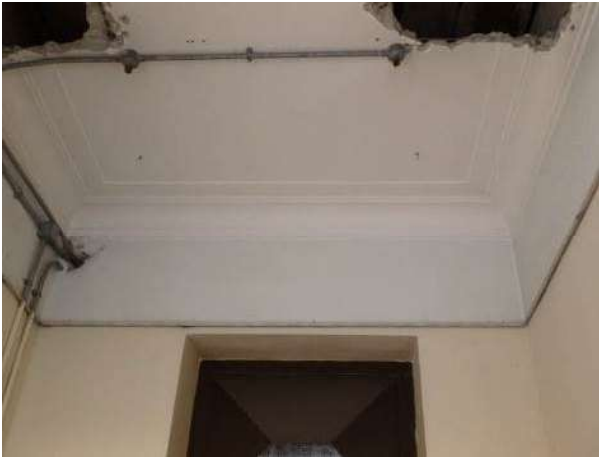
项目	建筑特色	规定处理方法
3.3	天花饰线	<p>a. 所有天花饰线(包括冠顶饰线)应原位保存。</p> <p>b. 所有天花饰线应保持外露，让公众观赏。安装垂吊式假天花，是可获考虑，惟设计应可让天花的饰线细节全部外露，不受影响，并须获古迹办批准。</p> <p>c. 参照现有式样，视乎需要修葺损坏的天花饰线。</p>

A photograph showing a ceiling with decorative moldings and a recessed lighting fixture. The ceiling is white with a simple rectangular molding. A dark, square recessed light fixture is visible in the center. The walls are a light beige color.

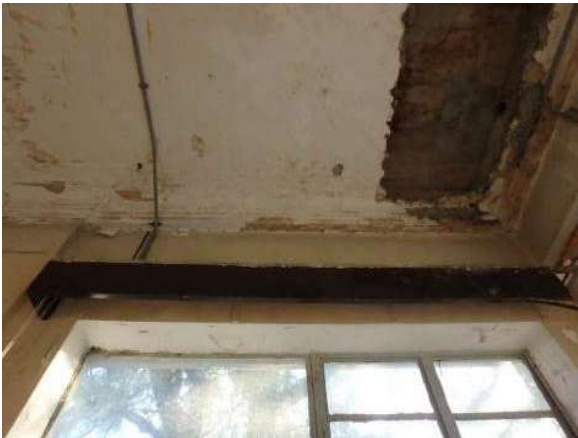
项目	建筑特色	规定处理方法
3.7	木窗簾盒	<p>a. 应原位保存在保存范围内的木窗簾盒。</p> <p>b. 尽量修葺损坏的窗簾盒。更换窗簾盒时，只可换上状况良好的旧木。参照现有式样为现存和新换的窗簾盒重修饰面。</p>

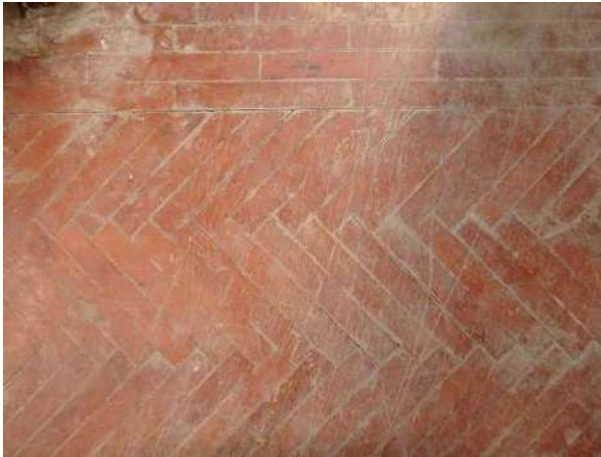
项目	建筑特色	规定处理方法
3.8	人字纹木地板	<p>a. 应原位保存在保存范围内的木地板。</p> <p>b. 视乎需要修葺损坏或残旧的地板。地板须涂刷木材防腐剂，并须参照现有式样为现存和新换的木地板重修饰面。</p>

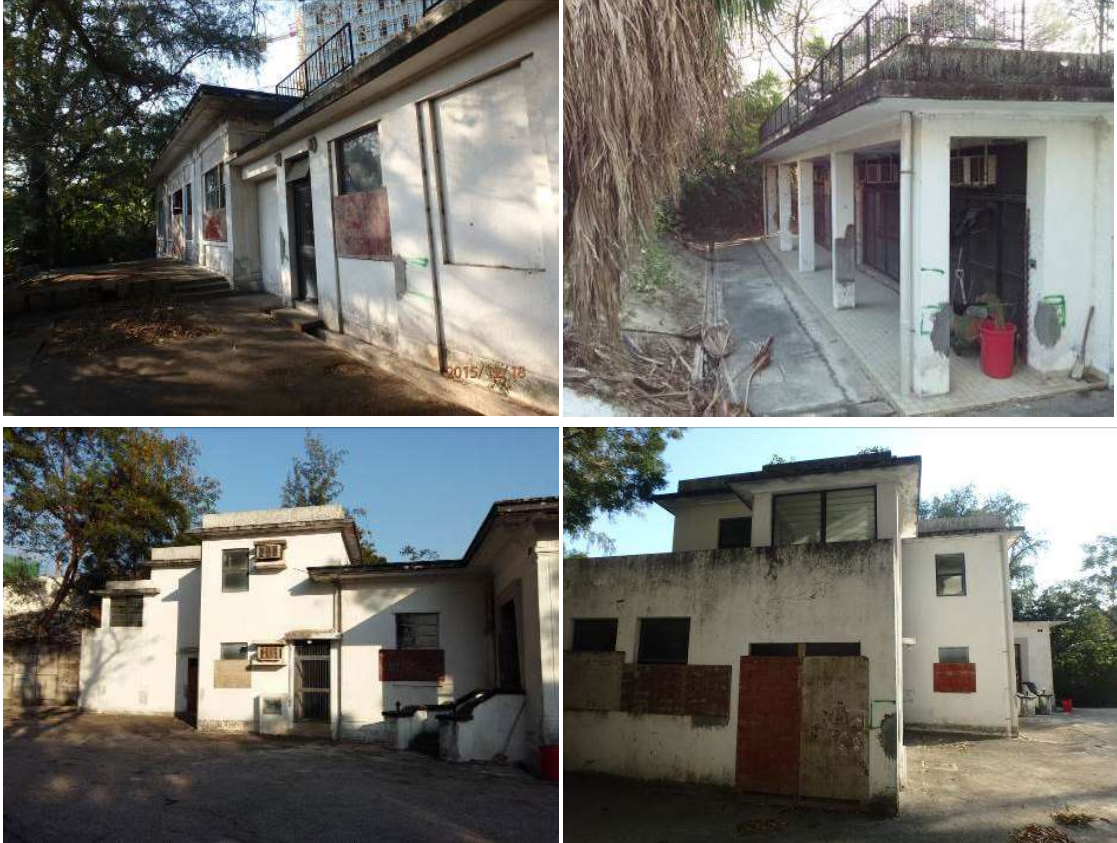
项目	建筑特色	规定处理方法
4.1	建筑设计	<p>a. 不反对在扩建部分进行改装和加建工程，惟必须符合下述条件：</p> <ol style="list-style-type: none"> 1. 加建楼层或构筑物不得超过现有护墙高度； 2. 安装在屋顶的屋宇设备、风喉、管道等，不得影响扩建部分西、南两个立面的外观； 3. 须原位存第4.2项所指的立面。新加设的构筑物不得突出这些立面；以及 4. 室内改装工程不得损坏第5.1项所指的梯间及楼梯的外观。 <p>b. 在扩建部分进行的改装和加建工程，均不对主楼的结构造成不良影响，这些工程须与主楼兼容，亦易于区分。</p> <p>c. 如改装和加建工程影响主楼的表面，必须参照现有式样修葺和重修饰面，以令古迹办满意为合。</p> <p>d. 扩建部分重修饰面所用颜色，须与主楼兼容。</p>

<p>The image block contains four photographs of a white building. The top-left photo shows a side view of the building with a balcony and a red door. The top-right photo shows a view of the building from a different angle, highlighting the balcony and the surrounding environment. The bottom-left photo shows a front view of the building with a red door and a balcony. The bottom-right photo shows a view of the building from a different angle, highlighting the balcony and the surrounding environment.</p>

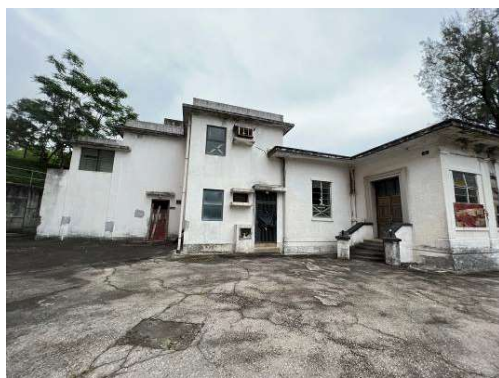
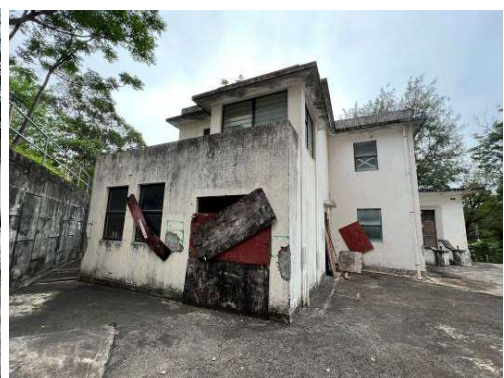
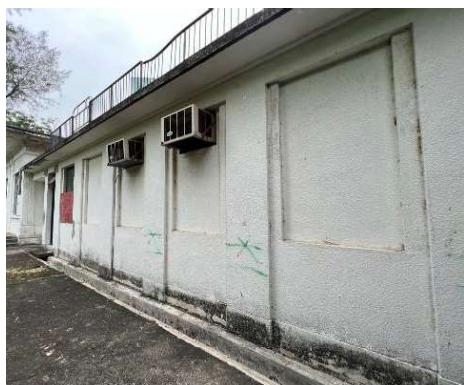
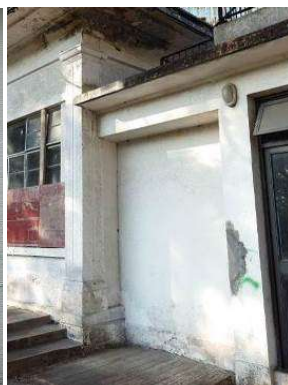
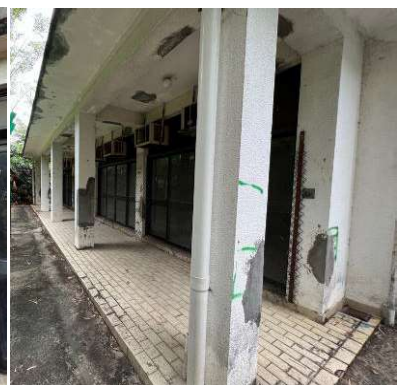
项目	建筑特色	规定处理方法
4.2	建筑物的立面	<p>a. 下图所示与主樓相連的西面和南两个立面、梯间和东面外廊部分的立面，包括所有护墙、屋檐、窗口及门口上方的鳍状遮挡、门口的花岗石门坎，以及外廊的壁柱、外露结构和天花，均应原位保存。</p> <p>b. 拆除现有冷气机。不得在上述立面上装设任何空调设备、遮蓬、鳍状遮挡等。</p> <p>c. 復原扩建部分与主樓之间的南面走廊上原有的开口，并装上透明的物料。</p> <p>d. 改动上述立面现存的开口或增加开口，须获古迹办批准。</p> <p>e. 视乎需要修葺剥落的混凝土及批荡。</p> <p>f. 如重铺东面外廊的铺面，新铺面的设计和物料须提交古迹办审批。</p>

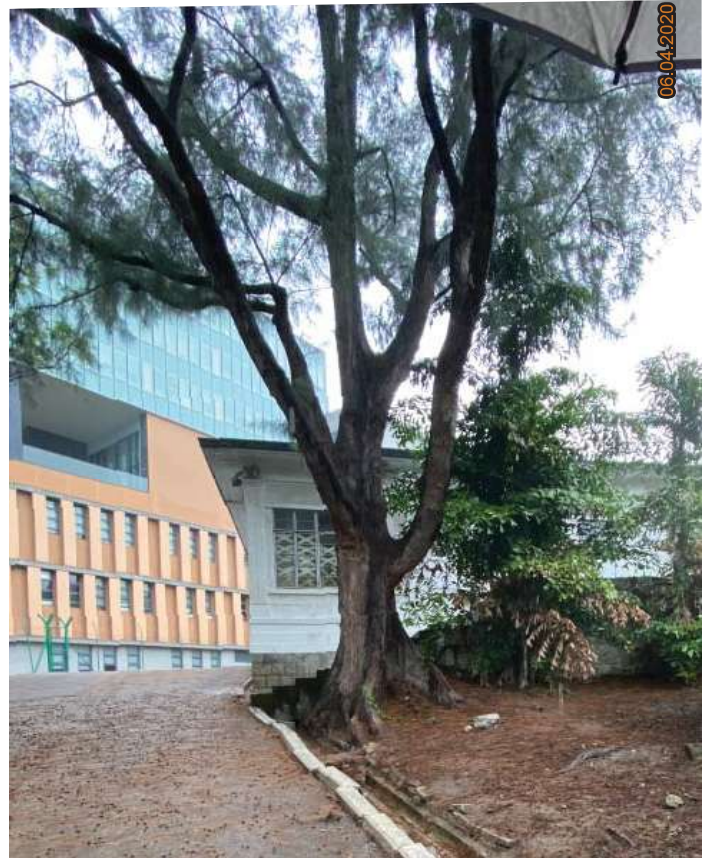
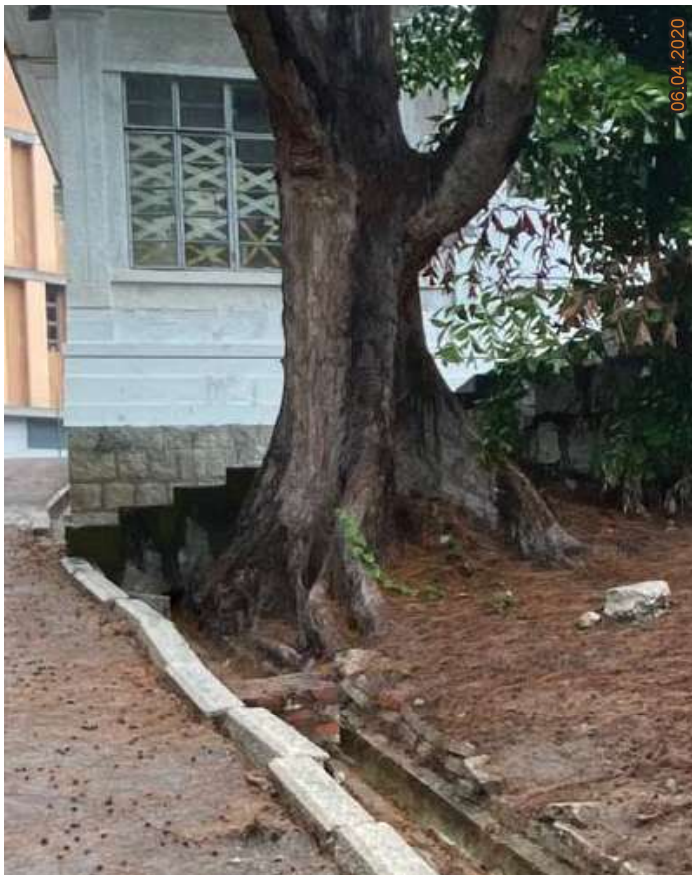
T25 - *Casuarina equisetifolia*

Casuarina equisetifolia
