活化歷史建筑伙伴计划

第 48 区前哥顿军营

Watervale House

资料册

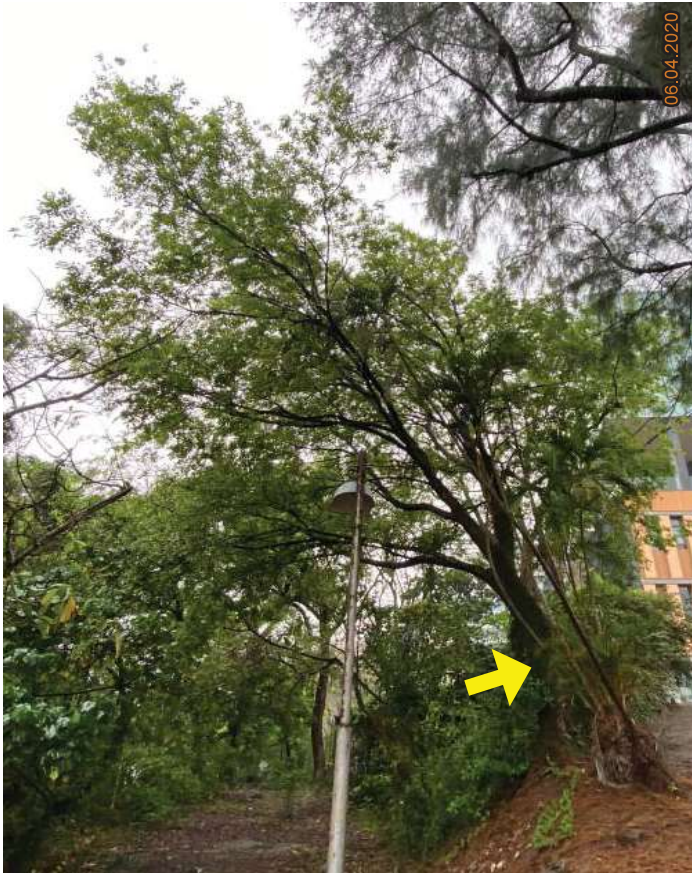
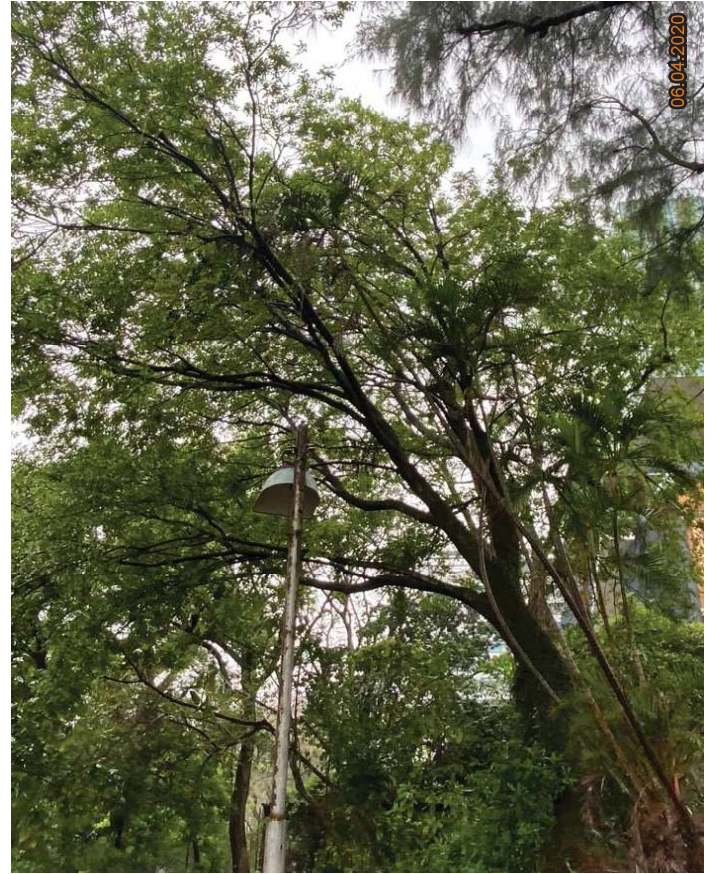
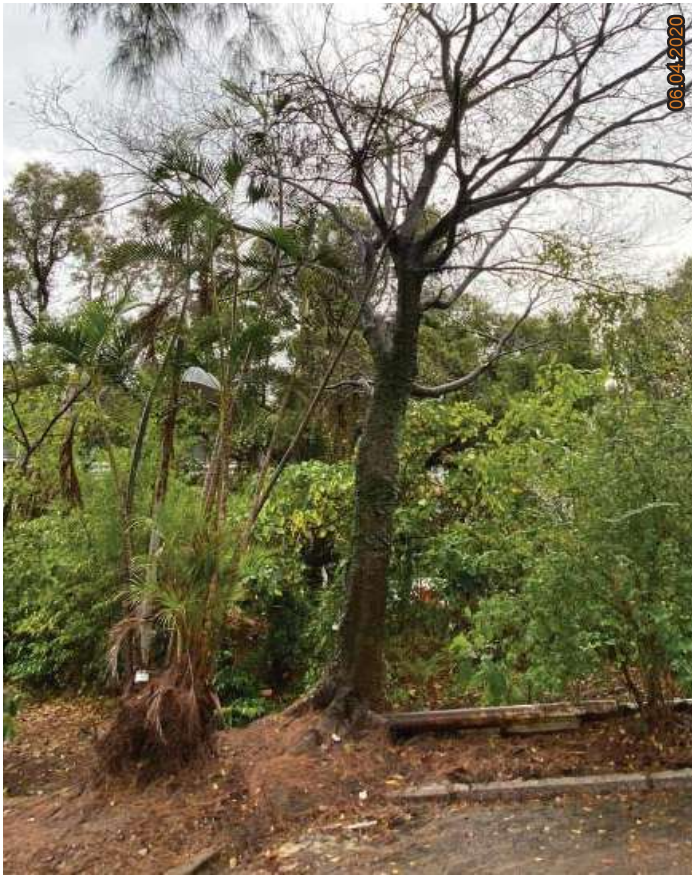
T26 - *Celtis sinensis*

Celtis sinensis

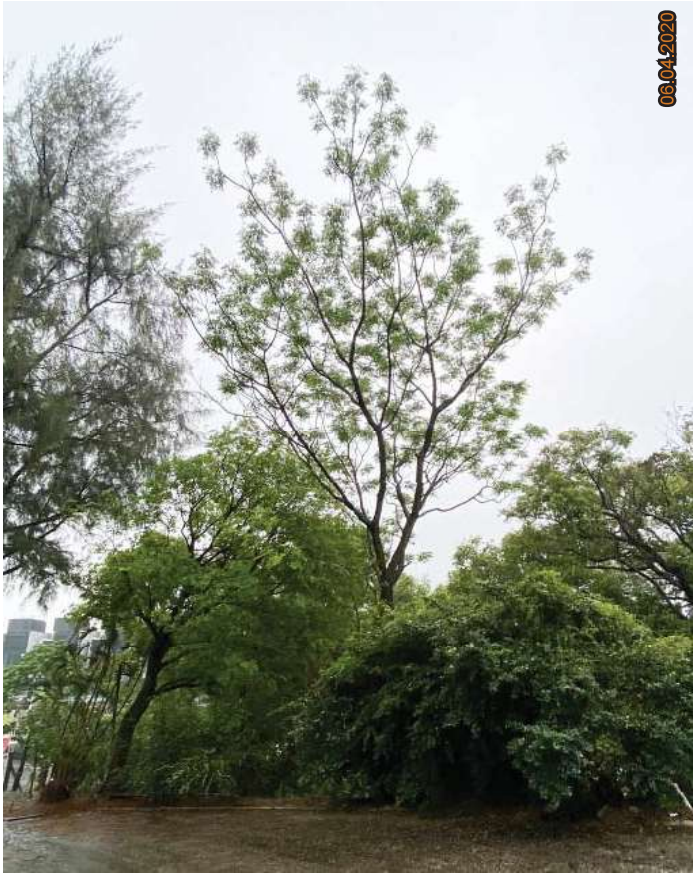
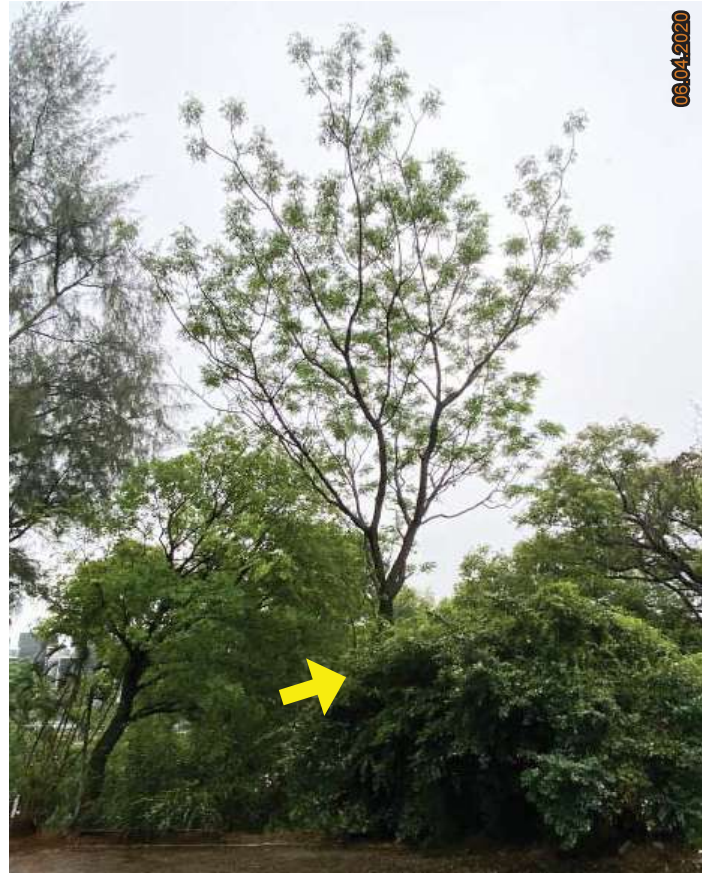
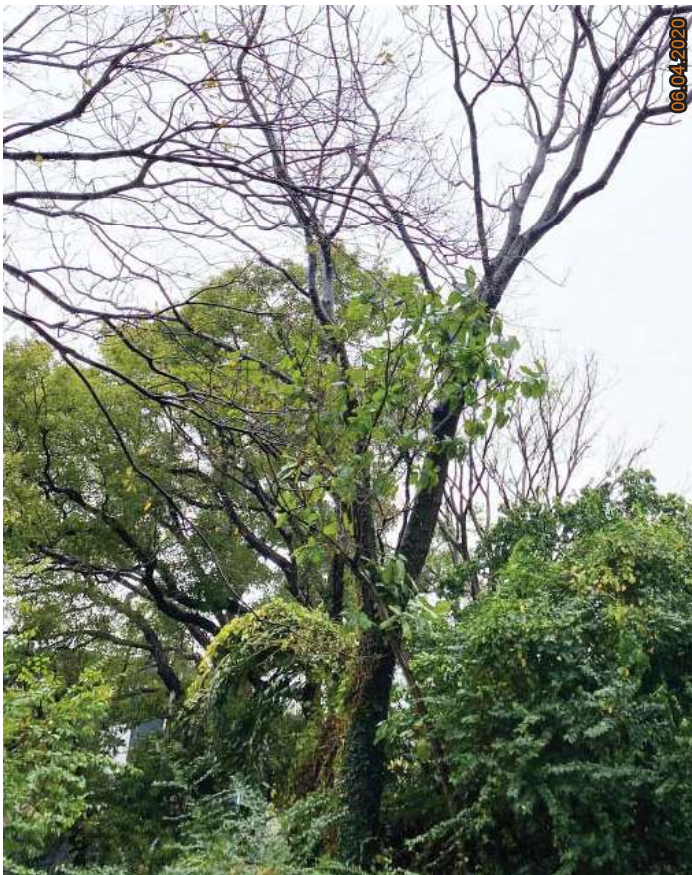
T28 - *Melia azedarach*

Melia azedarach

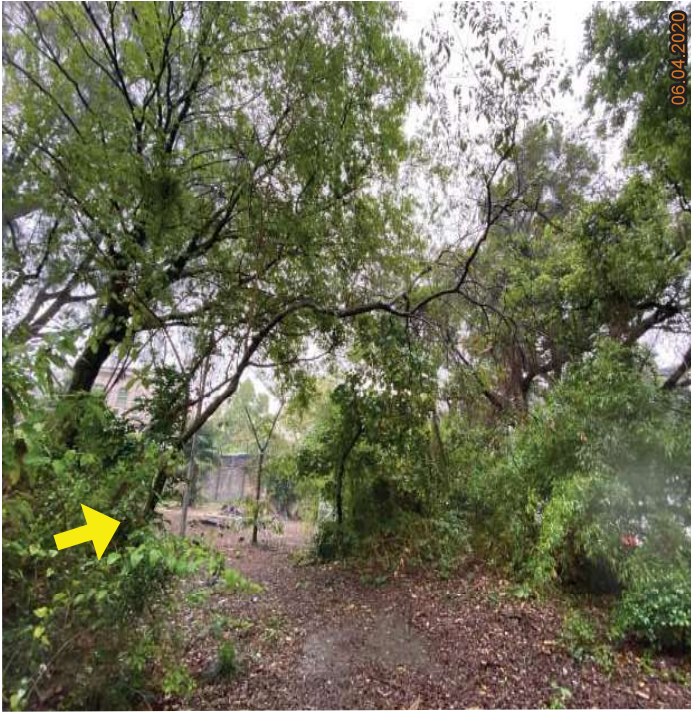
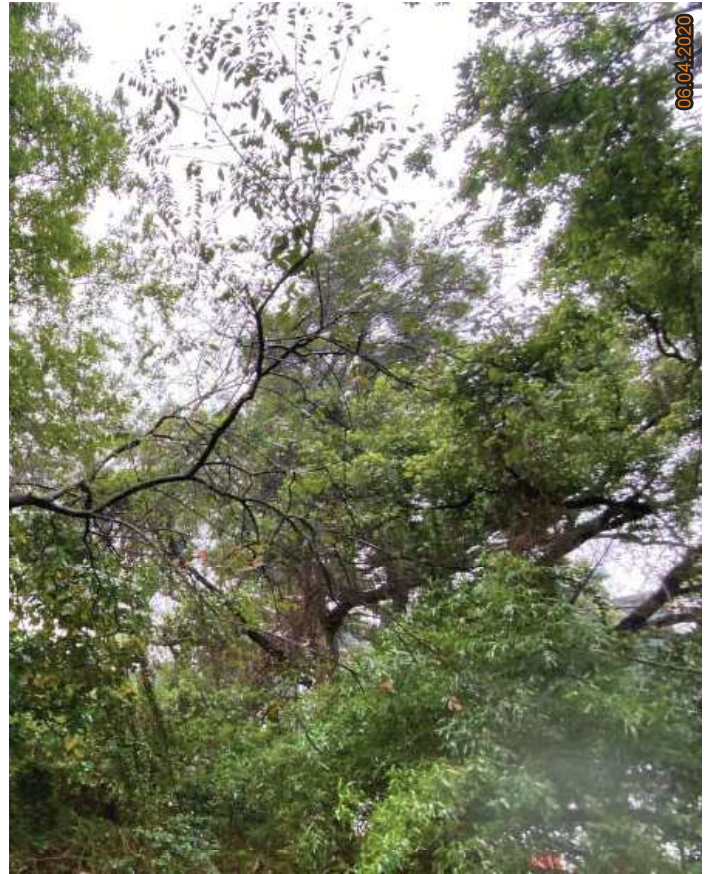
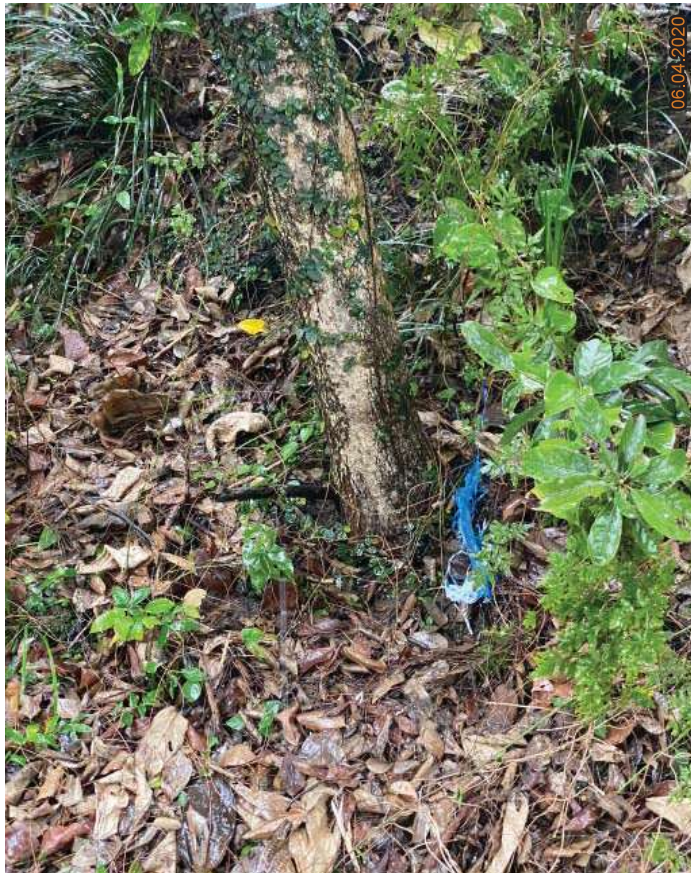
T29 - *Bridelia tomentosa*

Bridelia tomentosa

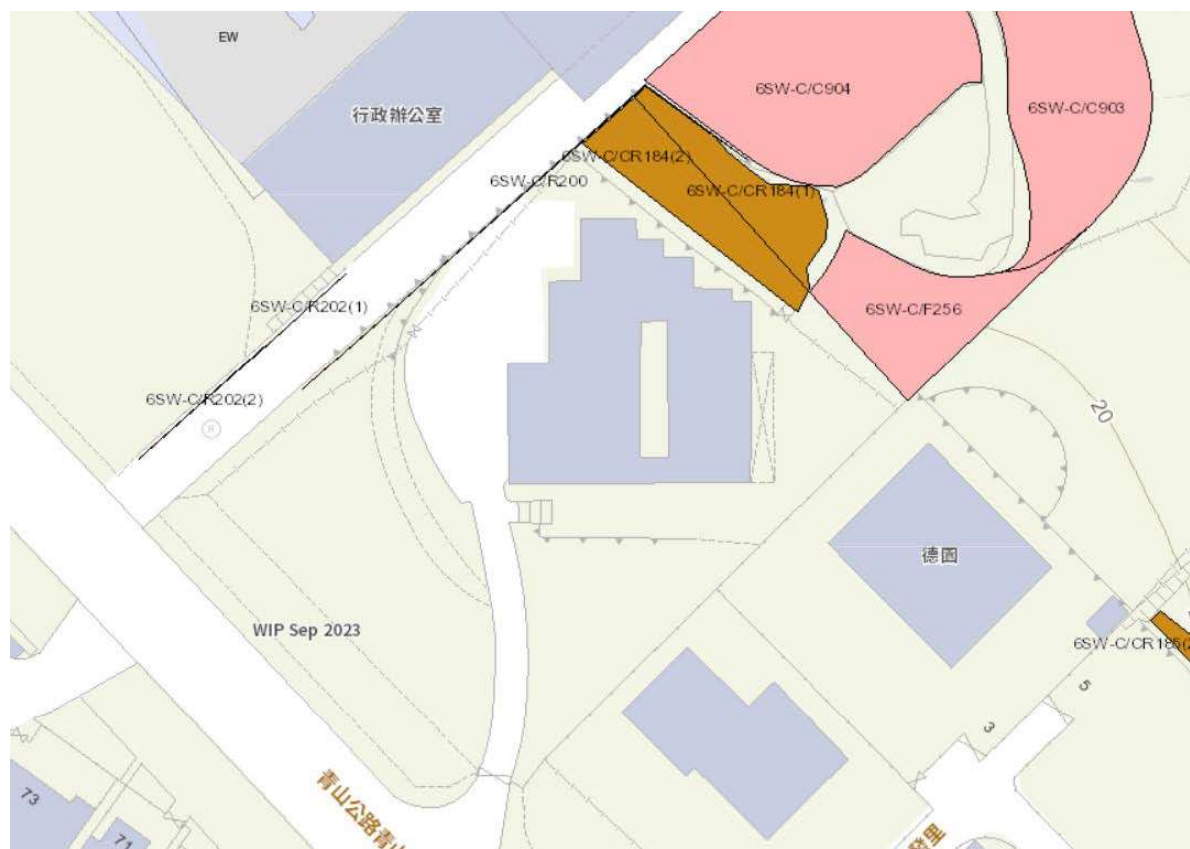
斜坡分布概览:

斜坡编号:	6SW-C/CR184
斜坡分段编号:	2
地点:	部分位于屯门市地段第558号余段内, 部分位于政府拨地 - 屯门第521号内 及 部分在未批拨的政府土地上
负责地段/负责方:	发展局
维修代理人:	建筑署
