活化歷史建築伙伴計劃

白樓

資料冊

日期：二零一九年十一月二十七日

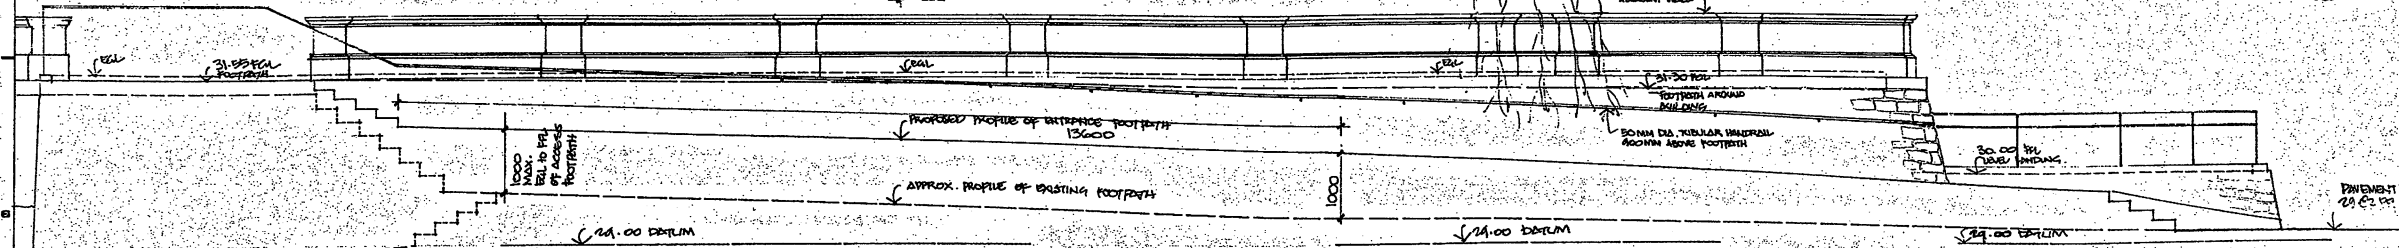
Elevational section thro' improved existing main entrance footpath 1:50

CAREFUL TAKE DOWN EXISTING EXTERIOR WALL + CLASH WITH NEW RAMP; (CONSIDER TO TOP OF EXISTING FOOTPATH LEVEL)

NEW FOOTPATH CONSTRUCTION:
 REINFORCED CONCRETE BALUSTRADE WALL TO EXISTING ENGINEERS WALL. FILL VOID WITH SELECTED COMPACTED FILL IN LAYERS; TO AVOID UNDESIRABLE SETTLEMENT. LAY 150MM BLIND + COMPACTED SELECTED SAND/GRANULES TO FINISH AS DISCUSSED; LAY 75MM THICK REINFORCED CONCRETE FINISH IN PANELS NOT EXCEEDING 3000MM LONG TO BECOME COMPACT TIE BLOCK PANELS; TIES TO BE 220X40X15MM THICK.

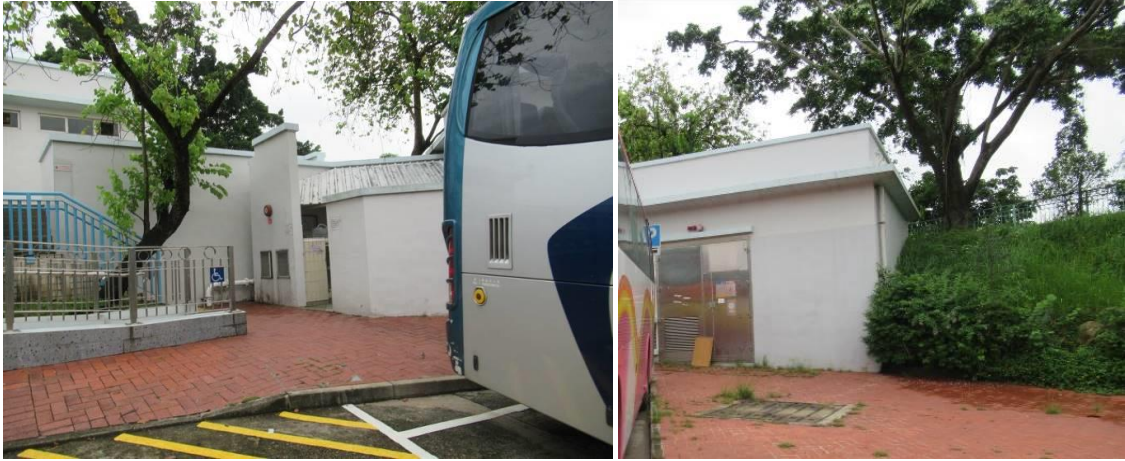
附屬建築 (垃圾收集站及電力變電站)

電力變電站和垃圾收集站等附屬建築物於 1995 年竣工。附屬建築物目前的結構狀況良好，主要的結構構件並沒有發現嚴重的結構裂縫、地基的不規則沉降、主要結構構件的明顯變形以及混凝土剝落等問題。

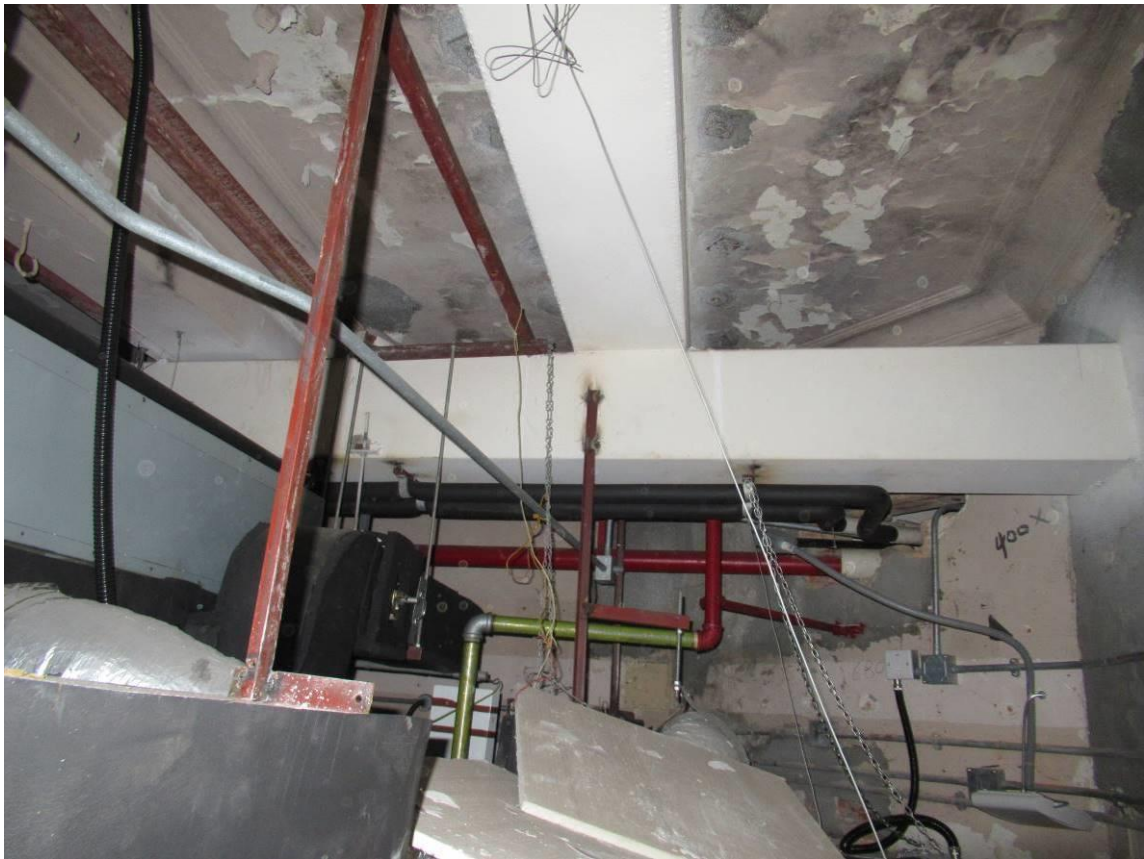
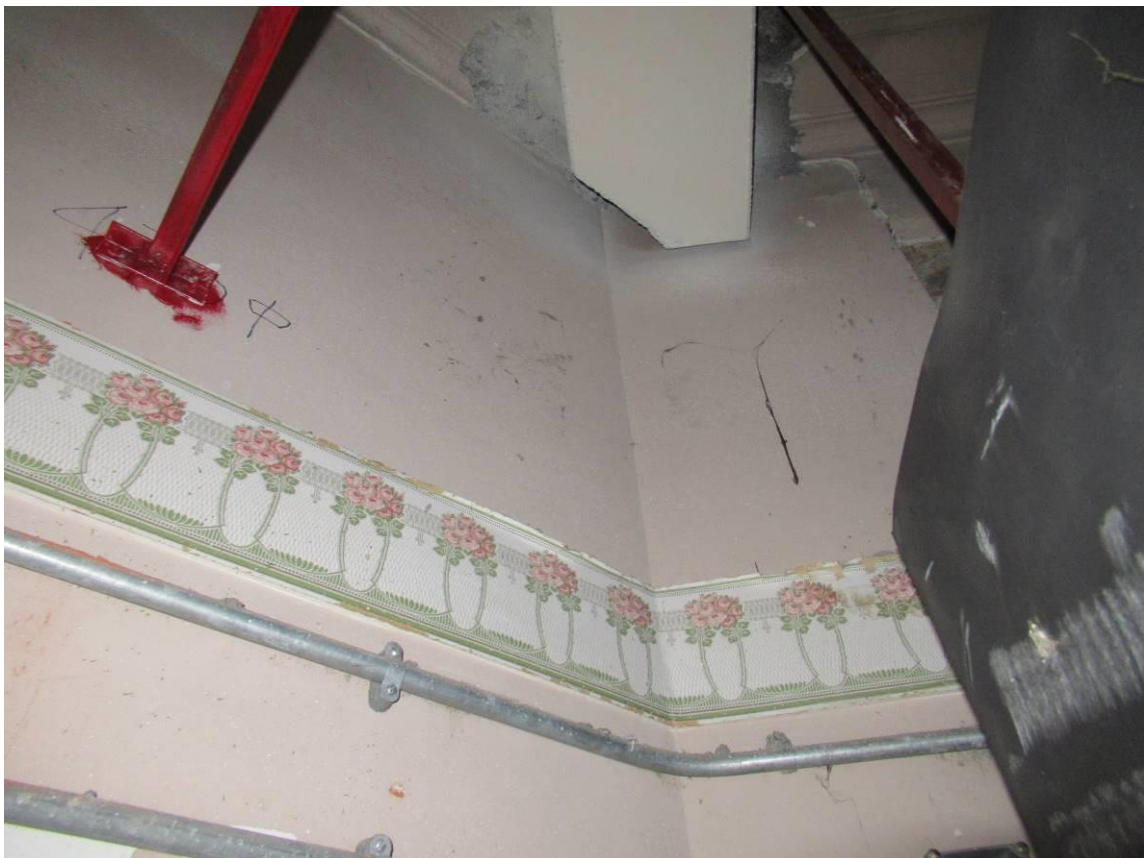
主樓假天花上的情況

| 項目 | 建築特色 | 規定處理方法 |
|--|---|---|
| 3.3 | 天花線 | <ul style="list-style-type: none"> a. 所有天花線（包括冠頂天花線）應原位保存。 b. 現時裝設的假天花令公眾未能欣賞天花線。可考慮盡量讓天花線外露，供公眾欣賞。 c. 可考慮裝設垂吊式天花板，惟須以可還原方式安裝，而且對現有歷史構件影響輕微，以及須獲古蹟辦批准。 d. 按需要和參照現有式樣修葺和修復破損的飾線，並重新髹漆。 |

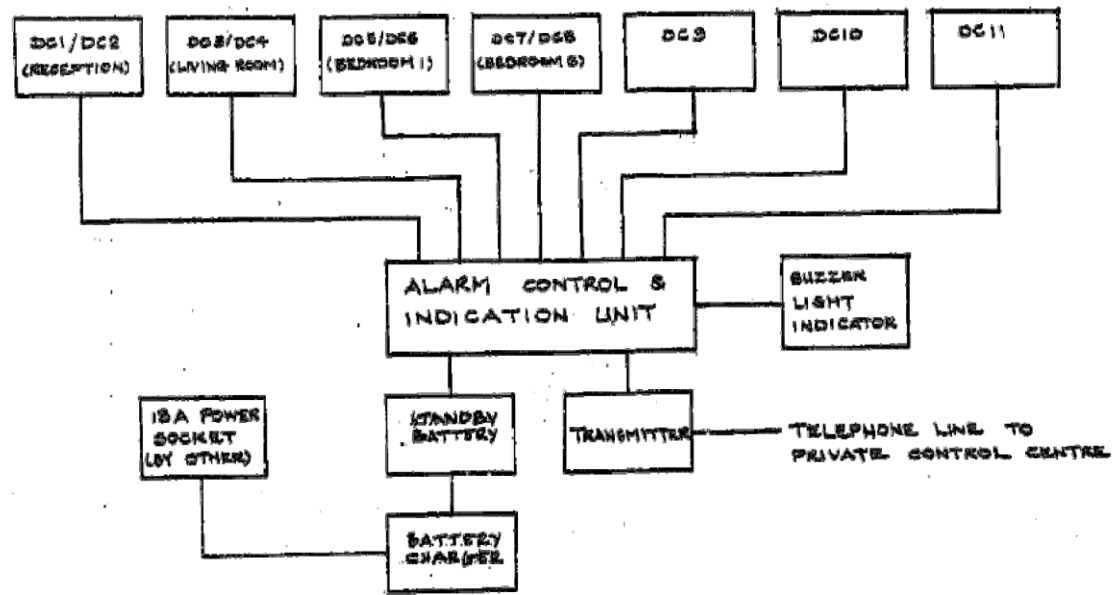
SCHMATIC WIRING DIAGRAM

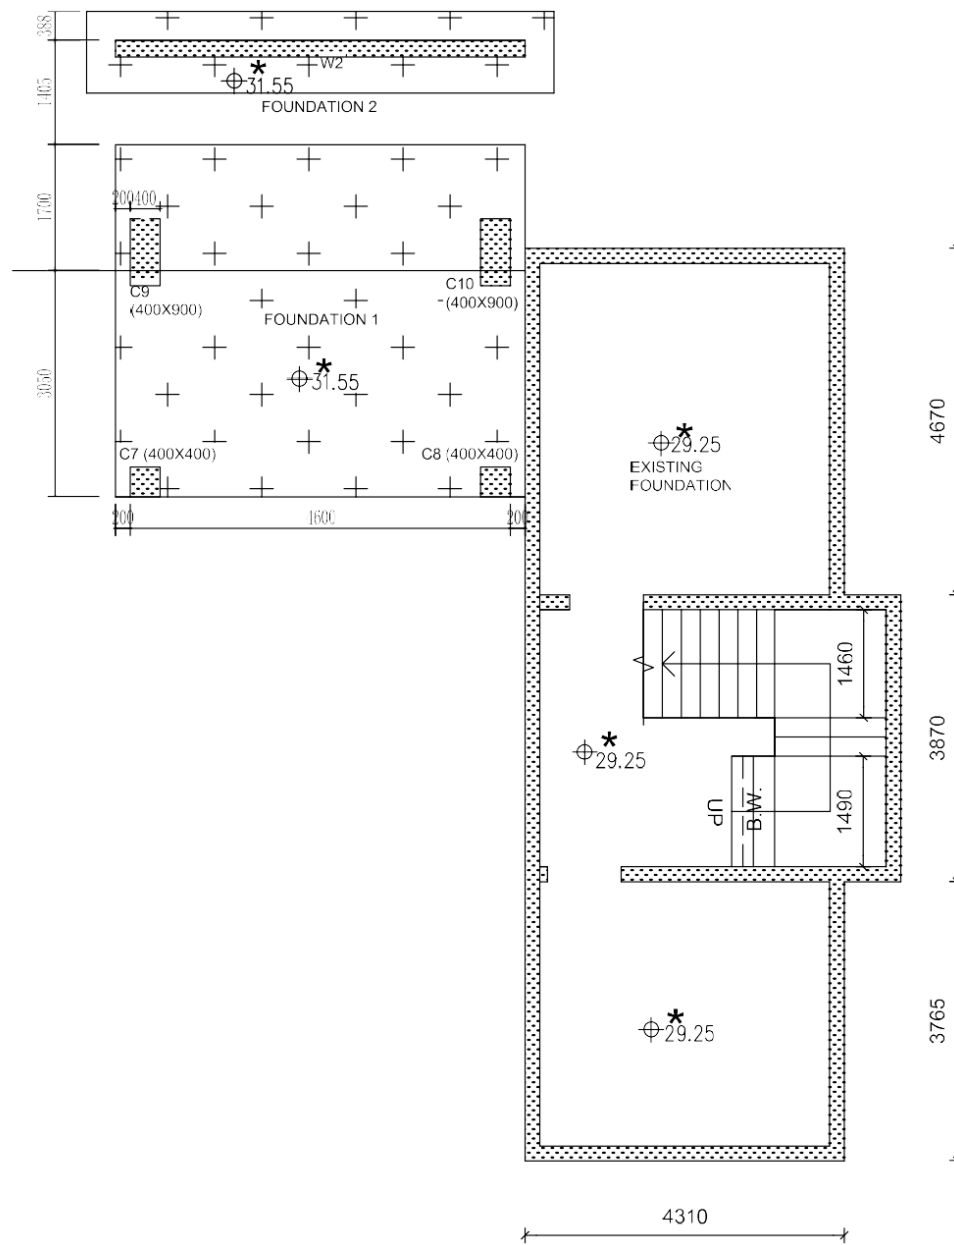
FRAMING PLAN OF BASEMENT

1. EXISTING R.C. STRUCTURAL WALL AND COLUMNS
2. APPROXIMATELY STRUCTURAL FLOOR LEVEL INFERRED/CALCULATED FROM AVAILABLE FOUNDATION RECORDS

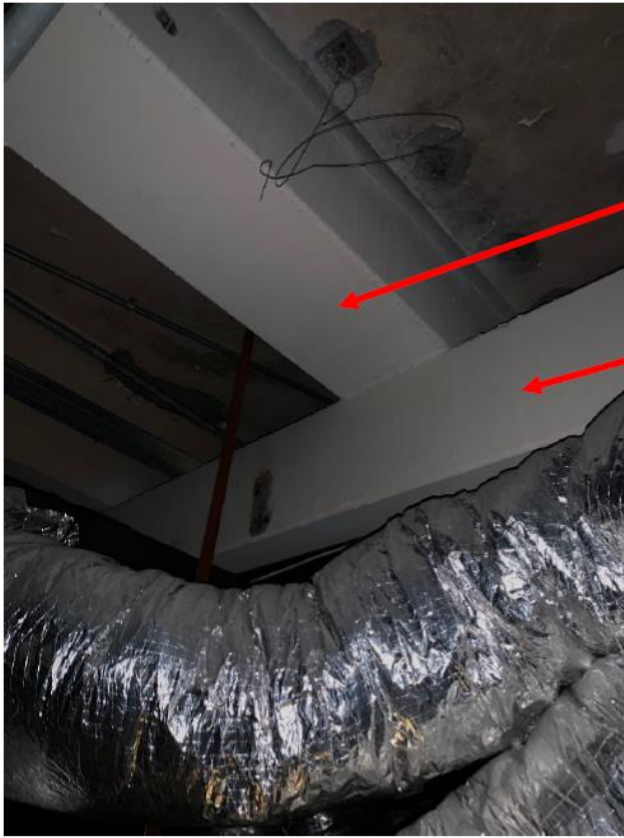
副四方鋼空心
截面梁

主四方鋼空心
截面梁

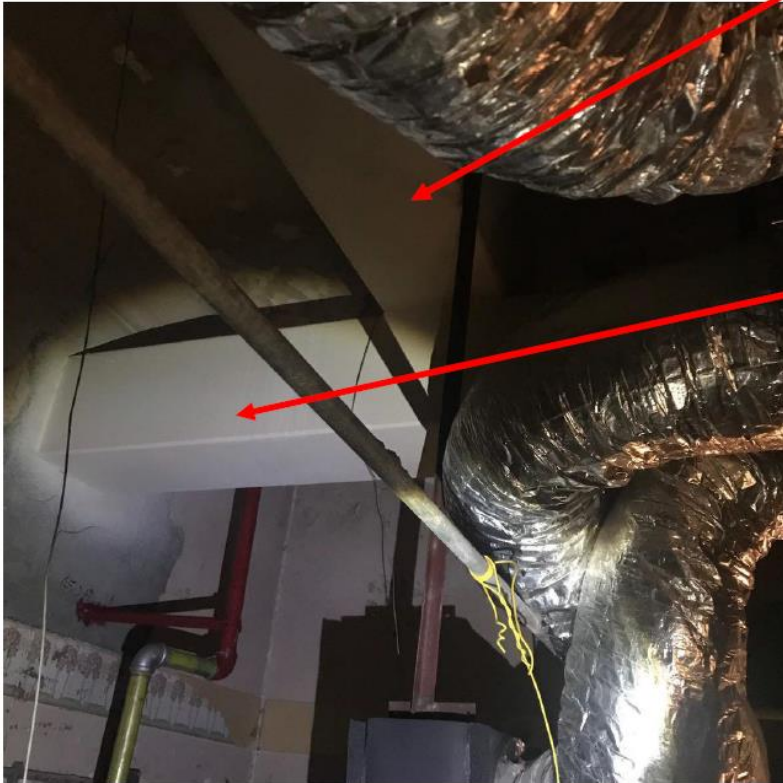
相片編號: 3

副四方鋼空心
心截面梁

主四方
鋼空心
截面梁

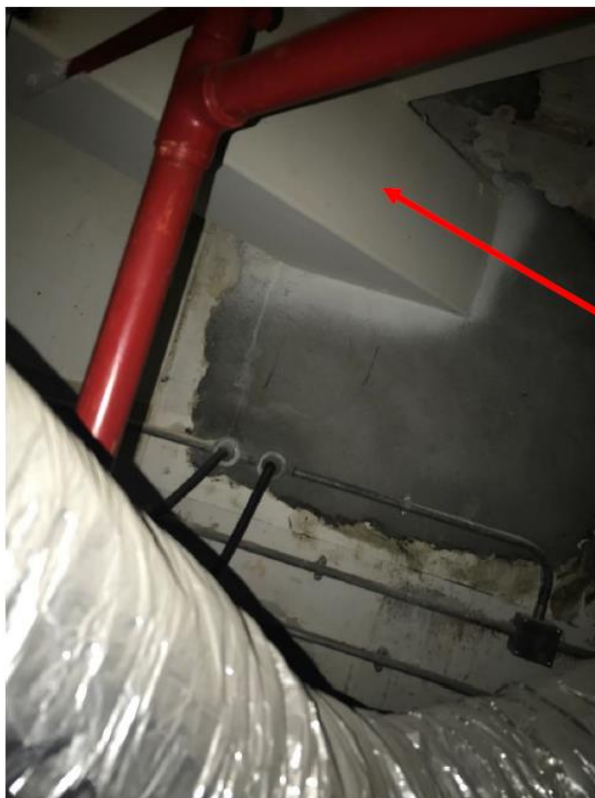
相片編號: _____ 4 _____

主四方鋼空
心截面梁

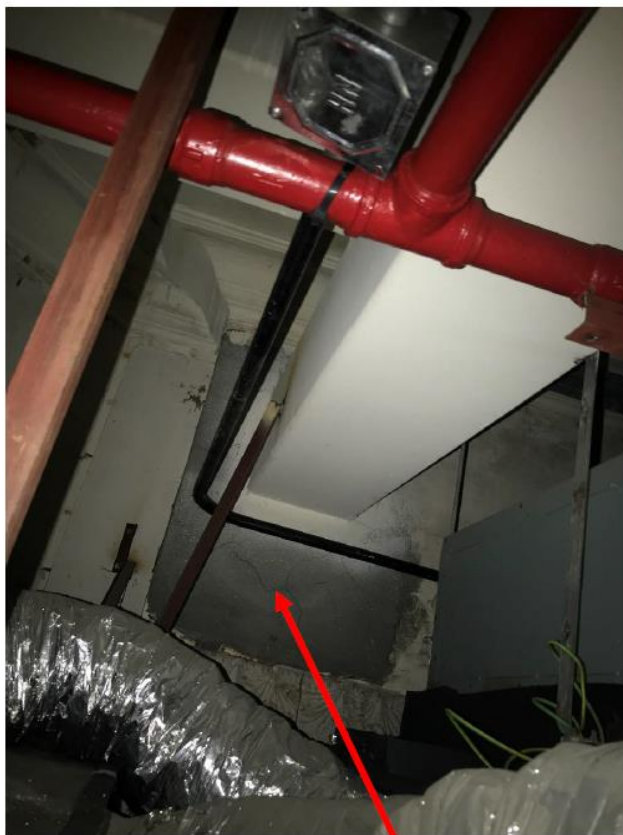
相片編號: _____ 5 _____

現有加固鋼空心截面樑的
建築物料的強度應按實際
需要作進一步驗證。

對於地下樓層的載重，考慮到有限的地基資訊，以及現時用作為公共娛樂場所並沒有超越負荷的跡象，相信地下樓層可以維持 5 千帕斯卡的外加活荷載。然而，由於工程質量或老化效應，可能會令主樓存在局部缺陷，建議進行進一步的測試或調查，以確定建築物當前或未來改變用途的任何缺陷。考慮到建築物已落成大約 80 年，在評估建築物的承載能力時應考慮減少約 30% 的老化因素。對於建築物料的強度，應按實際需要作進一步驗證。

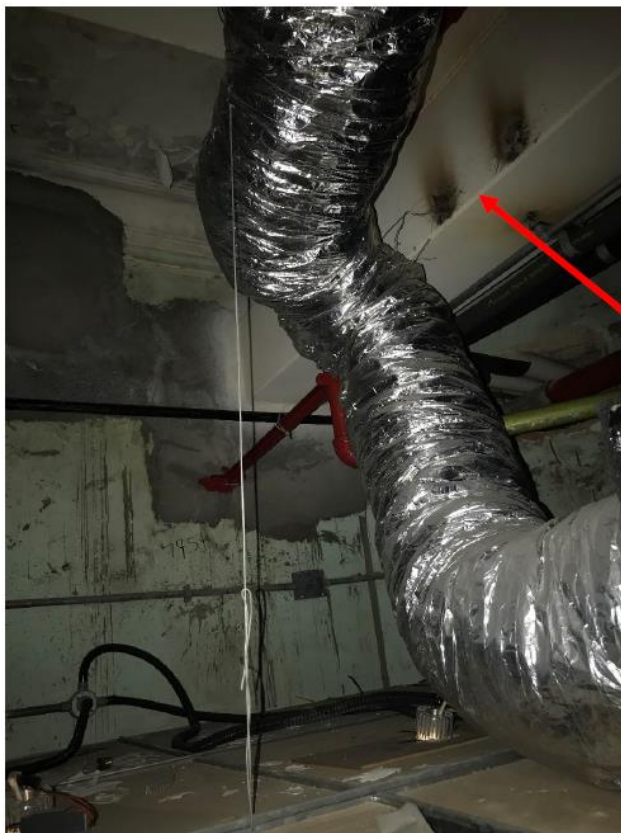
相片編號: _____ 6 _____

主四方鋼空
心截面梁

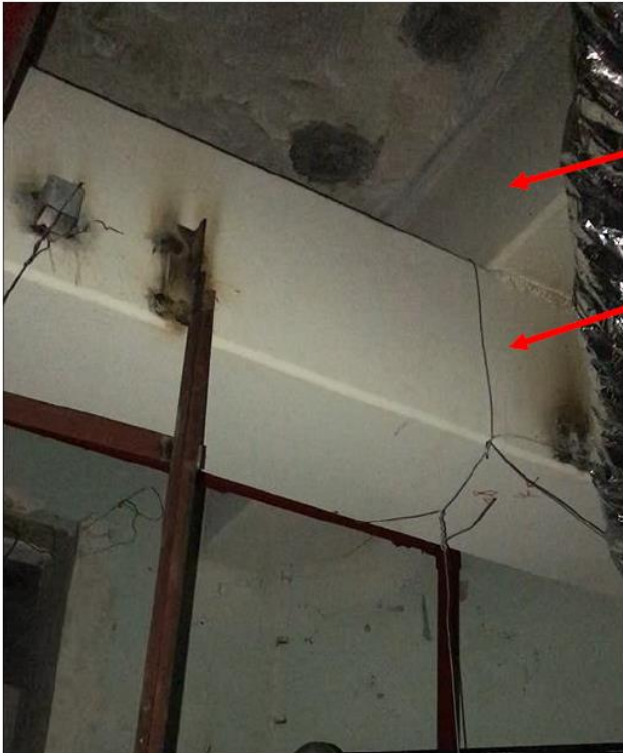
相片編號: _____ 7 _____

副四方鋼空
心截面梁

主四方鋼空
心截面梁

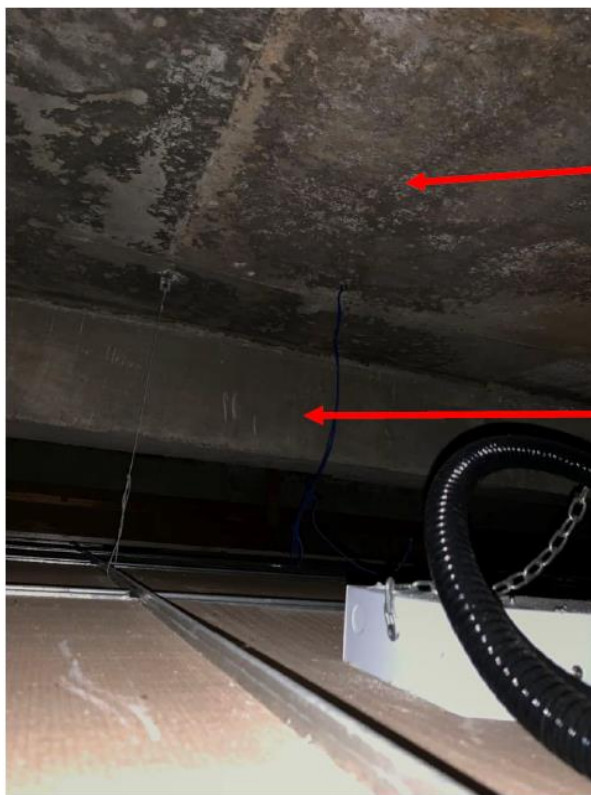
相片編號: _____ 8 _____

現有的
鋼筋混
凝土樓
板

現有的
鋼筋混
凝土橫
梁

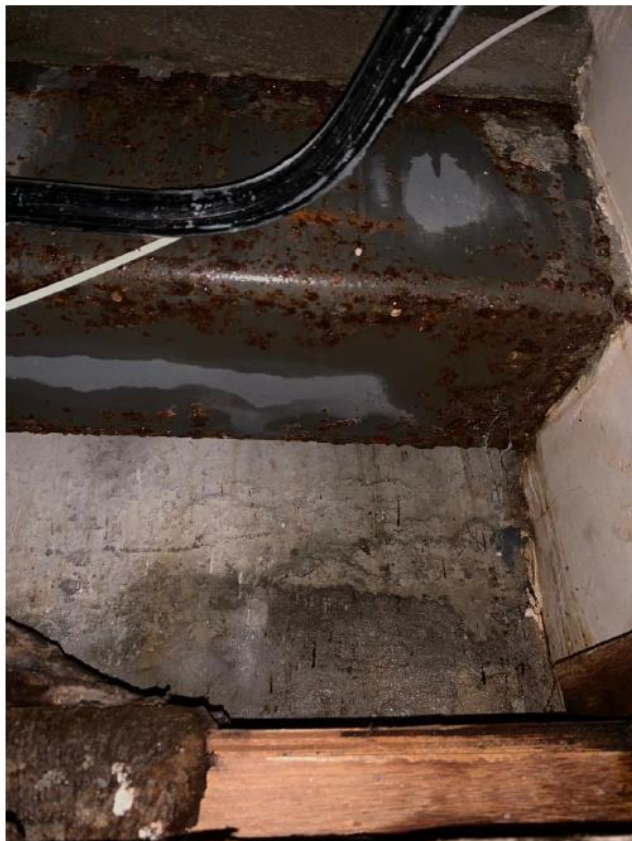
相片編號: _____ 9 _____

輕微漏水發現於熱帶風
暴[韋帕]之後
31-07-2019

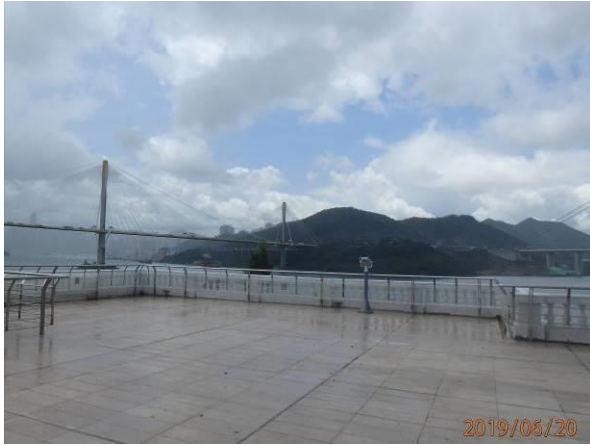
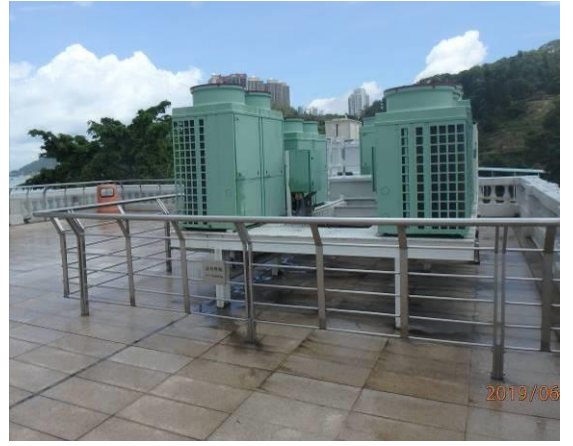
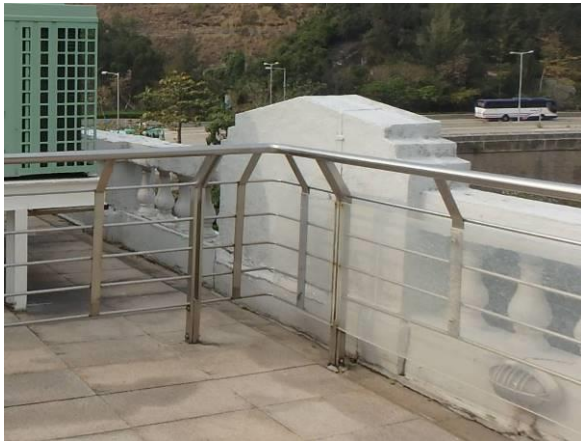
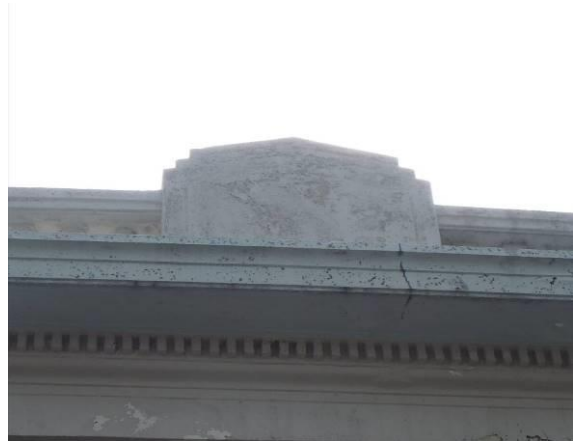
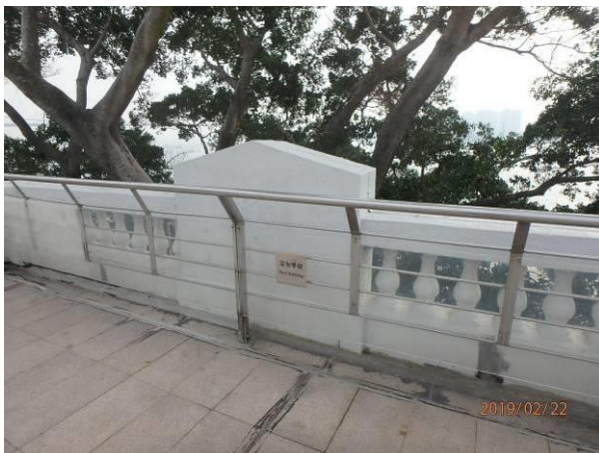
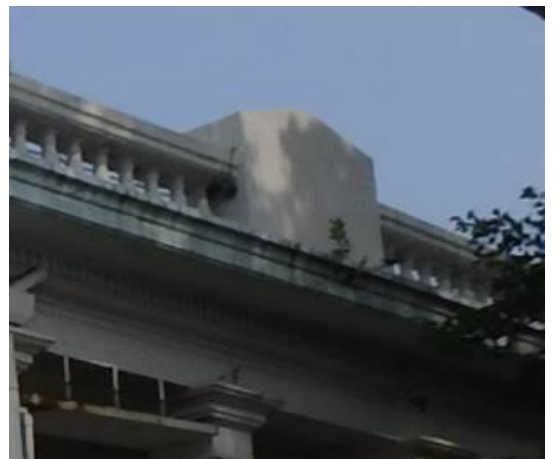
平屋頂

平屋頂連凸簷、扶欄，以及建於主入口和東南立面之上的實心護牆。

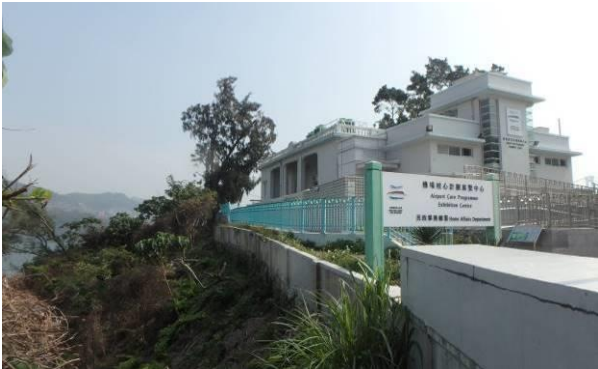
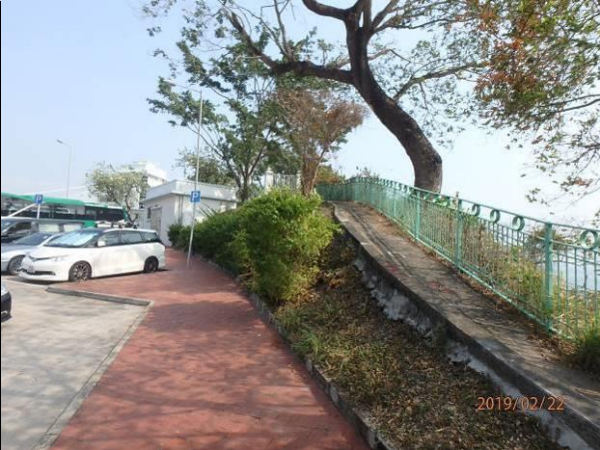
| 項目 | 建築特色 | 規定處理方法 |
|---|---|--|
| 1.1 | 環境／四周範圍 | <ul style="list-style-type: none"> a. 整體地形一般應保持原狀。 b. 通道及通往後院的舊閘門柱應原位保存。 c. 應更換前門通道的地台及牆壁飾面，設計應相互配合，而且可與歷史建築區分開來。 d. 可考慮更換沿前門通道而建的防護欄，惟設計應相互配合，而且可與歷史建築區分開來。 e. 可考慮進行場地通道改善工程，惟工程必須符合法定要求，以可還原的方式安裝，而且對古典甕形扶欄影響輕微，並須獲古蹟辦批准。 |

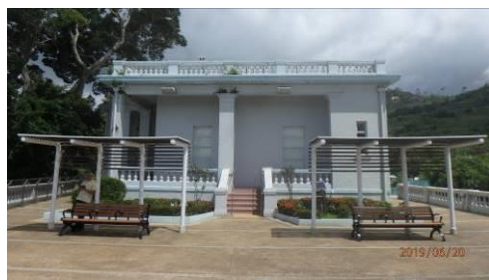
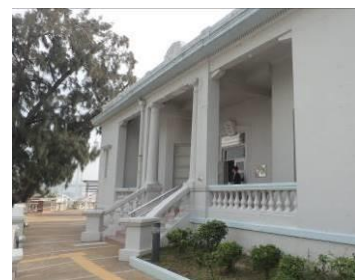
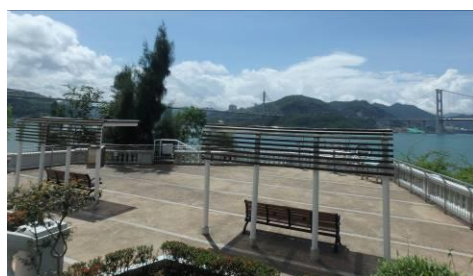
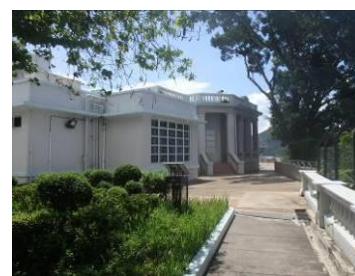
| 項目 | 建築特色 | 規定處理方法 |
|---|---|--|
| 1.3 | <u>歷史建築旁的三面空地</u> | <p>a. 歷史建築立面的景觀十分重要，應予保留。圍繞歷史建築三面的現有空地，應盡量保持空曠，讓市民欣賞建築物。</p> <p>b. 應保存下圖標示與歷史建築相連的空地(空地)，以盡量減少對建築物立面所造成的視覺影響，並保持遠眺馬灣海峽的景觀不受遮擋。</p> <p>c. 可考慮在空地以外的地方興建新建築物或構築物，作歷史建築的附屬用途(擬議工程)，惟工程必須符合法定要求及獲古蹟辦批准。</p> <p>d. 空地的園景設計應與周圍環境融合，以保存歷史建築的歷史特色。可考慮進行園景修復工程，惟須獲古蹟辦批准。</p> |

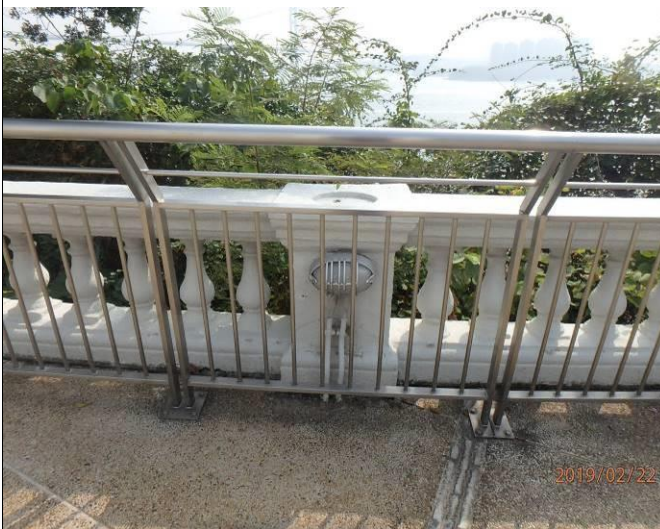
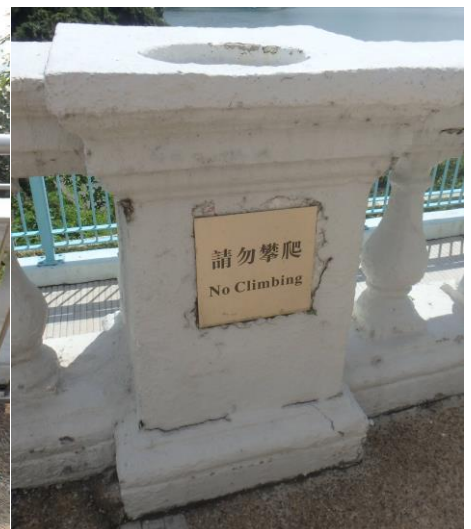
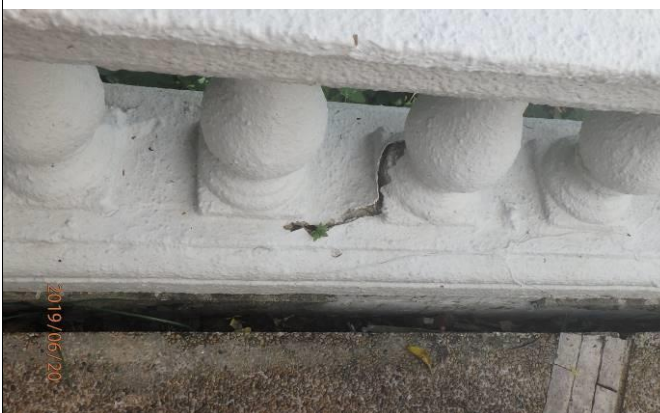
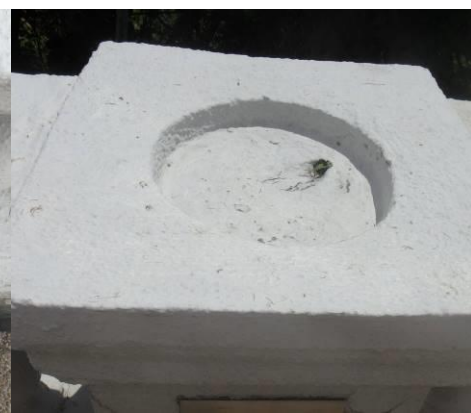
| 項目 | 建築特色 | 規定處理方法 |
|---|---|--|
| 1.4 | 院子周邊的古典扶欄 | <ul style="list-style-type: none"> a. 院子周邊的原有扶欄（包括所有外露的扶欄底座、古典甕形扶欄柱及厚身蓋頂）應原位保存。 b. 應拆除裝設在古典扶欄前方的不銹鋼扶欄。可考慮按法定要求為扶欄加設防護欄或進行改善工程，惟必須以可還原的方式安裝，而且對扶欄影響輕微，並須獲古蹟辦批准。 c. 新加防護欄或改善工程的設計應相互配合，而且可與歷史建築區分開來。 d. 移除固定在古典扶欄上的標示牌。 e. 清除扶欄表面上的青苔及嵌入式排水口的淤塞物。 f. 按需要修葺／鞏固扶欄下的擋土構築物。 g. 按需要修葺破損的批盪，參照現有顏色重新髹漆，塗料須獲古蹟辦批准。 |

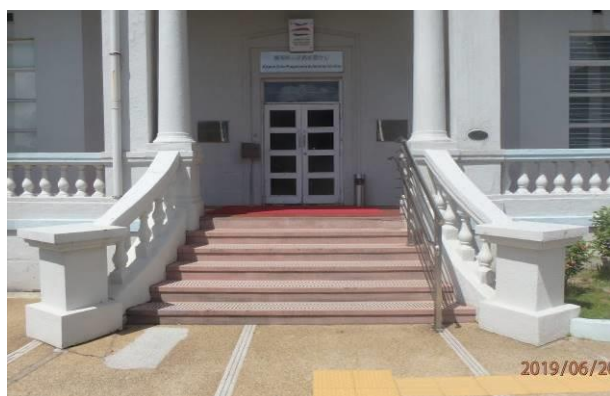
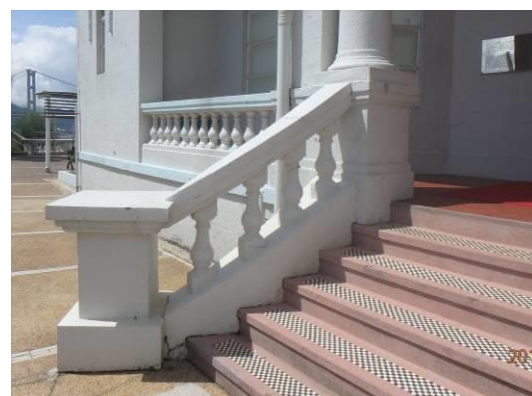
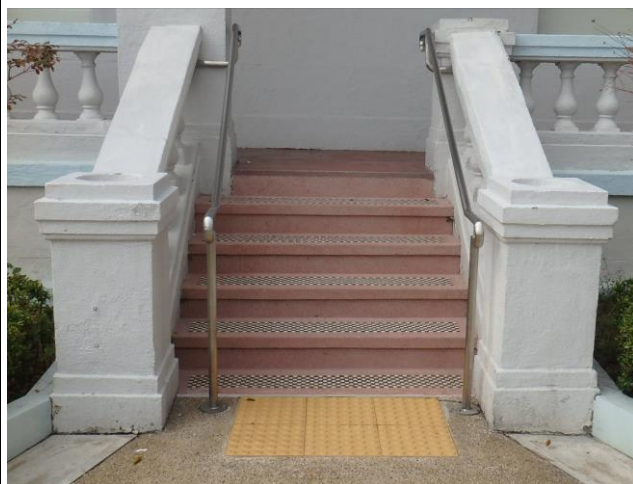
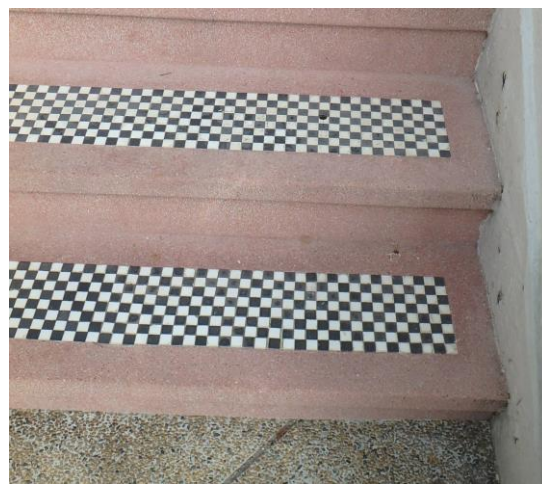
| 項目 | 建築特色 | 規定處理方法 |
|---|---|--|
| 2.2 | 連接外廊的樓梯 | <ul style="list-style-type: none"> a. 主入口的彎形樓梯、東南面及東北面兩道直樓梯(包括梯級、原裝地面飾面及古典的扶欄)，應原位保存。 b. 應用鬃毛刷或尼龍刷以清水清洗原裝的地面裝飾飾面，絕不能使用腐蝕性化學清潔劑。 c. 按需要和參照現有式樣修葺破損的地面飾面。水磨石地面的裂縫只可以擦洗的方式清潔，以去除污垢及油脂。 d. 可考慮按法定要求為樓梯通道加設防護欄或進行改善工程，惟必須以可還原的方式安裝，而且對歷史建築所造成的視覺及實體影響輕微，並須獲古蹟辦批准。 e. 擬議工程應相互配合，而且可與歷史建築區分開來。 f. 進行塗料分析，並研究扶欄原本的顏色。在進行翻新工程前，須向古蹟辦提交研究報告(連同調查結果、照片等)及建築物的建議配色方案，以供考慮。 g. 按需要為扶欄重新髹漆，塗料須獲古蹟辦批准。 |

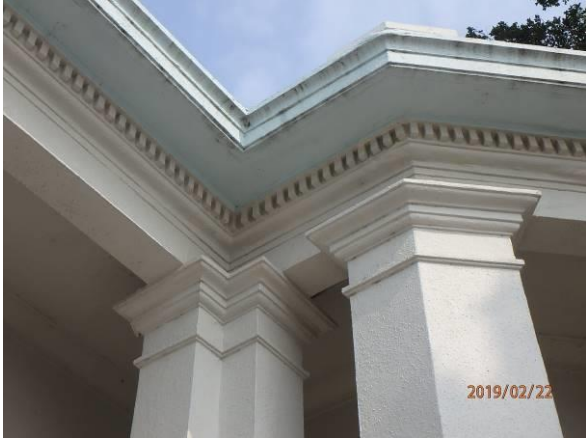
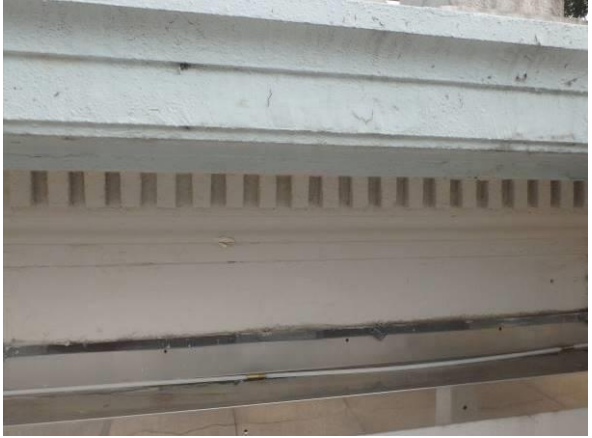
| 項目 | 建築特色 | 規定處理方法 |
|---|---|---|
| 2.5 | 外部簷楣 | <ul style="list-style-type: none"> a. 凸簷連沿邊的齒狀簷楣應原位保存。 b. 進行塗料分析，並研究屋簷及簷楣飾線原本的顏色。在進行翻新工程前，須向古蹟辦提交研究報告(連同調查結果、照片等)及建築物的建議配色方案，以供考慮。 c. 按需要和參照現有式樣，修復破損的齒狀簷楣，以及修葺破損的批盪。 d. 按需要為凸簷及簷楣飾線重新髹漆，塗料須獲古蹟辦批准。 |

建築外部包括現有的建築凸簷、外廊和欄杆。這些結構在現場檢查後大體上狀況良好，因沒有發現任何變形和裂縫，故沒有即時危險。

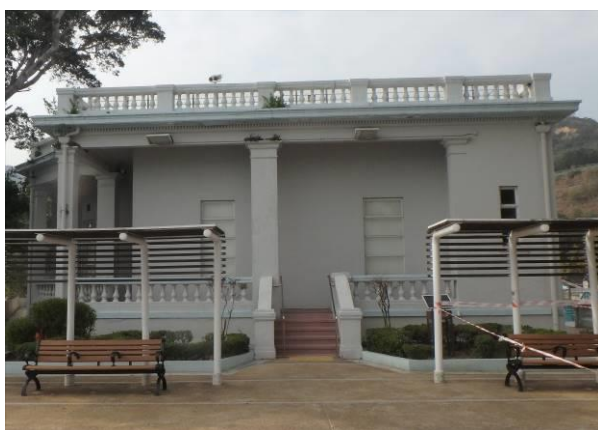
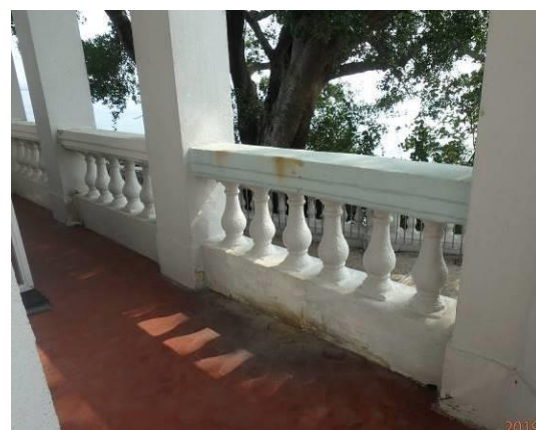
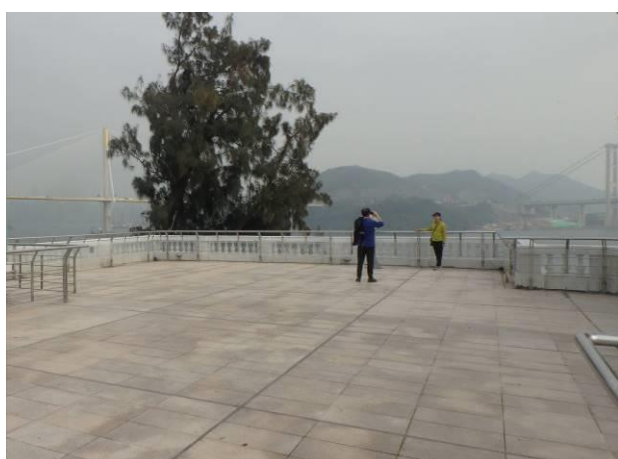
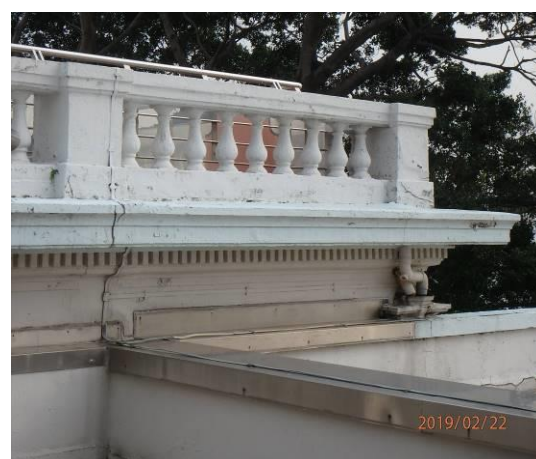
| 項目 | 建築特色 | 規定處理方法 |
|---|---|---|
| 2.6 | 外廊和天台的古典扶欄 | <ul style="list-style-type: none"> a. 外廊和天台沿邊的古典甕形扶欄（包括所有外露的扶欄底座、古典甕形扶欄柱及厚身蓋頂）應原位保存。 b. 應拆除裝設在天台古典扶欄前方的不銹鋼扶欄。可考慮按法定要求為扶欄加設防護欄或進行改善工程，惟必須以可還原的方式安裝，而且對扶欄影響輕微，並須獲古蹟辦批准。改善工程的設計不得影響現時的建築物立面，以及應相互配合，而且可與歷史建築區分開來。 c. 進行塗料分析，並研究扶欄原本的顏色。在進行翻新工程前，須向古蹟辦提交研究報告(連同調查結果、照片等)及建築物的建議配色方案，以供考慮。 d. 按需要和參照現有式樣，修復和修葺受損的批盪。 e. 參照現有顏色重新髹漆，塗料須獲古蹟辦批准。 |

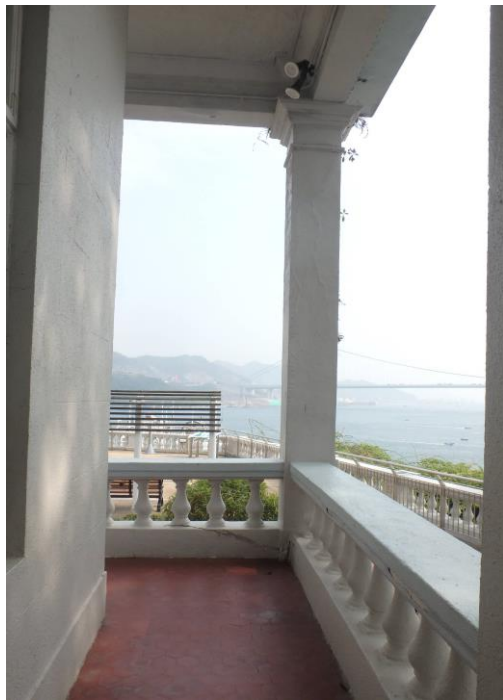
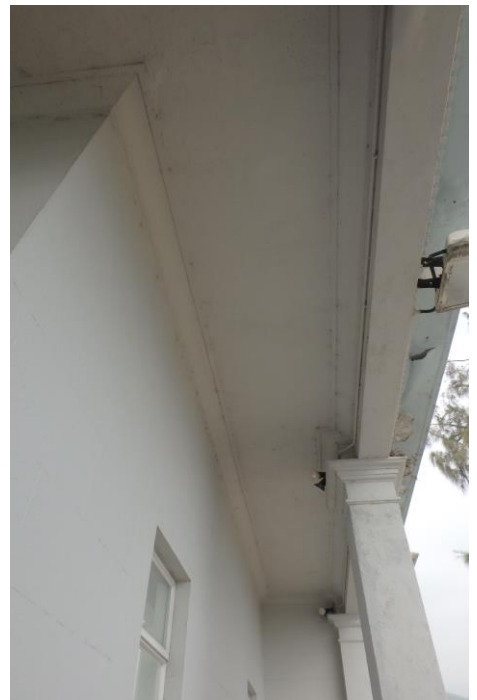
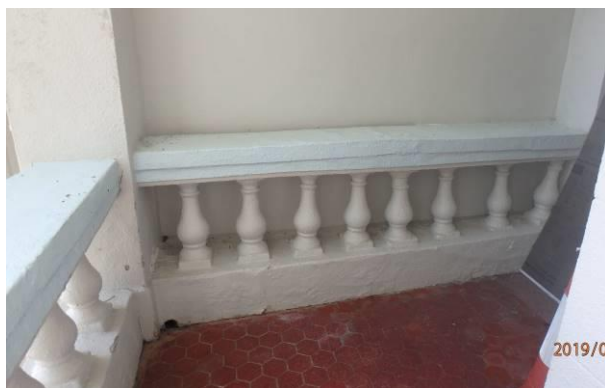
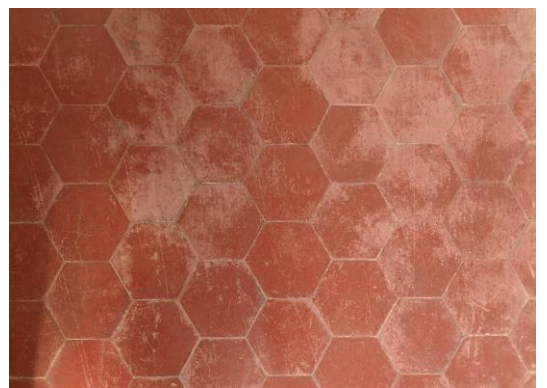
| 項目 | 建築特色 | 規定處理方法 |
|---|---|---|
| 2.7 | 外廊 | <ul style="list-style-type: none"> a. 三面的外廊均須保留開闊感，保持自然通風。所有外廊（包括外露天花板連牆簷飾線及地磚）應原位保存。 b. 外廊不得全部或局部圍封。 c. 外廊範圍內不得改動或加設開口、裝設垂吊式天花板或其他永久裝置。 d. 按需要和參照現有物料，修葺破損的地磚。 e. 按需要修葺破損的批盪牆身及天花板，並參照現有式樣重修飾面。 f. 可考慮把毗連新副樓的外廊現已圍封的一面恢復原狀，惟須獲古蹟辦批准。 |

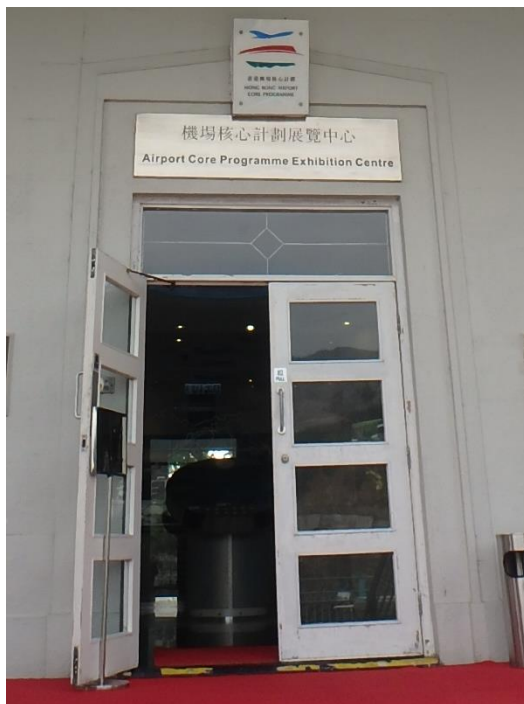
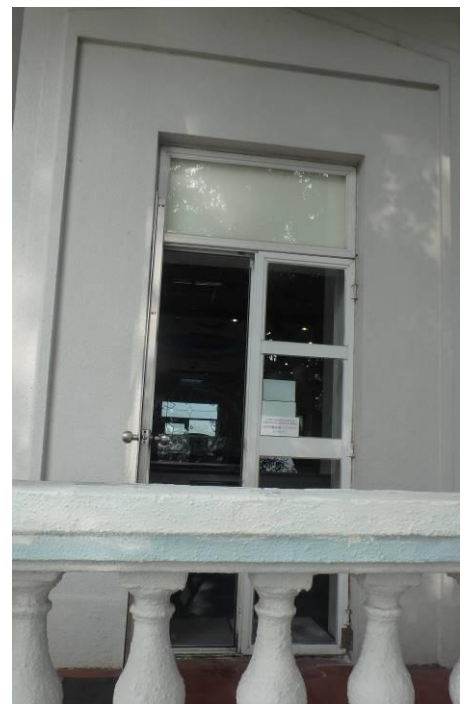
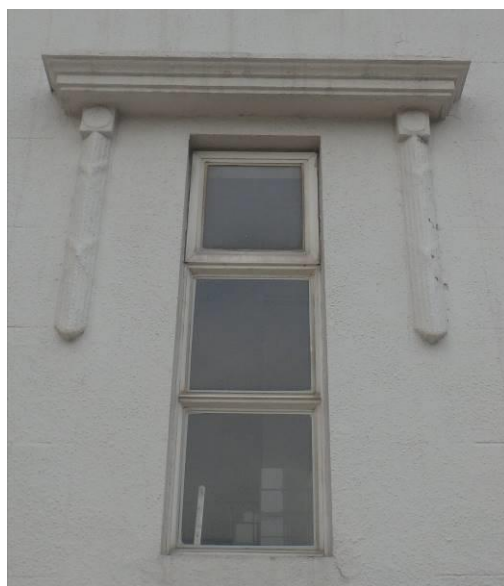
| 項目 | 建築特色 | 規定處理方法 |
|---|---|---|
| 2.8 | <u>外部飾線/灰塑</u> | <ul style="list-style-type: none"> a. 法式門及窗戶沿邊的飾線/灰塑應原位保存。 b. 拆除飾線上或附近的現有標示牌。 c. 研究歷史建築原本的布局。除非有充分證據證明現有茶水間的窗戶並非原裝，而且獲古蹟辦批准，否則不得改動該窗戶窗楣上的灰塑。在進行翻新工程前，須向古蹟辦提交研究報告(連同調查摘要等)，以供考慮。 d. 按需要修葺破損的飾線/灰塑，並參照現有式樣重修飾面。 |

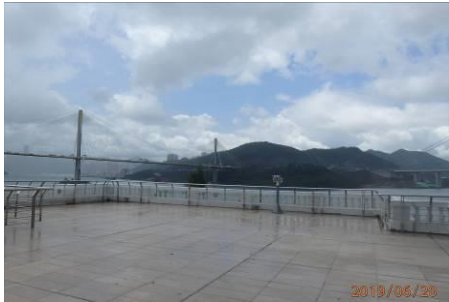
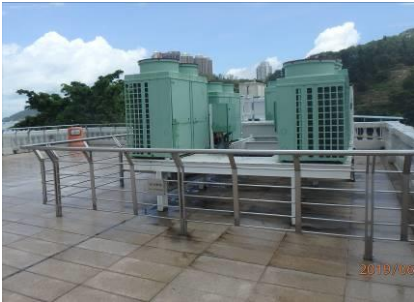
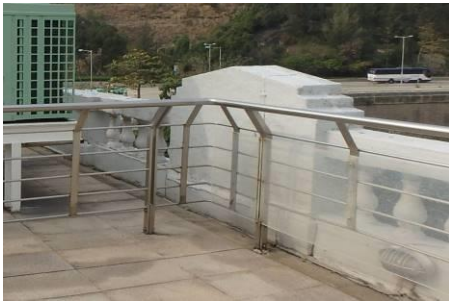
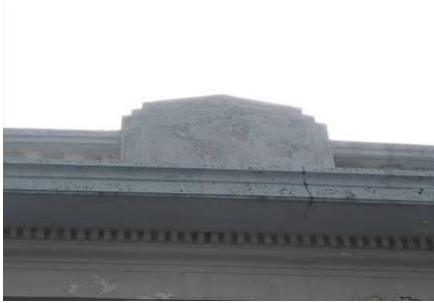
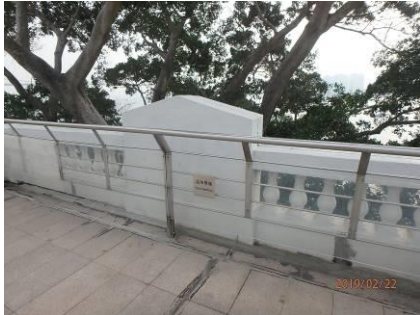
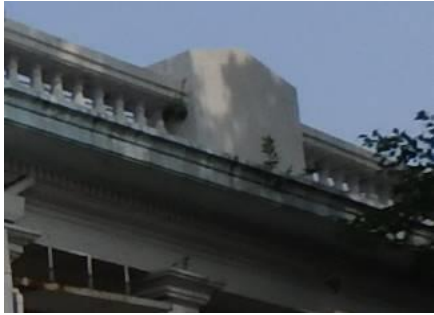
| 項目 | 建築特色 | 規定處理方法 |
|---|---|--|
| 2.9 | 平屋頂 | <p>a. 平屋頂連凸簷、古典甕形扶欄和建於主入口和東南立面上的實心護牆一般應保持原狀。</p> <p>b. 不得在天台加建樓層。</p> <p>c. 可考慮在天台安裝屋宇裝備、管道、喉管等，惟對歷史建築所造成的視覺影響輕微。這些新裝置連相關建築屏障的安裝位置須從立面往後移，並盡量遠離立面，以及須獲古蹟辦批准。</p> <p>d. 天台加建新構築物及裝置前，均須徵詢註冊結構工程師的意見，以及獲古蹟辦批准。</p> <p>e. 按需要修葺破損的天台樓板、防水層等，以及進行重鋪天台工程。</p> <p>f. 使用認可的除漆劑清除實心護牆上現有的油漆，然後用認可的可還原塗料及顏色重新髹漆。</p> <p>g. 按需要修葺破損的批盪，參照旁邊位置重修飾面。</p> |

在 1995 年，主樓通過加裝鋼製空心鋼樑來加固現有可到達的天台，以便能夠支承安裝空調系統的室外機組，而於現場結構穩定性檢查中並無發現任何問題，現有鋼樑的防火塗料仍然完好無損。具有剛性樑柱結構（門式支架）擴建部分的狀況比主樓更好。對於主樓和擴建部分，觀察到主要的結構構件並沒有發現嚴重的結構裂縫、地基的不規則沉降，主要結構構件的明顯變形以及混凝土剝落等問題。

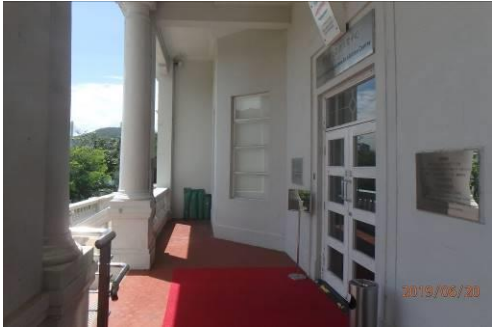
| 項目 | 建築特色 | 規定處理方法 |
|---|---|--|
| 3.1 | <u>空間布局</u> | <p>a. 以中軸線為本的對稱格局、擁有靠近大自然的開揚空間，以及向外廊方向開啓的窗戶及法式門，這些都應保持原狀。</p> <p>b. 可考慮改變室內間隔，以進行內部改裝及加建工程，惟須先徵詢註冊結構工程師的意見，以及獲古蹟辦批准。</p> <p>c. 除非獲古蹟辦批准，否則除間隔設備外，不得增設構築物或永久裝置。</p> <p>d. 使用認可的可還原塗料及顏色，為整座建築物內部重新髹漆。</p> |

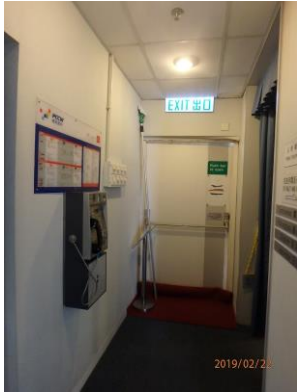
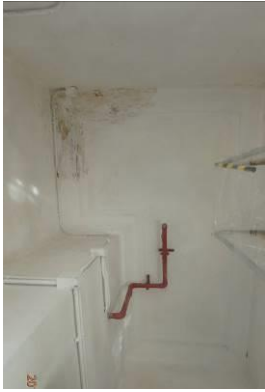
| 項目 | 建築特色 | 規定處理方法 |
|---|---|--|
| 3.2 | 建築結構 | <p>a. 所有原裝結構構件（包括承重牆、支柱、橫樑、地台樓板，以及支柱、橫樑、構件底面的飾線）均應保持原狀。</p> <p>b. 除非獲古蹟辦批准，否則不得在構件上鑽孔或加設開口。</p> <p>c. 研究原本的布局及結構，然後移除後加的構築物，以及在可行的情況下盡量把牆／支柱恢復原狀，惟須獲古蹟辦批准。</p> <p>d. 移除遮蓋原有承重牆、牆、橫樑及飾線(如有的話)的現代裝飾或裝置，在可行情況下盡量顯露上述構件。</p> <p>e. 可考慮加固或重整結構的任何部分，以符合法定要求，惟須先徵詢註冊結構工程師的意見，並獲古蹟辦批准。</p> <p>f. 按需要修補所有剝落的混凝土以及其他欠妥之處。</p> |

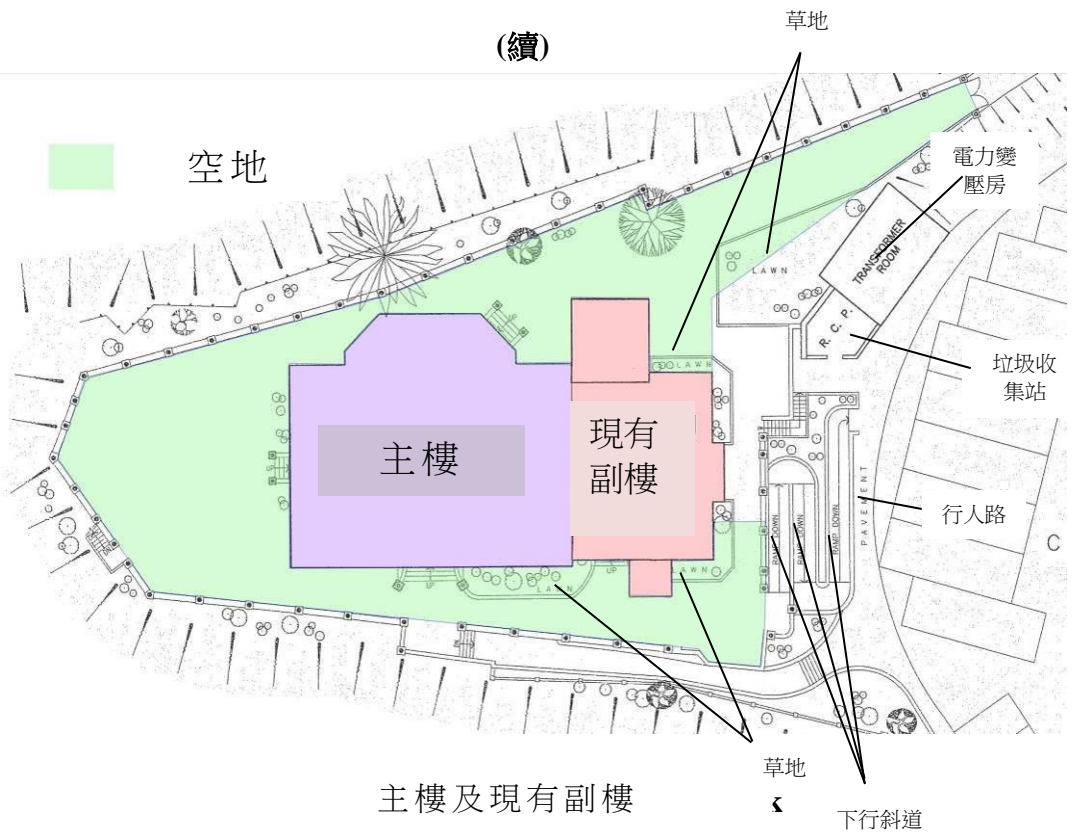
主樓及現有副樓

| 項目 | 建築特色 | 建議處理方法 |
|---|---|---|
| 1.1 | 連接歷史建築主樓的現有副樓 | <p>a. 附設傭人宿舍的原有副樓拆卸後，主樓後期加建了現有副樓，副樓狀況保持良好。可考慮繼續使用現有副樓，以減少對歷史建築的影響，惟須獲古蹟辦批准。</p> <p>b. 可考慮在該處興建設計較合適的新構築物，以配合新用途，而新構築物應能突出該址的文化價值，並能利便市民欣賞主樓建築。新構築物不應對歷史建築造成視覺上的干擾，亦不應影響四周的自然景觀，規模應與新用途相配，與歷史建築的體積比例亦應相稱而不會遮擋歷史建築。相關工程須獲古蹟辦批准。</p> <p>c. 可考慮在 C 區(範圍載於下圖)興建新地下構築物及／或建築高度不超過主樓齒狀簷楣的地面構築物(包括所有搭建的構築物)，作附屬用途、屋宇裝備及／或作為連接主樓地面層與天台的通道(C 區的擬議工程)，以符合法定要求，惟工程須獲古蹟辦批准。</p> <p>d. 應在可行情況下盡量繼續使用主樓天台原有甕形扶欄現有的開口作出入用途，不得在扶欄加設其他開口。</p> <p>e. 連接主樓天台與「C 區的擬議工程」地點的出入斜道(如有的話)的設計應着重輕巧，安裝位置應遠離立面，以減少對主樓的視覺影響。沿出入斜道所設的防護欄，應在可行情況下盡量降低高度。</p> <p>f. 「C 區的擬議工程」(如有的話)應為獨立的，並應在可行情況下盡量遠離主樓，而且不應對主樓的結構造成負面影響。</p> <p>g. 「C 區的擬議工程」(如有的話)應相互配合，而且可與主樓區分開來。</p> |

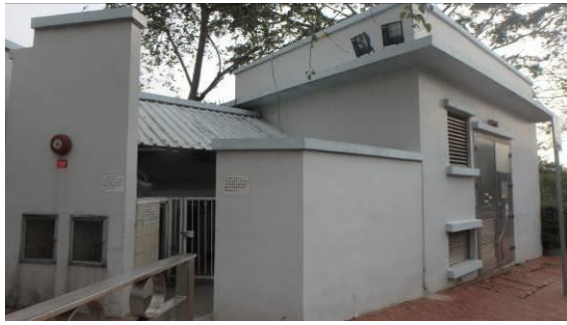
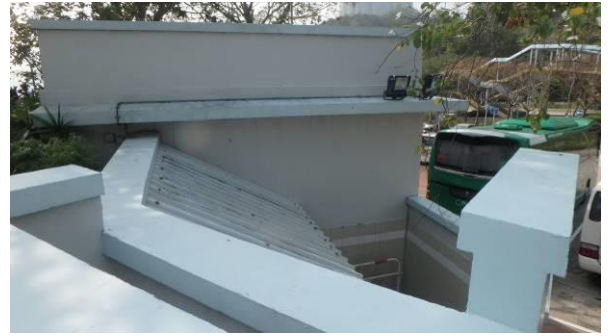
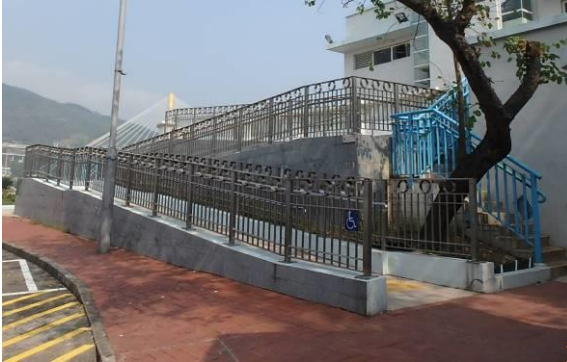
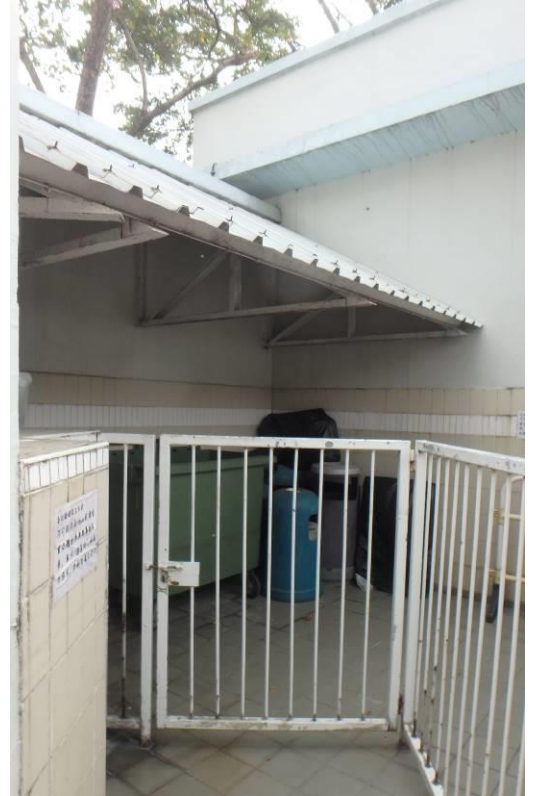
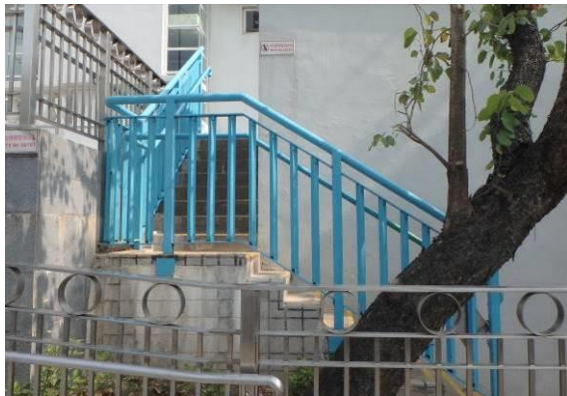
| 項目 | 建築特色 | 建議處理方法 |
|---|---|---|
| 1.2 | <p>歷史建築現有出入斜道、連樓梯、電力變壓房及輔助設施</p> | <p>a. 可考慮拆除歷史建築現時毗連青山公路的附屬設施，包括無障礙出入斜道、樓梯、電力變壓房及／或垃圾收集站等，並在A區及／或B區(範圍載於下圖)進行改動或加建工程，以配合新用途，惟須獲古蹟辦批准。</p> <p>b. 可考慮在A區(範圍載於下圖)興建新地下構築物及／或建築高度不超過主樓現有空地樓面竣工標高(主水平基準以上31.68米)的地面構築物，作附屬用途及／或屋宇裝備(「A區的擬議工程」)，惟須獲古蹟辦批准。可考慮打造連園景布置的綠化天台，以配合空地的設計。</p> <p>c. 可考慮在B區(範圍載於下圖)興建新地下構築物及／或建築高度不超過主樓高度(主水平基準以上37.60米)的地面構築物，作附屬用途、屋宇裝備及／或興建一道新樓梯／一部新升降機連其結構，作為連接主樓的無障礙通道(「B區的擬議工程」)，以符合法定要求，惟工程須獲古蹟辦批准。</p> <p>d. A區及／或B區的擬議工程(如有的話)應為獨立的，並應在可行情況下盡量遠離歷史建築，而且不應對歷史建築的結構造成負面影響。</p> <p>e. A區及／或B區的擬議工程(如有的話)應相互配合，而且可與歷史建築區分開來。擬議工程的設計應能突出該址的整體文化價值。</p> |
| <p>Legend:</p> <ul style="list-style-type: none"> A 區 (Yellow) B 區 (Orange) C 區 (Blue) 空地 (Green) <p>Diagram Labels:</p> <ul style="list-style-type: none"> 主樓 草地 下行斜道 電力變壓房 垃圾收集站 行人路 TRANSFORMER ROOM R.C.P. P.A.V.E.M.E.N.T. L.A.N.E. W. E.X.I.S.T. C | | |

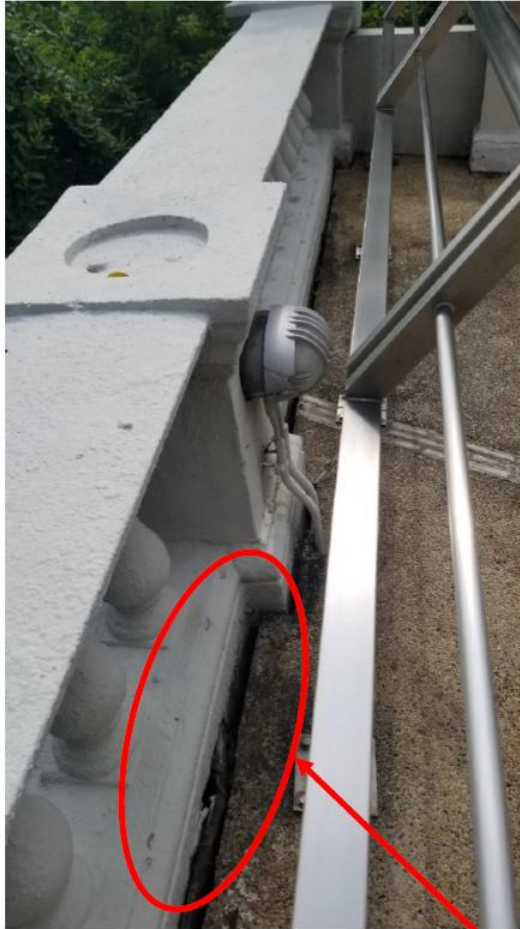
相片編號: _____ S1 _____

因泥土移動而導致一個明顯的空隙
