活化歷史建築伙伴計劃

白樓

資料冊

日期：二零一九年十一月二十七日

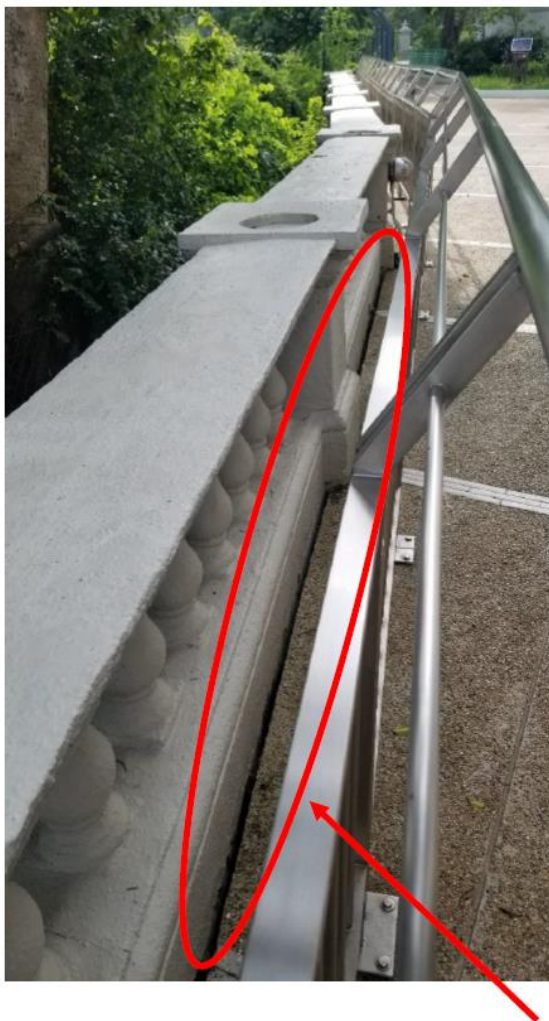
相片編號: _____ S2 _____

因泥土移動而導致一個明顯的空隙

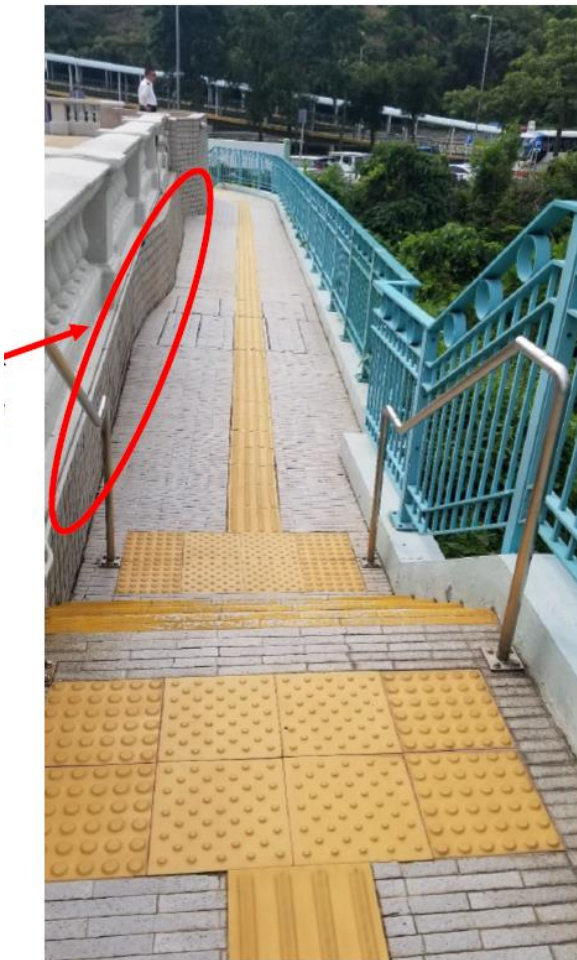
相片編號: S3

因泥土
移動而
導致一
個明顯
的空隙

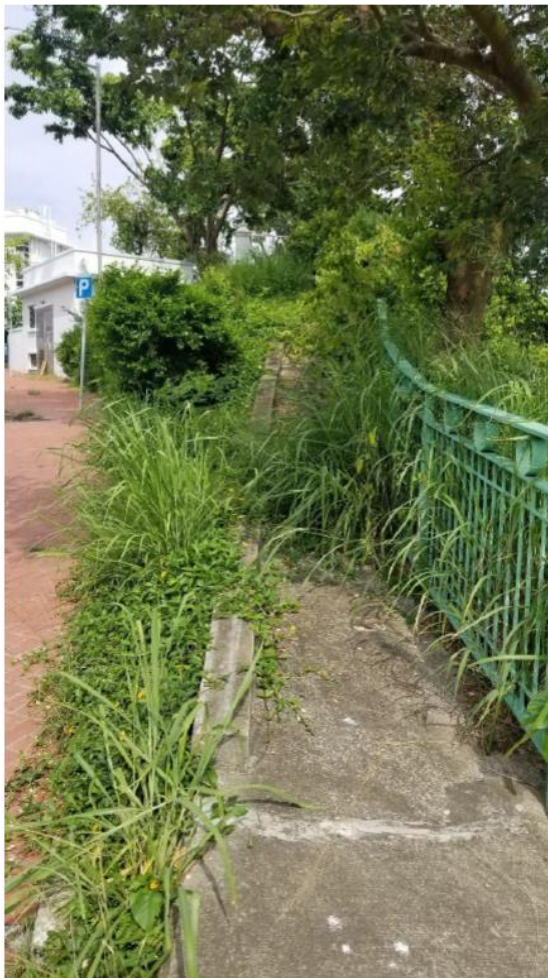
相片編號: _____ S4 _____

斜坡編號 6SE-C/C 445
狀況良好

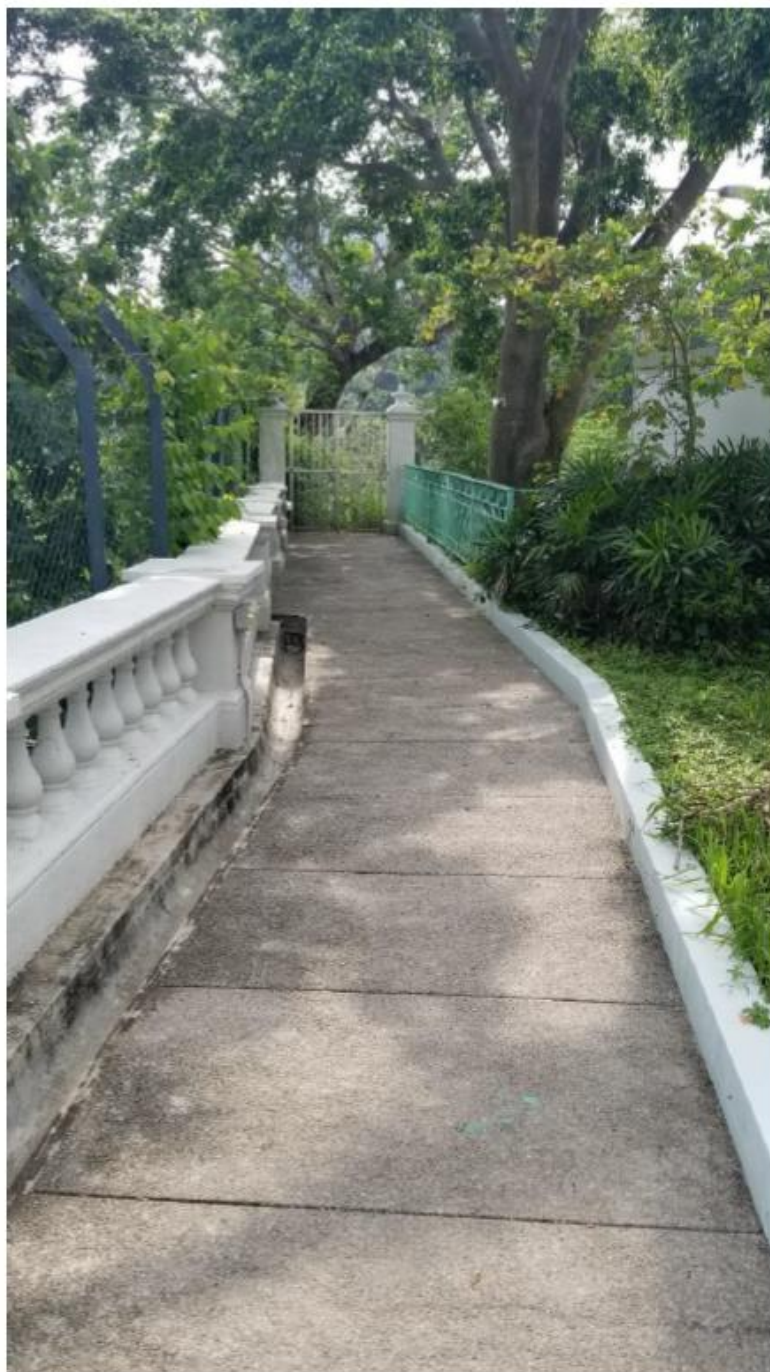
相片編號: S5

斜坡編號 6SE-C/C 82
狀況良好

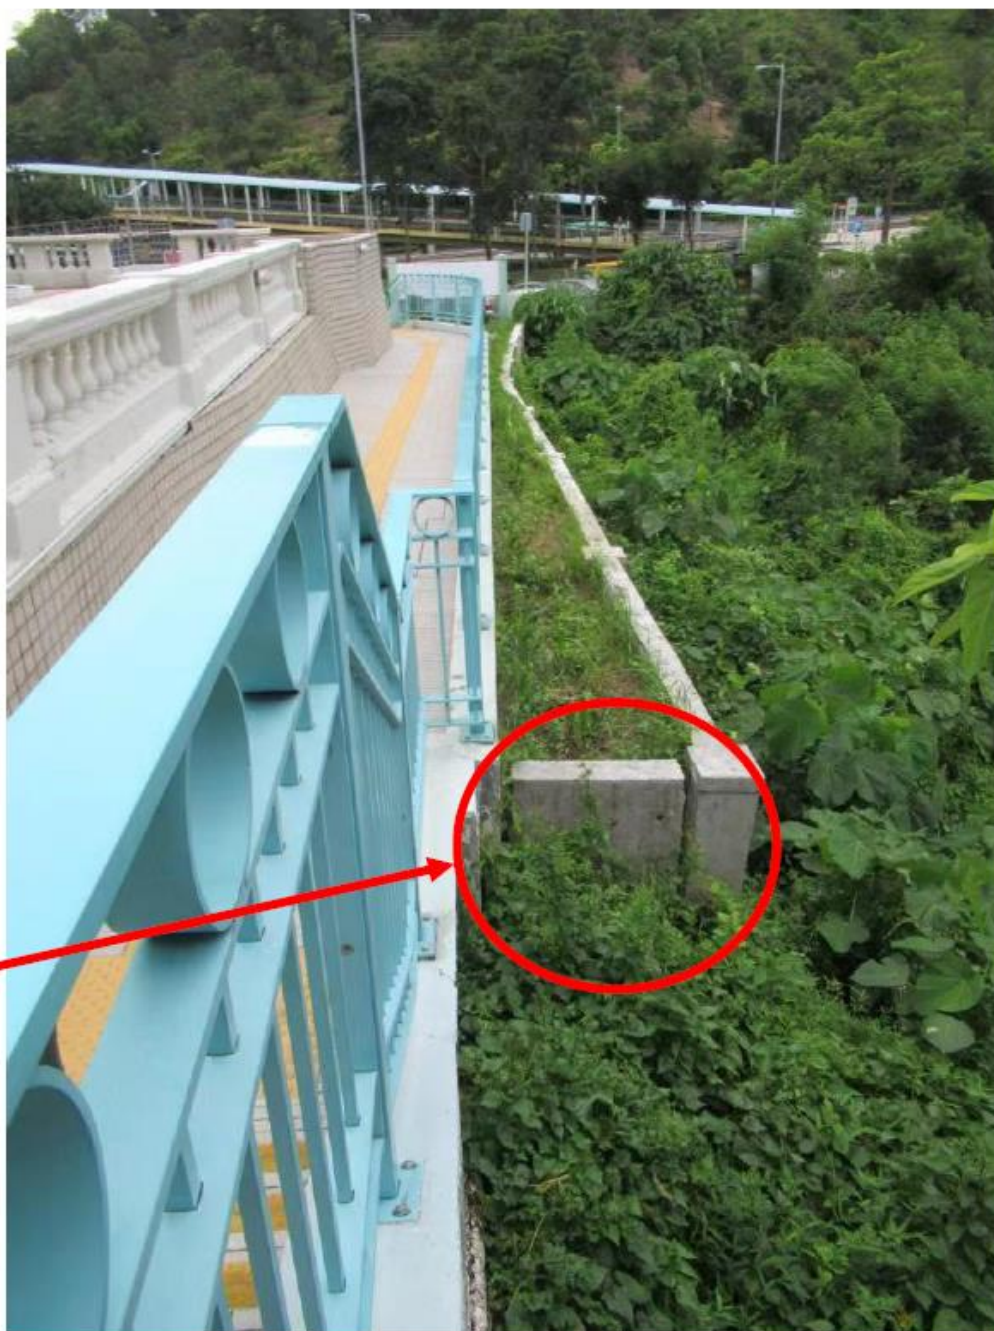
相片編號: _____ S6 _____

因泥土移動
而導致一個
明顯的空隙

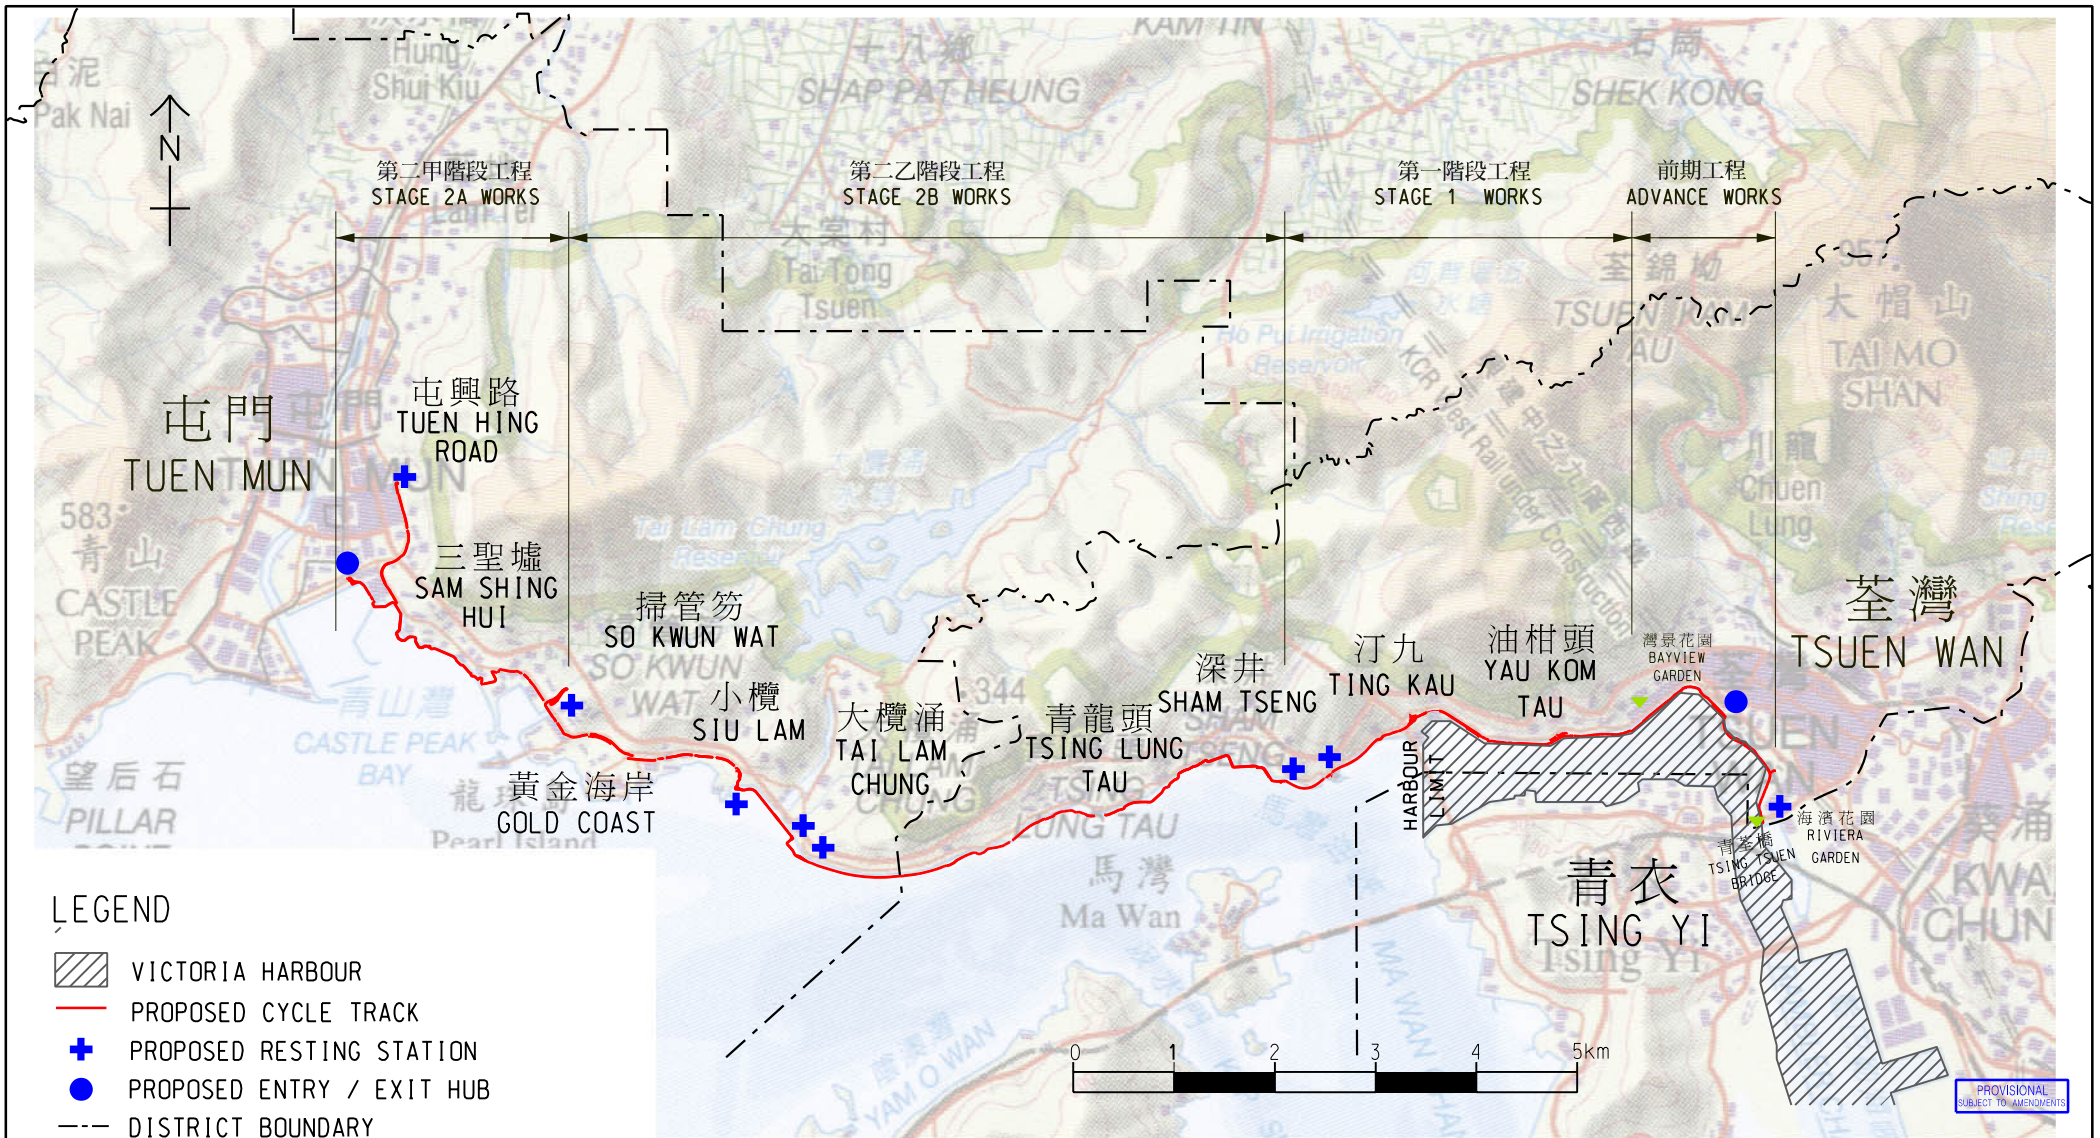
擬議單車徑的圖則

- VICTORIA HARBOUR
- PROPOSED CYCLE TRACK
- PROPOSED RESTING STATION
- PROPOSED ENTRY / EXIT HUB
- DISTRICT BOUNDARY
