活化歷史建築伙伴計劃

第 48 區前哥頓軍營

Watervale House

資料冊

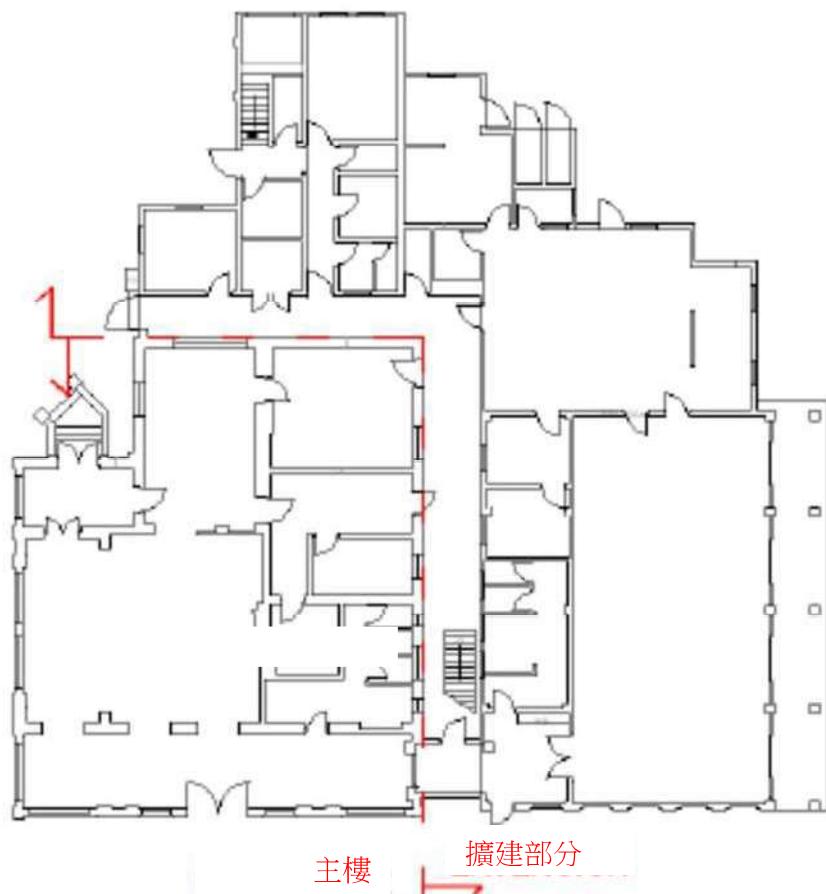
主樓和擴建部分的劃分圖

Watervale House 由兩個部分組成。原建築（以下簡稱「主樓」）約4.5米高，是戰前建成的單層住宅，有長屋簷環繞。如下劃分圖所示，主樓的東面和北面由L形的擴建部分（以下簡稱「擴建部分」）所包圍。Watervale House的建築圖則，包括位置圖、平面圖、立面圖和剖面圖均載於附錄V。這些建築圖則按粗略實地測量繪製，需進一步核實。

擴建部分包括地下(G/F)的餐飲設施和地下(G/F)及一樓(1/F)的員工宿舍。部分主樓的長屋簷因興建員工宿舍而被拆除。主樓和擴建部分之間有天井分隔。

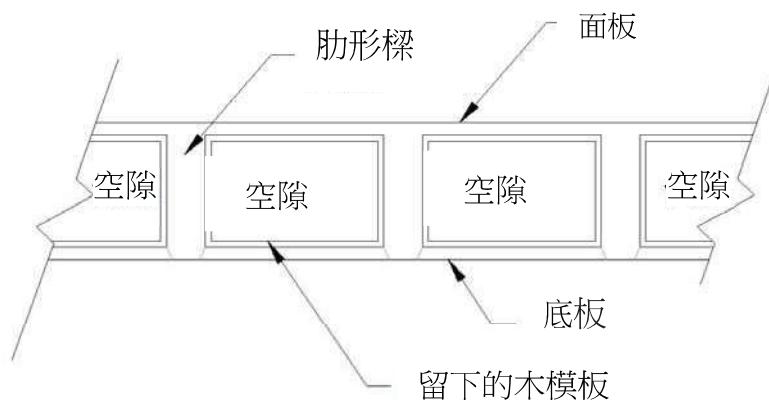
主樓屋頂肋形樑樓板的橫切面(不按比例)

屋頂的鋼筋混凝土底板打開了數個開口(見附錄VI的照片)，開口估計是前人為勘察而開鑿做成，迄今尚未修補。通過這些開口觀察到屋頂是肋樑結構樓板構造，而肋形樑樓板則由其邊緣的剛性樑所承托。以下是屋頂肋形樑樓板結構剖面：

獲選機構須進行全面的結構評估，包括詳細的現場勘測及進行適當的現場及實驗室檢測，核實和確認結構組件的資料和狀況及樓宇結構能力，以設計所提議的活化用途。須特別注意鋼筋混凝土肋形樓板的底板，因這些底板可能阻礙檢測空隙內有否結構上的缺陷和有關修復工作。

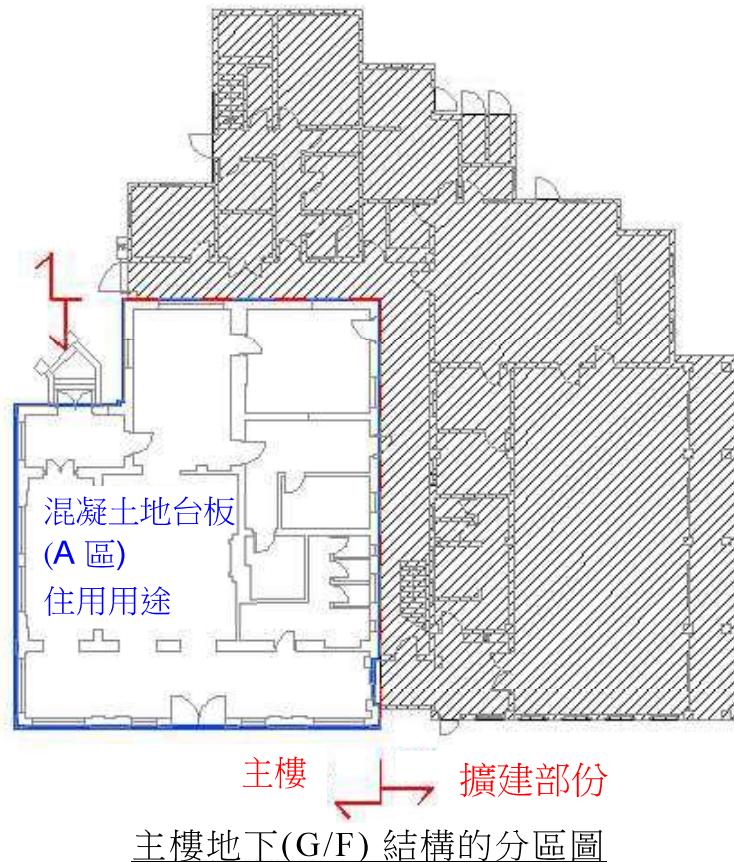
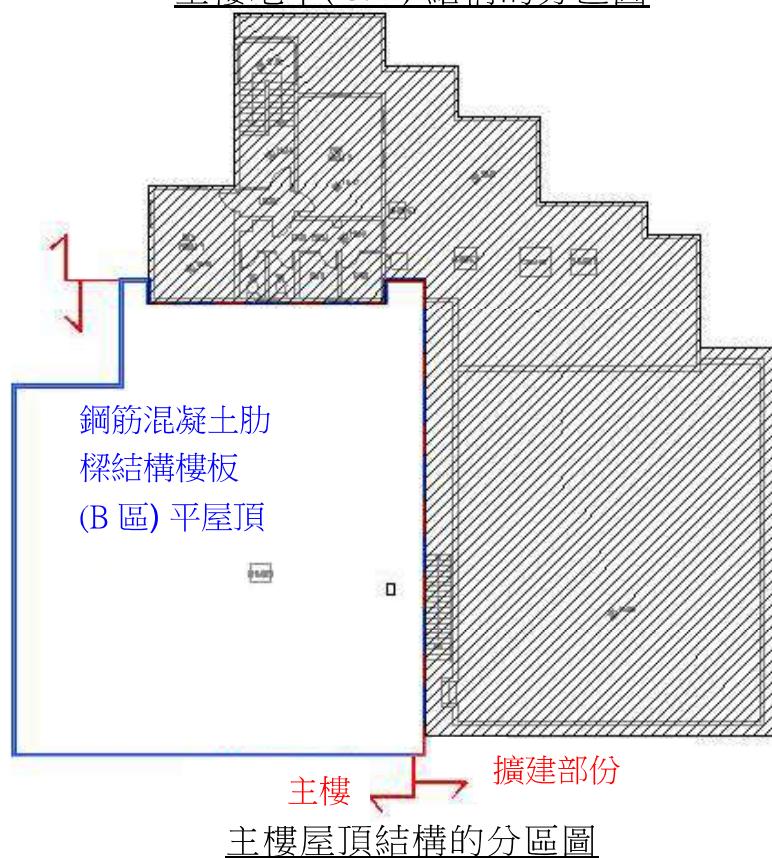
主樓的結構分區圖如下：

位置 (見主樓結構的分區圖 如下)		原用途	按照章程 最小設計 外加荷載 (kPa)	估計外加 荷載承受 能力(kPa)
地下 (G/F)	A 區	住宅用途	3.35	2
屋頂	B 區	平屋頂	2.68	1.5

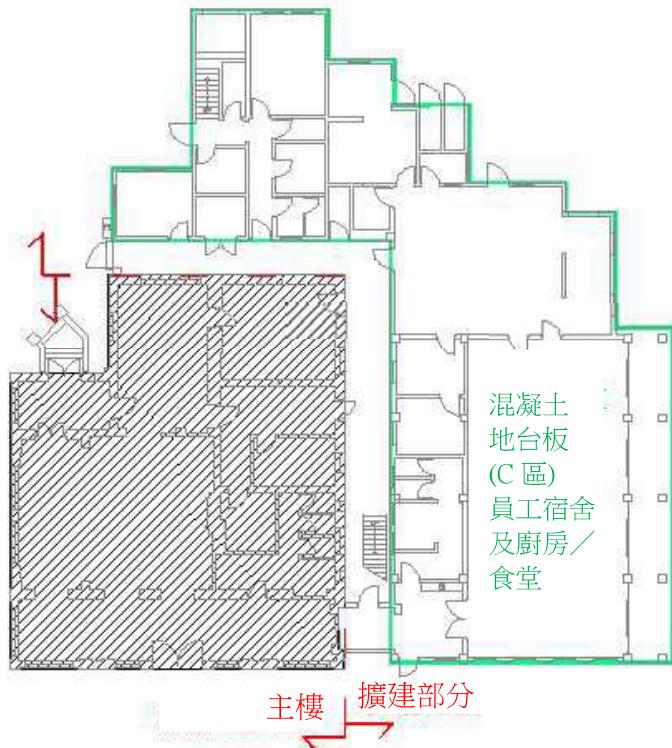
擴建部分地下 (G/F) 結構的分區圖

結構記錄圖沒有註明擴建部分的設計外加荷載。結構圖於1983至1984年繪製，估計是按照《1976年建築物(建造)規例(公制版)》(以下簡稱「規例」)的準則而設計。

擴建部分的結構分區圖如下：

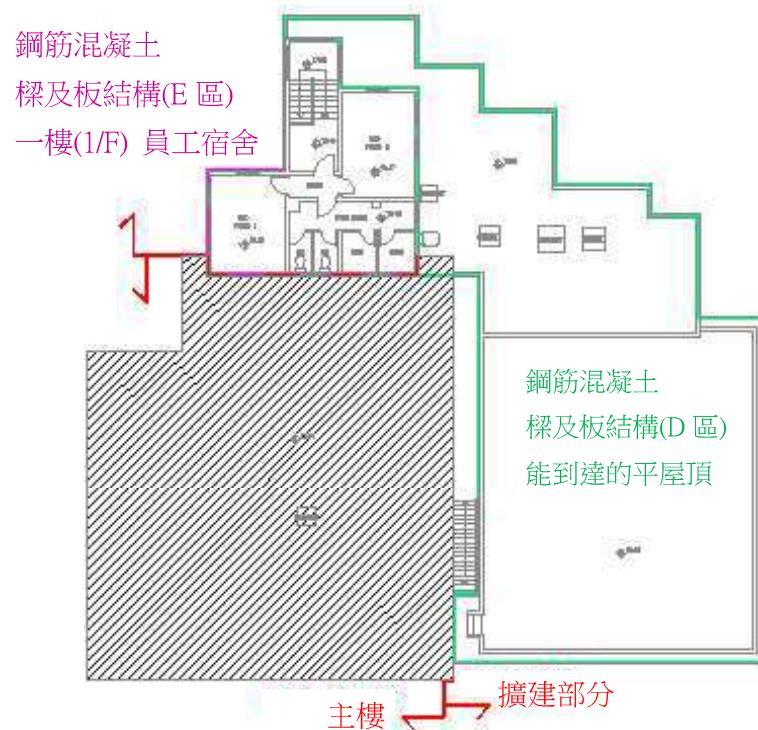
擴建部分一樓 (1/F) 結構的分區圖

鋼筋混凝土
樑及板結構
(F 區)
僅作維修通道

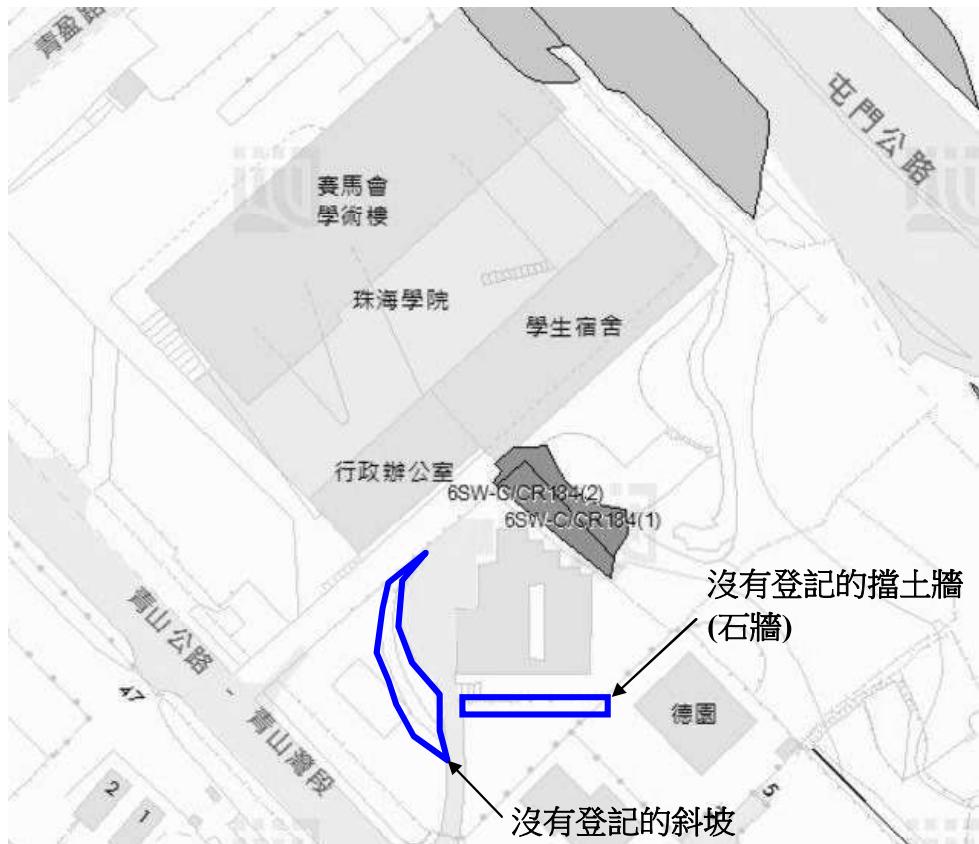
用地內有並不包括在SMRIS系統內的一幅斜坡及一幅擋土牆（這些斜坡及擋土牆顯示於下圖，以下簡稱為「沒有登記的斜坡」及「沒有登記的擋土牆」）。

沒有登記的擋土牆有些變形及在其旁邊的混凝土梯級有些輕微移位。

獲選機構日後須負責這些沒有登記的斜坡及沒有登記的擋土牆之維修和保養，並支付所需費用。

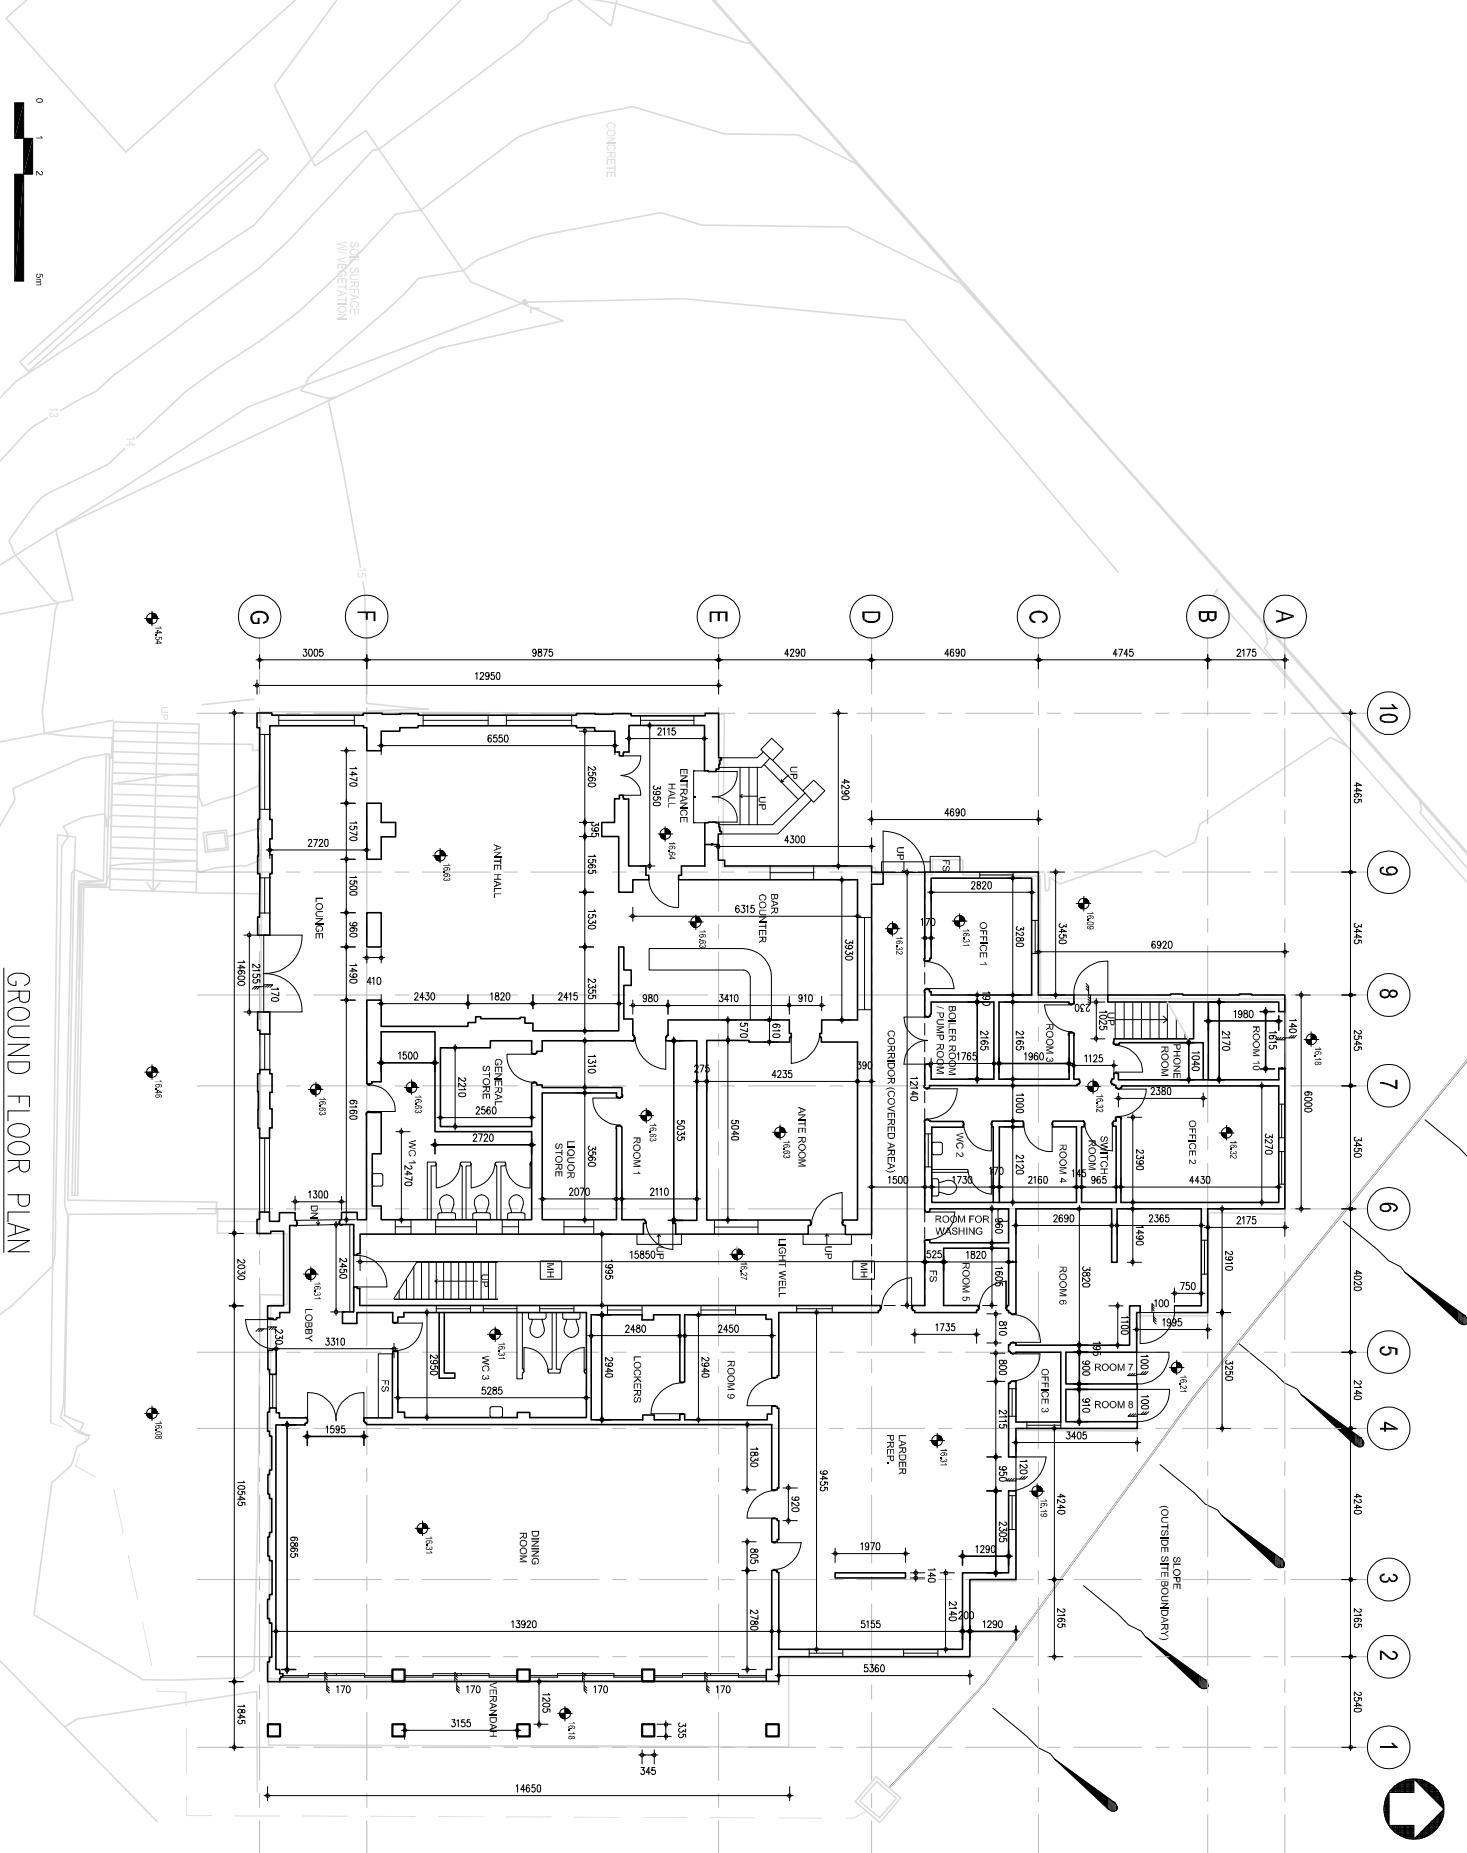
DRAWING TITLE : GROUND FLOOR PLAN			
PROJECT TITLE : RESOURCE KIT FOR WATERVALE HOUSE AT FORMER GORDON HARDY CAMP, CASTLE PEAK ROAD - CASTLE PEAK, MUN. N.T.			
DATE : 17/6/96	DRAWN : (A3)	DESIGNED : (A3)	CHECKED : (A3)
SCALE : 1:50			
JOB NO. : A002	DRAWING NO. :		
STATUS :

建築圖則	
圖則編號	圖則名稱
A001	用地平面圖
A002	地下(G/F)平面圖
A003	一樓(1/F)平面圖
A004	天台平面圖
A005	北立面圖
A006	南立面圖
A007	東立面圖
A008	西立面圖
A009	剖面圖 A-A
A010	剖面圖 B-B
SK01	地下入口圖

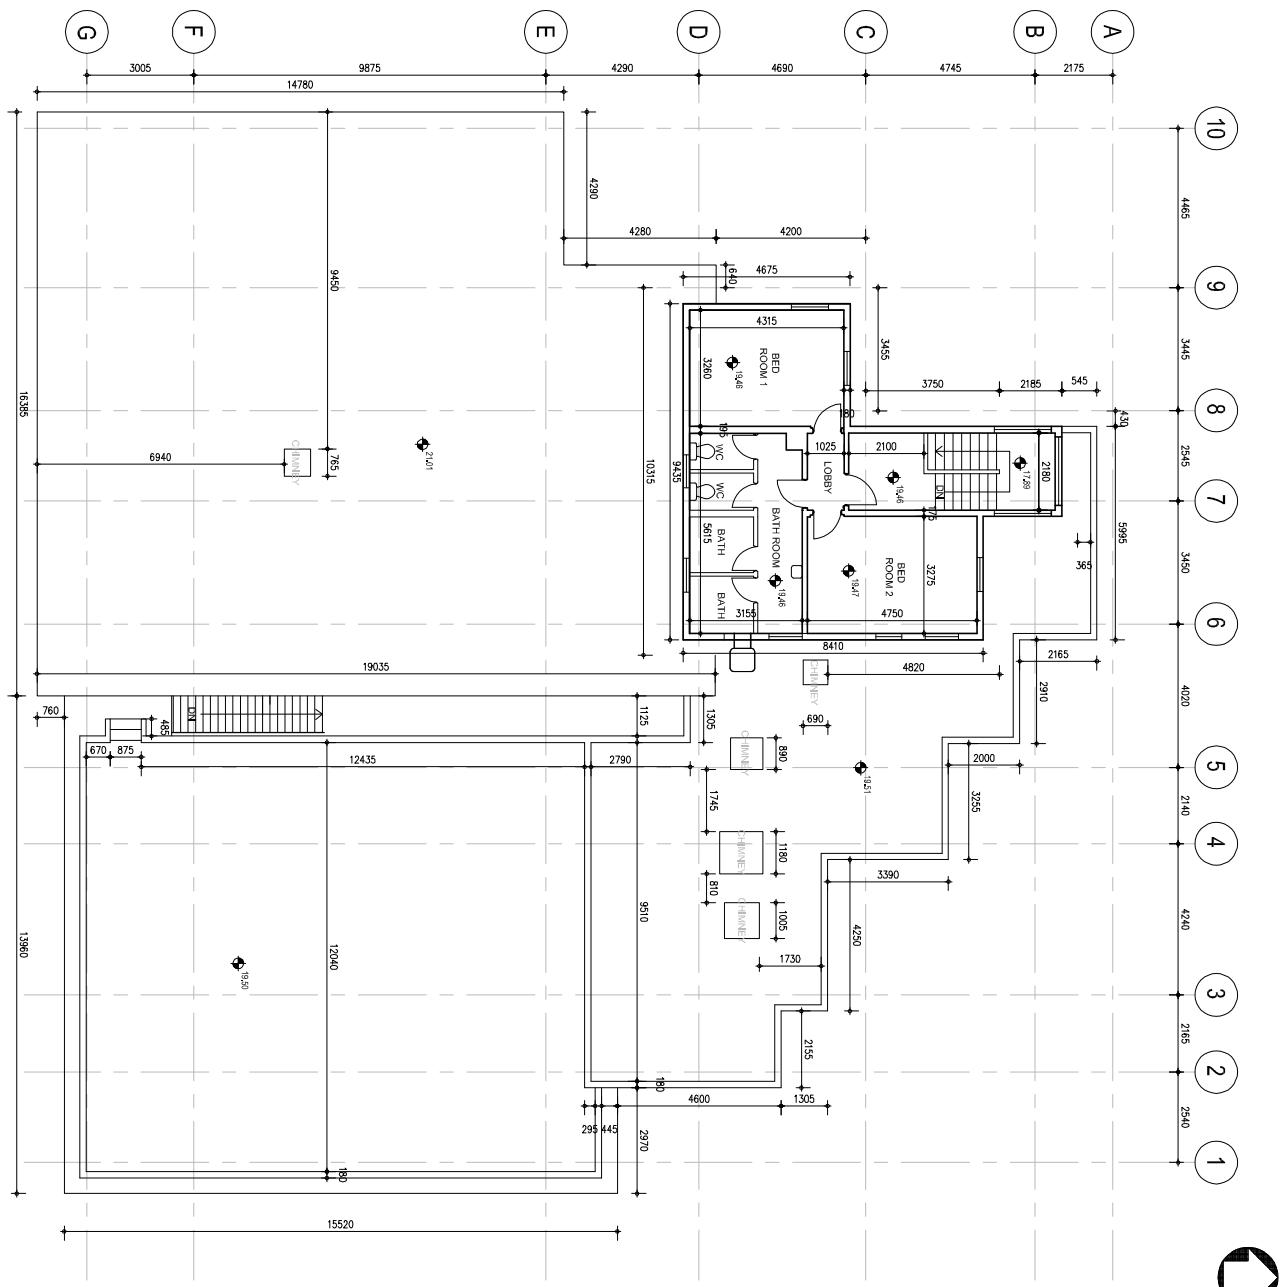
PROJECT TITLE : KIT FOR WATERVALLE			
HOUSE AT FORMER GORDON HARD			
CAMP, CASTLE PEAK ROAD-CASTLE			
PEAK BAY SECTION, PEAK AREA 4B,			
TUN MUN, N.T.			
DRAWING TITLE : FIRST FLOOR PLAN			
DATE :	DRAWN :	DESIGNED :	CHECKED :
17/6/16			SCALE 1:150 (A3)
JOB NO. :	DRAWING NO. :		
	A003		
STATUS :

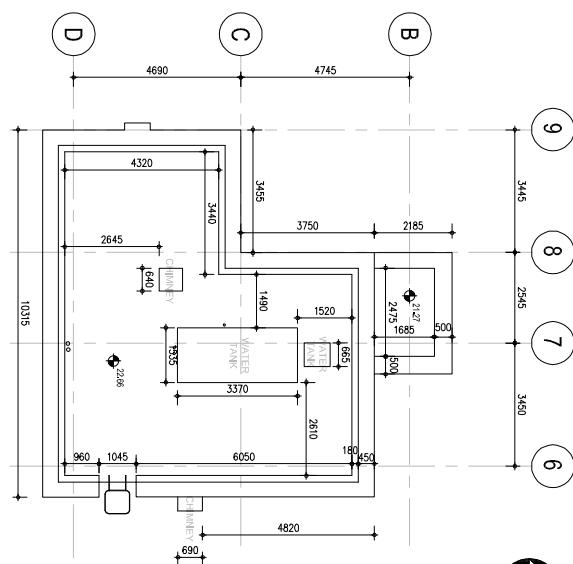
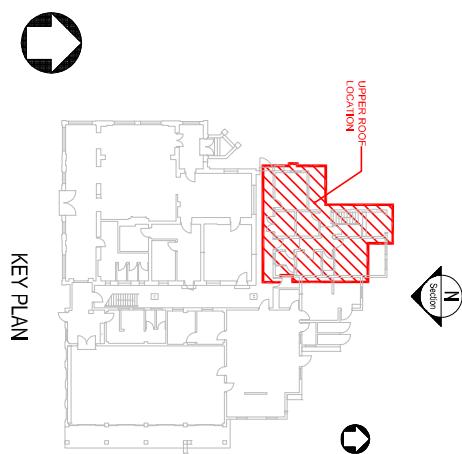
ROOF FLOOR PLAN

PROJECT TITLE:
RESOURCE KIT FOR WATERVALVE
HOUSE AT FORMER GORDON HAD
CAMP, CASTLE PEAK ROAD—CASTLE
PEAK BAY SECTION, AREA 4B,
TUEN MUN, N.T.

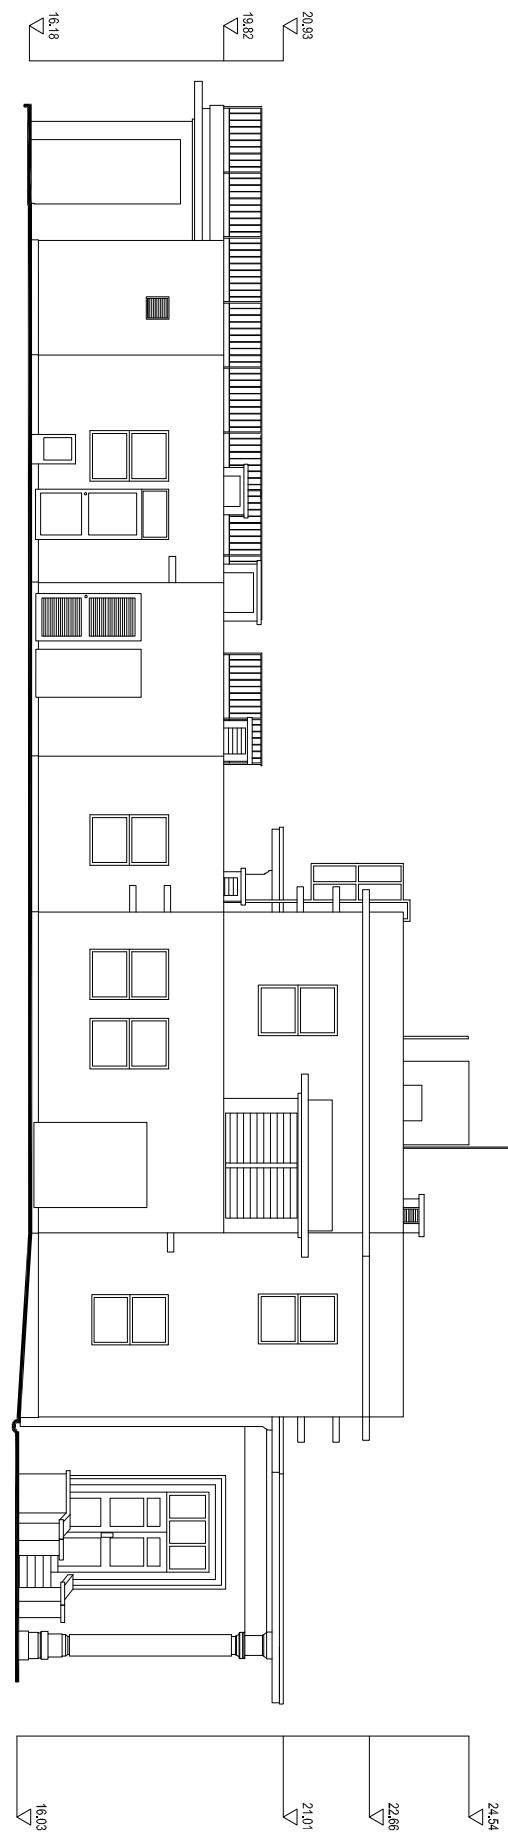
DRAWING TITLE :
NORTH ELEVATION

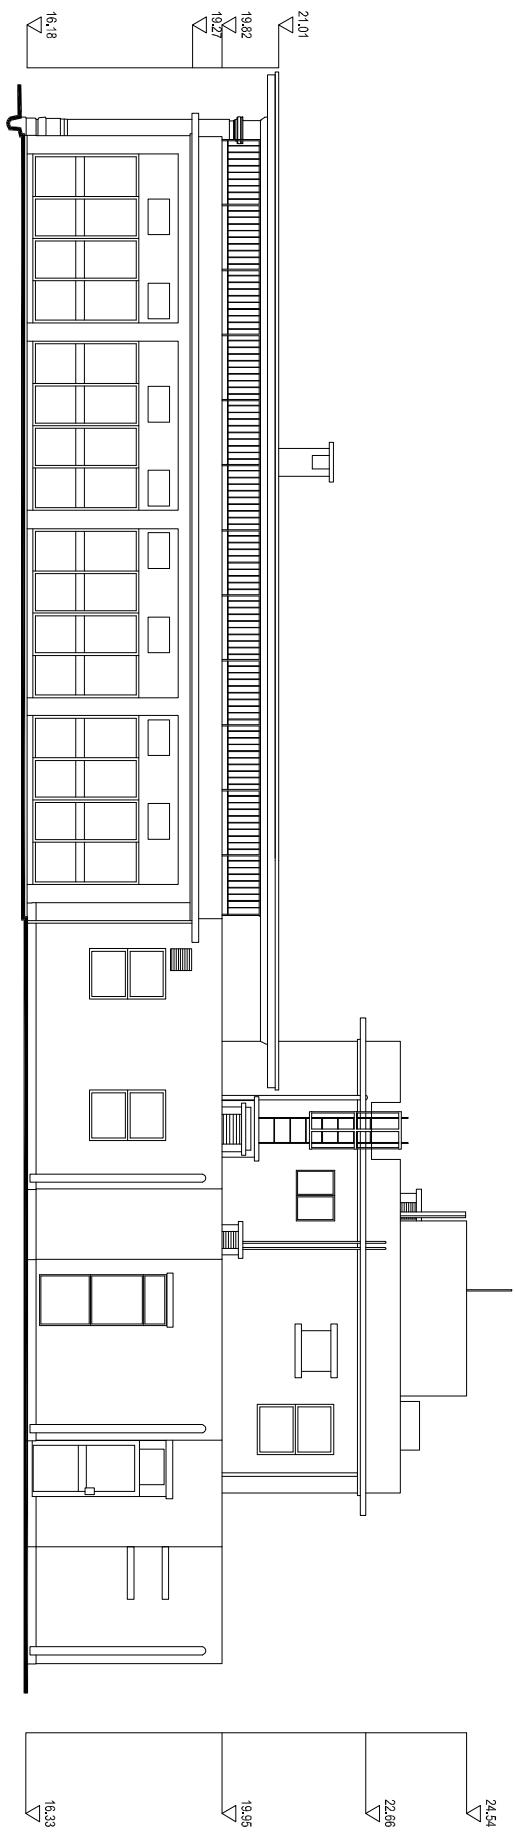
DRAWING TITLE :
EAST ELEVATION

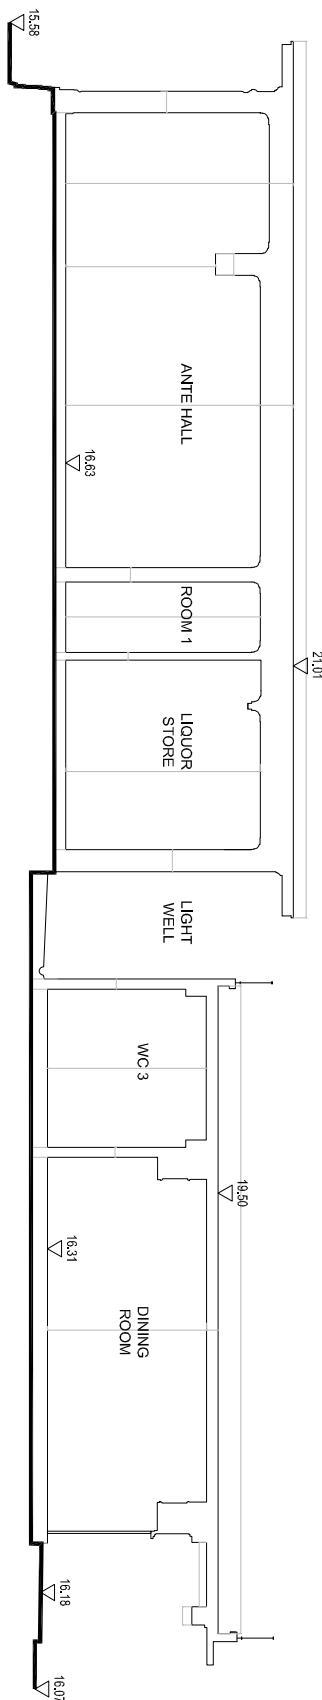
SECTION B-B

RESOURCE KIT FOR WATERVALE
HOUSE AT FORMER GORDON HARD
CAMP CASTLE PEAK ROAD-Castle
PEAK BAY SECTION AREA 48,
TUEN MUN, N.T.

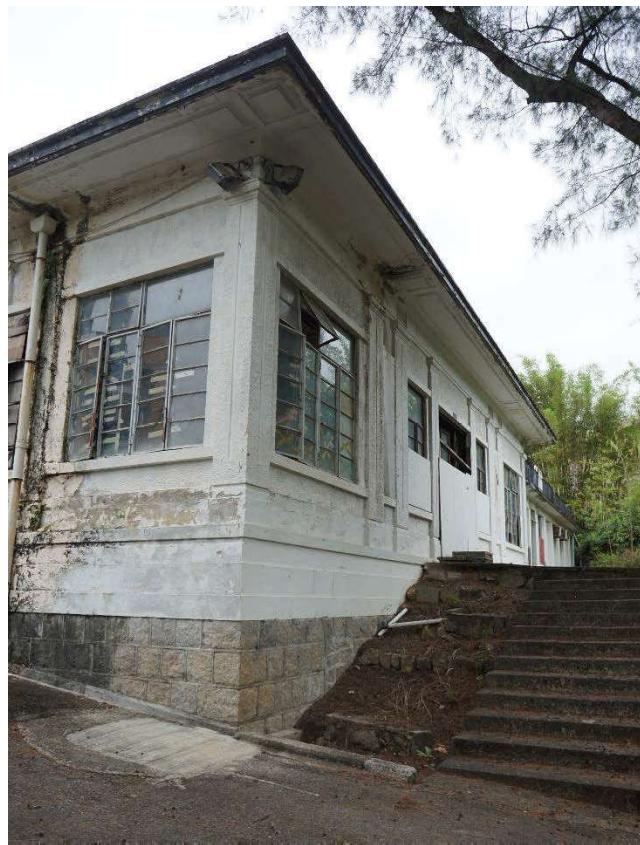
主樓的南立面

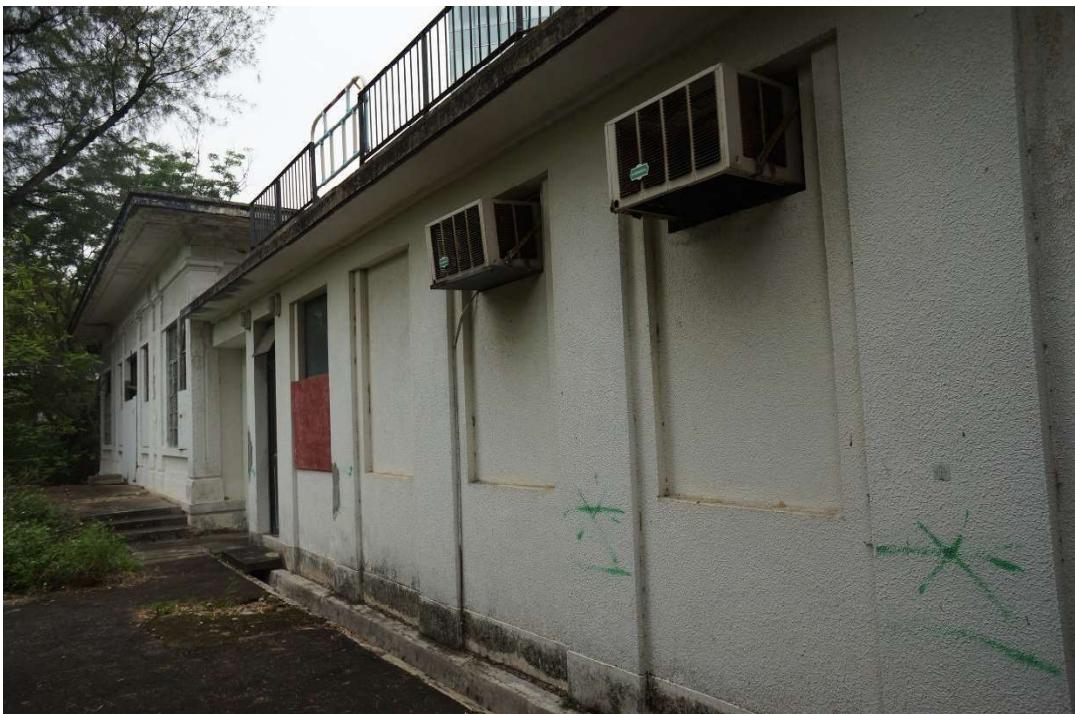
擴建部分的南立面

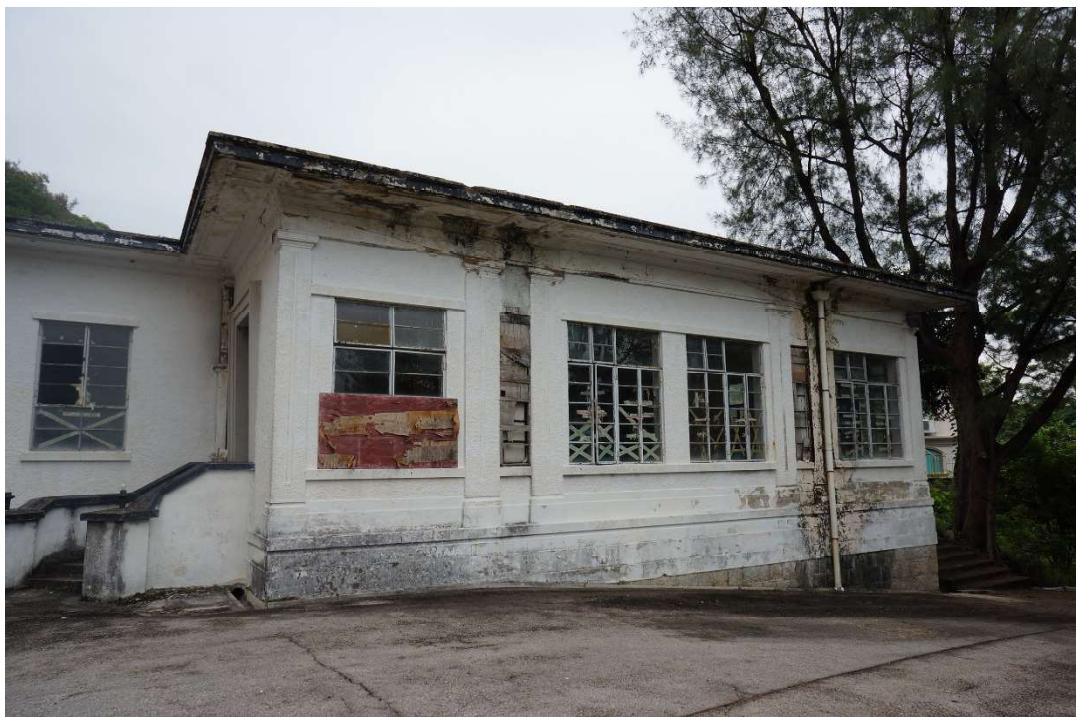
主樓的西立面

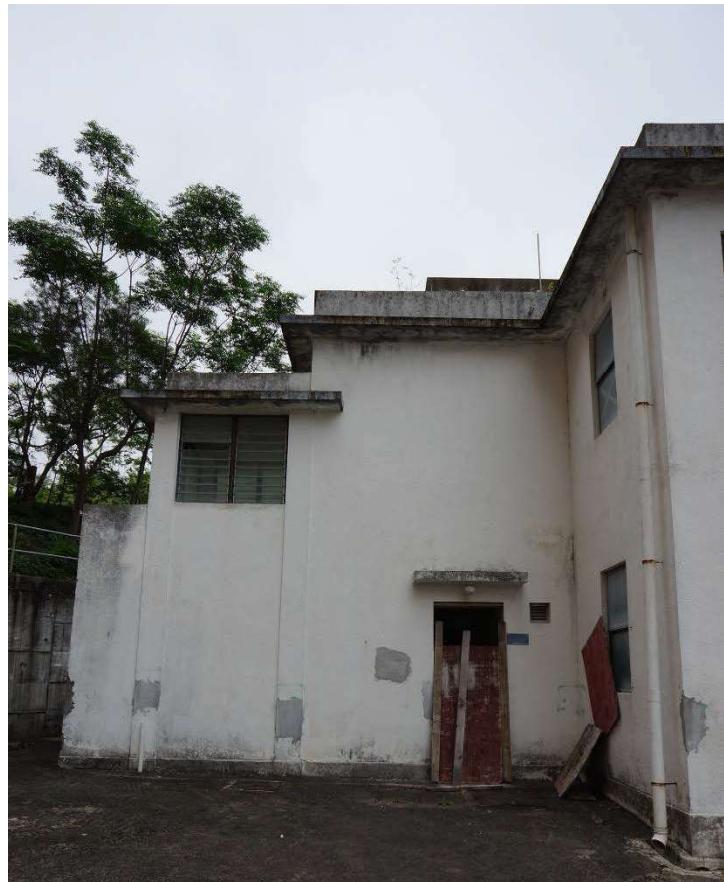
擴建部分的西立面

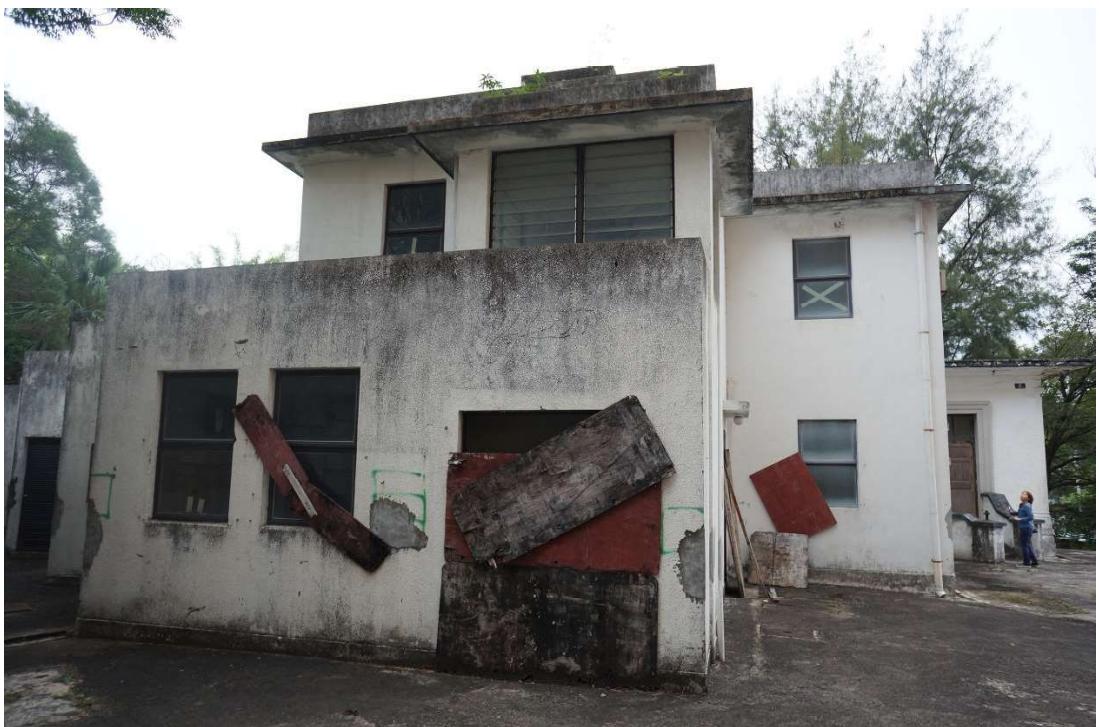
擴建部分的北立面

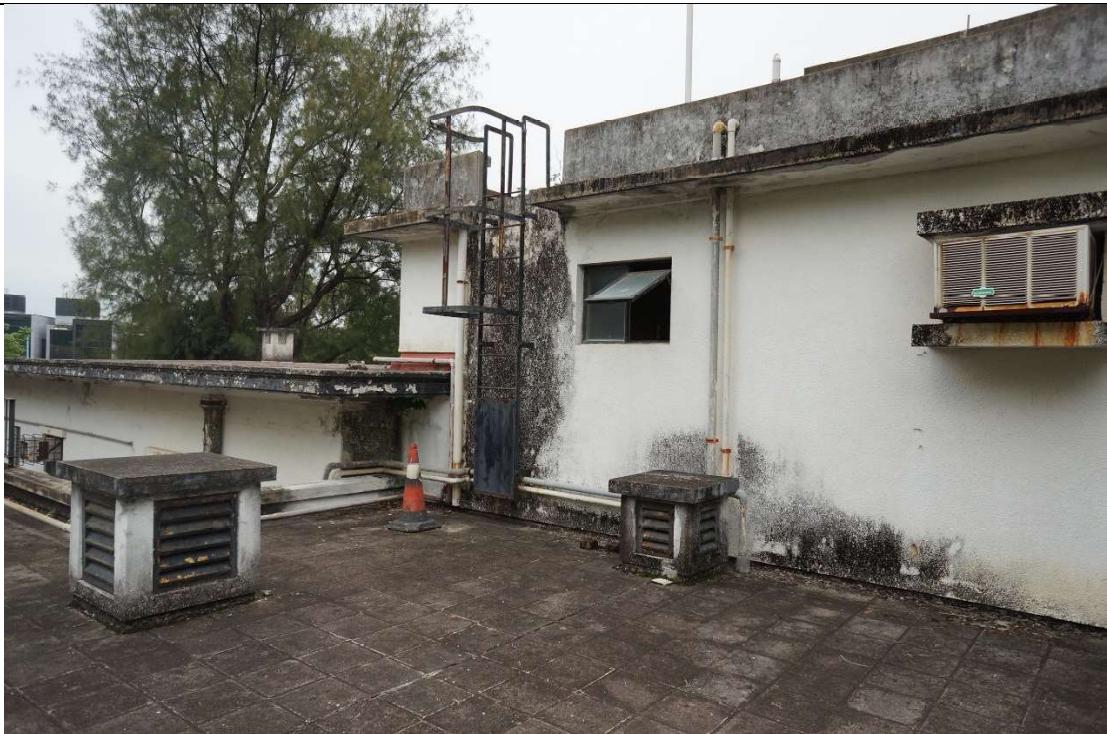
由擴建部分平台通往天台的貓梯的視圖

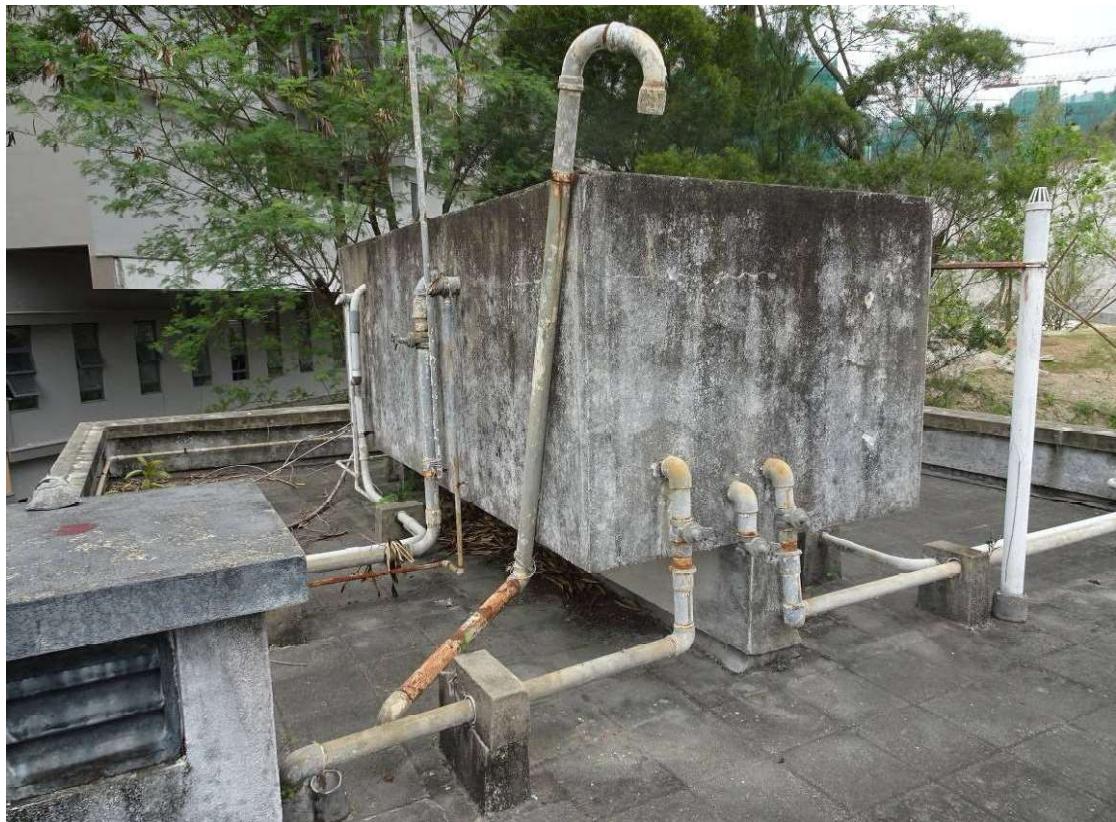
水缸的視圖

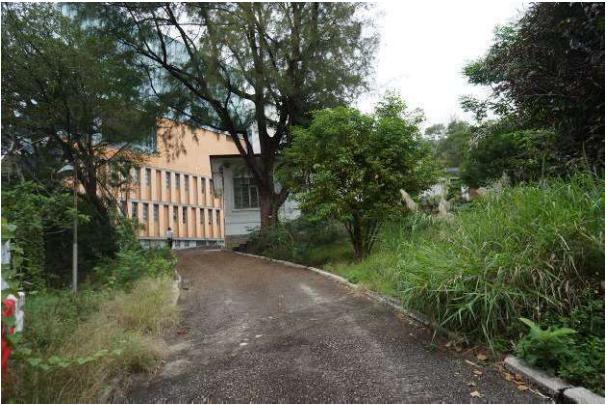
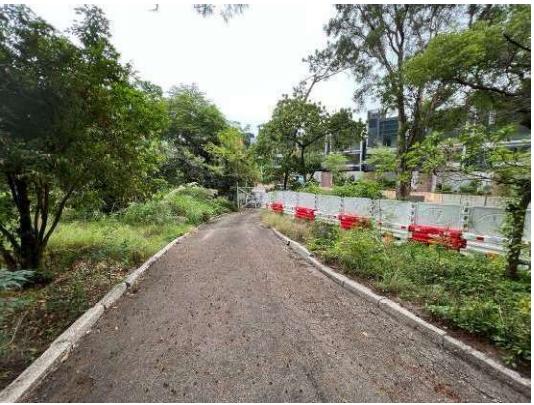
項目	建築特色
1.1	<p><u>布局／四周範圍</u> 整體的地形、現有的花木以及通往主樓入口處的行車道連花崗石路緣。</p>

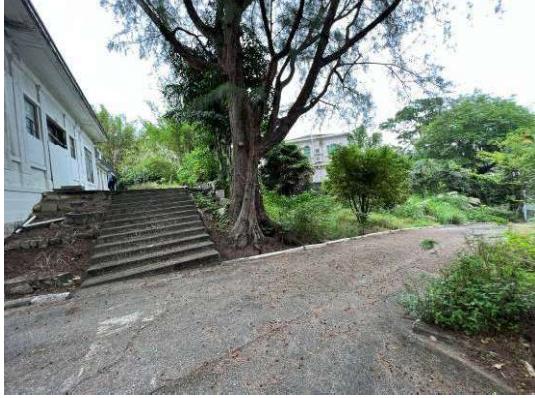
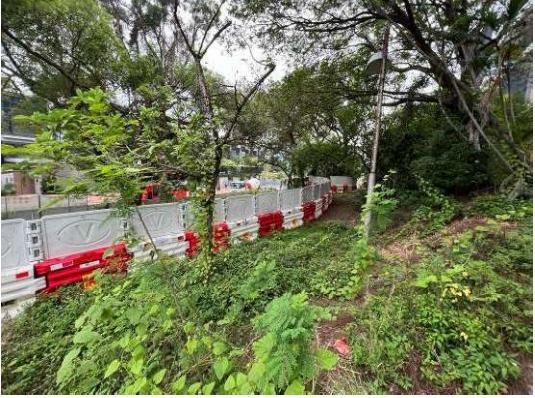
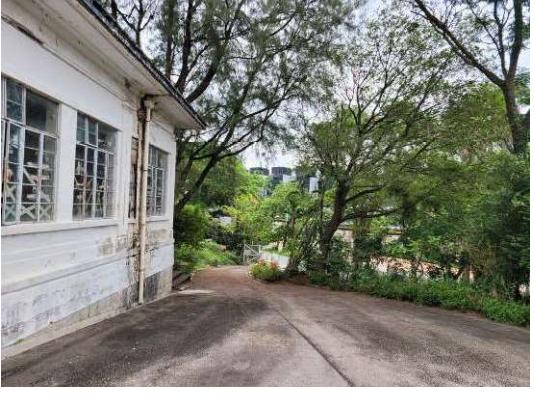
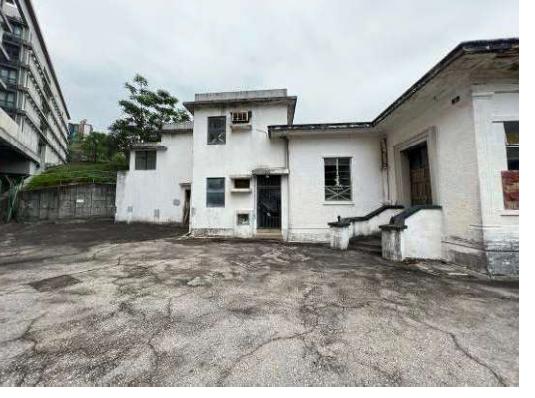
項目	建築特色
1.2	<p><u>主樓外面空地</u> 主樓西面和南面兩邊的空地。</p>

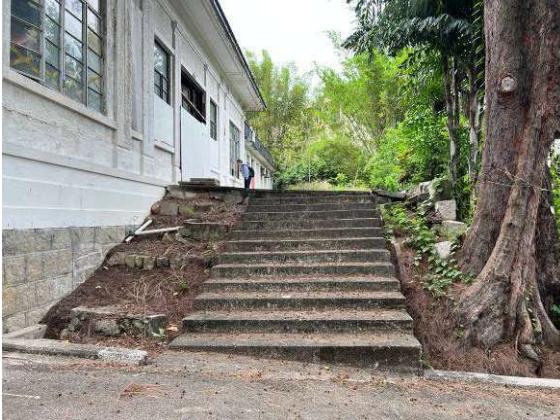
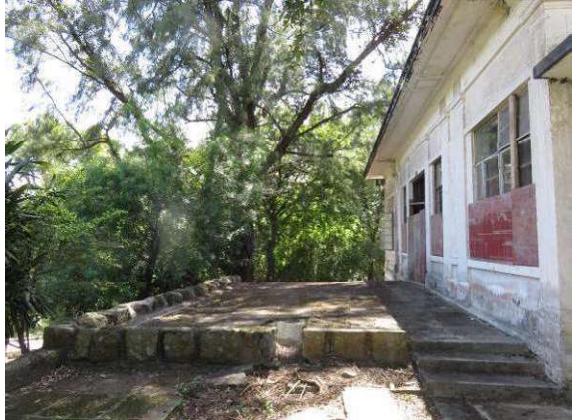
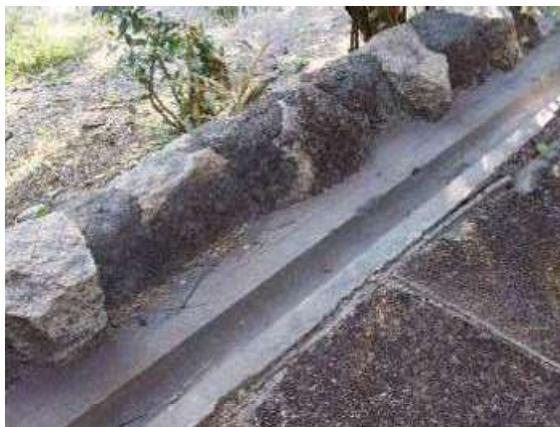
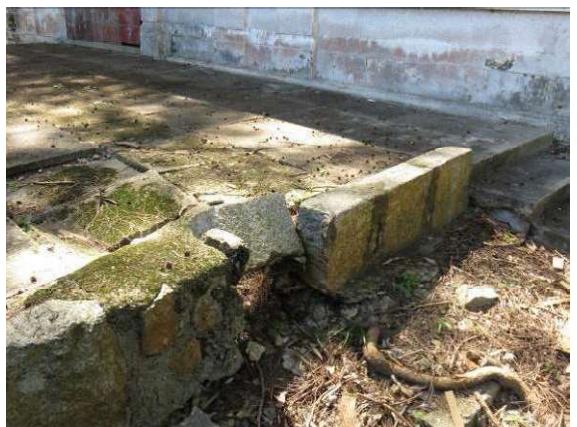
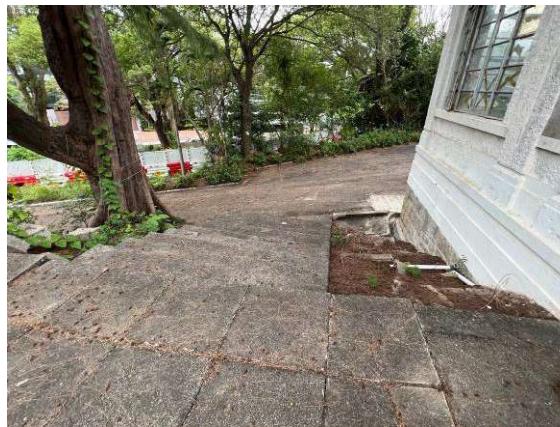
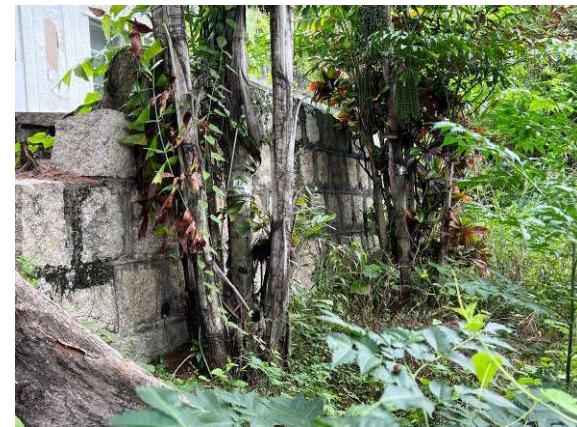
項目	建築特色
1.3	<p>平台 南面現存的平台，包括通往行車道和相連平台的梯級、石米飾面（地磚及梯級面）、矮毛石路緣及石砌面牆。</p>

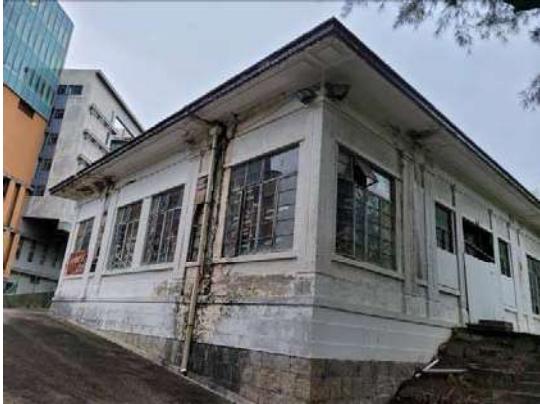
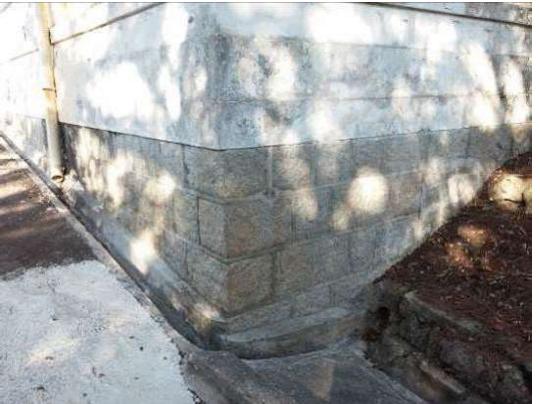
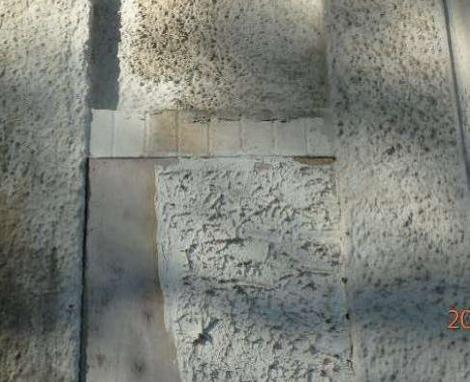
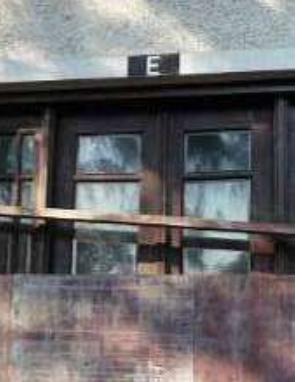
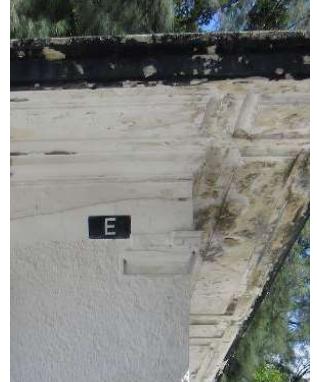
項目	建築特色
2.1	<p><u>建築物外立面</u></p> <p>建築物所有外立面，包括花崗石基座；批盪面(光滑面及粗灰泥面)；磚砌門楣、窗楣、門檻、窗戶及磚砌裝飾帶；以及牆上的「E」字指示標誌。</p>

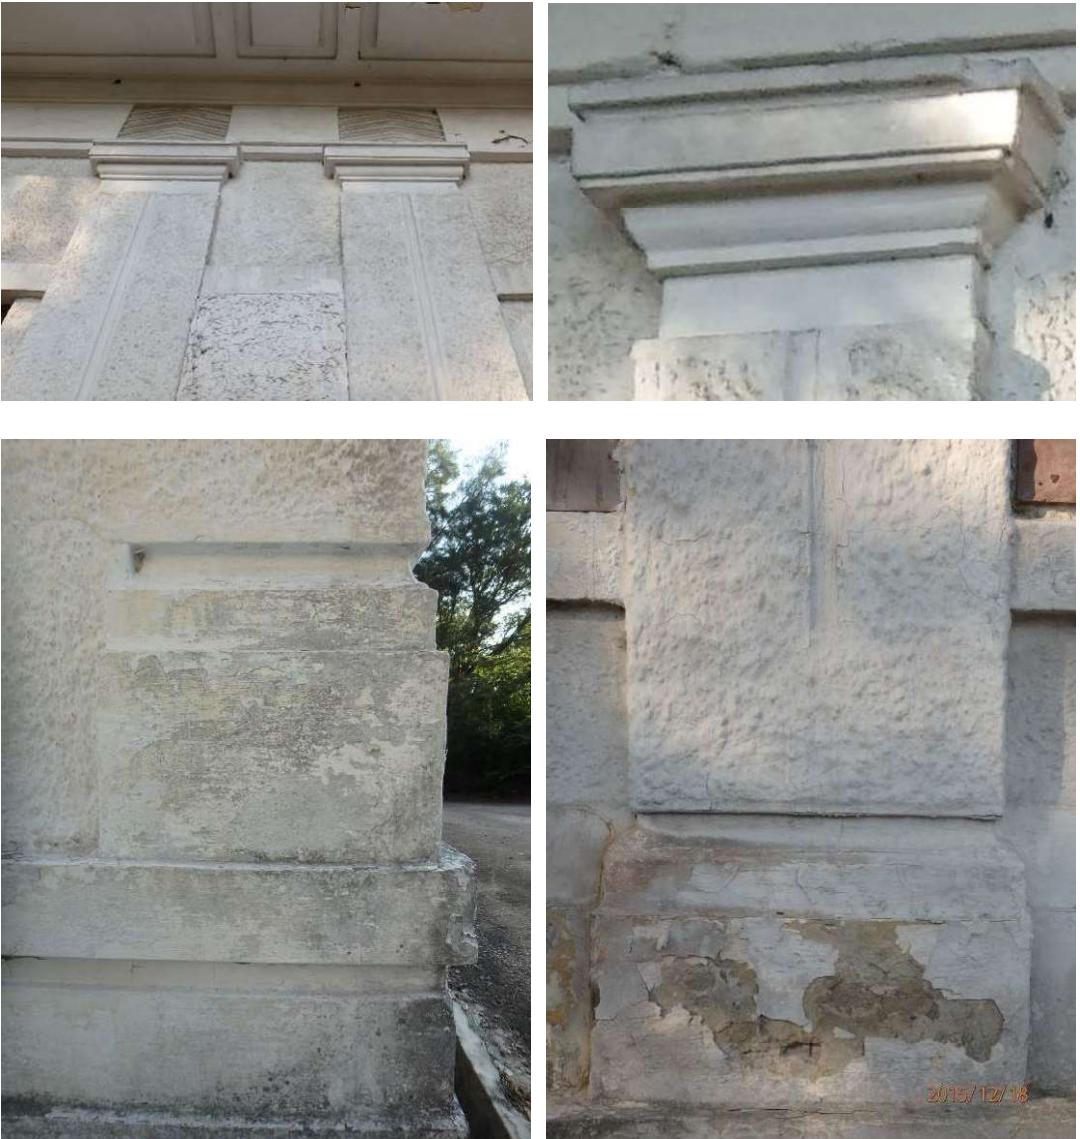
項目	建築特色
2.2	<p><u>外部壁柱</u> 外立面所有壁柱，連柱座、柱身、柱頭及柱身的垂直坑紋。</p>

<p>The four photographs show different views of the building's exterior columns. The top-left photo shows a row of columns with vertical fluting. The top-right photo is a close-up of a column capital. The bottom-left photo shows a column base. The bottom-right photo shows a column with peeling paint at the base, with the date '2015/12/18' printed in the bottom right corner.</p>

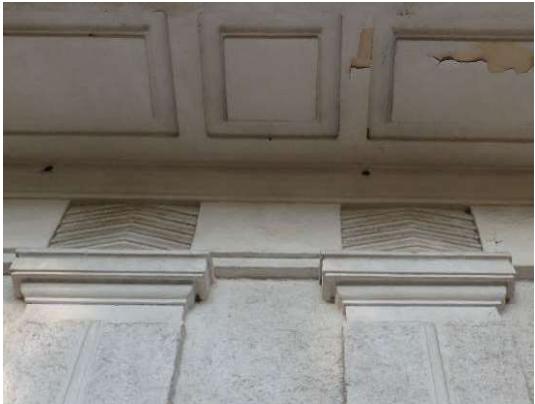
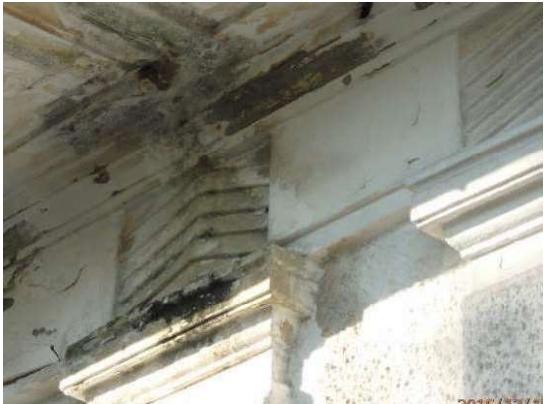
項目	建築特色
2.3	<p><u>外牆簷壁</u> 所有外牆簷壁，連飛簷及立體幾何紋飾。</p>

項目	建築特色	規定處理方法
2.3	外牆簷壁	<p>a. 應原位保存所有外牆簷壁連飛簷及立體幾何紋飾。</p> <p>b. 拆除西、南兩個立面簷壁上的燈具、管道等。</p> <p>c. 使用獲批准的方法除去舊塗料，然後使用獲批准的可還原塗料及顏色重新髹漆。</p> <p>d. 視乎需要，參照現有式樣修復破損的紋飾，以及修葺損壞的批盪。</p>

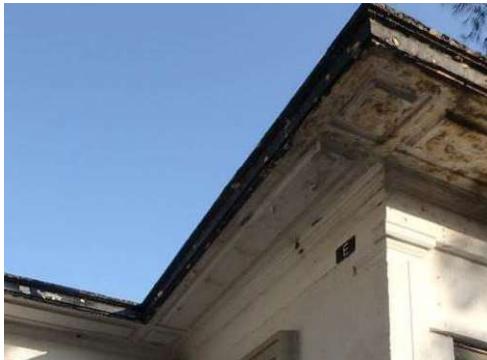
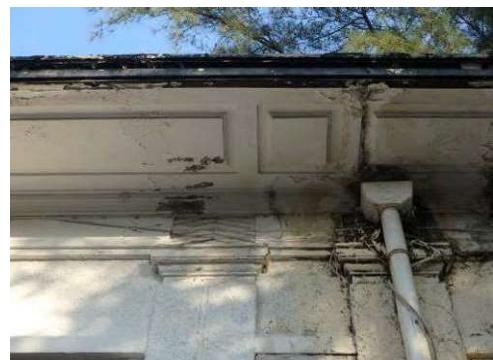
項目	建築特色
2.4	<p><u>簷底紋飾</u> 簷底所有立體幾何紋飾。</p>

項目	建築特色	規定處理方法
2.4	簷底紋飾	<p>a. 應原位保存簷底所有立體幾何紋飾。</p> <p>b. 使用獲批准的方法除去舊塗料，然後使用獲批准的可還原塗料及顏色重新髹漆。</p> <p>c. 視乎需要，參照現有式樣修復破損的紋飾，修葺損壞的批盪。</p>
