活化歷史建築伙伴計劃

第 48 區前哥頓軍營

Watervale House

資料冊

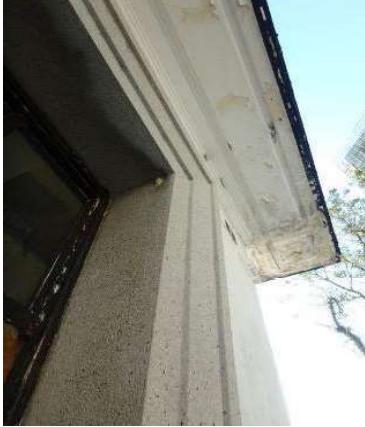
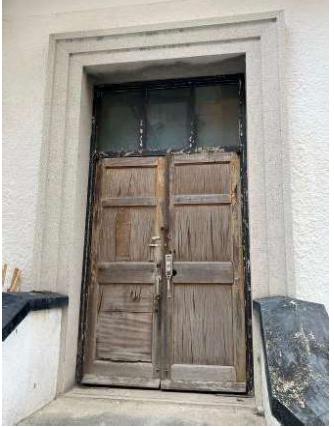
項目	建築特色
2.5	<p><u>入口處的門圍及門檻</u> 入口處以上海批盪作飾面的門圍及花崗石門檻。</p>

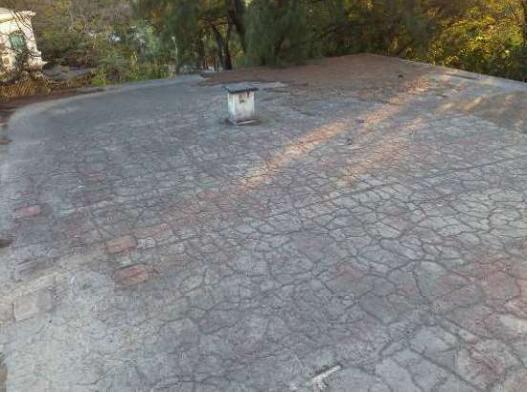
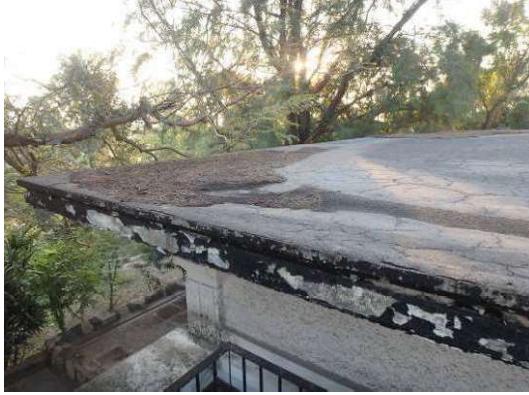
項目	建築特色
2.6	<p><u>平屋頂</u> 平屋頂連凸出的屋簷。</p>

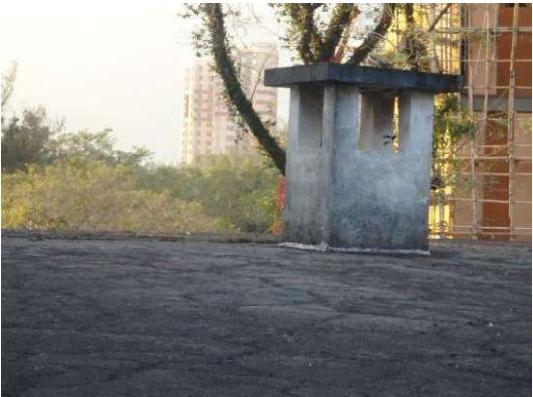
項目	建築特色
2.7	<p>煙囪 屋頂的煙囪</p>

項目	建築特色	規定處理方法
2.7	煙囪	<p>a. 應原位保存屋頂的煙囪。</p> <p>b. 視乎需要修補裂縫及損壞的混凝土。</p> <p>c. 可考慮封上煙囪口以防滲水，惟不可影響煙囪的外觀。</p> <p>d. 除去煙囪上的舊塗料，然後使用獲批准的可還原塗料及顏色重新髹漆。</p>

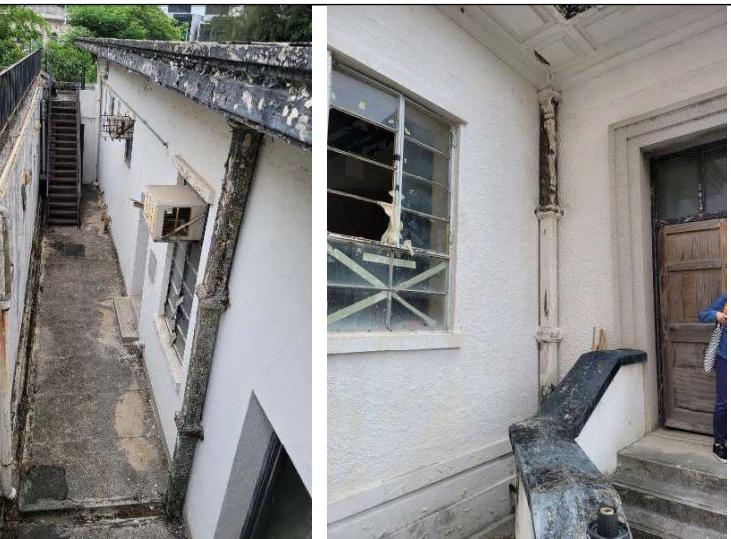
項目	建築特色
2.8	<p>原有的雨水管 (方形混凝土雨水)</p>

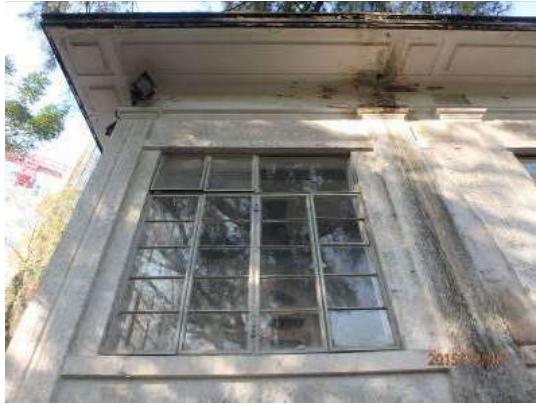
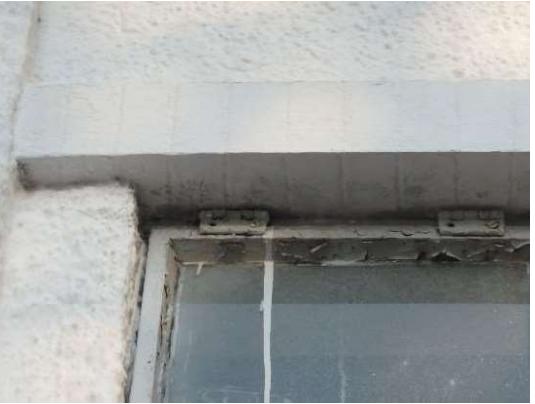
項目	建築特色
2.9	<p><u>鋼窗</u> 所有現存鋼窗及其部件</p>

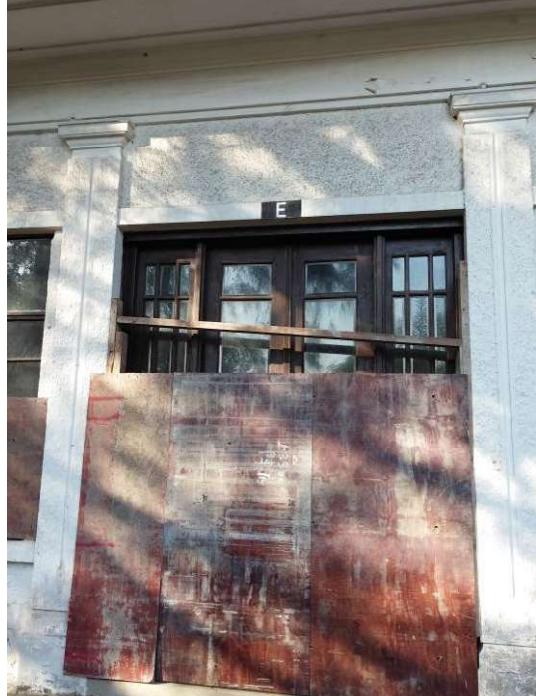
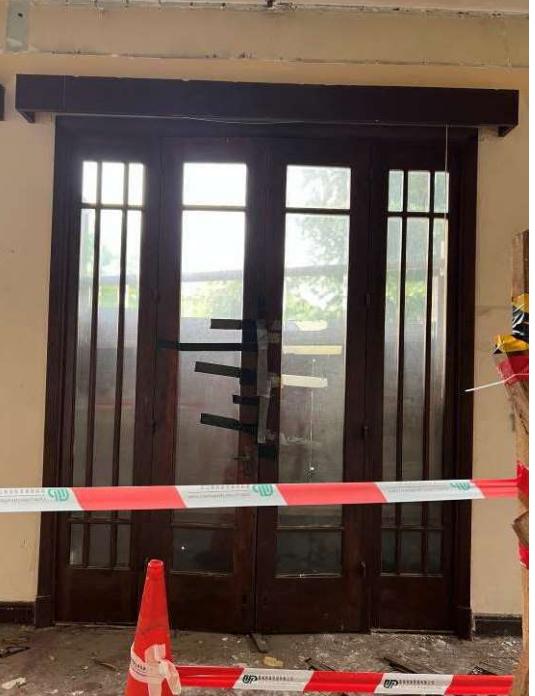
項目	建築特色
2.10	<p><u>平台木門連側窗</u> 通往平台的一對法式木門連側窗及其部件</p>

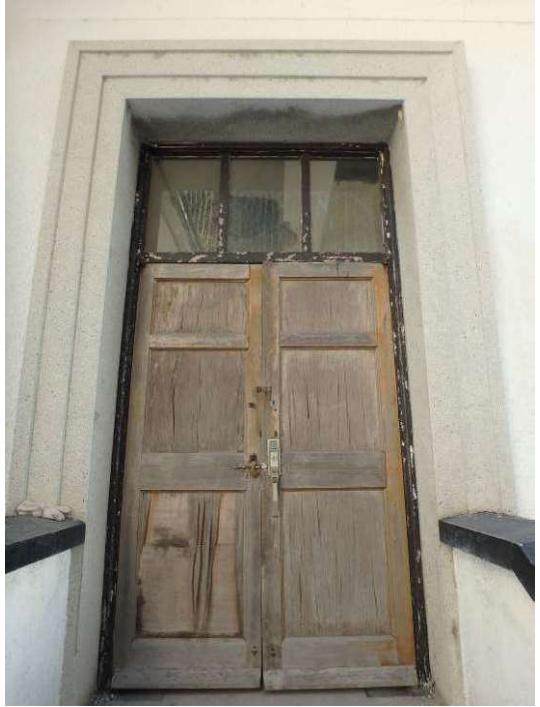
項目	建築特色
2.11	<p>入口處的木門連楣窗 現存的門框連上方的楣窗</p>

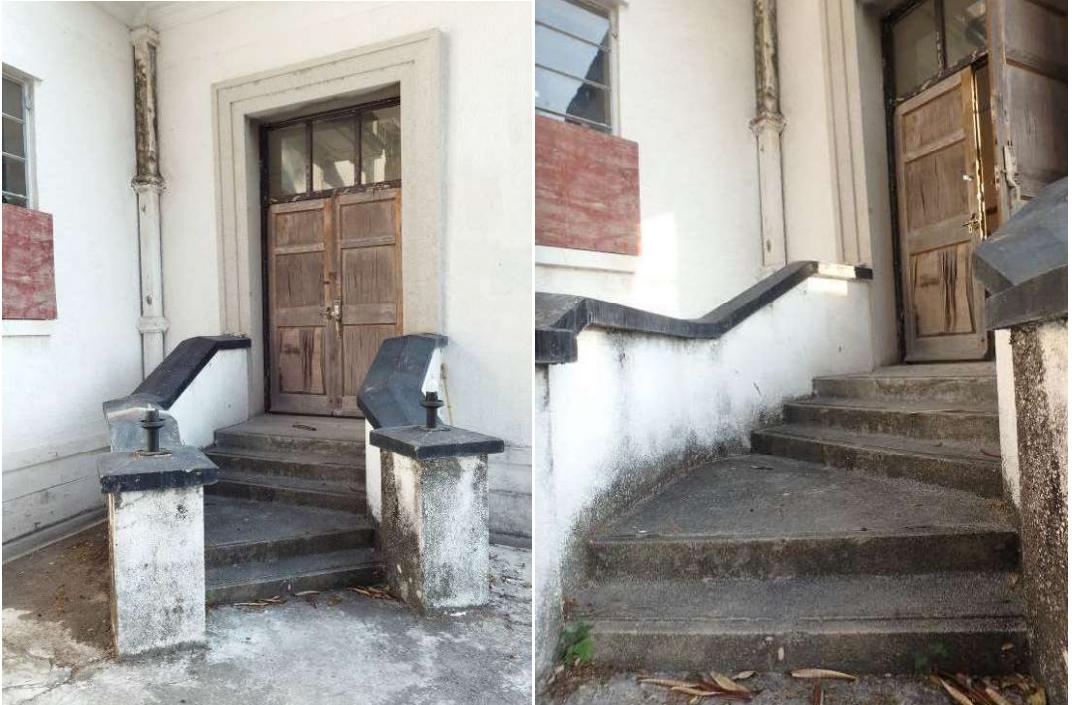
項目	建築特色
2.12	<p><u>主入口處樓梯</u> 入口處樓梯所有部分，包括梯級、梯台、護欄牆及其頂部，以及石米地台飾面。</p>

項目	建築特色	規定處理方法
2.12	主入口處樓梯	<p>a. 應原位保存主入口處樓梯所有部分，包括梯級、梯台、護欄牆及其頂部。</p> <p>b. 為符合法定要求，在樓梯加建防護欄或進行改善工程，是可獲考慮，惟必須以可還原方式進行，把對樓梯的影響減至最小，並須獲古蹟辦批准。</p> <p>c. 視乎需要，參照現有式樣修葺損壞的梯級、梯台、粗灰批盪、石米地台飾面及護欄牆的頂部。</p> <p>d. 清洗所有梯級及梯台的石米飾面。</p> <p>e. 除去現有塗料，重髹護欄牆。</p> <p>f. 視乎需要修葺入口處樓梯的燈具，裝回現存的燈罩。如現存的燈罩已經破爛或遺失，須換上與現有款式、大小及物料相符的新燈罩。</p>

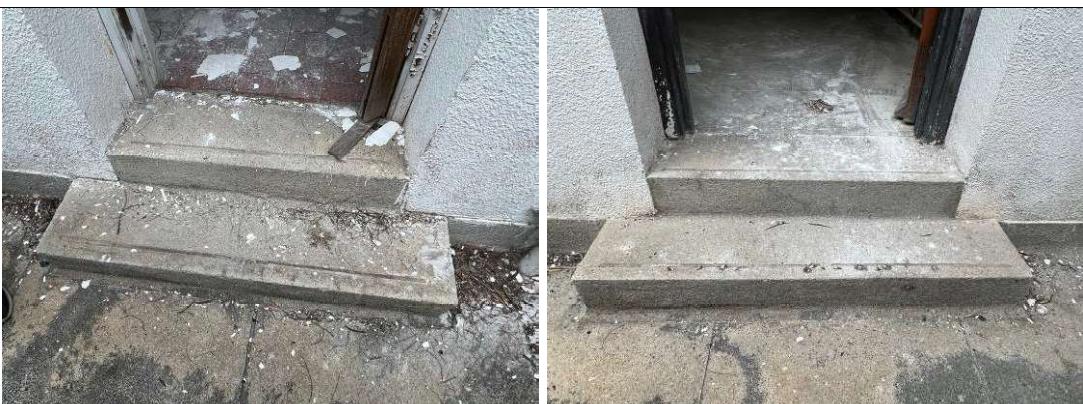
項目	建築特色
2.13	<p><u>花崗石門檻</u> 通往天井的門口的花崗石門檻</p>

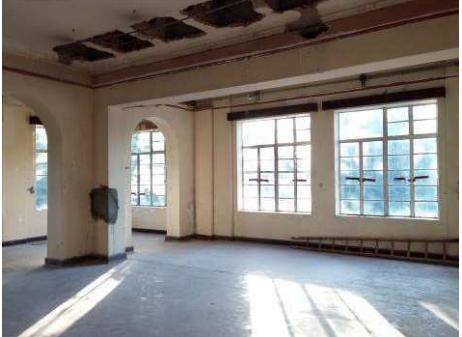
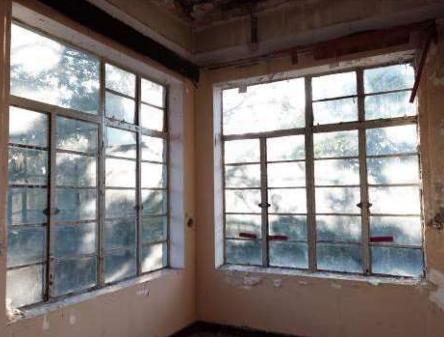
項目	建築特色
3.1	<p><u>空間布局</u></p> <p>門窗闊大，把大自然帶入室內，營造整體空間開闊的氛圍；木製地板、牆腳線、窗簾盒等有助營造暖意的室內飾面；以及帶有古典風味裝飾的天花線、拱門及壁柱等。</p>

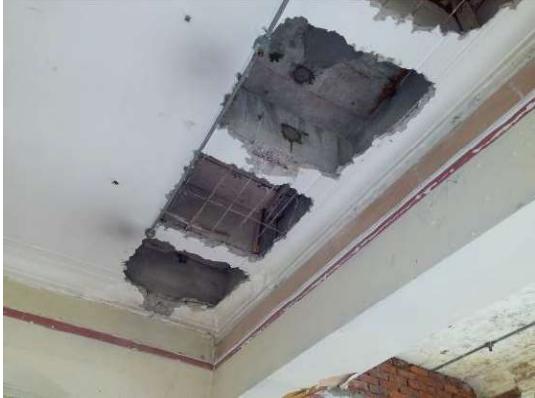
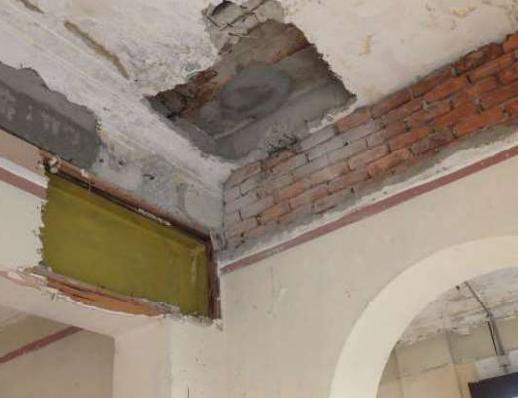
項目	建築特色
3.2	<p><u>建築結構</u></p> <p>所有原有的結構構件，包括支柱、橫樑、結構牆、拱形開口及屋頂原有的肋樑結構樓板等。</p>

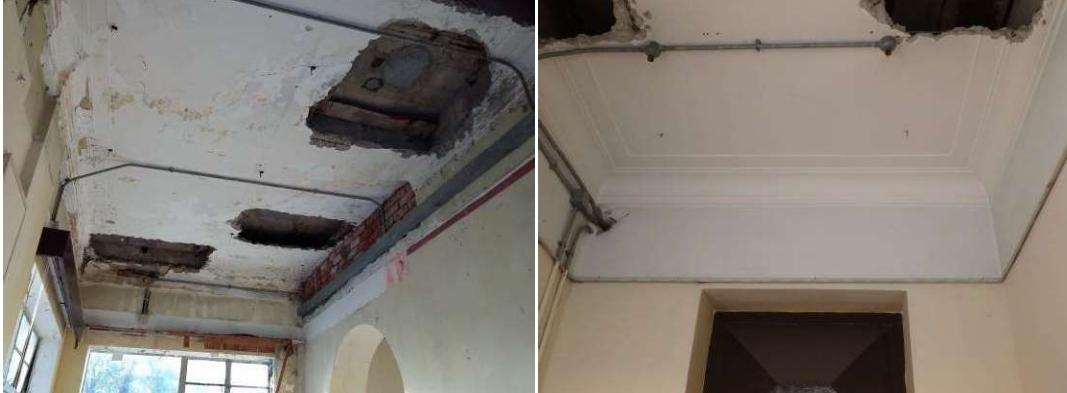
項目	建築特色
3.3	<p><u>天花飾線</u> 所有天花飾線，包括冠頂飾線。</p>

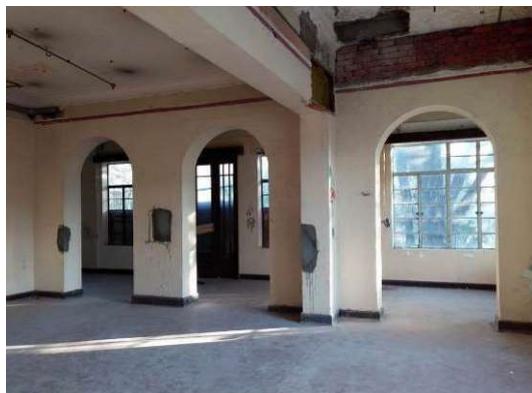
項目	建築特色
3.4	<p><u>拱門</u> 所有原有的拱門。</p>

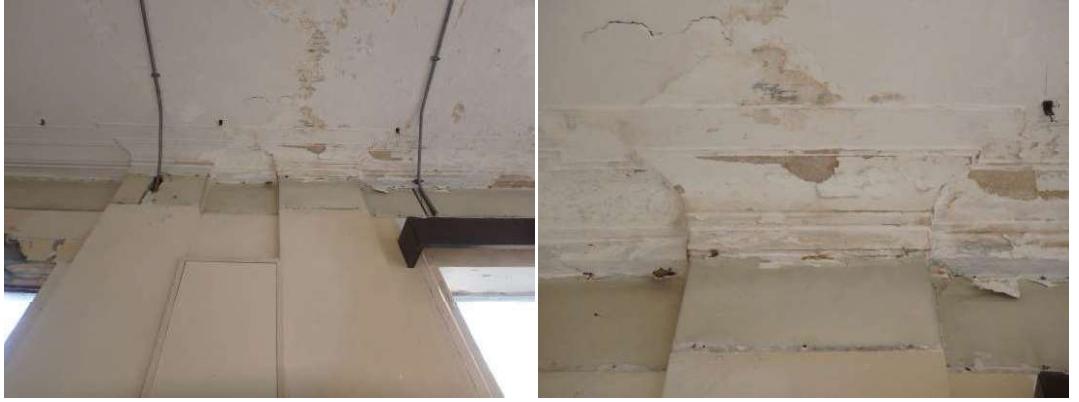
項目	建築特色
3.5	<p><u>內部壁柱</u> 所有壁柱。</p>

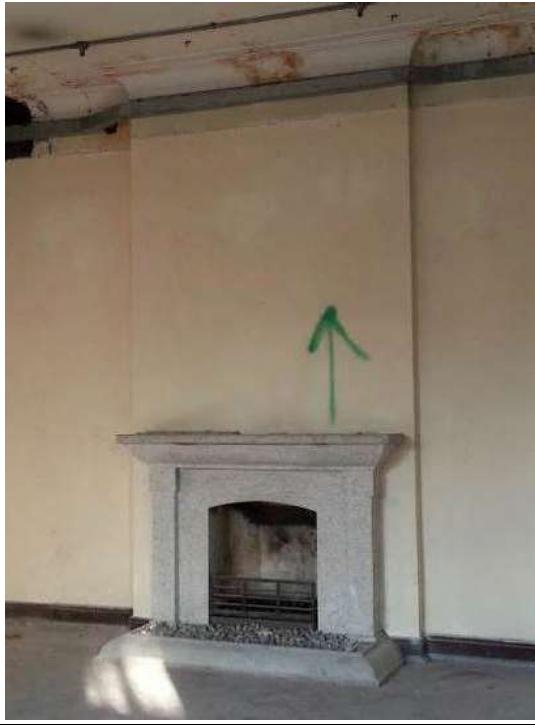
項目	建築特色
3.6	<p><u>壁爐及煙囪管道</u> 壁爐及煙囪管道，包括花崗石壁爐框、壁柱、壁爐架、爐牀及鐵爐柵。</p>

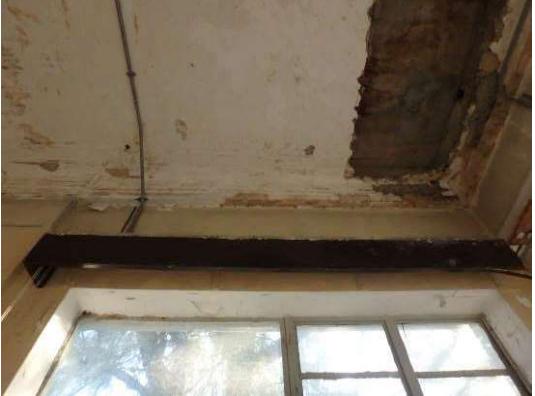
項目	建築特色
3.7	<p><u>木窗簾盒</u> 所有木窗簾盒。</p>

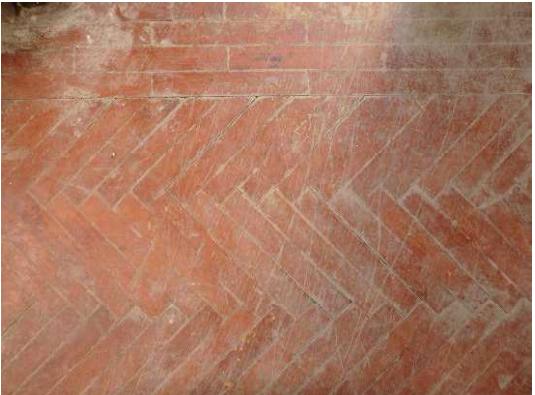
項目	建築特色
3.8	<p><u>人字紋木地板</u> 所有人字紋木地板，包括飾邊。</p>

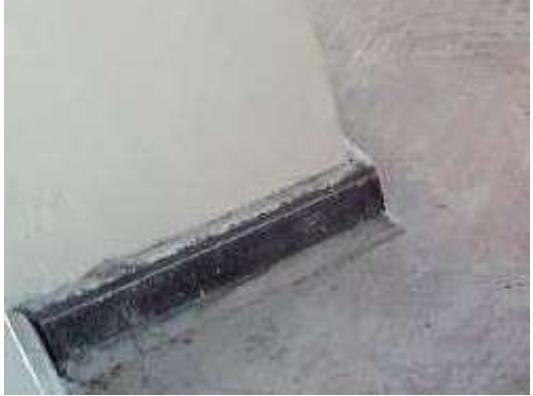
項目	建築特色
3.9	<p><u>木腳線</u> 所有木腳線。</p>

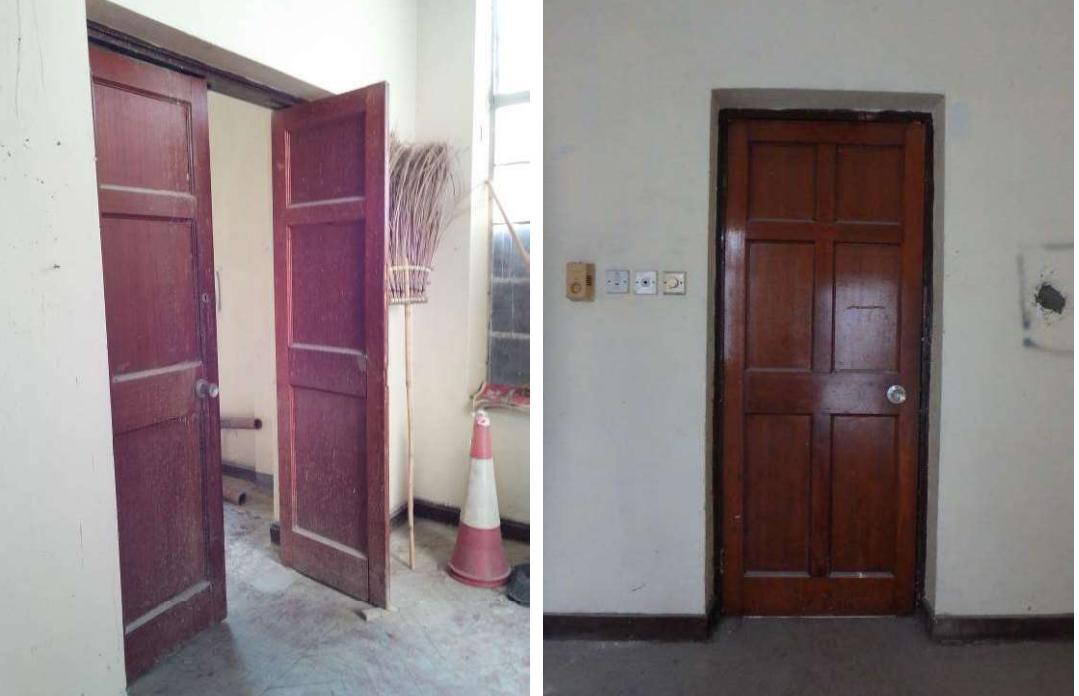
項目	建築特色
3.10	<p><u>室內木門</u> 所有現有的木鑲板門及門框。</p>

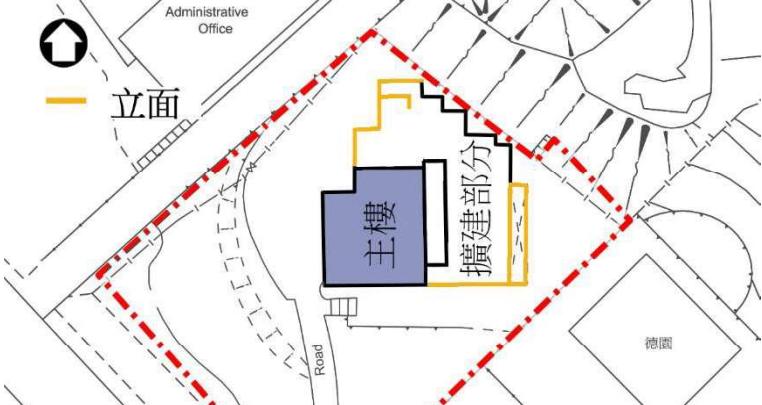
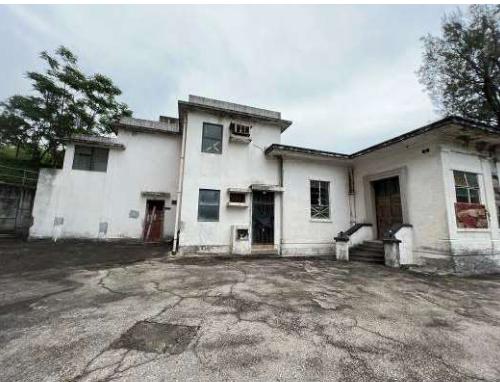
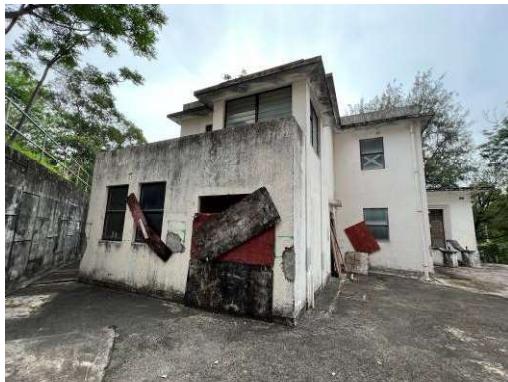
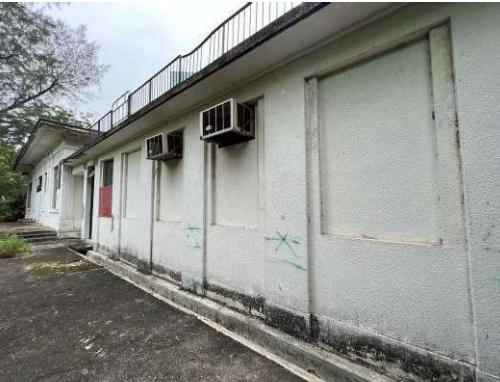
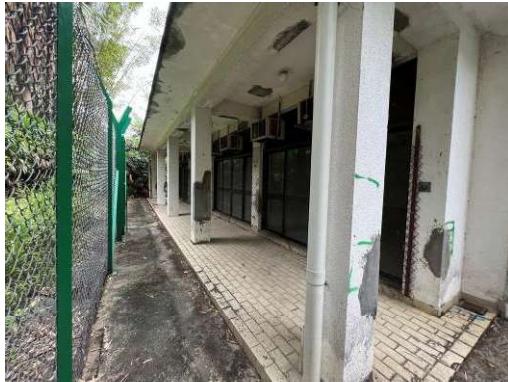
項目	建築特色
4.1	<p><u>建築物外立面</u> 下圖所示與主樓相連的南面和西面兩個立面、梯間和東面立面外廊部分的立面，包括所有護牆、屋簷、窗口及門口上方的鰭狀遮擋、門口的花崗石門檻，以及外廊的壁柱、外露結構和天花。</p>

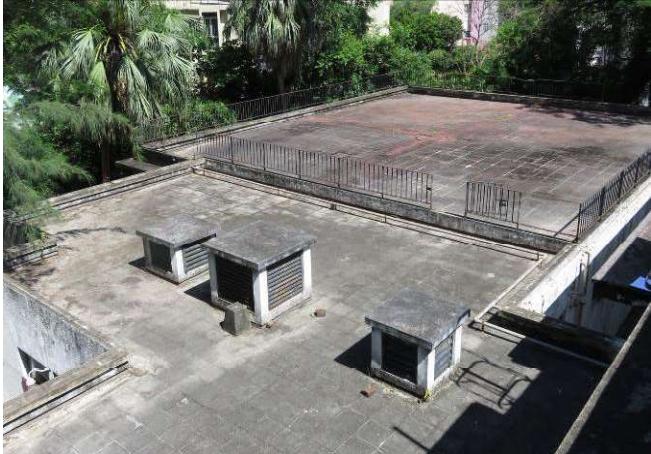
項目	建築特色
4.2	<p><u>平屋頂</u> 所有平屋頂。</p>

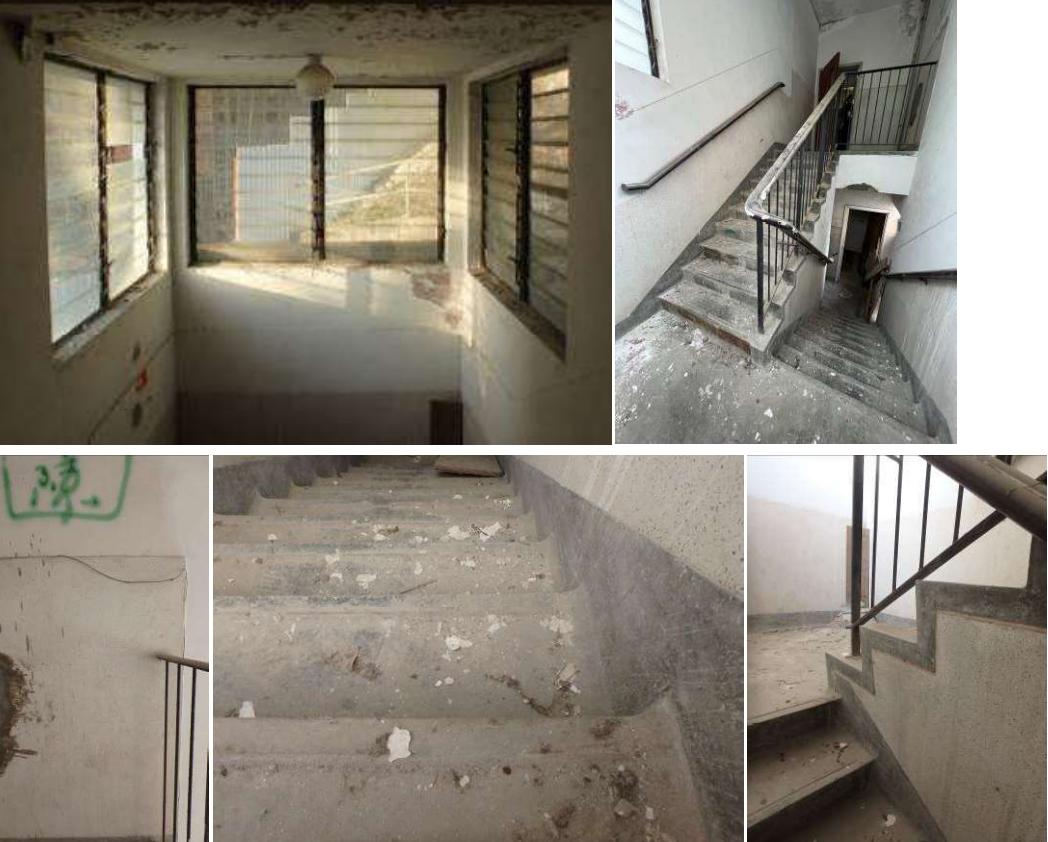
項目	建築特色
5.1	<p><u>梯間及樓梯</u></p> <p>擴建部分內的梯間及樓梯，包括窗口、金屬框玻璃百葉窗，以及樓梯、地台和牆裙上的水磨石飾面。</p>

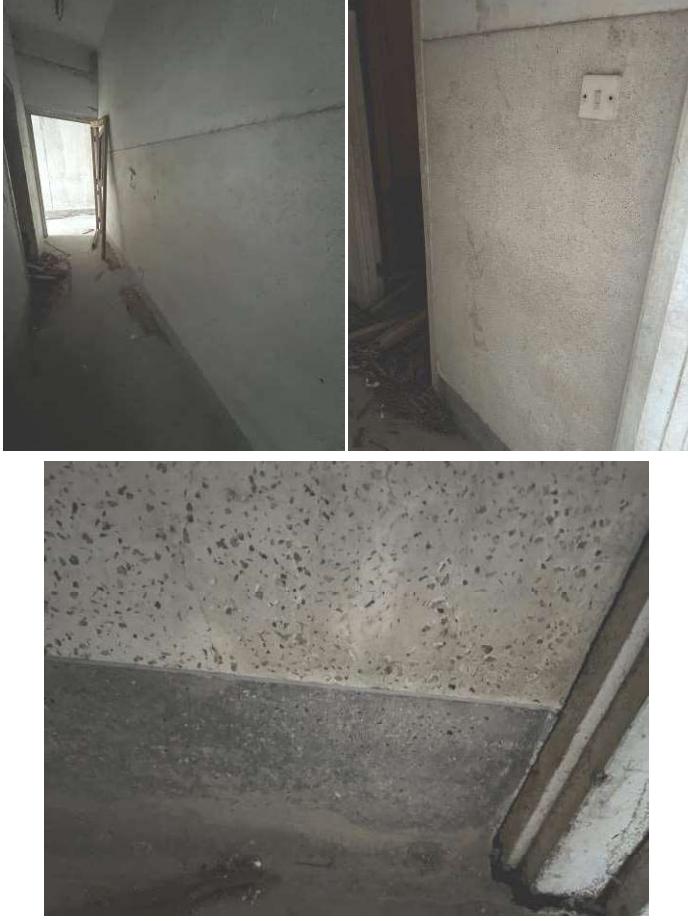
項目	建築特色
5.2	<p><u>走廊水磨石飾面</u> 擴建部分內的牆裙及走廊至梯間牆腳線上的水磨石飾面。</p>

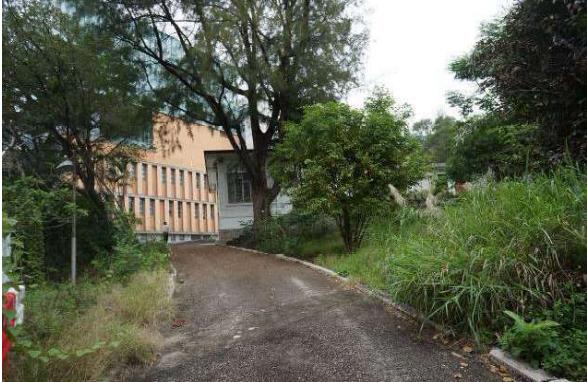
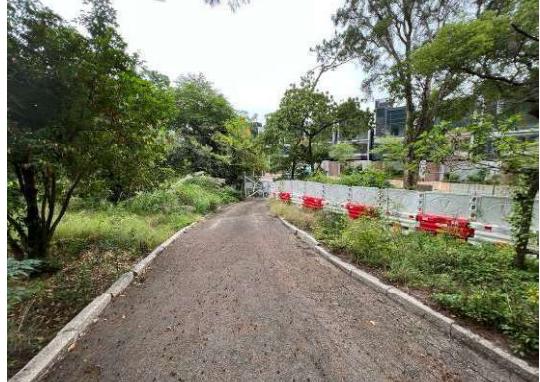
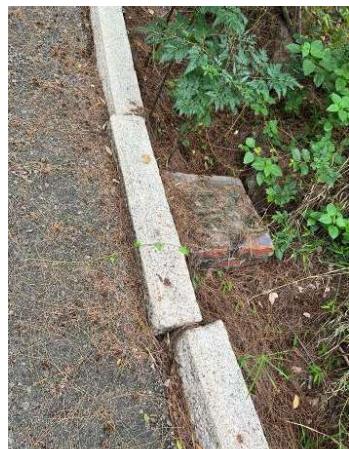
項目	建築特色	規定處理方法
1.1	布局／四周範圍	<ul style="list-style-type: none">a. 整體的地形、現有的花木以及通往主樓入口處的行車道，均應大致保持原狀。b. 除非這些花木對公眾及主樓構成危險，否則不得移除。c. 應原位保存沿著行車道的花崗石路緣。d. 視乎需要修復該處的排水設施、行車道路面及路緣。

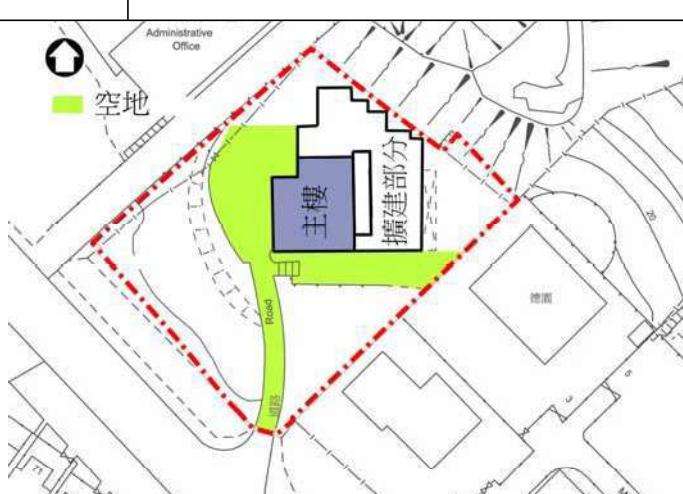
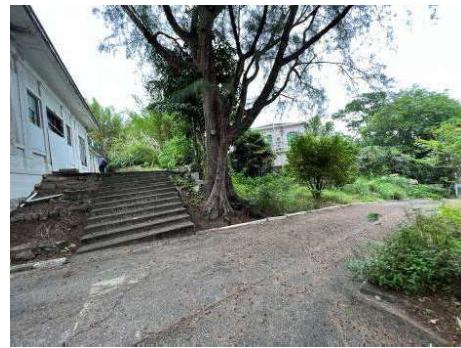
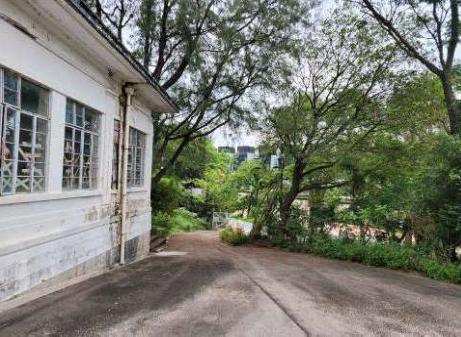
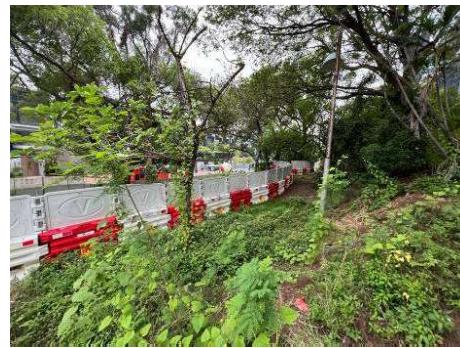
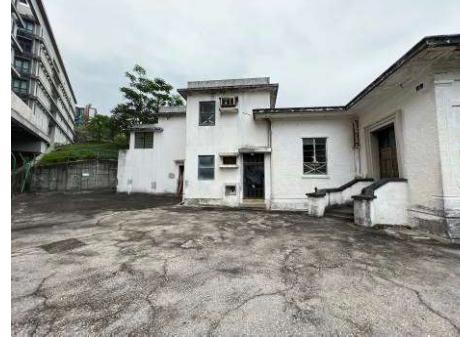
項目	建築特色	規定處理方法
1.2	主樓外面空地	<p>a. 主樓東、西及南立面的景觀十分重要，應予保留，讓公眾欣賞該建築物時不受遮擋。</p> <p>b. 為減少對建築物立面外觀的影響，毗鄰主樓的空地(見下圖)應予保留。</p> <p>c. 為符合法定要求而在上述空地以外位置加建建築物或構築物作主樓的附屬用途(擬議工程)，是可獲考慮，惟須獲古蹟辦批准。</p> <p>d. 擬議工程應為獨立建築物，施工地點須盡量遠離主樓。</p> <p>e. 擬議工程不應對主樓的結構造成不良影響。</p> <p>f. 擬議工程的設計應與主樓兼容，亦易於區分。</p> <p>g. 擬議工程的最終高度須低於主樓的屋簷水平。</p>

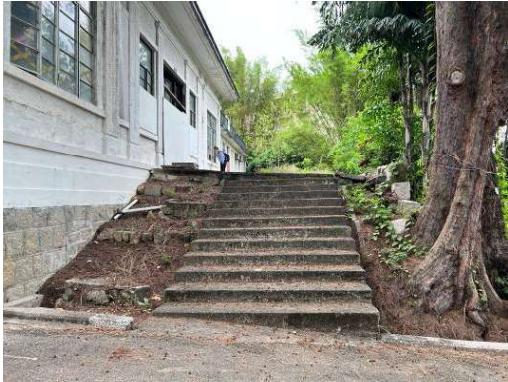
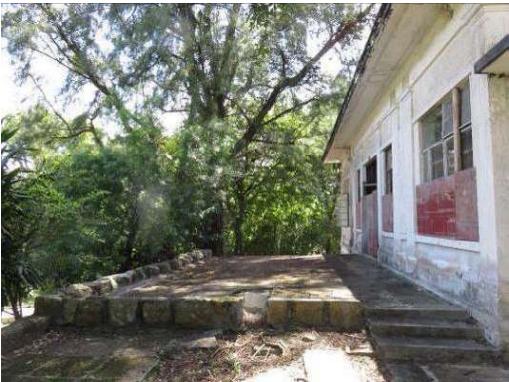
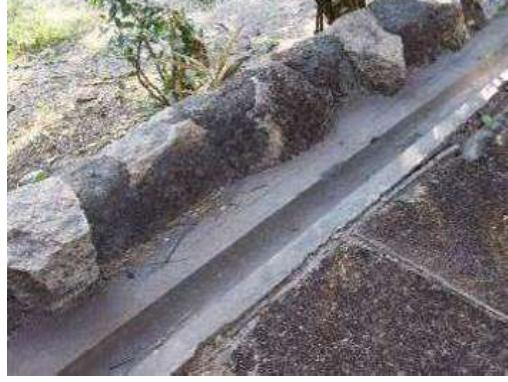
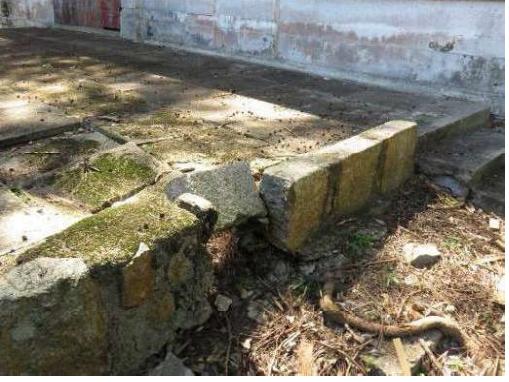
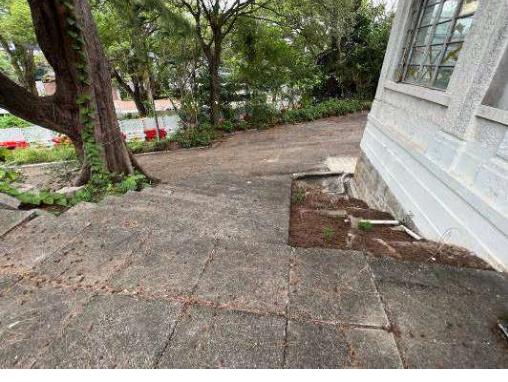
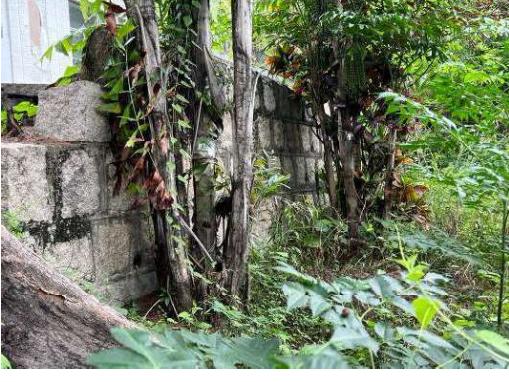
項目	建築特色	規定處理方法
1.3	平台	<p>a. 南面現存的平台，包括通往行車道和相連平台的梯級、石米飾面（地磚及梯級面）、矮毛石路緣及石砌面牆應大致保持原狀。</p> <p>b. 檢查平台的排水設計，確保雨水不影響主樓。</p> <p>c. 視乎需要，參照現有式樣修葺損壞的梯級，重新鋪砌不平的地台和花崗石路緣，替換損壞的石米飾面地磚及鬆脫的石塊。</p> <p>d. 檢查平台下方的擋土牆是否穩固，如須進行改善工程，應保留石砌面並參照現有式樣還原。</p> <p>e. 參照現有式樣，還原受擋土牆改善工程影響的石米飾面和路緣。</p>

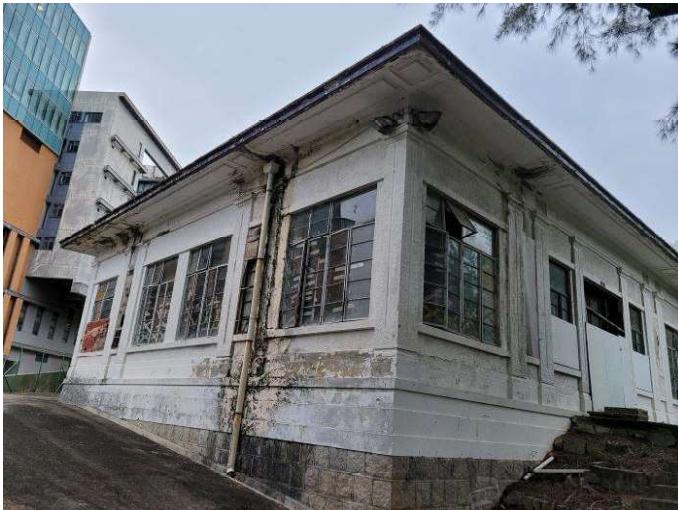
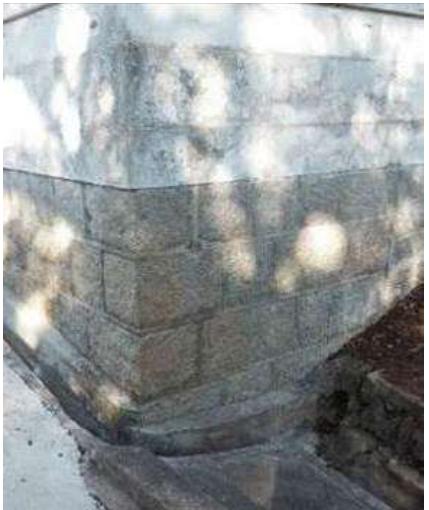
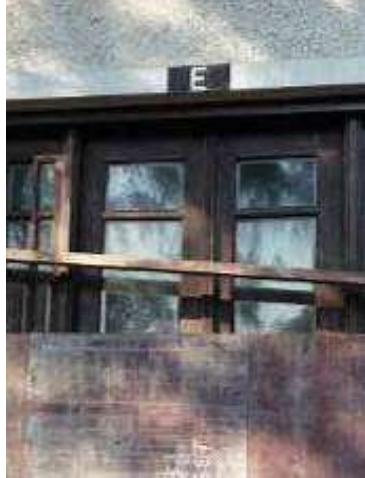
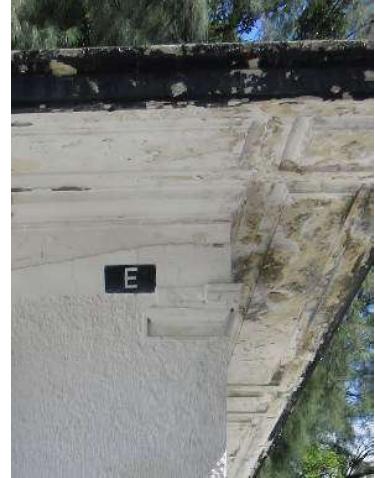
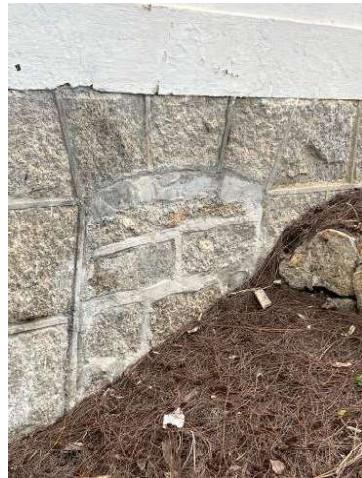
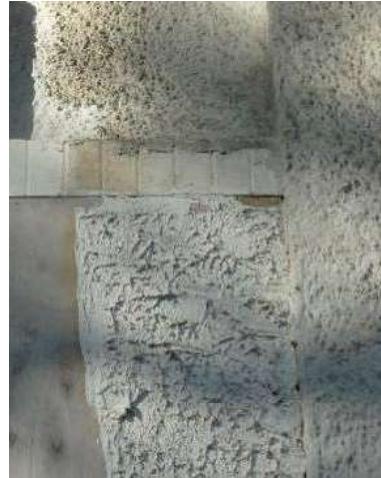
項目	建築特色	規定處理方法
2.1	建築物外立面	<ul style="list-style-type: none"> a. 應原位保存建築物所有外立面，包括花崗石基座；批盪面(光滑面及粗灰泥面)；磚砌門楣、窗楣、門檻、窗台及磚砌裝飾帶。 b. 在平台木門磚楣及近主入口處屋簷下髹上的黑底白色「E」字，應原位保存，施工期間必須保護周全。 c. 不得在建築物的立面加設新構築物、空調設備、遮篷、鰭狀遮擋等。 d. 不得改動立面現有的開口或增加開口。 e. 為外立面、鋼窗、入口處木門及平台木門連側窗的原本顏色進行研究及塗料分析，並向古蹟辦匯報研究結果及提交建築物的配色方案，以供審批。 f. 使用獲批准的去除塗料方法，除去批盪及磚塊上的塗料。 g. 研究在南面立面花崗石基座上一個已圍封的窗戶的改動及原本的功能，向古蹟辦匯報研究結果，並視乎需要提出改善工程的建議。 h. 視乎需要修葺損壞的批盪，參照旁邊批盪的式樣重修飾面。 i. 使用獲批准的可還原塗料及顏色重髹所有批盪。 j. 所有磚砌門楣、窗楣、門檻、窗台及磚砌裝飾帶一律保持清水飾面。視乎需要修葺損壞的磚塊及磚縫。 k. 所有花崗石構件一律保持清水飾面。清除所有花崗石上的青苔及污漬，視乎需要修復石縫。

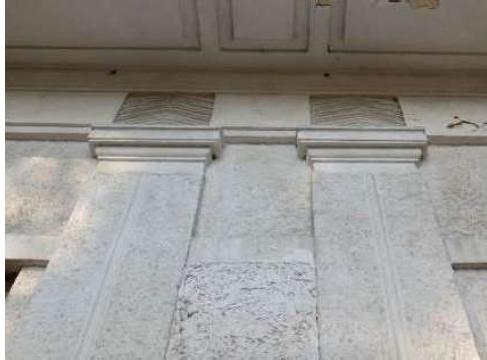
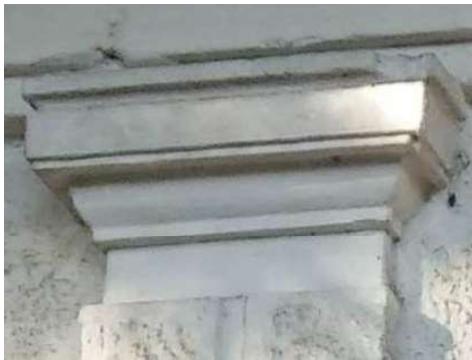
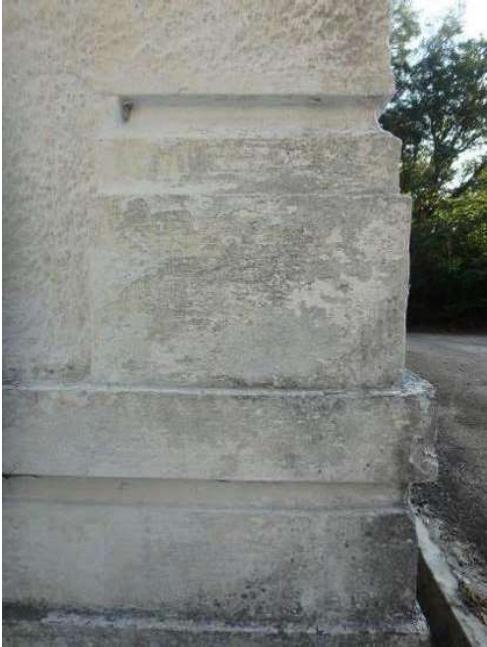
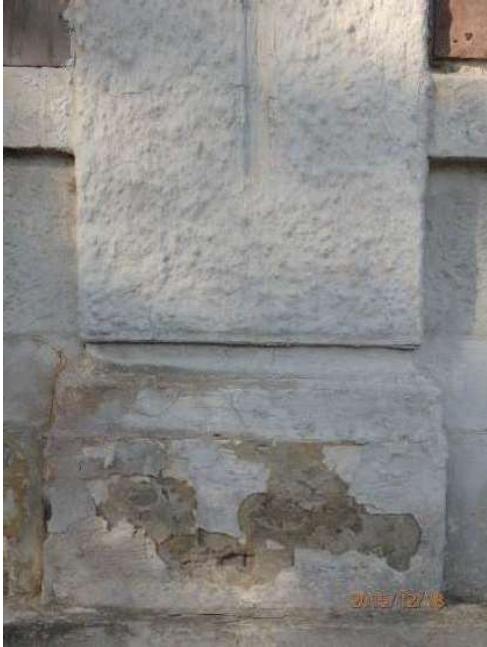
項目	建築特色	規定處理方法
2.2	外部壁柱	<p>a. 應原位保存外立面上所有壁柱連柱座、柱身、柱頭以及柱身的垂直坑紋。</p> <p>b. 使用獲批准的方法和物料除去舊塗料，然後使用獲批准的可還原塗料及顏色重新髹漆。</p> <p>c. 視乎需要修葺損壞的批盪，參照旁邊批盪的式樣重修飾面。</p>

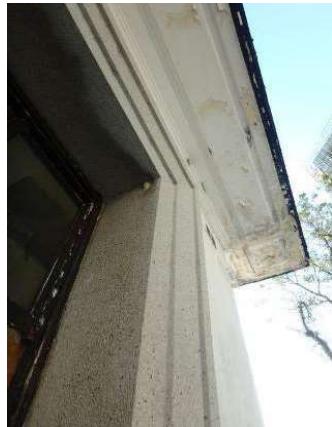
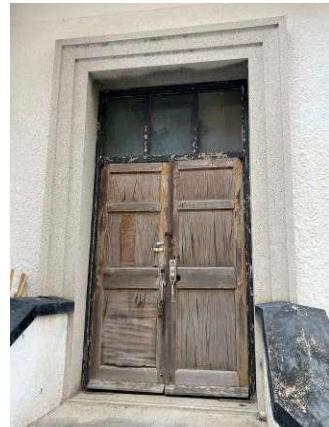
項目	建築特色	規定處理方法
2.5	入口處的門圍及門檻	<p>a. 應原位保存入口處以上海批盪作飾面的門圍及花崗石門檻。</p> <p>b. 清洗主入口大門門圍及花崗石門檻的上海批盪飾面。</p> <p>c. 視乎需要，參照旁邊批盪的式樣修葺損壞的批盪，並重修飾面。</p>

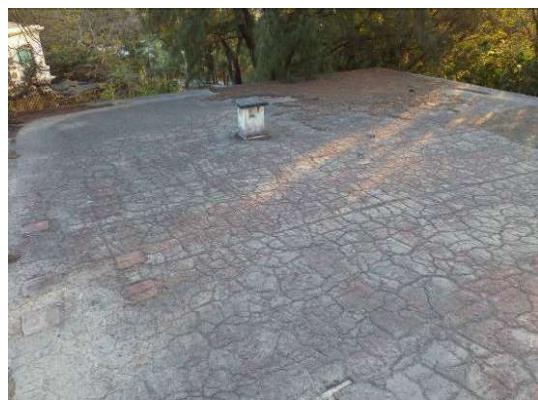
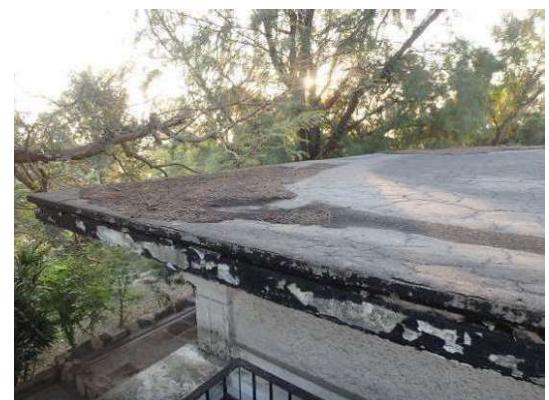
項目	建築特色	規定處理方法
2.6	平屋頂	<p>a. 平屋頂連凸出的屋簷均應大致保持原狀。</p> <p>b. 屋頂不得加建樓層。</p> <p>c. 屋頂不得加裝屋宇設備、風喉、管道等。</p> <p>d. 修葺損壞的天面及防水層，並視乎需要更換損壞的天面物料。</p> <p>e. 在修葺屋頂前，視乎需要修葺損壞的屋頂樓板。</p> <p>f. 視乎需要更換損壞的簷口板，然後重新髹漆。</p> <p>g. 盡量避免在主樓屋頂安裝防護欄。</p>

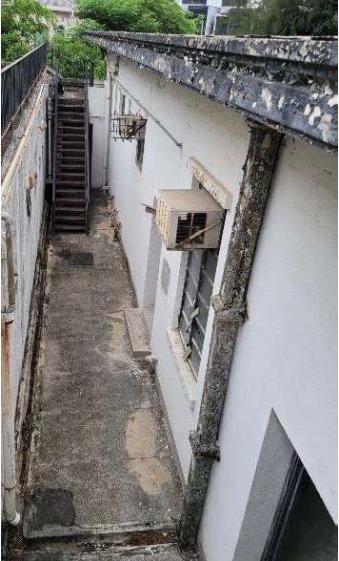
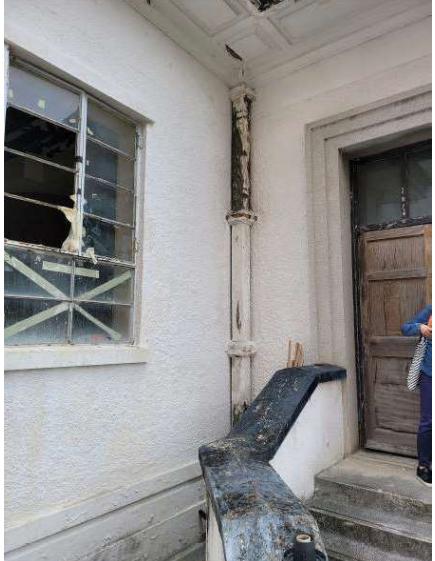
項目	建築特色	規定處理方法
2.8	原有的雨水管（方形混凝土雨水），以及屋頂、污水及廢水排水系統	<p>a. 應原位保存兩條方形混凝土雨水管連雨水斗，並視乎需要進行修葺，以保留外觀。查證水管的功能，並在可行情況下修復其功能。</p> <p>b. 視乎需要更換其他所有現存的屋頂、污水、廢水排水系統及相關部件。惟採用的設計及顏色必須與主樓兼容，並獲古蹟辦批准。</p> <p>c. 屋頂新設的排水系統設計及布局須獲古蹟辦批准。設計須避免在南和西兩個立面裝設出水口及雨水管。所有管道不可阻擋屋簷、簷壁及壁柱上的裝飾。</p> <p>d. 拆除多餘的管道後，參照現有式樣修復受影響的屋頂及牆身表面。</p>

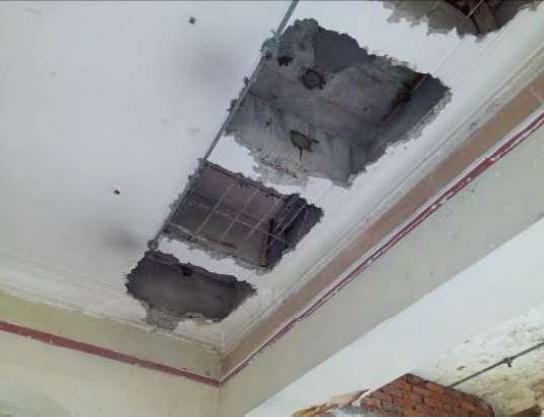
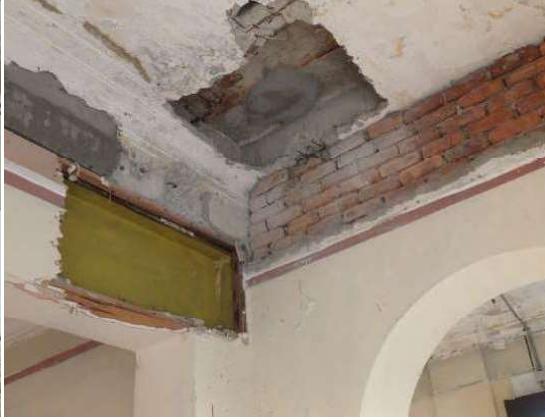
項目	建築特色	規定處理方法
3.2	建築結構	<p>a. 所有原有的結構構件(包括支柱、橫樑、結構牆、拱形開口及屋頂原有的隱蔽式肋樑結構樓板等)應大致保持原狀。</p> <p>b. 不得在結構上鑿開新孔或加設開口。</p> <p>c. 在結構任何部分進行加固或重建工程以符合法定要求，是獲可考慮，惟須先徵詢註冊結構工程師的意見，並獲古蹟辦批准。</p> <p>d. 在保存範圍內後來加建的鋼樑，與原有混凝土結構不協調，因此應予拆除。翻查歷史記錄，並按原有的設計及位置，還原有關支柱及拱門。</p> <p>e. 參照現有物料及設計，把原有隱蔽式肋樑結構樓板的所有鑿開和損壞的地方還原。在可行情況下盡量拆除留在原有隱蔽式肋樑結構樓板內的木模板。</p> <p>f. 視乎需要，修葺所有剝落的混凝土以及其他損壞的地方。</p>

獲選機構須進行全面的結構評估，包括詳細的現場勘測及進行適當的現場及實驗室檢測，核實和確認結構組件的資料和狀況及樓宇結構能力，以設計所提議的活化用途。須特別注意鋼筋混凝土肋形樓板的底板，因這些底板可能阻礙檢測空隙內有否結構上的缺陷和有關修復工作。

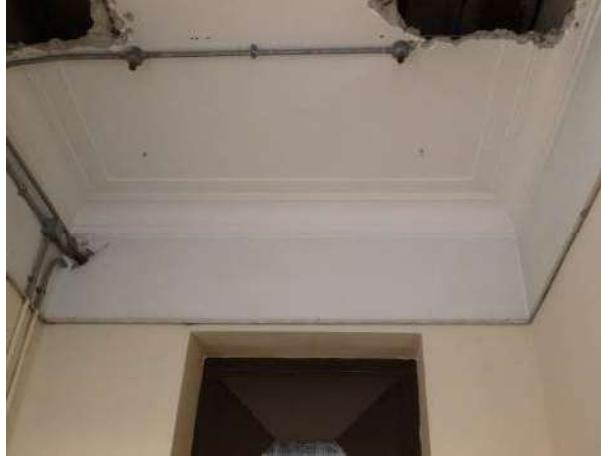
項目	建築特色	規定處理方法
3.3	天花飾線	<p>a. 所有天花飾線(包括冠頂飾線)應原位保存。</p> <p>b. 所有天花飾線應保持外露，讓公眾觀賞。安裝垂吊式假天花，是可獲考慮，惟設計應可讓天花的飾線細節全部外露，不受影響，並須獲古蹟辦批准。</p> <p>c. 參照現有式樣，視乎需要修葺損壞的天花飾線。</p>

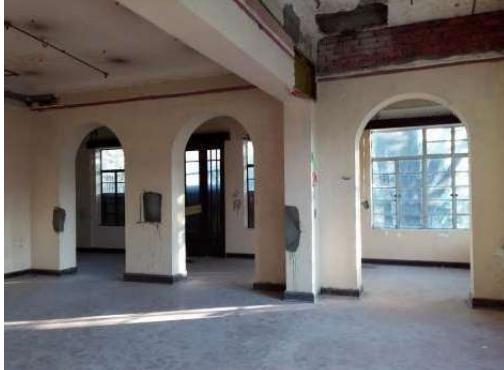
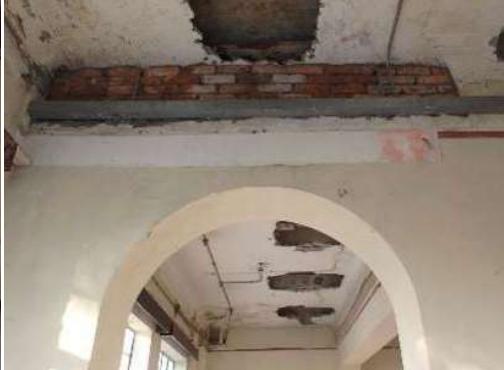
項目	建築特色	規定處理方法
3.4	拱門	<p>a. 所有原有的拱門應大致保持原狀。</p> <p>b. 應拆除後來加建的拱門(如右下方照片所示)。拆除拱門後，修復受影響的牆身、天花、天花飾線及飾面。</p>

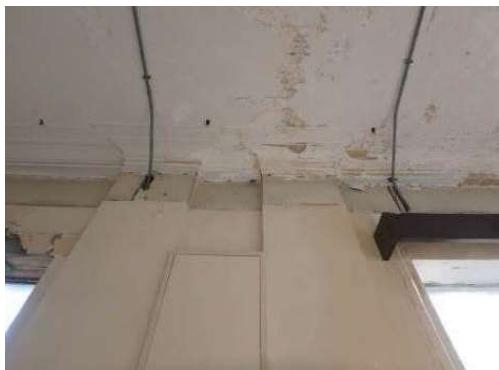
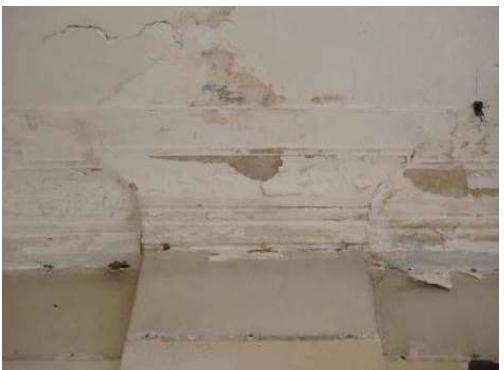
項目	建築特色	規定處理方法
3.5	內部壁柱	<p>a. 在保存範圍內所有壁柱應原位保存。</p> <p>b. 視乎需要修復損壞的飾面。</p>

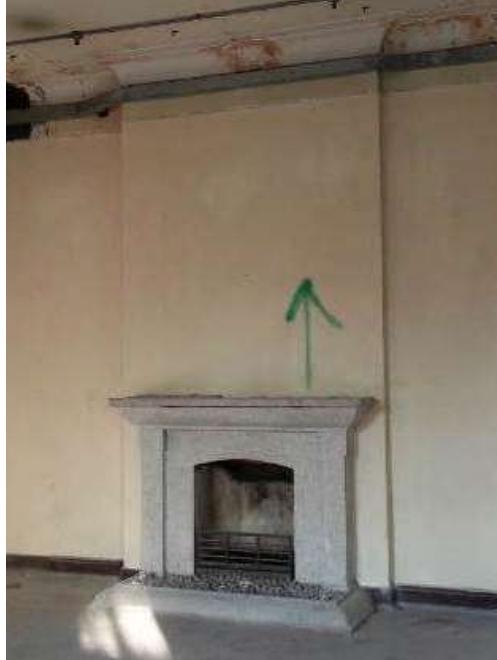
項目	建築特色	規定處理方法
3.6	壁爐及煙囪管道	<p>a. 原位保存壁爐及煙囪管道。</p> <p>b. 雖然現存的壁爐未必為原有設計，但除非可提供壁爐原有設計的證據及考慮修復壁爐，否則應原位保存花崗石壁爐框、壁柱、壁爐架、爐牀及鐵爐柵。</p>

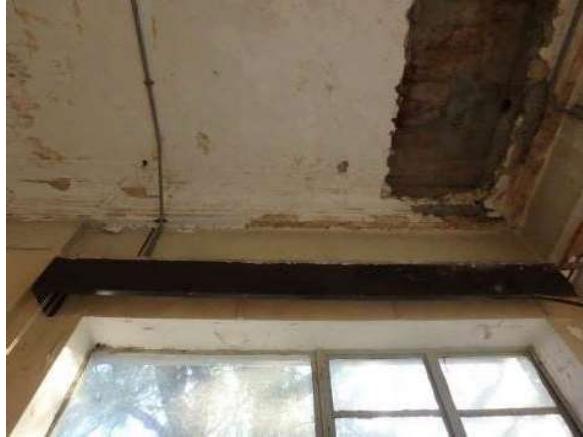
項目	建築特色	規定處理方法
3.7	木窗簾盒	<p>a. 應原位保存在保存範圍內的木窗簾盒。</p> <p>b. 盡量修葺損壞的窗簾盒。更換窗簾盒時，只可換上狀況良好的舊木。參照現有式樣為現存和新換的窗簾盒重修飾面。</p>

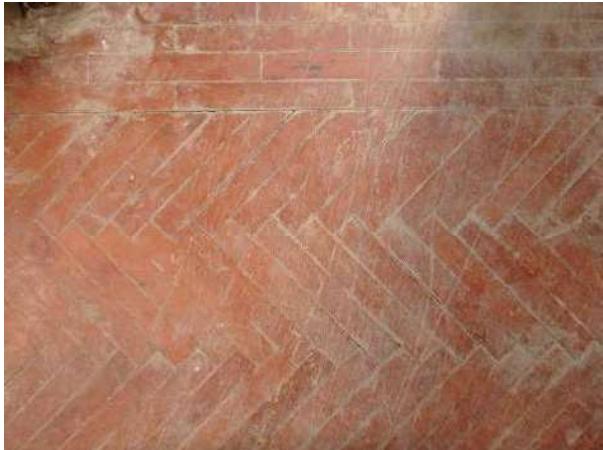
項目	建築特色	規定處理方法
3.8	人字紋木地板	<p>a. 應原位保存在保存範圍內的木地板。</p> <p>b. 視乎需要修葺損壞或殘舊的地板。地板須塗刷木材防腐劑，並須參照現有式樣為現存和新換的木地板重修飾面。</p>

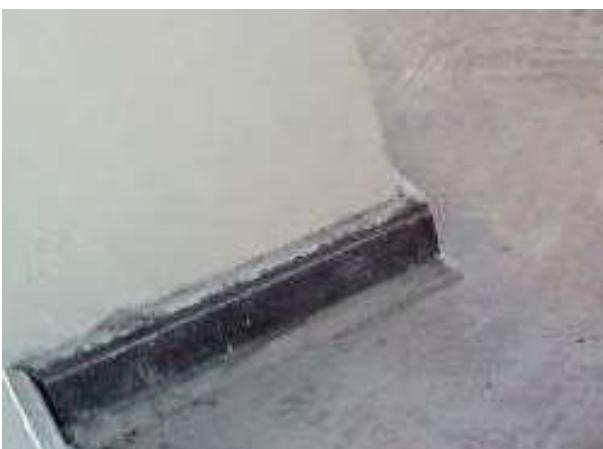
項目	建築特色	規定處理方法
3.9	木腳線	<p>a. 應原位保存在保存範圍內的木腳線。</p> <p>b. 視乎需要修葺損壞或殘舊的木腳線。木腳線須塗刷木材防腐劑，並須參照現有式樣為現存和新換的木腳線重修飾面。</p>

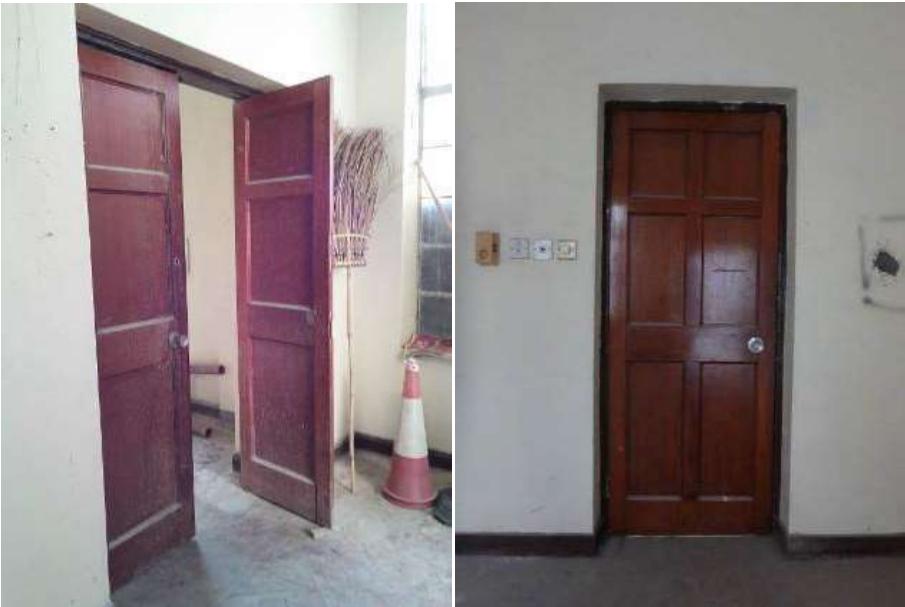
項目	建築特色	規定處理方法
3.10	室內木門	<p>a. 應盡量保留及修葺現存木鑲板門及門框，為其塗刷木材防腐劑及重修飾面。</p> <p>b. 如改變室內間隔，須小心拆下原有的鑲板門，其後重新裝在新開的門口。</p> <p>c. 新增和新換的木門的設計、飾面及金屬部件，均須獲古蹟辦批准。</p>

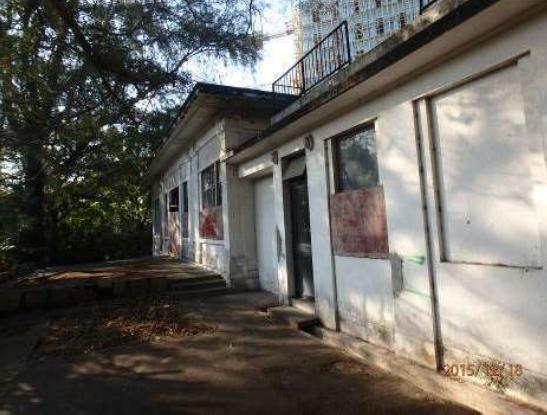
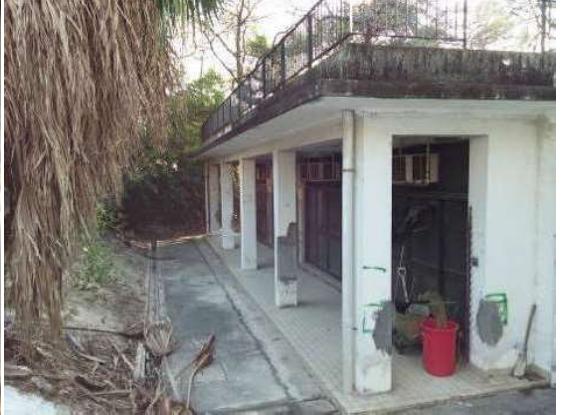
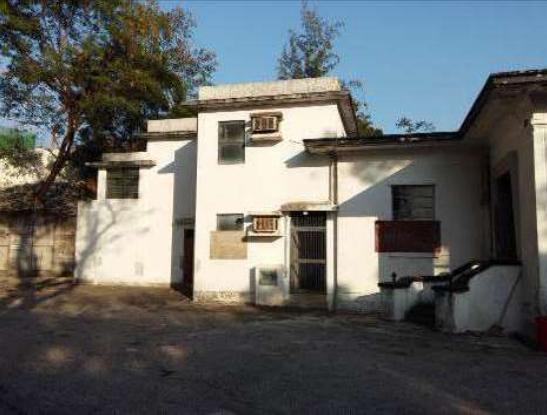
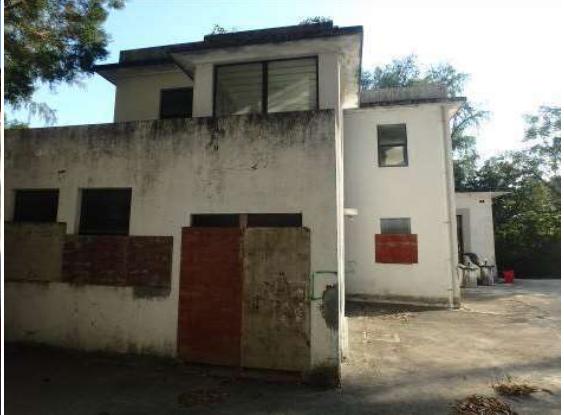
項目	建築特色	規定處理方法
4.1	建築設計	<p>a. 不反對在擴建部分進行改裝和加建工程，惟必須符合下述條件：</p> <ol style="list-style-type: none"> 1. 加建樓層或構築物不得超過現有護牆高度； 2. 安裝在屋頂的屋宇設備、風喉、管道等，不得影響擴建部分西、南兩個立面的外觀； 3. 須原位存第4.2項所指的立面。新加設的構築物不得突出這些立面；以及 4. 室內改裝工程不得損壞第5.1項所指的梯間及樓梯的外觀。 <p>b. 在擴建部分進行的改裝和加建工程，均不應對主樓的結構造成不良影響，這些工程須與主樓兼容，亦易於區分。</p> <p>c. 如改裝和加建工程影響主樓的表面，必須參照現有式樣修葺和重修飾面，以令古蹟辦滿意為合。</p> <p>d. 擴建部分重修飾面所用顏色，須與主樓兼容。</p>
