活化歷史建築伙伴計劃

第 48 區前哥頓軍營

Watervale House

資料冊

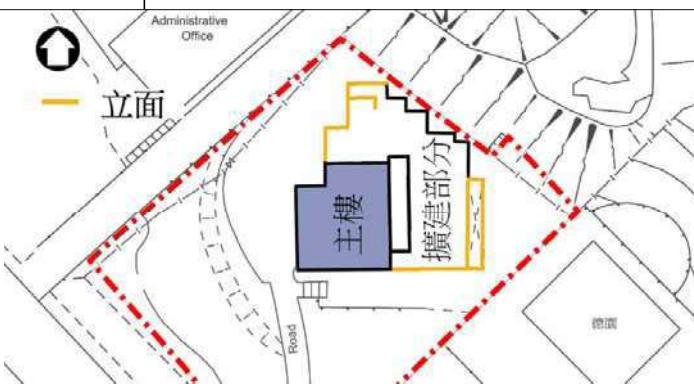
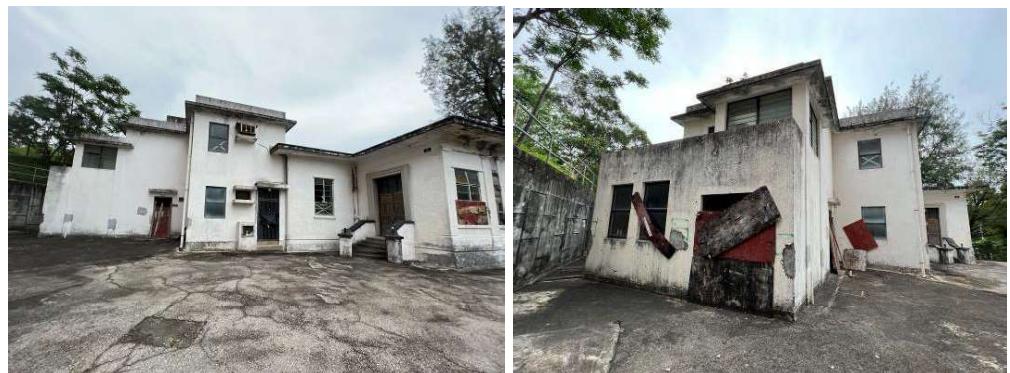
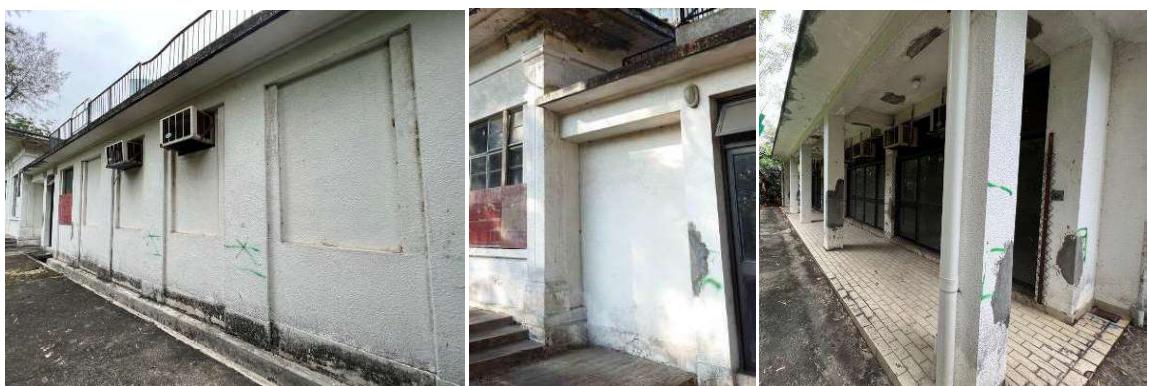
項目	建築特色	規定處理方法
4.2	建築物的立面	<p>a. 下圖所示與主樓相連的西面和南兩個立面、梯間和東面外廊部分的立面，包括所有護牆、屋簷、窗口及門口上方的鰭狀遮擋、門口的花崗石門檻，以及外廊的壁柱、外露結構和天花，均應原位保存。</p> <p>b. 拆除現有冷氣機。不得在上述立面上裝設任何空調設備、遮蓬、鰭狀遮擋等。</p> <p>c. 復原擴建部分與主樓之間的南面走廊上原有的開口，並裝上透明的物料。</p> <p>d. 改動上述立面現存的開口或增加開口，須獲古蹟辦批准。</p> <p>e. 視乎需要修葺剝落的混凝土及批盪。</p> <p>f. 如重鋪東面外廊的鋪面，新鋪面的設計和物料須提交古蹟辦審批。</p>

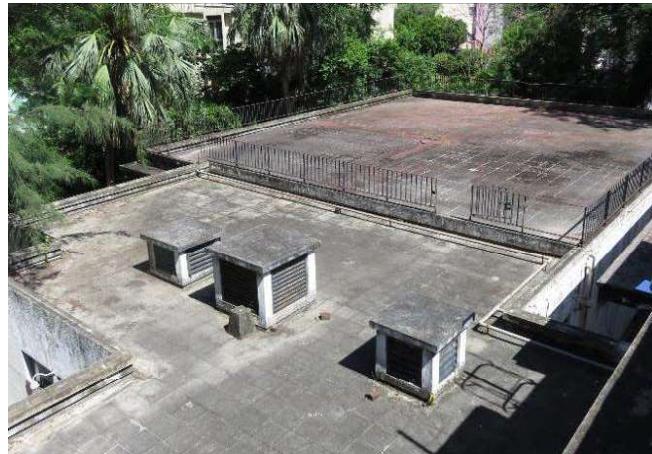
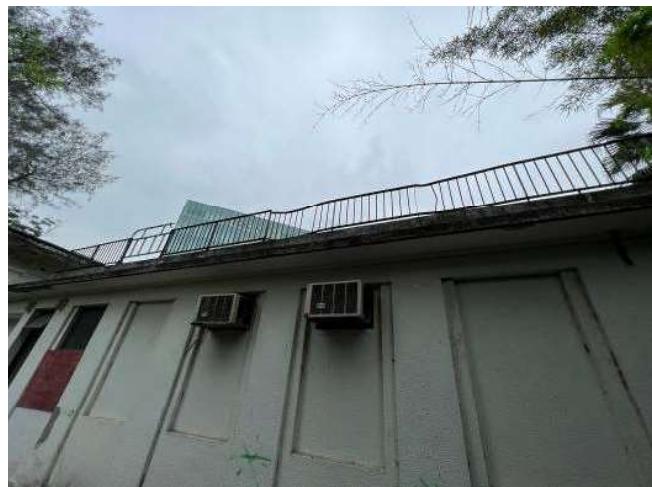
項目	建築特色	規定處理方法
4.3	平屋頂	<p>a. 盡量保留所有平屋頂。</p> <p>b. 視乎需要修葺損壞的天面防水層，以及更換損壞的水泥地磚。</p> <p>c. 安裝屋宇設備、風喉、管道等，以符合新用途的現行規定，是可獲考慮，惟安裝高度應盡量低，從行車道和現有的景觀區不應看到該等裝置。</p> <p>d. 安裝防護欄以符合新用途的現行法定要求，是可獲考慮。如保留擴展部分南立面的防護欄，防護欄須從南立面往後移。護欄的高度須盡量低，而該護欄不應從行車道和現有的景觀區看到。</p>

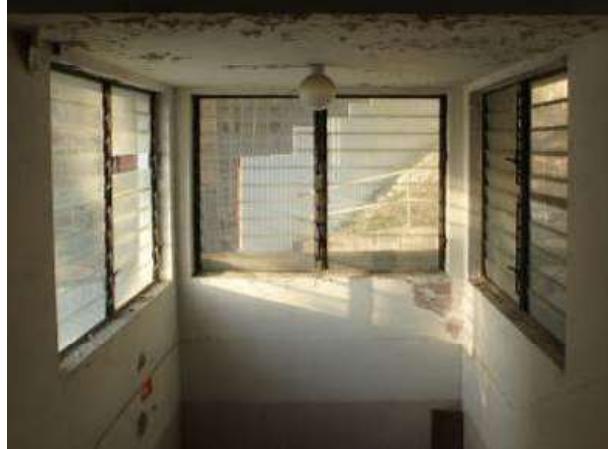
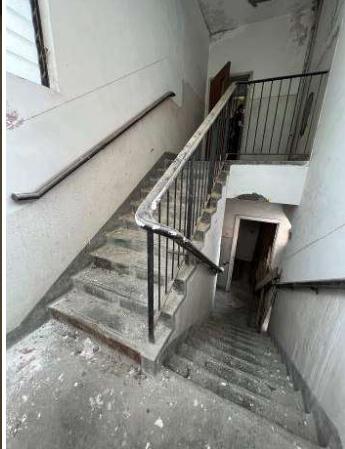
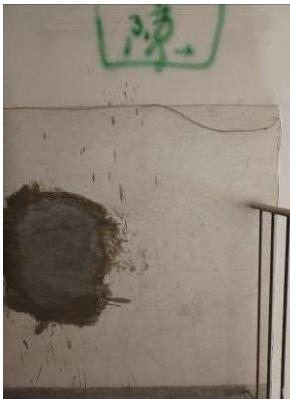
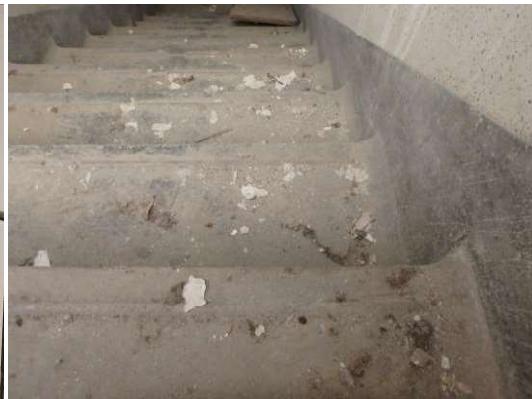
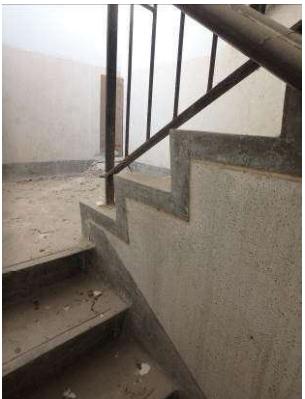
項目	建築特色	規定處理方法
5.1	梯間及樓梯	<p>a. 應原位保存擴建部分內的梯間及樓梯，包括窗口、金屬框玻璃百葉窗，以及樓梯、地台和牆裙上的水磨石飾面。</p> <p>b. 不反對為符合法定要求而更換樓梯扶手及扶欄。</p> <p>c. 為符合法定要求而對現有窗口進行改善工程，是可獲考慮，惟必須以可還原方式進行，把對建築構件影響減至最小，方便日後維修，並須獲古蹟辦批准。</p> <p>d. 視乎需要修葺剝落的混凝土、損壞的水磨石飾面以及其他損壞的地方。</p>

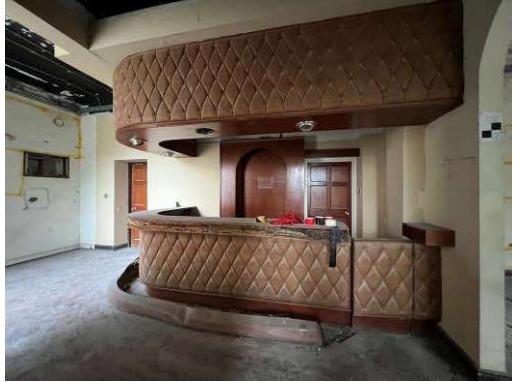
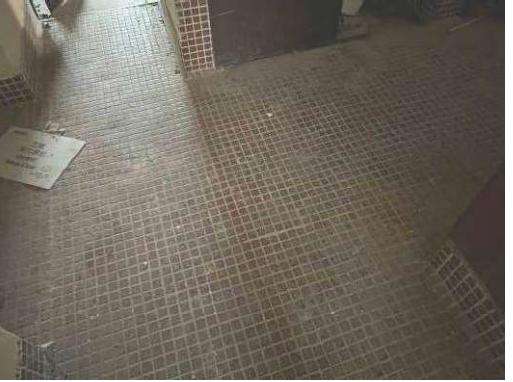
項目	建築特色	建議處理方法
1.1	吧台及馬賽克磚飾面	<p>a. 吧台反映英軍官會所時期的使用情況，在可行情況下盡量保留及修葺。</p> <p>b. 在可行情況下盡量保留及修葺在吧台範圍的馬賽克地磚及腳線飾面。</p>

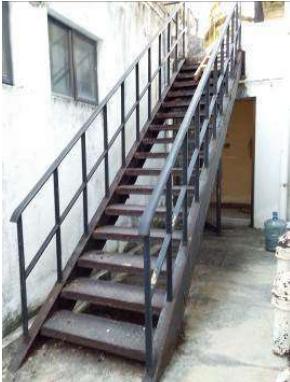
項目	建築特色	建議處理方法
2.1	通往平屋頂的金屬樓梯及欄杆	a. 拆走現有的金屬樓梯。另行設計通道通往屋頂，安裝在不顯眼處。

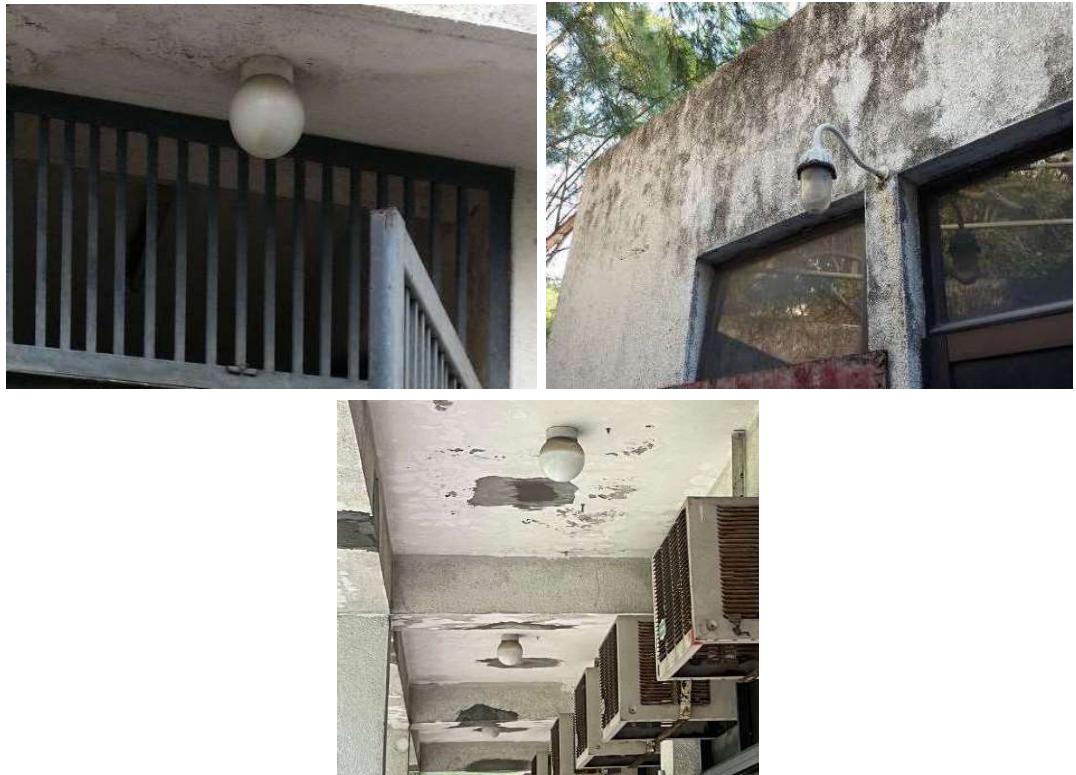
項目	建築特色	建議處理方法
2.2	裝飾燈具	a. 在可行情況下盡量保留及重用現有的裝飾燈具。

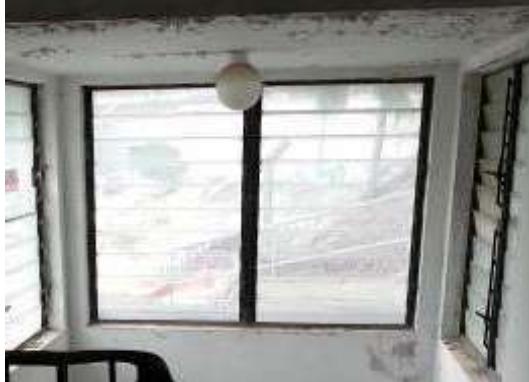
項目	建築特色	建議處理方法
3.1	裝飾燈具	a. 在可行情況下盡量保留及重用梯間現有的裝飾燈具。

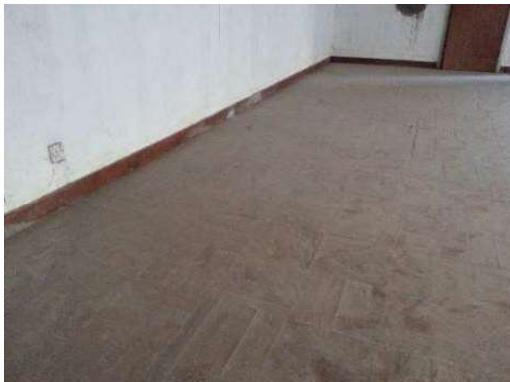
項目	建築特色	建議處理方法
3.2	木地板及腳線	a. 在可行情況下盡量保留及重用現有的木地板及腳線。

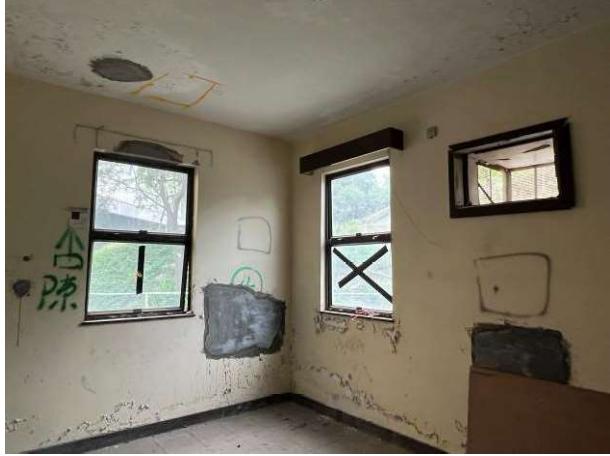
項目	建築特色	建議處理方法
3.3	木窗簾盒	a. 在可行情況下盡量保留及重用現有的木窗簾盒。

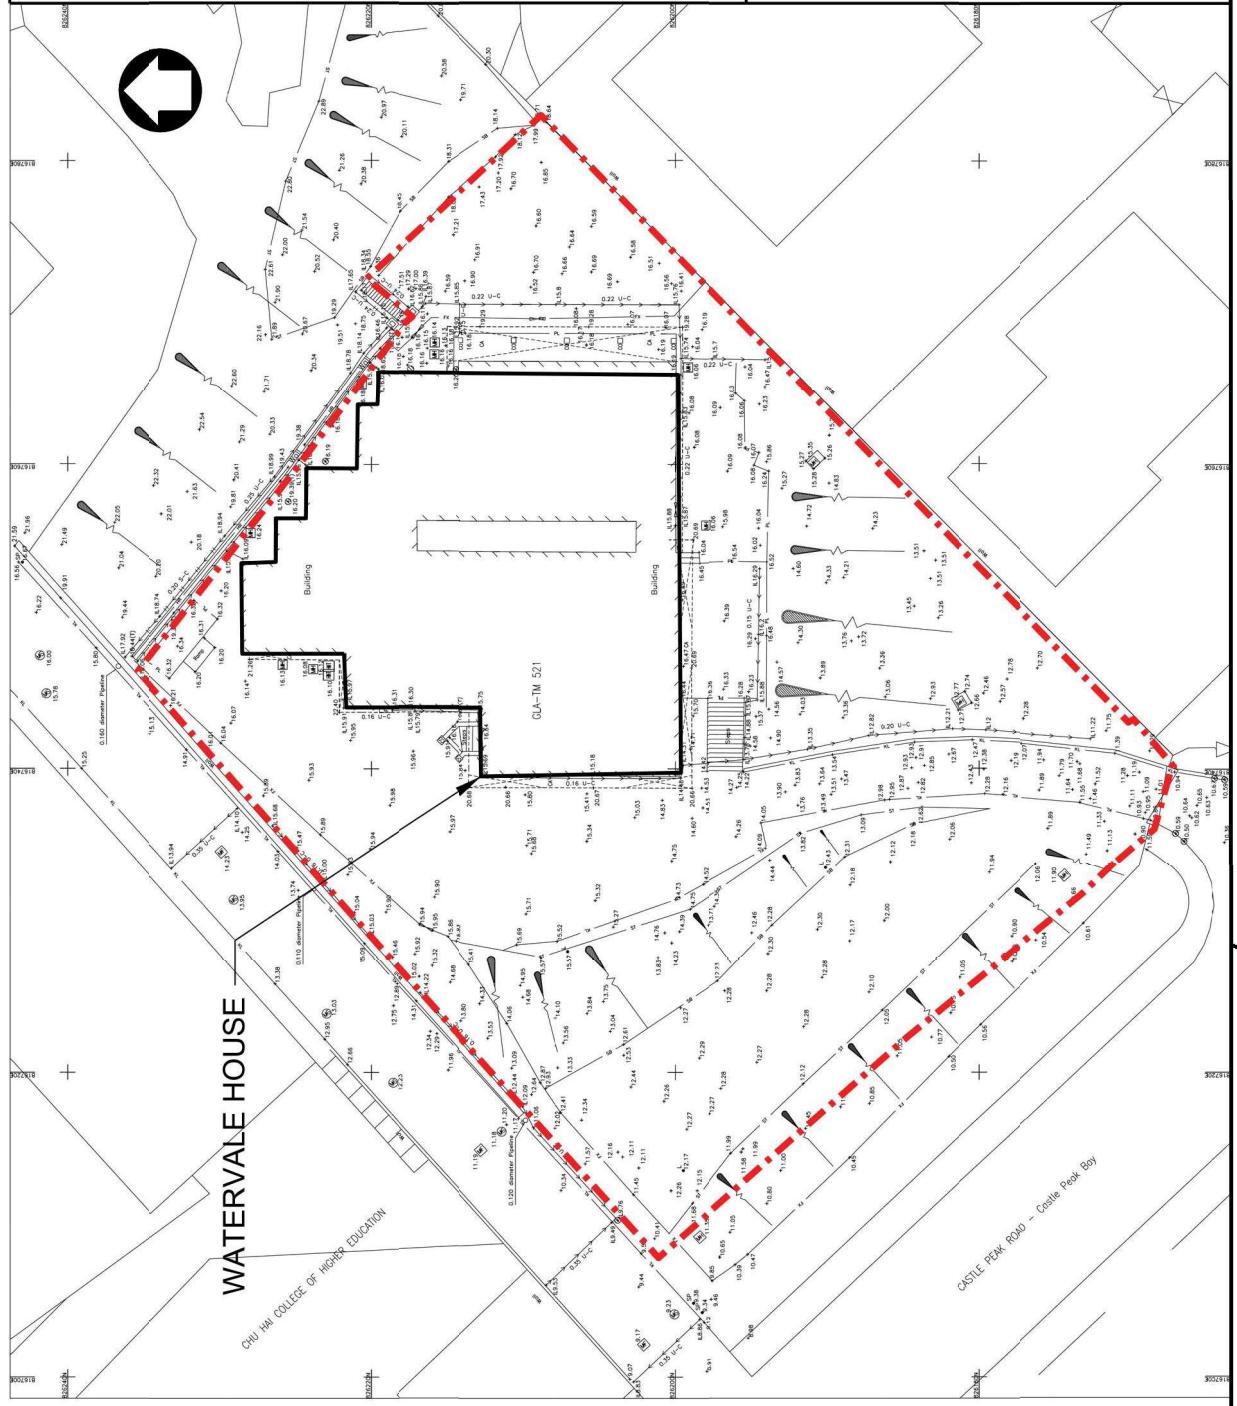
附錄 XIII (A)
地形測量圖

項目名稱:
新界屯門青山公路青山灣段第48區
前哥頓軍營 "WATERVALE HOUSE"

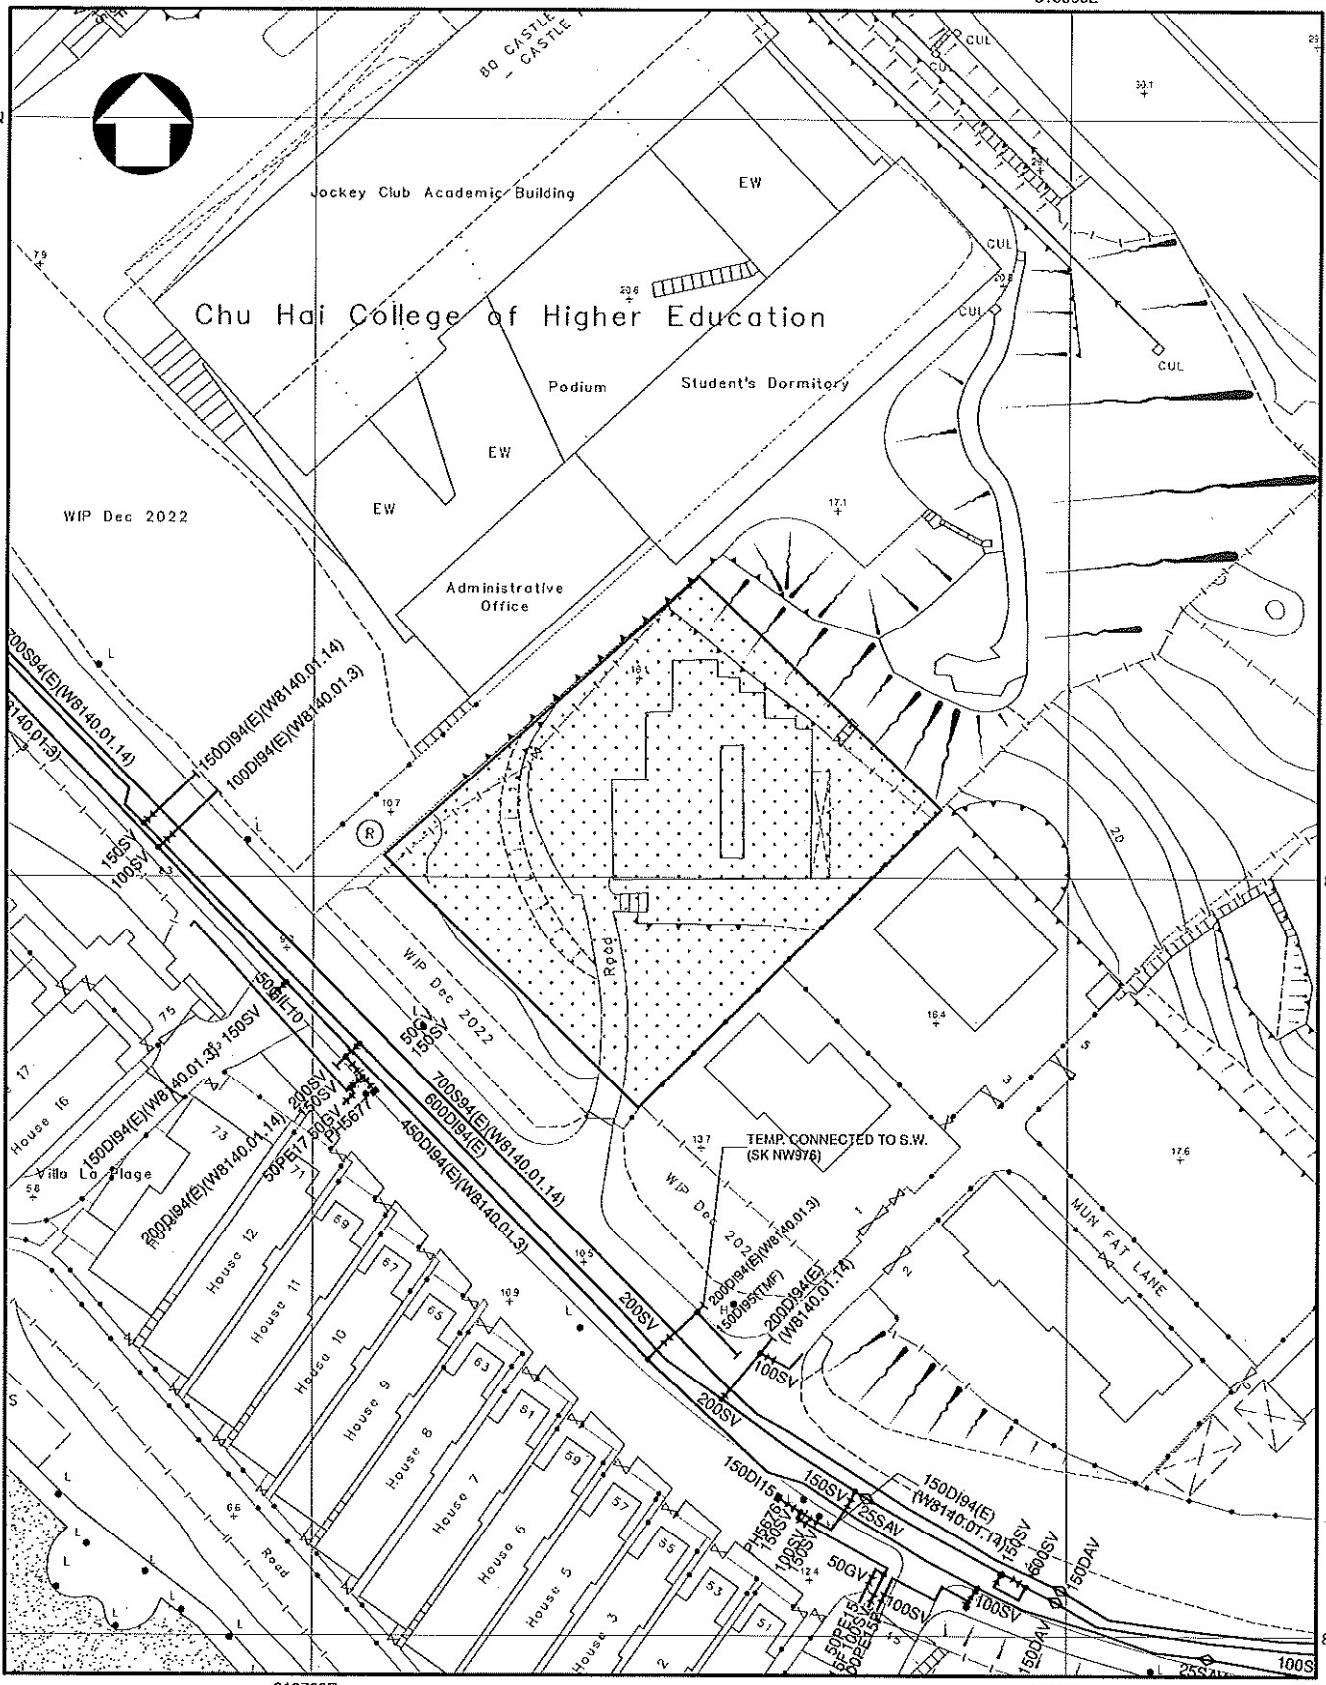
水務署
Water Supplies Department

- NOTES:
1. ALL DIMENSIONS ARE IN MILLIMETRES UNLESS OTHERWISE SPECIFIED.
 2. ALL LEVELS ARE IN METRES ABOVE PRINCIPAL DATUM.
 3. INFORMATION ON ALIGNMENT OF MAINS IS OF INDICATIVE VALUE ONLY. WHERE POSITIONAL ACCURACY MAY BE OF IMPORTANCE, DETAILS SHOULD BE SITE CHECKED.
 4. FOR MAINS RECORDS SIGN CONVENTIONS AND DESIGNATIONS SEE SKETCH NO. 3988.
 5. NO EXISTING WSD CABLE IN THE VICINITY OF THE SITE.
 6. NO PROPOSED WSD CABLE IN THE VICINITY OF THE SITE.
 7. THE SITE IS NOT WITHIN WSD GATHERING GROUNDS.
 8. NO WSD LAND ALLOCATION / WWR WITHIN THE SITE AREA.
 9. NO WSD SLOPES ARE AFFECTED IN THE VICINITY OF THE SITE.
 10. NO ASBESTOS CEMENT / UNKNOWN MATERIALS MAINS ON THE VICINITY OF THE SITE.
 11. NO CATHODIC PROTECTION MAINS ON THE VICINITY OF THE SITE.

SUBJECT SITE

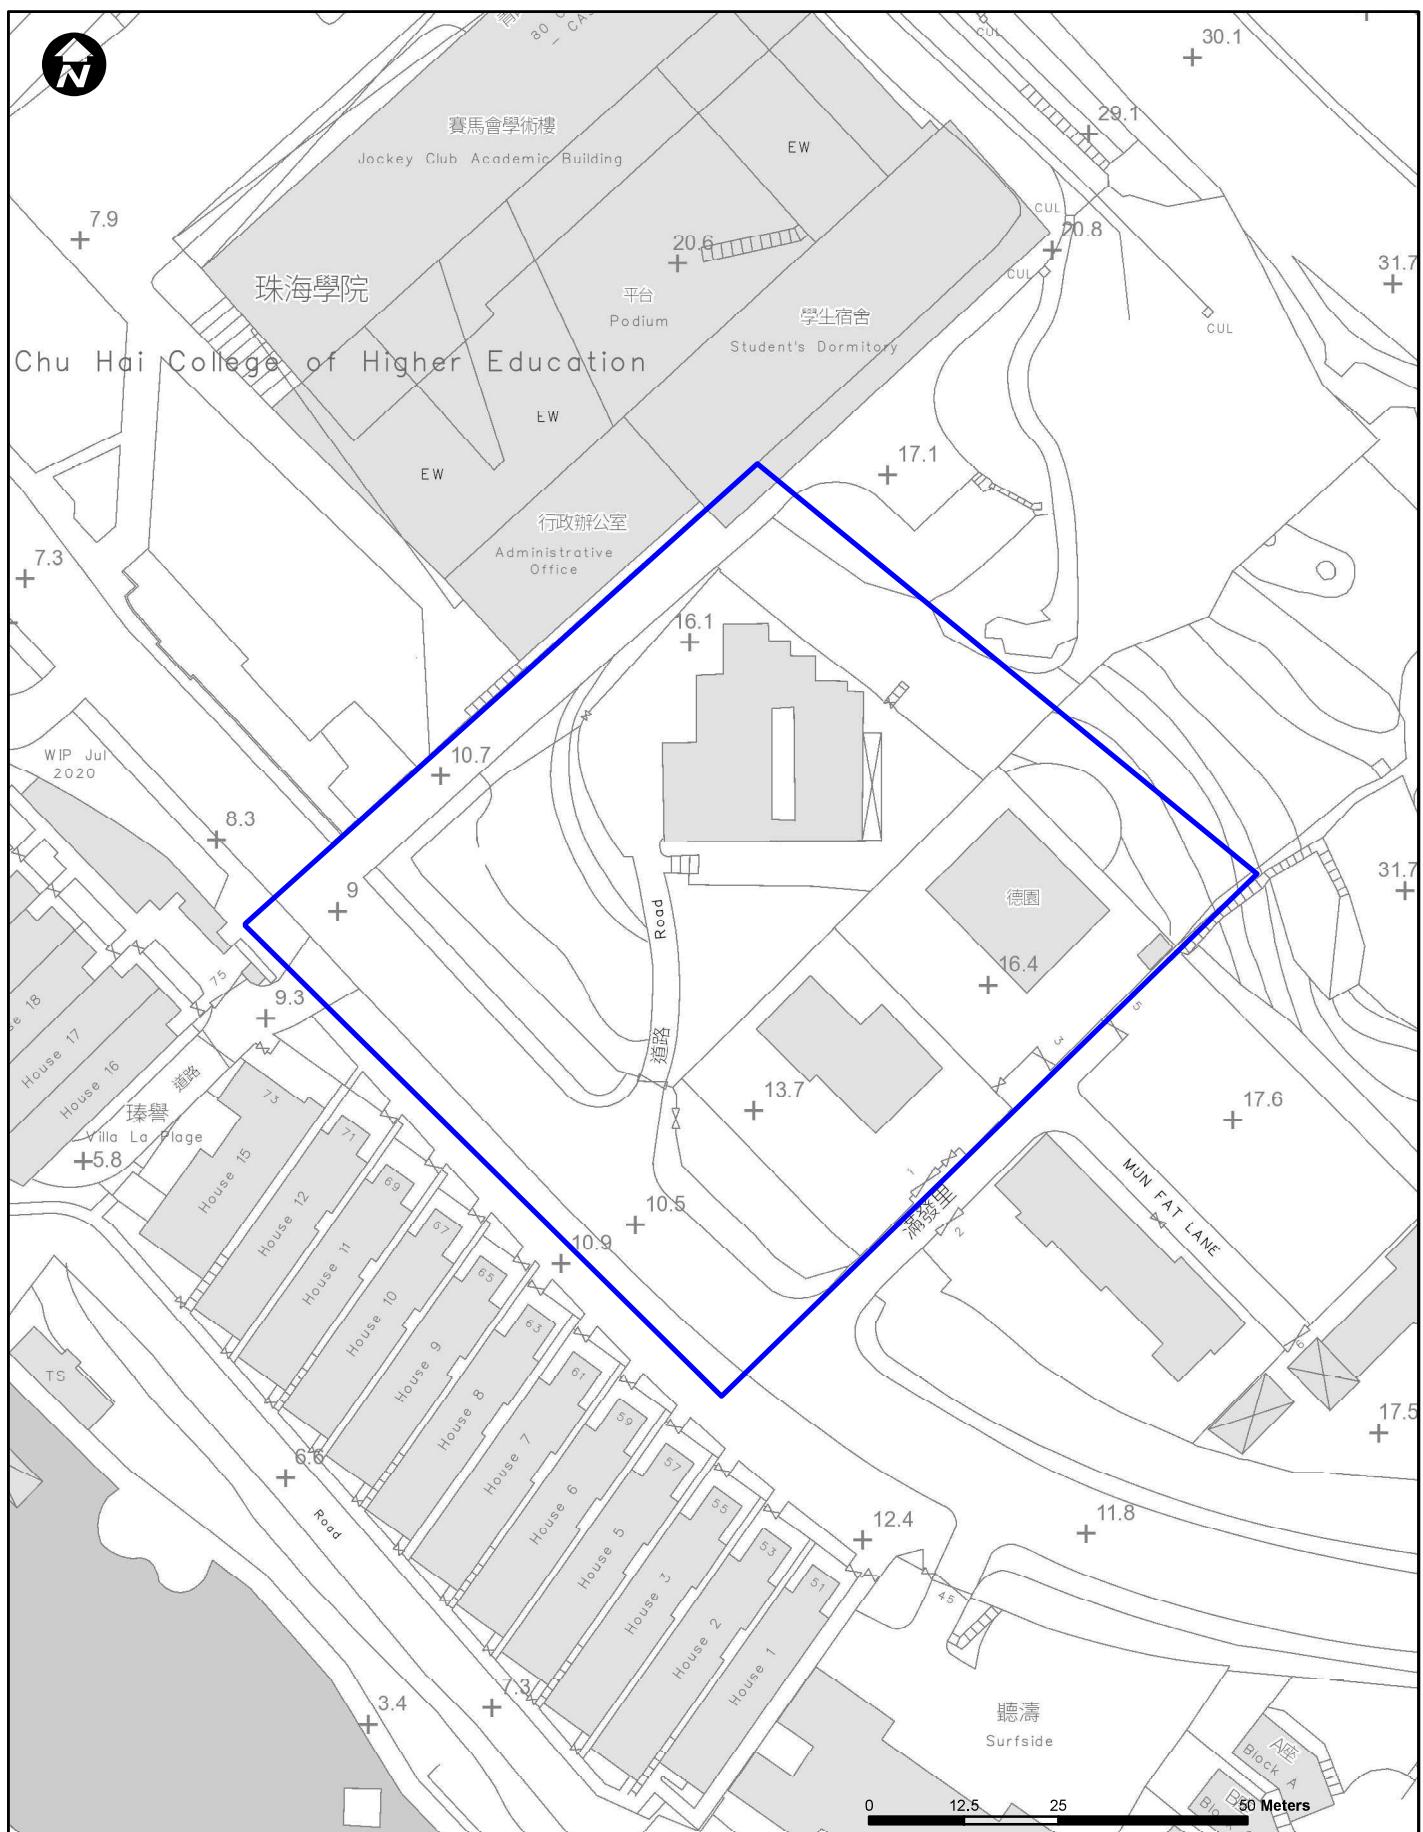
TITLE: Electronic Mark Plant Circulation		PREPARED BY: FONG Kin-wa	MAP : 06SW17A	SCALE: 1:1000
REQUEST ID: HYD-20230811-0001-Q	SHEET NO: 1 OF 1	ENDORSED BY: CHOW Wan-yin, Gilbert	COORDINATES: 816653.11, 826066.71(LL) 816839.67, 826309.63(UR)	
LEGEND :		ISSUED DATE: 11-Aug-2023	TUEN MUN / NT Region	
		OUR REFERENCE: Castle Peak Road - Castle Peak Bay , Area 48 - S for D		Highways Department Hong Kong 香 港 路 政 署

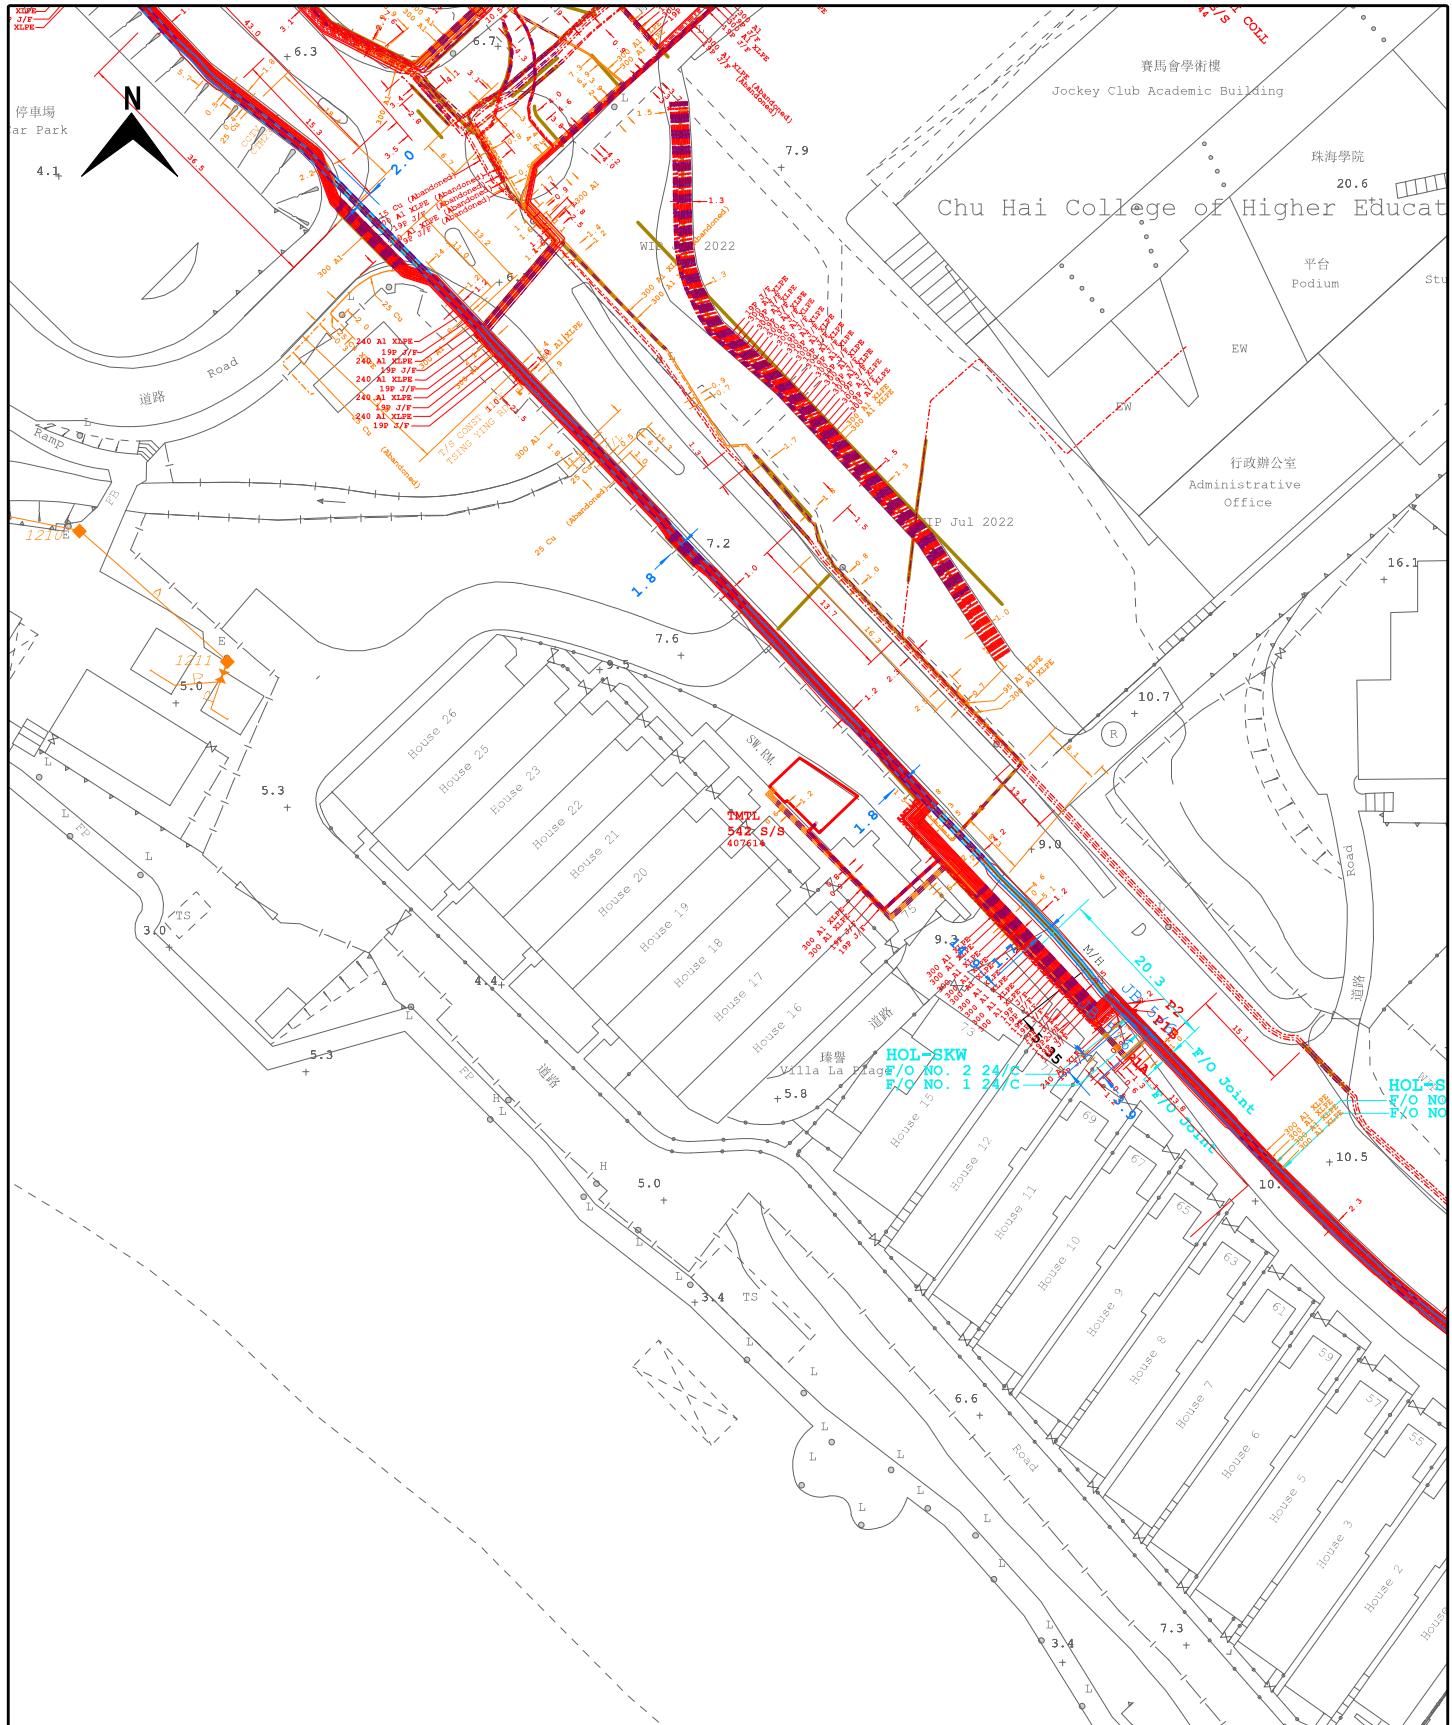
LEGEND	
400KV CABLE / SUBMARINE CABLE / OHL	LOW VOLTAGE CABLE
400KV OVERHEAD LINE TOWER	LOW VOLTAGE OVERHEAD LINE (1 PHASE)
132KV CABLE / SUBMARINE CABLE / OHL	LOW VOLTAGE OVERHEAD LINE (3 PHASE)
132KV OVERHEAD LINE TOWER	LOW VOLTAGE OVERHEAD LINE (ABC/Wall Mounted)
33KV CABLE	LOW VOLTAGE OVERHEAD LINE (PVC)
SUB	AERIAL EARTH WIRE (AEW)
033	PILOT CABLE
33KV OVERHEAD LINE	TEMPERATURE SENSING CABLE (DTS)
ABANDONED TRANSMISSION CABLE	FIBRE OPTIC CABLE
11KV CABLE	OVERHEAD LINE FIBRE OPTIC
SUB	SHALLOW COVER INSTALLATION
11KV OVERHEAD LINE	DUCT LINE
011

ALL LOCATIONS, MEASUREMENTS, DIMENSIONS AND DISTANCES ARE FOR CLP POWER INTERNAL USE ONLY. THEY SHOULD NOT BE SCALED AND ASSUMED ACCURATE. CLP POWER ACCEPTS NO RESPONSIBILITY IN THE EVENT OF ANY INACCURACY. EXTREME CARE MUST BE EXERCISED WHEN WORKING IN CLOSE PROXIMITY TO OUR EQUIPMENT. PLEASE CONTACT OUR REGIONAL OFFICE AS SOON AS YOU ARE READY TO COMMENCE WORK.

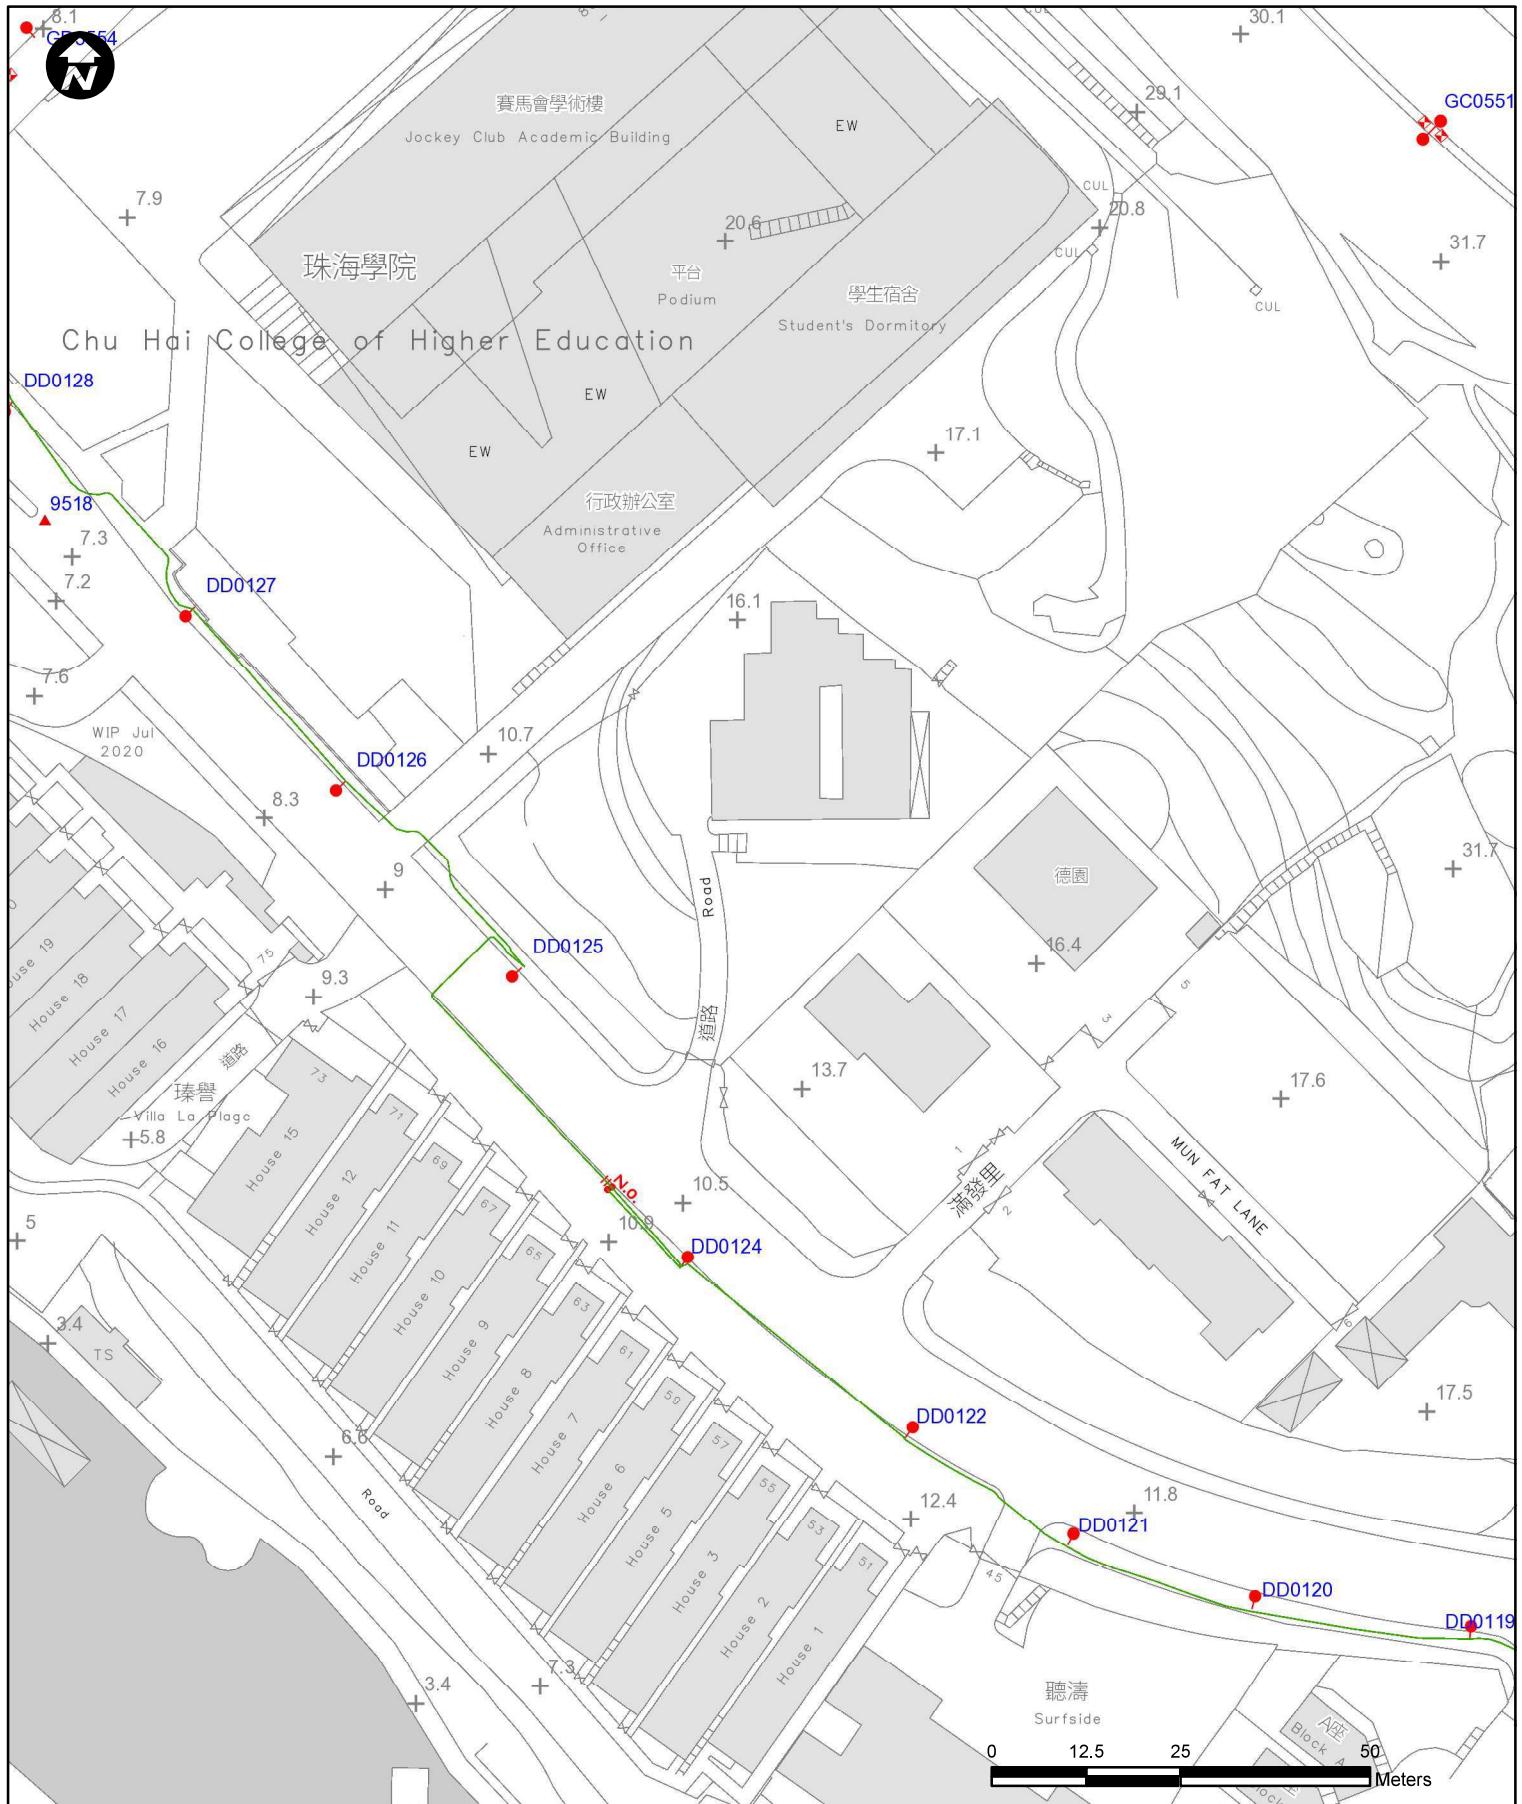
TITLE: PUBLIC LIGHTING INFORMATION

Legend :	OUR REF.: HYD-20230811-0001-R-HYD	SCALE: 1:1000 APPROX.	SHEET 1 OF 1
DISCLAIMER:			
ALL INFORMATION CONTAINED IN THIS DRAWING IS COMPILED FOR GENERAL INFORMATION PURPOSE. THE POSITIONS SHOULD NOT BE SCALED AND ASSUMED ACCURATE AND ALIGNMENTS OF THE EQUIPMENT ARE APPROXIMATE ONLY. THIS DIVISION ACCEPTS NO RESPONSIBILITY FOR ANY LOSS OR DAMAGE WHATSOEVER ARISING OUT OF OR IN CONNECTION WITH ANY INFORMATION ON THIS DRAWING. EXTREME CARE SHALL BE EXERCISED WHEN WORKING IN CLOSE PROXIMITY TO OUR EQUIPMENT.			
<img alt="Existing Public Lighting Cross Road Spare Duct Minimum 900mm

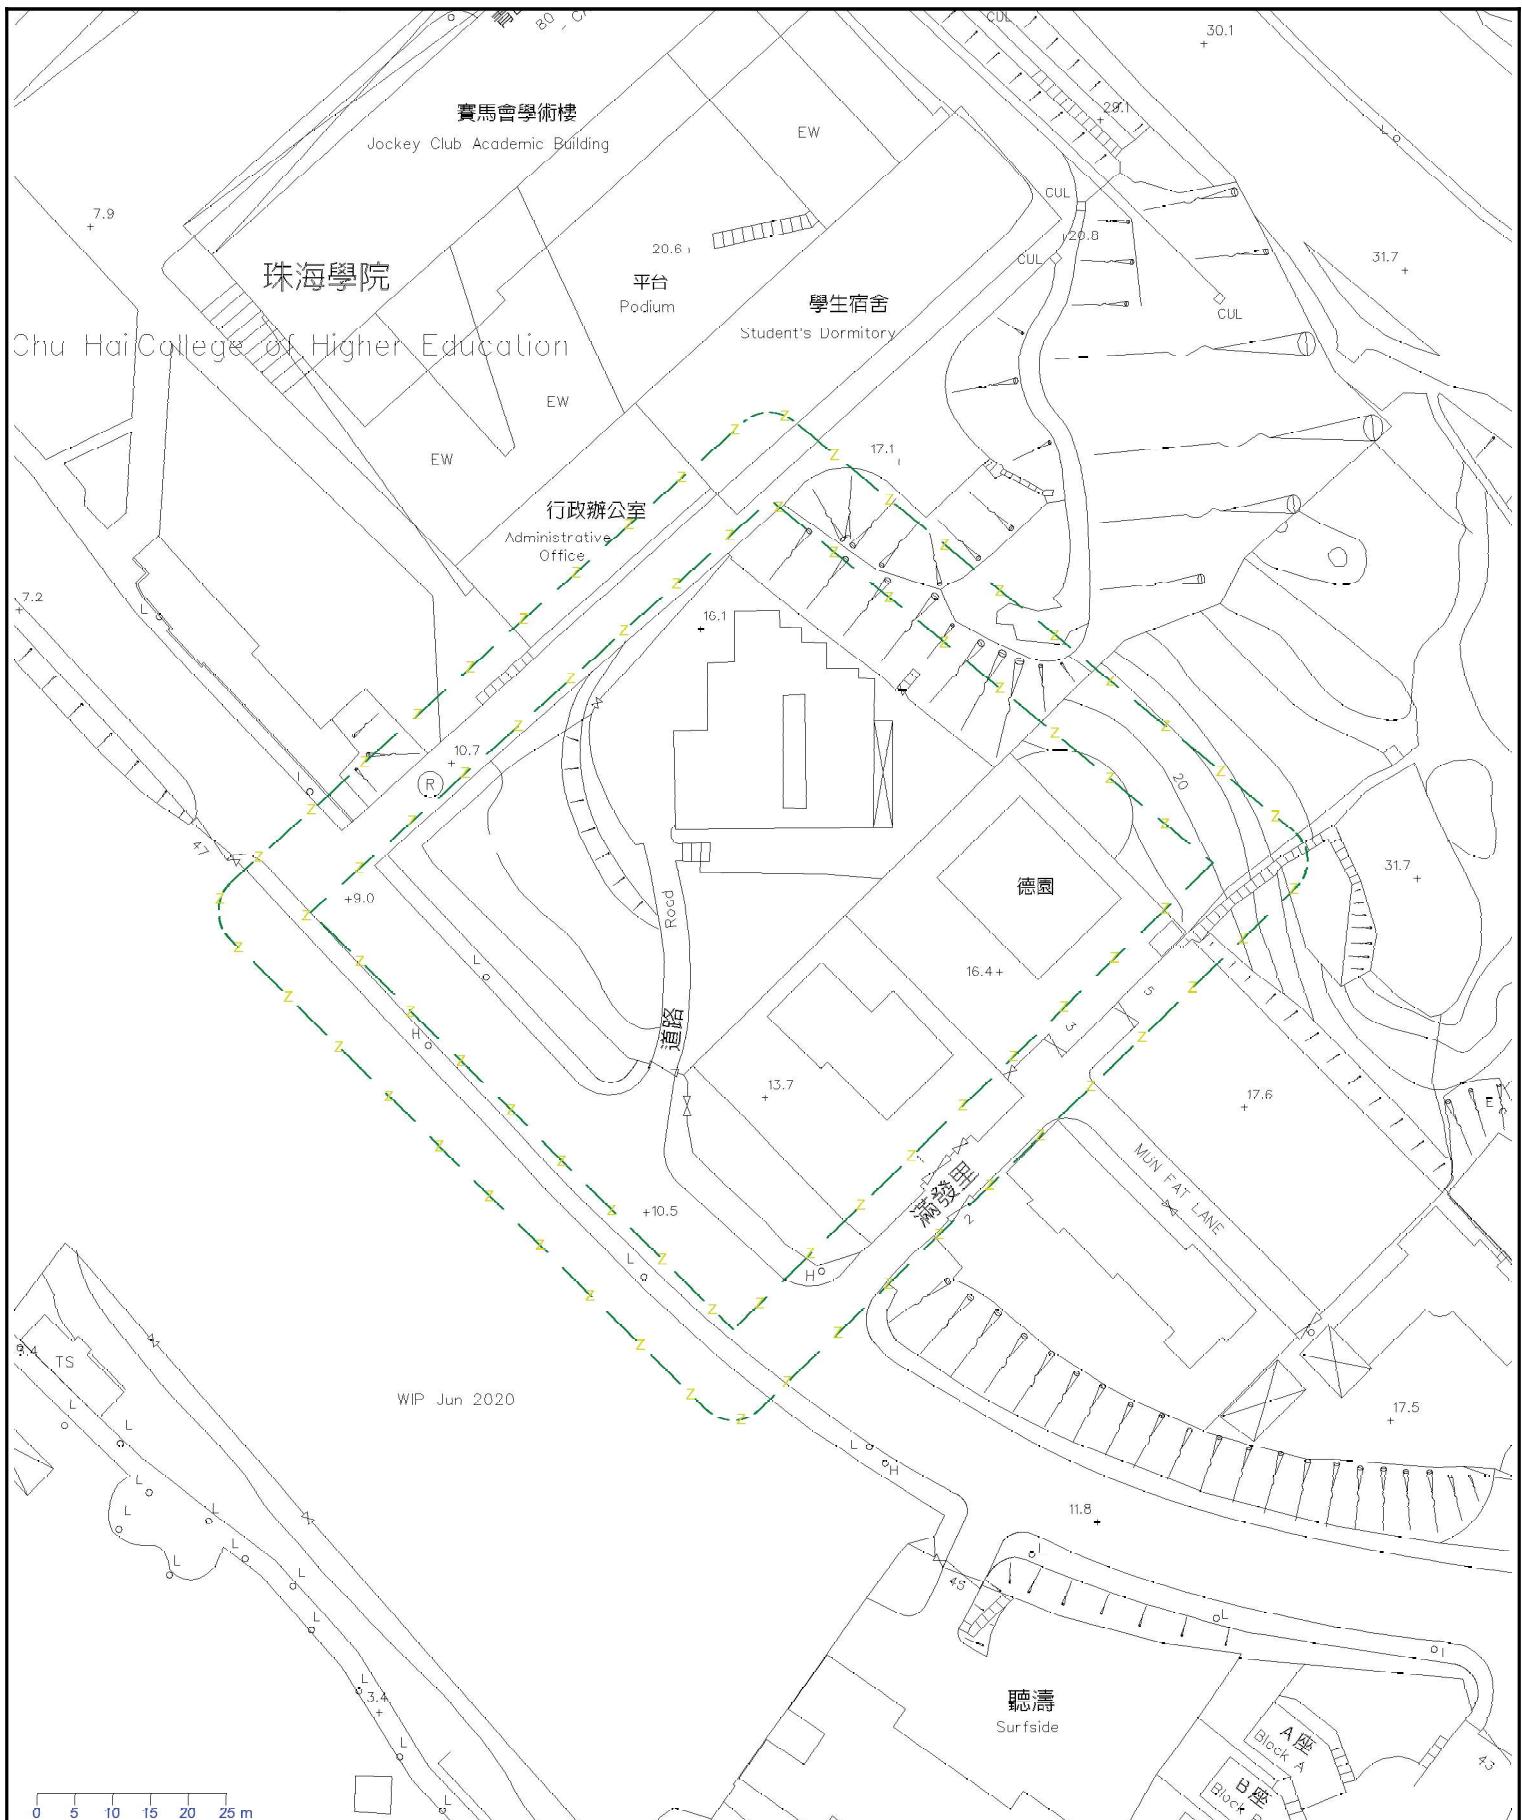
SECTION: NT Operation
REPLY REF.: HYD-20230811-0001-R-TGT

THE ALIGNMENT OF OUR PLANT SHOWN ARE APPROXIMATE AND INDICATIVE ONLY.
THE EXACT LINES AND LEVELS SHOULD BE AS CERTAINED BY HAND DUG TRIAL PITS.
PLEASE TAKE ALL NECESSARY PRECAUTIONS TO AVOID ANY DAMAGE TO OUR PLANT DURING EXCAVATION.

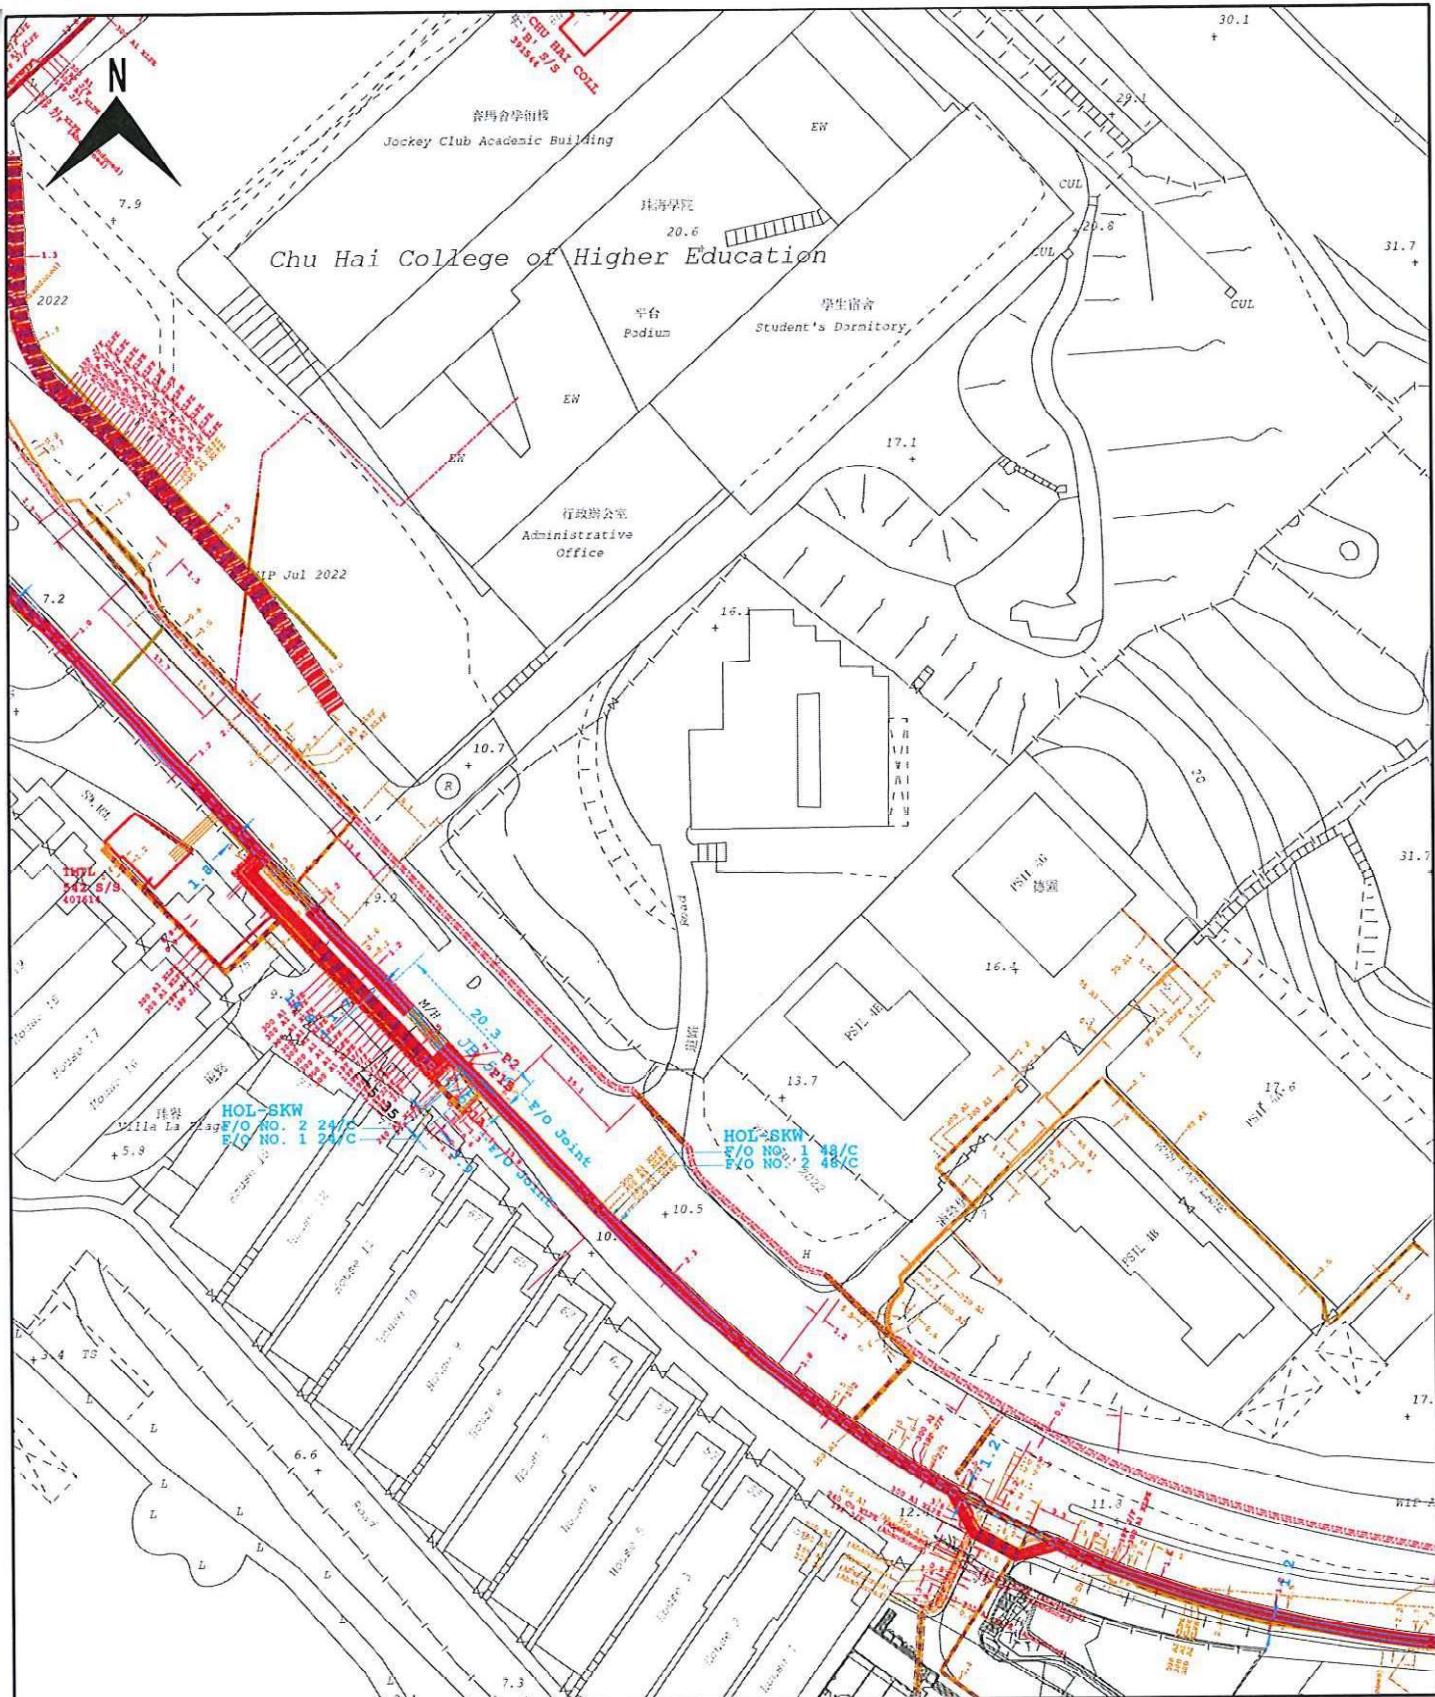
Legend	
—	400kV CABLE / SUBMARINE CABLE / OHL
—■—	400kV OVERHEAD LINE TOWER
—	132kV CABLE / SUBMARINE CABLE / OHL
—■—	132kV OVERHEAD LINE TOWER
—	33kV CABLE
—■—	33kV SUBMARINE CABLE
—○—	33kV OVERHEAD LINE
—	ABANDONED TRANSMISSION CABLE
—	11kV CABLE
—■—	11kV SUBMARINE CABLE
—○—	11kV OVERHEAD LINE

- Encl.: 1. Guidelines For Contractors Working In The Vicinity Of Electricity Cables And Overhead Lines
2. EMSD Reference Document No. NU/26/01
3. Drawing Reference No. : N-2023-1079-001
