活化歷史建築伙伴計劃

第 48 區前哥頓軍營

Watervale House

資料冊

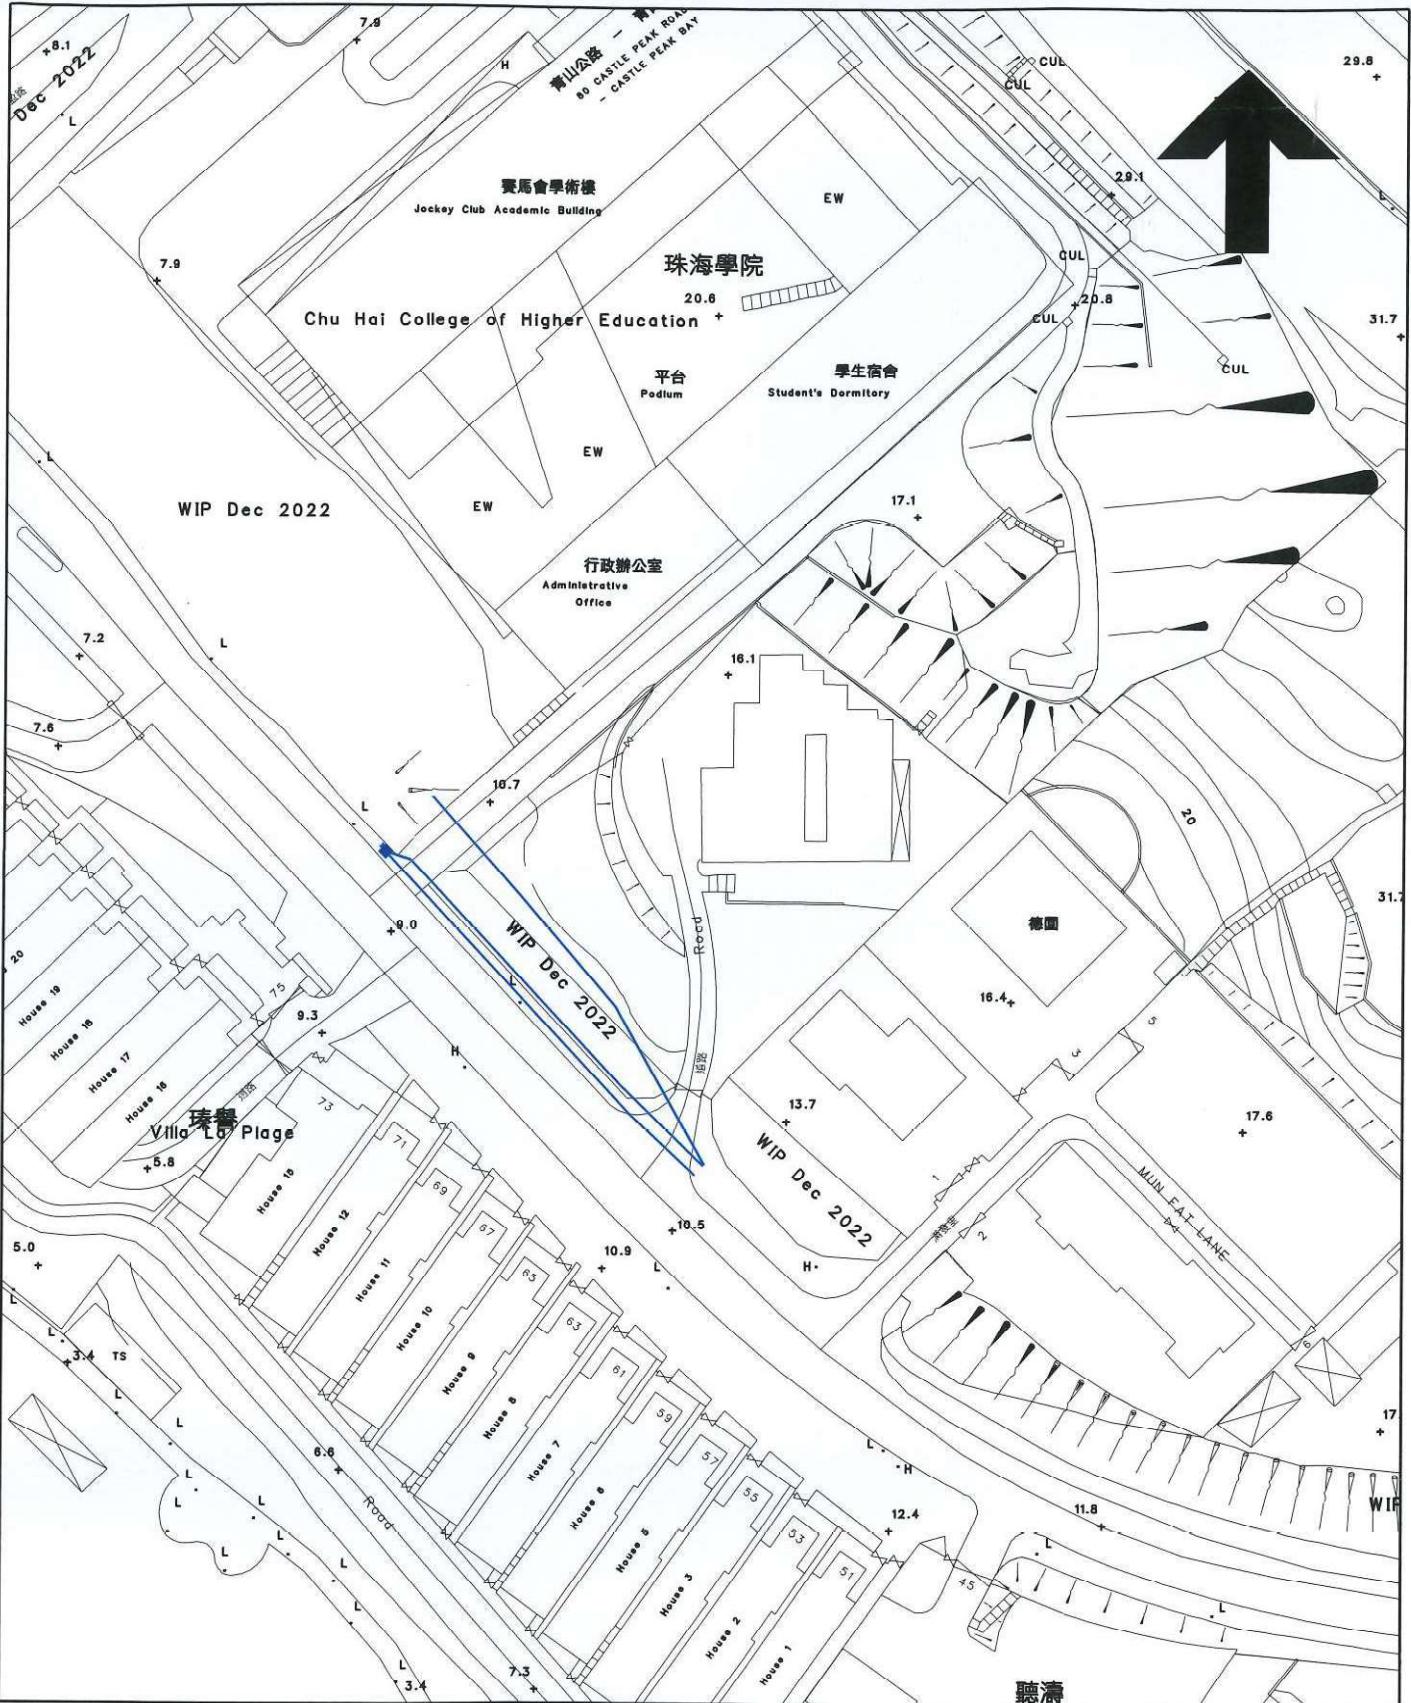
1. THE POSITION OF PLANT INDICATED ON THIS DRAWING IS APPROXIMATE ONLY.
2. THE DEPTH OF OUR EXISTING PLANT MAY VARY DUE TO UNDERGROUND OBSTRUCTIONS.

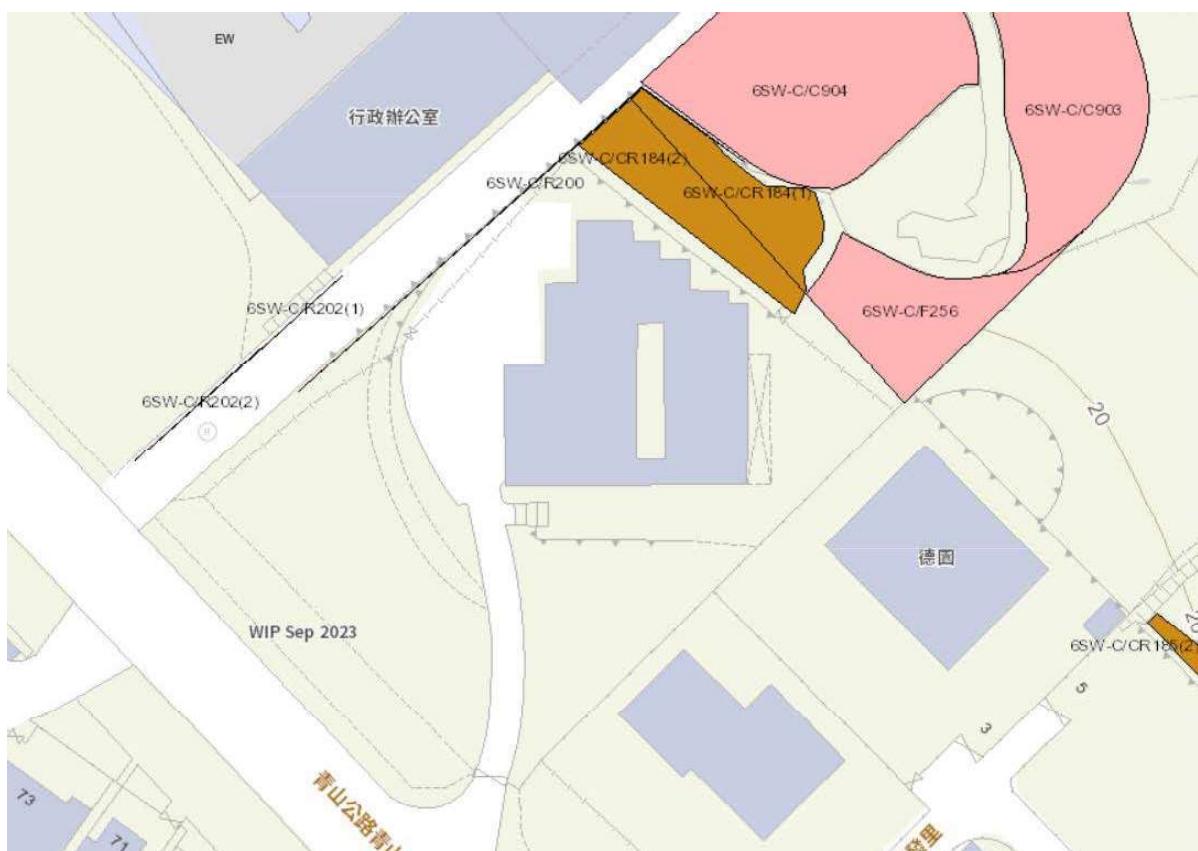
附錄 XVI
用地界線內或附近的斜坡

斜坡編號:	6SW-C/CR184
斜坡分段編號:	2
地點:	部分位於屯門市地段第558號餘段內，部分位於政府撥地 - 屯門第521號內 及 部分在未批撥的政府土地上
負責地段/負責方:	發展局
維修代理人:	建築署

斜坡分佈概覽:
