UNDERSTANDING

2 UNDERSTANDING

2.1 Ownership and Management

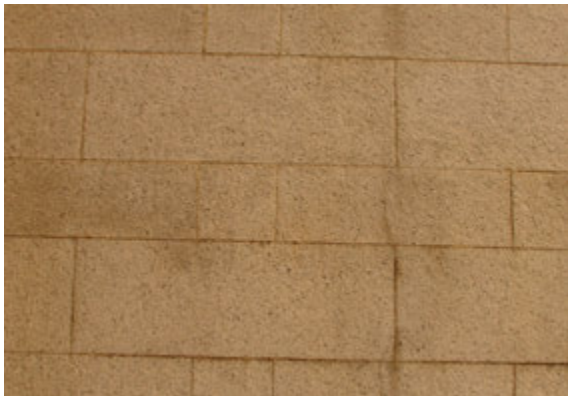
Granite cladding

Areas of granite cladding can be found to all the CGO buildings, although as an expensive material it tends to be used within the public areas of the site. It is laid in a variety of patterns, although the most prevalent type tends to be courses of alternate headers and stretchers followed by courses of larger stretchers.

There were historically a number of quarries within Hong Kong, as evidenced by place names such as *Stonecutter Island* and *Quarry Bay*. Originally the granite on the site came from Grampian Road Quarry, close to the old Kai Tak airport. When this closed a close match had to be found elsewhere; granite for the 2nd and 3rd phases possibly came from the Diamond Hill Quarry. The relative expense of the material is evidenced by the fact that it is replaced with ceramic tiling on the Main Wing Annexe extension, constructed c. 1989.

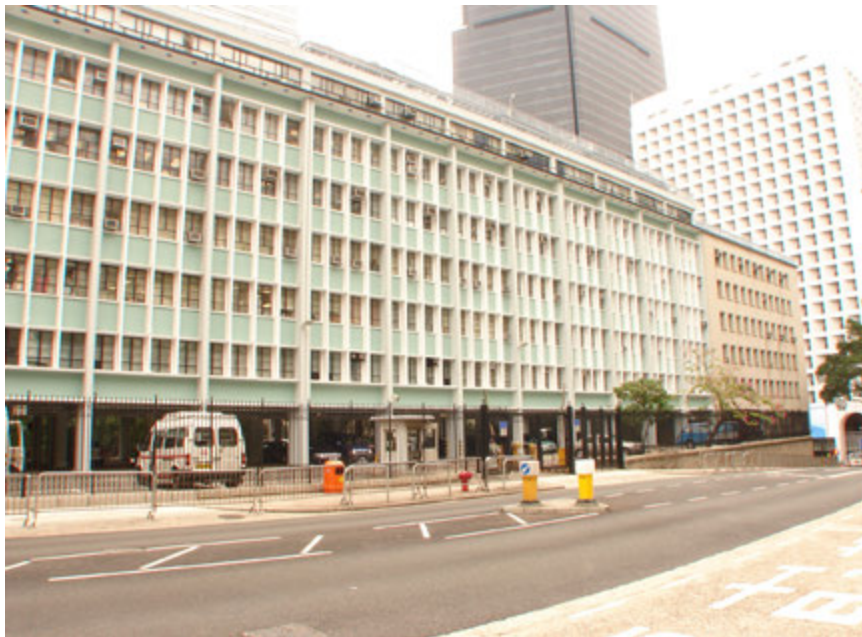
The main central section and the eastern section of the East Wing, elevation 1

Each is of 8 lights (2 vertical rows of 4), the top 6 of which are contained within side-hung casements (3 to each). The two bottom panels are fixed; many of these have been altered to allow for retro-fitting of air conditioning units.

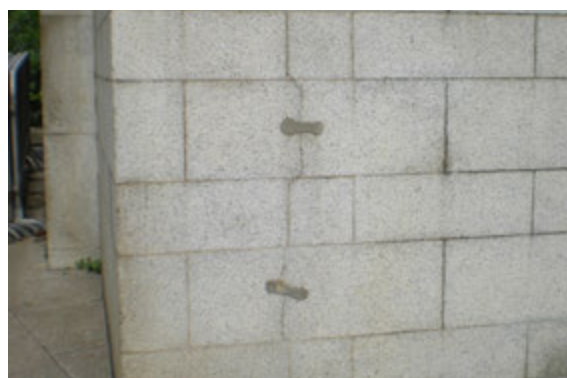
Cracks in the granite walling

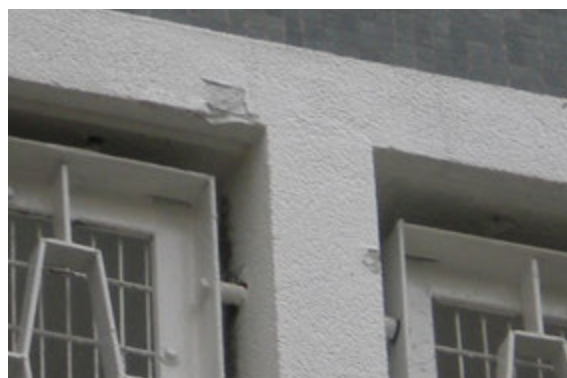
Spalling to the concrete of the Central Wing

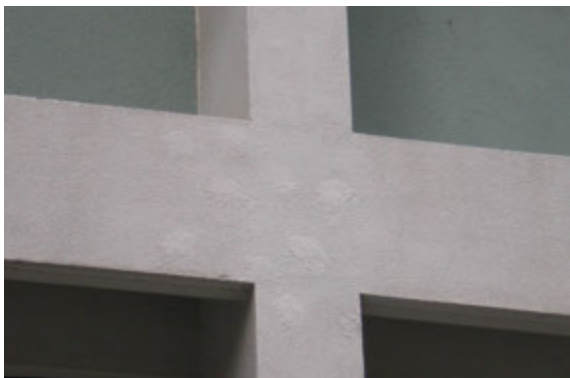
Concrete repairs on the West Wing

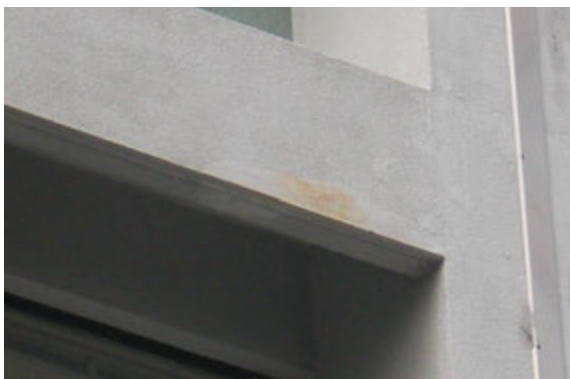
Staining on the West Wing

The design of the exposed frame, with deep horizontal ledges, means that the elevation is subject to staining to the front faces from water run-off. This is once again apparent despite the recent redecoration.

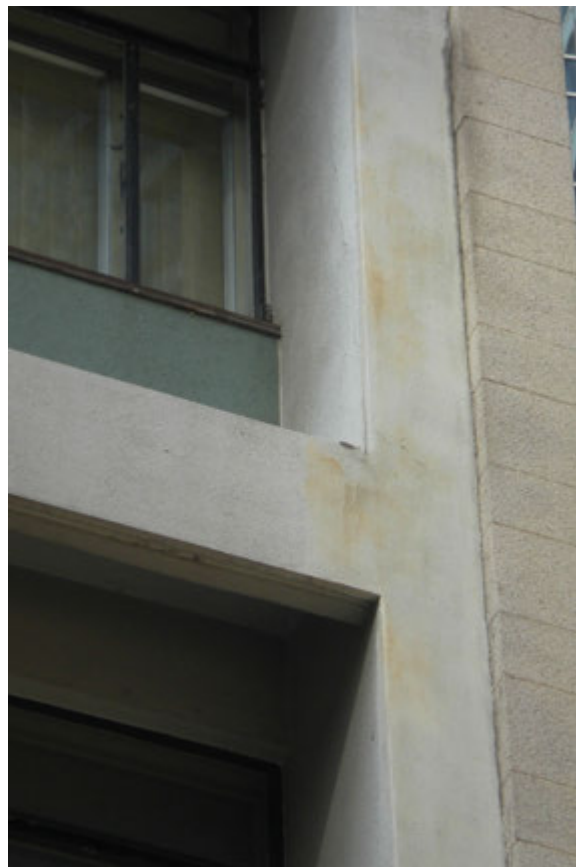
Staining on the West Wing

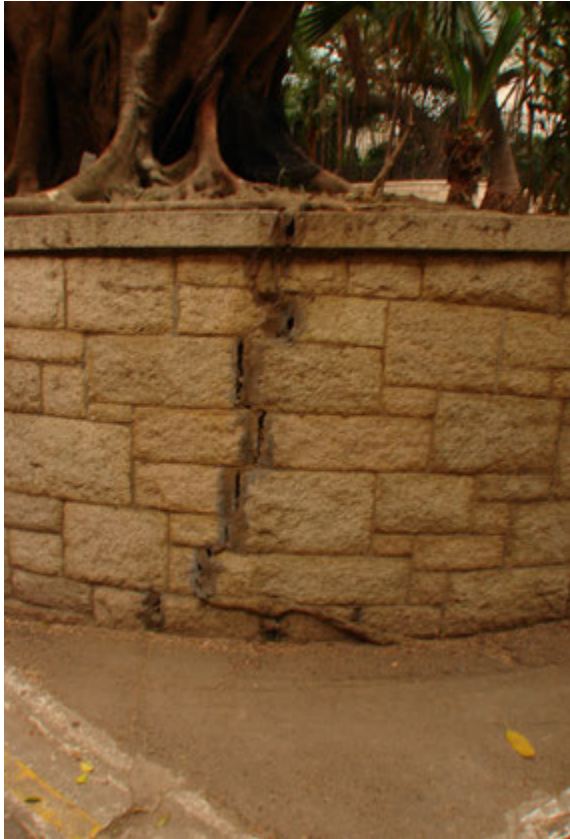
A large crack in a retaining wall for a flower bed

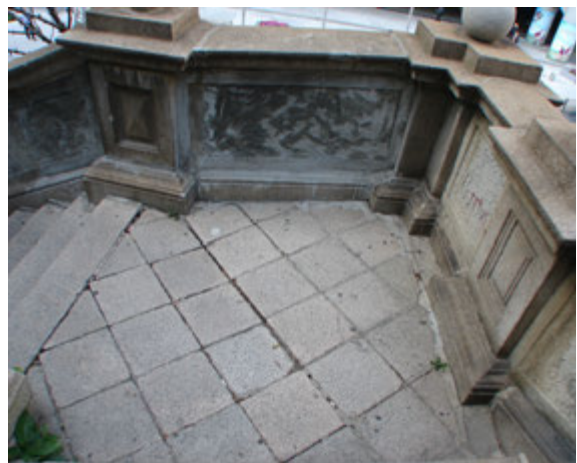
Concrete repairs and gaps in the paving of the Battery Path steps

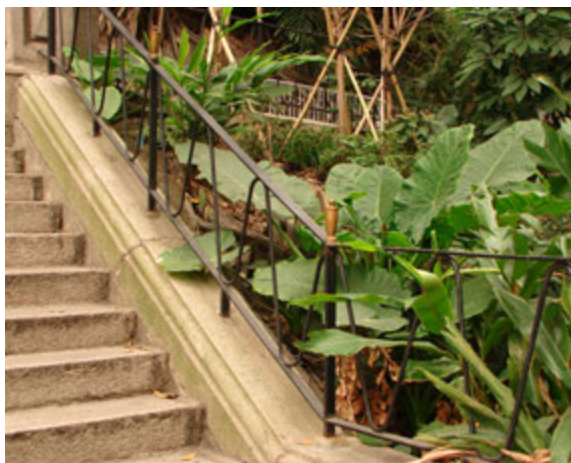
Wave pattern railings from the 1950s

There are two different designs of railings on and around the CGO site. The first is a waist height iron railing with wave pattern bars and gilded gold finials on each main upright. These railings were designed and installed when the CGO were constructed in the 1950s. Examples of this type of railing can be found along Battery Path and beside the northern driveway leading into the CGO Complex.

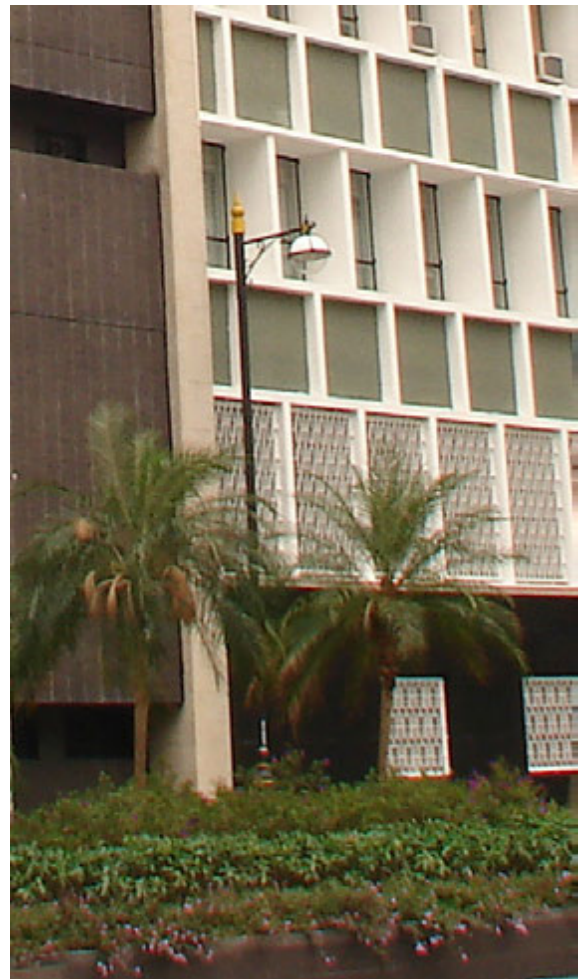
A lamp post outside the Central Wing

Within the compound is another lamp post outside the Central Wing which has a different design. The plain post is also topped by a gold finial but the globe shaped lamp hangs off to the side from a projecting bar which is supported by a decorative brace.
